# Mythe Medium WAZ – Phase 2 Gloucester

Archaeological Watching Brief

## **Mythe Medium WAZ – Phase 2, Gloucester**

### **Archaeological Watching Brief**

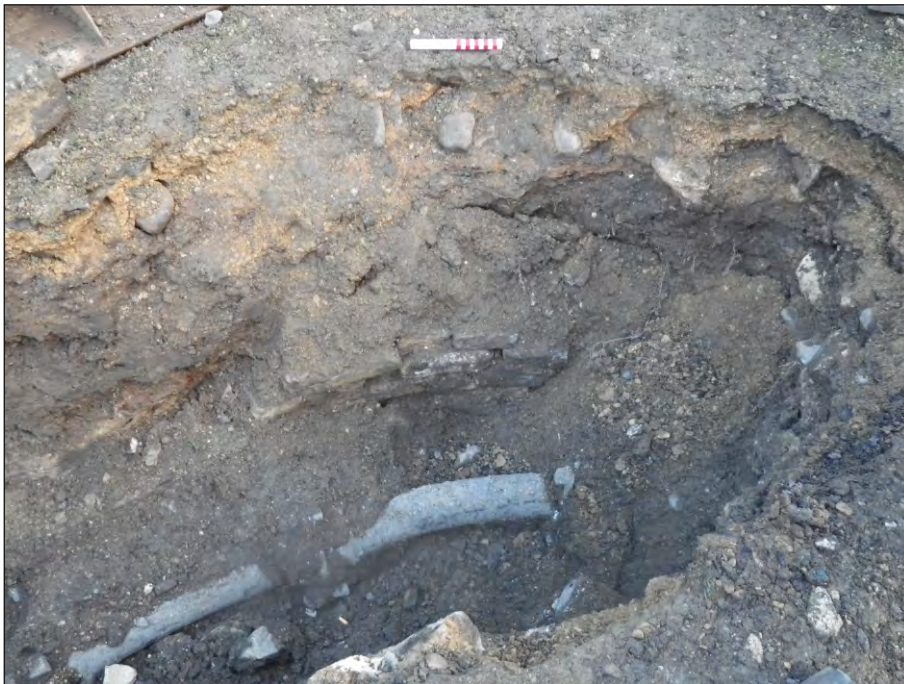
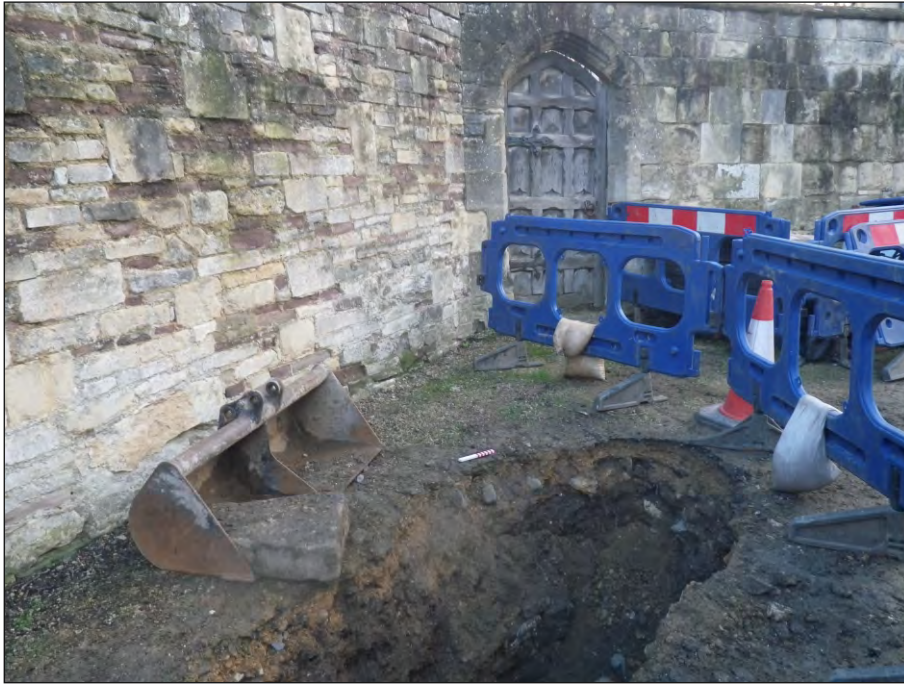
Plate 2: Wall 304 in trench 3 (Heritage Zone 1), camera facing north-east

Plate 3: Wall 304 in trench 3 (Heritage Zone 1), camera facing north-east

- 4.2.3 Trench 3 was located in between the Junior and Senior houses of the King's School, Gloucester. It measured 2.9 m long by 1.1 m wide and was dug to a depth of 1.18 m. The basal deposit within trench 3, recorded at 1.05 m–1.18+ m below ground level, was a dark grey brown sandy clay (305) found to contain 18th-century pottery and oyster shell. A c. 1 m length of wall could be seen in the northern side of the trench, running on a broadly east–west alignment and extending from 0.61 m to 1.05 m below ground level (bgl) (Pl. 2). The wall (304) stood at least four courses high and comprised rectangular dressed stone blocks, individually approximately 0.2–0.3 m long. A layer of dark grey clay (303) was recorded in association with the wall, although it was not possible to determine a relationship between that it and wall 304. A yellowish, sandy aggregate preparation layer (302) and the modern ground surface (301) complete the deposit sequence within trench 3.

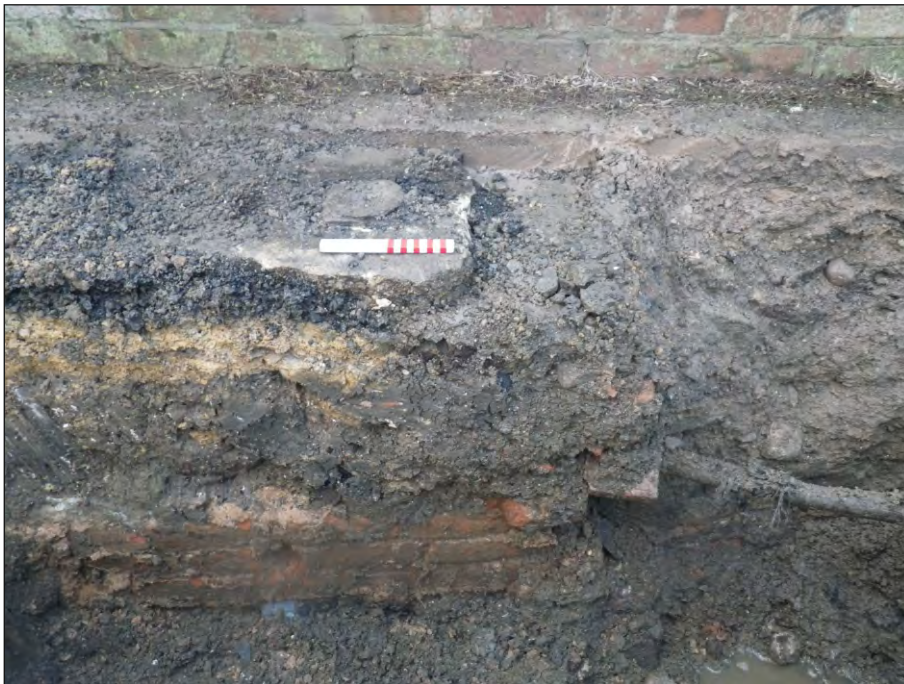
Plate 4: Wall 1205 in trench 12 (Heritage Zone 1), camera facing west

- 4.2.6 Trenches 11 and 12 were eventually contiguous, formed a right-angle in plan and lay in the roadway on the western (trench 11) and southern (trench 12) sides of the grassed area encircling the Royal Gloucestershire Hussars Yeomanry war memorial. The basal deposit within trench 11 was a mid-grey clay (1106), encountered at 0.72–1.25 m bgl and found to contain clay tobacco pipe fragments, medieval and post-medieval pottery, and oyster shell fragments. This was overlain by a 0.07 m thick layer of pale grey ash (1105), which was in turn sealed beneath a 0.23 m thick layer of dark grey brown sandy clay representing the backfill of the existing pipe trench. This was sealed beneath a modern aggregate preparation material and layers of tarmac (1103, 1102 and 1101).

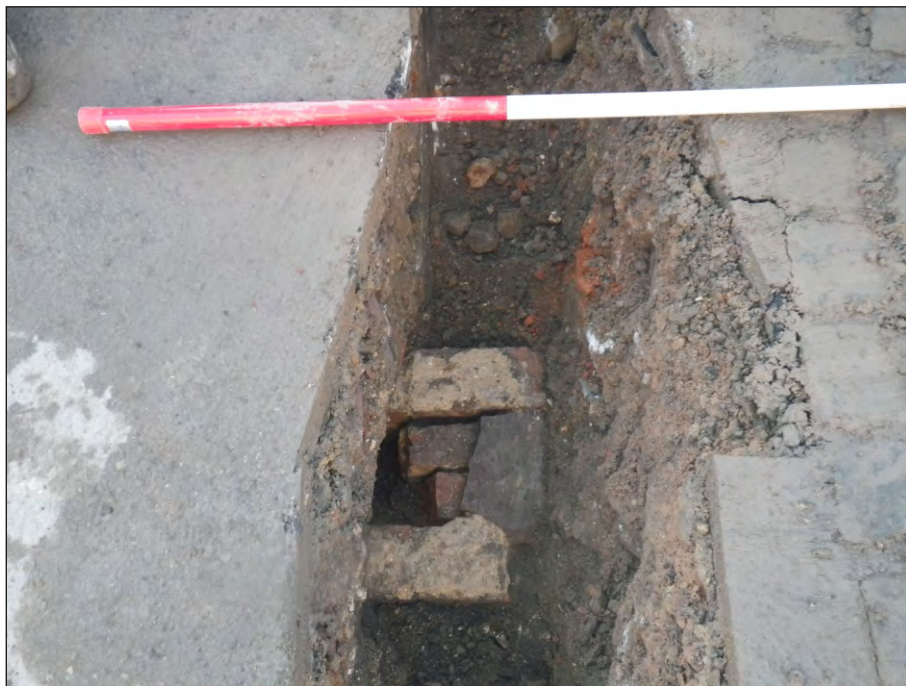
Plate 6: Drain 1906 in trench 19 (Heritage Zone 1)

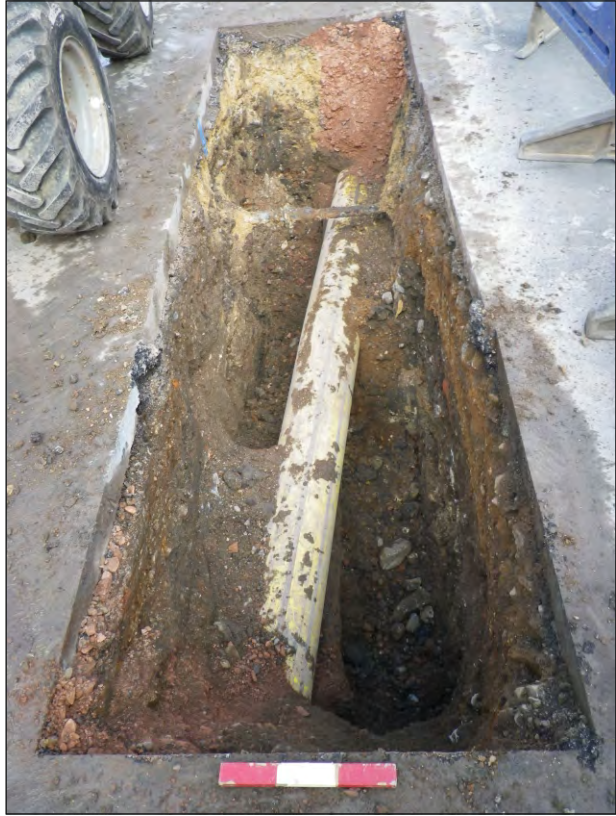
Plate 7: Trench 136 in Heritage Zone 3, camera facing north

- 4.4.6 The results of the watching brief were in Heritage Zone 3 were largely negative; remains of archaeological significance were only recorded in trenches 130 and 139. Plates 7–9 show a representative selection of the sterile trenches within Heritage Zone 3.

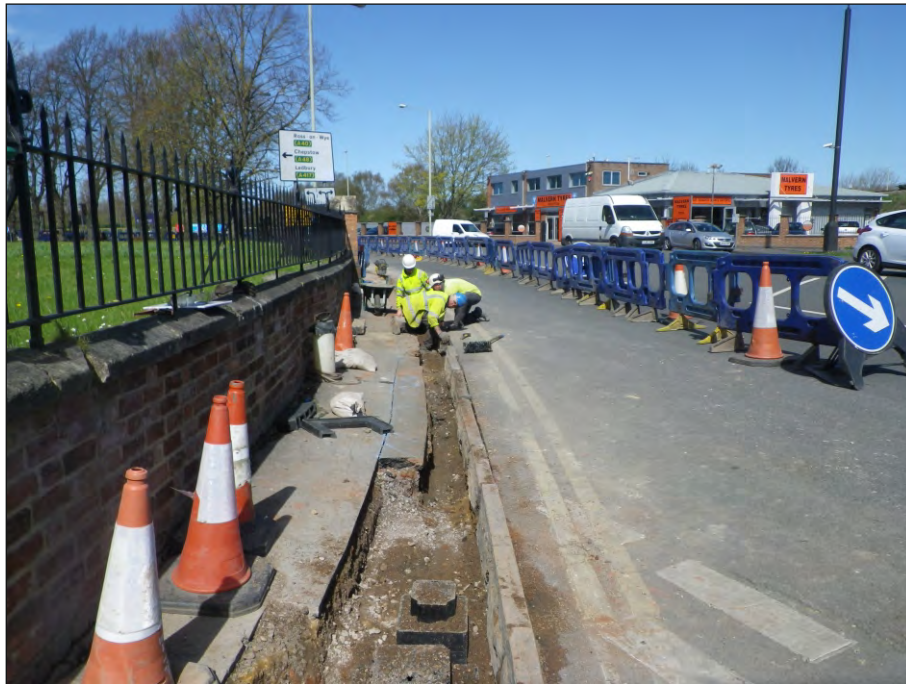
Plate 11: Trench 139 in Heritage Zone 3, camera facing west

- 4.4.9 Trench 139 extended for approximately 50 m, following the footpath separating Priory Road from the open ground surrounding St. Oswald's Priory (Plate 11). The trench was relatively narrow (0.4 m) relative to its length and attained a maximum depth of 0.80 m. The soil profile within the trench sides was variable, but typically comprised a basal deposit of dark brown silt loam (13903; 0.12–0.70 m), overlain by modern yellow aggregate (13902; 0.08–0.12 m bgl), overlain in turn by the modern tarmac ground surface (13901).

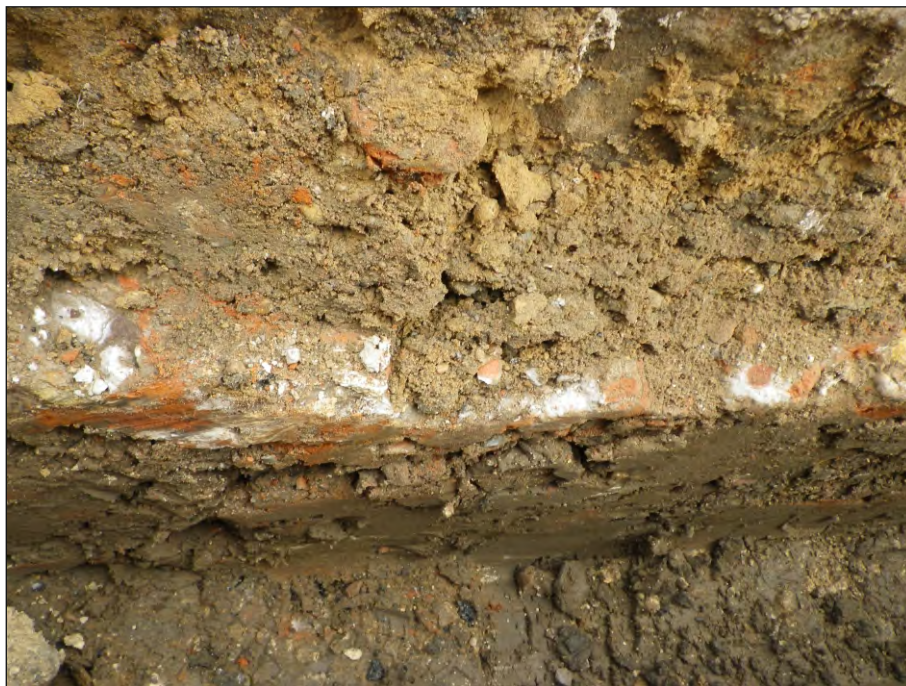
- 4.4.10 A short length of brick wall was seen in the northern trench wall, towards the eastern end of the trench. A single course of bricks survived; the structure followed the alignment and lay beneath the modern kerbstones separating Priory Road from its flanking footpath (Plate 12). The wall appears to be post-medieval but its full form and function could not be discerned.

Plate 12: Wall in trench 139 (Heritage Zone 3), camera facing north-east

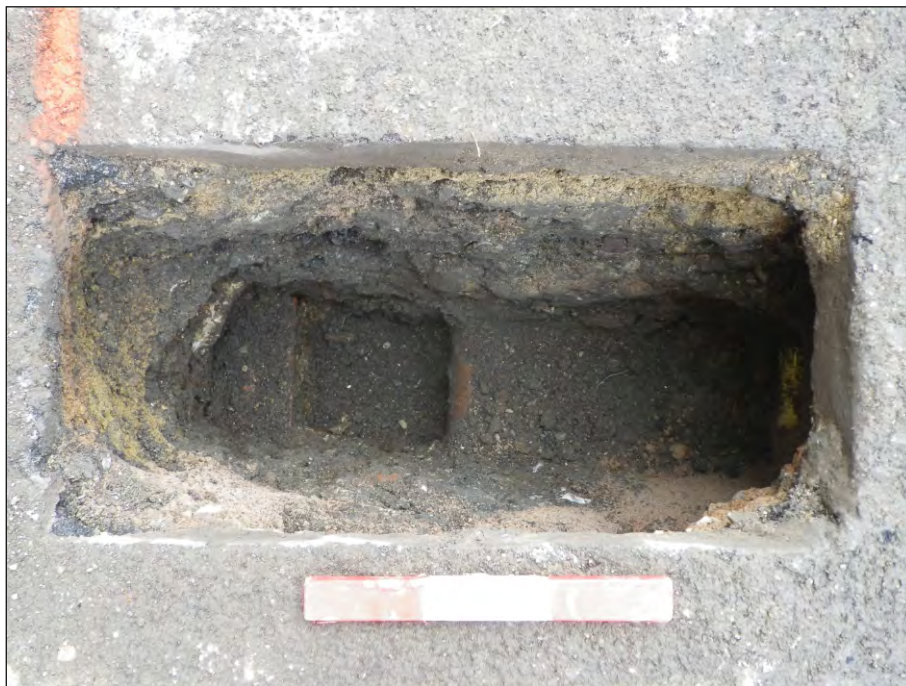
Plate 14: Trench 105 in Heritage Zone 4

- 4.5.3 The results of the watching brief were in Heritage Zone 4 were entirely negative, with no remains of archaeological significance recorded. Pottery of late 19th to early 20th-century date was recovered from trenches 104, 106 and 112. Plates 13–15 show a representative selection of the sterile trenches within Heritage Zone 4.

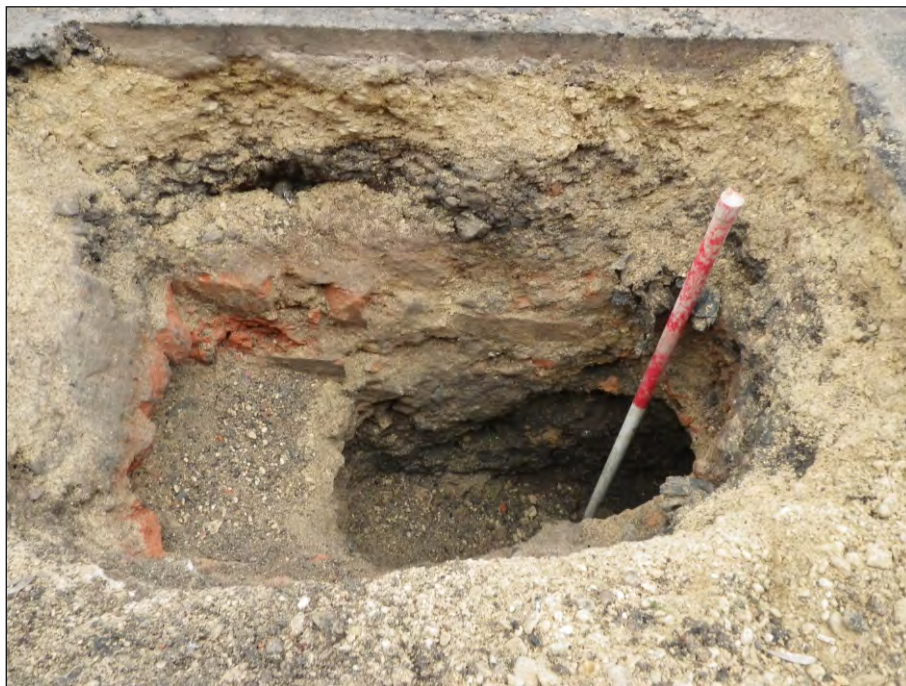
Plate 20: Brickwork 3304 in trench 33 (Heritage Zone 5), camera facing south-west

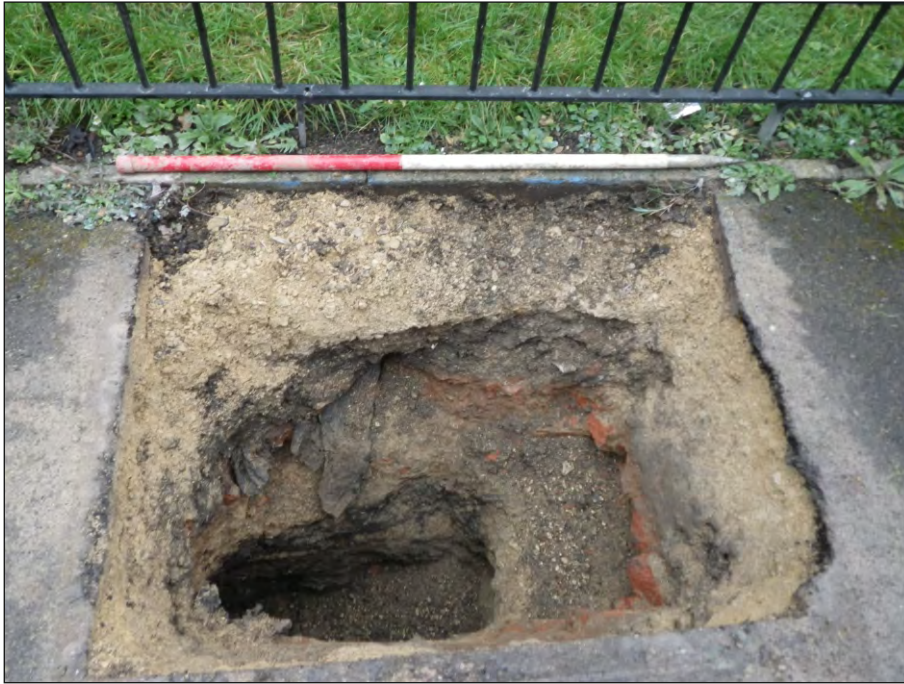
Plate 21: Brickwork 3304 in trench 33 (Heritage Zone 5), camera facing north-east

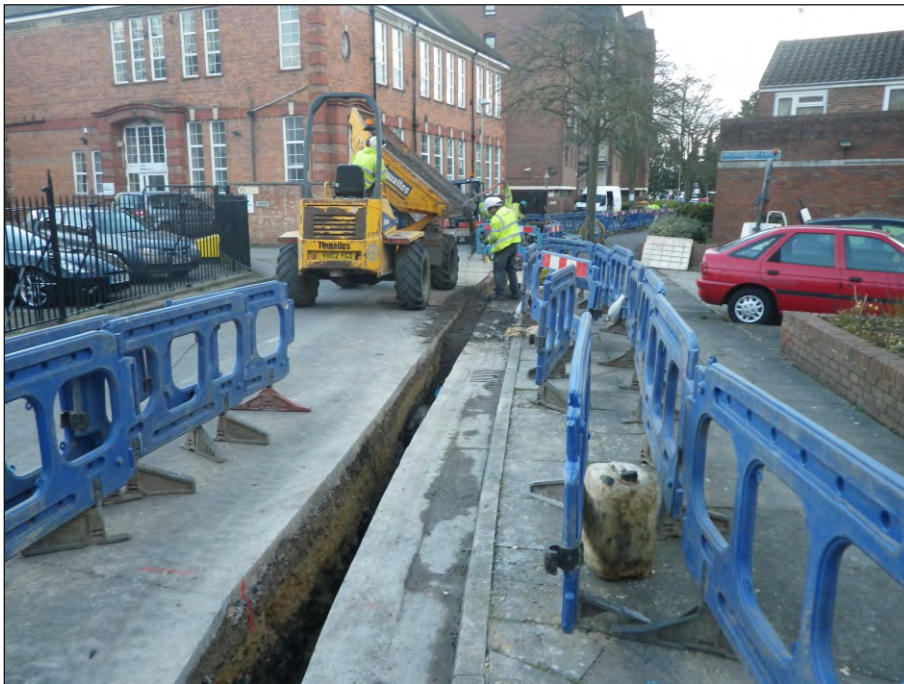
Plate 22: General view of trench 39 in Heritage Zone 5, camera facing north-west

- 4.6.7 Trench 39 was excavated along the length of much of Clare Street and measured over 100 m long by 0.3 m wide, and was typically dug to a depth of 0.9 m bgl (Pl. 22). The composition of deposits was variable along the length of the trench. A buried tarmac road surface was visible within the trench walls at 0.07 m bgl for a stretch of the trench to the south of Archdeacon Court. This may represent the road which served the 19th-century housing. No other archaeological remains were noted in trench 39, although its narrow width in proportion to its depth constrained visibility.

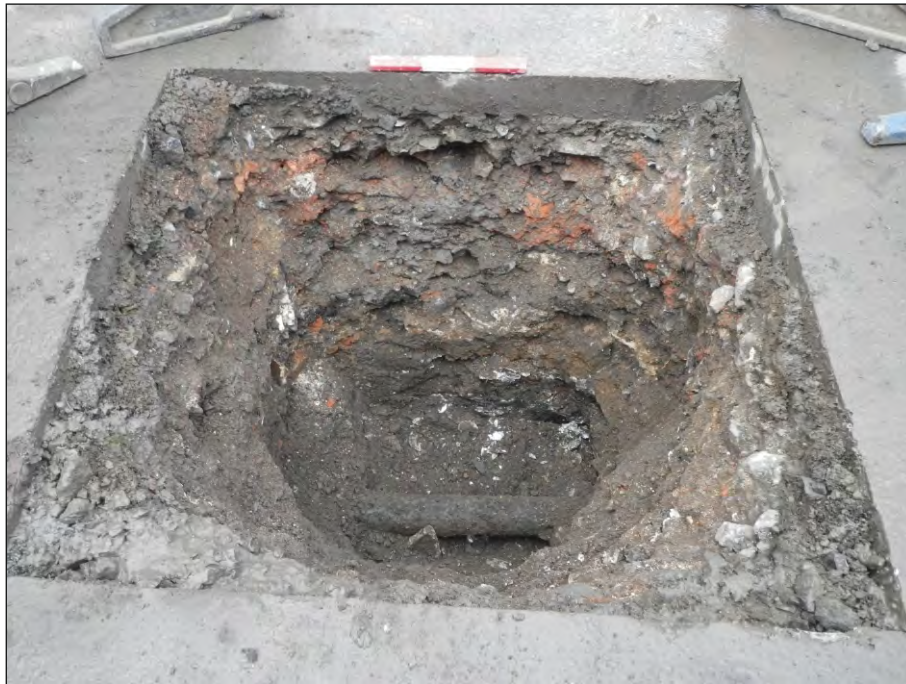
- 4.6.3 The results of the watching brief were in Heritage Zone 5 were, once again, largely negative, with no remains of archaeological significance recorded in the great majority of the trenches. Deposits encountered in these trenches largely comprised undated basal dark soils, backfill of service trenches, modern aggregate levelling and tarmac. Plates 16–19 show a representative selection of the sterile trenches within Heritage Zone 5. Archaeological remains were recorded in twelve trenches, and comprised either surfaces/structures (trenches 33, 36, and 39) or dark soil deposits containing animal bone and/or artefacts of post-medieval–modern date (trenches 47, 50, 57, 62, 63, 64, 65, 69 and 74).

Plate 23: Deposit 4703 in trench 47 (Heritage Zone 5), camera facing north-west

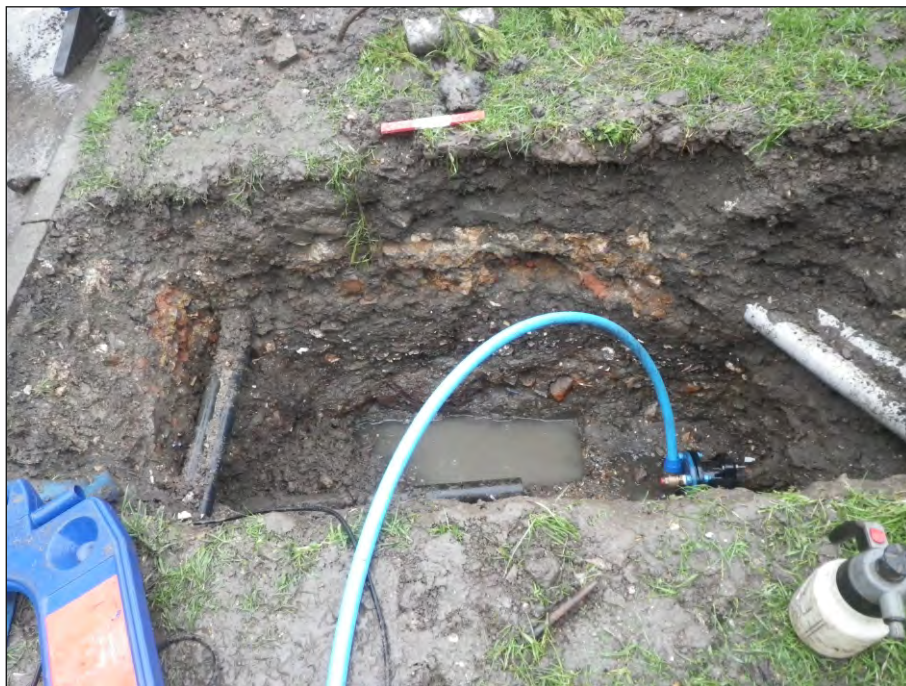
Plate 24: Deposit 5003 & 5004 in tr 50 (Heritage Zone 5), camera facing north-west

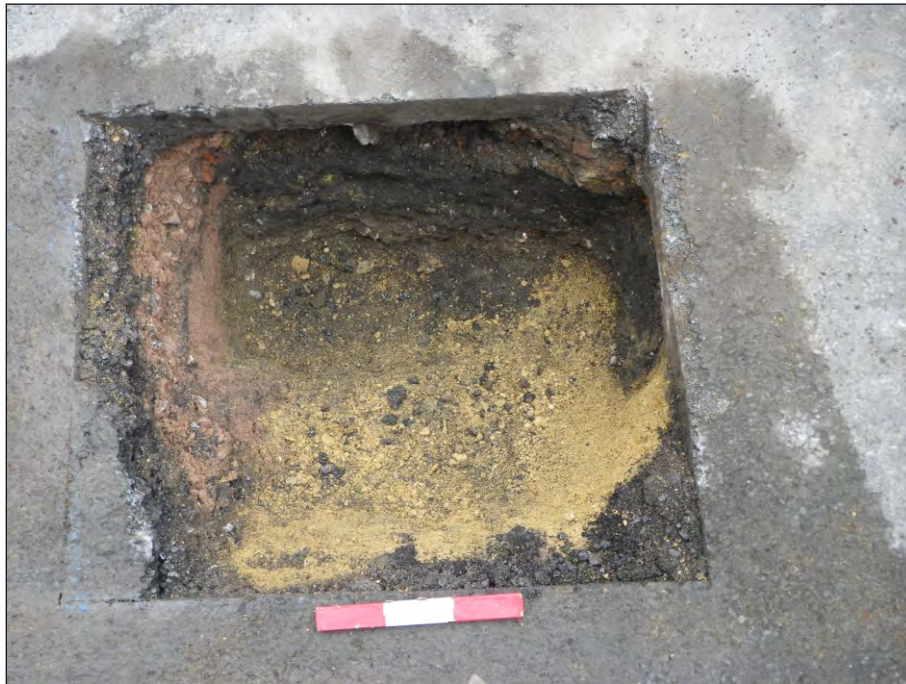
Plate 25: Deposit 6204 in trench 62 (Heritage Zone 5), camera facing west

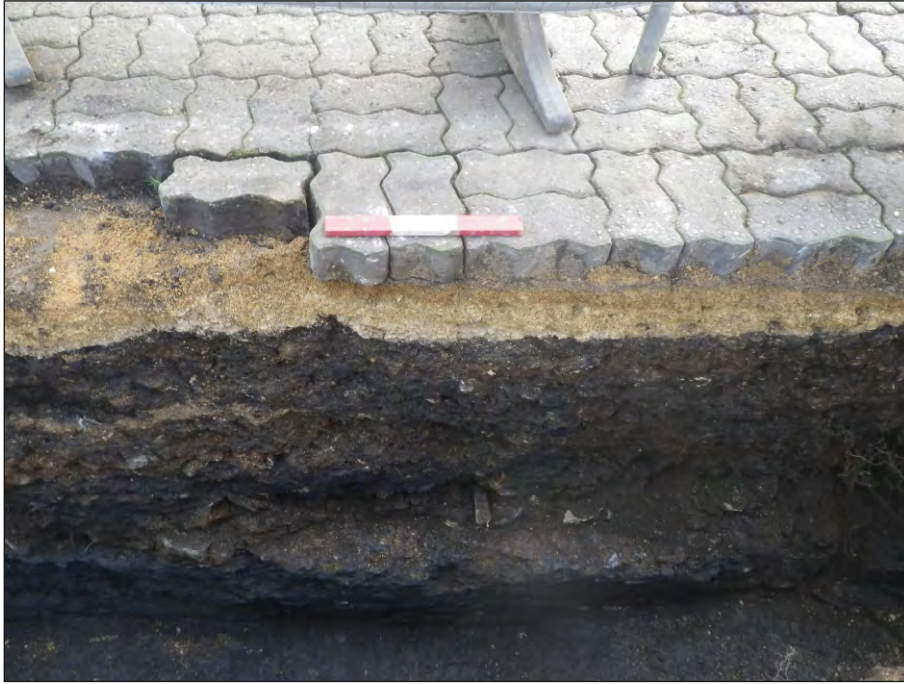
Plate 29: Deposits 8016–20 at the SW end of trench 80, camera facing south-east

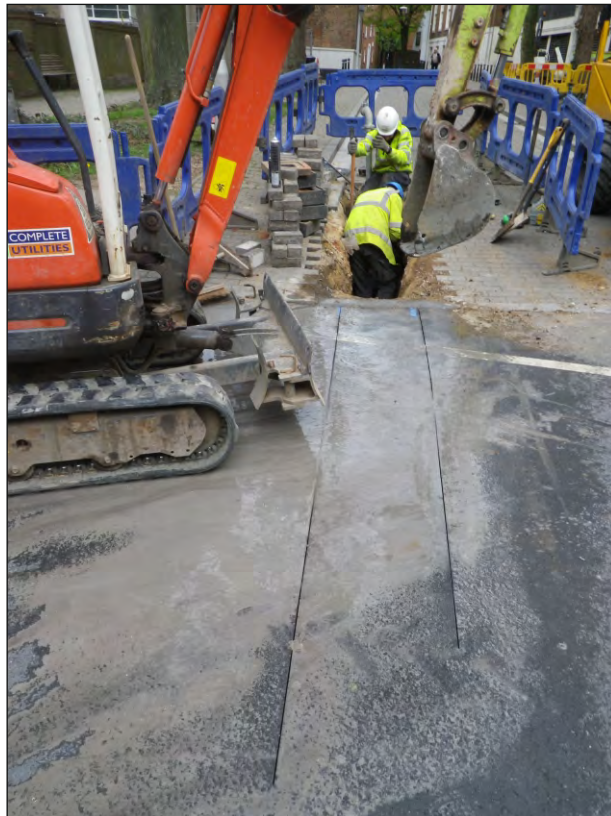
Plate 30: Trench 171 in Heritage Zone 9, camera facing north

- 4.10.21 Trenches 171 and 172 were eventually contiguous, and ran from the south end of Berkley Street, westwards along Longsmith Street, and into Barbican Road (Pl. 30). The basal deposit in trench 171 comprised a very dark greyish brown silty clay loam. Numbered 17104, this deposit was encountered at 0.8–1.1 m bgl. There are fieldwork records of animal bone within this deposit, but no further details are known.
- 4.10.22 A similar deposit of dark greyish/blackish brown loamy sand was the deepest observed deposit in trench 172. Numbered 17206, this deposit was encountered at 1.33–1.50 m bgl and purportedly contained animal bone and two metal objects, again no longer present in the archive.

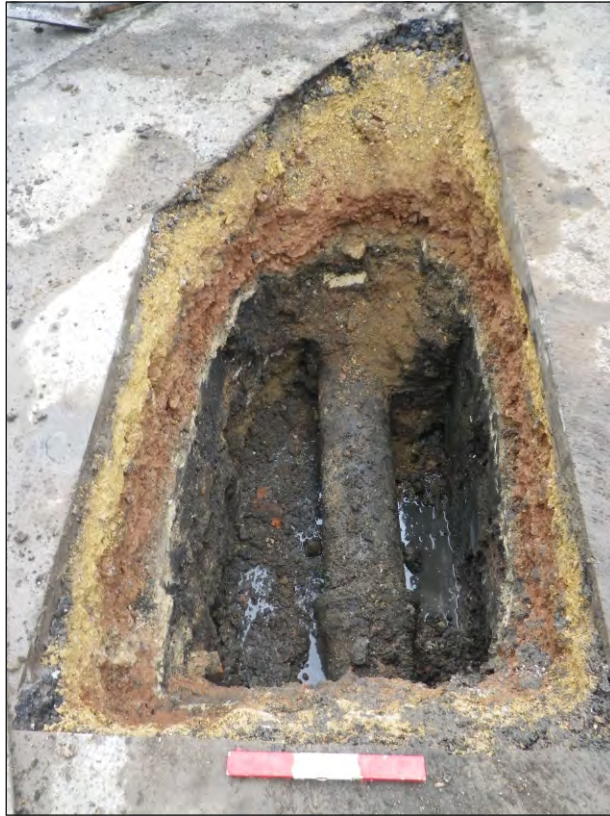
Plate 31: Trench 178 in Heritage Zone 10, camera facing south-west

- 4.11.3 No remains of archaeological significance were recorded in any of the trenches. The only trench found to contain artefacts was trench 173.
- 4.11.4 Within these archaeologically uninformative trenches, upcast appeared to largely or entirely represent previously disturbed material, and no intact stratigraphy of provably archaeological origin was discernible. The typical deposit sequence within these trenches was as follows: modern ground surface (typically tarmac), overlying a yellowish, sandy aggregate preparation layer, overlying modern mid-red stone ballast, overlying a basal dirty, dark brown stony clay deposit within which the existing water pipe was located (eg, trench 178, see Pl. 31).
