58 Harnham Road, Harnham Salisbury, Wiltshire

Archaeological Evaluation Report

Planning Application Ref: 15/12337/FUL
Ref: 112260.03
February 2016

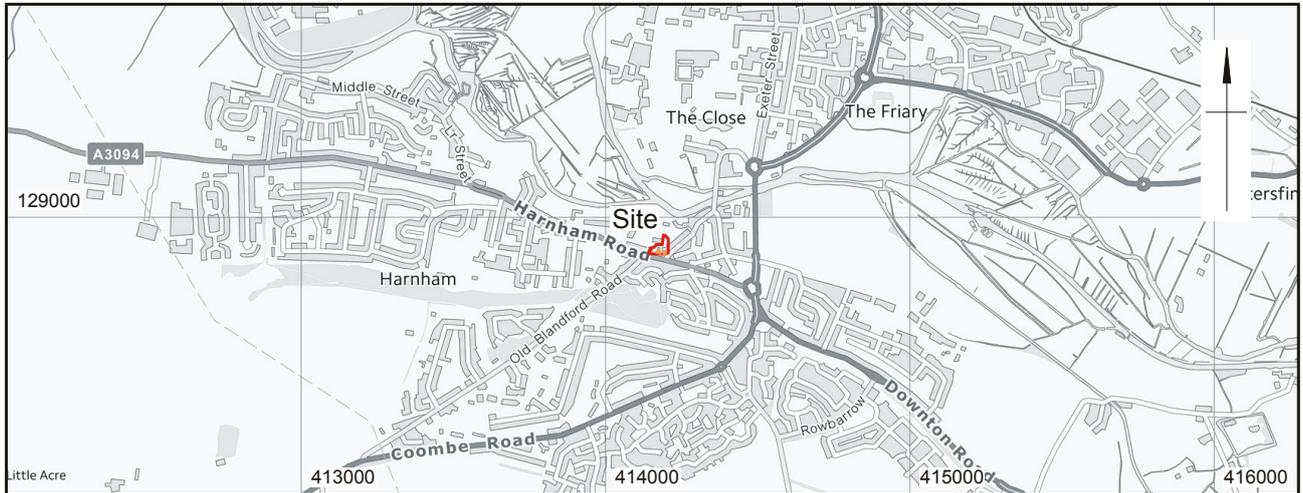
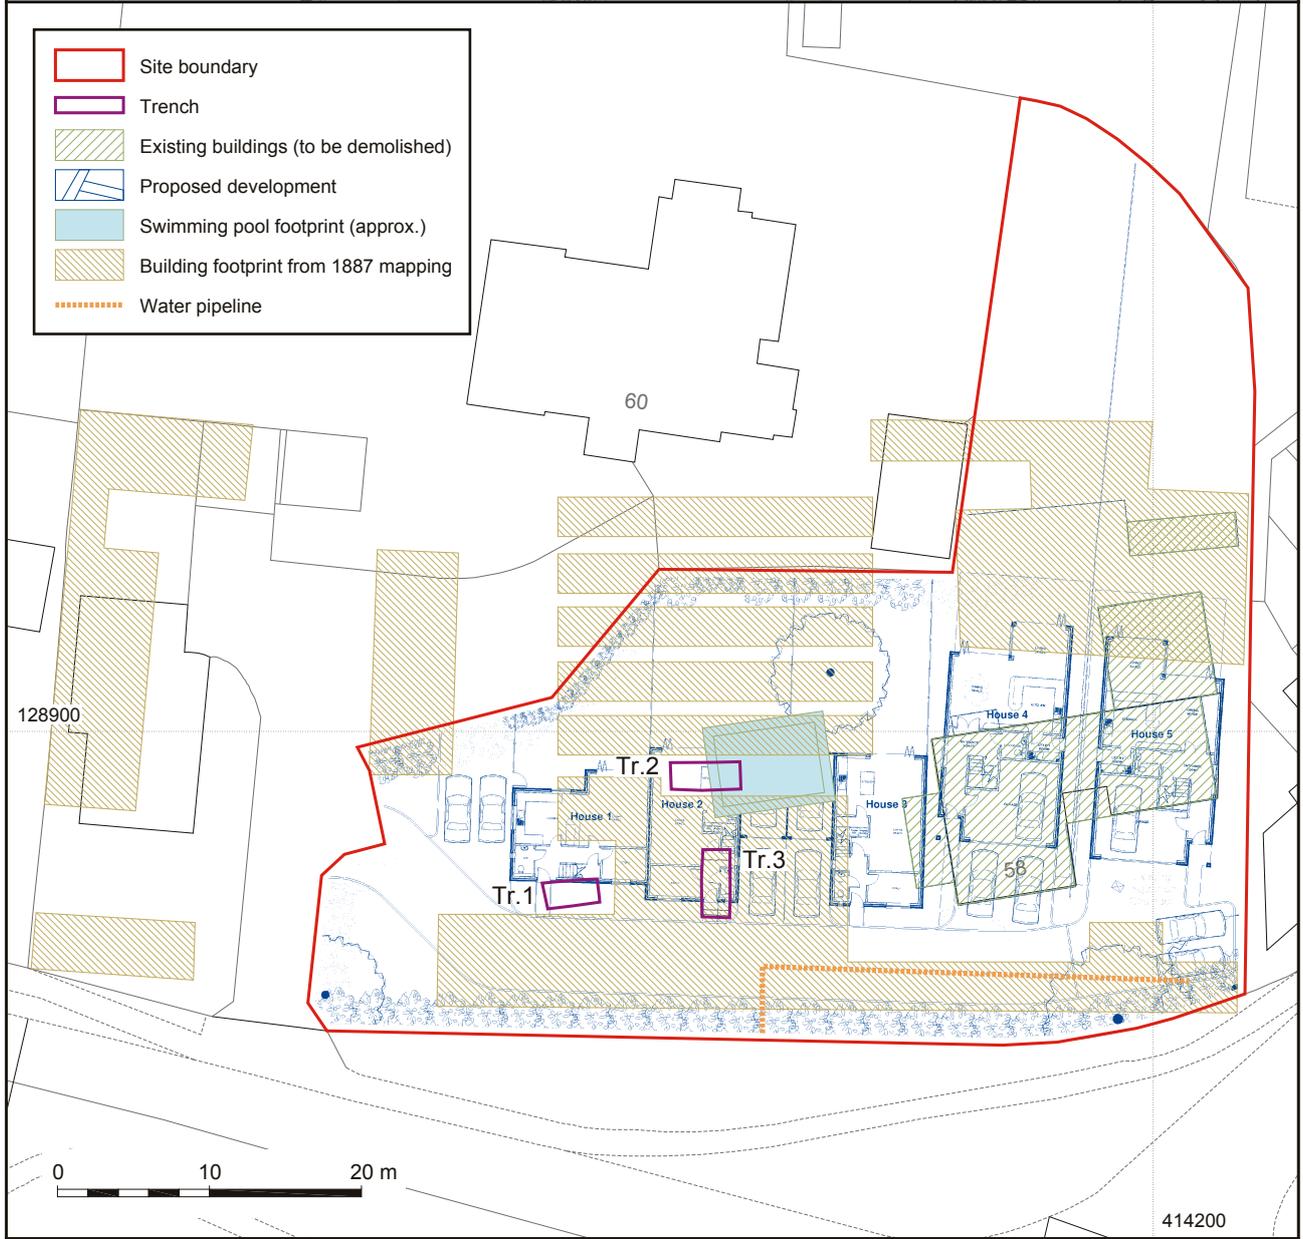
Figure 1

Site and trench location

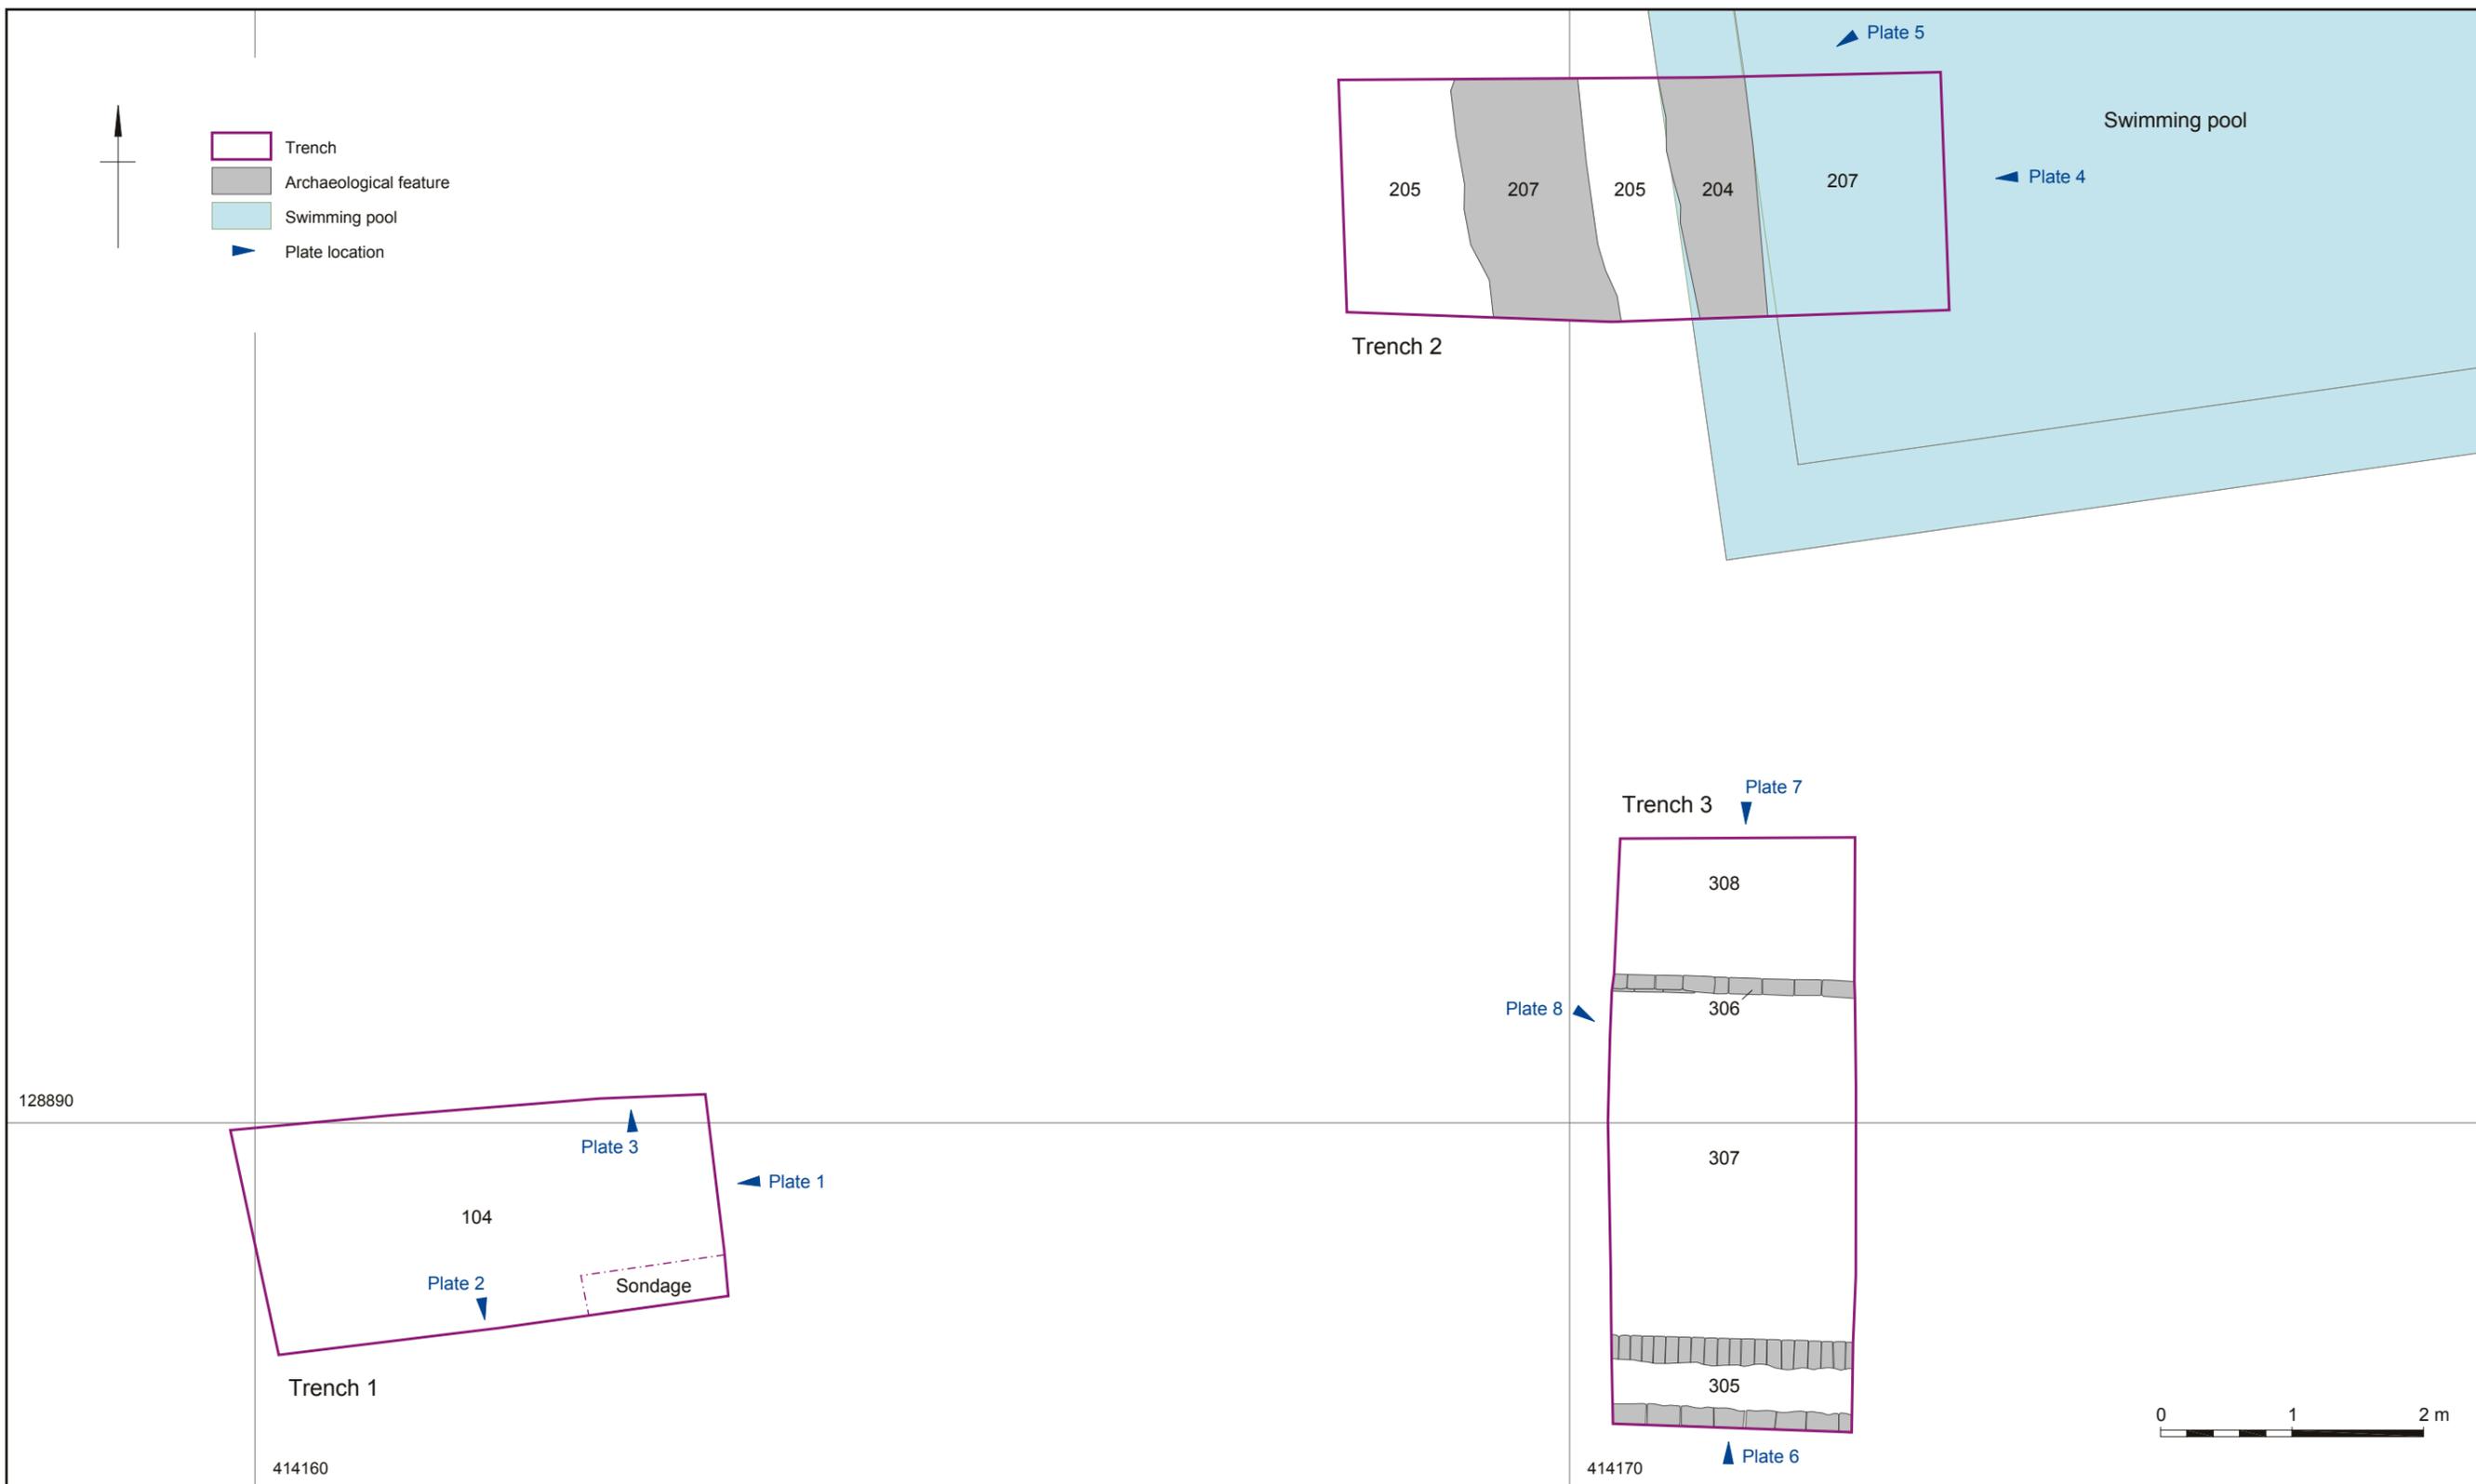
Figure 2

Detail of Trenches 1-3

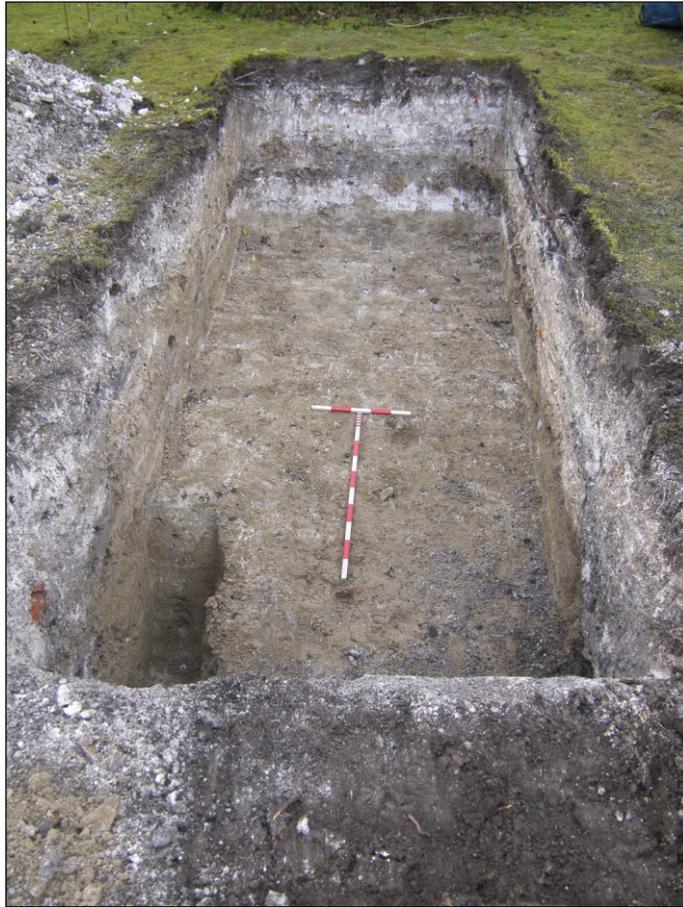
Plate 1: Trench 1 from the east (scale 1m, 0.50m)

- 6.3.2 The earliest observed deposit within Trench 1 overlay the truncated natural **104** and was recorded as a 0.04 m thick grey brown silt deposit **103**. It is probable that this is the old ground surface which accumulated through trample activity during the construction of the whiting factory. The surface was then sealed beneath a series of dumping and levelling deposits of redeposited chalk, brick rubble and other waste which formed a 0.57 m thick heterogeneous deposit **102**. It is possible that deposit **102** was laid down during the construction of the factory but may also include layers which derived from the demolition of the factory.

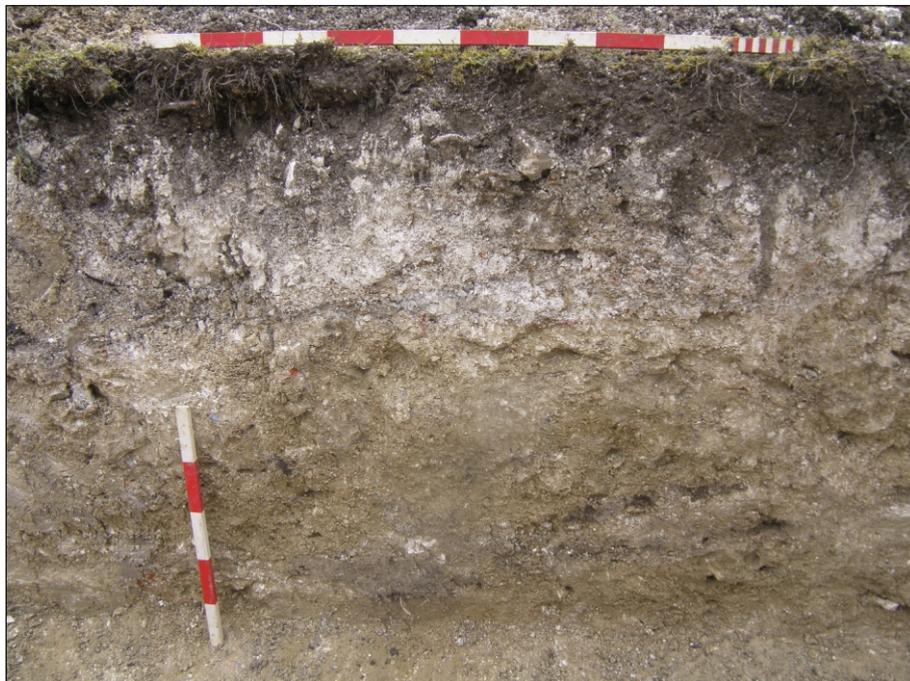
Plate 2: North facing representative section of Trench 1 (scale 1m, 0.50m)

- 6.2.1 The overlying topsoil and turf was recorded as 0.17-0.18 m thick dark brown silty loam which lay directly over levelling and landscaping deposits associated with the demolition of the old whitening factory and the construction of the new house, and swimming pool and the subsequent infilling of the pool with debris. (**Plates 2, 3 5 and 8**)

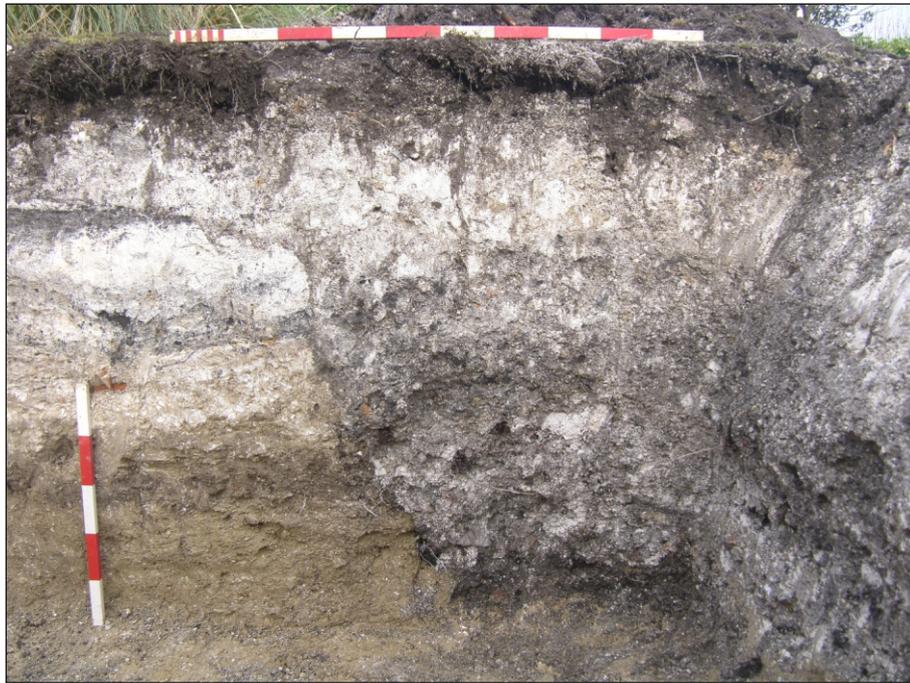
Plate 3: South facing section of Trench 1 showing cut 105 (scale 1m, 0.50m)

- 6.3.3 Cutting through deposit **102** was a north–south aligned cut feature **105**, recorded as at least 0.70 m wide and 0.80 m deep and infilled with redeposited chalk **106**. It is likely that this is part of a robber trench for the removal of walls associated with the factory.

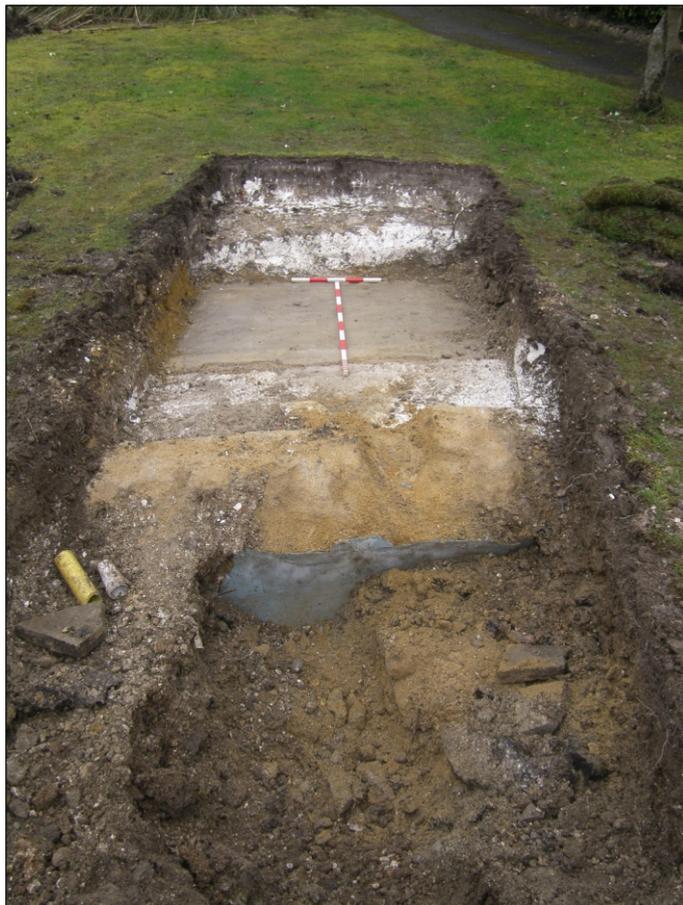
Plate 4: Trench 2 from the east showing blue fibreglass lining of swimming pool (scale 1m, 0.50m)

- 6.3.5 Also cutting deposit **205** was cut **203**; the construction trench for a swimming pool which was subsequently backfilled. Within the cut **203** was a 0.70 m thick concrete block wall **204** bonded with yellow sandy mortar and lined with a waterproof fibre-glass covering which formed the outer wall of the swimming pool. The pool had been backfilled with a mix of modern rubble including concrete blocks and tarmac and waste building materials: bricks and plastic pipes.

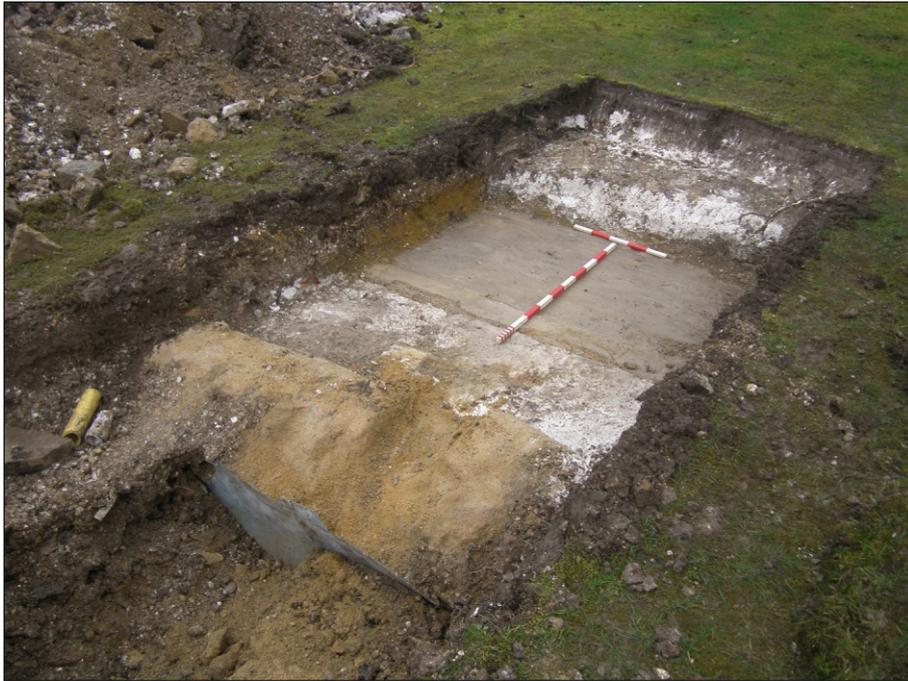
Plate 5: Trench 2 from the north-east (scale 1m, 0.50m)

- 6.3.4 The earliest observed deposit in Trench 2 was just 0.20 m below the current ground surface at 52.71 m a OD. The origin and date of this redeposited chalk layer **205** is unclear, although it appears likely to belong to the construction phase of the factory. It was subsequently cut through by north–south aligned concrete foundation structure **207** (within cut 206). Structure **207** was recorded as 1 m wide, but no thickness was ascertained and had clearly been the foundation for a brick structure as the imprints of bricks were visible in the concrete; however what function the brick structure served within the factory is unclear.

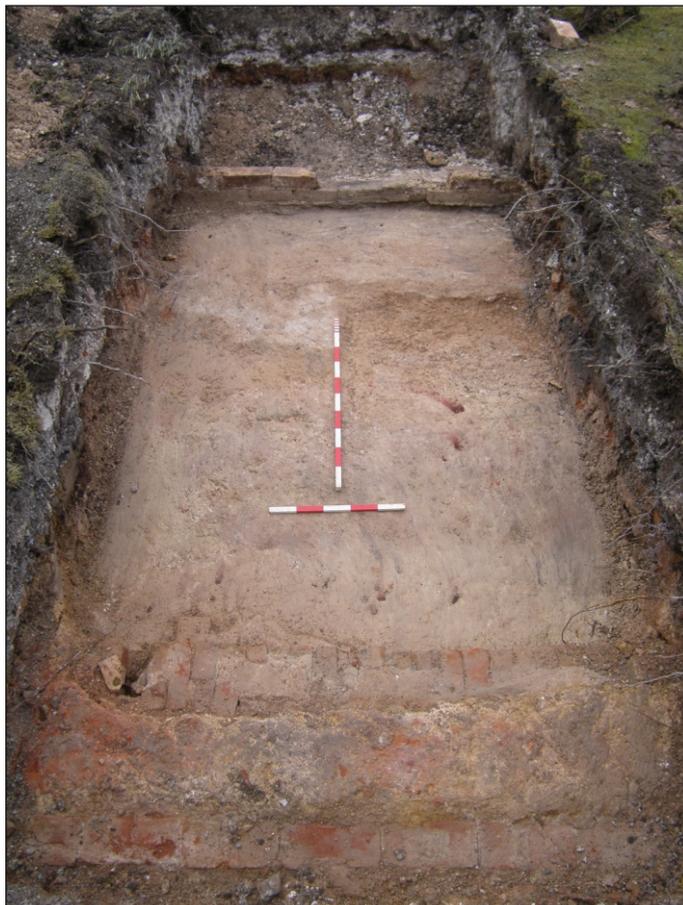
Plate 6: Trench 3 from the south (scale 1m, 0.50m)

- 6.3.6 The earliest structure within Trench 3 was a concrete raft **307** which was encountered at 0.77 m below the current ground surface at 52.19 m aOD and probable formed the main foundation and possibly floor base for the factory. It is probable that foundation **307** was sealed by a tile or perhaps wooden floor which was subsequently removed, this floor would have butted two walls which were constructed directly upon foundation 307.

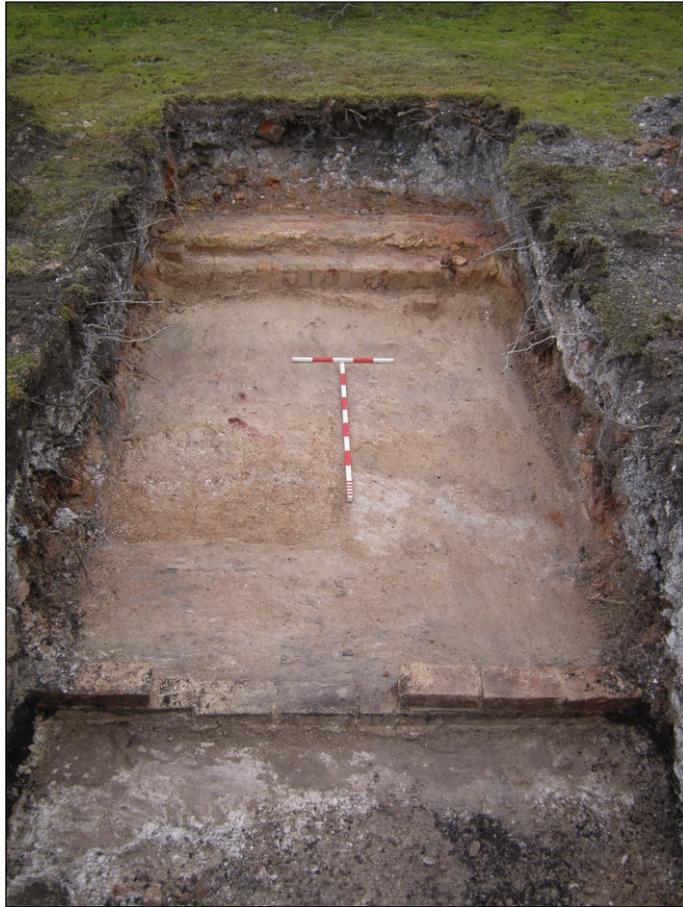
Plate 7: Trench 3 from the north (scale 1m, 0.50m)

- 6.3.7 At the southern end of Trench 1 an east–west aligned brick built aligned brick built wall with rubble and mortar core was observed. Wall **305** was recorded as 0.70 m wide and 0.25 m high and only survived as two courses on the southern side one course on the northern side. The surviving courses were built in stretchers over on-end headers and the bricks were recorded as un-frogged and 0.23 x 0.11 x 0.07m in size. It is unclear if this wall was the outer wall of the factory or an internal load-bearing structure.

- 6.3.8 Towards the northern end of the trench wall **306** was recorded. This was a single brick wide wall and survived for two courses in stretcher bonded with a light yellow sandy chalk mortar. The brick size was equal to that in wall **305**. The function of **306** is unclear though it is unlikely to be load-bearing.

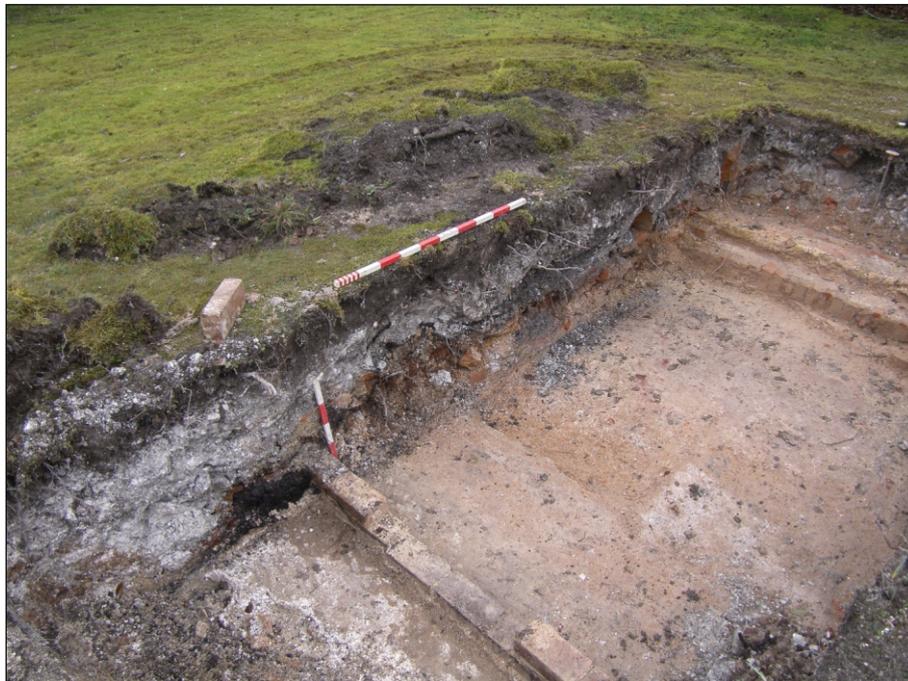
Plate 8: Oblique shot of the west facing section of Trench 3 (scales 1m, 0.50m)

- 6.3.9 Following the demolition of the factory and the removal of walls **305** and **306**, material from the building which could not be recycled or reused was dumped and used to level the ground (Deposit 304) which was formed of broken bricks and other rubble within a matrix of waste mortar (cleaned off bricks to be recycled) and redeposited chalk most likely left over from the factory. This deposit sealed walls **305** and **306** and was in turn sealed by layer **303** which was solely derived from the cleaning of mortar off bricks.
- 6.3.10 Deposit **303** was sealed by a deliberate dumped deposit of mixed and mottled redeposited dirty chalk (deposit **302**) which was then cut through by cut **308** which was possibly a later robbing trench for removal of structures associated with the factory or may form the construction cut for the swimming pool to the north.
