Archaeological Watching Brief Report

#### **Archaeological Watching Brief Report**

Document Ref: 105471.03 Planning Application Ref: 14/07652

Wessex Archaeology was commissioned by Wiltshire Council to carry out an archaeological watching brief at Beversbrook Sports Facility, Calne, Wiltshire (NGR 399845 172890). The watching brief was undertaken between the 16<sup>th</sup> February and 3<sup>rd</sup> March 2016 and comprised the archaeological monitoring of works associated with the excavation of a drainage network in the area of the new pitch, tree and hedge removal, the excavation of a re-routed drainage ditch and hedge line and the topsoil stripping of an All Weather Pitch.

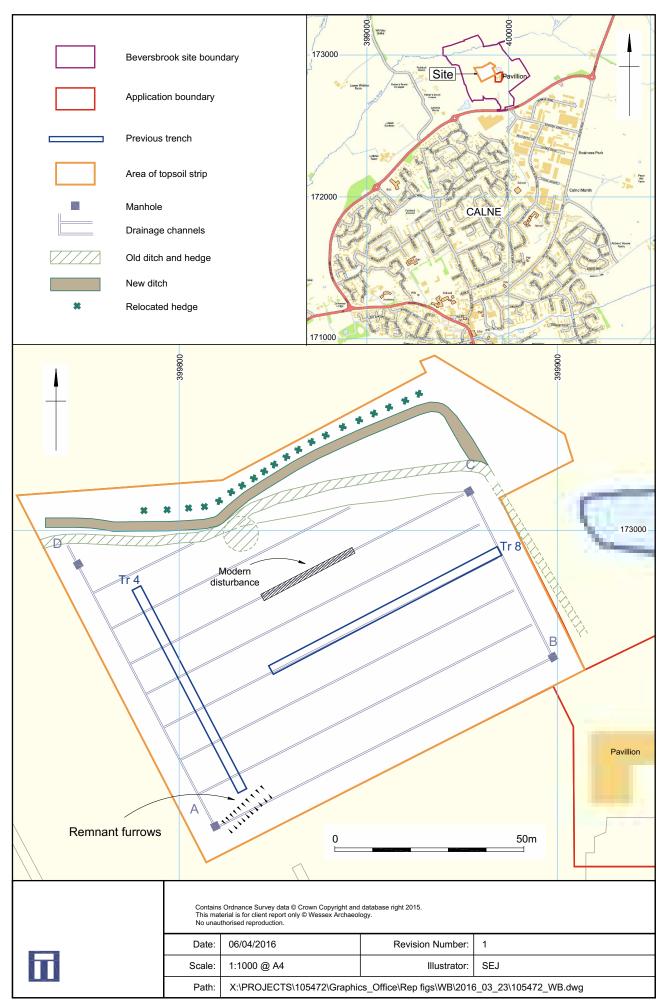
Figure 1: Site location showing watching brief results

2.1.4 A previous evaluation by Cotswold Archaeology in 2007 (Saunders and Alexander 2011) excavated two trenches within the current Site boundary in the location of the proposed AWP (Trench 4 and Trench 8, **Figure 1**)). These trenches revealed a modern pond (Trench 4) and an undated ditch (Trench 8).

- 4.1.1 The watching brief area comprised the monitoring of the machine topsoil stripping of a 6,618m² All Weather Pitch preceded by the machine excavation of a drainage grid, the removal and replanting of a hedge/tree line and the excavation of an associated re-routed drainage ditch (**Figure 1**).

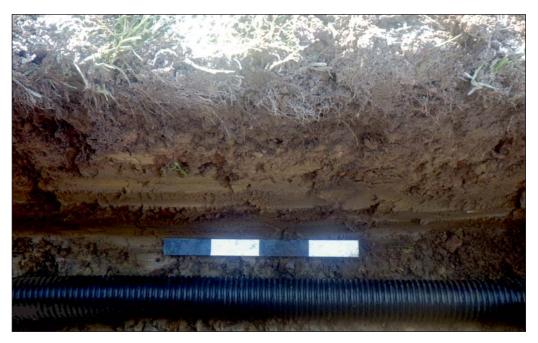
- 4.1.2 Eleven drainage channels approximately 0.4m wide and 0.5m deep were excavated at regularly spaced intervals across the proposed All Weather Pitch creating a drainage network (**Figure 1** and **Plate 1**) with four manholes measuring between 1.5m² and 2.4m² and approximately 1.5m deep incorporated into the corners of this network. The drainage network was cited within an existing grassed sports pitch and a consistent stratigraphic sequence was observed throughout. No subsoil was present within this area and a level natural horizon was found to be overlain by a 0.2m thick topsoil and turf horizon.

Plate 1: North west facing section of narrow drainage channel

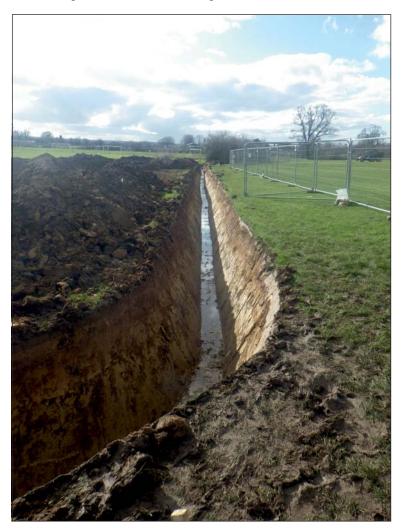
- 4.1.4 To the north of the watching brief area the excavation of a re-routed drainage ditch (Figure 1 and Plate 2) was also monitored. The new ditch was approximately 1.1m wide and between 0.8m to 1m deep. A consistent stratigraphic sequence was recorded in the sides of the ditch along its length and comprised a c0.2m thick layer of mid to light yellow brown clay loam subsoil overlying the natural clay deposits. A 0.05m to 0.1m thick modern buried topsoil overlay the subsoil and was sealed by a c0.05m thick layer of re-deposited natural material likely to have derived from the levelling of adjacent grass pitch. This levelling layer was overlain by the extant 0.2m thick layer of topsoil and turf (Plate 4). Several shallow and irregular undulations within the top of the subsoil horizon were found to be filled with topsoil and are thought to represent furrows.

Plate 2: View along new drainage ditch taken from the north east

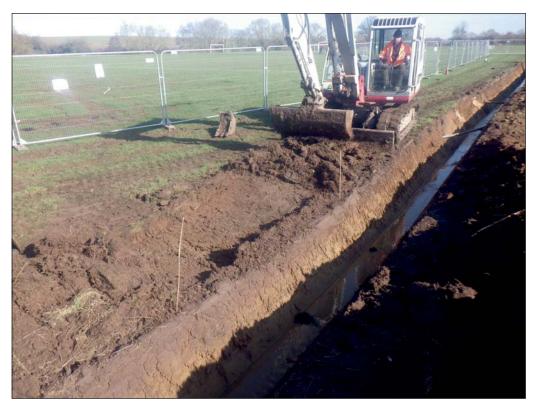
- 4.1.3 The removal and reinstatement of an extant hedge/tree line was observed (**Figure 1** and **Plate 3**). No archaeological features or deposits were observed within the tree planting holes and excavation of the hedge for reinstatement did not exceed the depth of the extant topsoil.

Plate 3: Machine excavation of new hedge line taken from the south east

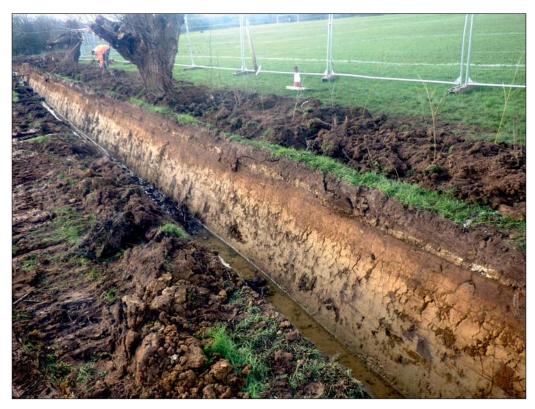
Plate 4: New drainage trench showing stratigraphic sequence taken from the east

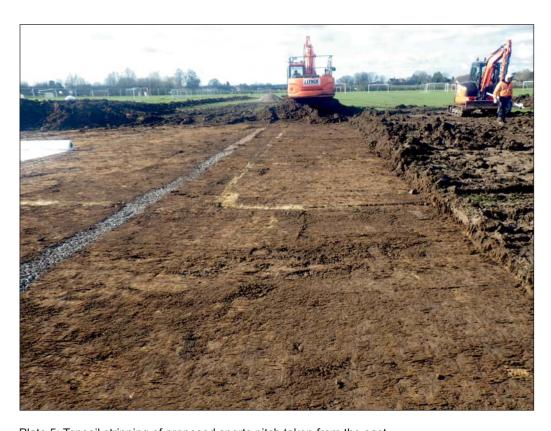
- 4.1.5 Topsoil was removed across the extent of the new All Weather Pitch (**Plate 5**) and the area levelled for the proposed pitch. Topsoil stripping in some areas did not remove all of the topsoil deposits. At the southern limit of this area the remains of several shallow (0.5m wide and 0.05m deep max) north-east to south-west aligned furrows were noted. Previous landscaping across the centre of the new pitch had truncated these features, however the continuation of these furrows were noted within the sides of the new drainage ditch at the northern end of the site. A layer of modern detritus including plastic was also recorded in the centre of the new pitch. No other archaeological features or deposits were observed.

Plate 5: Topsoil stripping of proposed sports pitch taken from the east
