Premier Inn: Redhill Brighton Road, Salfords, Surrey

Archaeological Evaluation Report

Planning Ref: 15/00683/F
Ref: 111370.02
April 2016

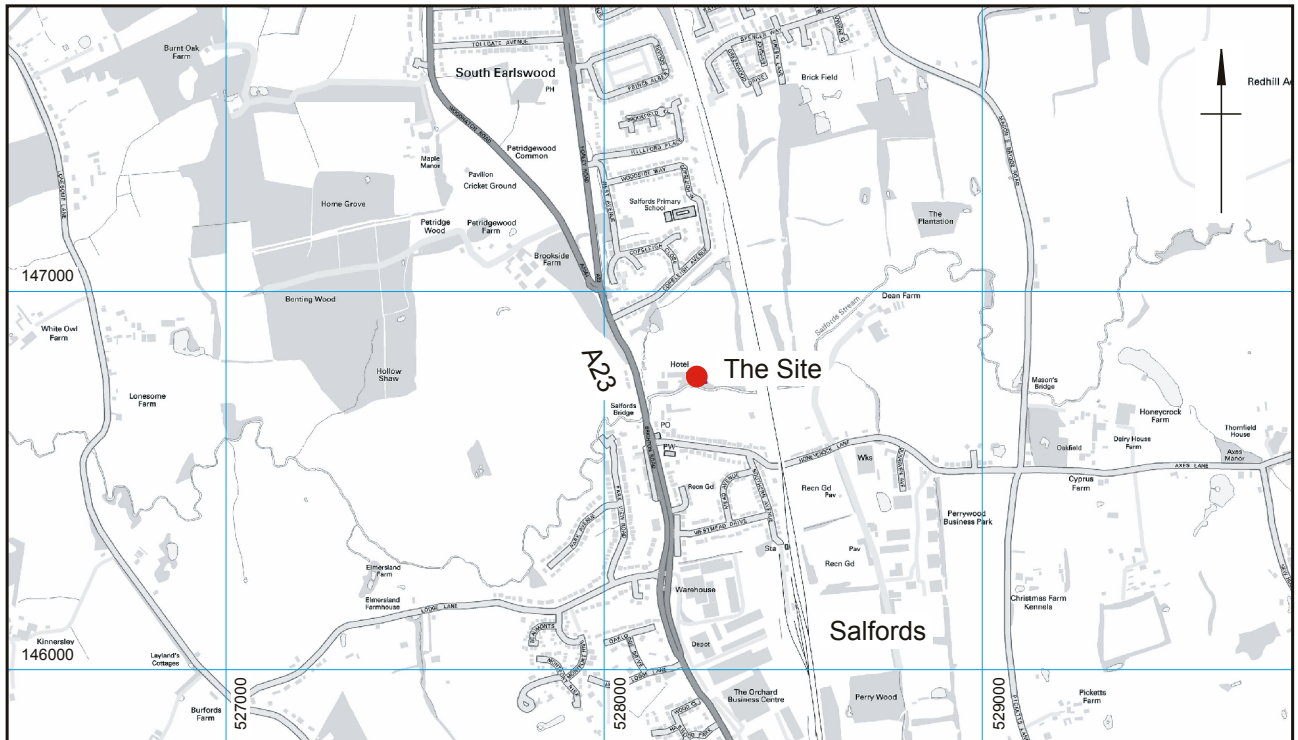
Figure 1

Location of the Site, development area and evaluation trenches

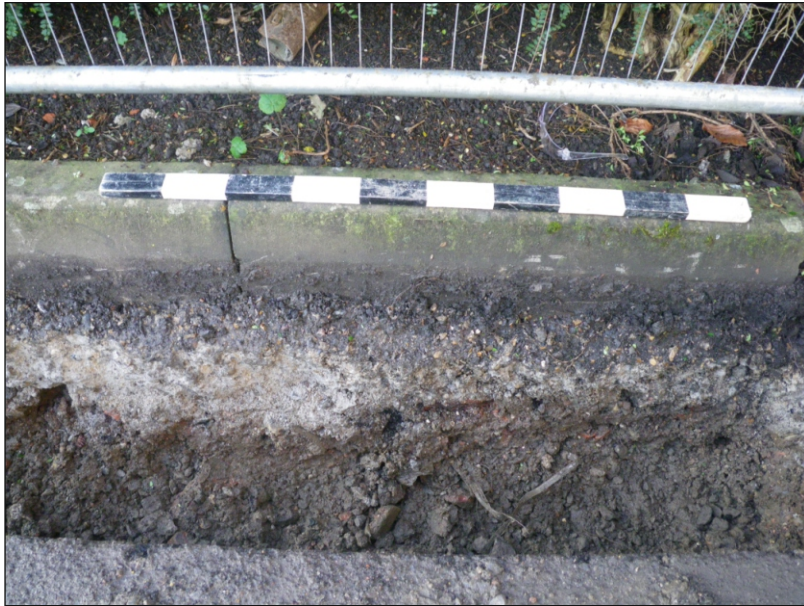
plate 1: Watching brief cable diversion trench, north facing section

- 4.1.1 The works subject to watching brief (rerouting of electricity supply) (**Plate 1**) exposed no archaeological remains.

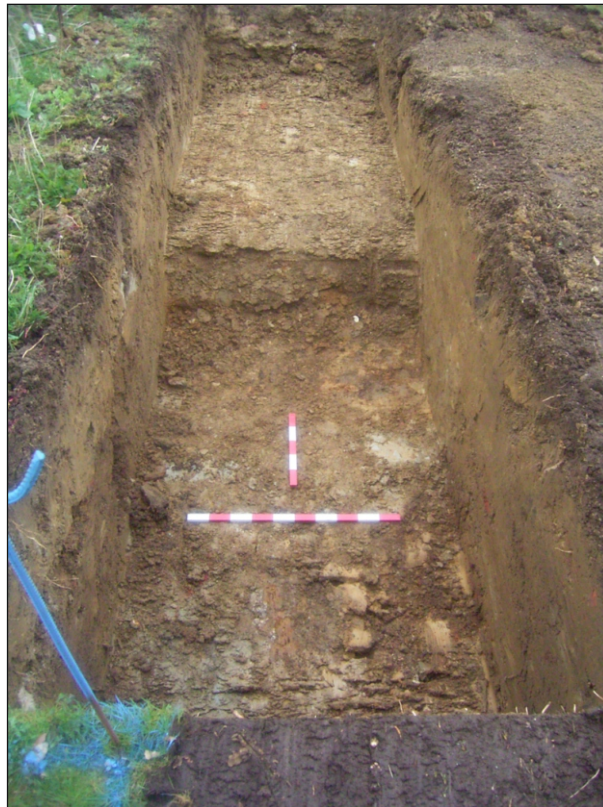
Plate 2: Trench 2 facing west

- 4.2.1 The underlying natural was exposed in Trenches 2, 3 and 4, (203, 304 and 404) and consisted of mid-yellowish brown very compact sandy clay with occasional rounded stone inclusions. This was exposed at 300mm Below Ground Level (BGL) in the north of the site (**Plates 3 & 4**) and at 600mm BGL in Trench 2 (**Plate 2**). It was not exposed in Trench 1.

- 4.3.2 All trenches revealed modern made ground deposits. In Trenches 3 and 4 (302 and 402), these consisted of compacted brick rubble to 300mm BGL, forming the makeup for the existing car park, while Trenches 1 and 2 revealed thicker deposits (102/103 and 202) of rammed clay with brick and concrete rubble. These extended to 1.20m BGL in trench 1 and 0.6m BGL in Trench 2 (**Plate 2**). These are most likely to relate to the construction of

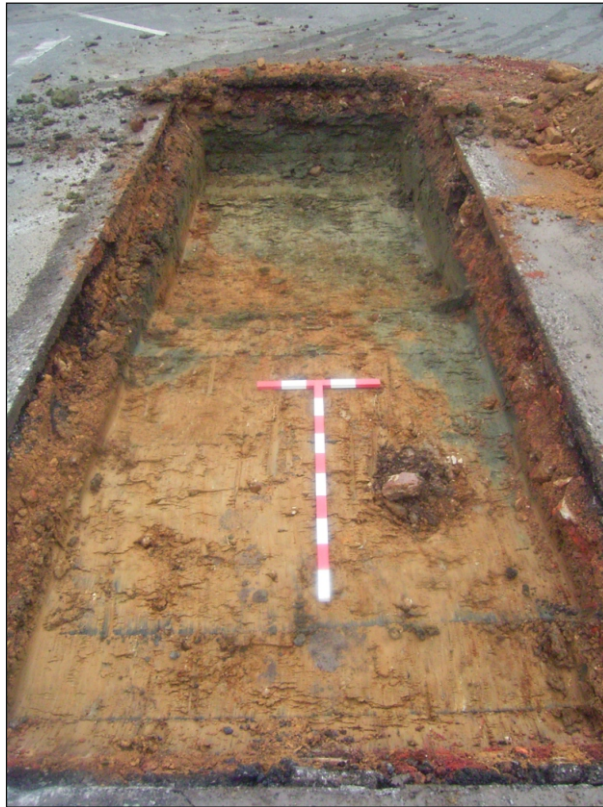
Plate 3: Trench 3 facing south-east

- 4.2.2 Within Trenches 3 and 4, a heavily gleyed natural (303 and 403) was revealed which overlaid natural deposits 304 and 404. The gleyed deposits both comprised of a dark bluish grey coarse sandy clay, with common, poorly sorted, water-worn small to medium flint gravels (**Plates 3 & 4**). Within Trench 3, deposit 304 was investigated by machine to a depth of 0.7m BGL and revealed an undifferentiated deposit with no laminations. Both gleyed deposits have been interpreted as natural, and most likely represent areas in the natural which have been subject to anaerobic conditions.
