Castleward Derby

Archaeological Evaluation Report

Ref: 100161.02
September 2013

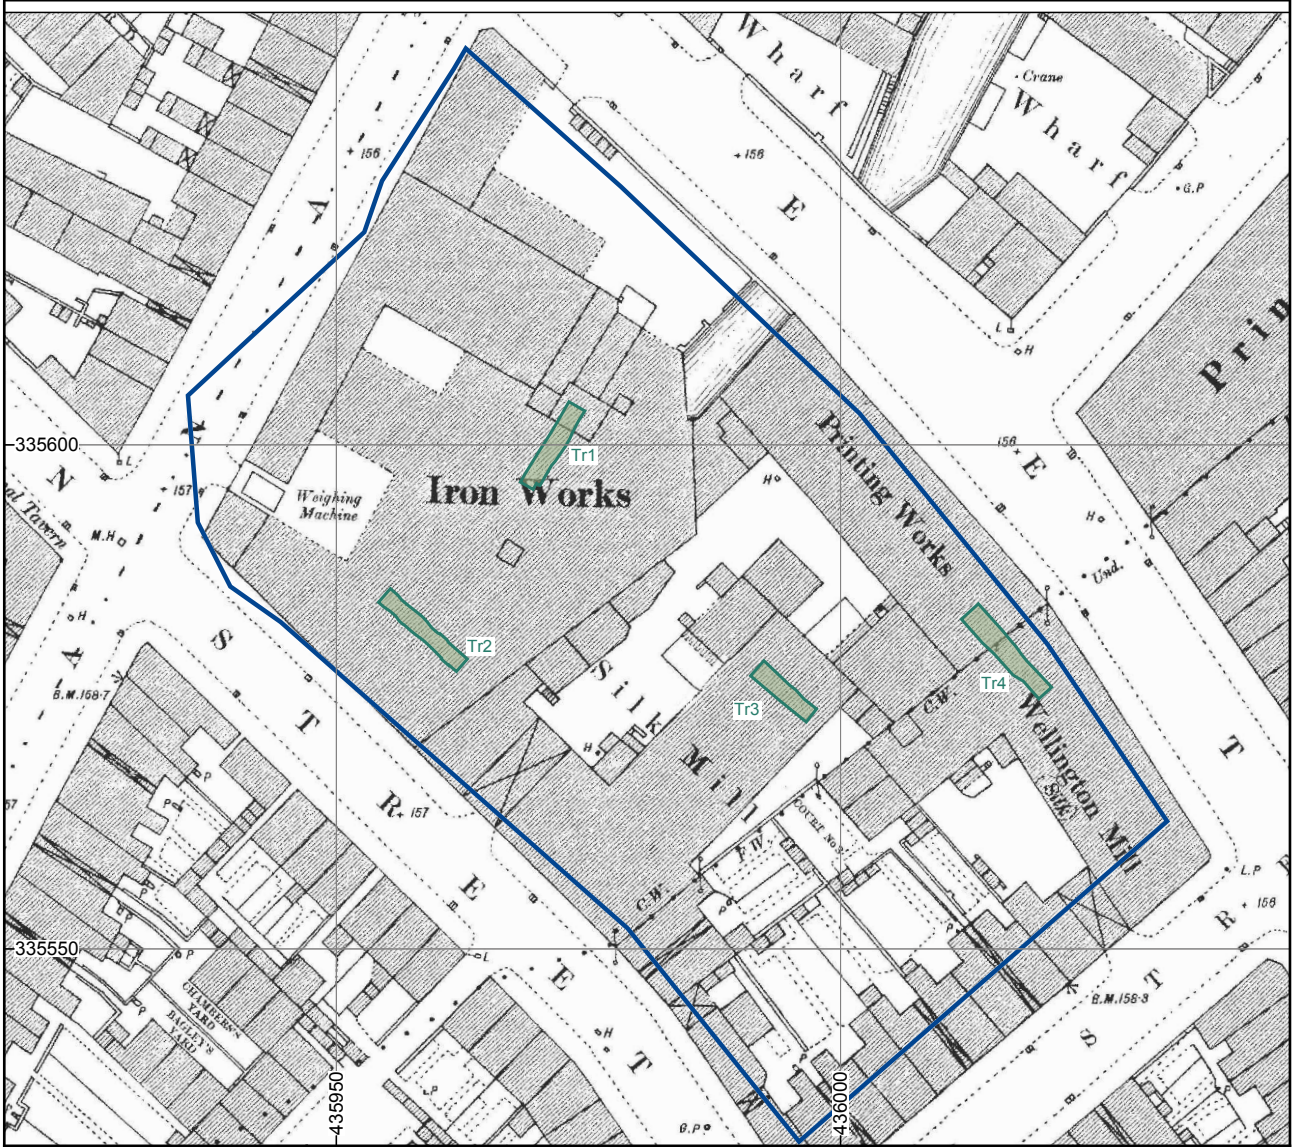
Figure 1

Site plan and trench locations on 1884 OS

- 3.3.1 Four trenches were excavated, each measuring between 7.5m and 10m in length (**Figure 1**). It was not possible to locate Trench 3 in the position intended due to the presence of a large pile of spoil on Site, so it was relocated approximately 10.5m to the north-east, still within the Silk Works.

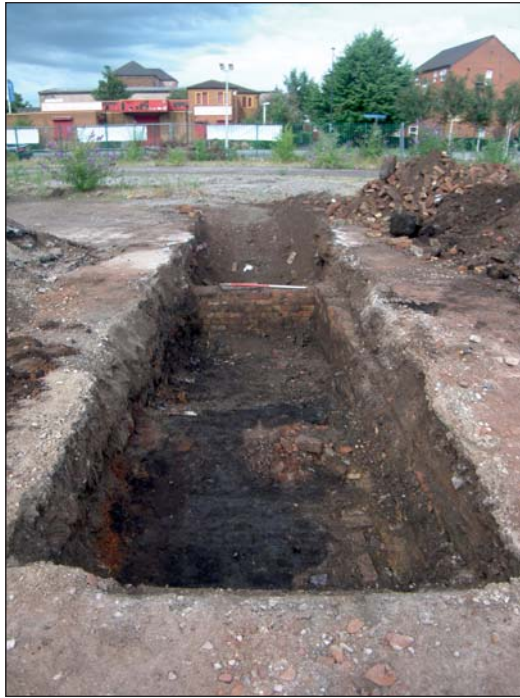
Plate 1: Trench 1 from south-west

- 4.2.1 Trench 1 was targeted on the Iron Works and crossed a wall present on the historic mapping (**Figure 2, Plate 1**).
- 4.2.2 The most significant features comprised two walls forming a right-angle. Wall **104** corresponded with a wall seen on the historic mapping. It consisted of three skins of machine bricks and modern cement mortar, with atypical bricks included in the construction. In addition, a sandstone windowsill or similar was seen, with some ferrous staining on the upper surface. It is possible that this was the base of an aperture for a shaft or some other mechanical installation, or perhaps a window for a lightwell as it lay at 0.5m BGL.
- 4.2.3 Wall **104** ran north-west to south-east and wall **105** formed the north-east to south-west return and was comprised of identical materials. The wall continued for at least 8.4m, with

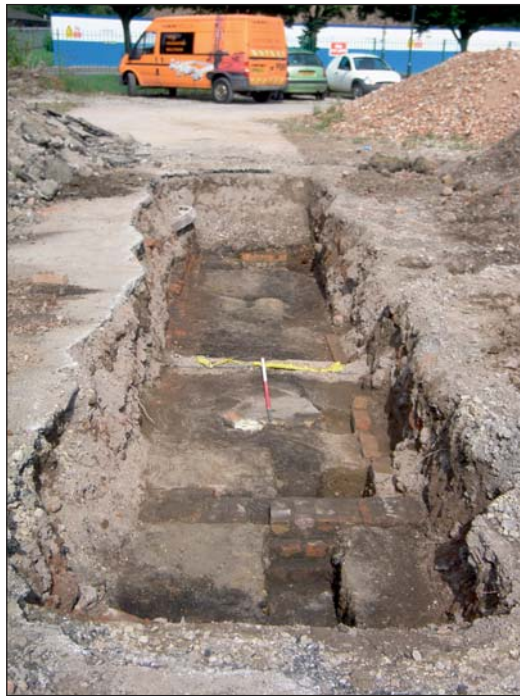
Plate 2: Trench 2 from south-east

- 4.3.1 Trench 2 was targeted on a blank area within the iron works where preserved internal features were revealed (**Figure 3, Plate 2**).
- 4.3.2 At the south-east end of the trench, the earliest deposit was a clay-rich industrial made ground (**212**). A sandstone and red-brick drain or conduit (**214; Plate 5**) was trench built (**213**) within this material. The drain was lime mortared and ran north-east to south-west at the south-east end of the trench and was truncated at both ends (**Figure 3**).

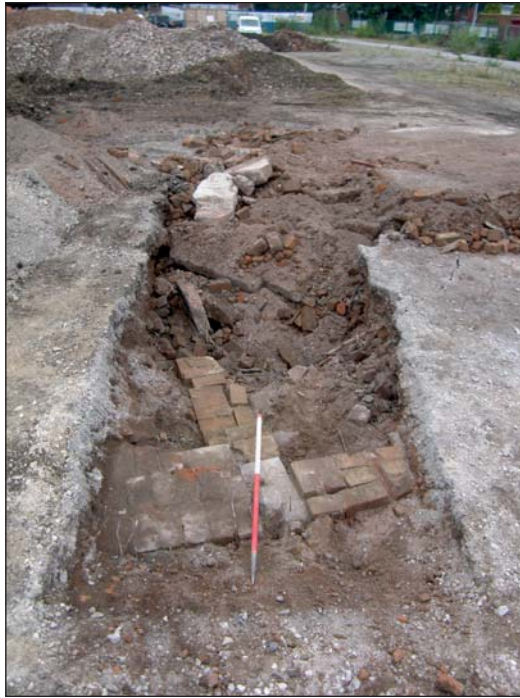
Plate 3: Trench 3 from south-west

- 4.4.1 Trench 3 was located in the central silk mill shown on the 1884 Ordnance Survey map (**Figure 4, Plate 3**). Most of Trench 3 consisted of loose brick rubble extending to a depth of over 2m BGL (**301**), and overlain by tarmac (**300**).

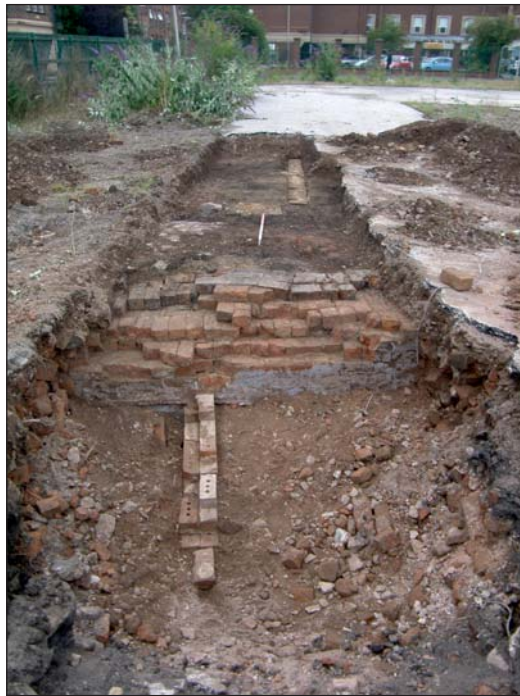
Plate 4: Trench 4 from north-west

- 4.5.1 Trench 4 was targeted on the boundary between the printing works and Wellington Silk Mill (**Figure 5, Plate 4**). The boundary was found and good preservation was demonstrated within Wellington Mill.

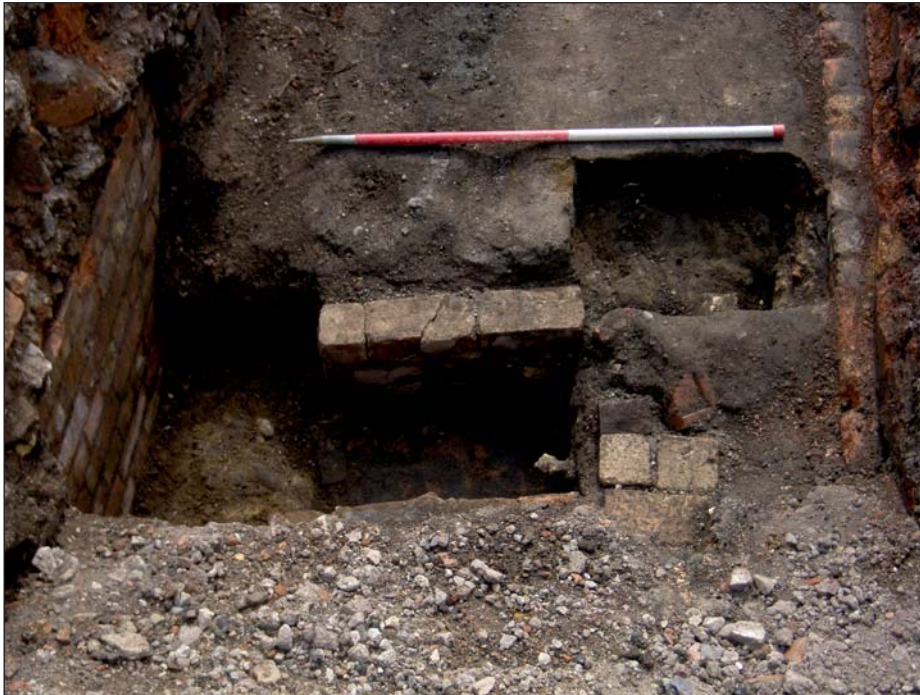
Plate 5: Drain **214** and associated contexts

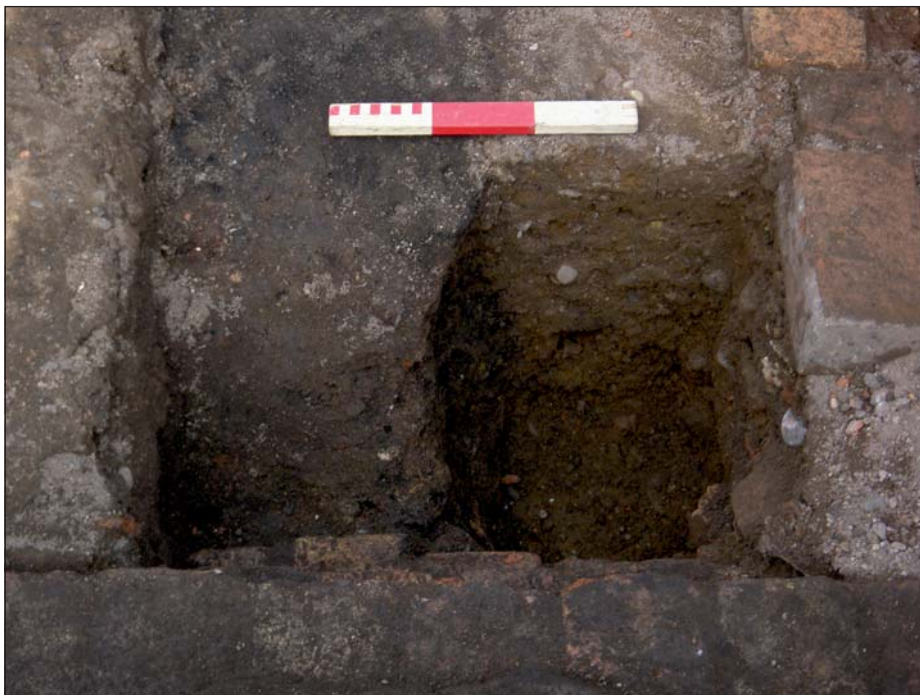
Plate 6: Construction cuts **225** and **223**

- 4.3.5 In the centre of the trench, construction cut **225 (Plate 6)** for wall **228**, analogous to **217** at the south-east end, was revealed in section. The wall was of the same materials (machine bricks and sandy mortar) and alignment as **210** in the south-east. The cut was filled with brown sandy industrial material **226**, similar to **218** in the south-east. A second construction cut (**223, Plate 6**) for a small structure (**203**) consisting of a single skin and course of unmortared red bricks and firebricks, was cut through the fill of cut **225**. Cut **223** was backfilled with **224**, a similar mortar-rich sandy industrial material to **219** at the south-east end of the trench.

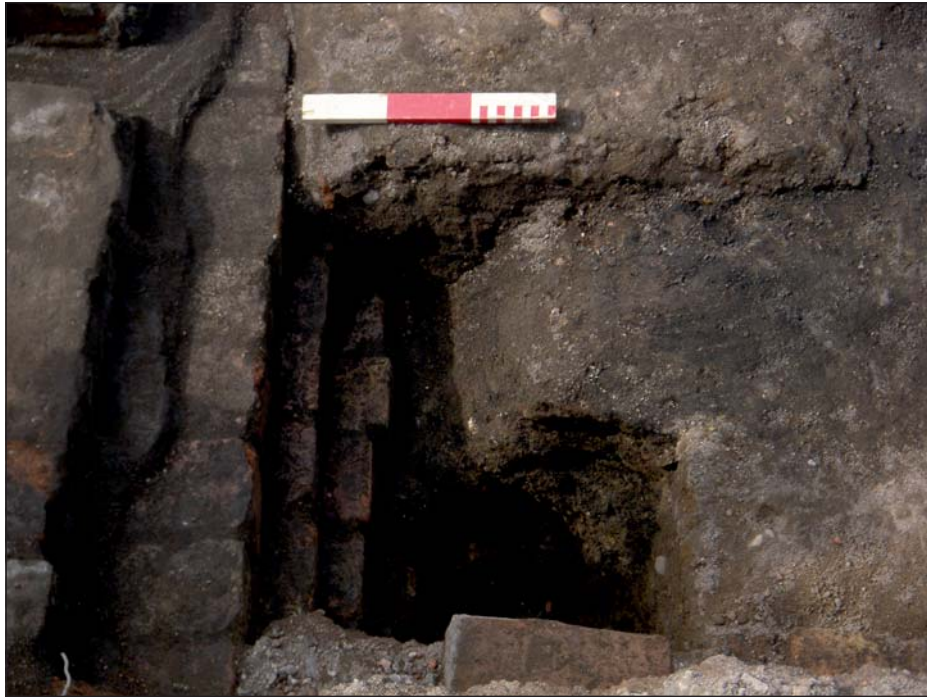
Plate 7: Construction cut 221

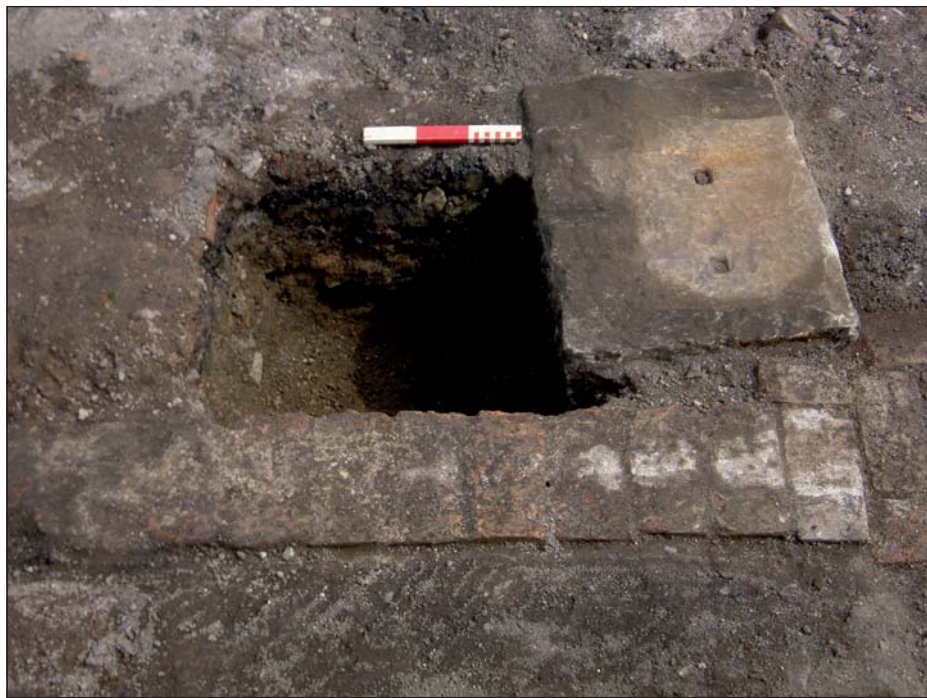
Plate 8: Machine base 407 and associated contexts

- 6.1.4 Trench 3 contained a lime-mortared wall.
- 6.1.5 The lime-mortared boundary between two works was revealed in Trench 4, as well as a machine base preserved *in situ* at a depth of 0.22m BGL.
