Thorley Lane Bridge Replacement Junction 5, M56, Manchester

Archaeological Watching Brief Report

Ref: 104680.01 September 2014

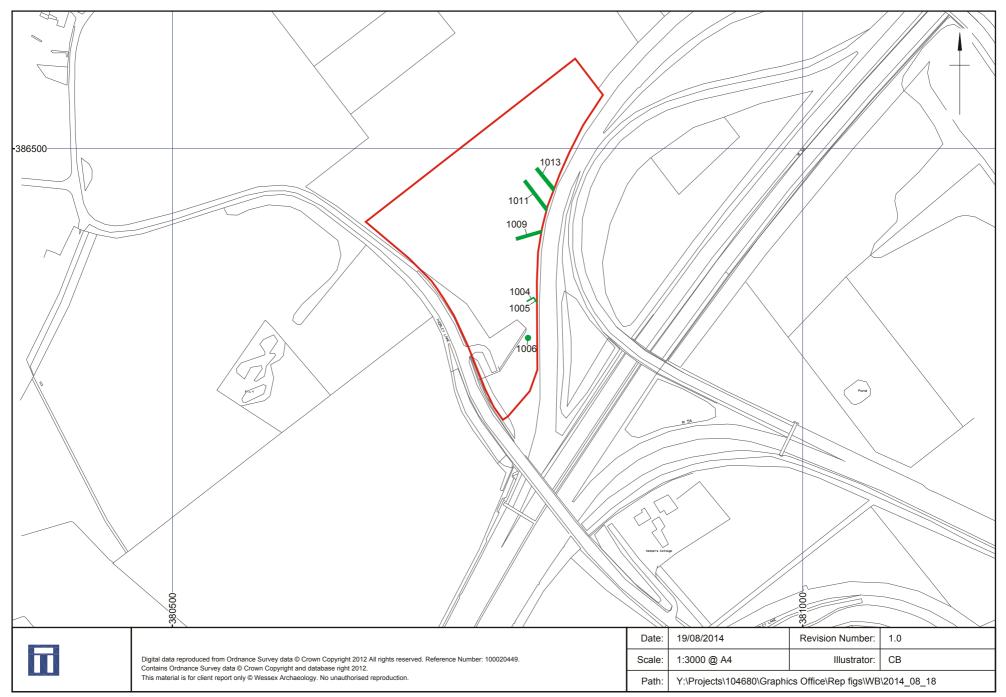
4.1.1 Topsoil stripping for a temporary site construction compound formed the focus of the archaeological monitoring (**Figure 1**). Within this area structural remains comprising brick walls were encountered. In addition, a series of ditches marking former field boundaries was identified in the northern part of the Site (**Figure 2**).

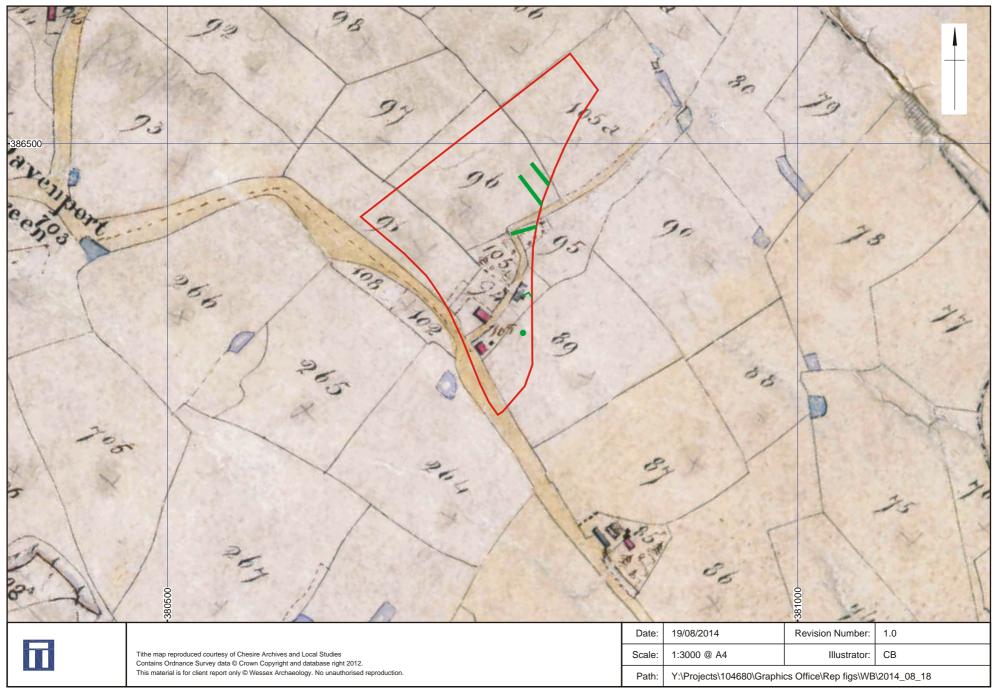
- 2.6.3 The local tithe map of *c*. 1842 shows Thorley Cottages standing within the Site (**Figure 3**). Furthermore, the remains of plots of land were identified within the Site during the Heritage Assessment. Thorley Cottages comprised two square buildings. According to the Crewe rentals, these buildings were occupied by the Perrin and How families in the 18th century. By 1840 one building was owned and occupied by George Garner, the other was owned by the Earl of Stamford and occupied by Andrew Garner Senior. It is not directly known when Thorley Cottages were built, but they may, like those at Davenport Green and Etrop Green, date from the 16th-17th century.

- 6.1.3 The ditches described above are likely to represent former field boundaries. It is thought that two of these (**1009** and **1013**) correspond to plot boundaries marked on the 1840s tithe map. The recovery of the 19th- or early 20th-century pot sherd from one of these features would not be at odds with this interpretation.

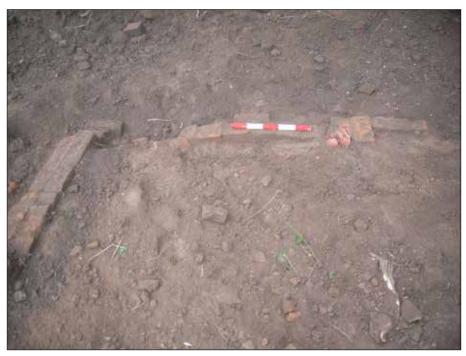
- 4.2.1 An arrangement of brick walling was identified in the southern part of the Site, close to its eastern edge. Wall **1004** ran on a northeast to southwest alignment for 1.65m, seemingly having been truncated to the southwest. Two courses survived, with the wall being 0.25m wide, and consisting of a double skin of stretchers, that is bricks laid with their long sides sharing the alignment of the wall. Beneath wall **1004** a bedding layer of angular fragments of sandstone (**1007**) was recorded (**Plates 1** and **2**).

- 4.2.3 A second segment of brick walling, **1005**, was present at the northeastern end of **1004** (**Plate 1**). This measured 2.4m in length, and also stood two courses high. When recorded this wall was not aligned at right-angles to **1004**, but ran on a NNW to SSE alignment. Its skewed orientation may, however, have been due to machine disturbance, rather than signalling a lack of contemporaneity with **1004**. Wall **1005** appeared to butt against (and therefore post-date) wall **1004**. Like **1004**, the component bricks of wall **1005** were unfrogged, again suggesting a relatively early construction date.

Plate 1: Walls 1004 (left) and 1005

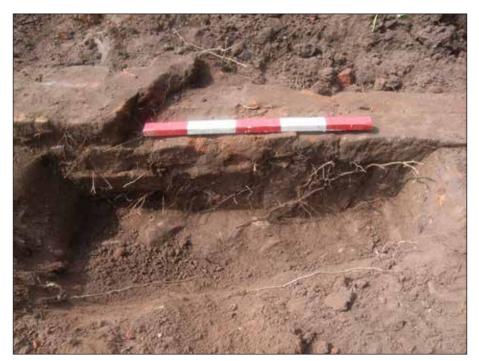
- 4.2.2 Together, **1004** and **1007** probably formed the outer wall of the final manifestation of Thorley Cottages, prior to demolition in the 1970s. The bricks were unfrogged, which would suggest a relatively early construction date.

Plate 2: Sandstone footings 1007 beneath wall 1004

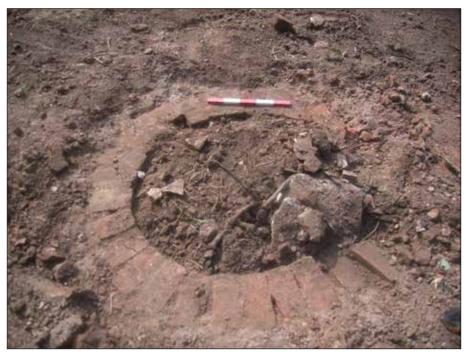
- 4.2.4 Approximately 20m to the south of the walls described above, lay a *c*. 1.6m-diameter brick-lined well, **1006** (**Plate 3**). The bricks were unfrogged and aligned so their long edges radiated out from the centre of the circle. The arrangement did not form a complete circuit: a *c*. 0.5m-long gap in its eastern segment was probably the result of machine truncation.

Plate 3: Brick-lined well 1006

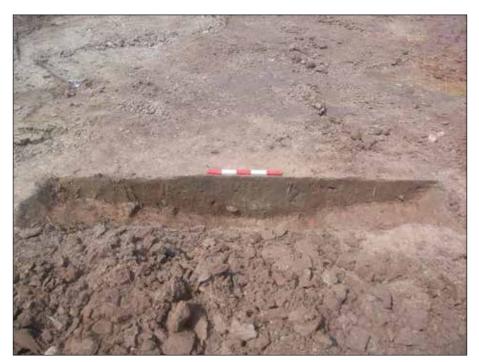
4.3.1 A trio of ditches was intermittently visible running across the northern part of the Site. Ditches 1011 and 1013 followed a northwest to southeast alignment; to their south, ditch 1009 was aligned more ENE to WSW. Ditch 1013 was the most substantial of the three features, measuring 3m in width by 0.45m deep (Plate 4). All of the ditches contained a similar greyish brown sandy fill. No relationships were recorded between any of the ditches, or between the ditches and the structural remains described above.

- 5.1.1 A single sherd of a refined whiteware plate with green transfer-printed decoration of probable 19th- or early 20th-century date (L. Mepham, pers. comm., 06/08/2014) was recovered from ditch **1013**. The sherd weighs 26g and is in a fresh, relatively unabraded condition.
- 5.1.2 No other finds were recovered.

Plate 4: Southeast facing section of ditch 1013

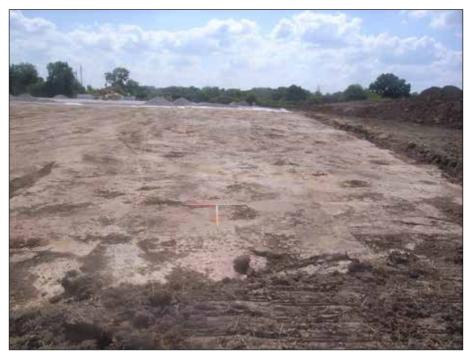
- 6.2.1 The archaeological remains survive only in one part of the Site and in relatively poor, fragmented condition.
- 6.2.2 Following the demolition of the cottages in the 1970s, the Site appears to have been comprehensively levelled. This was probably achieved by cutting the western and central areas down into natural deposits, whilst the eastern side was cut to a lesser degree and perhaps filled a little. This allowed some archaeological remains to survive on the eastern side and resulted in the the flat ground recorded by the watching brief (**Plate 5**).

Plate 5: Site at the completion of monitoring, looking southwest
