LCUK Cauldon Works, Staffordshire

Proposed Extension to Limestone Quarry:
Archaeological Evaluation Report

Report reference: 63500.03

September 2006

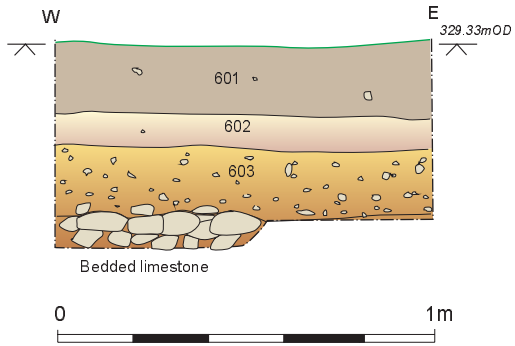
Trench 6

- 3.2.1 A consistent soil-sequence was seen in the majority of trenches (see **Figure 2**):

- 3.2.2 Topsoil appeared to have developed from longstanding use as pasture. It comprised a mid-greyish brown, slightly clayish silt, usually stone-free, but with occasional small-large limestone pieces. Rare items of modern pottery etc. were noted.

- 3.2.3 Subsoil comprised a mid–yellowish brown subsoil of similar composition and inclusions. Some sub-division of the subsoil was noted, although this is probably a result of post-depositional disturbance and sorting. The base of subsoil graded into an intermittent mid yellow, orange, or sometimes reddish brown clay-silt (occasionally silty clay, rarely purer clay), set around and between bands and other outcrops of weathered, geologically inclined Carboniferous limestone.

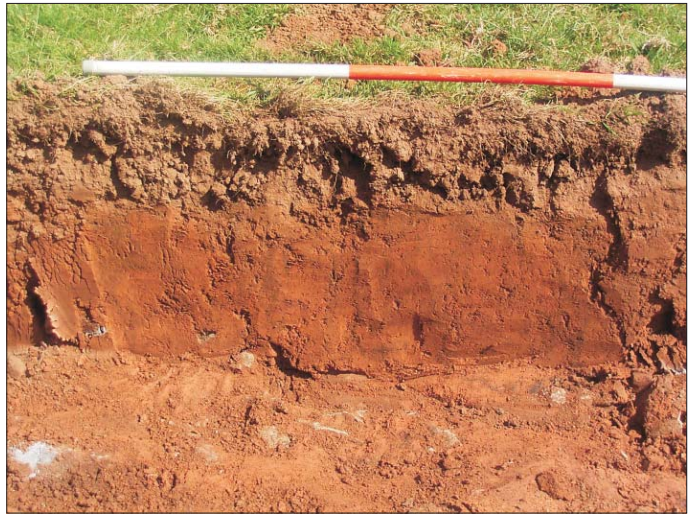
Plate 1. Trench 8 representative section

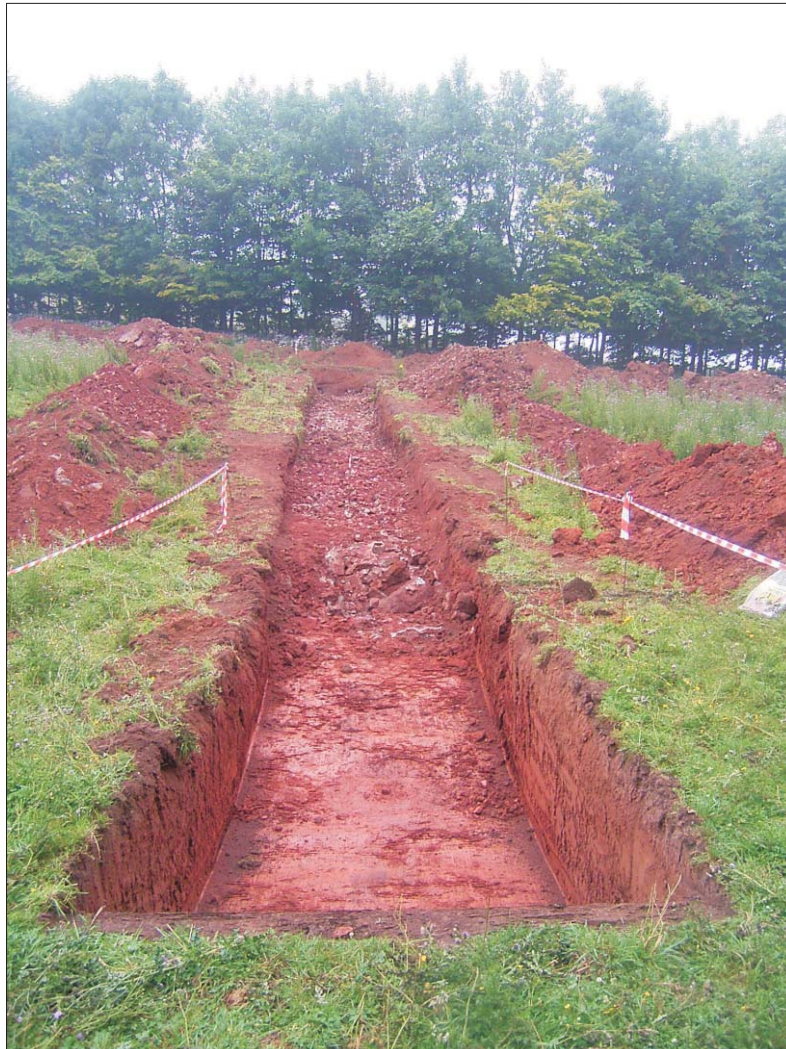
- 3.2.6 A large east-west aligned limestone fissure, recorded as [104], (or possibly a collapsed cave system) was identified at the southern end of **Trench 1** (see **Figure 2, Plate 2**). This feature is reflected in the Site's surface topography as a steep-sided coombe, albeit exaggerated in places by small extraction pits.

- 3.2.7 This feature is at least 7m wide, although its southern edge was not exposed, and the true width may be between 8-10m. It was mechanically excavated to 1.55m below ground level (BGL - measured at the base of the surface depression), then hand-augured to an additional 1.15m without any stone inclusions or significant change in fill composition being encountered.

- 3.2.8 Two fills were defined during the feature excavation: the upper deposit (**105**), was a mid-red silty clay, whilst the lower fill, (**106**), was a mid-orange brown silty clay. No artefacts were recovered from either fill.

Plate 2. Trench 1 viewed from the south

6.1.3 The extent and depth of the possible limestone fissure (Feature **[104]**) at the southern end of **Trench 1** remains uncertain. Although some potential for the recovery of palaeo-environmental from this feature remains, no dating evidence was located within its fills during the evaluation, therefore indicating a low potential for a meaningful interpretation of any such assemblages.
