219-221 Bow Road London Borough of Tower Hamlets

Archaeological Evaluation Report

Planning Ref: PA/14/03660
MoL Site Code: BOO16
Ref: 115160.01
February 2017

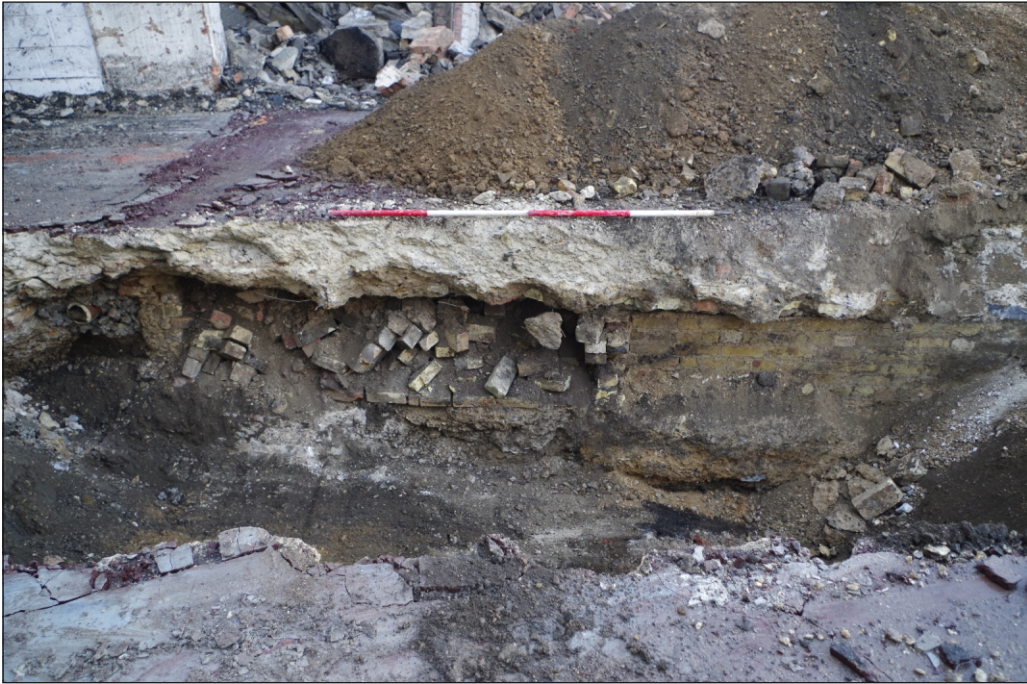
Plate 1: Southeast facing section of Trench 1, showing unstable made ground

4.3.1 Trench 1 was located in the north-west area of the Site and was aligned south-west to north-east. The trench originally measured 10m x 1.80m, however this was shortened due to existing buildings and demolition work onsite. The trench was excavated to a depth of 1.70m below ground level (BGL) (9.36m aOD). The made ground in this trench was deemed too unstable to ensure safe entry to the base of the trench therefore all recording took place from ground level only. The natural geology was observed at a depth of approximately 1.60m BGL and was heavily truncated by modern wall foundations (**Plate 1**).

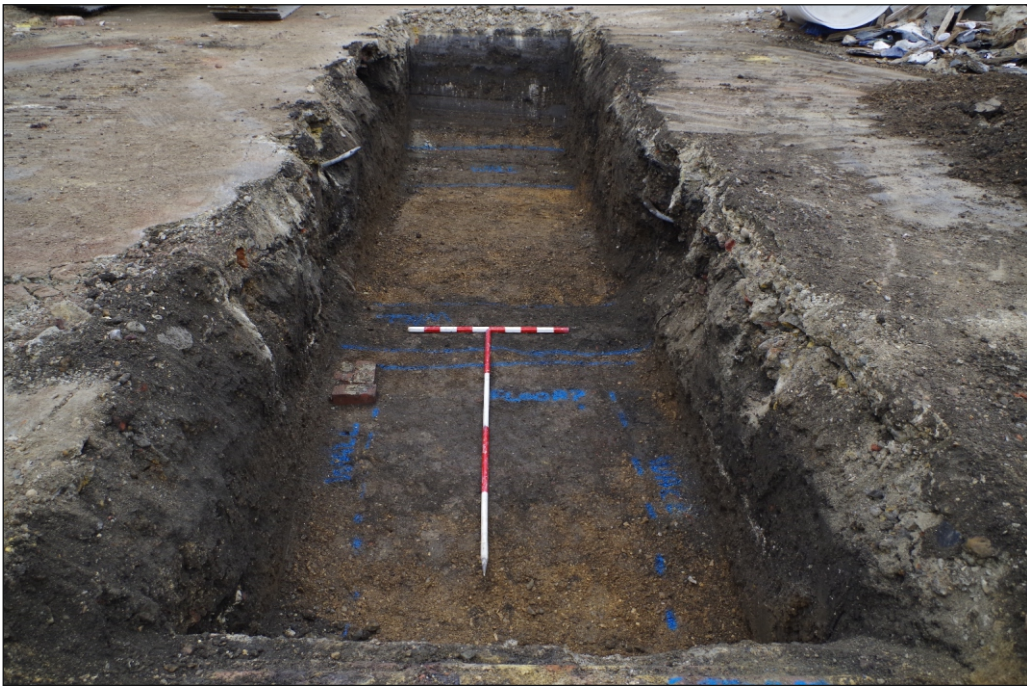
Plate 2: Trench 2 looking northwest

4.3.2 Trench 2 was located to the north of the Site and was aligned north-west to south-east. The trench measured 10m x 1.80m and was excavated to a depth of 1.30m BGL (9.30m aOD). The natural geology was observed at a depth of 1.20m BGL (**Plates 2-4**). Wall foundation cut **207** was located in the north-west limits of the trench and was found to be extremely shallow at only 0.02m in depth. Cut **207** was identified to be associated with a former small structure identified on the 1896 Ordnance survey map and would have formed part of the structure's south-east facing wall (See **Figure 3**). Foundation cut **204** was located in the south-east end of the trench. A single course of modern brick remained *in situ* and was identified as modern in date. A brick was also removed from structure **205** for dating purposes and found to be of 19th century date (See 5.3.1).

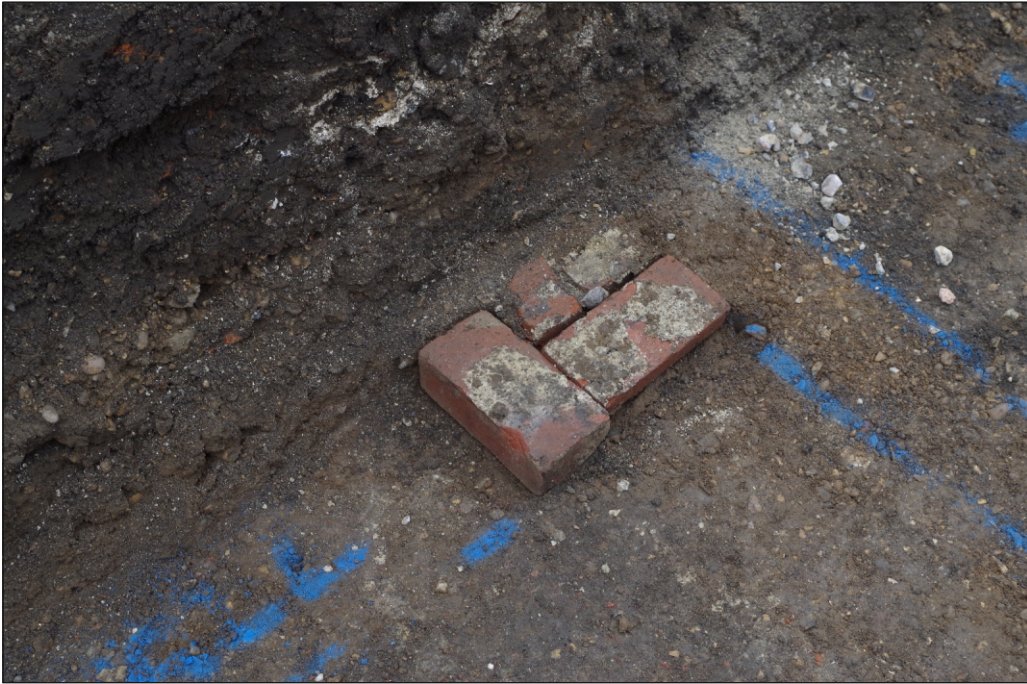
Plate 3: Structure 205 in Trench 2

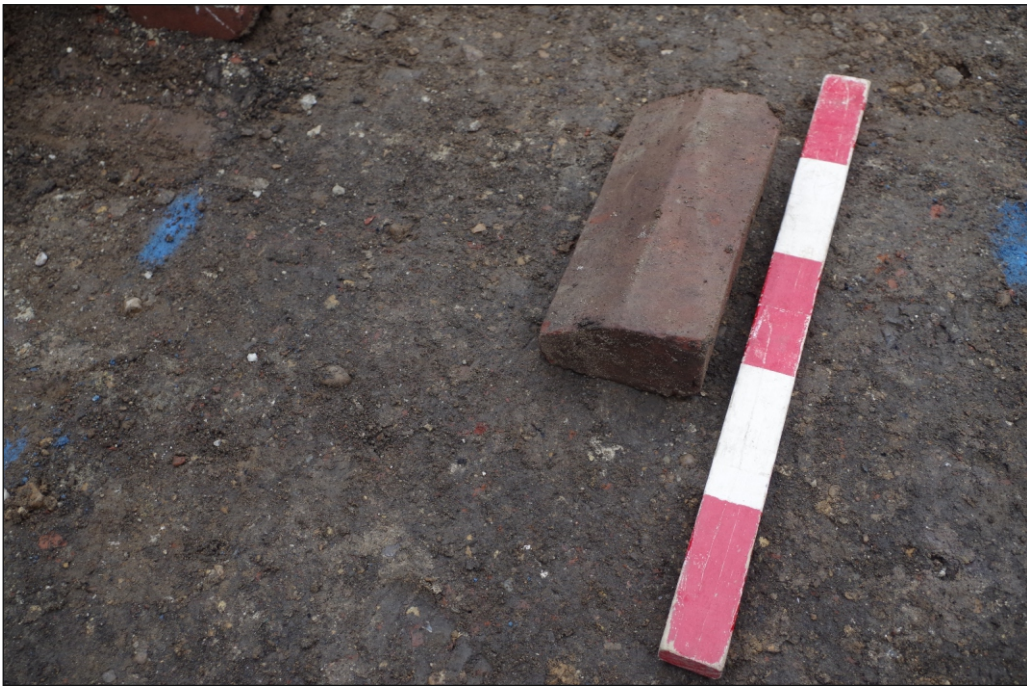
Plate 4: Brick from wall 205

5.3.1 Two brick samples were retained. The example from structure **406** is an unfrosted brick (235 x 115 x 60mm) in a coarse fabric, probably dating from the period c.1550–1666. The second example, from wall context **205**, is a 19th/20th century brick of plinth stretcher form (chamfered along one long edge).

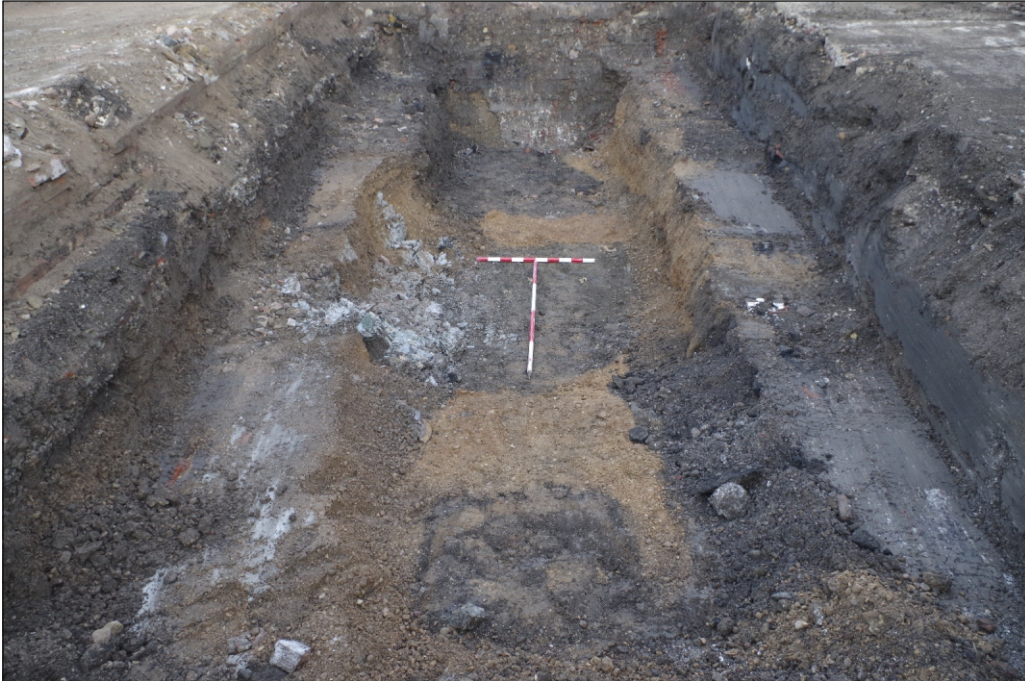
Plate 5: Trench 3 looking northeast, showing modern truncation and unstable made ground

4.3.3 Trench 3 was located in the eastern area of the Site and was aligned south-west to north-east. The trench measured 8m x 1.80m at the base and excavated to a maximum depth of 2.00m BGL (8.30m aOD). Due to its depth, the trench was stepped 1.00m along the sides. The natural geology was observed at a depth of 1.40m BGL. The trench was heavily truncated by modern building rubble or demolition material and due to unstable made ground it was recorded from ground level only (**Plate 5**).

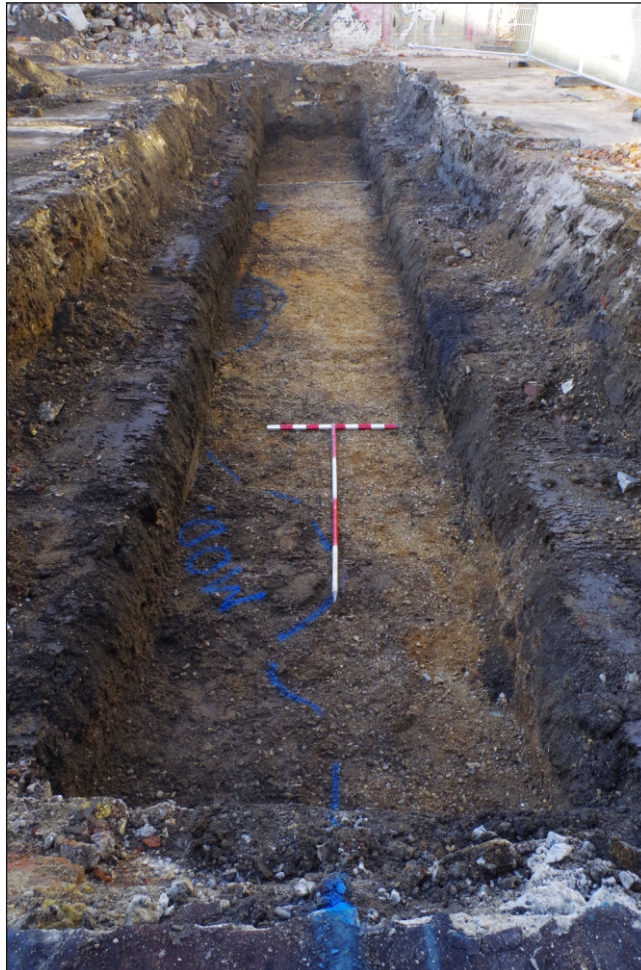
Plate 6: Trench 4 looking northeast

4.3.4 Trench 4 was located along the eastern edge of the Site and at right angles to Trenches 3 and 5. It was aligned north-west to south-east and measured 15m x 1.80m. The trench was excavated to a maximum depth of 1.43m BGL (8.70m aOD). Due to its depth, the trench was stepped 1.00m along the sides. The natural geology was observed at a depth of 1.38m BGL. There were three distinct areas of modern truncation observed along the base of the trench and a modern wall truncated the made ground **402** at the south-west end of the trench. A single course of bricks **406** identified as a former wall, was observed at the north-west end of the trench, with construction cut **407** and backfill **408**. A sample of one of the bricks from wall **406** was retained for identification and dating purposes. (**Plates 6-8**).

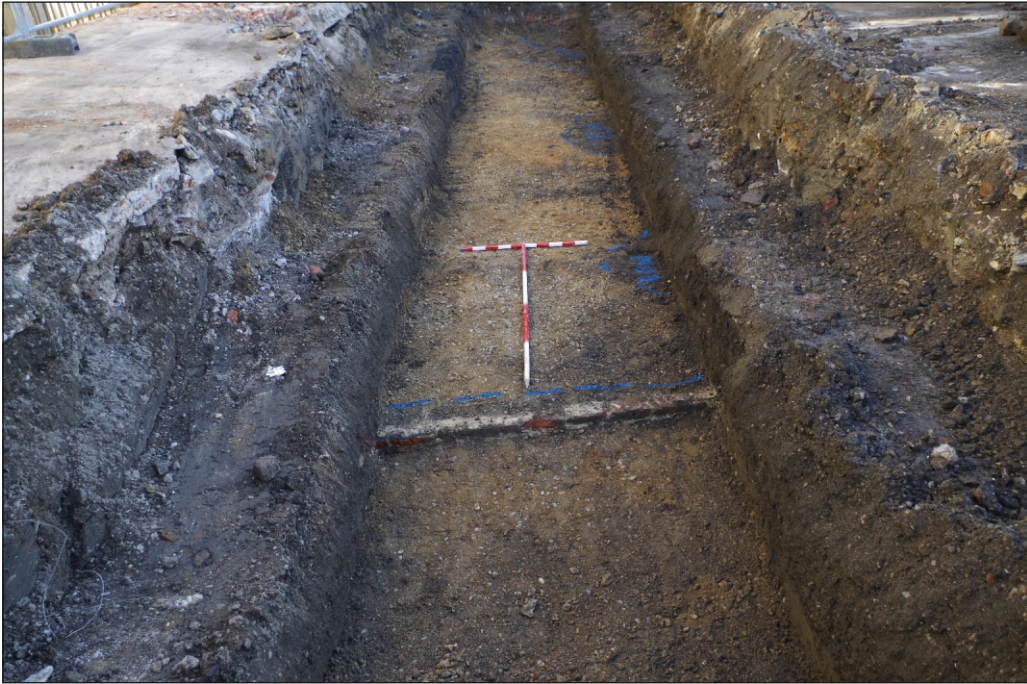
Plate 7: Structure 406 in Trench 4

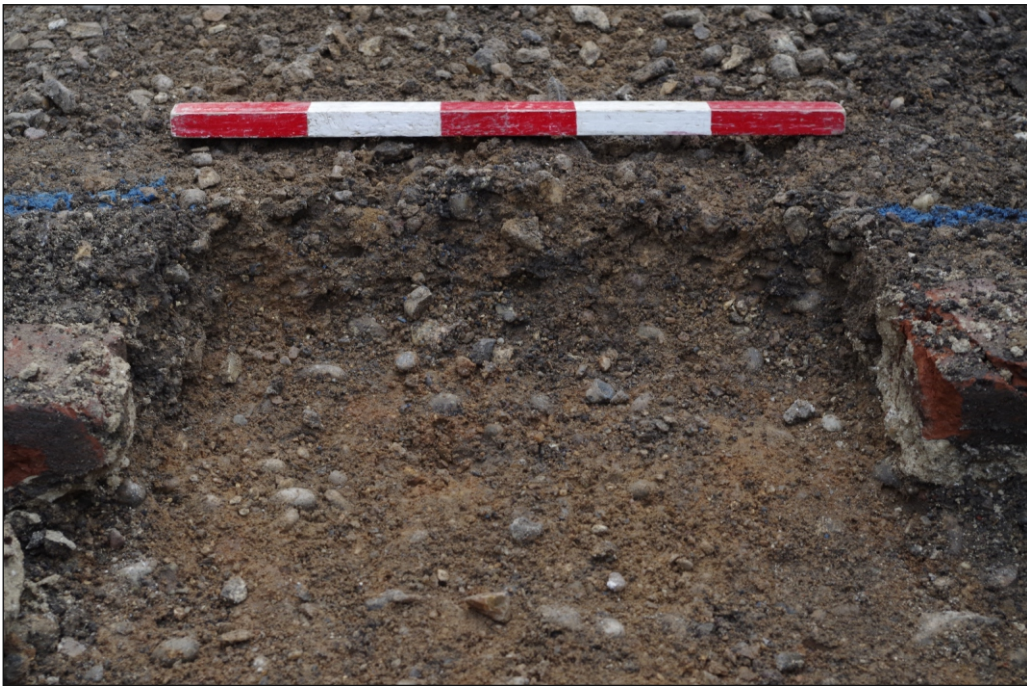
Plate 8: Slot through wall 406, showing fill 408 and cut 407

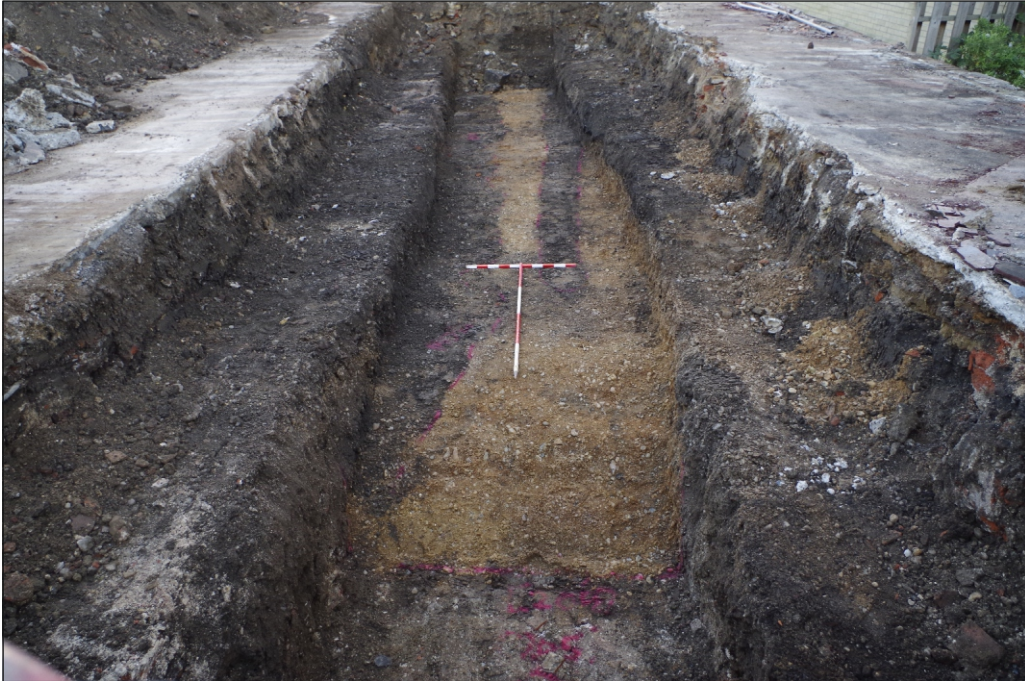
Plate 9: Trench 5 looking northwest

4.3.5 Trench 5 was located in the eastern area of the Site and aligned south-west to north-east. The trench measured 13.8m x 1.80m at the base and was excavated to a depth of 1.50m BGL (8.45m aOD). Due its depth, the trench was stepped 1.00m along the sides. The natural geology was observed at a depth of 1.40m BGL. At the south-west end of the

trench wall **506** with its associated cut **504** and backfill **505** was observed to cut the made ground. The wall was identified during the initial stepping of the trench and was found not to continue down to the natural horizon. Upon investigation it was established that wall **506** was of relatively modern construction and was proved to cut into made ground deposit **502** (Plates 9-10). Modern disturbance **507** was identified running across the centre of the trench and was recorded to be 0.20m deep. A second possible linear feature **508** was also identified running on a north-east to south-west alignment at a similar depth to **507**. Upon investigation both features were found to contain large quantities of modern material and were identified as further modern disturbance. The feature's identified in Trench 5 are all located within the development footprint of the L-shaped structure recorded on the 1896 Ordnance survey map and were likely formed as a result of the construction and demolition of the building (Heritage Collective 2014:16).

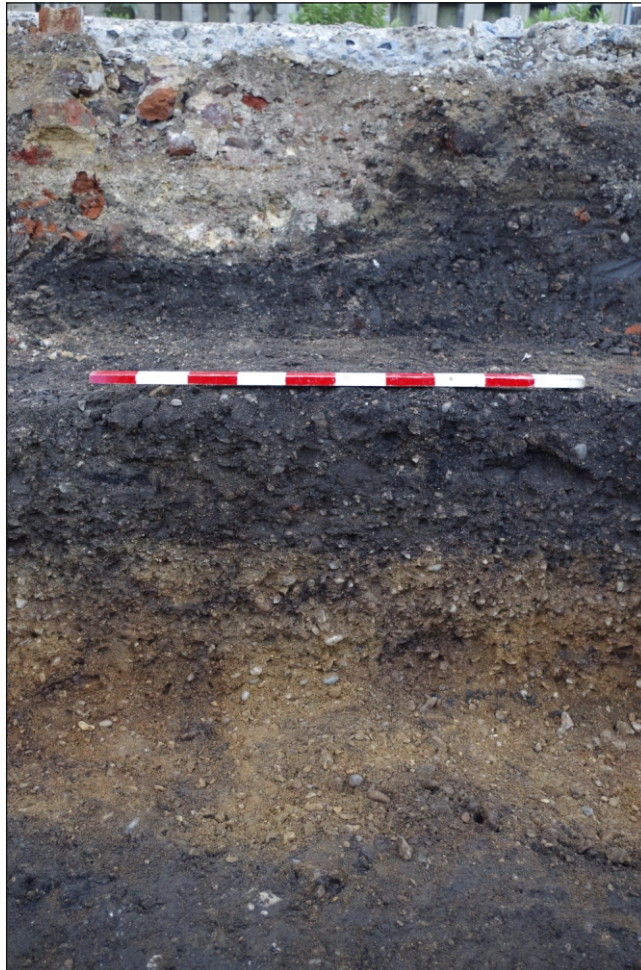
Plate 10: Trench 5, southwest facing section
