# Perham Down World War I Practice Trenches, Salisbury Plain, Hampshire

Archaeological Evaluation Report

Ref: 113940  
January 2017

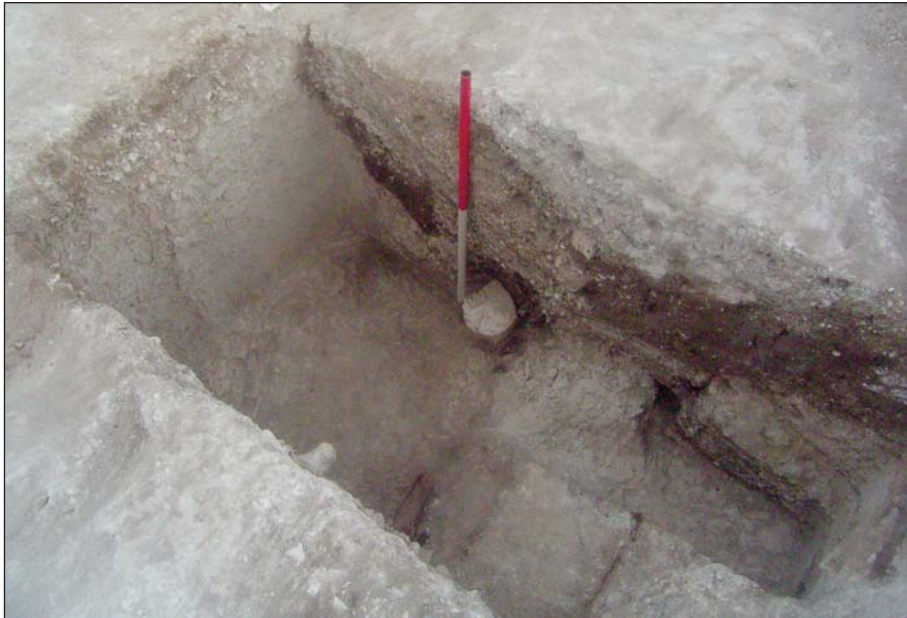
Plate 4: Trench 2: Front Line, Trench [235] and Sap [236]; note carved chalk plaque in section, view from south-east (scale = 1 m)

- 6.1.7 The most significant object found came from near the bottom of the Front Line in trench 2 (see **Plate 4**) and comprises two (non-joining) fragments of a chalk plaque; only a 1 m wide section was excavated here and other fragments of the plaque are likely to lie nearby. The size and shape of the complete object is uncertain, as is where it was set up, though it seems likely that this was near where it was found. Its location, however, clearly demonstrates that it was broken and discarded during the use of the Front Line as it was found in a context which post-dated the first fire step and predated the second (see above).

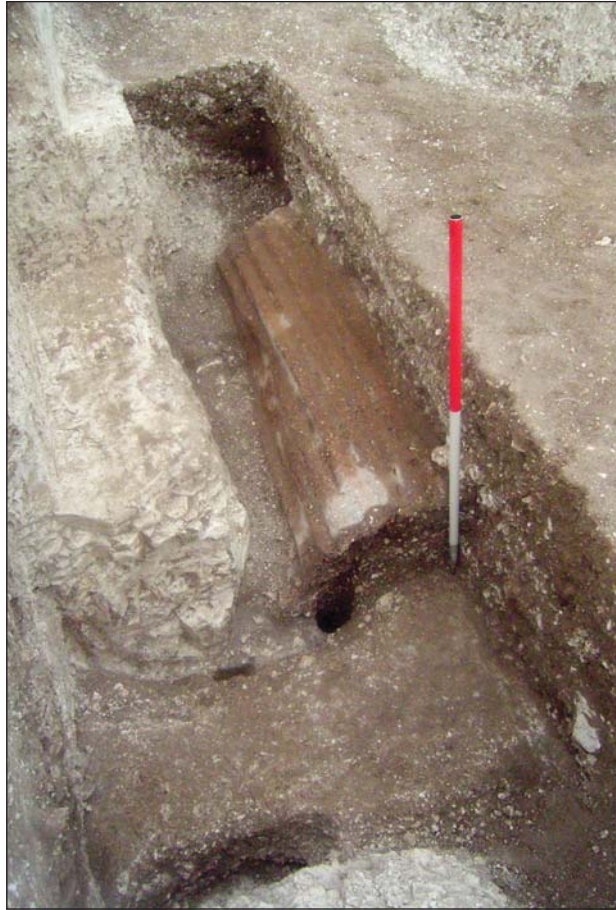
Plate 9: Trench 4: Shelter [428], half-excavated showing corrugated iron sheet in section, view from south-west (scale = 1 m)

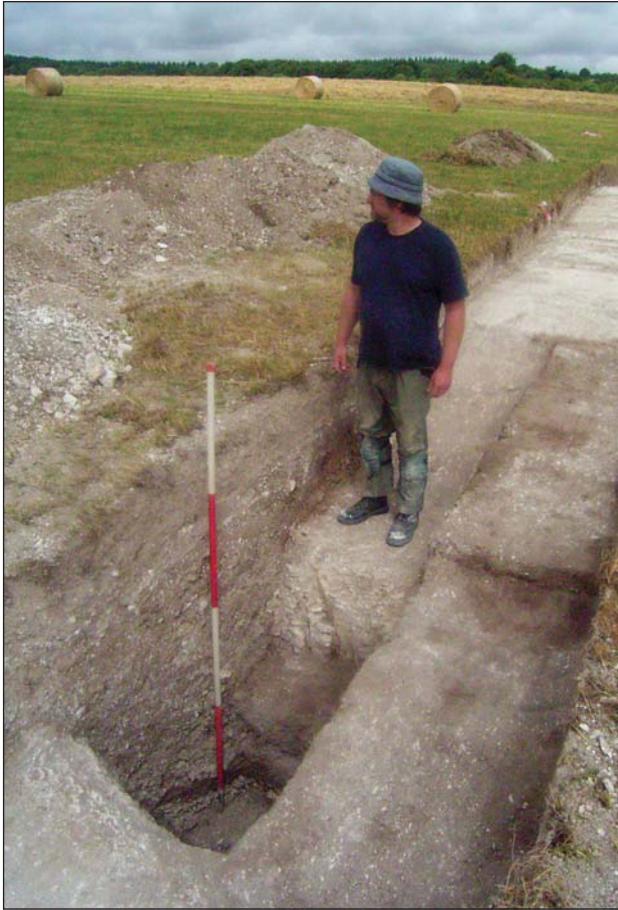
Plate 13: Trench 6: Supply Trench [615] / [616], view from south-east (scale = 2 m)

- 5.7.3 Trench [615] was the deeper of the two elements, with the base at 1.5 m, and at the top it was broader with a width of 2.6 m, including a 1 m wide shallower section on the south side (Figure 10; Plate 13). The somewhat concave profile below this was undoubtedly a result of post-abandonment weathering and erosion, but below 0.8 m it was near-vertical, approximately 0.8 m wide, with a narrow shelf 0.45 m above the base, perhaps to facilitate the carrying of stretchers (see trench 3 above for a similar feature). A slot filled with loose chalk (613) along the south side at the base reflects the former presence of a (timber) revetment, and it is likely that a counterpart existed along the north side (not fully excavated, to enable access). Between these slots was trample layer (614) 0.08 m thick.

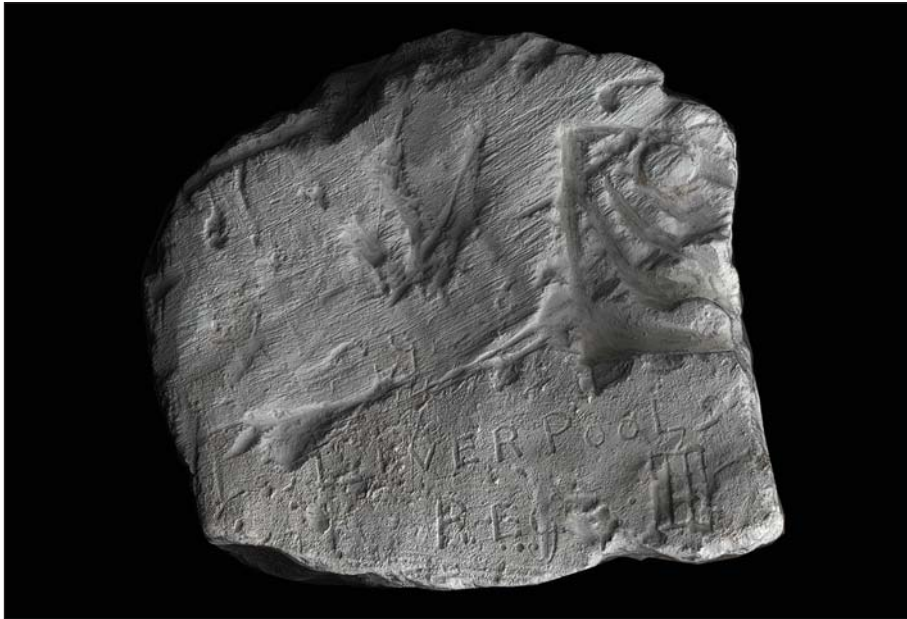
Plate 15: RTI photograph of chalk plaque fragment from trench 2: Front Line
