Former Grill Bar (The Mile House) London Road, St Albans, Hertfordshire

Archaeological Evaluation Report

Report reference: 65130.03

May 2007

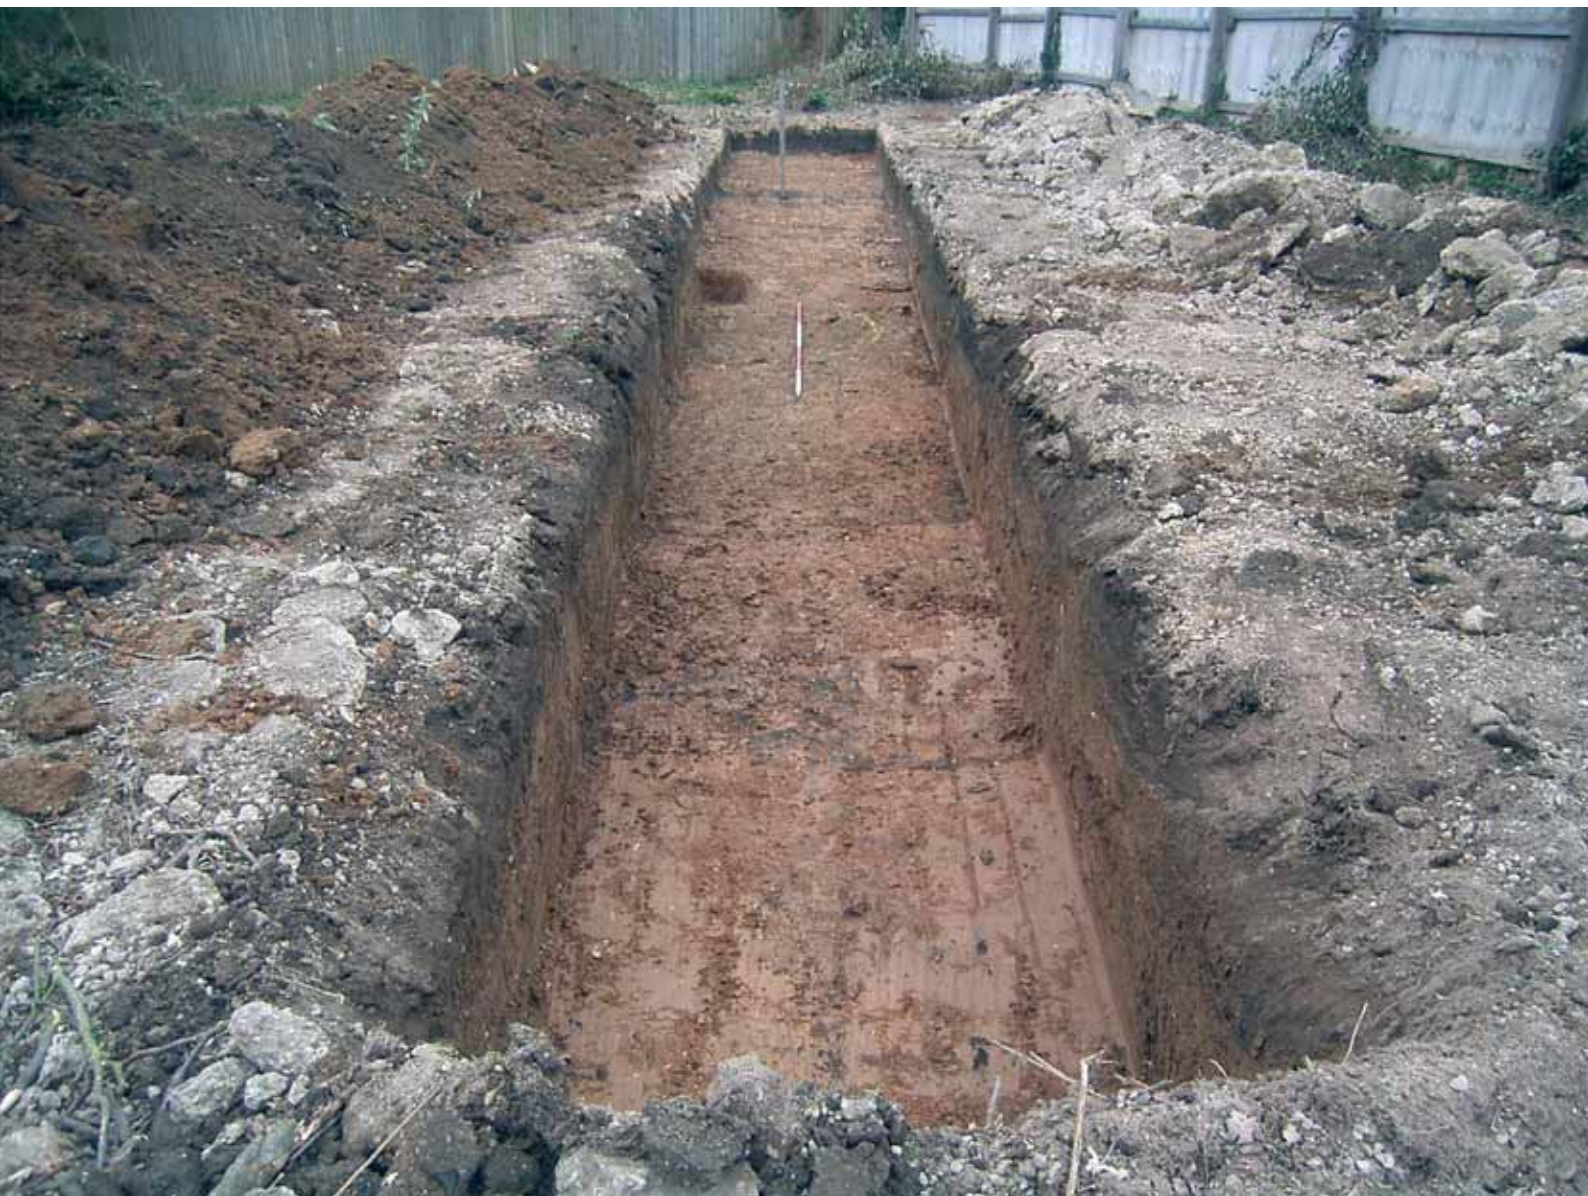
- Front cover. Trench 1 from the south-east
Figure 1. Site and trench location
Figure 2. Plate 1: Trench 2 from the east
Plate 2: Trench 3 from the south-east
Plate 3: Trench 4 from the north-west
Plate 4: Trench 5 from the north-east
Back cover. View of the Site from the south-east

- 5.2.1 In Trenches 1 and 3 which were aligned north-west – south-east and parallel to the London Road edge of the Site, natural geology was encountered at a depth of between 1.10m and 1.20m. No evidence for a ditch that may have been associated with the Tudor Boundary was identified. Given the close proximity of these trenches to London Road and therefore the 16th century boundary bank, these two trenches were thought to be the most likely candidates for providing evidence for the associated boundary ditch. A modern treethrow (**105**) was noted in Trench 1 (**Front cover** and **Figure 1**) and a number of modern services were identified in Trench 3 (**Figure 1** and **Plate 2**).

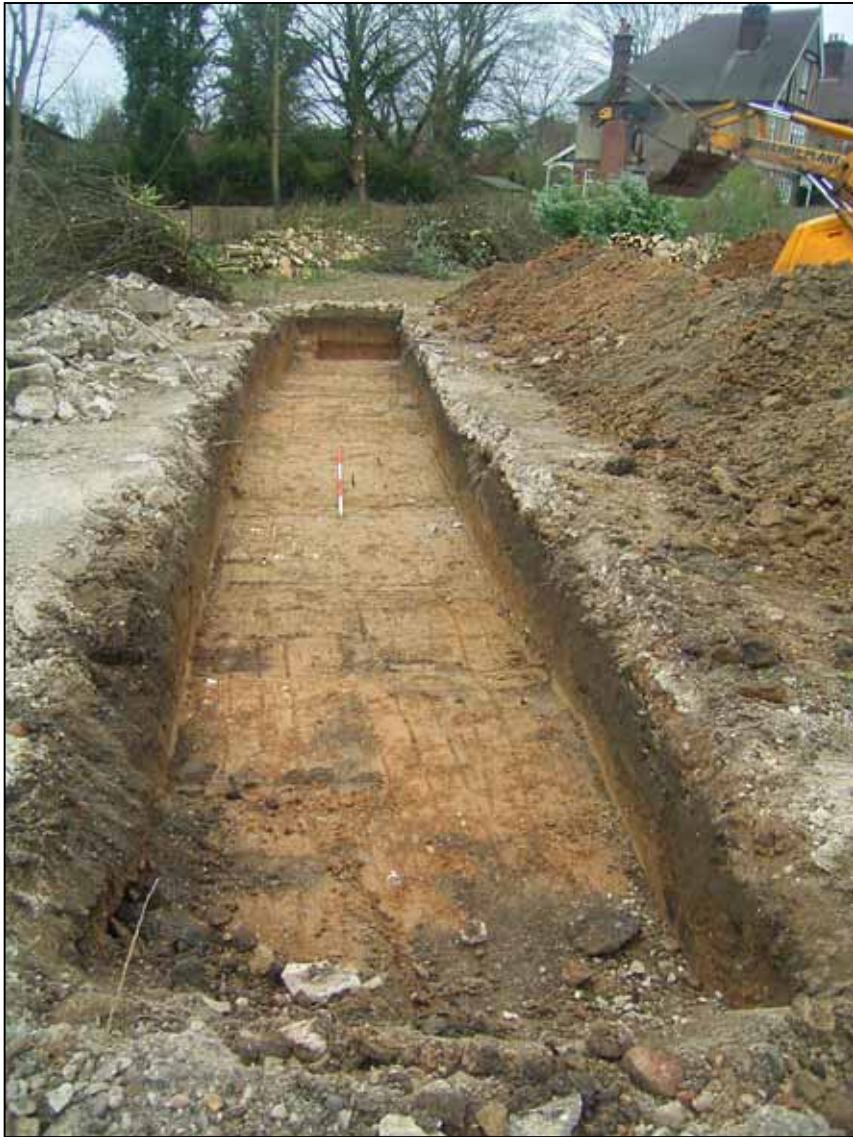
- 5.2.2 In Trench 2, the majority of deposits related to modern made ground horizons, and natural geology was encountered at a depth of 1m below the present ground surface. At the eastern end of the trench, a number of modern services were encountered and the opening of the trench was curtailed 2m short of its proposed full extent of 20m. No archaeological features or finds were encountered (**Figure 1** and **Plate 1**).

Plate 1: Trench 2 from the east

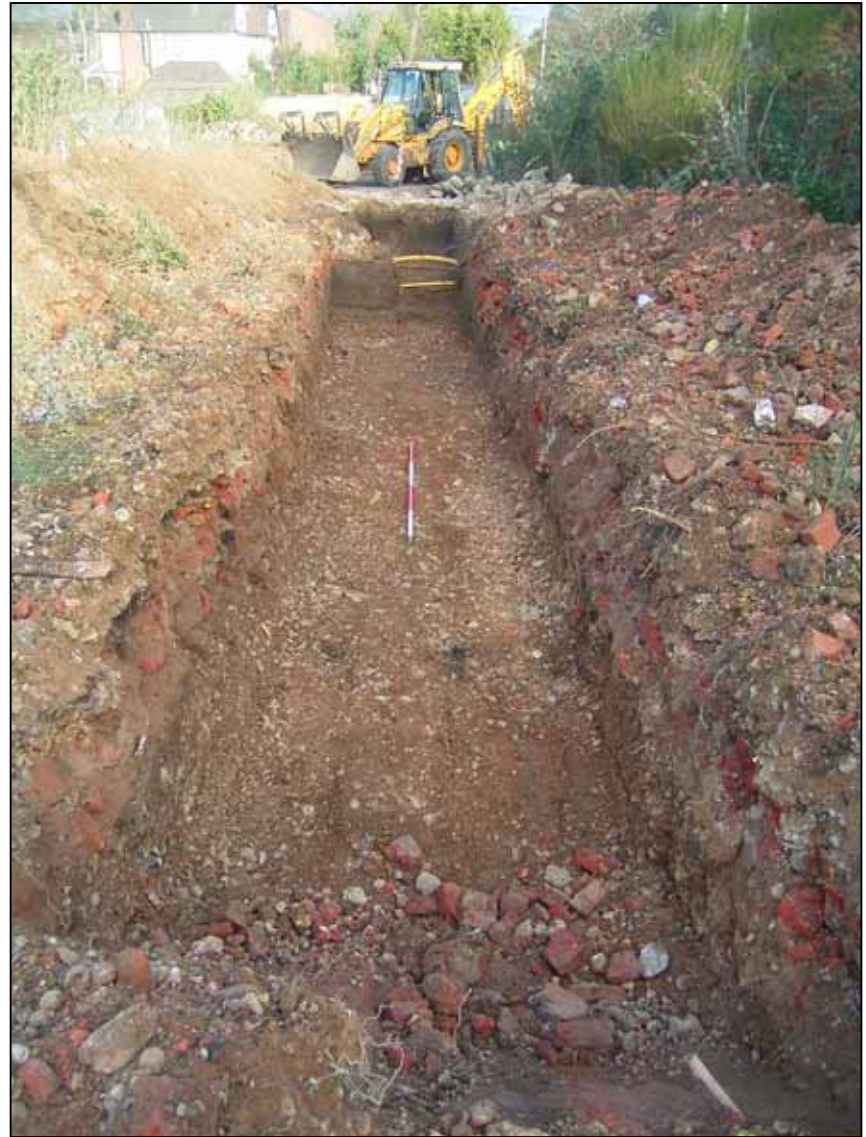
Plate 2: Trench 3 from the south-east

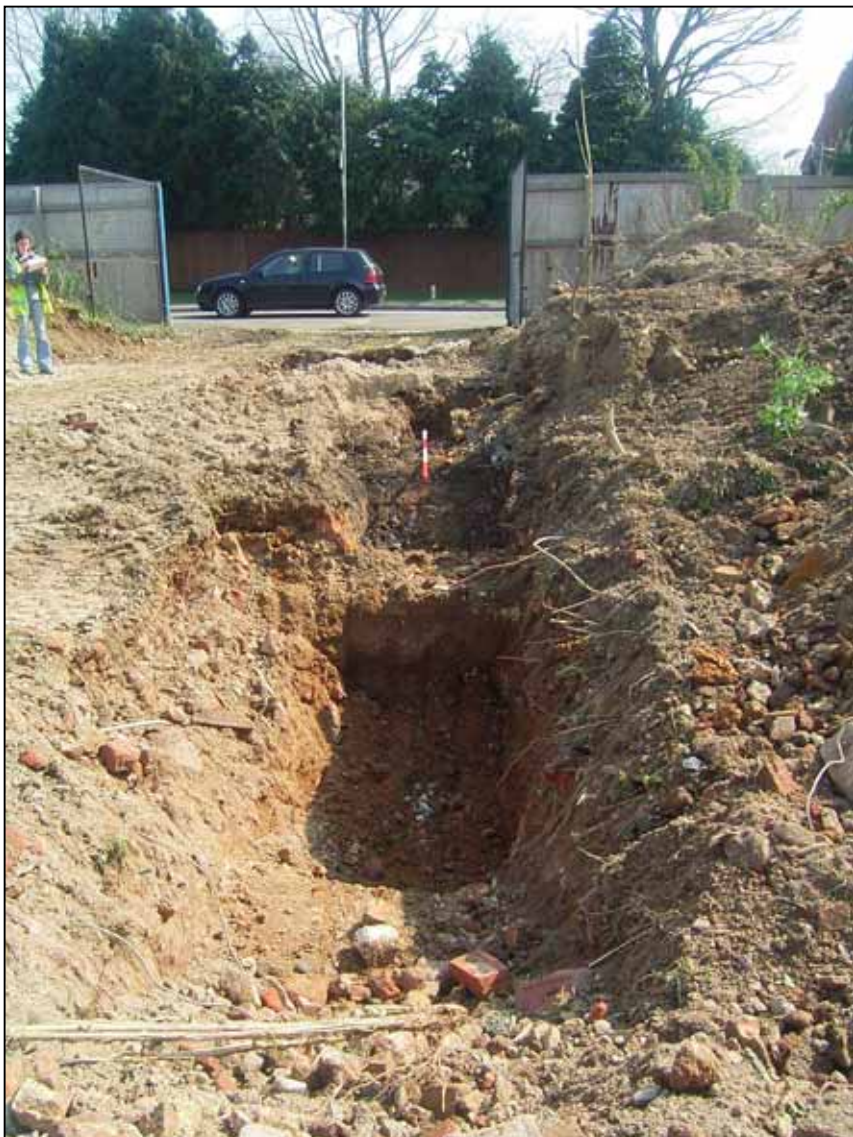
- 5.2.3 Trench 4 had been subject to major modern disturbance, as a result of its direct location over the former Grill Bar. A series of services were encountered in the south-eastern part of this trench, including a man hole cover and two water pipes. Modern wall footings associated with the foundations of the Grill Bar were present in the central and western parts of the Trench, truncating all earlier deposits in this area. Natural geology was noted at 1.25m below the modern ground surface demonstrating that any previously surviving archaeological horizons would have been completely truncated by the former building. No archaeological features or finds were identified (**Figure 1** and **Plate 3**).

Plate 3: Trench 4 from the north-west

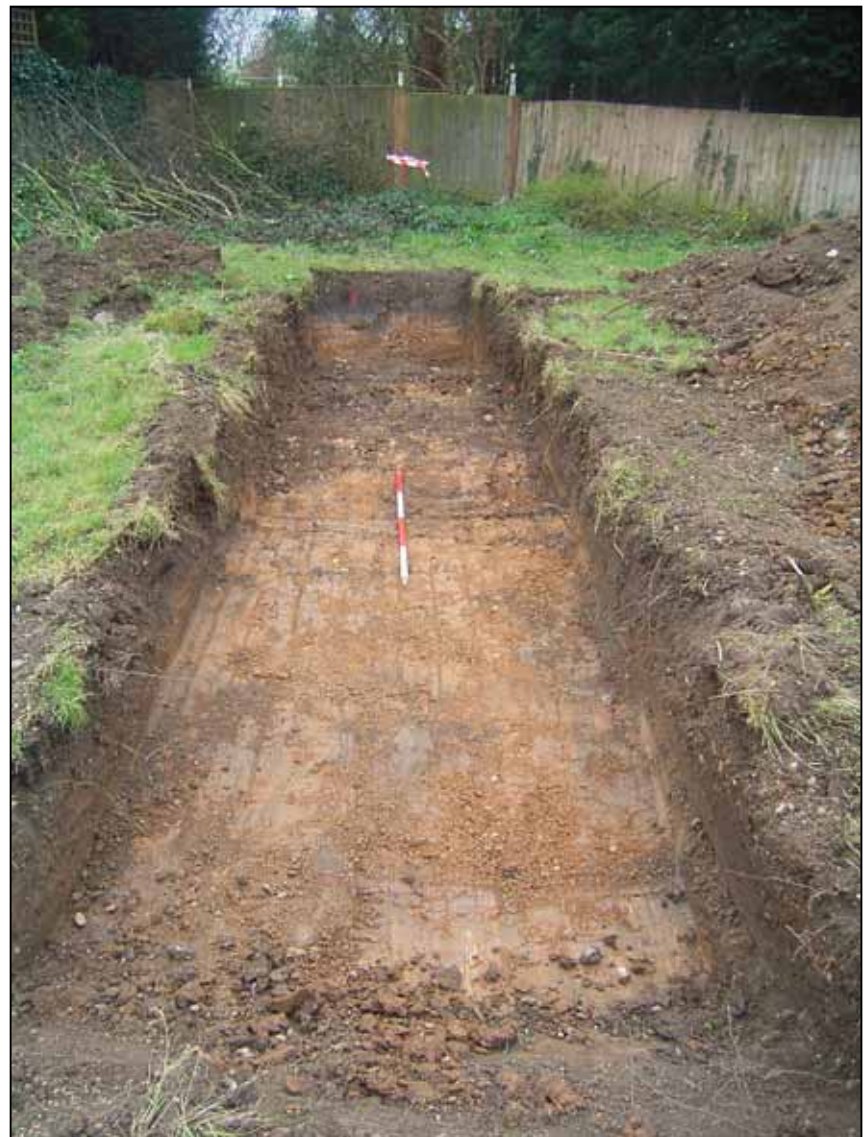
- 5.2.4 Trench 5 was opened within the former garden of the Grill Bar which had been laid to grass. After removal of modern topsoil and made ground, natural geology was encountered at a depth of 0.6m in the southern part of the trench and 0.45m in the northern part of the trench. This confirms the results of the geological borehole survey in this area, which had encountered a shallow depositional sequence (KF Geotechnical 2003). A large modern rubbish pit (**504**) at least 2.5m in diameter, truncated the

natural geology in the southern part of the trench. No archaeological features or finds were retrieved (**Figure 1 and Plate 4**).

Plate 4: Trench 5 from the north-east
