Union Wharf,
Orchard Place, Leamouth E14,
London Borough of Tower Hamlets

Report on Archaeological Evaluation

**Reference: 65500.04
MOL UWF07**

Date: June 2007

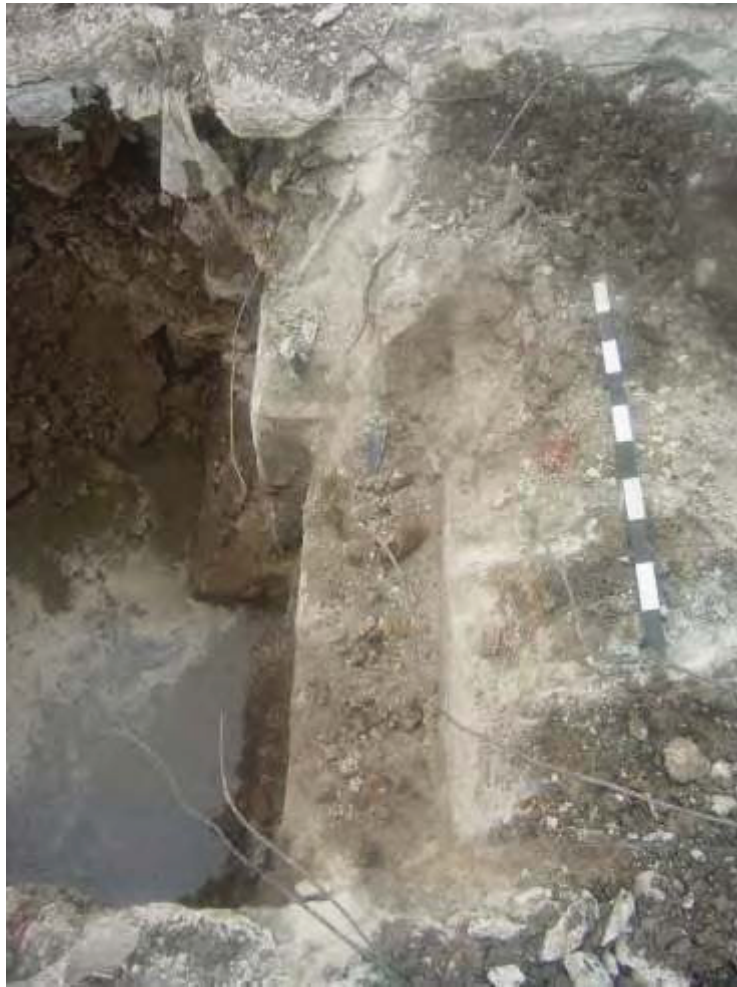
Plate 1. Trench 1 concrete haunching from the west

- 6.1 Both the concrete haunching and the top of the box piling from the 1945 reconstruction were visible (see **Figures 2, 3 and Plates 1 & 2**). No remains of the original structure were present. The trench was dug to a depth of 4.5m, at which point the sides became unstable due to incoming water.

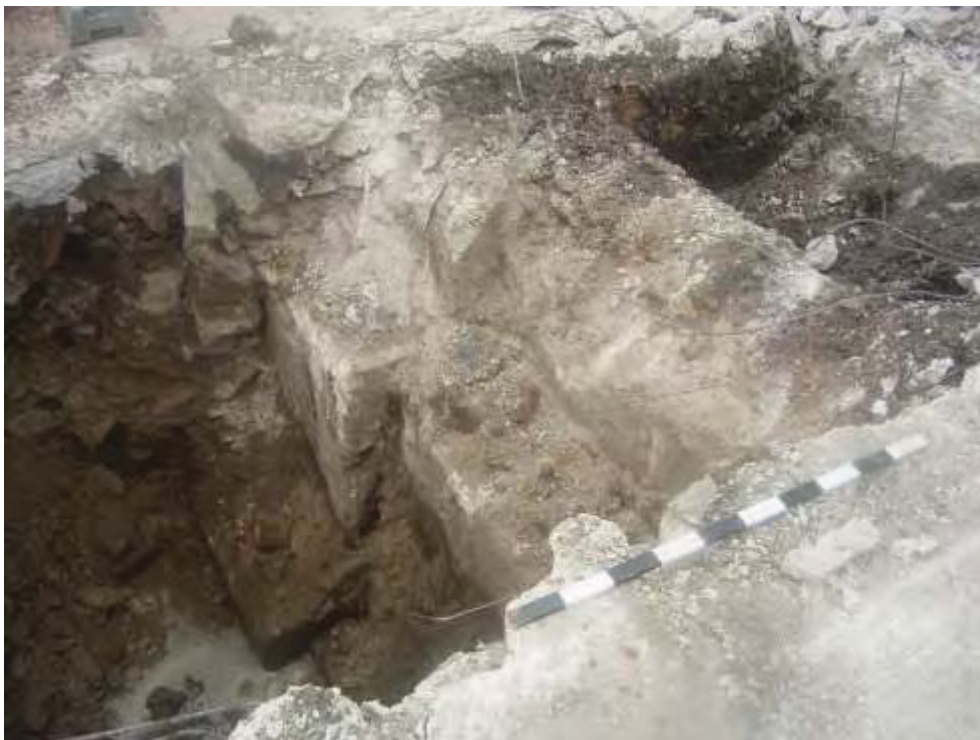
Plate 2. Trench 1 concrete haunching from the north east

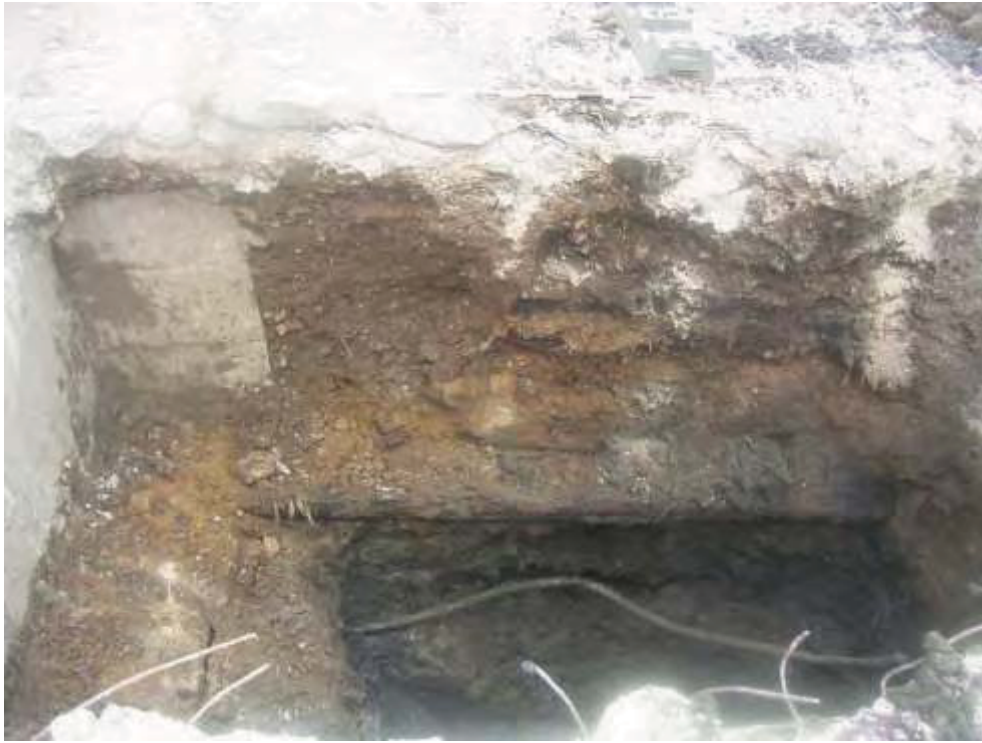
Plate 3. Trench 2 from the north showing piling

- 6.2 Again the concrete haunching and the top of the rake piles were visible, as were several of the anchoring steel ties (See **Figure 4 and Plates 3 & 4**). As in trench 1, none of the original structure remained behind the mass concrete walls. The trench was dug to a depth of 6m before becoming unstable.

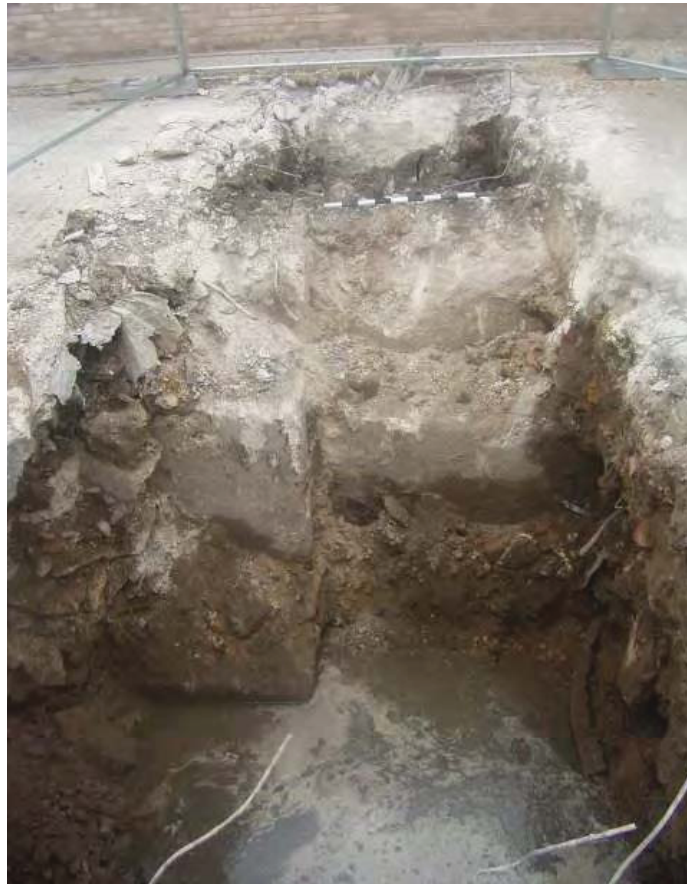
Plate 4. Trench 2 from the east showing haunching with tie rods
