Berrington Walled Gardens Leominster, Herefordshire

Archaeological Evaluation

Ref: 115360.06
February 2017

Archaeological Trial Trenching

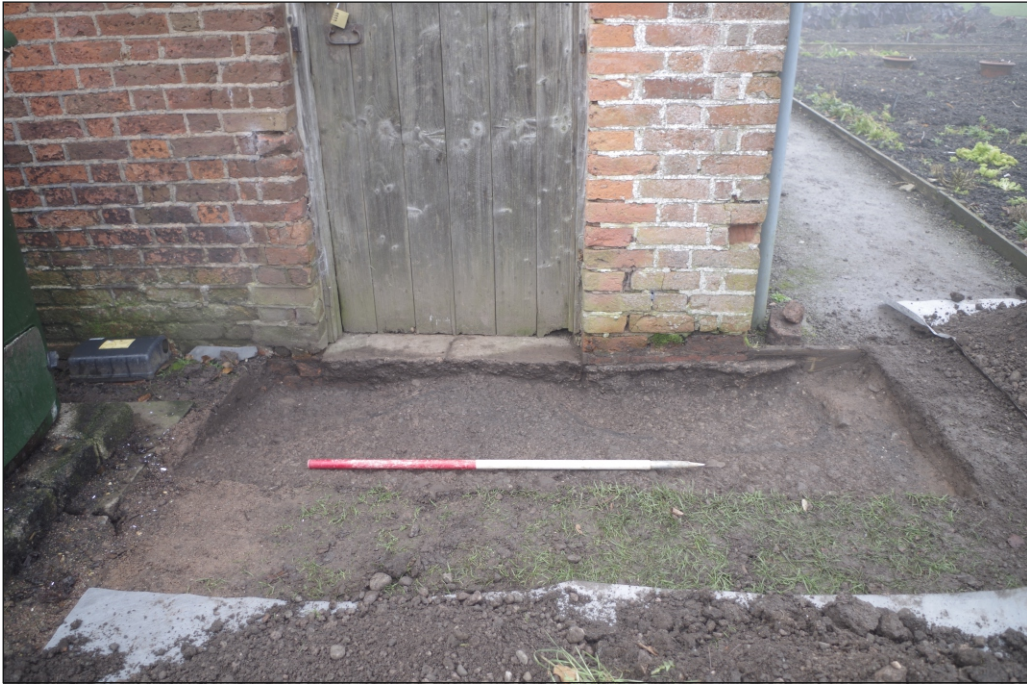
Plate 1: Trench 1, view from east

- 4.2.2 A layer (**102**) (**Figure 2, Plate 1**) of rounded pebbles of different size and shape set in mortar-like bedding formed an extremely compacted hard standing or floor butting the brick wall of the potting shed and matching the geophysical survey results. No further walls were identified. To the north the structure had a distinctive straight edge to the yellowish brown alluvial deposit (**103**) identified in most trenches across the Site. This was overlain by turf (**101**) representing the current garden surface.

- 4.2.3 It is highly likely that the structure represented the bedding for a brick floor similar to the one in the potting shed, which is assumed to have survived from the original glasshouse. Abundant window glass fragments and nails immediately overlying this structure supports this interpretation.

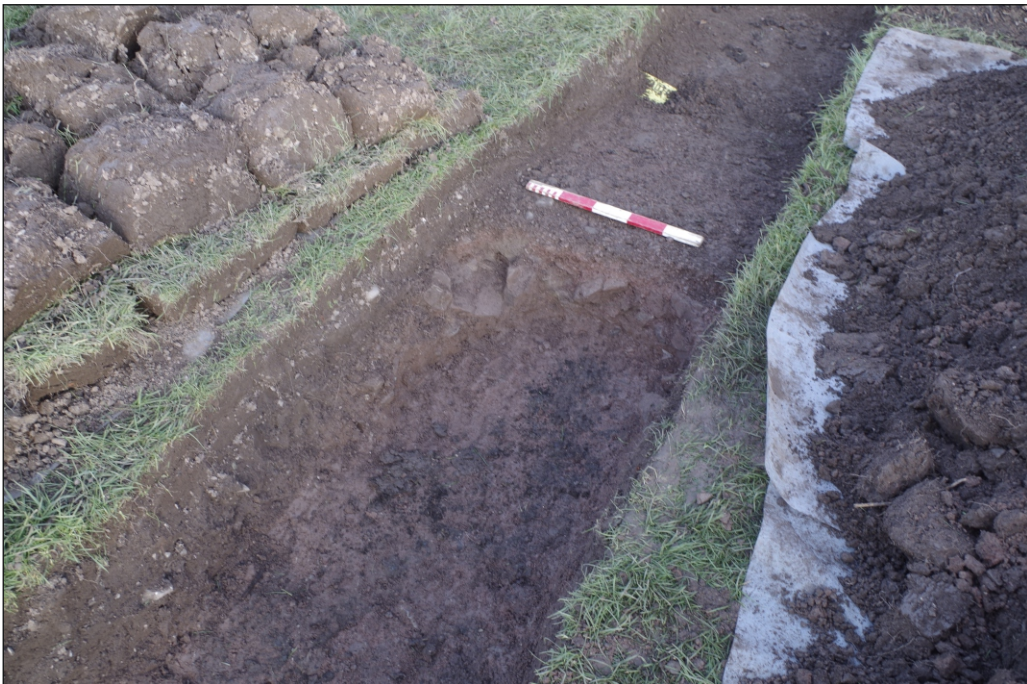
Plate 2: Trench 2, view from southwest

- 4.3.1 Trench 2 (**Figure 2, Plate 2**) was located in the northeast of the Walled Garden (**Figure 1**). It was 5.00 m long, 0.80 m wide and excavated to a depth of 0.45 m, targeting a garden path shown on the 1887 map and shown in the radar survey.
- 4.3.2 Immediately overlain by garden soil (**202**) and the turf layer (**201**) the surface of the expected garden path (**203**) could be identified in its full width of 1.80 m. The layer consisted of pea gravel in red sand disturbed by a modern electric cable at its eastern edge.
- 4.3.3 To investigate the construction of the garden path a slot was cut down to the yellowish brown alluvial deposit (**204**) (**Figure 2, Plate 3**). The section showed a hard core consisting of medium sized sandstone pebbles (**205**) forming a distinctive central camber.

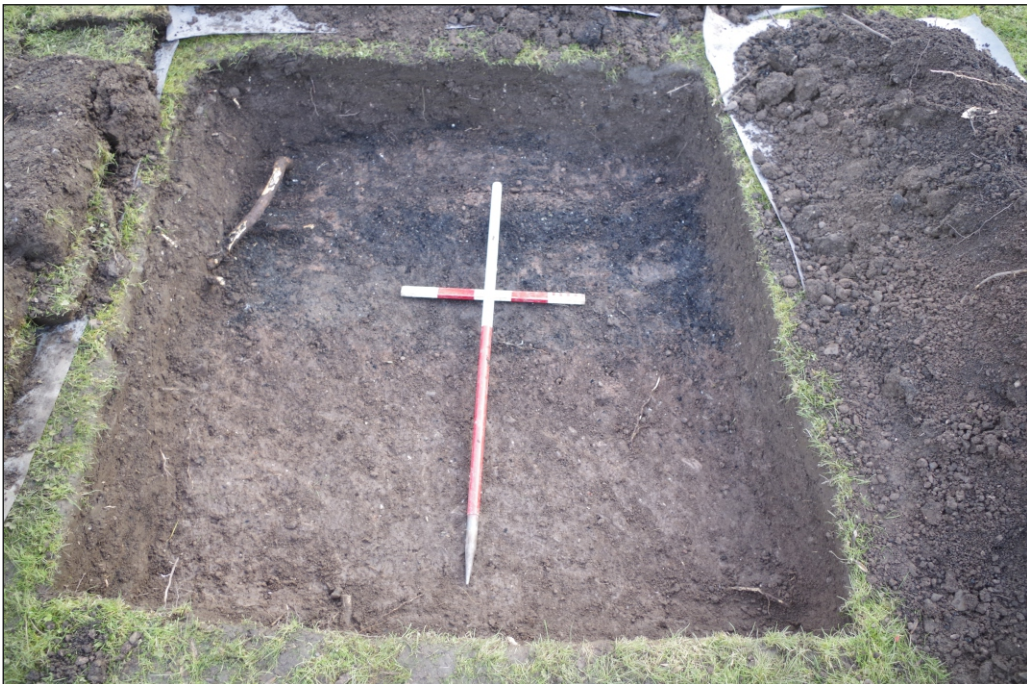
Plate 4: Trench 3, view from north

- 4.4.1 Located in the orchard (**Figure 1**), trench 3 consisted of a 1.5 m square situated in the southwest of the walled garden. The aim of the trench was to find any traces of former planting trenches such as those shown on the 1887 estate plan. The trench (**Figure 3**,

Plate 4) was excavated to a depth of 0.30 m where the yellowish brown alluvial deposit (**304**) was identified that was represented across the Site.

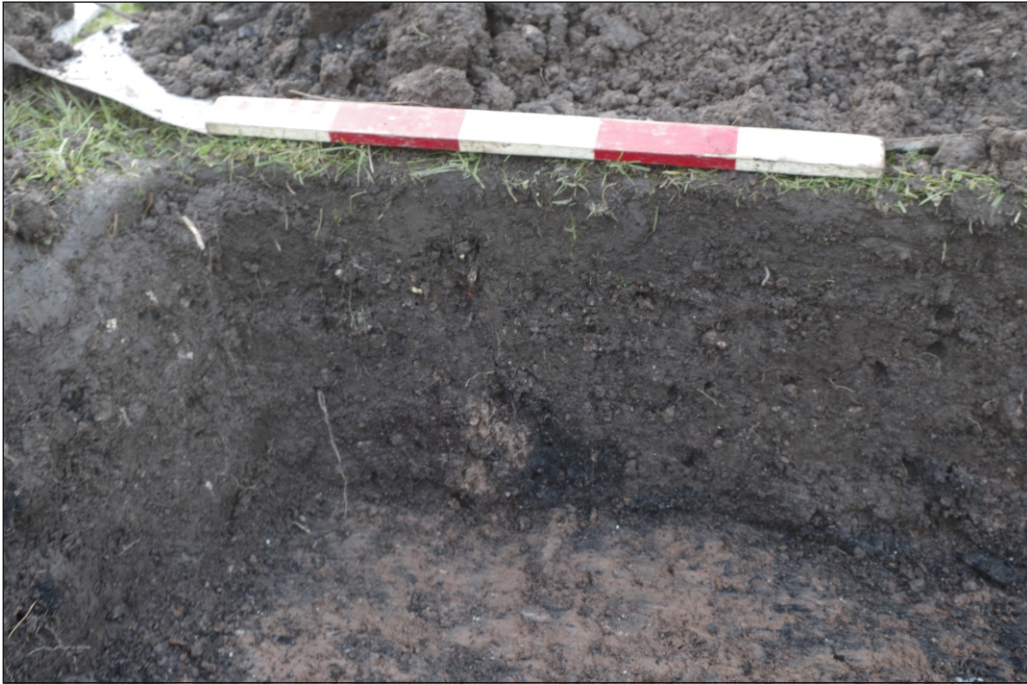
Plate 5: Trench 3, east-facing section plant bed

4.4.2 This layer formed a small linear deposit in east-west alignment directly overlain by a thin layer of black organic material (**303**) 0.02 m thick and covering the heap in a strip from the southern trench edge for 0.90 m to the north (**Figure 3, Plate 5**).

4.4.3 The features identified in this trench showed similarities to the current strawberry beds and may be relatively modern. There is no clear evidence that beds have survived from the late 19th century.

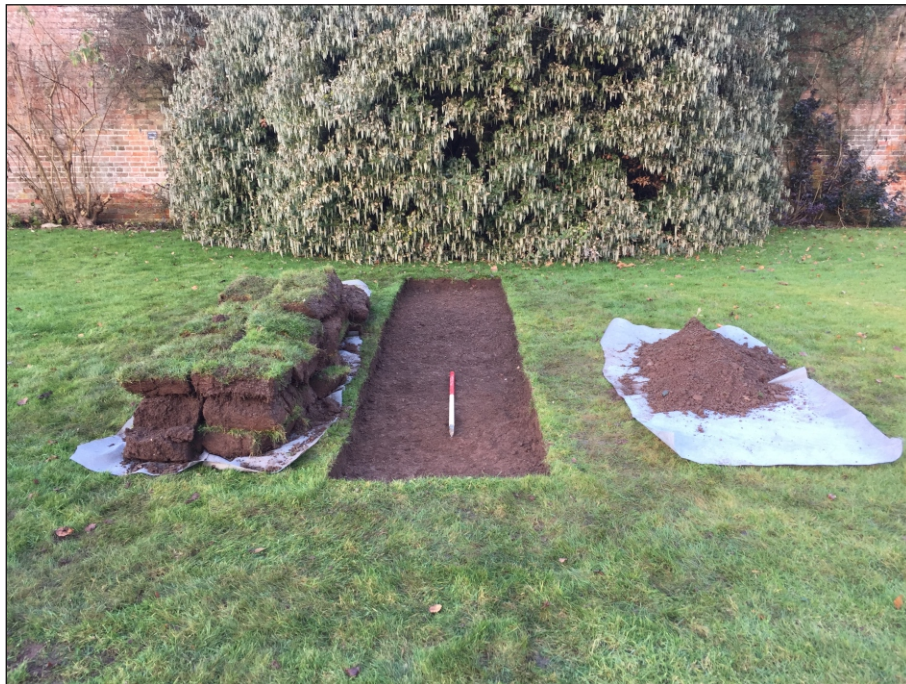
Plate 6: Trench 4, view from south

4.5.1 Trench 4 (**Plate 6**) was located beyond the southern wall of the Walled garden targeting remains of a large building shown on the tithe map. The excavated area measured 5.00 by 0.70 m and extended 0.15 m below the current ground level.

4.5.2 Immediately overlain by the turf (**401**) was the layer of compacted pea gravel (**402**) uncovered with a 2.00 m width. This feature was similar to other top layers of garden paths discovered across the Site. The soil butting the feature in the north consisted of dark brown garden soil (**403**) and was contained CBM, pottery, glass and metal artefacts relating to the garden. A second layer of red pea gravel (**404**) at the southern end of the trench was less compact than **402**.

4.5.3 The compact gravel feature **402** matched the garden path of the 1887 map located between the southern garden wall and the fountain. The looser layer of gravel **404** could represent the border of the plant beds to the south. No remains of buildings were discovered. Remains at a greater depth are possible, however, the excavation stopped at the level of the first archaeological feature identified in the trench.

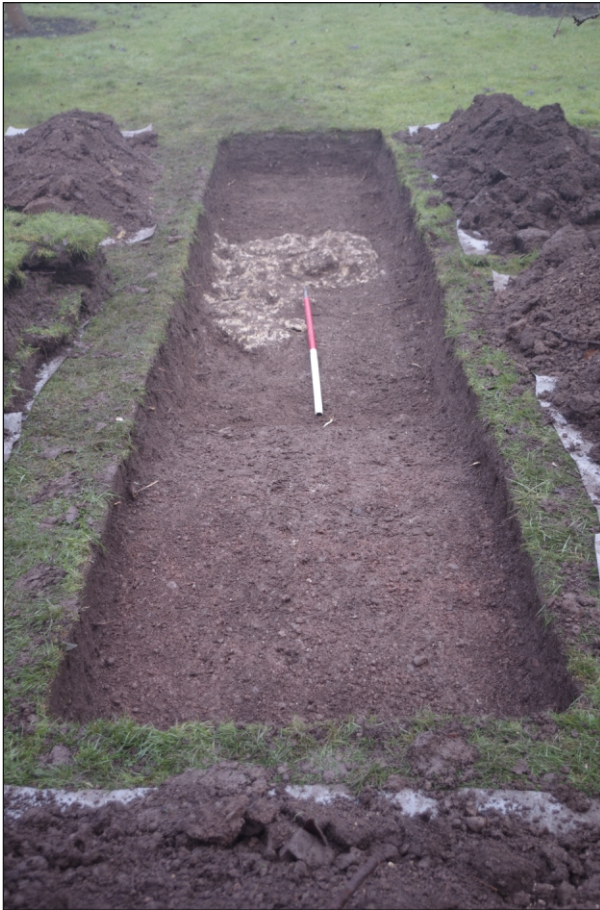
Plate 7: Trench 5, view from south

4.6.1 Trench 5 (**Figure 3, Plate 7**) was located within the walls of in the southeast portion of the Walled garden. It was 5.00 m long and 0.70 m wide. The excavation stopped at a depth of 0.20 m. The aim of the trench was to find remains of the building shown on the tithe map and garden features of the 1887 map.

4.6.2 Overlain by garden soil (**502**) and turf (**501**) was red compacted pea gravel (**503**) identified. A further feature was located to the north by an area of light greyish white mortar (**505**). The material was very friable and as agreed left in situ without further investigation (as agreed on site with E. Jones). Abundant finds of CBM were contained in the underlying soil (**504**).

4.6.3 Layer **503** was similar to feature **402** and matched the garden path shown on 1887 map running in east-west along the southern garden wall. The mortar bed is may be associated with the large building shown on the tithe map in the southern part of the garden, prior to the southern garden wall being moved north sometime between 1844 and 1887. The mortar bed is possibly a spillage of building material during the construction process or representing a foundation bedding for the first layer of stone material, although it does not seem substantial enough to be part of a building.

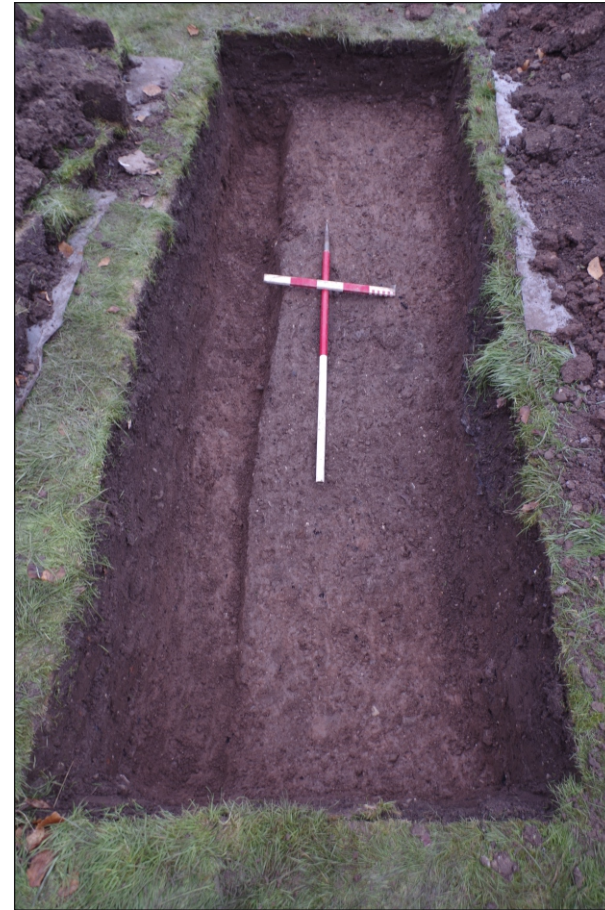
Plate 8: Trench 6, view from west

4.7.1 The position of Trench 6 (**Plate 8**) was moved from the stable area to the northwest part inside the Walled Garden. The trench measured 3.00 by 1.10 m and was excavated to a

depth of 0.40 m. The aim was to find the extension of the curvilinear wall which was identified as linear anomaly continuing to the south in the radar survey.

- 4.7.2 Excavation was stopped at the yellowish brown alluvial deposit layer/subsoil (**603**) similar to the natural deposits found across the site. Finds from this layer were probably imported when this area was used as garden by the inhabitants of the small lodge (comment Nick – Head Gardener) and by bioturbation. A further slot extending into this layer was dug to a depth of 0.60 m to find any structures or cuts associated with a former wall. The subsoil was overlain by a 0.30 m thick layer of garden soil (**602**) containing abundant iron nails.

- 4.7.3 The results of the geophysical survey did not show up in the excavated trench. No structural remains were found. The huge amount of iron nails could be associated with a structure in this location, however, there is no evidence for a continuation of the curvilinear Garden wall. It is possible that the bricks were removed and re-used (re-used bricks are present in the rectangular wall) but it should be noted that there was no evidence for a wall cut in the trench.

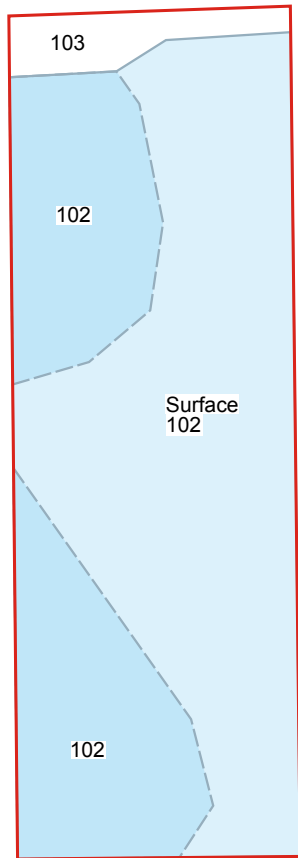
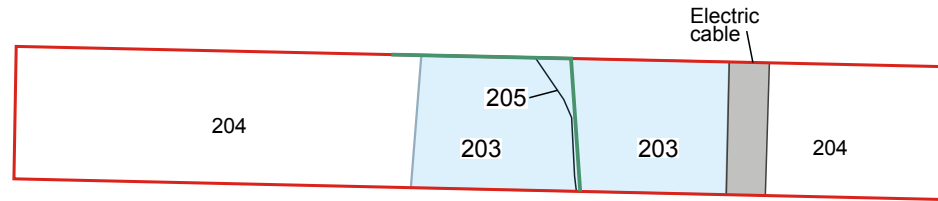
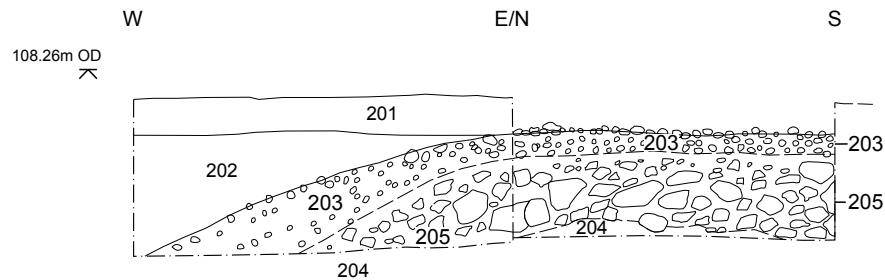
Figure 2

Plan of Trench 1

Plan of Trench 2

Wrap-around section of slot in path 203/205
