Winterbourne Medieval Barn Winterbourne, South Gloucestershire

Archaeological Evaluation

Accession Code: BRSMG tbc
Ref: 116640.01
May 2017

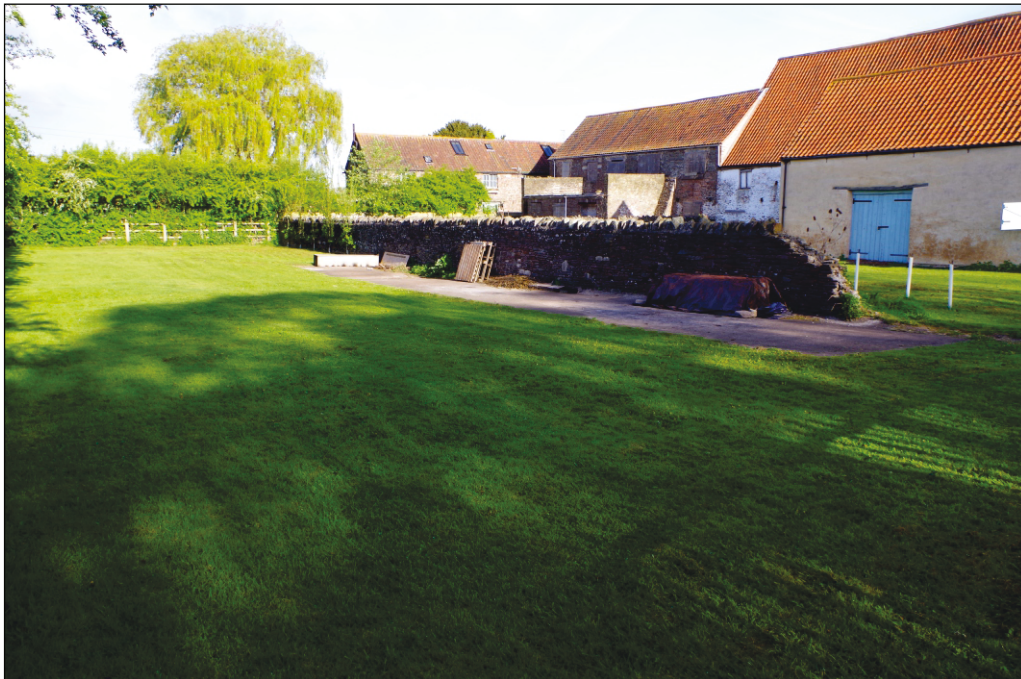
Cover: Lawns on the southern side of the barn, the location of trenches 2 – 4, looking west
Plate 1: Ditch 112 in Trench 1 with stone-lined drain 114 cutting through it, looking west, 1m scale
Plate 2: Stone-lined drains 106 and 109, looking east, 1m scale
Plate 3: Linear gully 304 in Trench 3 looking west, 0.50m scale
Plate 4: Linear ditch 404 in Trench 4, looking north-west, 0.50m scale
Plate 5: Wall 1004 and stone post pad 1006 in Test Pit 1, looking south, 1m scale
Plate 6: Location of TP2, showing floor of the old cow barn, looking north, 1m scale
Plate 7: TP4 showing the base of the breeze block wall and associated soils, looking north, 0.50m scale

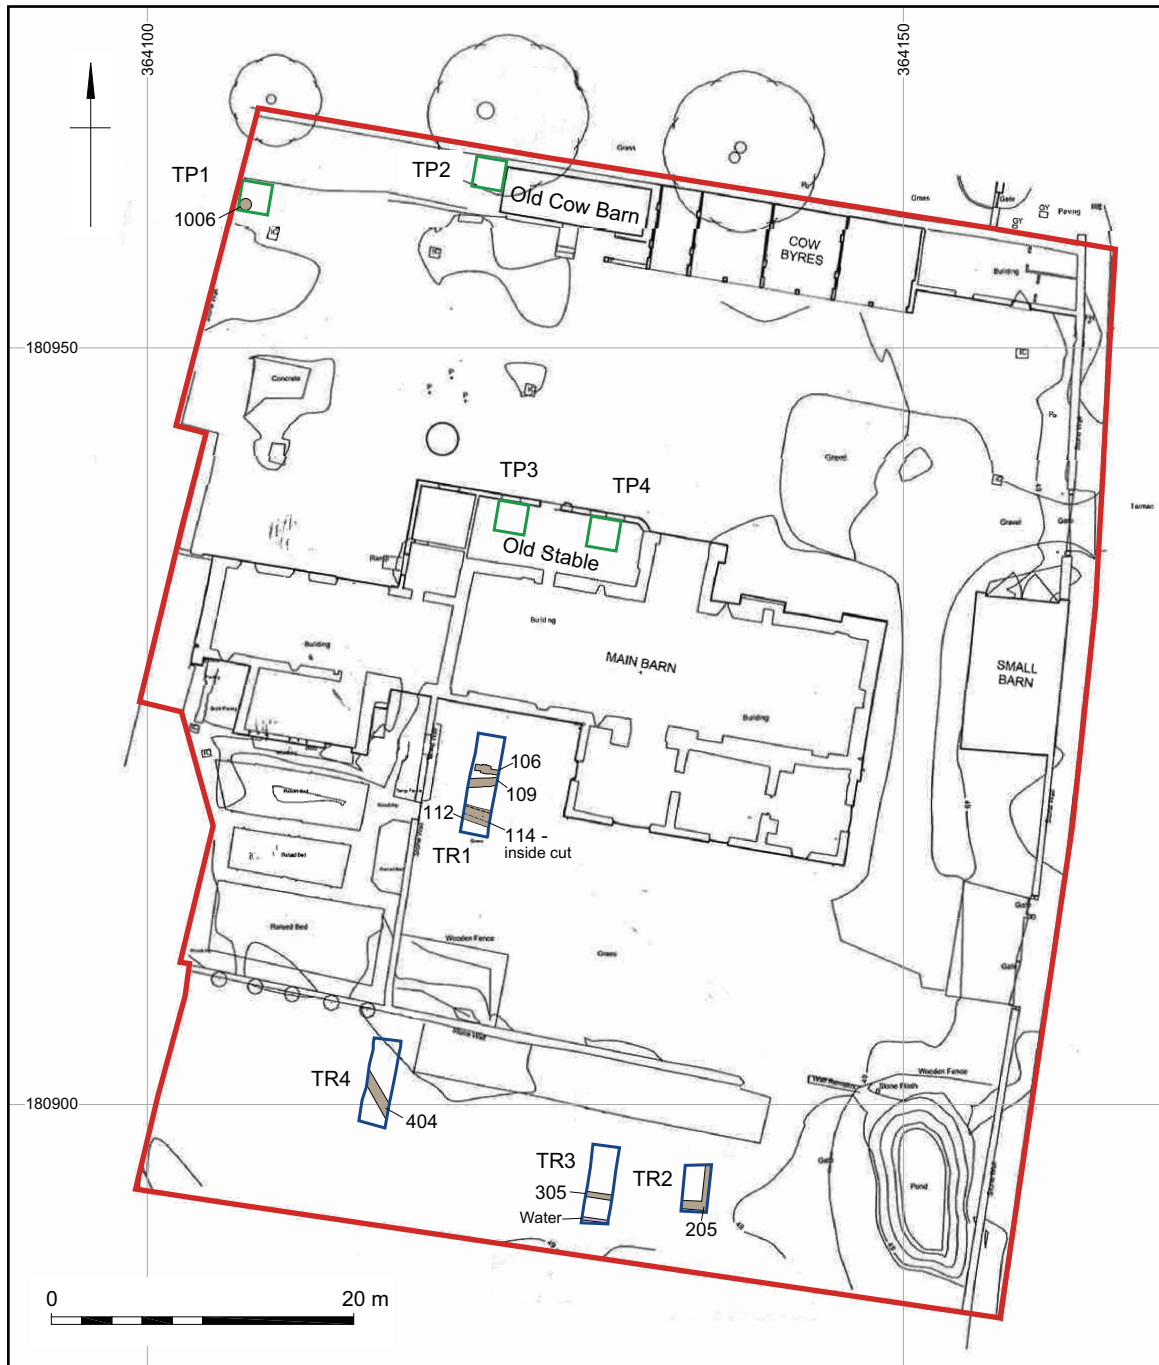
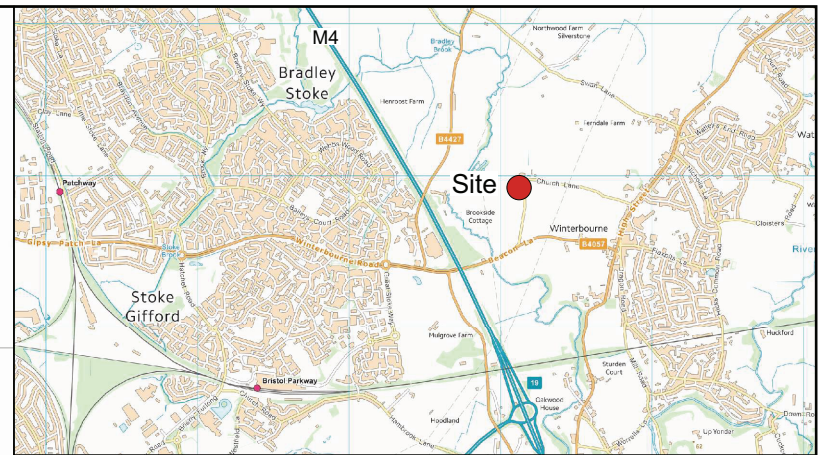
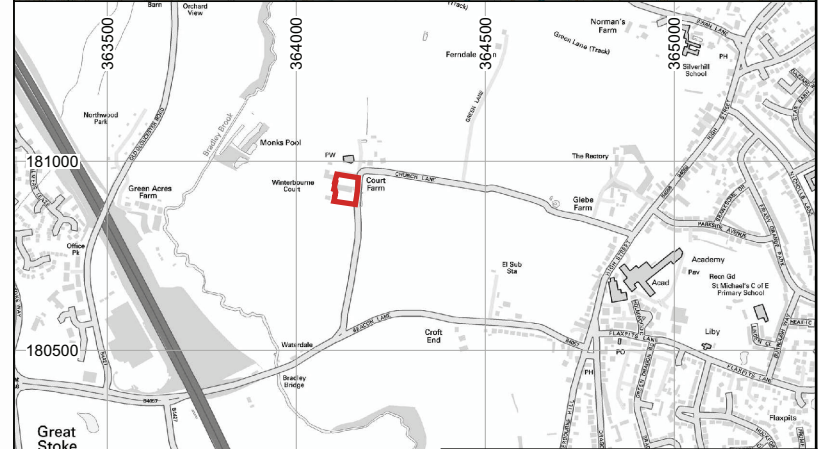
Figure 1

Site location plan

1.1.1 Wessex Archaeology (WA) was commissioned by West Waddy ADP on behalf of Winterbourne Medieval Barn Trust (hereafter 'the client'), to undertake an archaeological evaluation at Winterbourne Medieval Barn, near Winterbourne, South Gloucestershire, centred on National Grid Reference (NGR) 364130, 180933 (hereafter referred to as 'the Site', **Figure 1**).

1.1.2 The works comprised the hand excavation of four test pits (**Figure 1**) to the north of the barn, and four machine-excavated trenches to the south of the barn.

- 4.2.1 These three trenches were located in the southern paddock (**Figure 1**) Trench 2 measured 3.4 m x 1.85 m x 0.76 m, Trench 3 measured 6.74 m x 1.85 m x 1 m, and Trench 4 measured 6.20 m x 1.85 m x 1.20 m. They were targeted at the potential large ditch interpreted from the geophysical survey.

- 4.3.1 Test Pit 1 was located against the western Site boundary wall (1004), adjacent to the edge of the (demolished) Old Cow Barn concrete floor (**Figure 1**). A compacted mid-orange-brown sandy-silt (1002) was revealed at 0.35 m BGS. Deposit 1002 contained occasional stone rubble fragments, and there was evidence for animal burrowing up against the boundary wall. Deposit 1002 was excavated to a depth of 0.69 m, to expose the footings of 1004.
- 4.3.2 Wall 1004 had a stepped footing which extended c. 50 mm to the east. The footing was observed at c. 0.24 m BGS, equal to the depth of two courses below the turf line. The construction trench (1003) for wall 1004 was visible cutting through 1002, to a depth of 0.54 m. A single large mortared lump of stone and rubble (1006) was revealed up against the 1004 in the south-western corner of the test pit and formed a flat 'pedestal' at the same

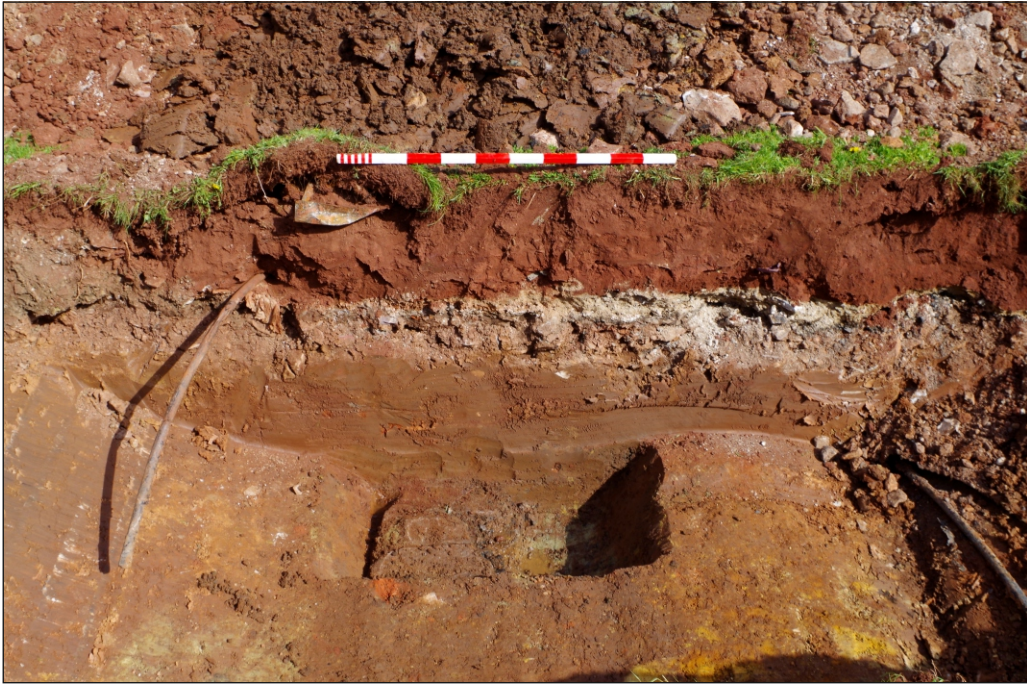
Plate 1: Ditch 112 in trench 1 with stone based drain 114 cutting through it, looking west, 1m scale

- 4.1.2 Cut through deposit 104 were three linear features, all aligned east-west. The earliest was a small ditch located at the southern end of Trench 1 and had a U-shaped profile (112) which had gradually silted up, becoming backfilled by a dark pink-brown fine textured clay-silt with green pockets, and organic staining at the base (113, **Plate 1**). A number of fragments of pottery were recovered from deposit 113, including large joining sherds from a late Ham Green Ware jug dating from the mid-13th century. A later stone-lined drain (114), re-using the original line of the earlier ditch, had been dug through the silted backfill 113. The stone slabs (115) of drain 114 sat on the natural subsoil at the base of the ditch, and were probably an attempt to allow water to flow more freely. The cut for drain 114 had also been allowed to silt up (116). The similarity between soil type 116 and 113 were suggestive of the same method of deposition.

5.4.2 The small assemblage from context 113 is all medieval. The presence of large sherds of late Ham Green Ware and a single sherd of Redcliff Ware, suggests a probable deposition date in the second half of the 13th century.

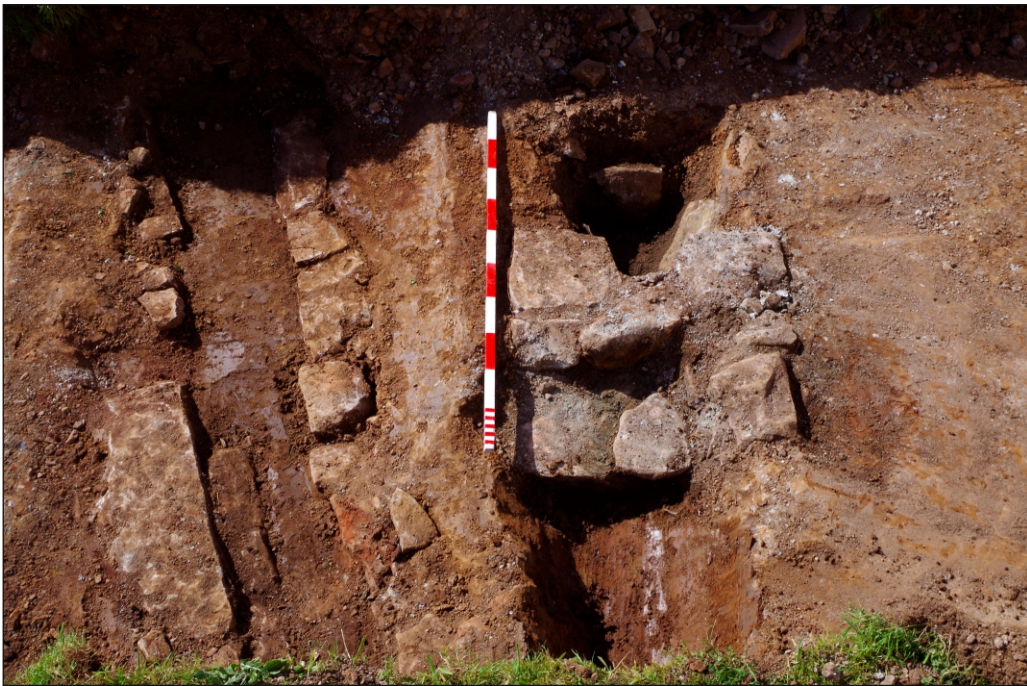
Plate 2: Stone lined drains 106 and 109, looking east, 1m scale

- 4.1.3 Immediately to the north of 114, were two stone-lined drains, again on an east-west alignment, both of which also cut through buried soil 104. Both drains were much shallower than 114 (**Plate 2**). The northernmost (106) was only stone-lined to the west (107), with the line of its cut becoming less distinct towards the eastern side of the evaluation trench. Drain 106 was backfilled with a dark grey-brown silt which contained the remains of smashed glass bottle fragments dating from between 1905 and 1930. The top of drain 106 was revealed at 0.65 m BGS, and measured 0.20 m in depth and 0.40 m wide.

- 4.1.4 The second drain (109) was better constructed, with stones lining the sides along its length (110) and a dark red-brown clay-silt fill with no noted inclusions (111). It was 0.60 m wide and orientated west-south-west to east-north-east which means that it may have intersected drain 106 to the east (beyond the edge of the evaluation trench).

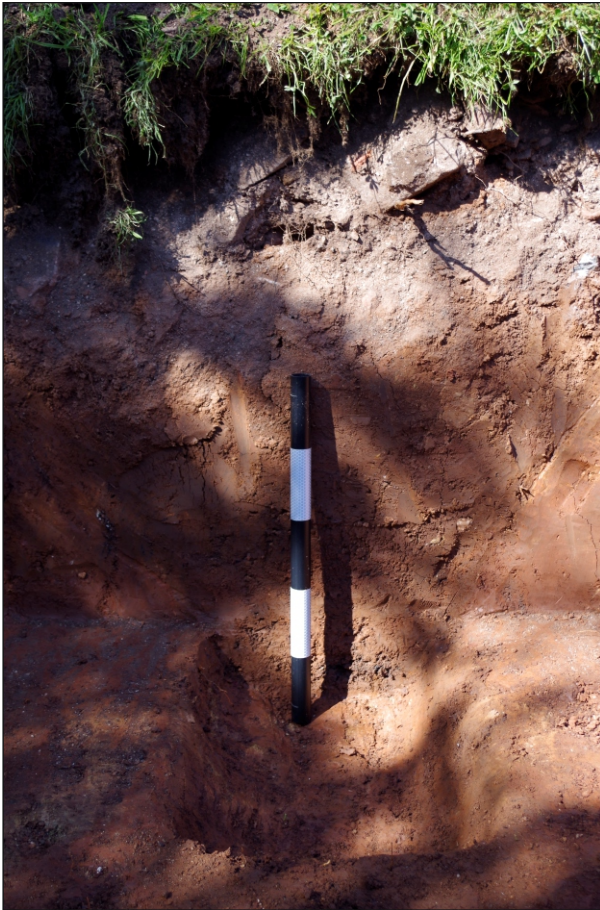
Plate 3: Linear gully 304 in trench 3 looking west, 0.50m scale

- 4.2.4 In each trench a linear ditch-like feature was found to cut through the compacted soil layers. In Trench 2 the ditch was 0.35 m wide and 0.66 m in depth (204), it was orientated east-west at the southern end of the trench before turning ninety degrees northwards, along the eastern edge of the trench. The fill of 204 was a compact red-orange-brown silty-clay, with occasional carbonised wood fragments and small stone fragments (205). The western continuation of ditch 204 was recorded in Trench 3 (304). The fill of 304 (303) was identical to that of 204 in Trench 2 (**Plate 3**). No dateable finds were recovered from 304.

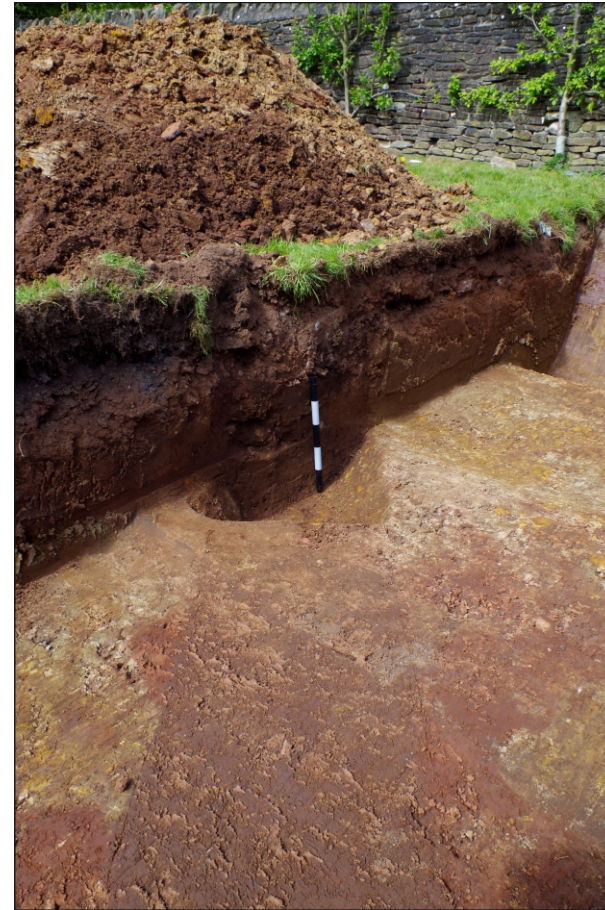
Plate 4: Linear ditch 404 in trench 4, looking north-west, 0.50m scale

- 4.2.5 In Trench 4 a ditch (404) was observed cutting diagonally across the trench, orientated north-west to south-east. This was wider than the ditch recorded in both Trenches 2 and 3, being 0.90 m wide at the top and 0.40 m wide at the base, with a depth of 0.58 m (**Plate 4**). The moderately sloping sides were more suggestive of a boundary ditch than a drainage ditch and its original function may have been as a field boundary. It was filled with a mid-brown sandy silt rich clay, with occasional small stone fragments and carbonised wood flecks (403). No datable finds were recovered from 404.

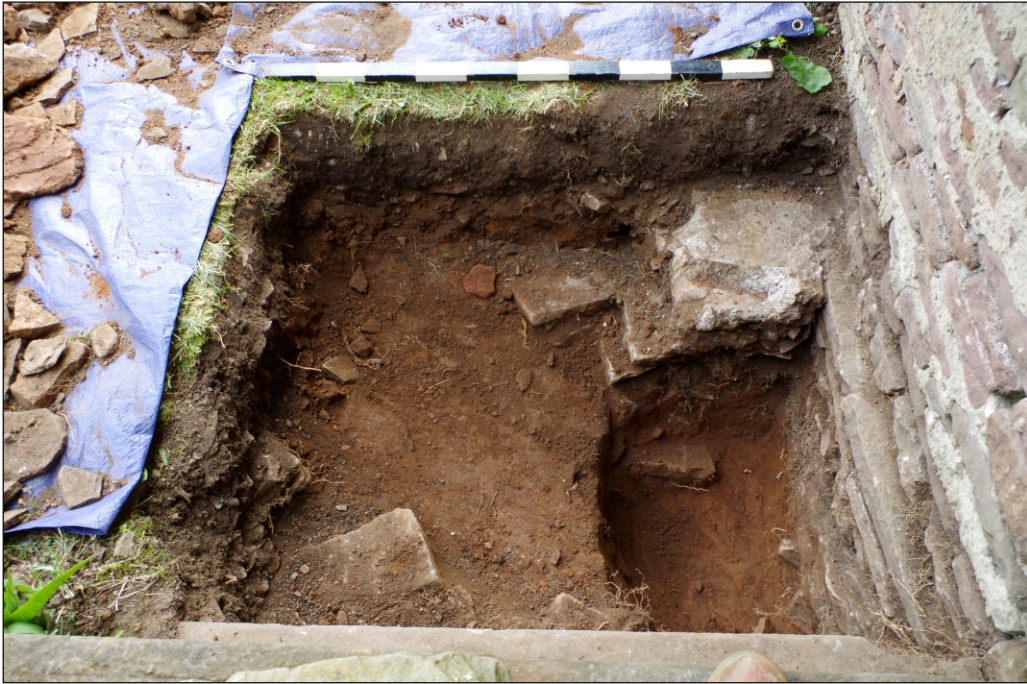
Plate 5: Wall 1004 and stone post pad 1006 in test pit 1, looking south, 1m scale

height as the footings and may have originally formed a post-pad, potentially for an open fronted barn with timber posts (**Plate 5**).

- 4.3.4 It should also be noted that boundary wall 1004 appears to be of 19th-century date, being bonded with a mid-grey mortar with coal flecks and pointed with an off-white mortar containing inclusions of washed coal and lime flecks. The lowest stones of the stepped footing are un-coursed and only roughly bonded. Of interest is the fact that the gable wall of the Old Cow Barn, has several phases of rebuilding, and whilst the upper courses also appear to be 19th-century in date, the central section of the wall is bonded by pink and buff-brown mortars suggestive of an earlier, possibly 18th-century date.

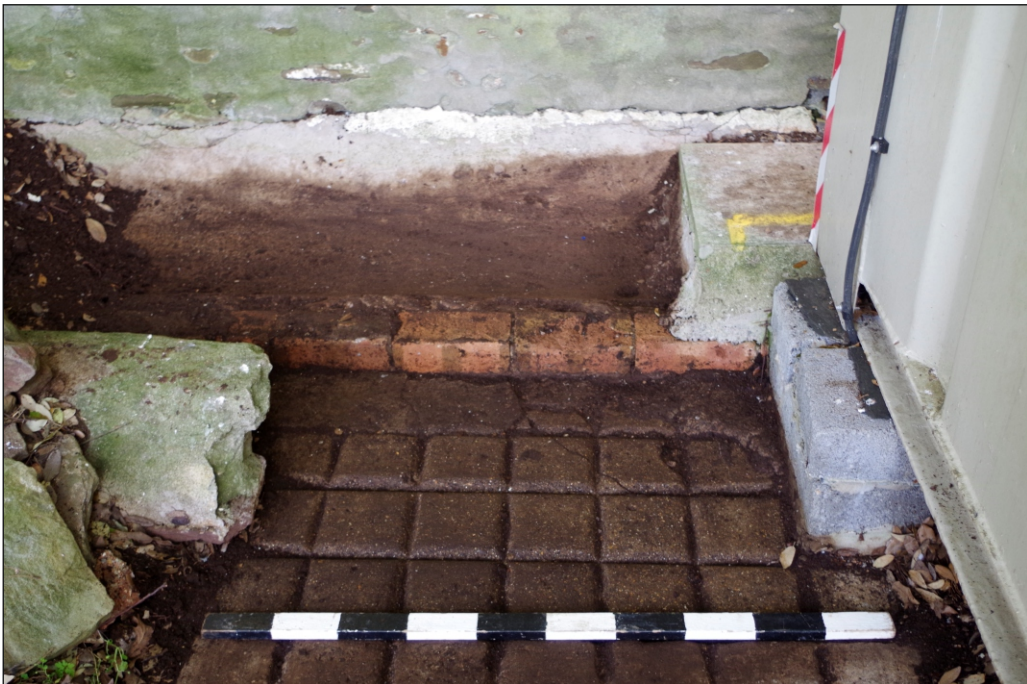
Plate 6: Location of TP2, showing floor of the old cow barn, looking north, 1m scale

- 4.3.5 Test Pit 2 was located against the northern boundary wall within the footprint of the Old Cow Barn. However, the concrete floor of the barn was intact at this location so it was photographed and abandoned (**Plate 6**).

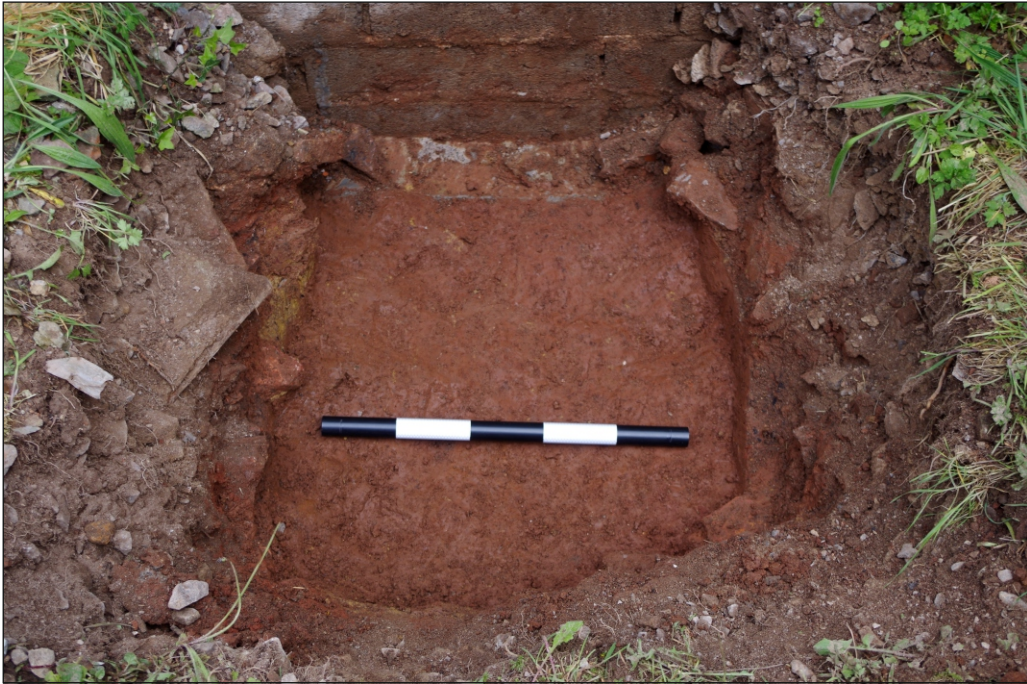
Plate 7: TP4 showing the base of the breeze block wall and associated soils, looking north, 0.50m scale

- 4.3.7 Overlying 3003 and 4003 was a layer of disturbed red-orange sandy clay with frequent medium and small sized stone fragments (3002 and 4002), observed at c. 0.24 m BGS. This layer was also very compacted and contained late-17th-century pottery sherds in Test Pit 4, as well as a handmade nail and flecks of carbonised wood and ash. This seems to have been a deliberately dumped layer, probably to make up the ground level prior to building work. The Tithe Map, dating to 1840, depicts a smaller building in the area of the stable than that shown on later mapping, so it possible that layer 3002/4002 relates to either just before or just after the Old Stable building was in use. The construction trench for the later concrete block wall also cut through all deposits in TP3 and TP4 (**Plate 7**).
