Beacon Park, Lichfield Staffordshire

Archaeological Watching Brief

Accession Number: 2017.LH.22
Ref: 116260.01
June 2017

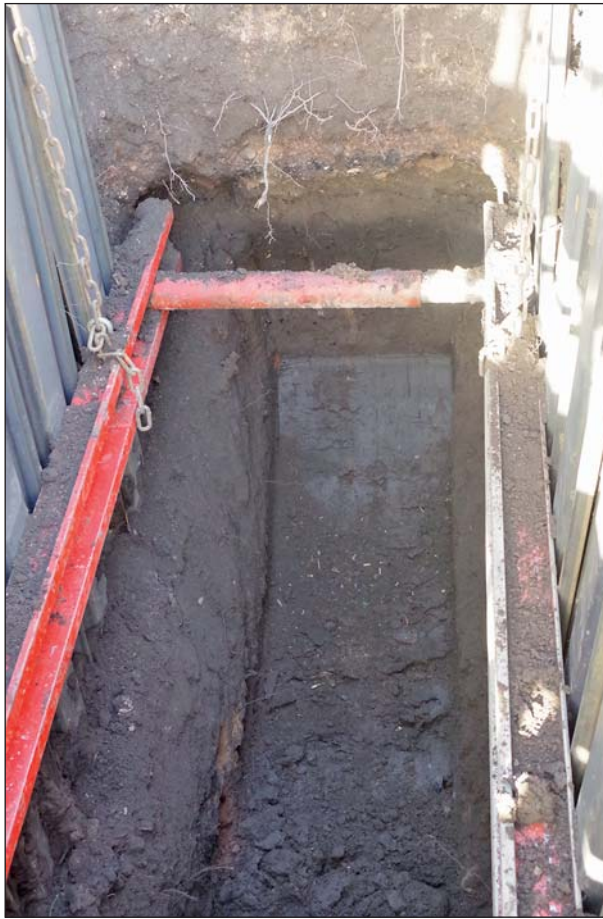
Plate 1: Working shot showing basal silt 3008

- 4.2.2 The lowest layer identified was a silt layer, which was seen in almost all frames below 0.9 m to 1.6 m bgl (2004, 3008, 4004, 5005, 6005, 7003, 8005, 9003, 10004, 11005, 12004, 13003 and 14005, Plate 1). The basal silt layer was not identified in Frame 1 due to the previous disturbance. The silt layer was dark brown, grey brown or yellow brown in colour. Seven environmental samples were taken from the basal silt deposits from different frames. These silt deposits likely represent redeposited material recorded historically as having been dredged from the Minster Pool and used to backfill the former Upper Pool in the 1850s. This interpretation is consistent with the environmental results presented below. The finds report concludes that the assemblage recovered from the basal silts need not be later than the 18th century in date, somewhat earlier than the recorded dredging date of 1850.

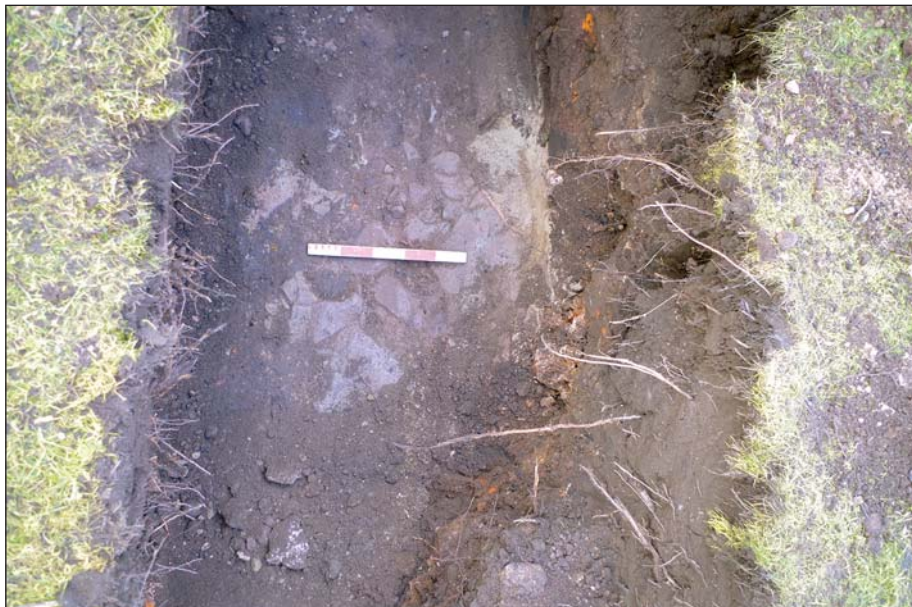
Plate 2: Wall 3006

- 4.4.1 Frame 3 contained a complex series of structures on multiple levels (Figure 1). The basal silt deposit (3008) in Frame 3 was overlain by an 'L'-shaped fragment of sandstone wall (3006, Plate 2), 1 m by 0.6 m by 0.2 m deep, which was in turn overlaid by a layer of made ground (3005). A partially surviving pavement (3004, Plate 3) overlay made ground 3005 and consisted of handmade red brick, of 18th or early 19th century date, bonded with pinkish white sandy lime mortar. This pavement extended across Frame 3, but was not seen in either Frame 2 or Frame 4. Pavement 3004 was built on sandstone wall 3006, and was generally one course deep, except where sandstone wall 3006 was absent, where pavement 3004 was three courses deep.

- 4.4.2 It seems likely that sandstone structure 3006 represents an earlier, separate phase of activity and was opportunistically utilised by the builders of pavement 3004. Made ground layer 3007 overlay pavement 3004. Rough cast concrete raft 3003 sat on top of made ground 3007, and acted as a foundation for garden wall 3009 (Plate 4). Garden wall 3009 was aligned east to west and comprised three courses of a single skin of handmade red bricks with pinkish lime mortar. Garden wall 3009 was overlain by made ground levelling layer 3002 and by topsoil 3001.

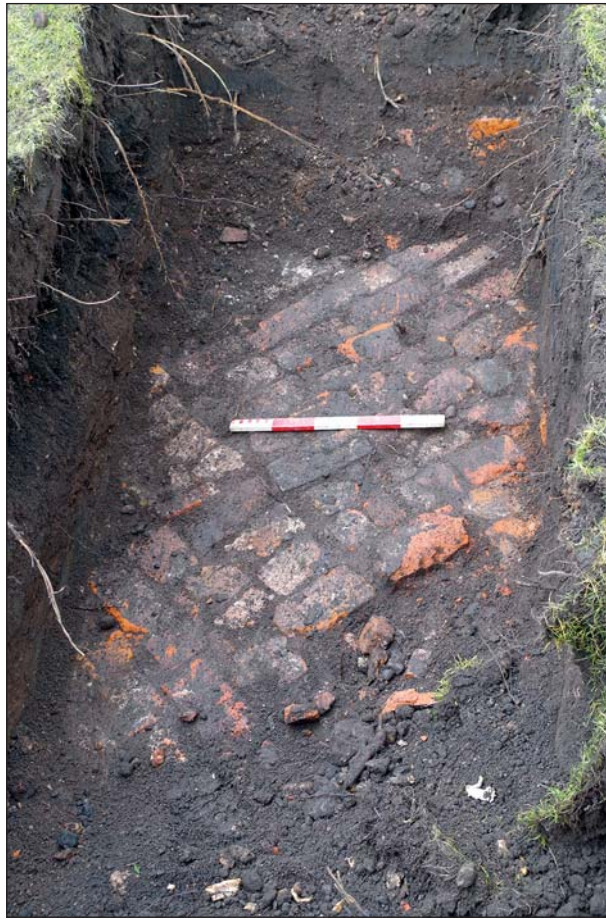
Plate 3: Pavement 3004

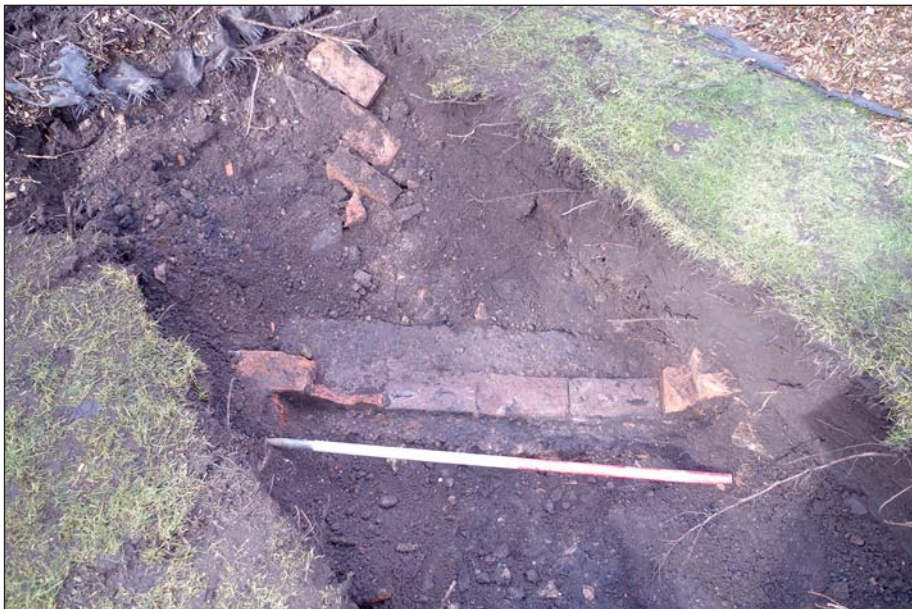
Plate 4: Garden wall 3009

- 4.4.3 The structures of Frame 3 appear to represent a progression of short-term garden-related structures as the level of the ground was built up. Due to their position in the stratigraphic sequence, the later structures can be said to be of 19th/20th century date, whereas the sandstone wall and pavement may be slightly earlier in date.

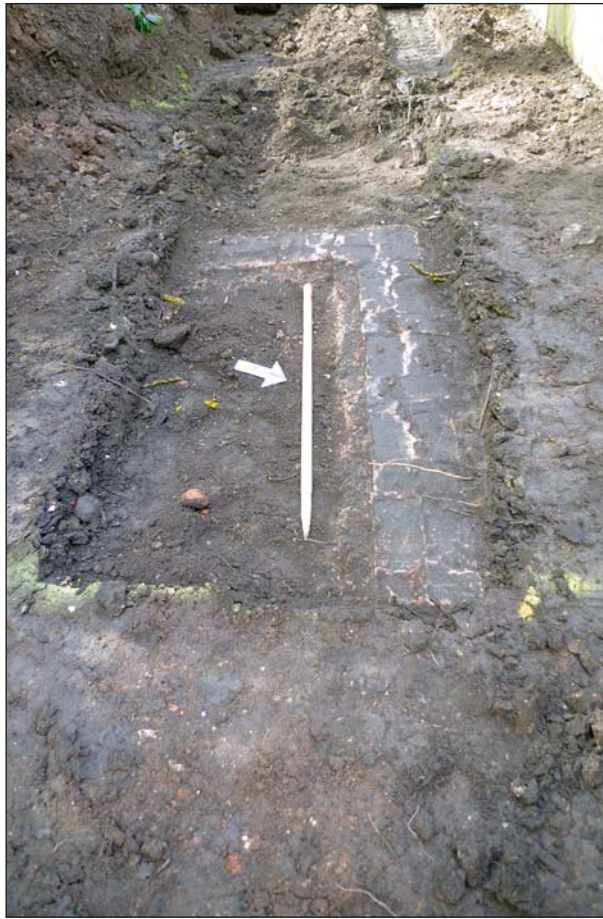
Plate 5: Garden wall 6002

- 4.4.4 Frame 6 contained a rough cast concrete raft (6003) forming the foundation of a garden wall (6002, Plate 5) of two skins of handmade red brick, of 18th or early 19th century date, bonded with pinkish white sandy lime mortar. Structures 6002 and 6003 sat above the upper layer of made ground (6004), which contained 19th/20th century pottery, and below the topsoil (6001). Structures 6002 and 6003 were similar in form and stratigraphic placement to structures 3003 and 3009 from Frame 3, indicating a 19th/20th century date for the structures.

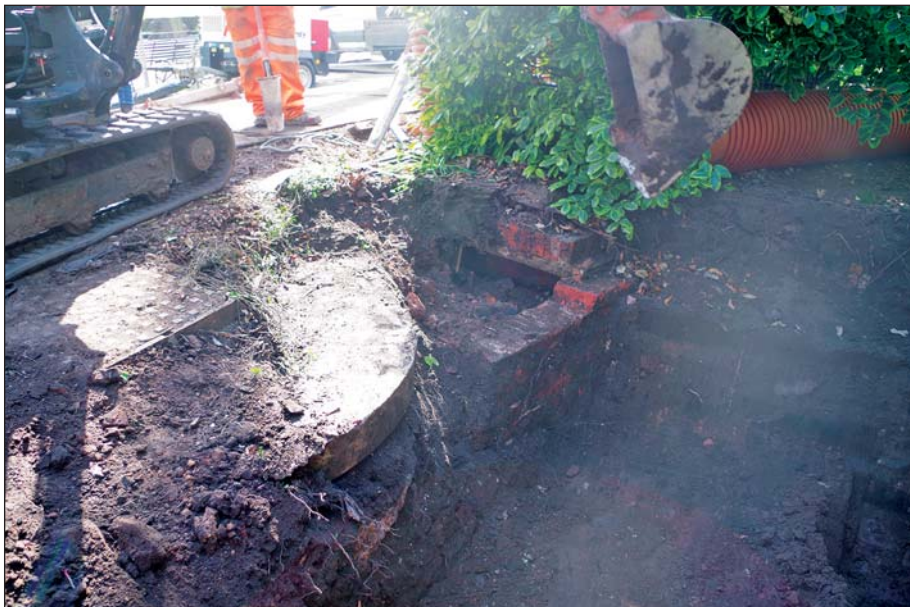
Plate 6: Inspection chambers 14003 (far, brick) and 14004 (near, concrete)

- 4.4.5 Two former inspection chambers (“manholes”) were encountered in Frame 14, where a further inspection chamber was installed as part of these works. The eldest inspection chamber was built of handmade red brick and was 1 m square (14003, Plate 6). The later inspection chamber (14004, Plate 6) was constructed in concrete.
