54 Elloughton Road, Brough East Riding of Yorkshire

Historic Building Record

Planning Ref: 15/03662/PLF,
APP/E2001/W/16/3157839
Ref: 118350.02
October 2017

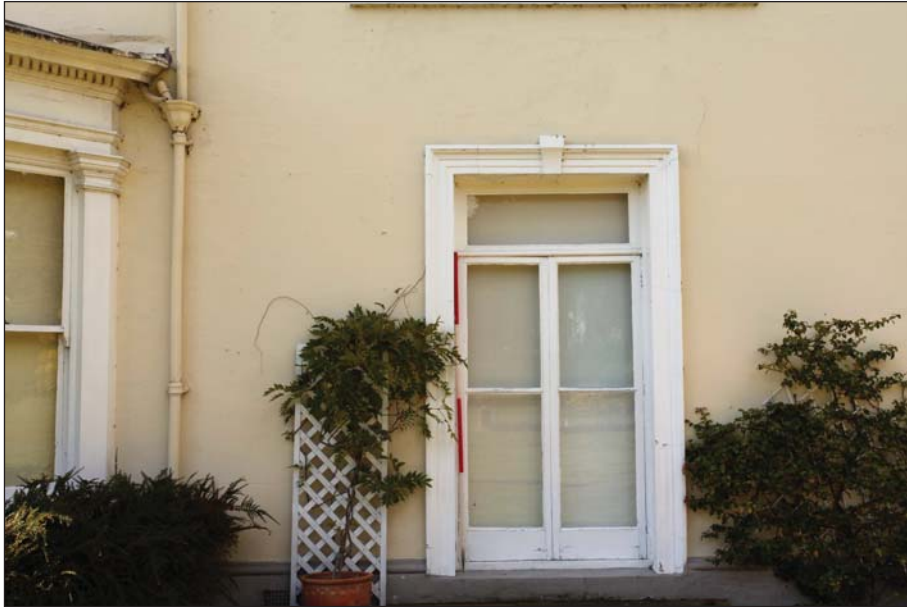
Plate 13: Detail of doorway within the northernmost bay

- 3.3.11 The northern gable wall comprised an original doorway with surrounds comparable to the window openings within the west elevation (Plate 13). The doorway was accessed through a short step from where the continuous plinth emanated sideways. It contained a glazed double door with a plain fanlight above it. It is suggested that the actual door might have been a later replacement whereas the fanlight was a primary feature. The first floor of the northern gable wall contained a large tripartite window which would have replaced a smaller opening comparable to the corresponding sash window within the southern gable.

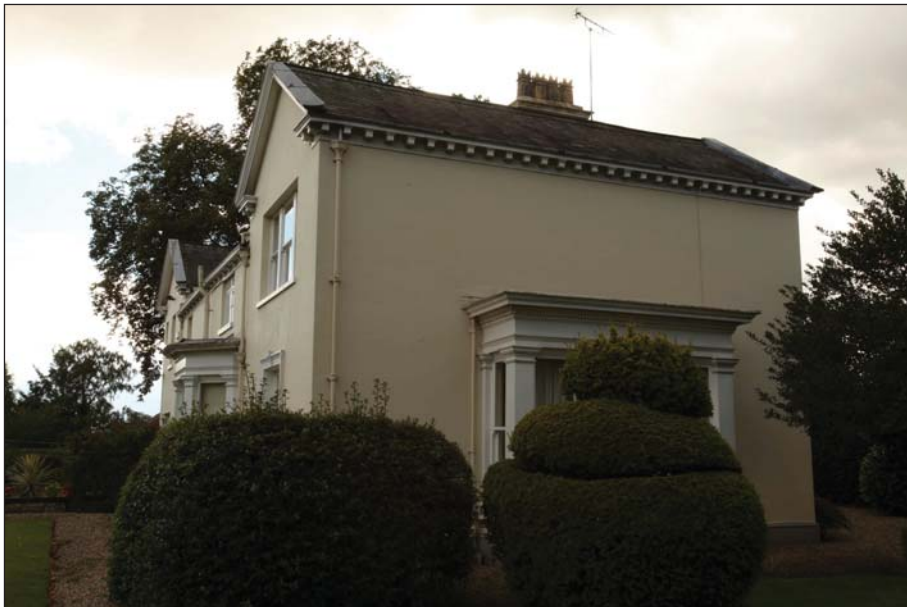
Plate 14: General view of the north elevation

- 3.3.12 The north elevation encompassed an elegant tripartite bay window on the ground floor with comparable design to the canted bay windows observed within the west and east elevations. It also included the modillioned cornice and moulding plinth contiguous within the principal west elevation including. The pitched slated roof contained short copings covered with lead flashing (Plates 14 and 15).

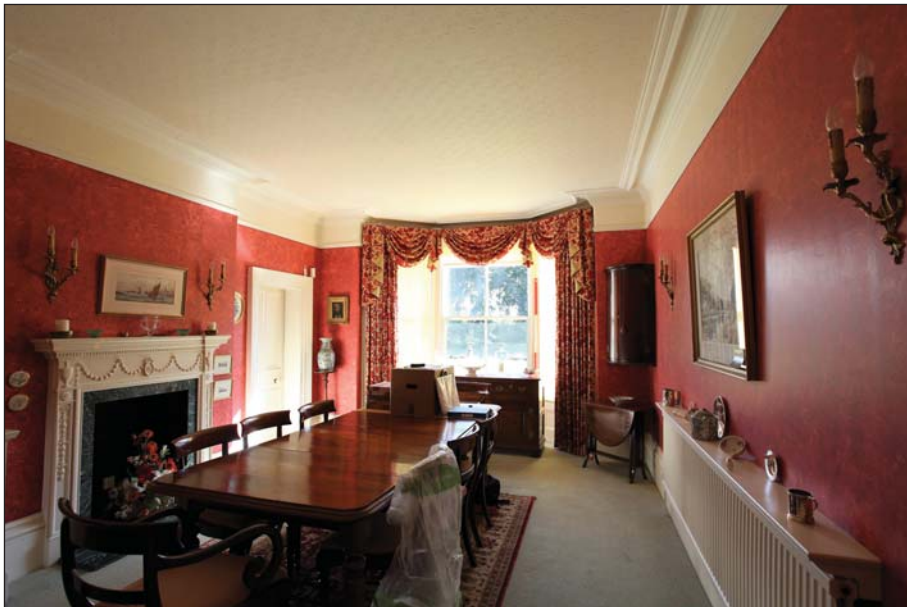
Plate 32: Dining room G4 looking east with canted bay window

- 3.3.18 The dining room G4 contained a canted bay window, of comparable design to the one observed within the drawing room G3, located within the east wall facing the rear garden (Plate 32). The north wall encompassed a chimney breast with a later fire place and mantelpiece equivalent to the one within G3 and an inserted built-in cupboard to the west of the chimney breast creating a flush face with additional skirting board and plaster cornice (Plate 33).

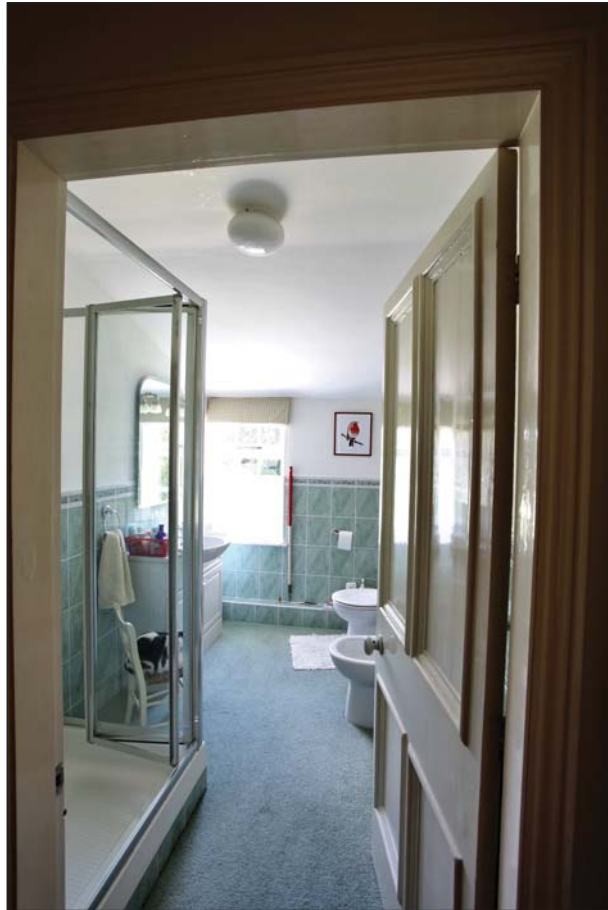
Plate 59: Bathroom F9

- 3.3.28 Bathrooms F9 and F10 consisted of a later arrangement created with the insertion of a dividing stud wall between them. Each bathroom encompassed a panelled door comparable to the ones observed within the entire first floor although the one within F10 was a later insertion which might have reused an original one dismantled from corridor F1 as indicated by vertical scars beneath the plaster consoles. The bathrooms contained modern fabrics and an inserted window within the east wall which lit both parts despite being divided by the inserted stud wall. Of note was an obsolete chimney breast within the north wall of bathroom F10 (Plates 59 – 61).

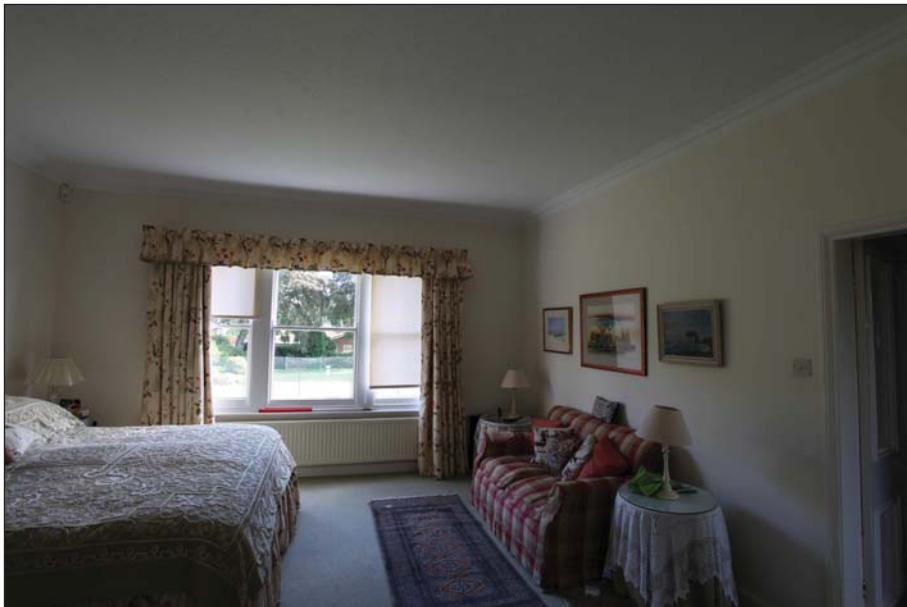
Plate 62: Bedroom F11 looking east

- 3.3.29 Master bedroom F11 located within the northernmost area of the first floor had been altered significantly including the insertion of a large window within the east wall and a stud wall with a wide segmental arched opening bisecting the room into two spaces. The skirting boards and plaster cornices were later replacements. The west wall, however, retained its original sash window (Plates 62 – 64).

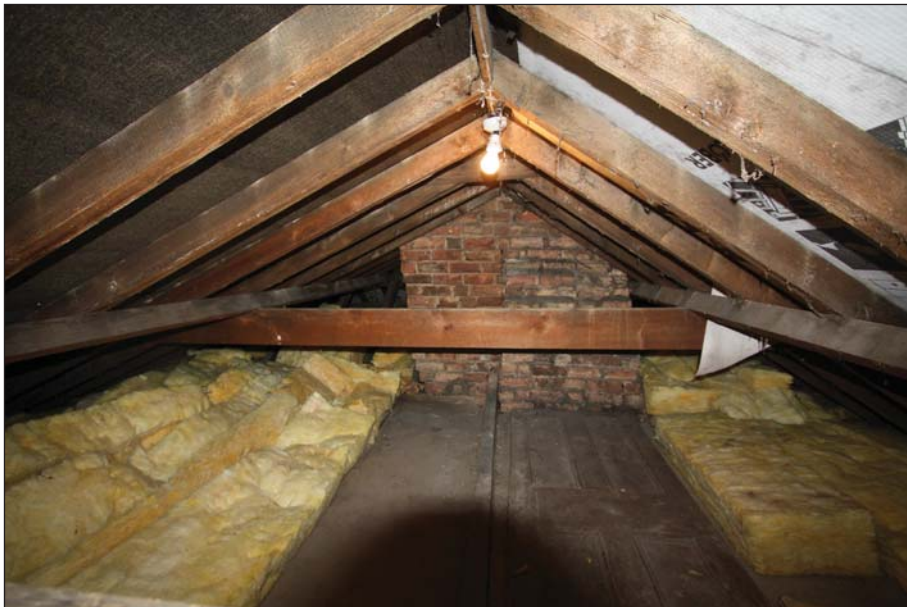
Plate 68: Loft area showing brick chimney stack

- 3.3.31 Access to the loft was gained from the ceiling hatch within room F6 which included a loft ladder. Despite limited accessible space inside the loft, it was possible to identify that the roof structure consisted of a modern replacement with soft-wood common rafters some of which with upper collar clasp single scantling purlins. The chimney stacks projecting through the ridge were built with hand-made orangey bricks bonded with lime mortar (Plate 68).
