20 Bishophill, York North Yorkshire

Archaeological Watching Brief Report, Phase 2

Planning Ref: 15/02645/FULM
Ref: 107774.01
December 2017

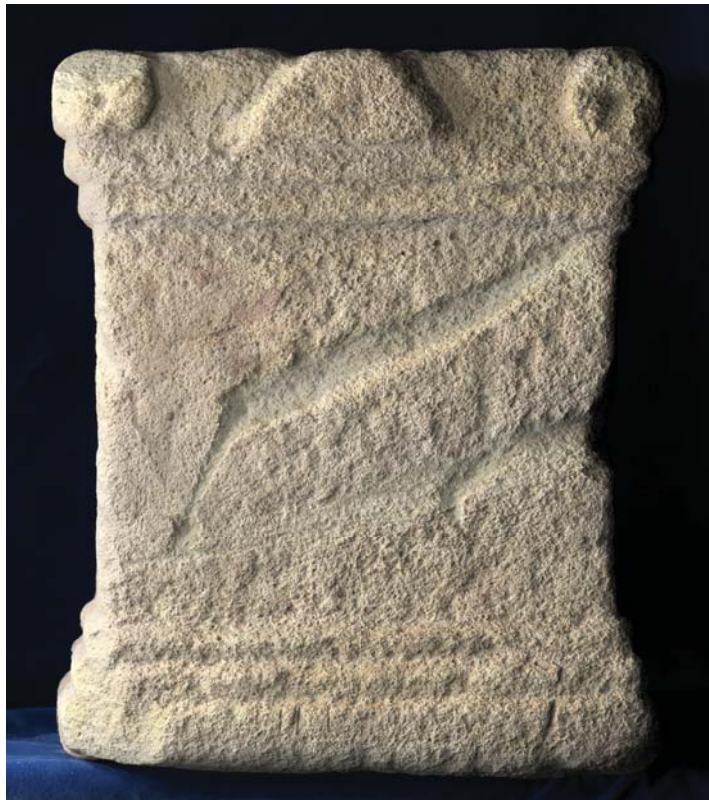
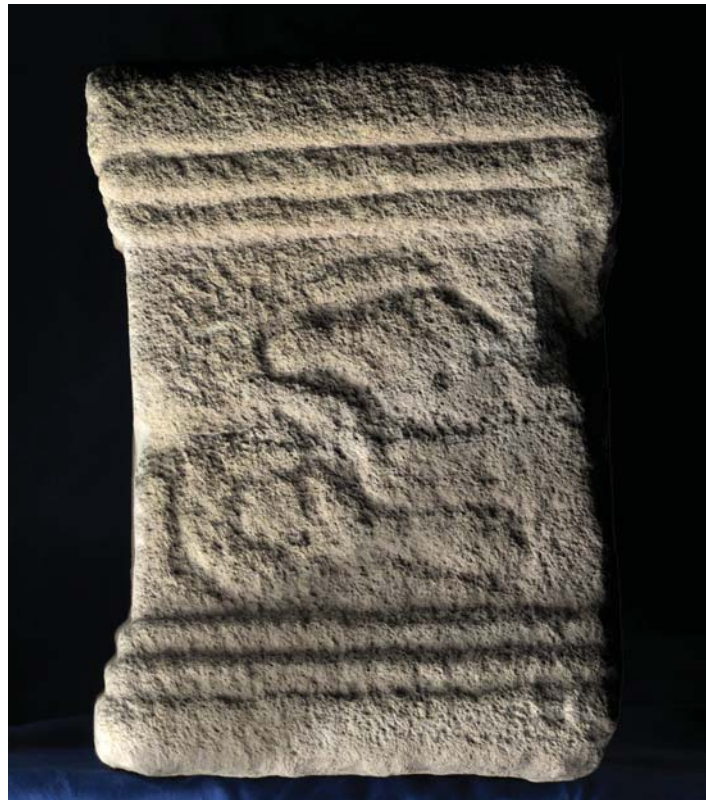
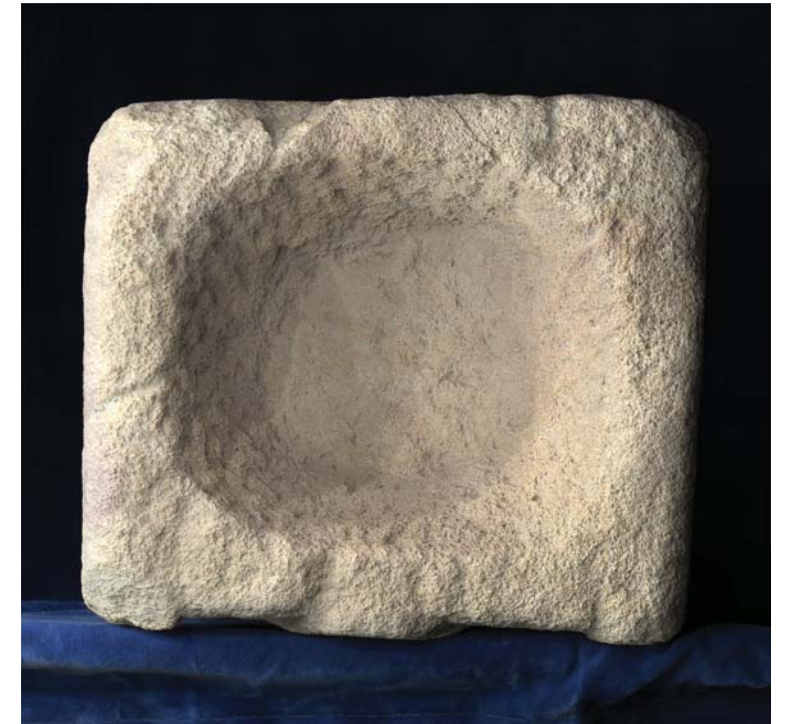
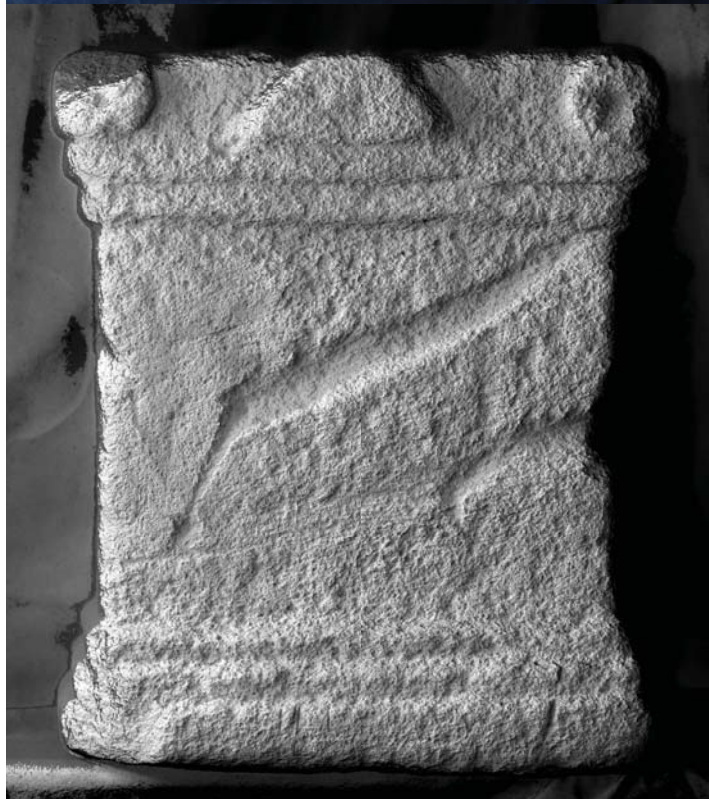
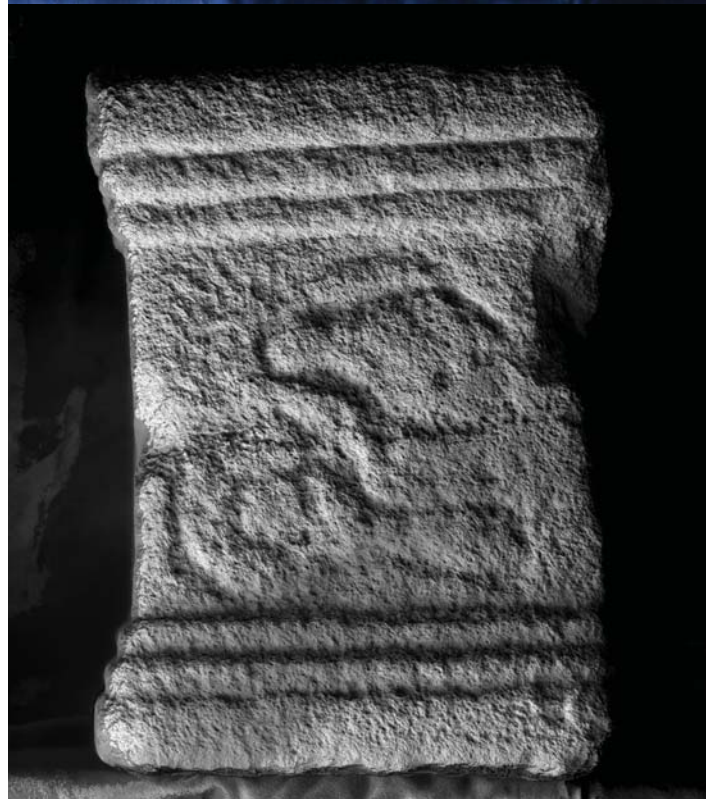
Figure 6

RTI recording of Romano-British Altar - diffuse colour at top with specular enhancement below

- 6.4.1 A complete Romano-British stone altar was recovered from amongst demolition rubble in one of the 19th century cellars. The altar is made of Millstone Grit, and stands 390 mm high. It is heavily abraded, and shows some recent damage in the form of chips and scrapes. There are traces of carving on one face, which appears fairly crudely executed. Reflectance Transformation Imaging (RTI) has shown this to comprise a patera and a jug or flagon, but there is no sign of any lettering on the front of the altar. The top has been hollowed out (the tool marks are visible) to form a dished surface. Whether this was integral to the original altar, or represents some later re-use, is uncertain. Given the object's provenance, in cellar backfill, a re-use as (for example) a garden ornament could be possible (Figure 6).

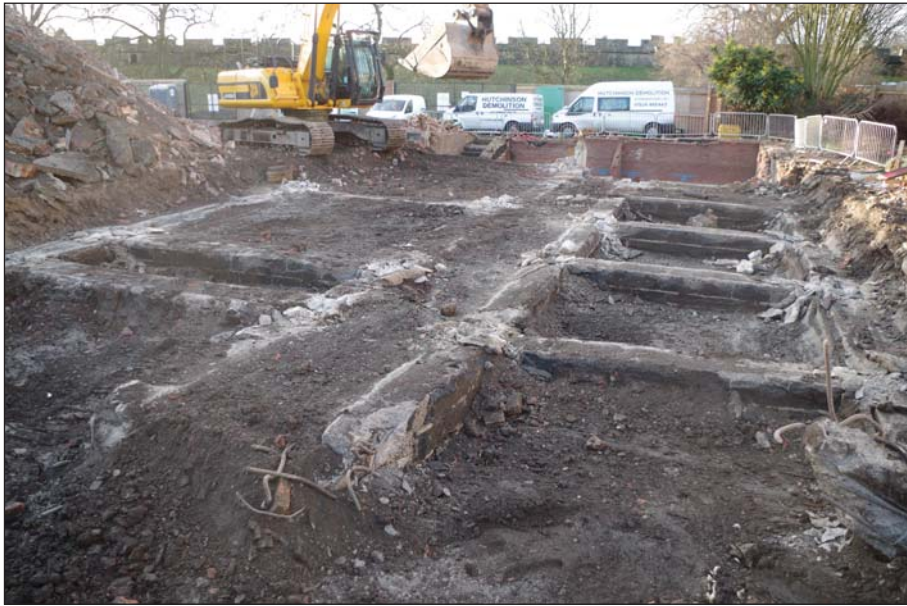
Plate 1: Concrete foundations of Oliver House within areas 1, 3 and 6 and cellar walls 401

- 5.3.1 Areas 1, 3 and 6 contained the foundation of the demolished Oliver House (Figure 3, Plate 1). Concrete foundation beams 402 were broken out and removed without exceeding the agreed 16.66 m impact depth. However Concrete piles exceeding this depth were surveyed and left *in situ*. The concrete foundation beams were 0.6 m wide and 0.65 m deep and spaced at a distance of 2.5 m.

5.3.2 At the western limit of area 2 the modern cellar of the demolished Oliver House was recorded. The cellar consisted of brick walls (401), a concrete floor and concrete ring beam foundations (402). The size of this structure made piling through it impossible and as such the foundations were broken out and removed. The impact depth of these groundworks reached 15.3 m aOD, with natural clay substrate identified at this depth.

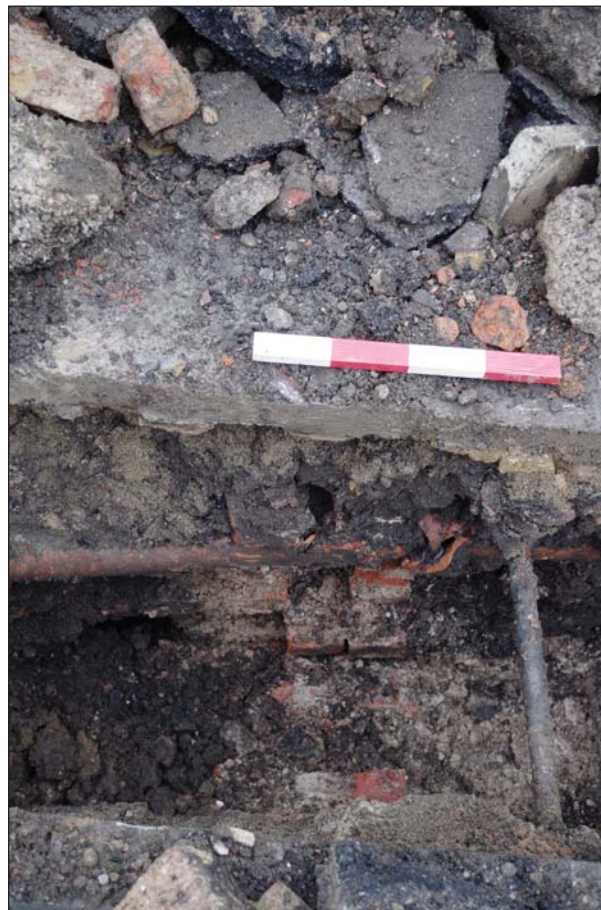
Plate 2: Red brick walls identified within area 2

5.4.1 The cutting of a gas trench was monitored beneath the pavement to the north of the Site (area 2). The trench was 0.5 m wide and excavated to a maximum depth of 1.2 m below ground level (17.3 m aOD). Three red brick walls were identified within the trench; 203, 204 and 205 (Figure 3, Plate 2). The walls were identified at a depth of 0.8 m below ground level and their foundations were not reached. These walls were all two skins thick and made of unfrogged red brick. Walls 203 and 204 correlate with structures first depicted on the 1852 OS map. Wall 202 correlates with a structure first depicted on the 1892 OS map.

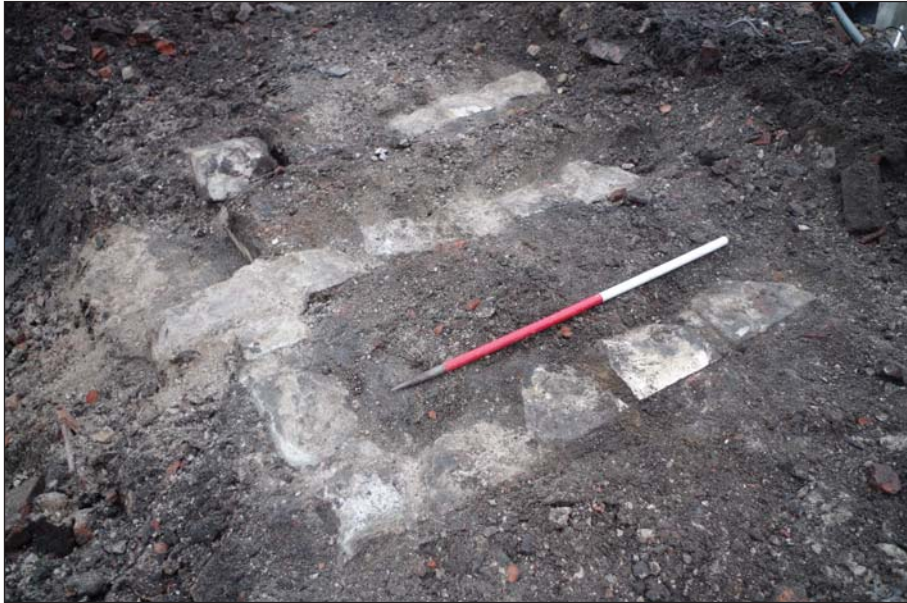
Plate 3: Stone walls 304-307 within area 3

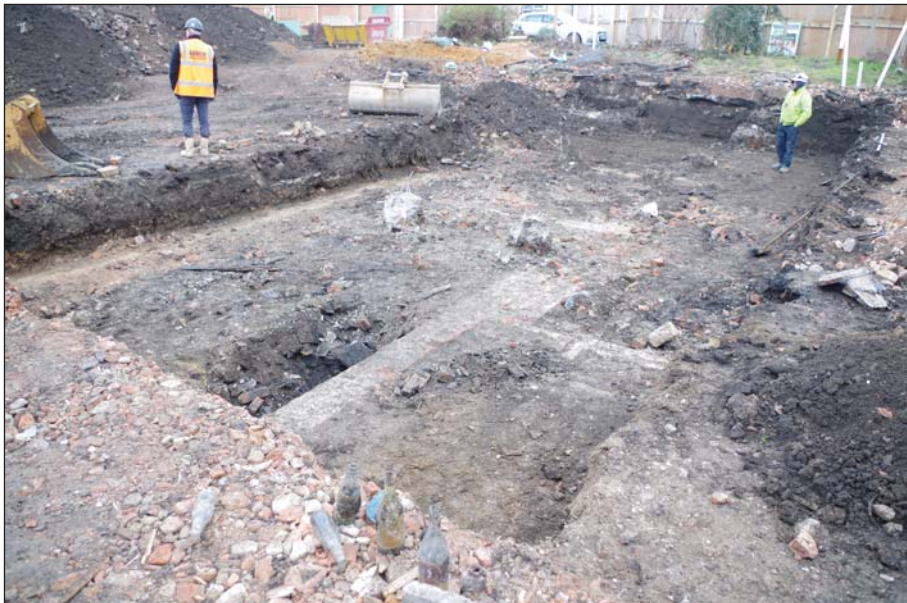
Plate 4: Structures 606-609 within area 1

5.4.5 Located within area 1 were a series of structures surviving beneath and between the modern concrete foundations of Oliver House at 17.3 to 16.9 m aOD (Figure 3, Plates 4-5).

5.4.6 Structures 120, 121, 123-127, 606-609, and 614-616 all sit within the footprint of a northwest–southeast aligned terraced building recorded on the 1852 OS map. The walls were constructed from unfrogged red brick and were two skins thick, and recorded to a maximum depth of five courses without the foundations being reached. Tiled floor 613 was bounded by walls 606, 608 and 609 and had a black and red checked pattern (Plate 6). Structure 126 formed a brick lined drain for the dwelling and would presumably have been situated within the footprint of a kitchen.

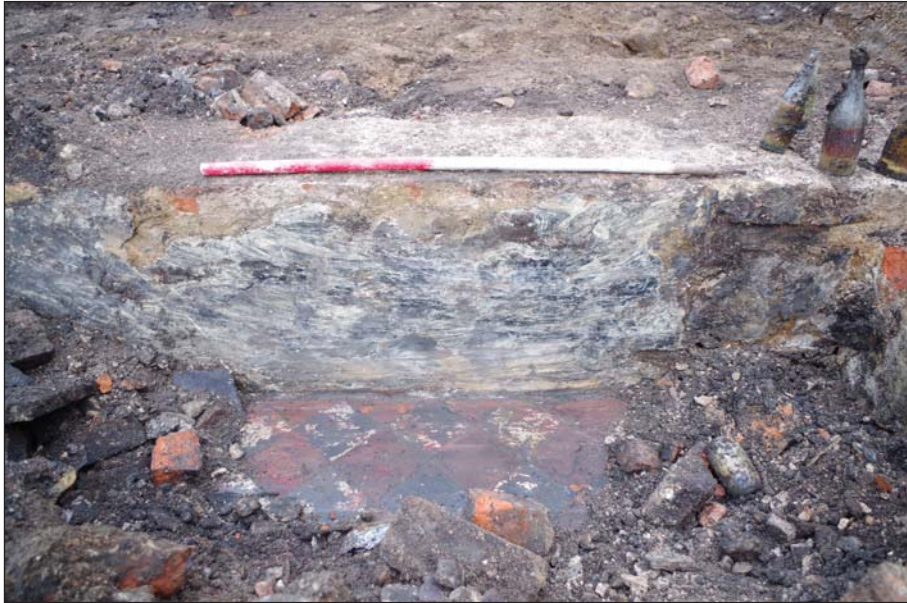
Plate 5: Wall 609 within area 1

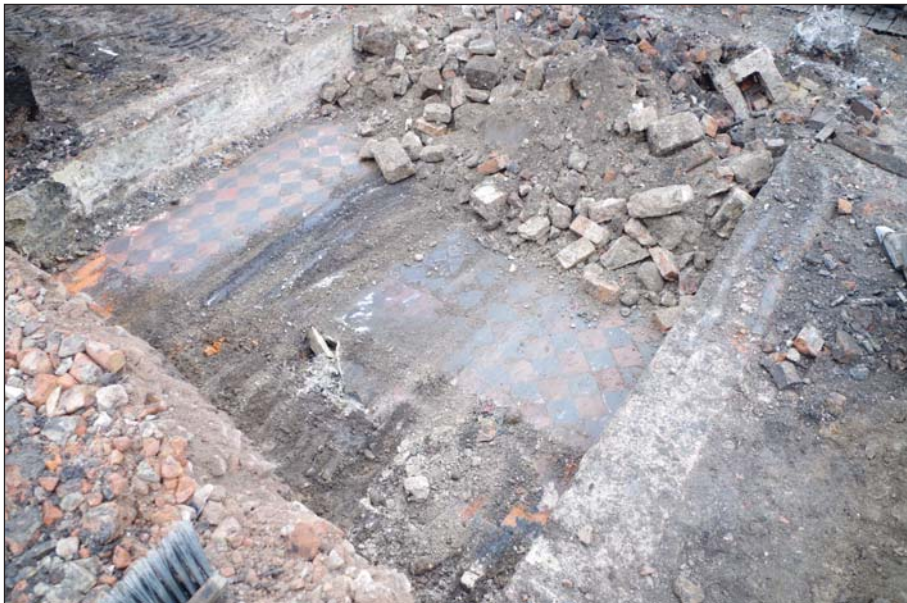
Plate 6: Tiled floor 613 within area 1

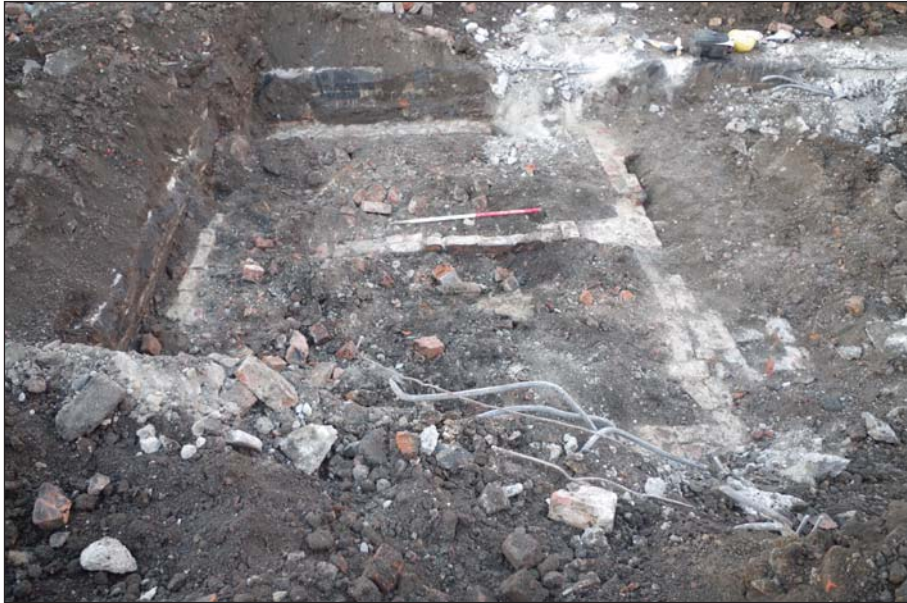
Plate 7: Structures 109-117, 604-605 and 610-611 within area 1

5.4.7 Structures 109–117, 604–605 and 610-611 are situated immediately to the east of the terraced building described above and correlate with structures first depicted on the 1892 OS map (Plate 7). The walls were constructed from unfrogged red brick and were two skins thick, and recorded to a maximum depth of five courses without the foundations being reached. These structures abut the terraced building and likely served as outbuildings. Structure 611 represents the remains of a red brick floor. Structures 112, 115 and 610 all

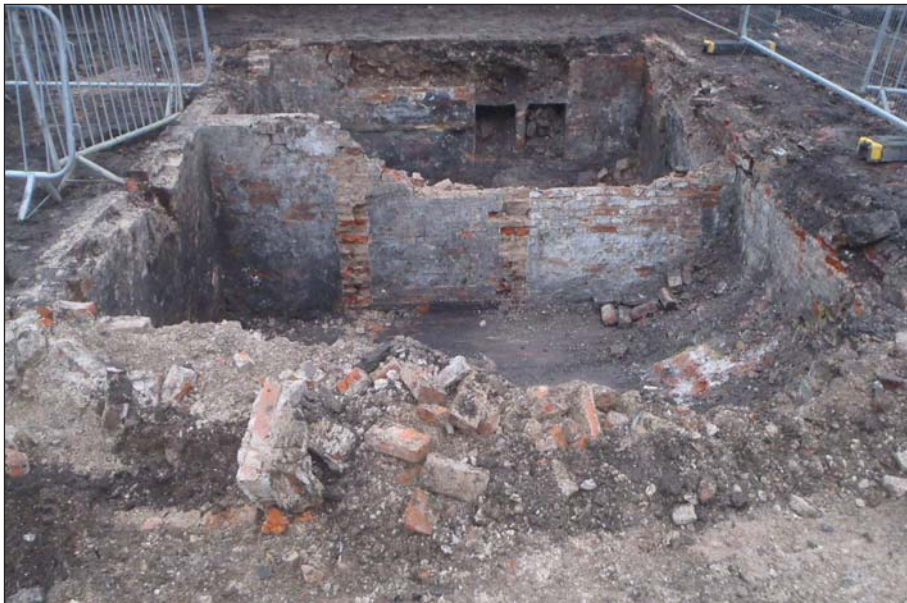
Plate 8: Cellars 409 and 420 within area 4

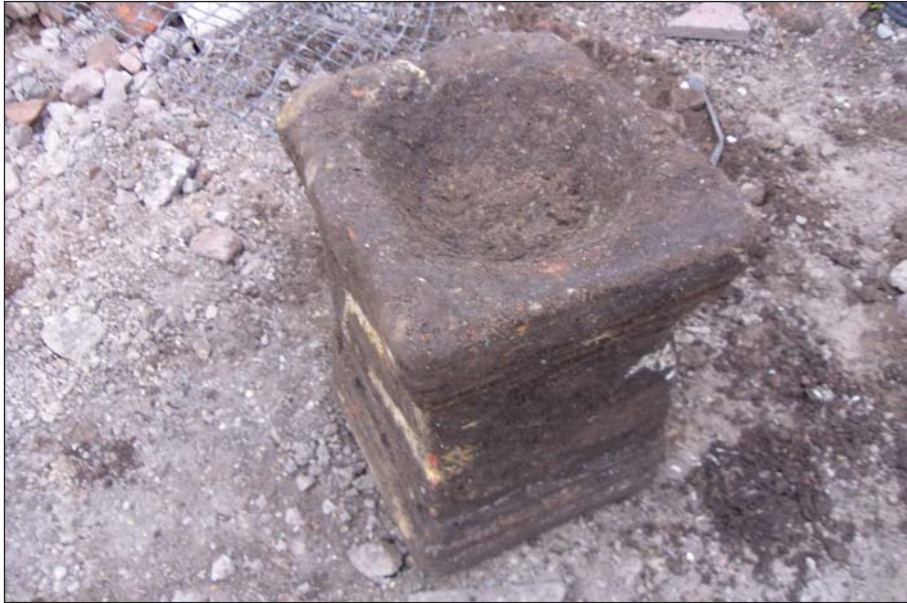
Plate 9: Roman altar recovered from site

- 5.4.9 Structure 421 correlates with the outer wall of terraced buildings fronting on to Bishophill Junior/Lower Priory Street. The unfrogged red brick wall was recorded running on a north west to south-east alignment for 20.50 m before turning 90 degrees to the north-east. The wall was two skins thick and the foundation was not reached. Within the footprint of this terraced building cellars 409 and 420 were recorded (Plate 8). Demolition material was removed from the cellars with machine assistance. Fill 410 of cellar 420 was found to contain the badly weathered remains of a probable Roman altar within the mixed demolition material (Plate 9).

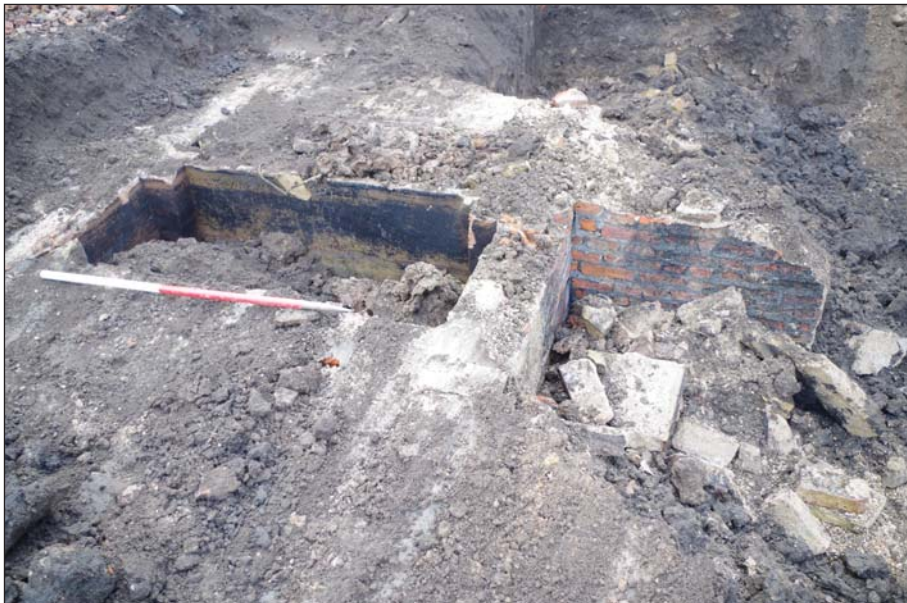
Plate 10: Structures 503 and 505-509 within area 5

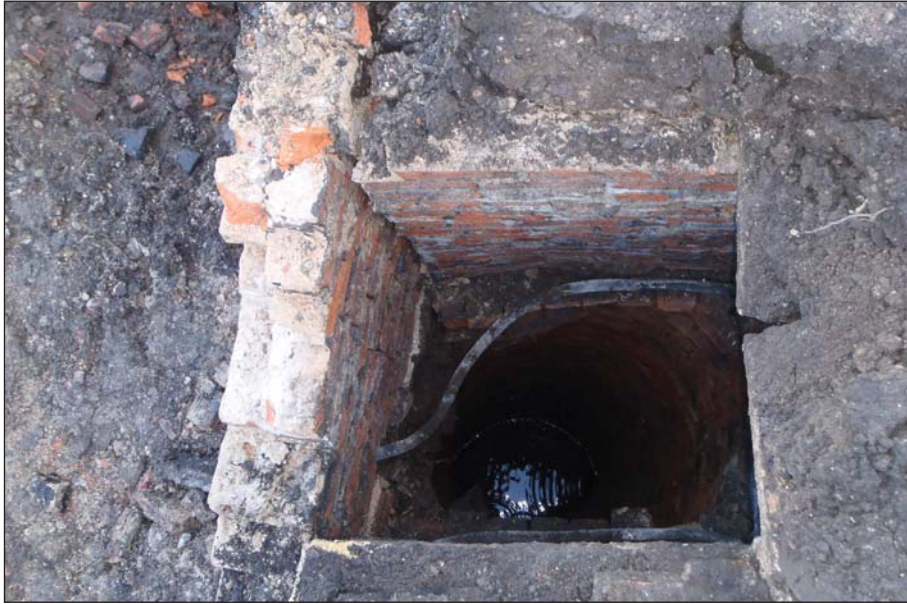
Plate 11: Upper courses of well 503 within area 5

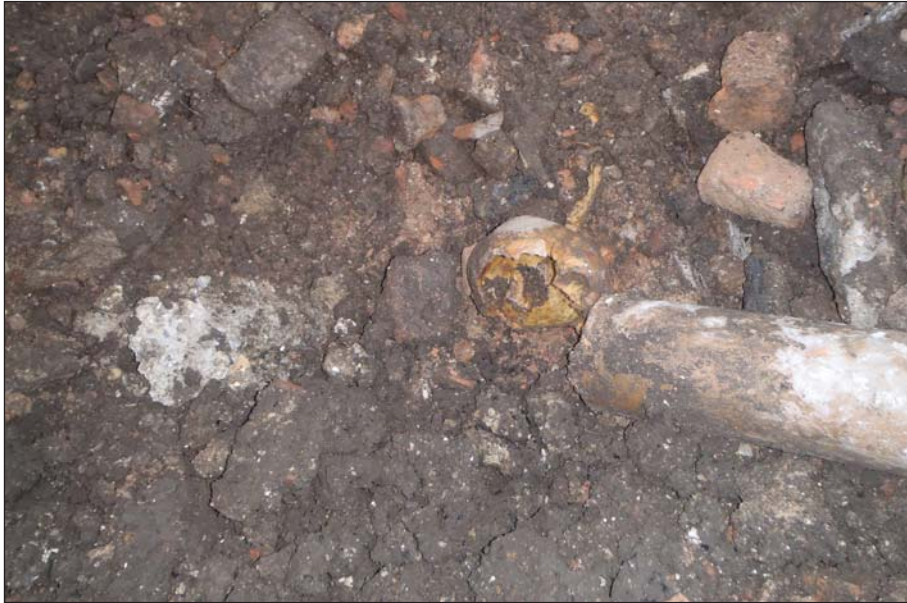
Plate 13: Human skull recovered during removal of manhole 412

- 6.7.1 A near complete human skull, found redeposited in the construction cut for a brick manhole, was subject to analysis. The skull may have derived from any of the underlying deeply stratified deposits, through which the feature was cut; it is therefore of uncertain date.

- 6.7.3 A summary is presented here, details are in the archive. The near complete skull is in very good condition (Grade 0–1), though it is missing the maxilla, part of the base and the mandible. There is some dry-bone fragmentation and localised erosion, most of which is likely to have occurred as a result of disturbance and redeposition. Iron-rich calcareous precipitate 'tide-marks' are present on the internal and external surfaces.

- 6.7.4 The cranium is that of an adult, at least 35 years of age and probably female. It has a cranial index of 78.9, which puts it into the mesocranic, or 'medium' category of skull shape. Pitting seen on the roof of the left orbit (*cribra orbitalia*) is a characteristic indicator of physiological stress, particularly in archaeological remains. The condition has been linked to anaemia resulting from a deficiency in iron and/or Vitamin B12, which may be associated with dietary lack, certain diseases/conditions (particularly gastrointestinal), severe blood loss and heavy parasitic load (Lewis 2010, 408; Molleson 1993; Roberts and Manchester 1997, 163–9; Walker *et al* 2009).
