Hucclecote Centre Churchdown Lane, Hucclecote Gloucester

Historic Building Record

Ref: 103731.01
April 2014

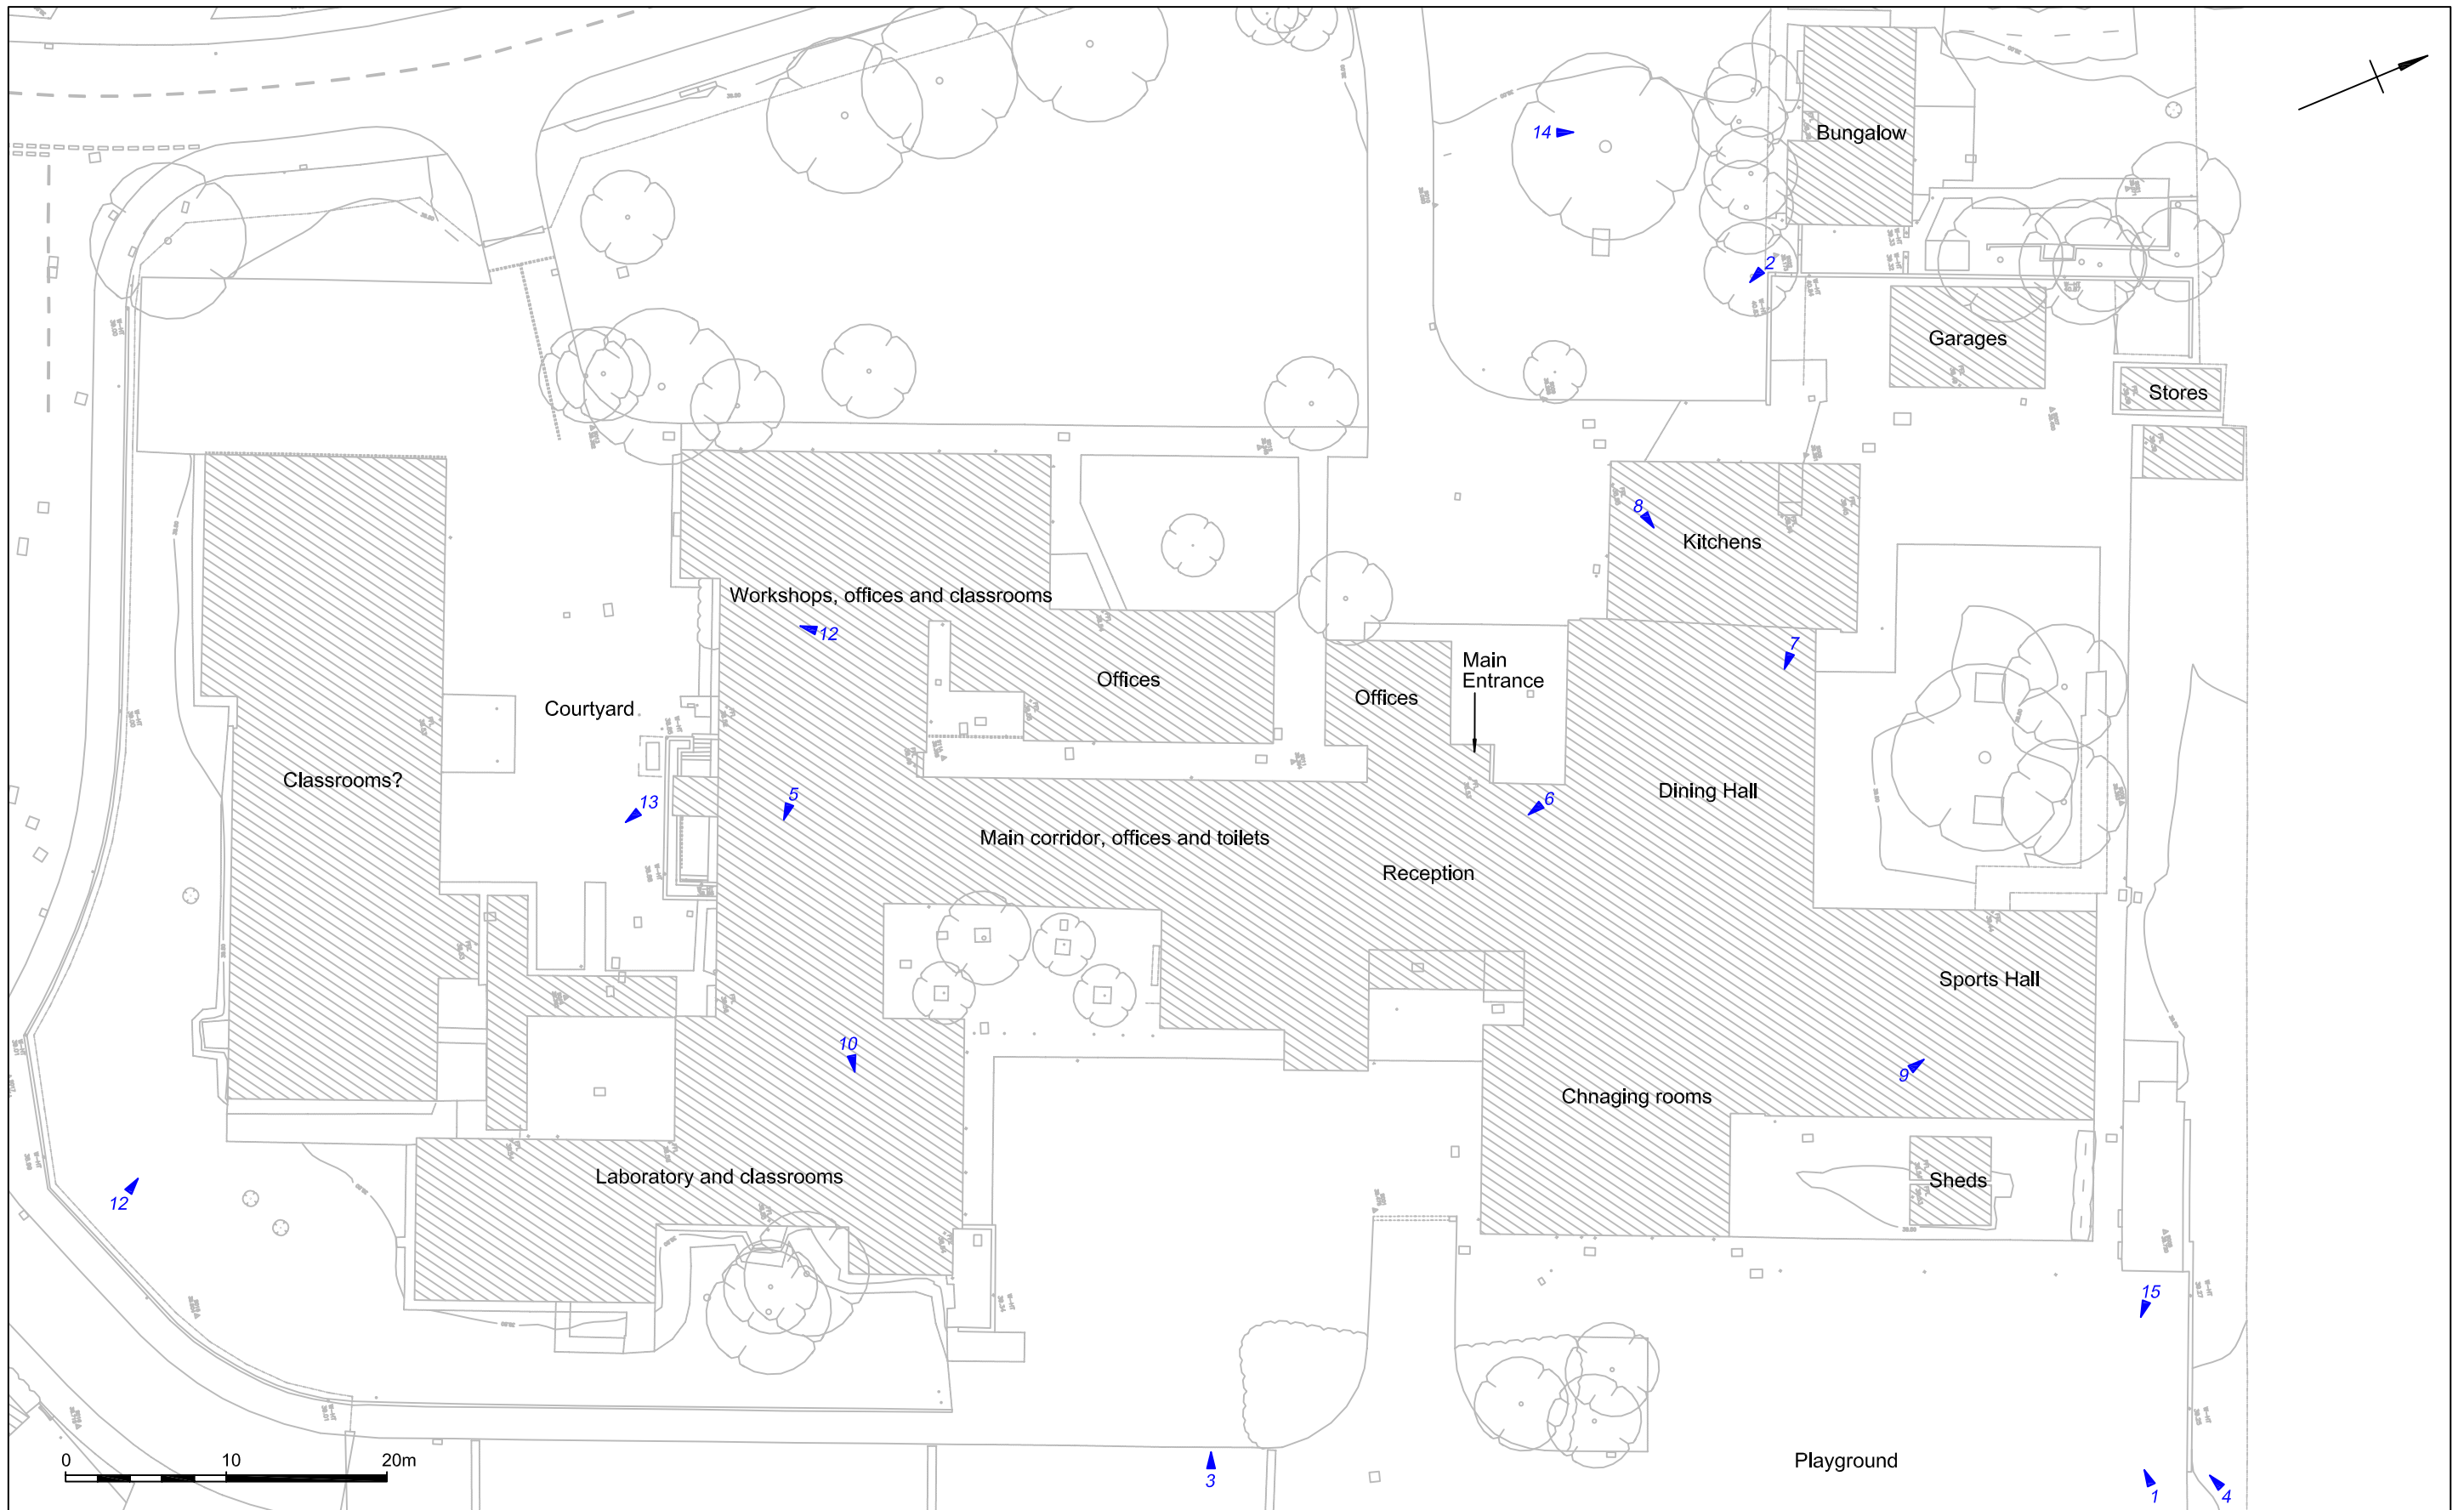
Figure 2

- 2.3.1 No drawn record was made of the buildings, however, a client-supplied site plan has been annotated and presented within the report (**Figure 2**) showing the ground floor arrangement of the Site and the location and direction of the selected images.

Ground floor plan of Hucclecote Centre

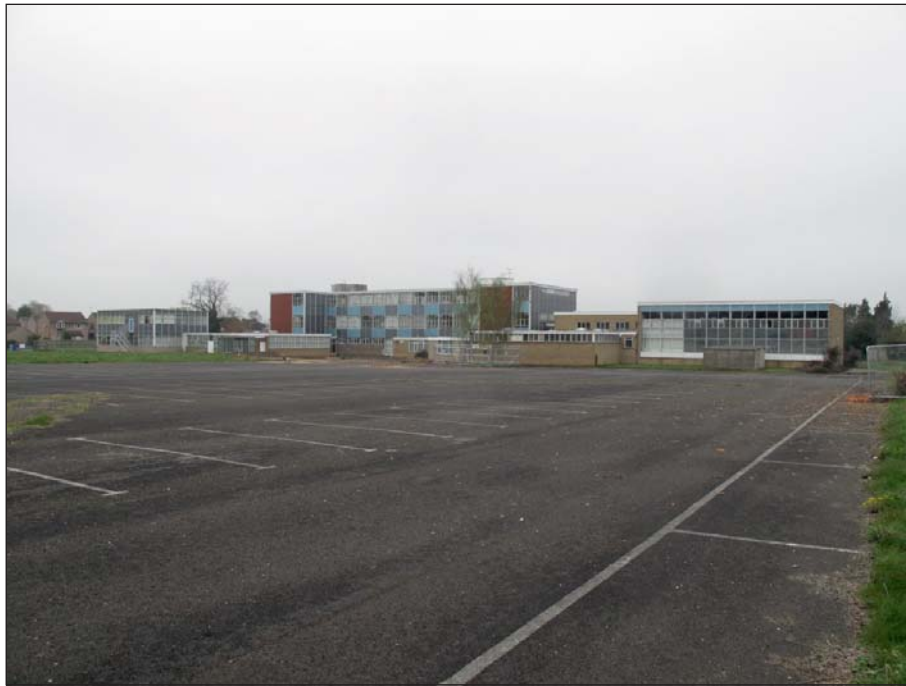
- 3.1.1 The main building comprises a large and irregular-shaped structure which is orientated north - south along its long axis and measures approximately 120m in length and 55m in width at its greatest extent (**Figure 2, Plates 1-2**). At the heart of the complex is a central three-storey block, which is 'I'-shaped in plan (**Plate 3**) with single and two-storey rectangular extensions situated on all sides, often in a staggered arrangement (**Plate 4**).

Plate 1: Hucclecote Centre viewed from the north-east

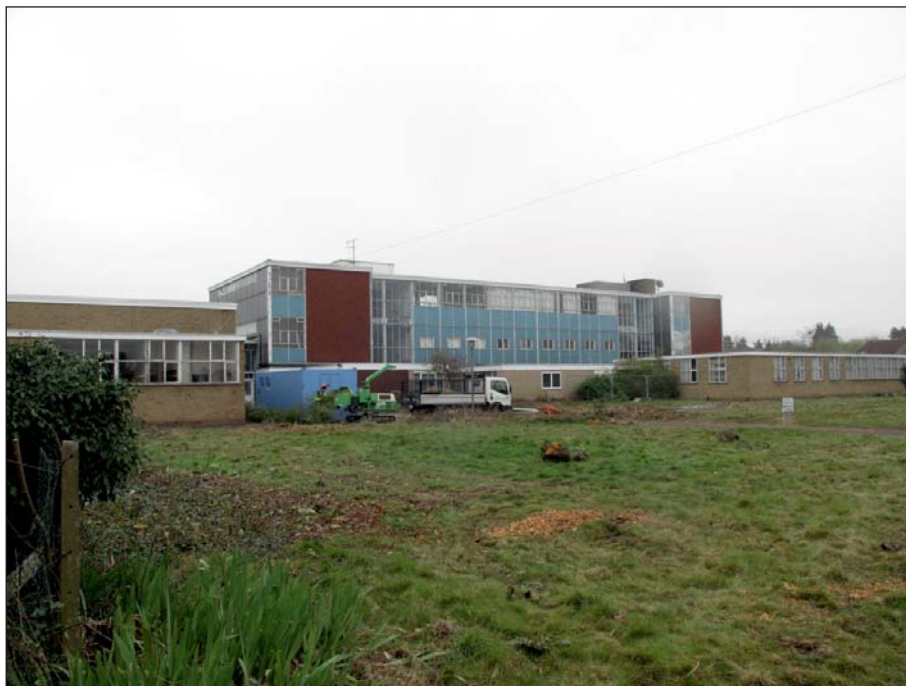
Plate 2: Hucclecote Centre viewed from the north-west

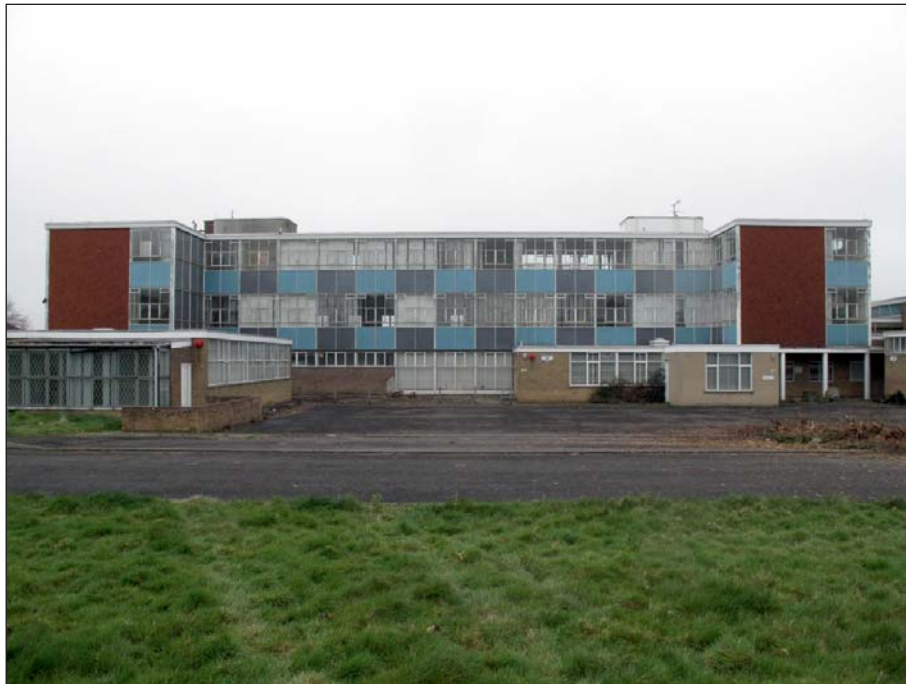
Plate 3: Central block of Hucclecote Centre viewed from the east

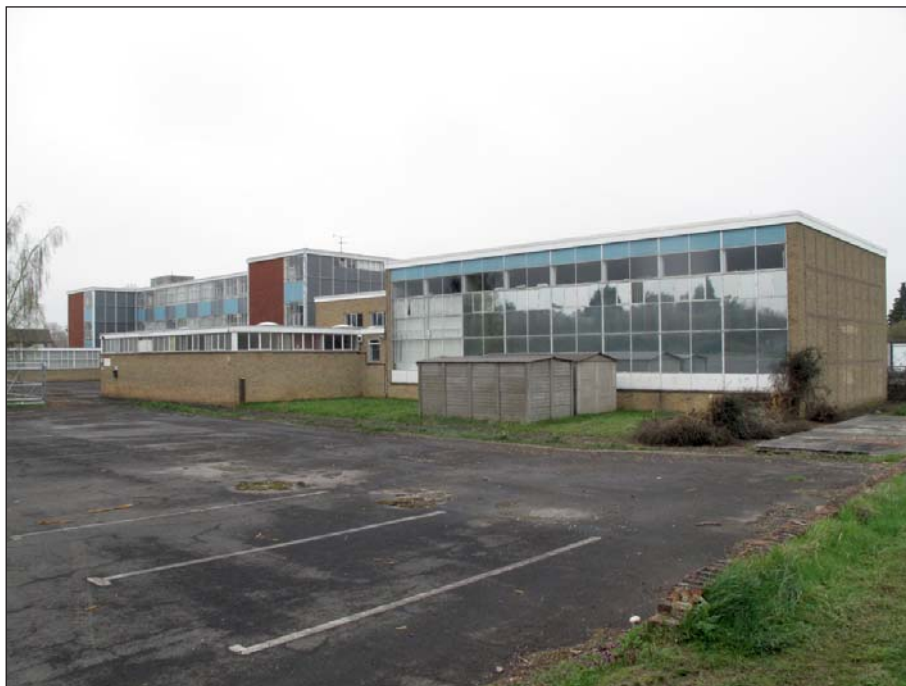
Plate 4: Hucclecote Centre viewed from the north-east

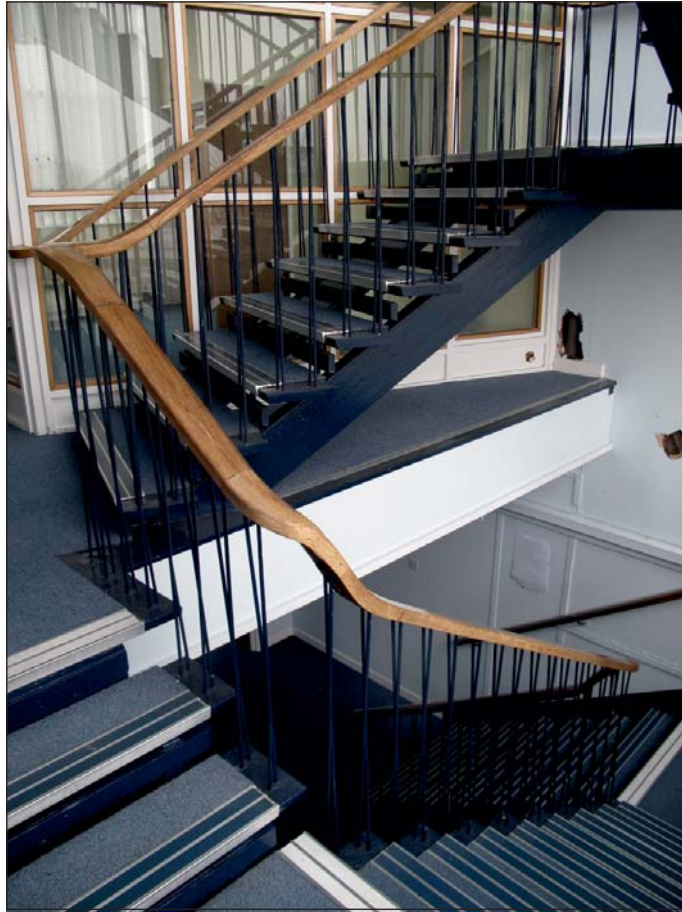
- 3.1.5 At ground floor level the central 'I'-shaped building comprises a long north-south orientated central corridor with offices and toilets situated on either side. At the north and south end of the corridor a spiral staircase leads to classrooms on the first and second floors (**Plate 5**). The main entrance into the building is situated at the northern end of the corridor on the west elevation, which leads into an 'L'-shaped Reception area (**Plate 6**). To the north of the Reception are two large joined, single-storey extensions: the dining/assembly hall (**Plate 7**), with attached kitchens (**Plate 8**) and storerooms to the west, and the former sports hall (**Plate 9**) with associated changing rooms and storerooms. At the southern end of the main building the corridor splits into two providing access into a number of workshops and offices to the west, and a large laboratory (**Plate 10**) and teaching rooms to the east.

Plate 5: Spiral staircase

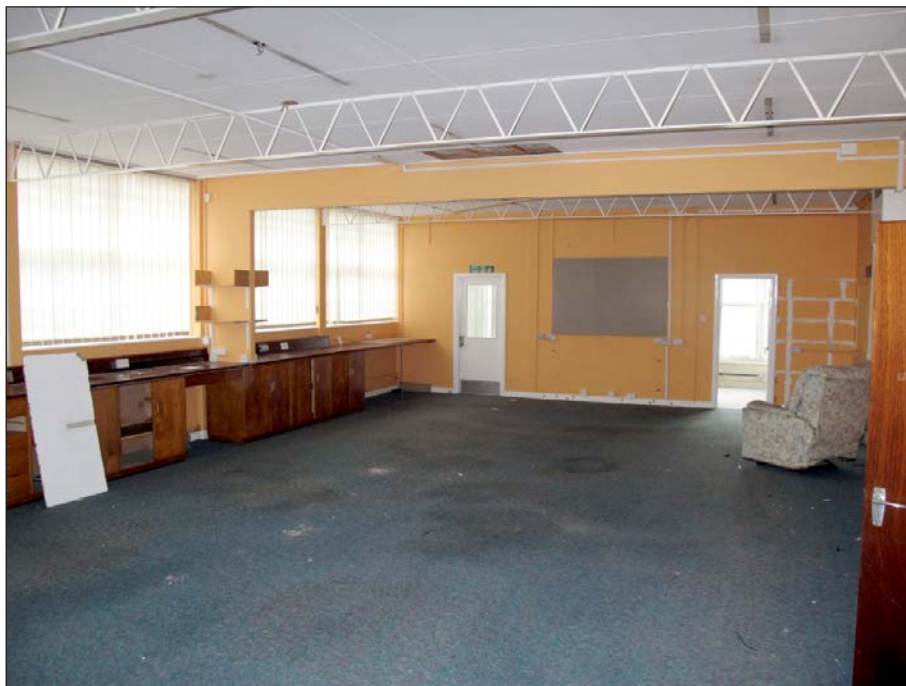
Plate 10: Former Laboratory

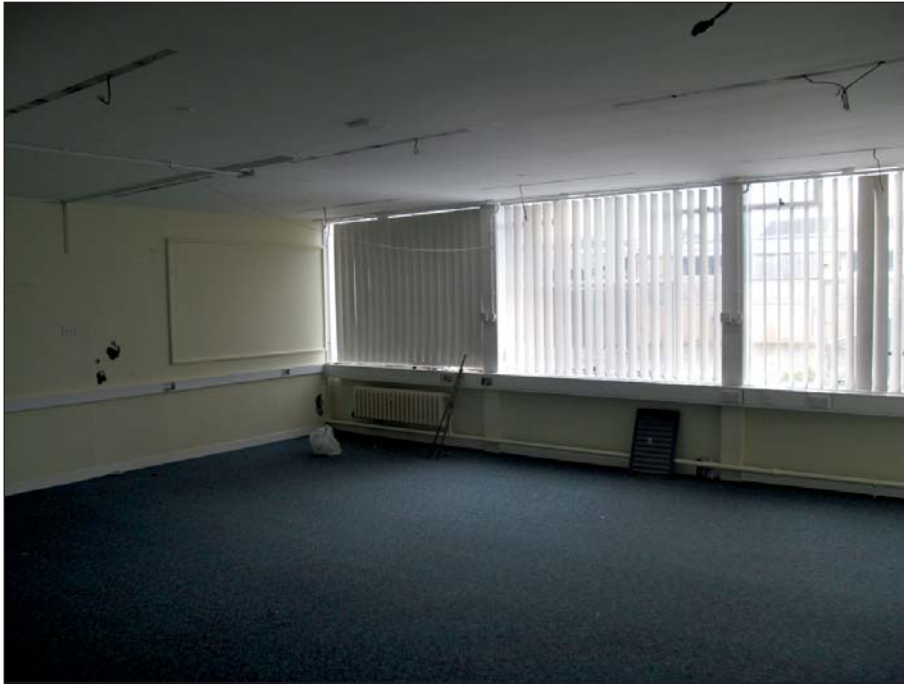
- 3.1.6 The first and second floors each contain six large classrooms (**Plate 11**), some of which have later been subdivided following the change of use in the late 20th century.

Plate 11: Typical large classroom latterly used as office space

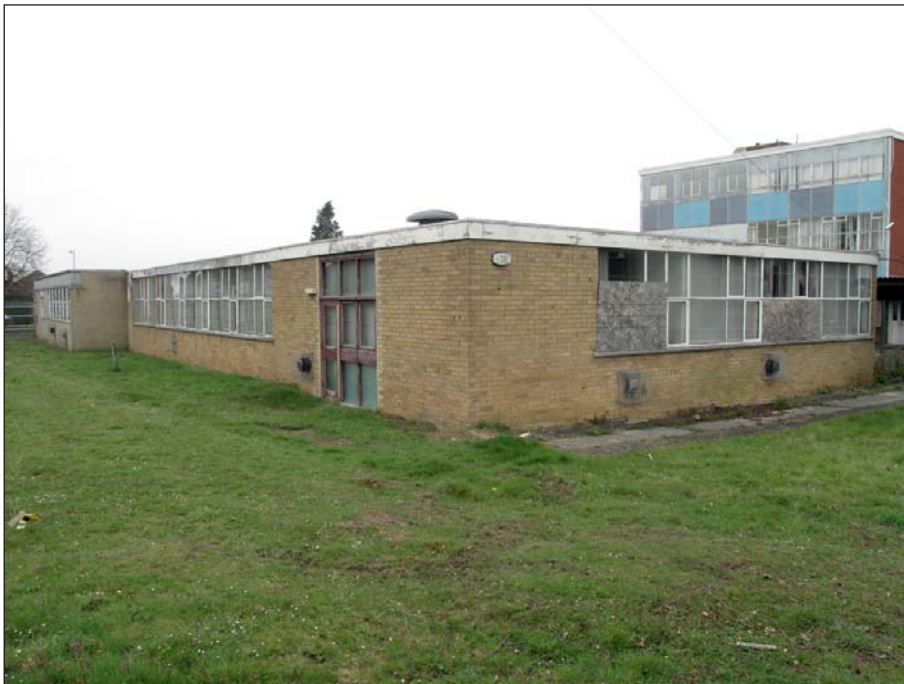
- 3.1.8 To the immediate south of the main building is a large, single-storey, rectangular building of pale brick measuring 40m in length and 15m in width (**Plate 12**) which, from brief examination, appears to have incorporated additional classroom facilities, although no access was available into this building during the site visit. Although constructed in similar style, historic mapping indicates that the building is a later construction, possibly during the 1970s when additional class capacity or facilities were needed. The area between the two buildings forms a narrow courtyard with covered walkways at the eastern end (**Plate 13**).

Plate 12: Large detached building to the south

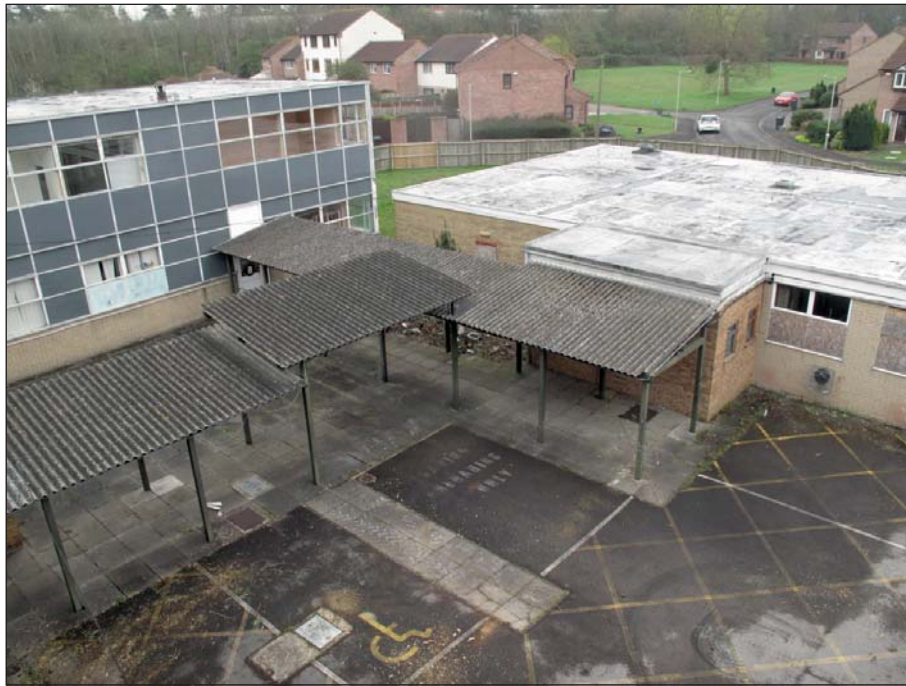
Plate 13: Courtyard with covered walkways

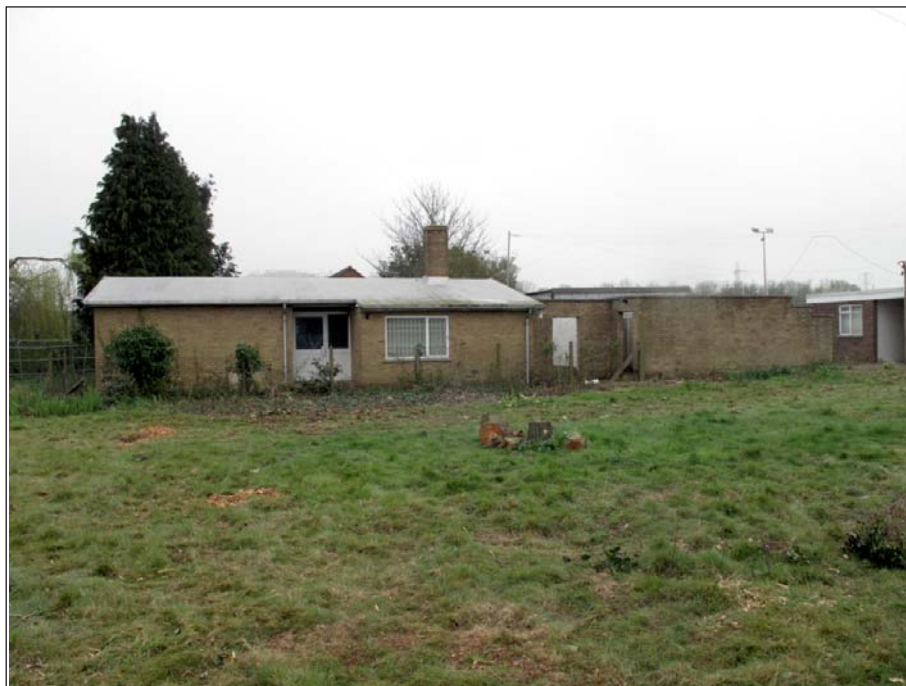
- 3.1.9 Away from the main building a small bungalow of pale brick with pitched roof is situated to the west of the kitchens, which most likely represents the caretaker's accommodation (**Plate 14**). A small number of ancillary buildings are situated to the north, including garages and storage sheds. To the north-east of the school is a large expanse of tarmac (b) (**Plate 15**) which formerly comprised a school playground and tennis courts, although latterly the area was used as a car park when the building changed use.

Plate 14: Caretaker's bungalow

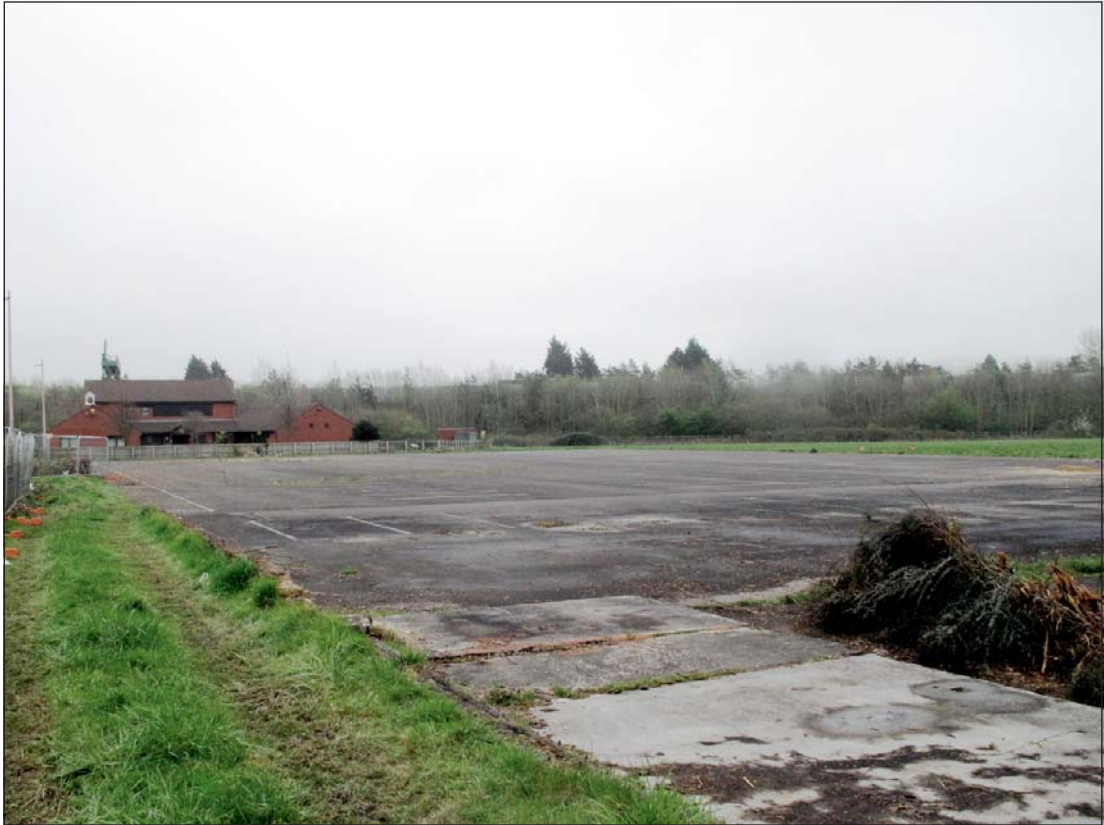
Plate 15: Area of hardstanding to the east - formerly a school playground and tennis courts
