# Marlborough College Generator and Cable Installation, Wiltshire

Archaeological Watching Brief

Ref: 204910.03  
November 2018

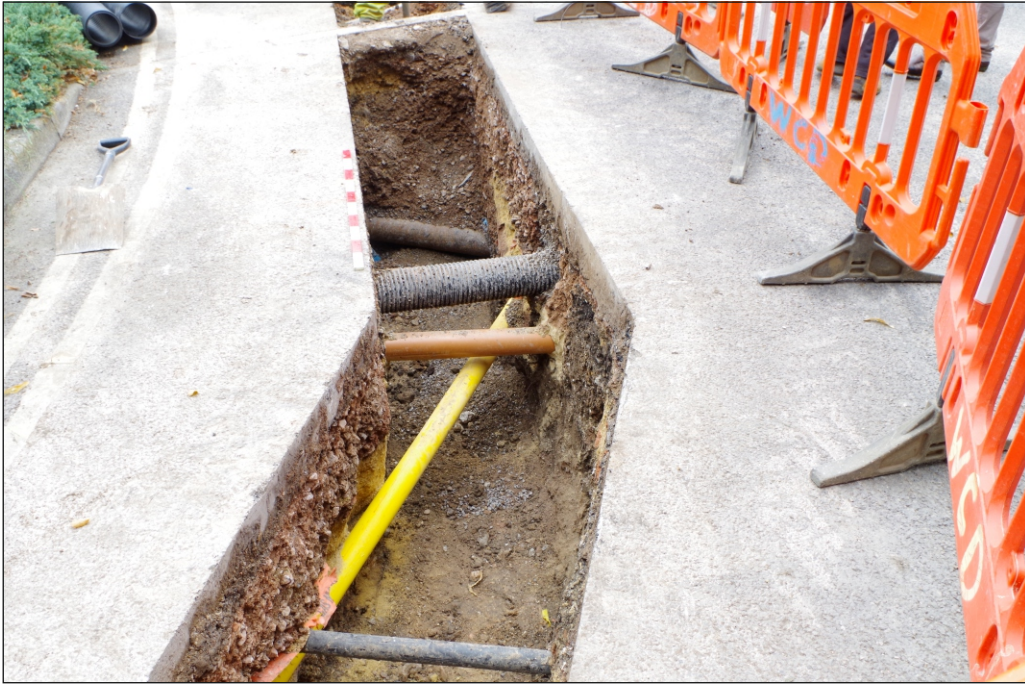
Plate 1: Section of the cable trench in tarmac area, located west of Heywood Block, view from the north

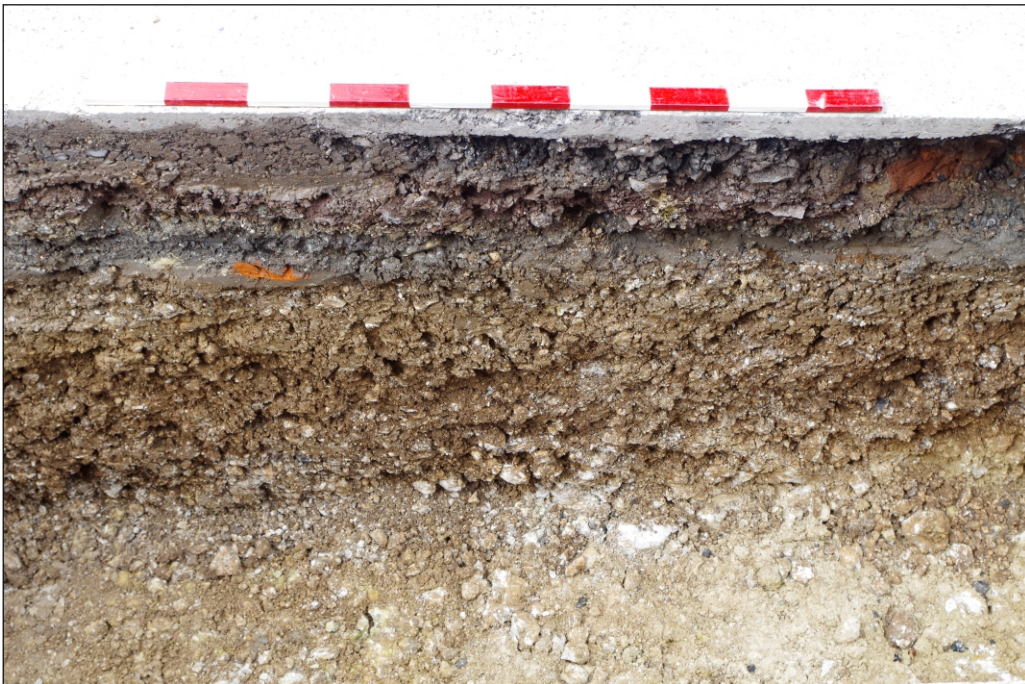
- 4.2.1 The general stratigraphic sequence encountered was approximately 0.75 m of made ground within the tarmacked area, which was intercut by multiple services. Beneath the made ground lies the natural of light yellowish white degraded chalk with fluvial flint gravels.
- 4.2.2 From the east of the Language centre, within the green fields area, lies imported topsoil of light greyish brown sandy silt (measuring 0.18 m thick), which overlays made ground (measuring between 35 m and 70 m thick). Natural flood plain deposits were identified from 0.87 m below ground level at the eastern end of the cable trench, which consisted of light grey calcareous gravels.

Plate 2: East facing representative section of made ground and soil sequence (1 x 1 m)

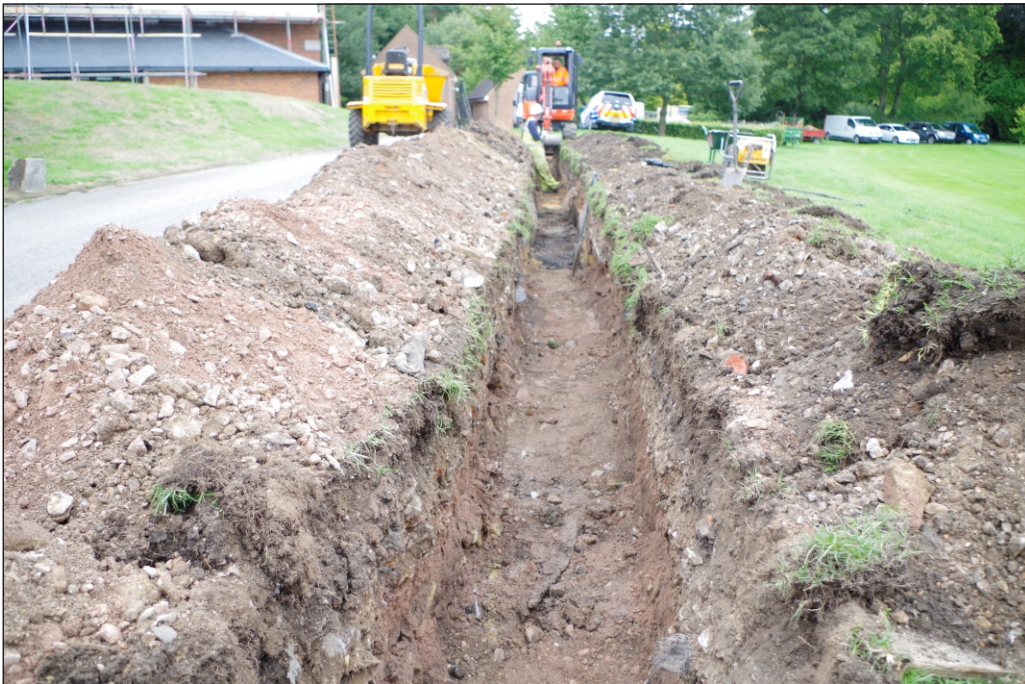
- 4.3.1 The watching brief monitored the route of the cable trench, which ran from the south-western elevation of the Common Room, southwest of Staff Block, Leaf Block and Heywood Block, all within a tarmac area (**Plates 1 and 2**). The cable trench then turned to the north-east immediately south of the Language Centre within an area of green fields until it intersected with Pewsey Road (**Plates 3 and 4**).

Plate 3: Section of the cable trench located south of language centre, view from the west

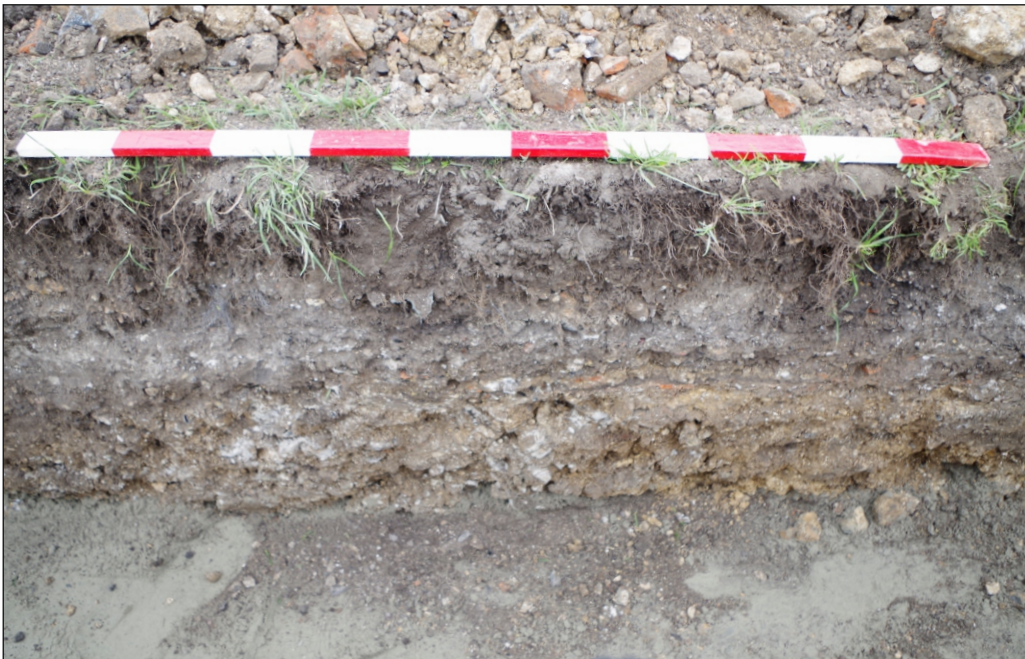
Plate 4: South facing representative section of made ground and soil sequence (1 x 1 m)

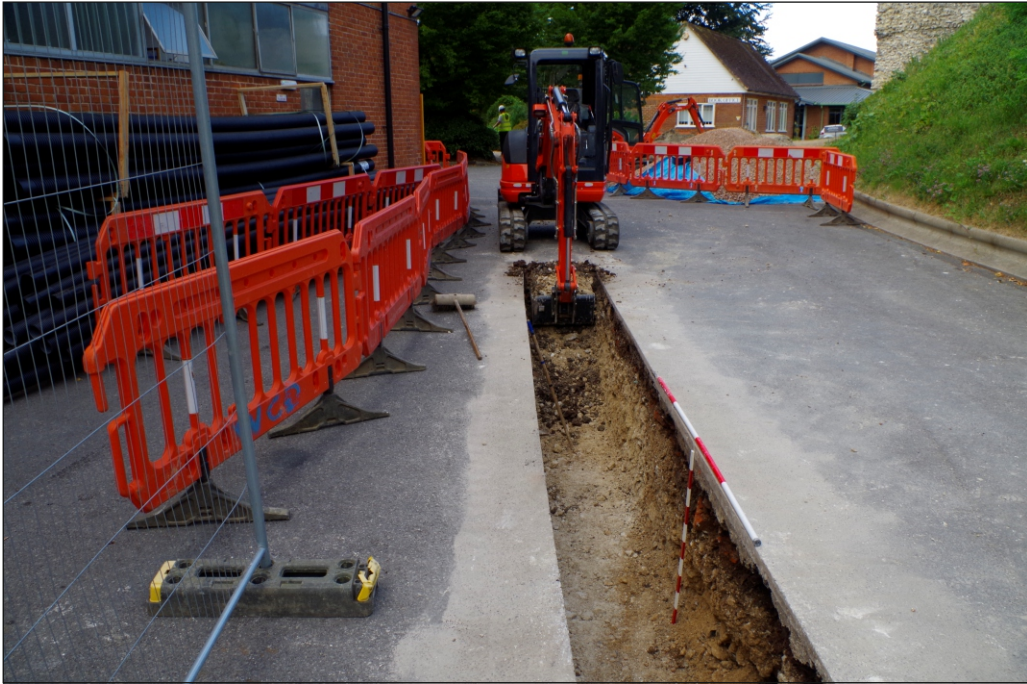
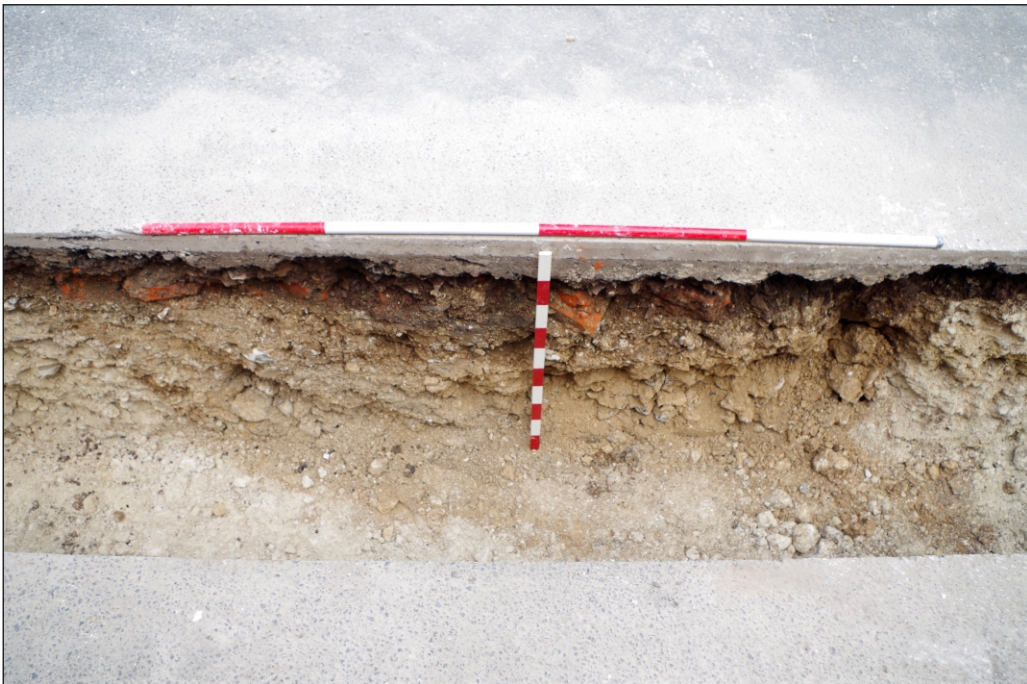
- 4.3.2 During the excavation wall footings were identified in four locations. Wall footing 105 was uncovered to the north east of the staff block (**Plate 5 and 6**). To the south of the Staff block, a north west – south east aligned wall footing 112 was located, containing footing material similar to that found within wall footing 105 (**Plate 7**). A possible wall footing 118 was recorded to the west of Heywood block (**Plate 8**). However, these features have been subject to heavy truncation from the modern disturbance of service trenches and as such the alignment and dimensions are unknown or not clear.

Plate 5: North facing section of cable trench with location of wall footing 105 (1 x 1 m, 1 x 2 m)

Plate 6: South-east facing section of wall footing 105 continuing into the base of trench (1 x 1 m, 1 x 2 m)

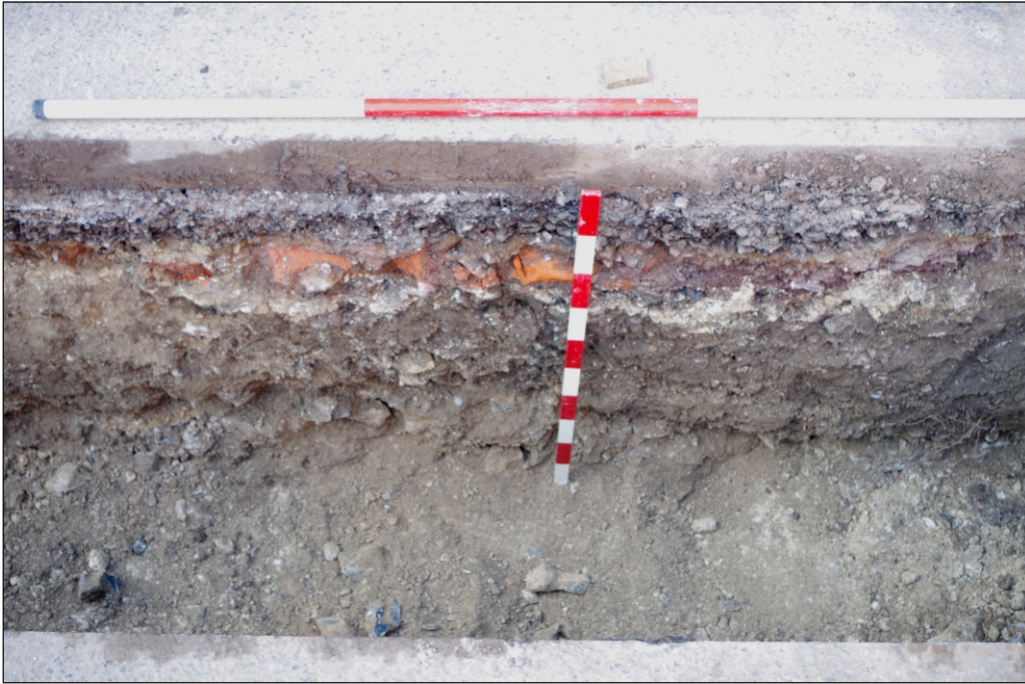
- 7.1.3 To the south of the Staff block, the north-west south-east aligned wall footing 112 appears to have a fill containing footing material similar to that found within wall footing 105, which suggests a contemporary date. However, the position of wall footing 112 appears to be too far west for the eastern curtain wall structure and thus could be part of a contemporary internal building.

Plate 7: North-east facing section of wall footing 112 (1 x 1 m, 1 x 2 m)

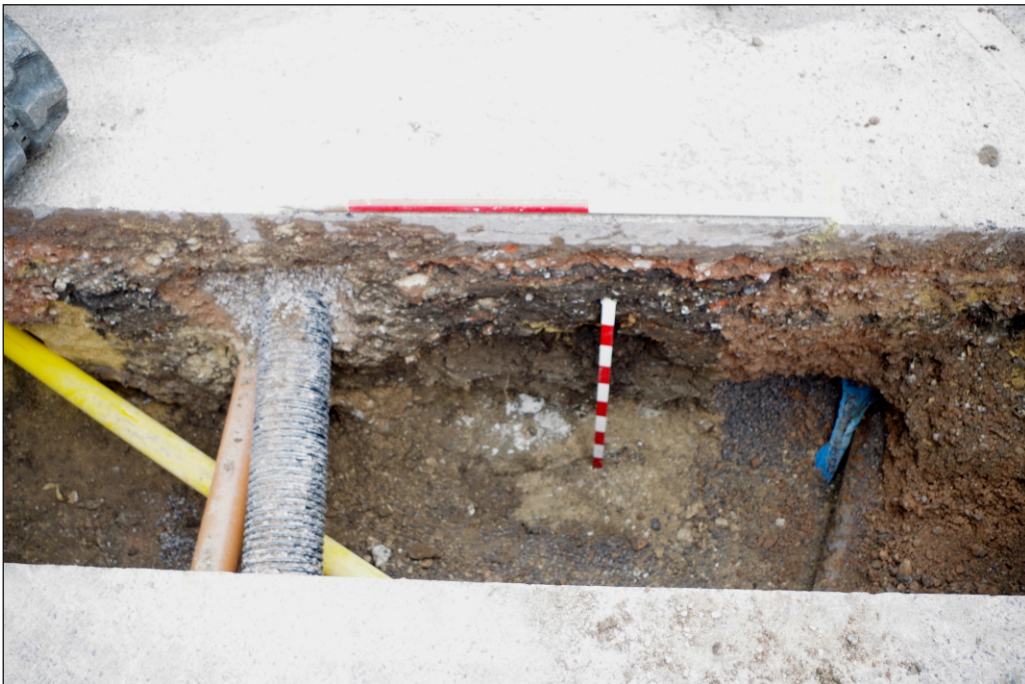
Plate 8: West facing representative section of heavily truncated wall footing 118 (1 x 1 m, 1 x 2 m)

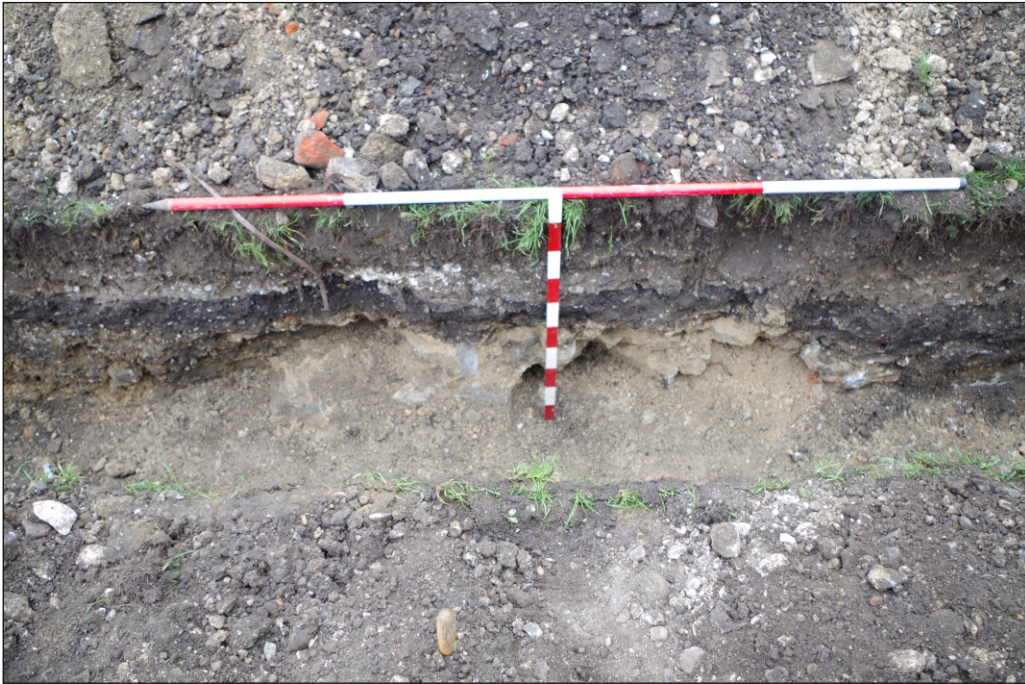
- 4.3.3 To the south of the language centre, a north-east south-west possible wall footing 133 was uncovered (**Plate 9**).

Plate 9: South-west facing section of wall footing 133 (1 x 1m, 1 x 2 m)

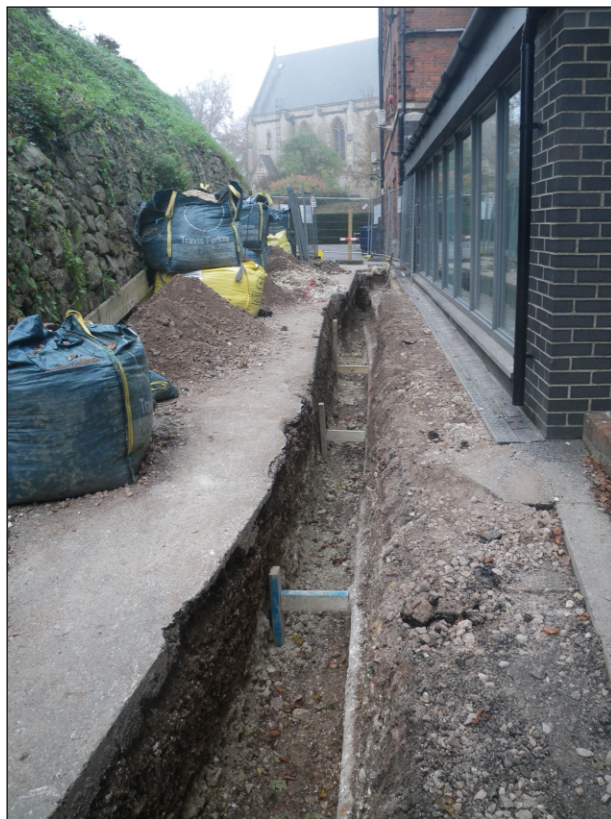
4.3.4 In addition to the wall footings, a 10.90 m length of redeposited chalk, 150, was identified in the north-east facing section of the north-western end of the trench next to the Common Room. Viewed in the trench as a small mound (**Plate 10, 11 and 12**), it is possible that this layer is related to the mounds make up. However, due to numerous utility trenches running through this section of the trench, it is difficult to confirm this.

Plate 10: Section of the cable trench at the location of layer 150, view from the south-east

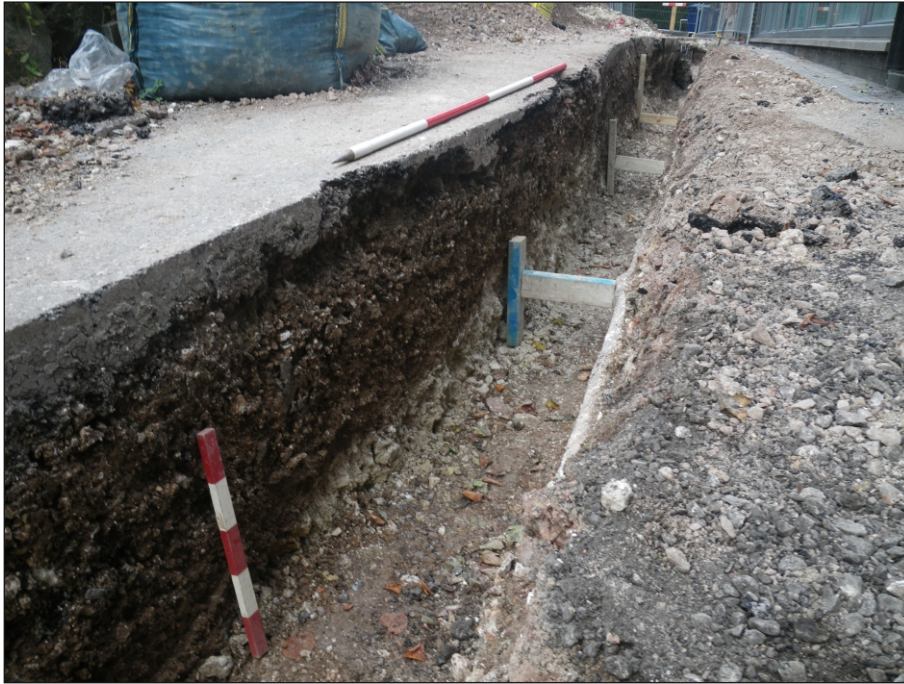
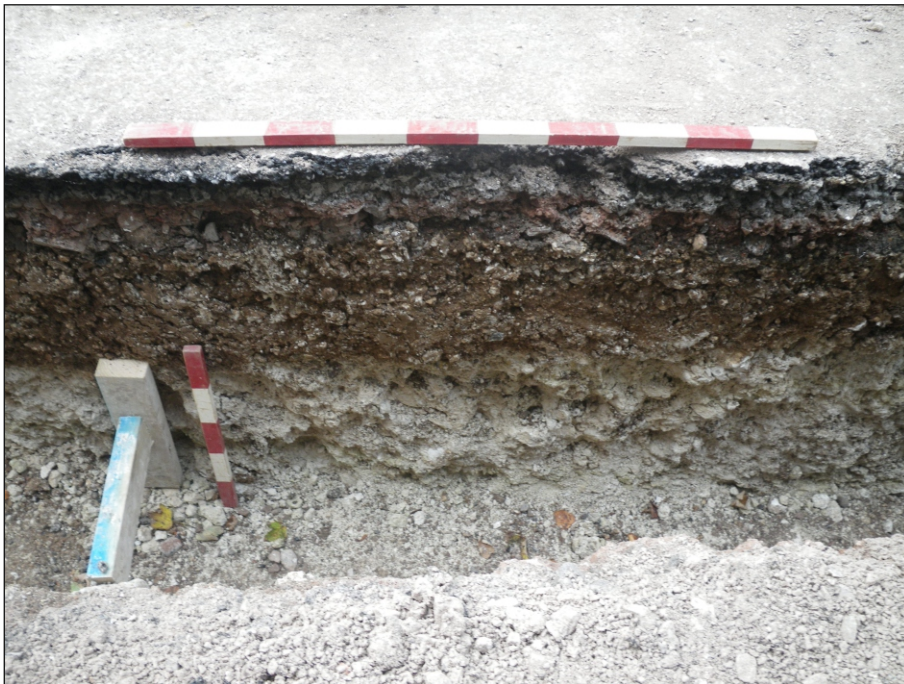
- 7.1.6 Redeposited chalk layer 150 may relate to the mounds make up or core. It was noted that in order to create a safe walkway between the current buildings and the mound, a section of the mound was straightened. Layer 150 seems to correspond to where the mound would have been, and it is possible that it is part of the original earthwork in order to construct the mound. The fact that this deposit was only partially visible in the opposing side of the trench does suggest it was sloping away from the mound.

Plate 11: Oblique view of layer 150 from the east (1 x 0.50 m, 1 x 2 m)

Plate 12: North-east facing representative section of 150 at its thickest (1 x 0.50 m, 1 x 1 m)
