Kirkthorpe Weir Wakefield West Yorkshire

Historic Building Recording

Ref: 115030.01
December 2016

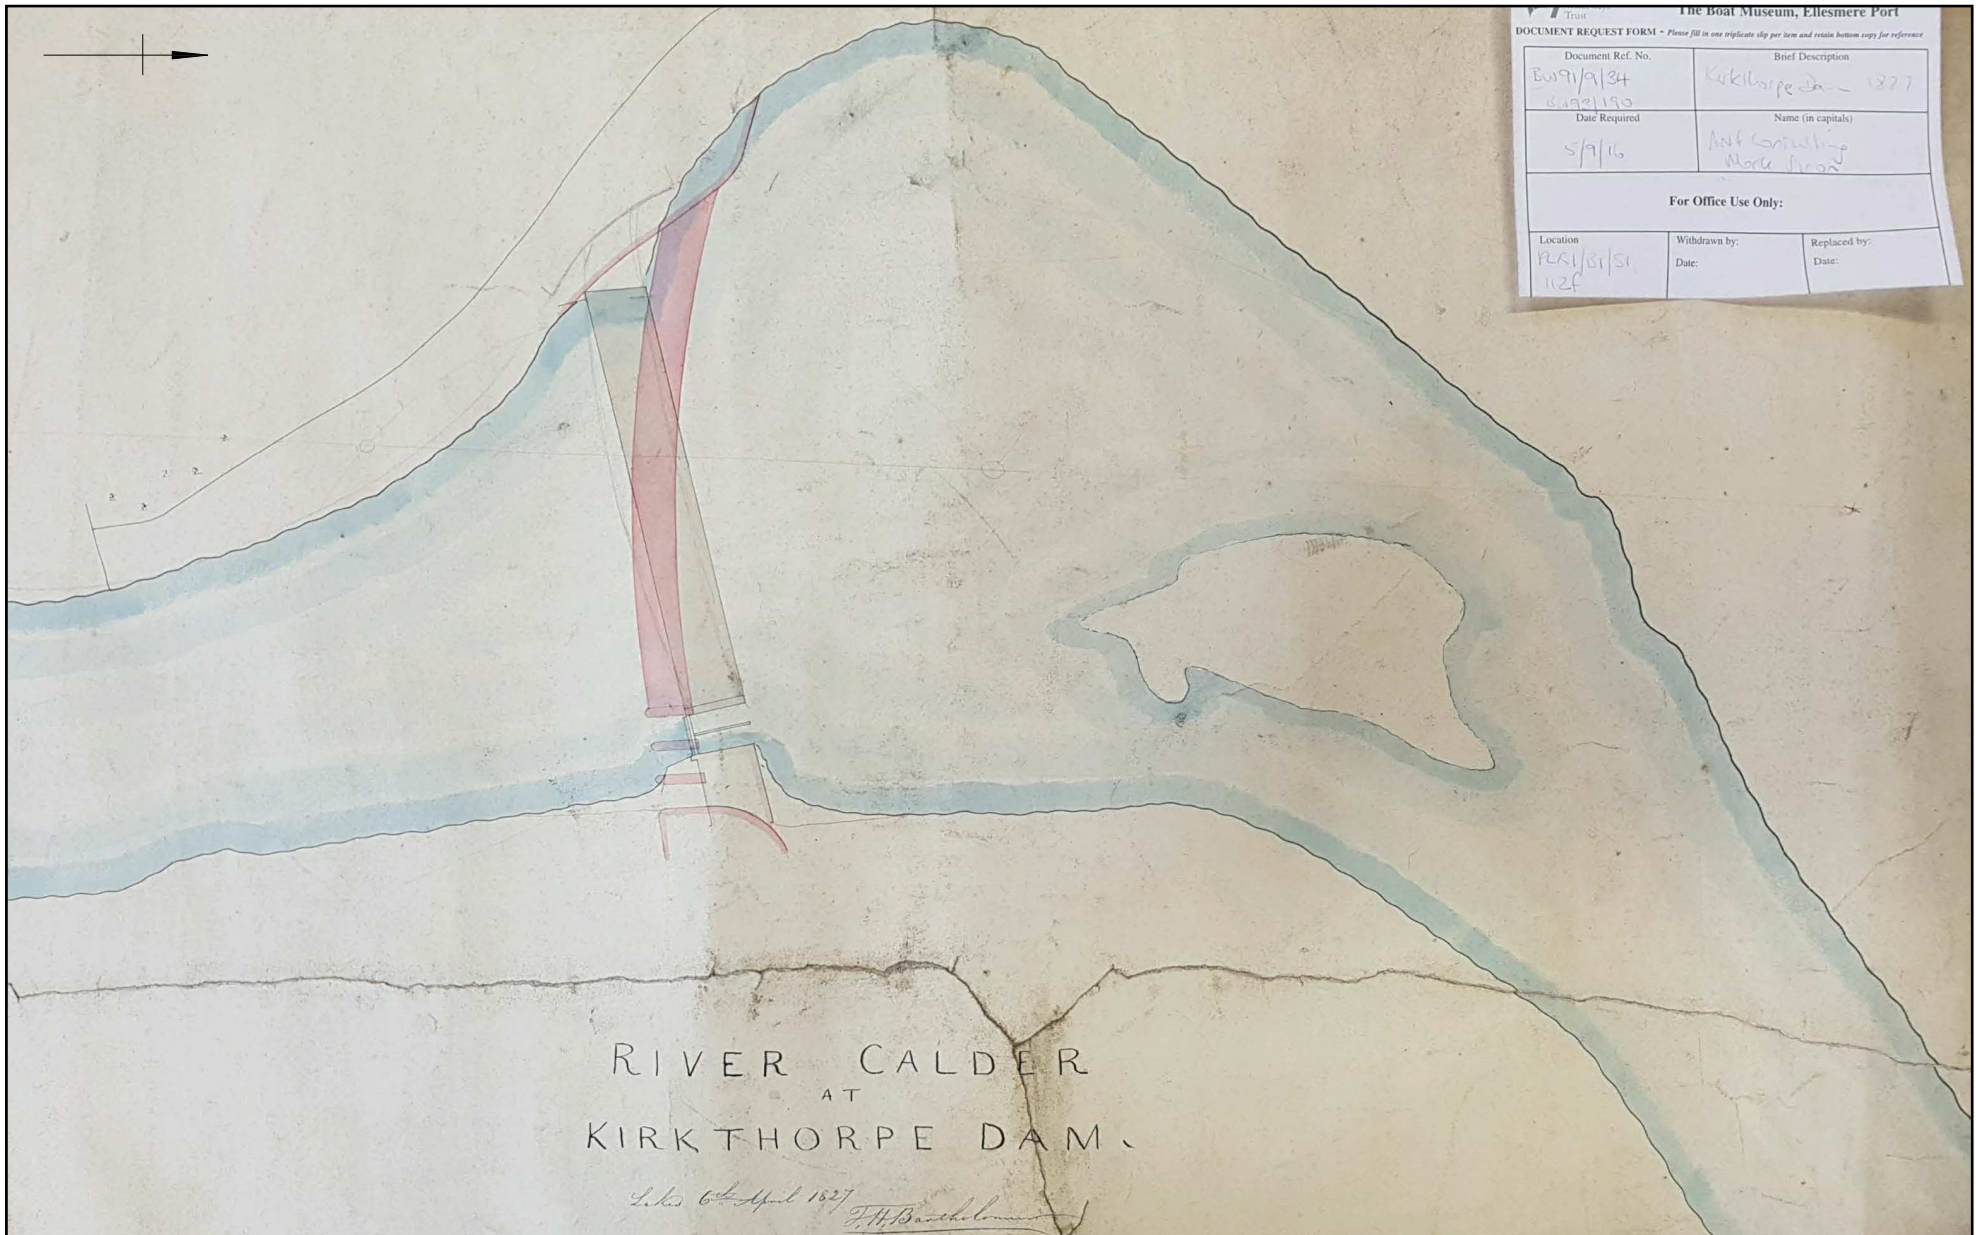
Figure 3

- 5.4.3 The original weir across the river, which was an oblique structure with two sluices, was completely replaced in 1827 by the extant structure that comprises a curved and stepped weir with three sluices (Figure 3). The original designs for the 1827 structure are held at the Canal and River Trust Archives and are reproduced as Figures 3-5. The plans show the details of the ashlar stepped curved weir, with three sluices comprising stepped piers located to the east of the weir structure, and the plan form of the ashlar stone wingwalls.

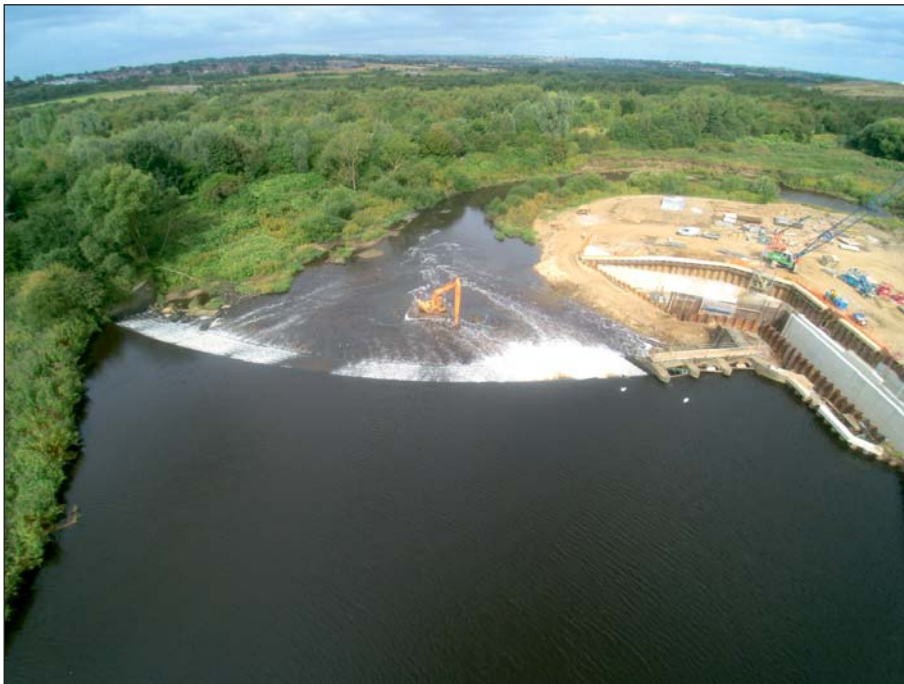
Plate 20: Aerial view of weir, sluices and new hydropower station site during works on 1st September 2016 following movement of central pier (Client Digital 20)

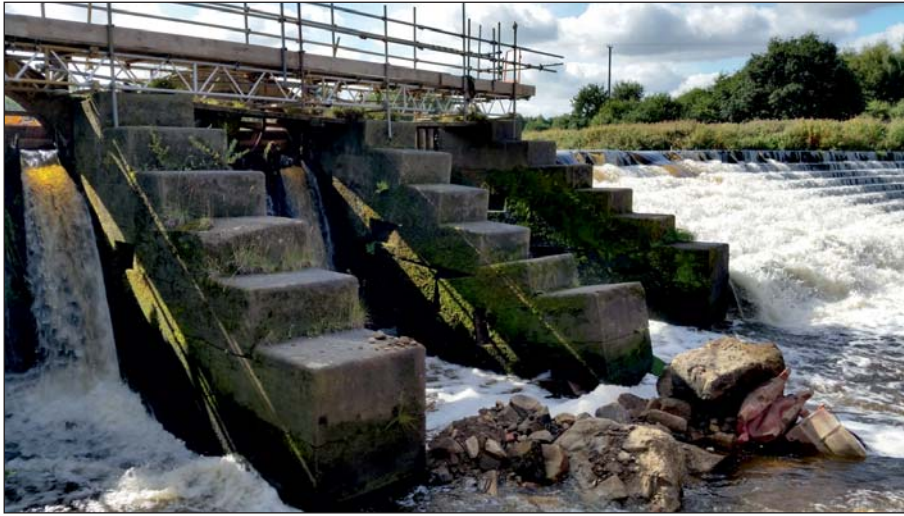
Plate 27: Downstream detail of sluice piers following subsidence of central pier (Client Digital 27)

- 7.1.4 The weir and its sluices have remained largely intact for the last 200 years almost, and are the property of the Canal and Rivers Trust. An unfortunate scour hole beneath the central sluice pier has caused the movement of the pier, which has in turn provided an opportunity for the archaeological recording of the structure during a time when an unprecedented amount of the structure is visible.

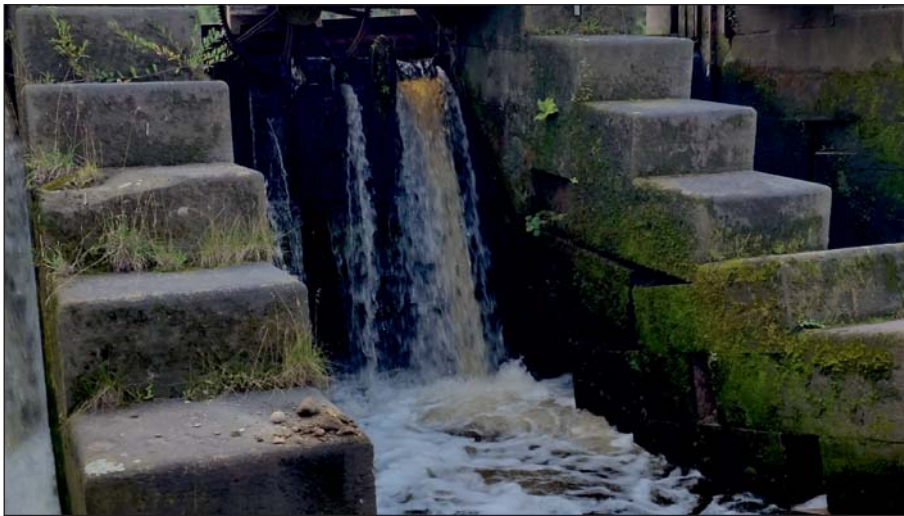
Plate 28: Downstream detail of central sluice and damage to pier (Client Digital 28)

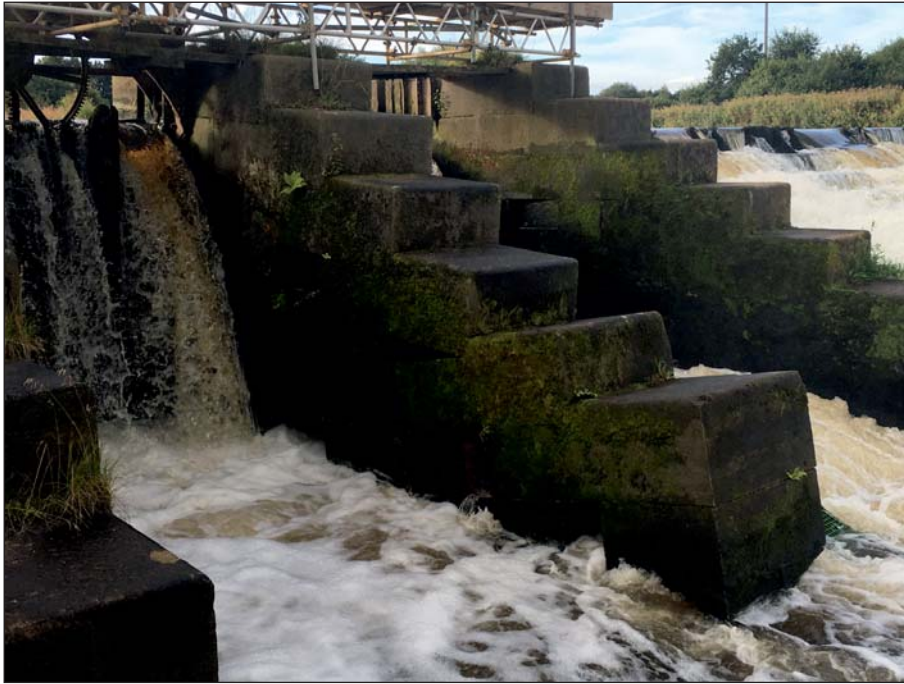
Plate 29: Downstream detail of sluice piers following subsidence of central pier (Client Digital 29)

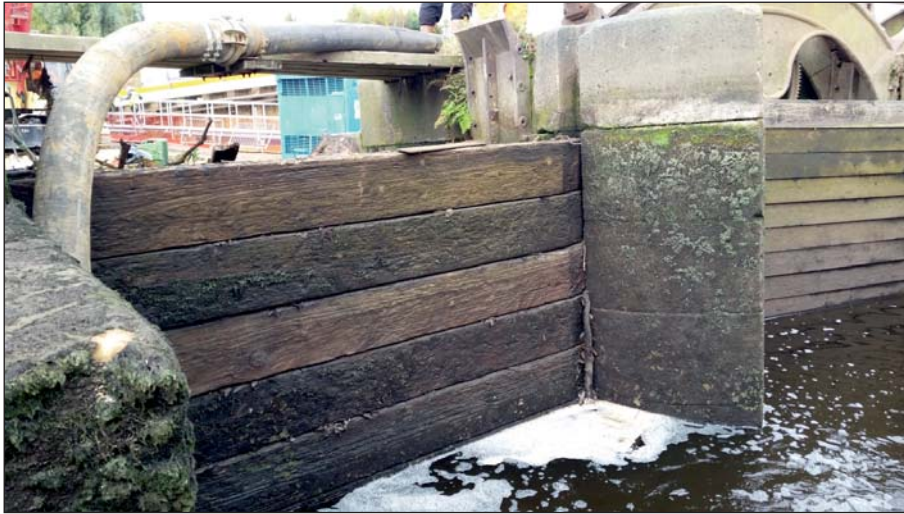
Plate 39: View of the timber boards of westernmost sluices from upstream post-piling (Client Digital 39)

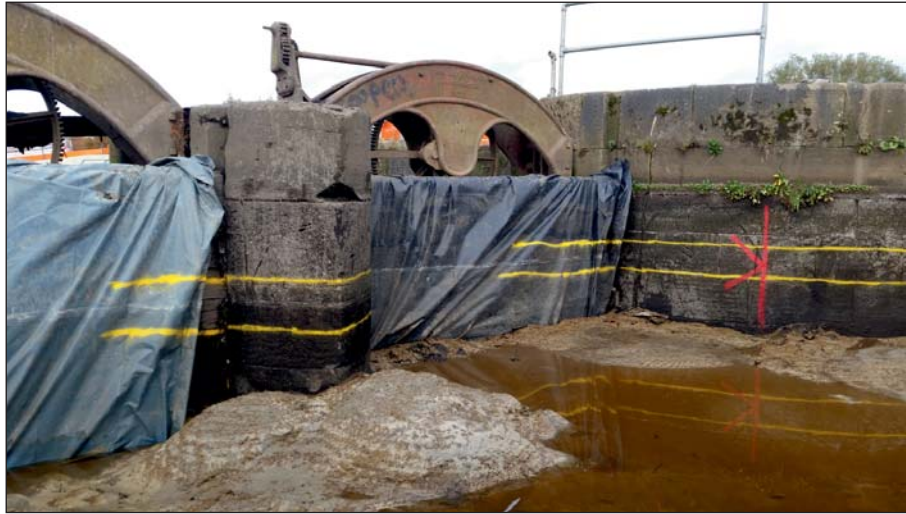
Plate 43: Detail of easternmost sluice from upstream post-piling, showing levels for new concrete slab (Client Digital 43)

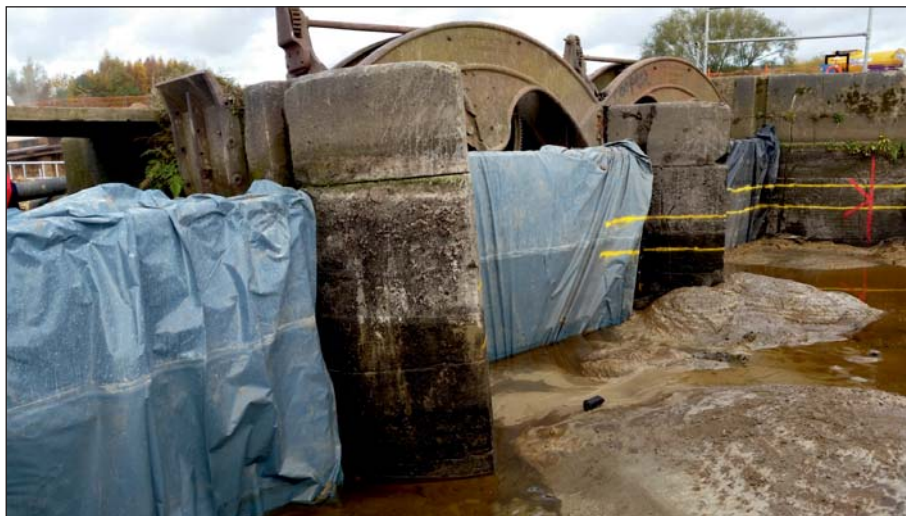
Plate 44: View of the sluices from upstream post-piling, showing levels for new concrete slab (Client Digital 44)

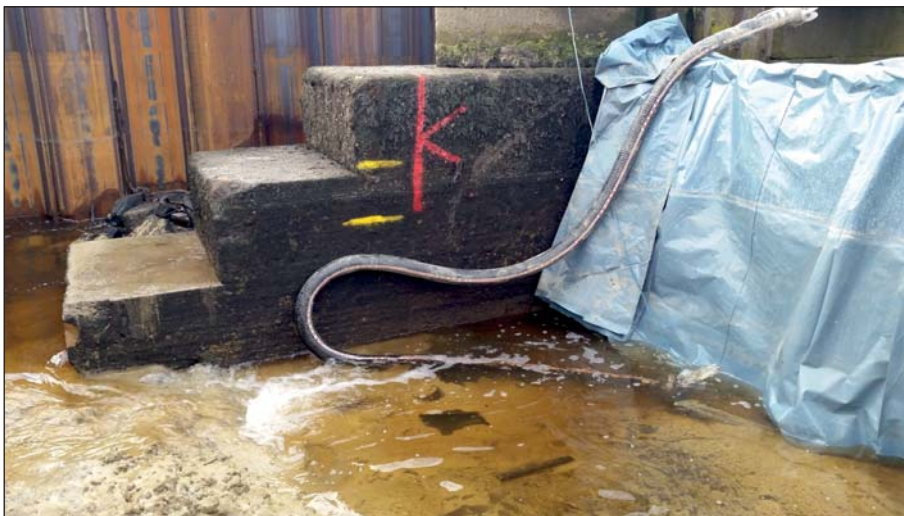
Plate 46: Detail of westernmost pier with stepped upstream side showing levels for new concrete slab (Client Digital 46)

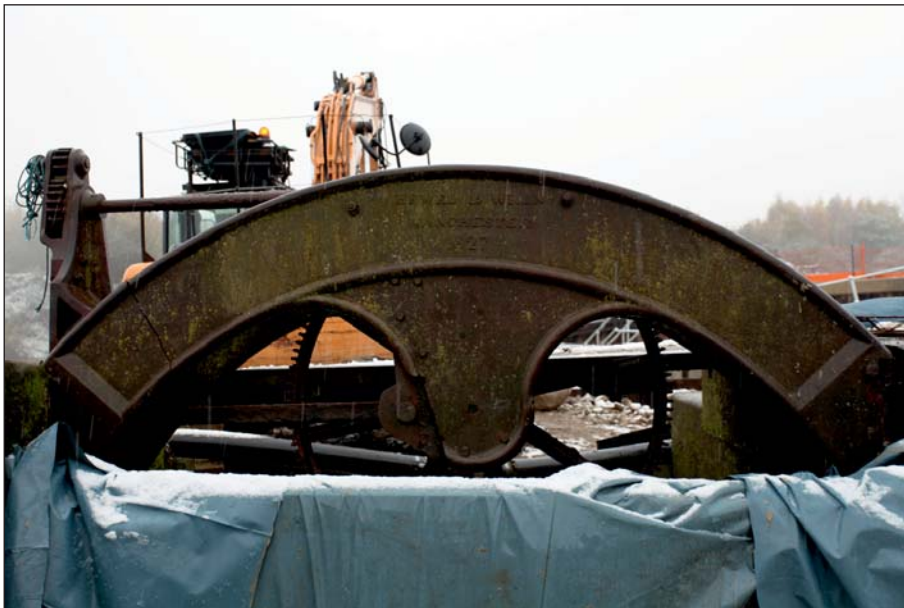
Plate 52: Detail of central sluice cast iron mechanism from downstream (Digital IMG_0211)

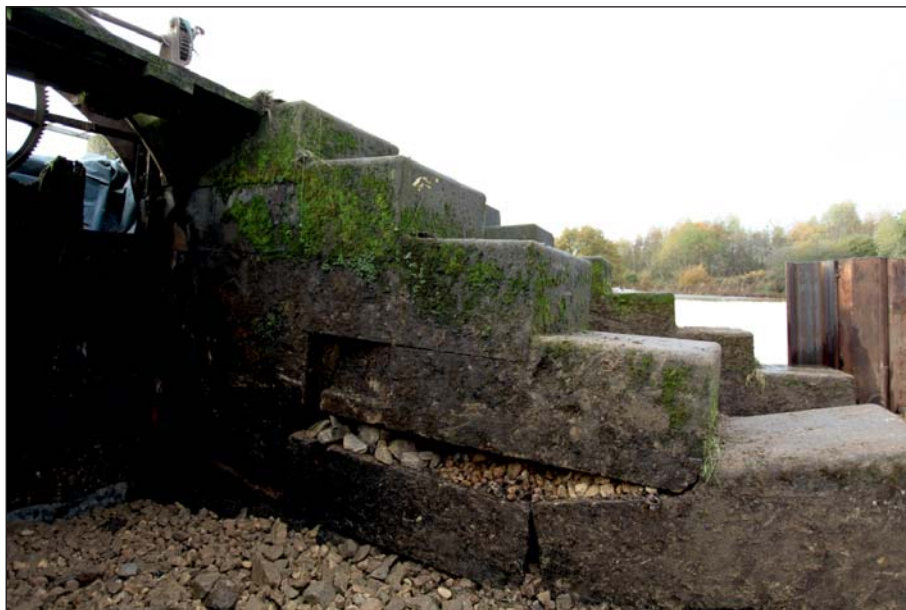
- 6.2.2 The two easternmost sluices have retained original 1827 cast iron winding gear, each displaying the name and date: 'HEWES & WREN MANCHESTER 1827' on both the north and south faces of the cast iron plates surrounding the gear (Plates 48-52, 59-61). Unfortunately, the cast iron fittings of the winding gear have broken in several places within the central sluice, due to the movement of the central pier. In addition, located downstream on the inner faces of ashlar piers for each sluice were recess, with angled return on the western recess, in order for timbers to be placed within the slots (Plates 59,62, 63, 65-68).

Plate 62: View of the east elevation of the central pier within the central sluice, showing recess and collapse damage (Digital IMG_0248)

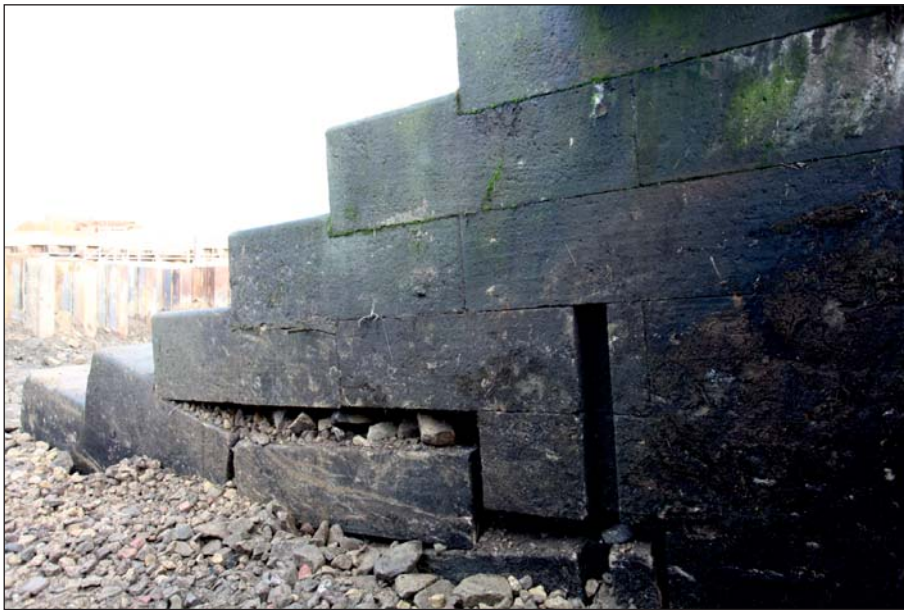
Plate 66: Detail of the west elevation of the central pier within the westernmost sluice, showing recess and collapse damage from downstream (Digital IMG_0245)

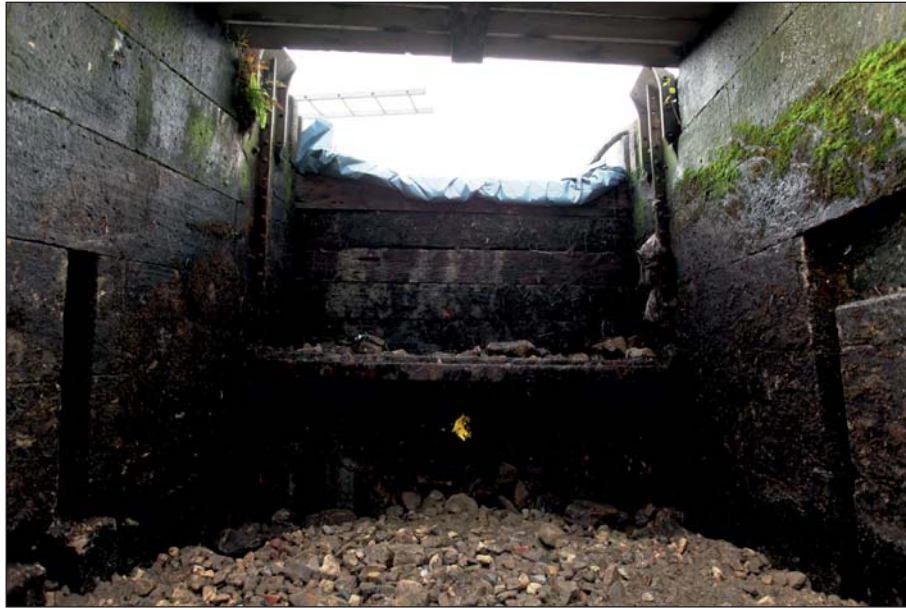
Plate 67: Detail view of the downstream westernmost sluice, showing arched opening (Digital IMG_0238)
