'The Stables', Huddersfield Railway Station, St. George's Square, Huddersfield, West Yorkshire

Historic Building Recording

Planning Application Ref: 2010/65/91286/WI

Report reference: 75610.03

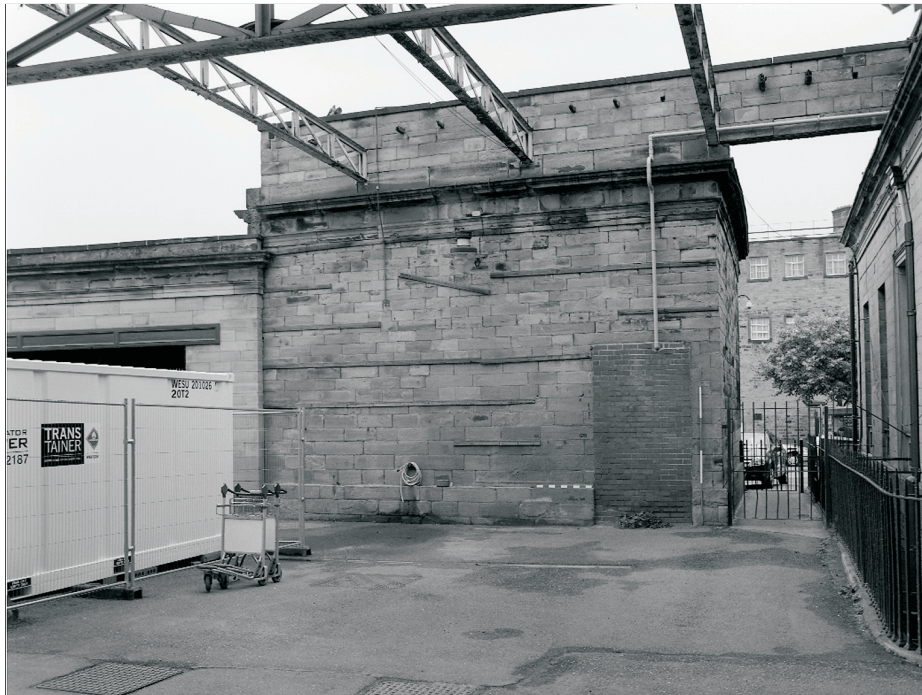
Plate 5: General view of west elevation of Building 1 showing blocked doorway and raised parapet with remains of former platform roofing (film 1.7)

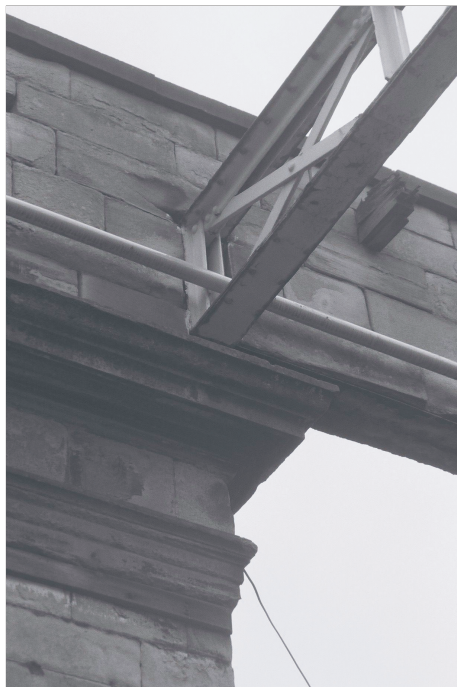
Plate 6: Detail of lattice girder of former platform roofing attached to parapet of Building 1 (film 7.30)

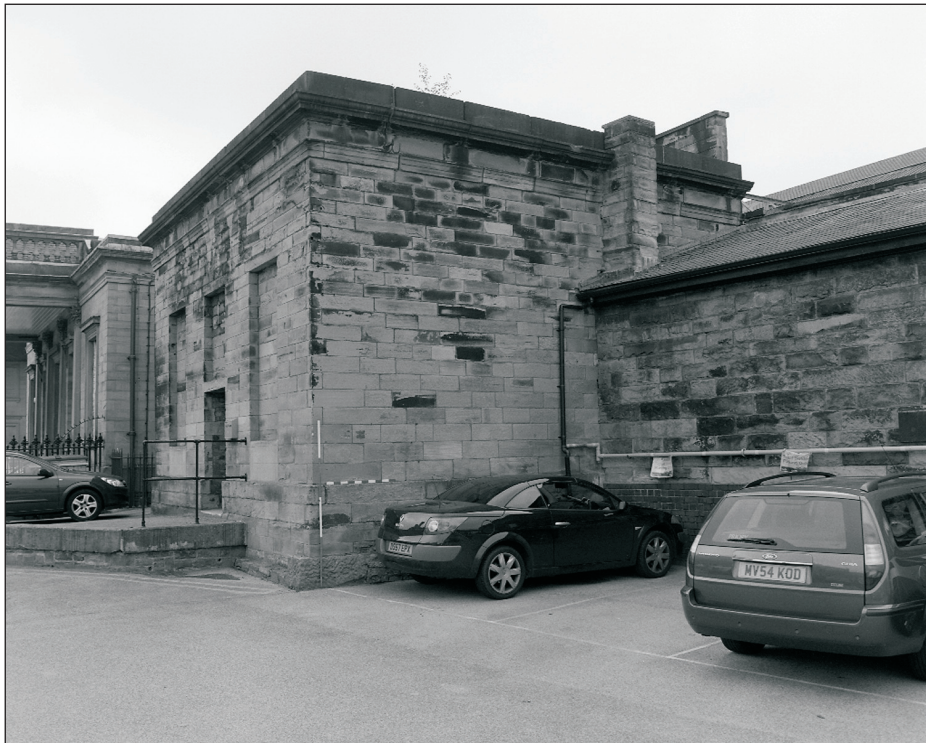
- 4.2.4 The north elevation (**Plate 7**) is the same as the south, except for an added external stone chimney stack which originated within G2 and is contemporary with G2 and Building 2. The top of this projects from the lean-to roof of Building 2 and is loosely keyed into the north wall of Building 1. Both cornices had been cut back for the addition of the chimney stack (**Plate 7**). The top of the chimney stack has been capped and is no longer in use.

Plate 7: General view of north elevation of Building 1, showing added chimney stack (film 4.5)

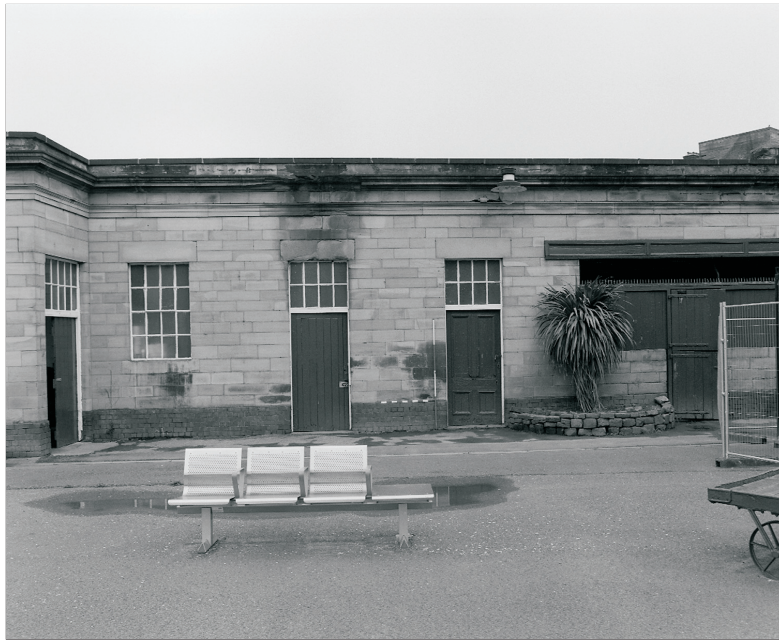
- 4.2.7 The southern half of the western elevation (**Plate 10**) contains two central doorways each with multi-paned over-lights. The northernmost door is a timber planked replacement whilst the adjacent door contains its primary timber panelled door (**Plates 10 and 15**). To the north is a further window, whilst to the south is a wide opening with central timber Dutch door (**Figure 11 and Plates 11 and 16**). The lower section of this opening, to the height of the top of the Dutch door, contains a timber partition infill, yet the upper section is left open. The opening is supported by a riveted I-section/fabricated lintel which has been covered externally with timber panelling (**Plate 11**).

5.1.3 Externally the buildings have not altered much in the last hundred years. Building 1 has had the main entrance blocked within the west elevation and a secondary entrance inserted in the east elevation. Building 2 has had a window inserted into the east elevation and part of its parapet and former platform roofing removed. There is also some heat damage to the stone work above the doorway to G4 (**Figure 11 and Plate 10**) due to a fire which also damaged the roof within G4

Plate 10: General view of west elevation of Building 2, showing doorways to G3, G4 and G5 and heat damaged stonework (film 1.3)

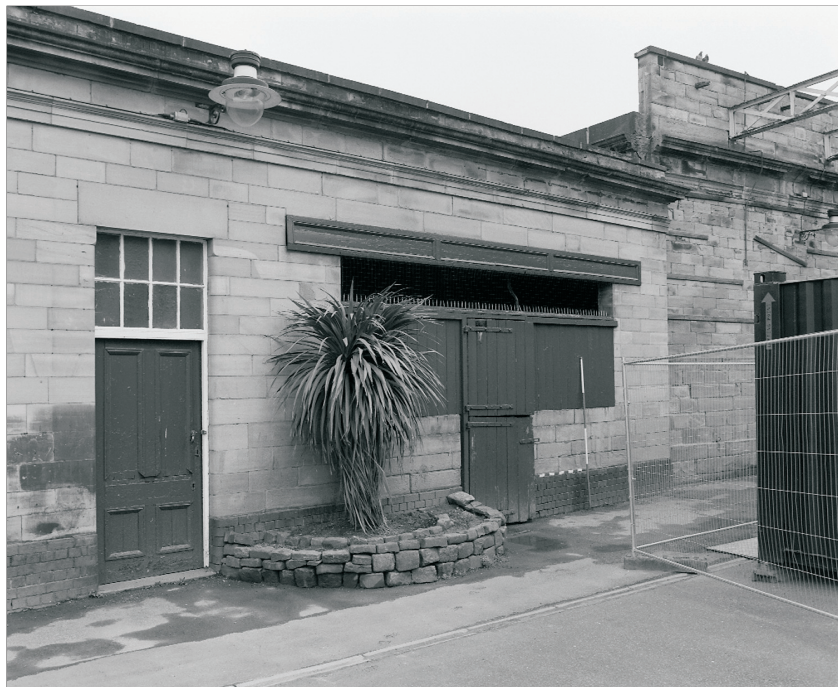
Plate 11: View of west elevation of Building 2 showing doorways to G2 and G3 (film 1.5)

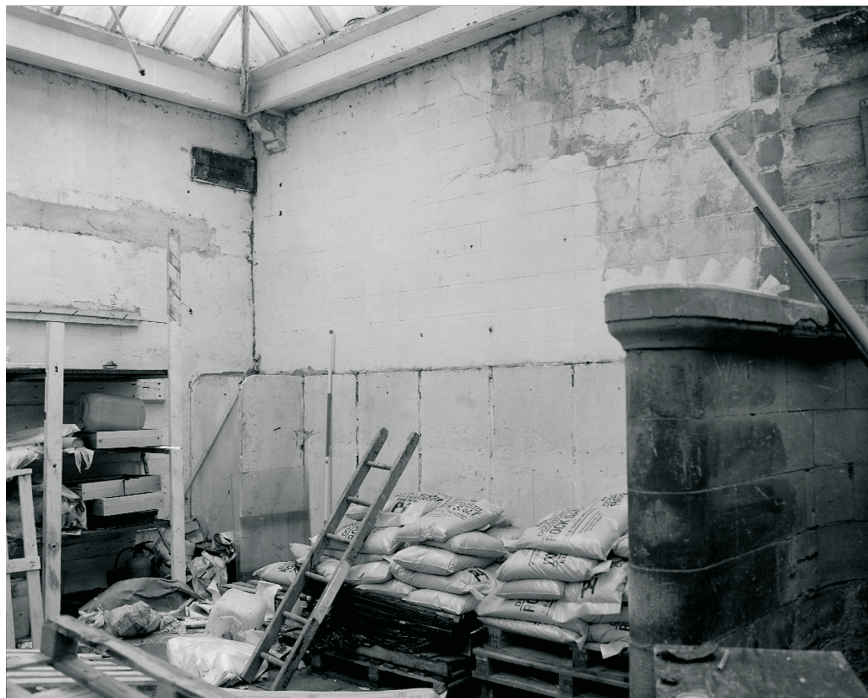
5.1.4 Internally Building 1 has had the majority of its original features removed except for a single primary toilet cubicle and part of the urinal partitions (**Plates 22 and 24**). However, the roof, although not watertight at the time of survey, is an interesting surviving feature of the building (**Figure 9 and Plate 26**) and is due to be removed and replaced during the forthcoming refurbishment works. The ashlar modesty baffle partitions are also an important feature (**Plate 21**). Within Building 2, the main historical fabric has been retained with only minor alterations and repairs.

Plate 22: View of the south-east corner of G1 showing former urinals (film 5.8)

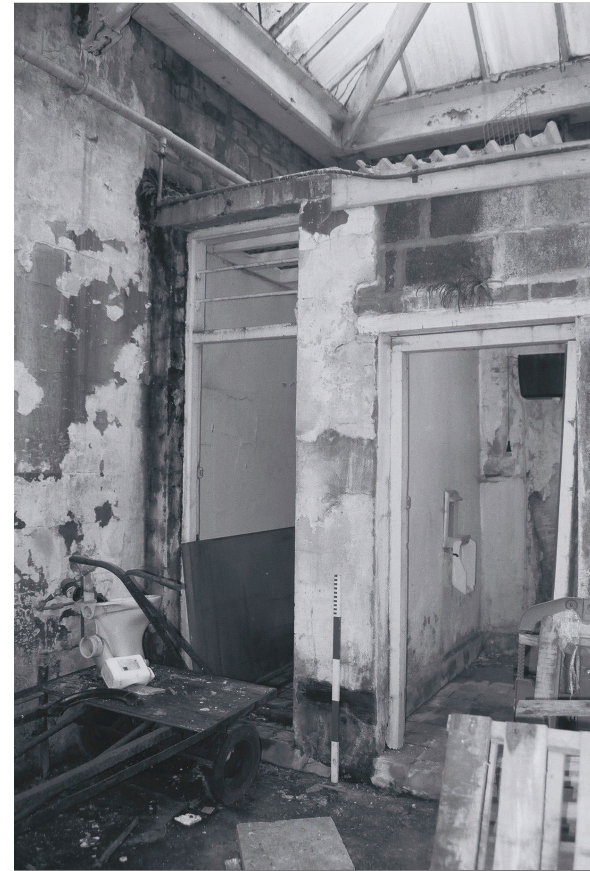
Plate 24: View of former toilet cubicles, north-west corner of G1, Building 1 (film 7.34)

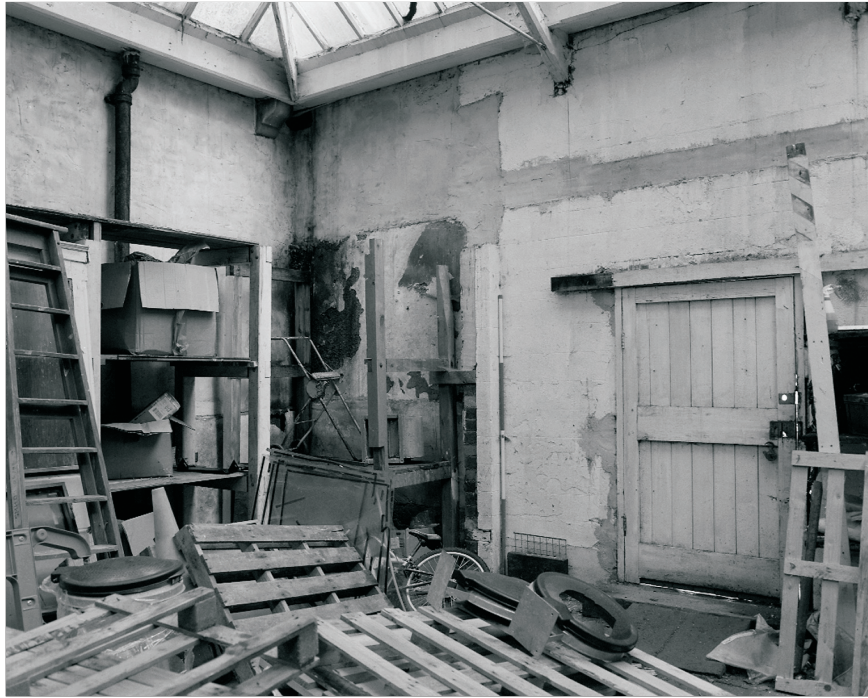
Plate 25: General view of north-east corner of G1, showing modern doorway in east wall and scars of former toilet cubicles, Building 1 (film 6.1)

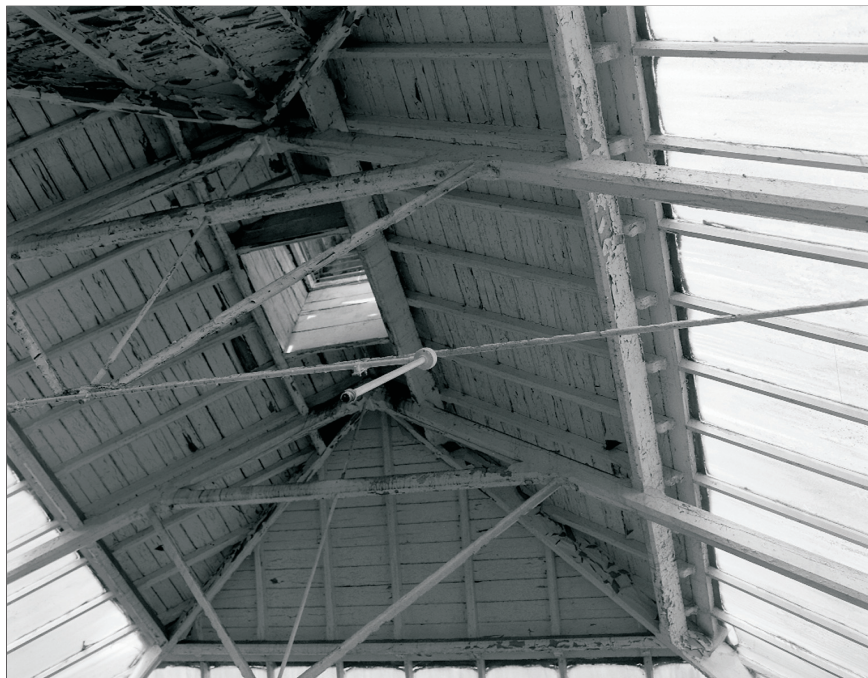
Plate 26: Detail of timber and iron trussed pyramidal roof of G1, showing glazed lower section, Building 1 (film 6.3)

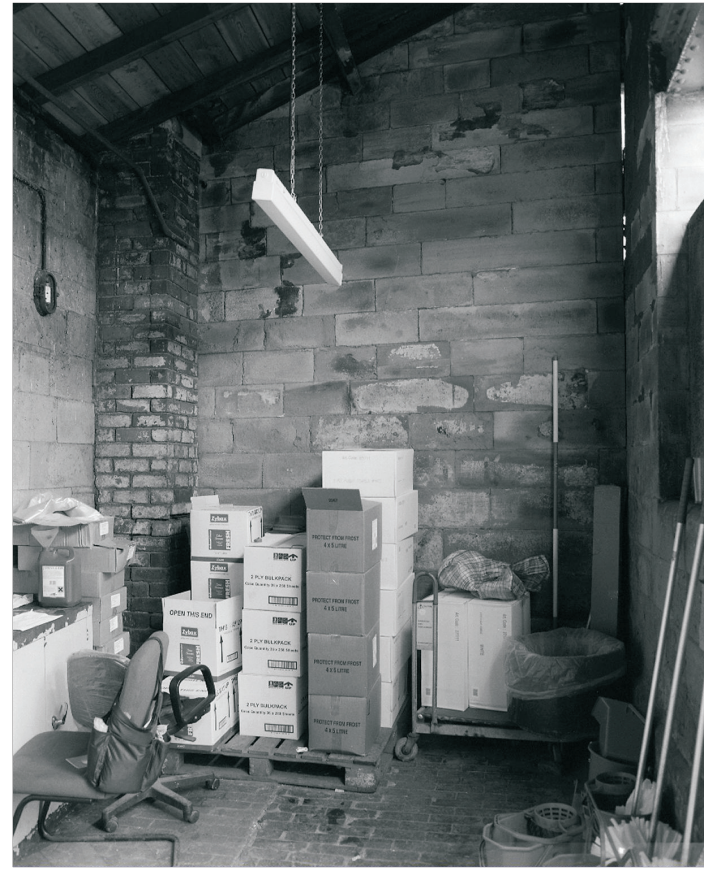
west walls are constructed from stone with brick plinths. The dividing wall to the north is brick. Within the south-east corner there is a brick chimney (**Plate 28**). This was largely obscured at the time of survey, therefore any flues leading into the chimney stack were not observed. Externally this chimney stack is constructed from stone as previously described. Within the north wall is a blocked arched opening (**Plate 30**). This on first impressions appeared to be a blocked fireplace. However, the brick wall is not particularly thick and there is no evidence of a chimney stack or truncated chimney stack externally. The opposite elevation of the wall, to the north within G3, was obscured and so it is not known whether this opening originally continued through the whole wall or was a narrow recess. Therefore, the function of this opening it is currently unknown.

Plate 28: General view of G2, Building 2 showing brick chimney flue in south-east corner (film 2.3)

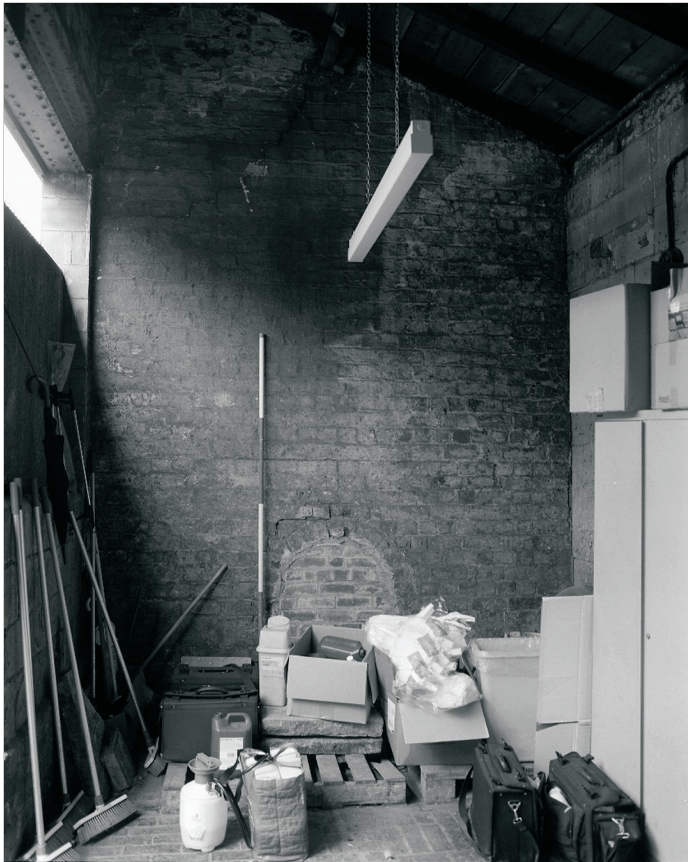
Plate 29: General view of G2, showing blocked arched opening in north wall, Building 2 (film 2.2)

Plate 30: Detail of blocked arched opening, north wall of G2, Building 2 (film 7.23)

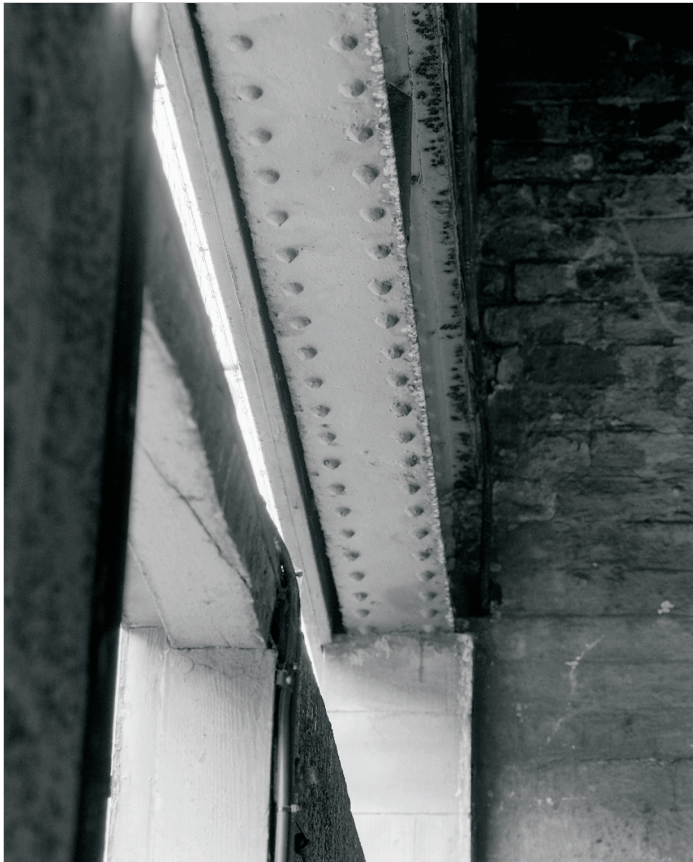
- 4.3.6 The west wall contains a large opening with central doorway (as previously described). This is supported by a riveted I-section/fabricated lintel (**Plate 31**). The function of this opening is unknown, but may have been to provide substantial ventilation to the room. The floor is brick with dark brick set in a square pattern with red brick, possibly secondary to the southeast side of the floor (**Plate 32 and Figure 8**). The slate covered lean-to roof is supported by a simple timber half truss with iron bracing (**Plate 33**). The lower section of the roof slope has undergone repairs with modern replacement boards carrying the external slate covering.

Plate 31: Detail of riveted I-section lintel, west wall of G2, Building 2 (film 2.5)

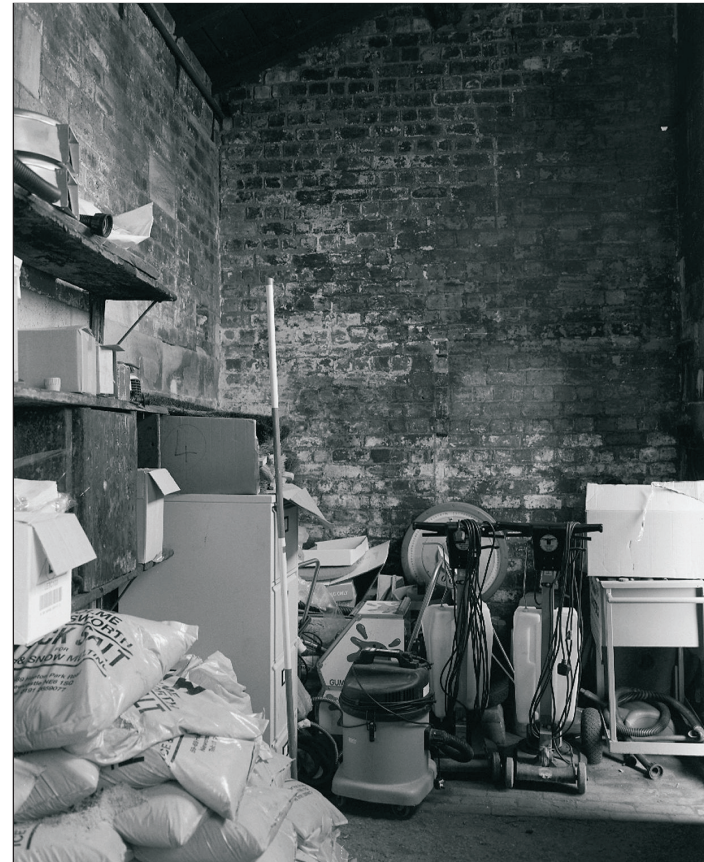
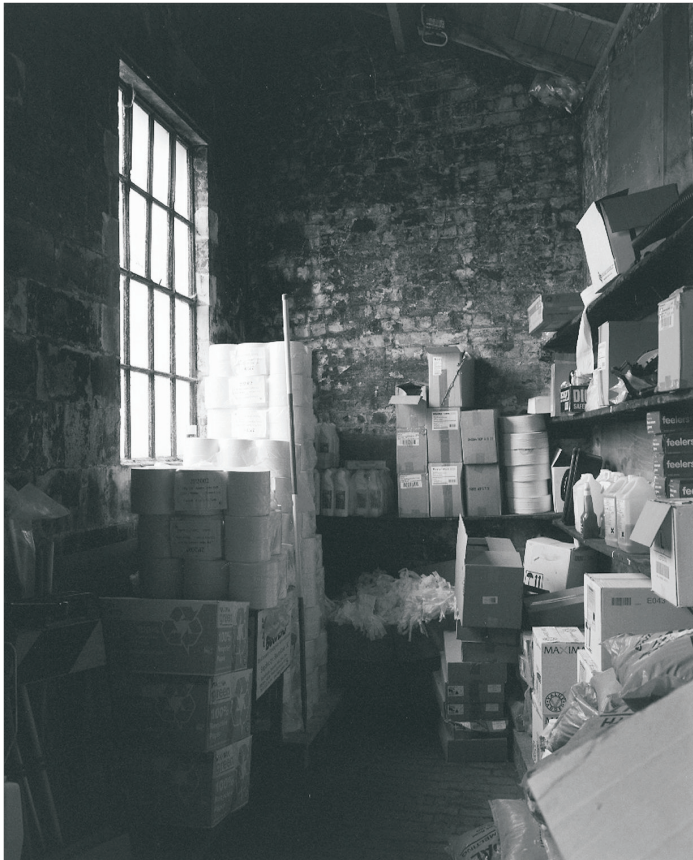
- 4.3.8 Room G4 (**Plates 35 and 36**), positioned to the north of G3, is a long and narrow room which tapers to the north with an angled north wall (**Figure 8**). All walls were of the same construction as that within G3. The west wall contained a doorway with a modern replacement door and adjacent window to the north (**Plates 35 and 36**). Timber shelving is positioned around the north and east walls. The floor has a brick finish, apart from a narrow channel running from the doorway across the room to the east which has been filled with concrete. The truss and a large section of the roofing had been recently repaired and replaced due to fire damage.

Plate 35: General view of G4, Building 2 (film 2.10)

Plate 36: General view of G4, showing window in west wall, Building 2 (film 3.1)

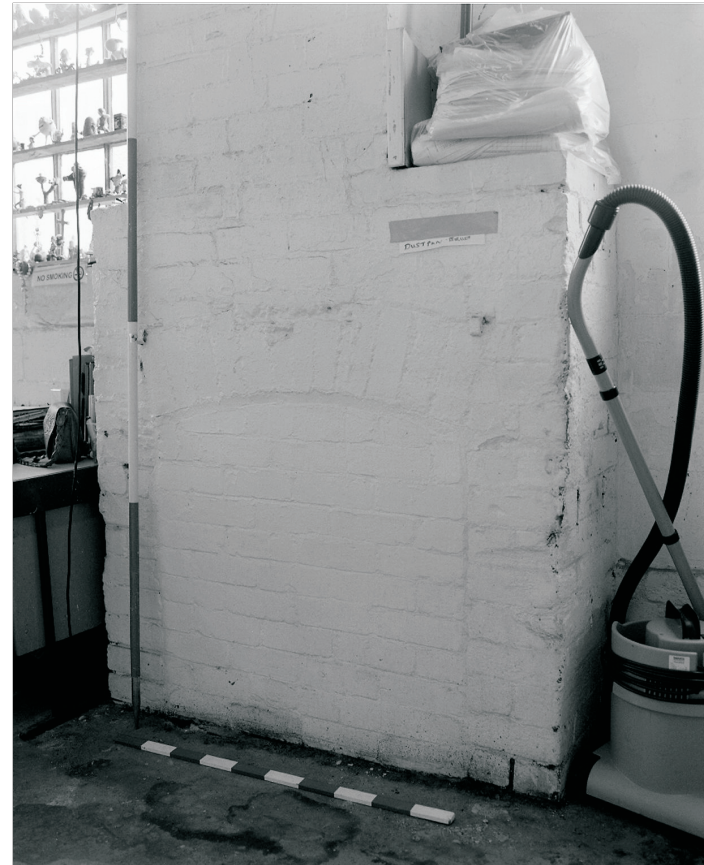
Plate 39: Detail of blocked fireplace, west wall of G5, Building 2 (film 3.7)
