Downton Primary School Downton, Wiltshire

Archaeological Evaluation Assessment Report

Archaeological Evaluation Report

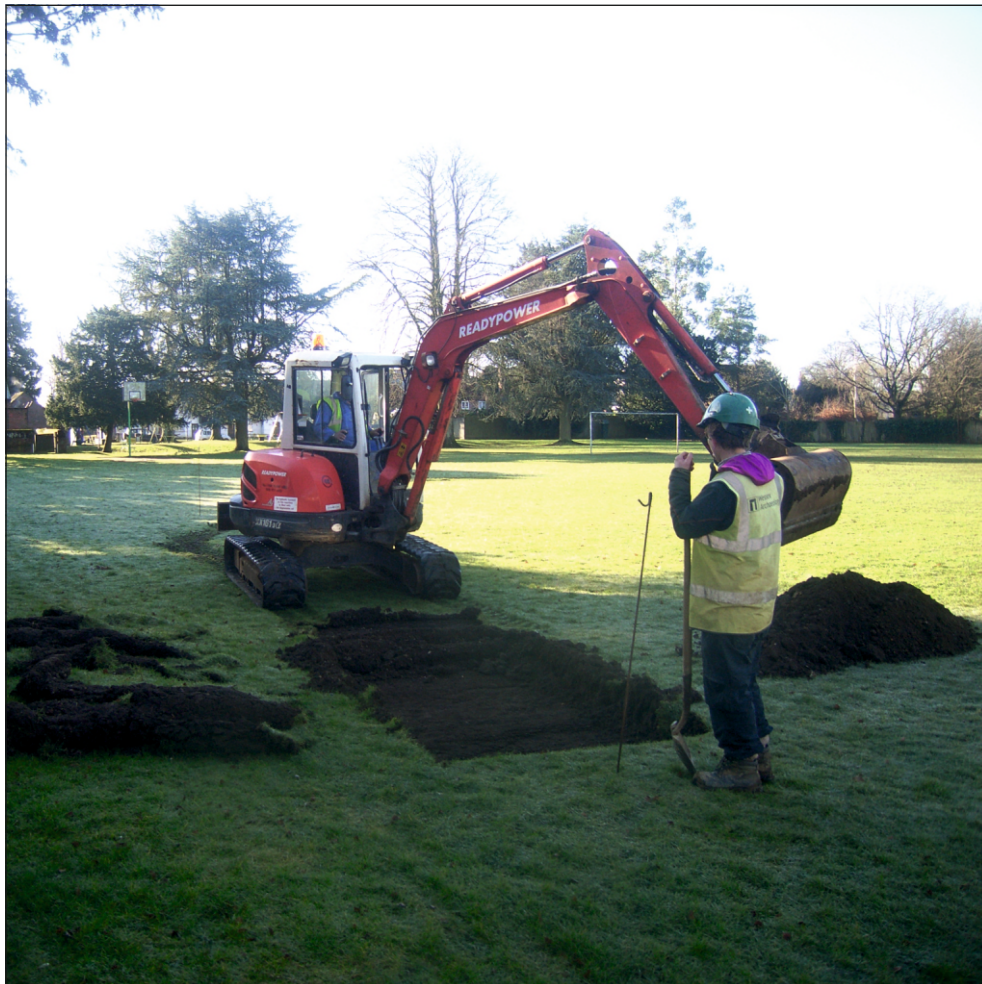
- 5.3.1 Trench 1 was located within the Memorial Gardens, in an area used as a playing field (see cover photo). The trench was aligned approximately north-south, slightly realigned to avoid a tree canopy, and measured 15m x 1.7m. The trench was excavated to a maximum depth of 0.6m (**Plate 1**) before rapid groundwater ingress prevented any further excavation.

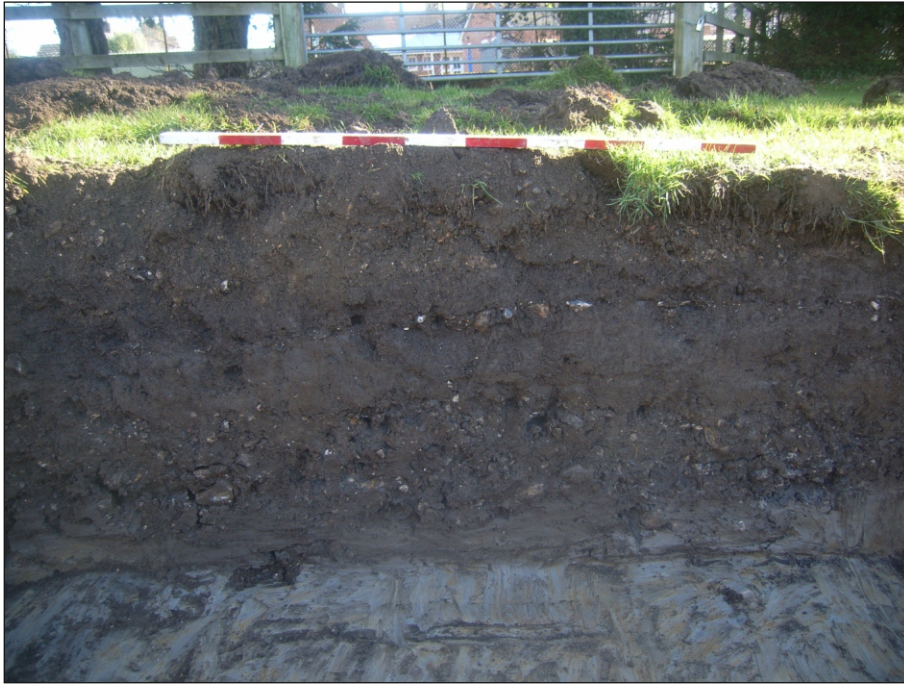
Plate 1: West facing section Trench 1

- 5.3.2 A 0.2m thick topsoil (101) of dark blackish brown silty loam contained moderate flint gravel and frequent rooting, with trace amount of modern detritus. The topsoil overlay a 0.05m thick layer of buried topsoil (102), very similar to the layer above it, which suggests that the area was possibly re-turfed/resurfaced when it became public gardens. This in turn overlay 0.05m thick dark brownish-grey silty clay subsoil (103), containing rare gravel.

- 5.3.3 Below the subsoil was a 0.20m thick layer of poorly sorted alluvial gravel (104) in a dark grey matrix, capping light grey alluvial clay (105) of at least 0.1m thickness. At this point rapidly flowing groundwater was encountered, preventing any further excavation.

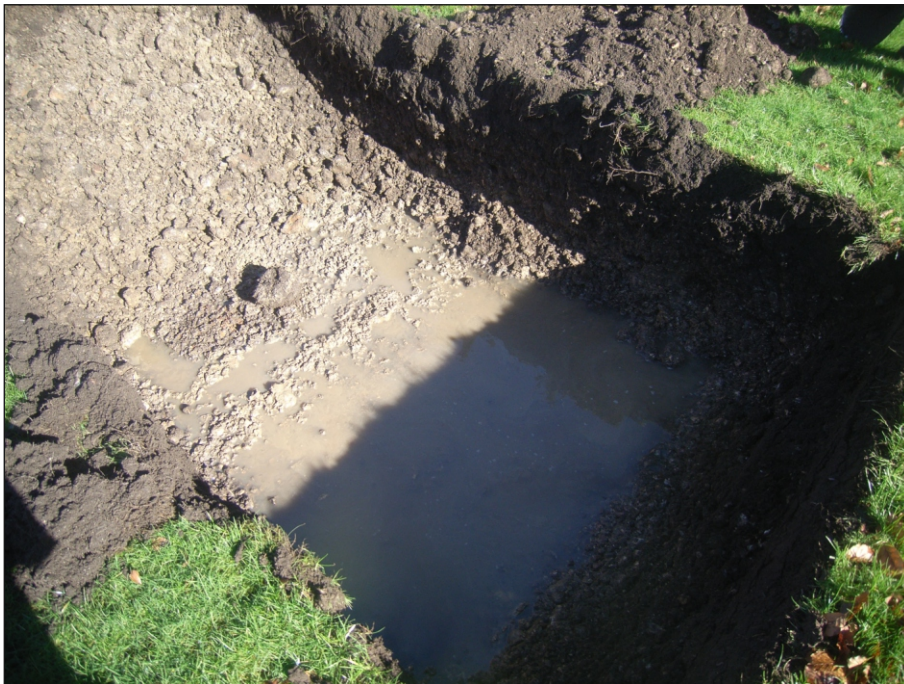
Plate 2: Machine excavation of Trench 2A taken from the south west

- 5.4.1 Trench 2 was also located within the Memorial Gardens, in an area used as a playing field. As noted above, and as a result of observations concerning the groundwater during the excavation of Trench 1, the proposed 15m trench was replaced by three smaller machine-excavated test pits (**Plate 2**) along the length of the proposed trench. A consistent sequence of deposits was encountered throughout the three test pits.

- 5.4.2 A dark blackish brown silty loam topsoil (201) measuring 0.20m thickness, overlay a 0.28m thick layer of made ground (202) formed of reworked river gravels in a sandy loam matrix. This capped a 0.12m thick layer of river terrace gravel (203) within a coarse yellow sandy matrix.

- 5.4.3 In each of the test pits the water table was breached at around 0.45m below ground surface, effectively at the base of layer 202. Inundation became very rapid at 0.6m depth, preventing any further excavation.

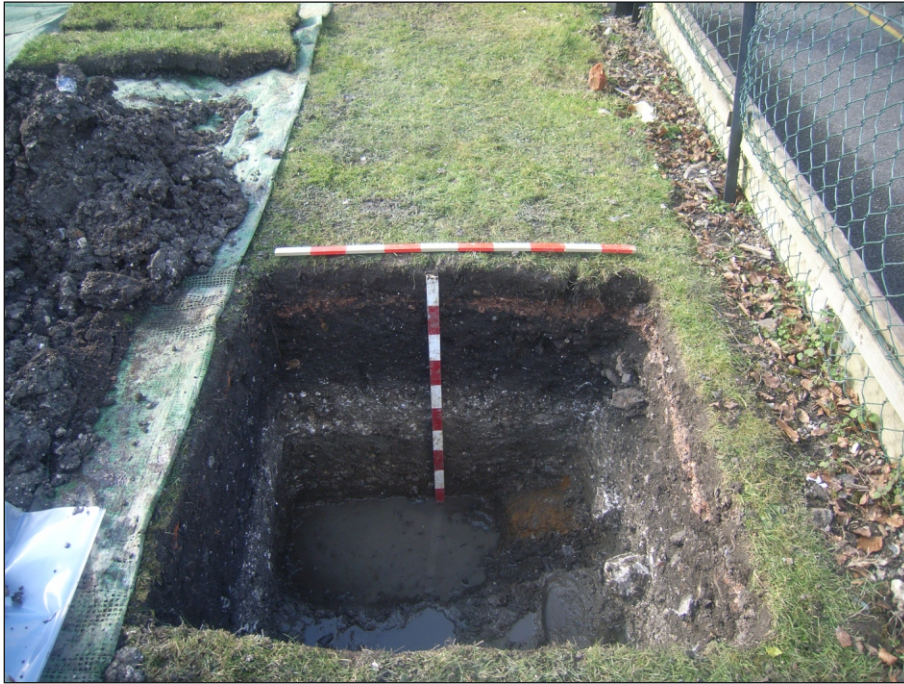
Plate 3: View of Test Pit 3 taken from the east

- 5.5.1 Test Pit 3 (**Plate 3**) measured 1m by 1m, and was located on a small strip of grassed area on the fringe of the car park area of Downton Primary School, immediately to the south of the school playground.
- 5.5.2 A 0.10m thick turf and topsoil layer (300) overlaid a sequence of made ground deposits, buried soils and alluvial gravels. Directly beneath the turf was a 0.05m thick gravel construction deposit layer of type 1 hoggin (301), which capped a 0.32m thick dark brown

silty loam buried topsoil layer (302), containing occasional CBM, pottery and other artefacts of clearly modern origin; these were noted on the archive records but not retained.

5.5.3 Below this deposit, a 0.18m thick chalk rubble levelling layer (303), comprising large angular chalk nodules and crushed chalk within a light grey sandy clay matrix, was encountered, with pottery and CBM recovered suggesting a medieval or later date. This in turn overlaid a 0.05m thick dark grey-brown coarse sand layer with frequent gravels (304), which in turn capped a 0.22m thick layer of small-medium alluvial flood gravel in a coarse sand matrix (305).

5.5.4 At the base of the test pit a 0.15m thick mid-dark brown silty sand peat layer (306) was encountered, at which point the water table was breached. The layer contained a small amount of animal bone, and hence although undated a precautionary environmental sample was also taken. Notwithstanding the groundwater ingress, the test pit had reached the maximum permissible depth on H&S grounds; however, rapid 'mattock testing' suggested another layer of alluvial gravels lay immediately below this organic deposit.
