Galloper Offshore Wind Farm

Heritage Method Statement:
Recovery of AB_OSP_Mag_145: Aircraft Material

Post-excavation Assessment report

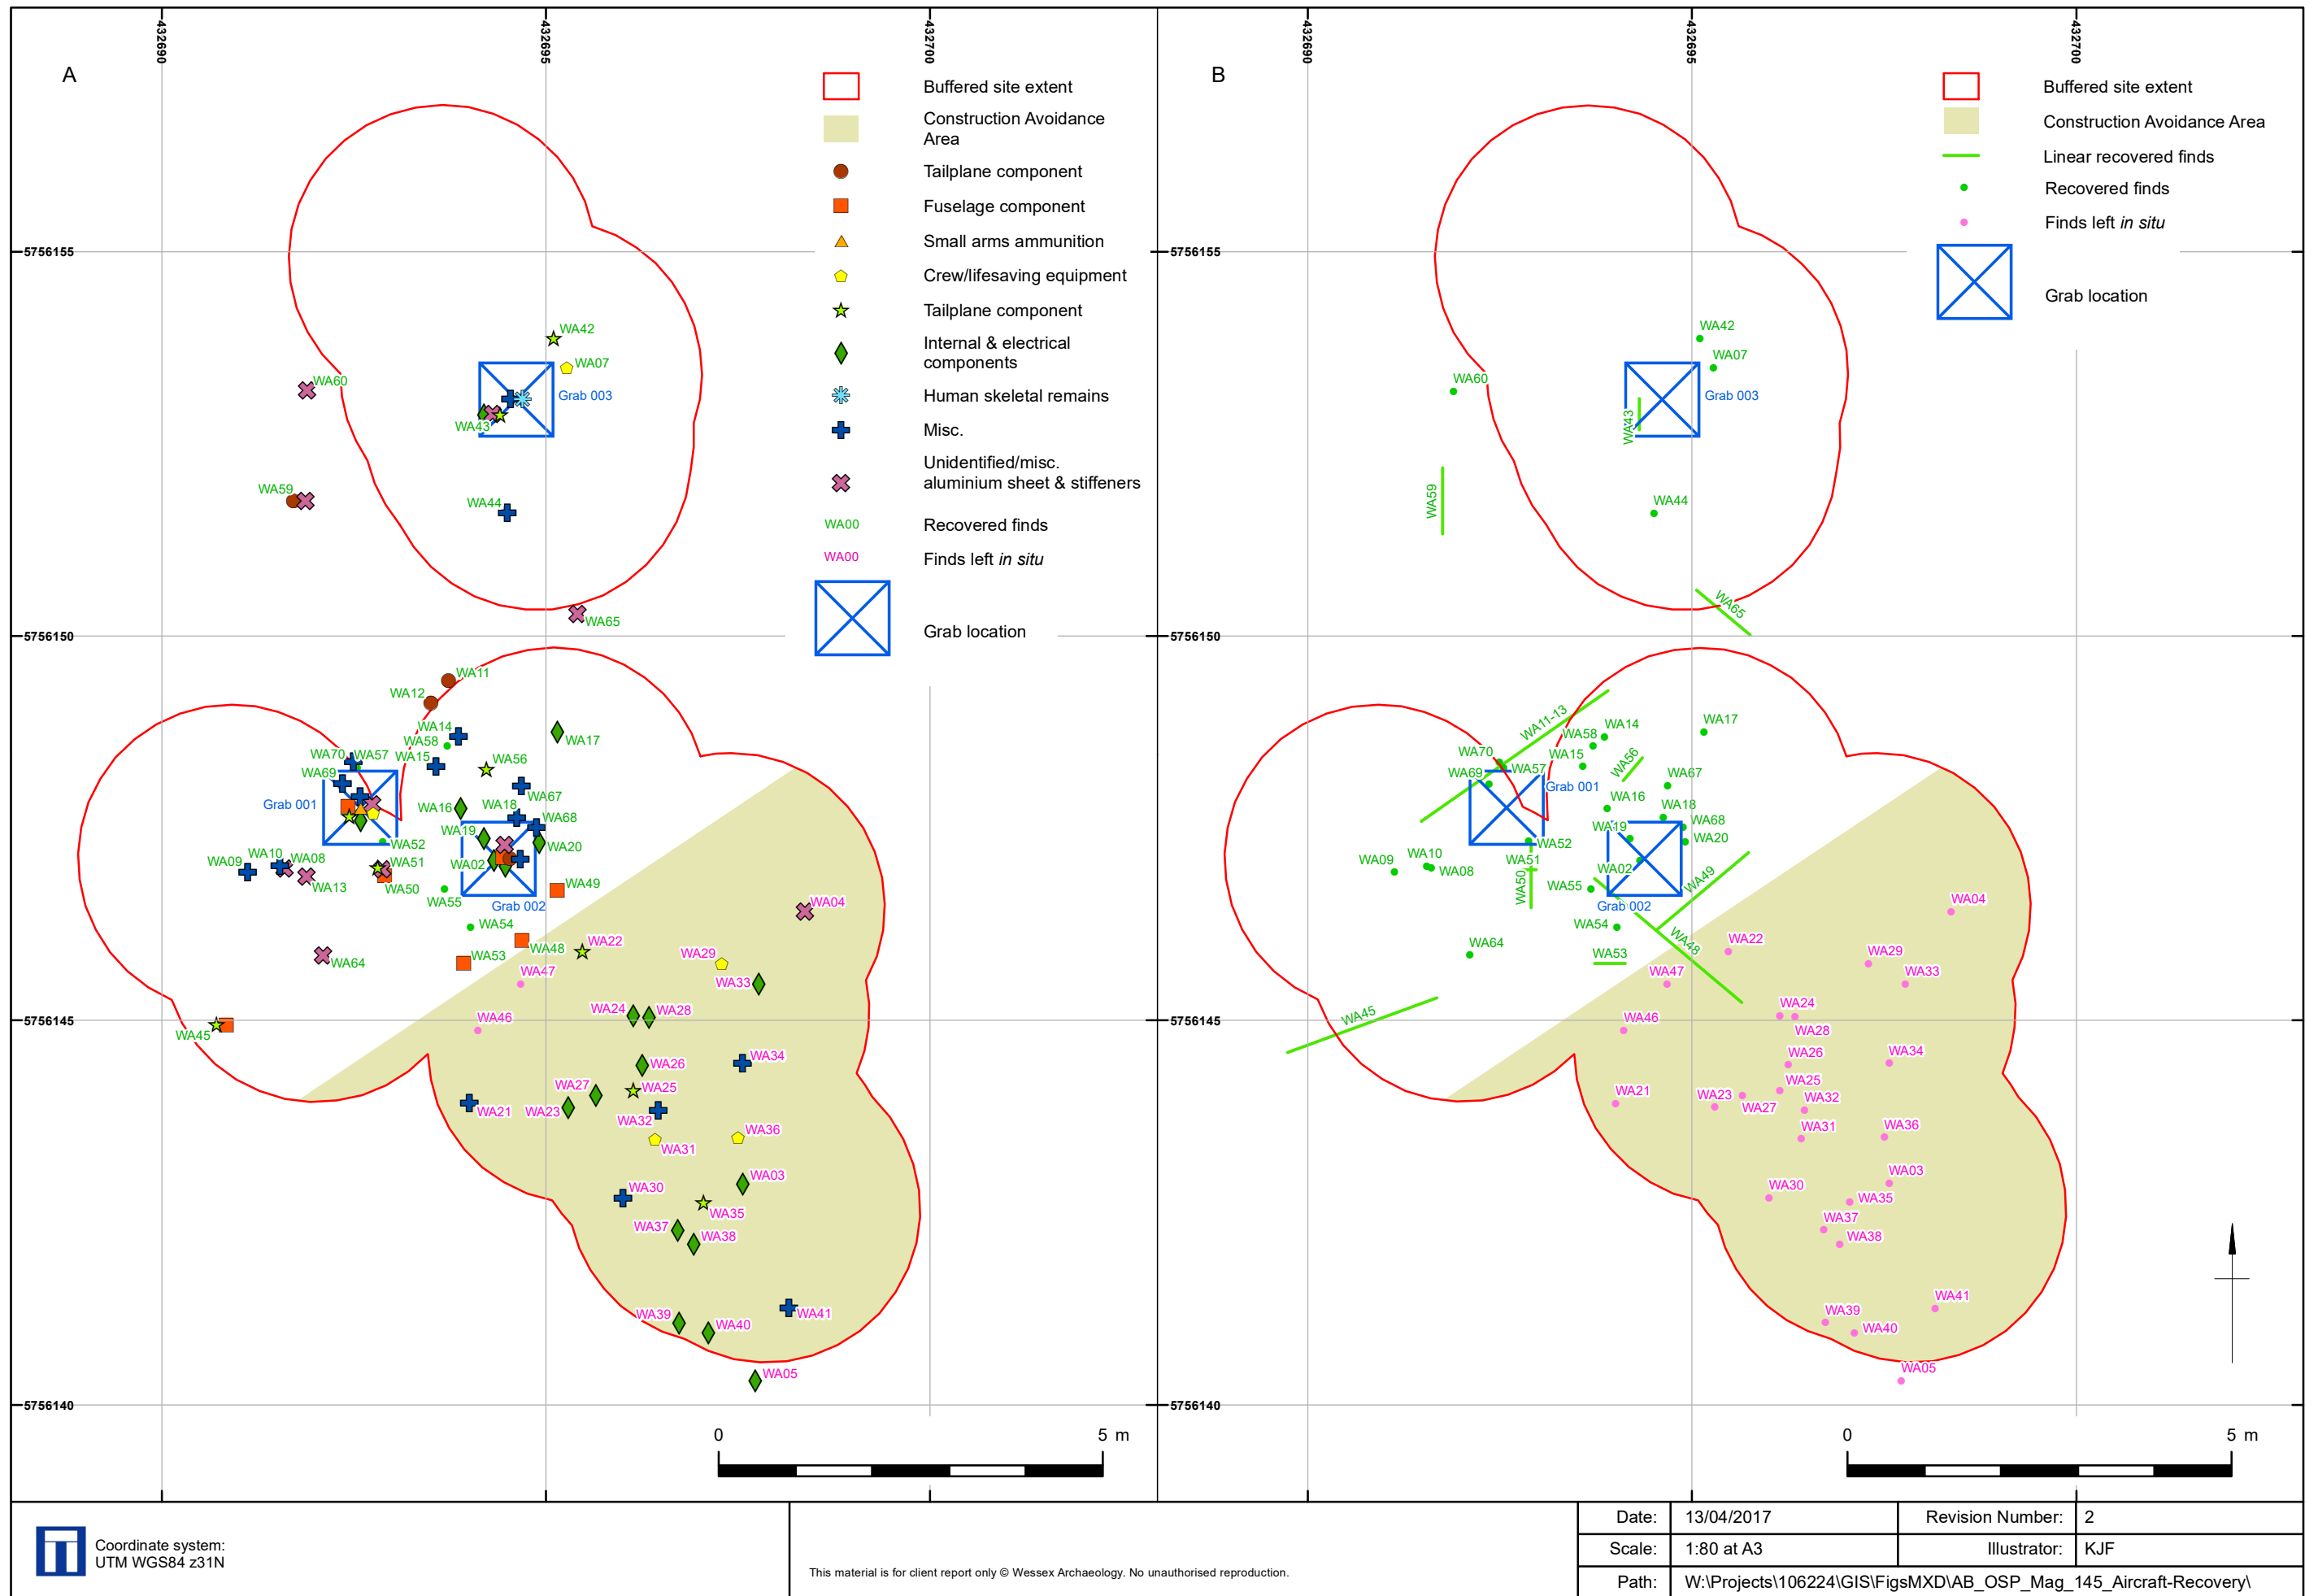
Figure 3

Plan of archaeological material observed during mapping phase

- 3.2.1 A total of 182 finds were recovered from the finds locations shown in **Figure 3**. All the finds recovered were either small fragments or individual items. As a result of this and the fact that many were recovered by clam shell grab, the orientation of only a small proportion was recordable. No coherent aircraft structure or large item such as an engine were either observed or recovered. **Appendix 1** contains a catalogue of the recovered finds.

- 3.2.15 Fragments of what appear to be parachute shroud were observed (WA0043; **Figure 3**). If it is parachute, it is not known whether this might be for personnel or for equipment deployment. These fragments were not recovered, as they lay outside of the area thought to be subject to impact.

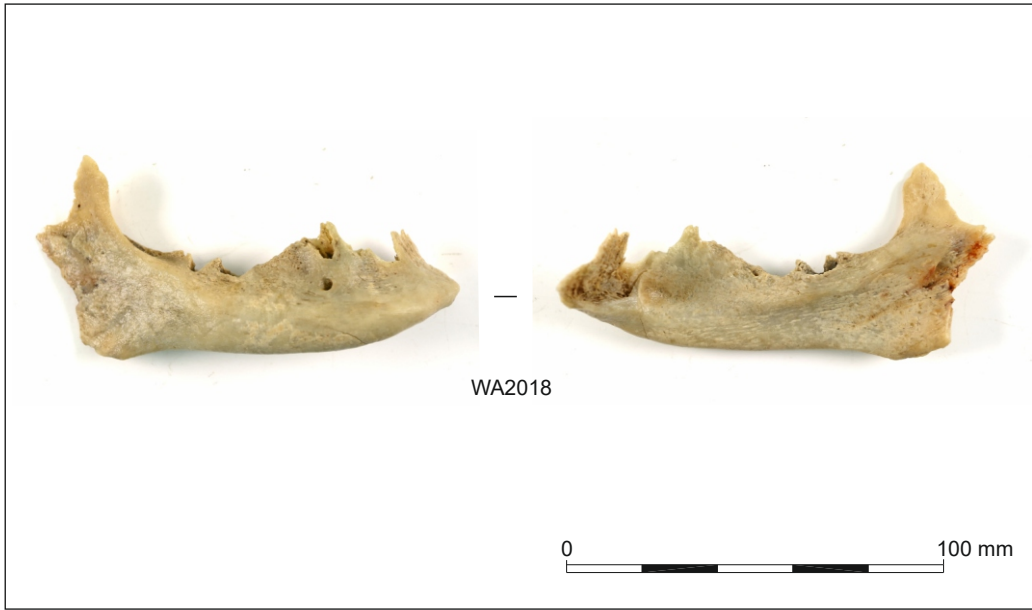
Plate 1: Mandible fragment

- 3.2.3 A small worn adult right and anterior mandible fragment was found in the upcast of Grab 3 (**Figure 3; Plate 1**). It exhibits ante mortem loss of the right P2-M1 teeth, with full resorption of sockets and narrowing of alveolus. Although this level of tooth loss is occasionally seen in young males with poor dental hygiene or diet, and certain dental defects can lead to early tooth loss, it suggests that the deceased is unlikely to have been younger than 30 at the time of death. The squared mental protuberance suggests that the deceased was male.
- 3.2.4 This type of object is difficult to spot against the background seabed sediment present on site (sand and gravel) in poor visibility. Therefore, whilst it was not seen during the mapping phase and is therefore likely to have been buried, it is not possible to state with absolute confidence that it was buried.

8.4.1 Following full recording and analysis, it is anticipated that the human mandible will ultimately be repatriated by the US authorities. Pending repatriation, it will remain in wet storage at WA South in the care of the Conservation Manager. It will gradually be desalinated to reduce the risk of deterioration due to its removal from the marine environment.

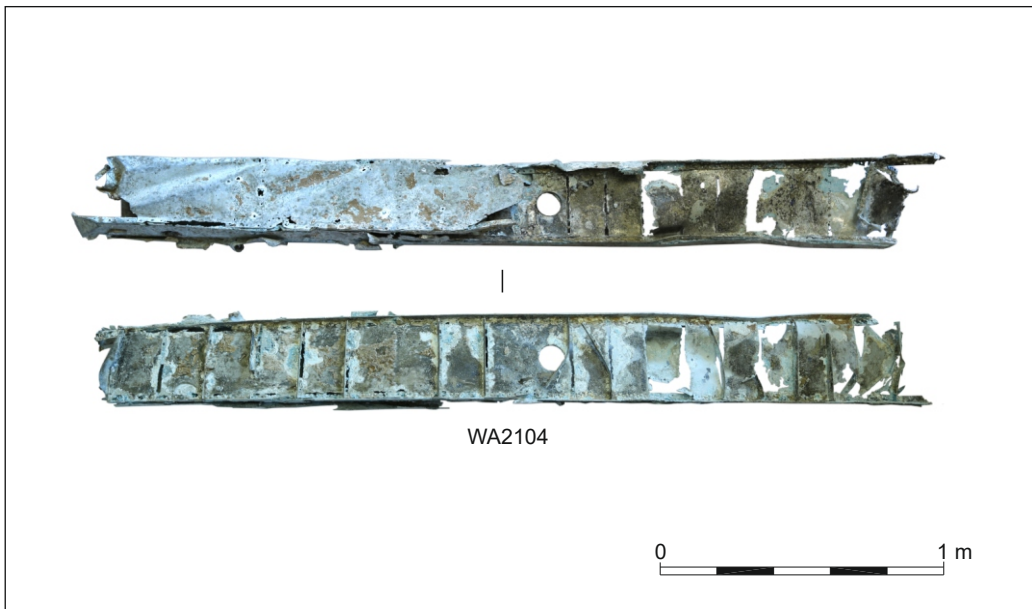
Plate 2: Spar

- 3.2.5 A riveted box-section aluminium girder, 2.97 m long, was located in the vicinity of WA0011 (**Figure 3; Plate 2**). This can be identified as a probable vertical spar from the tail of the aircraft. This was the only large piece of wreckage found.

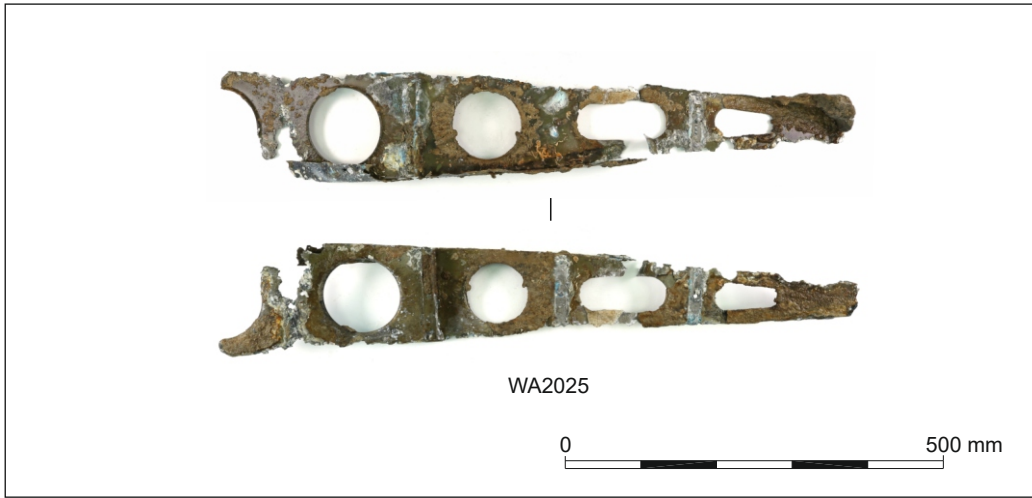
Plate 3: Rudder or tail-plane rib

- 3.2.6 An end-fragment of a small webbed frame was found. This has a longitudinally curved shape and narrows to one end. Its shape and size suggest that if originating from a large aircraft then it is likely to be part of a rudder or tail-plane rib (**Plate 3**).

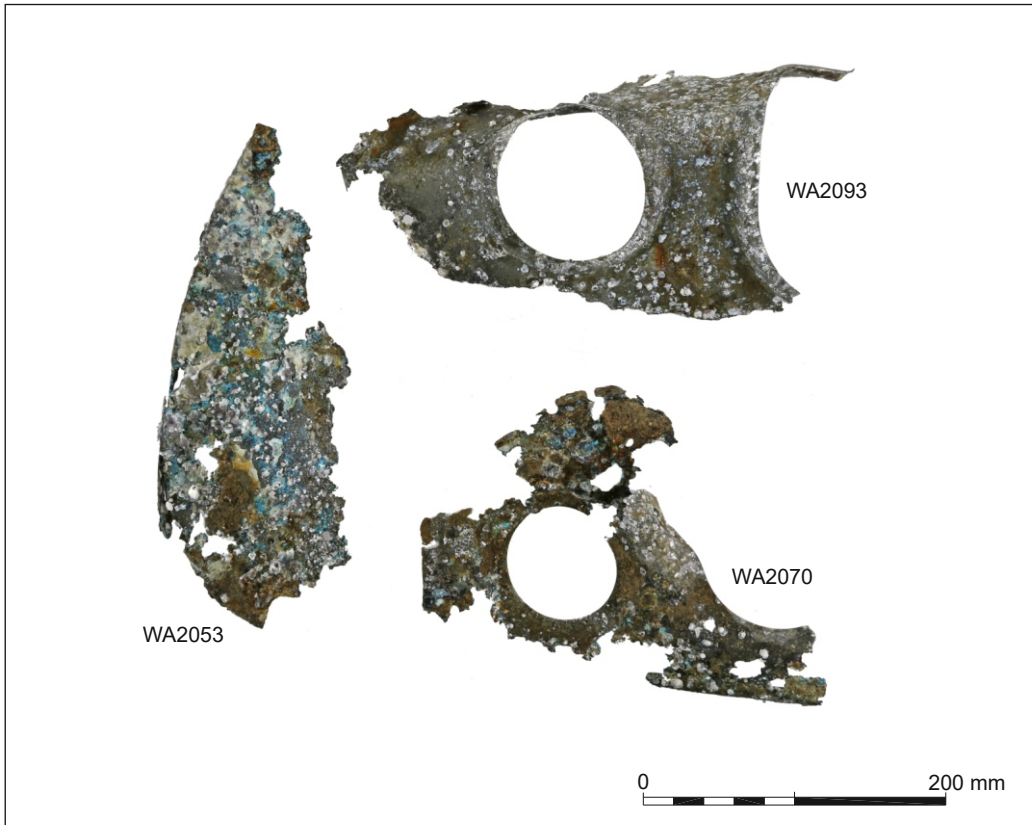
Plate 4: Web frame

- 3.2.7 A number of small fragments of webbed aluminium frame were found, of a type typically used in aircraft construction (**Plate 4**).

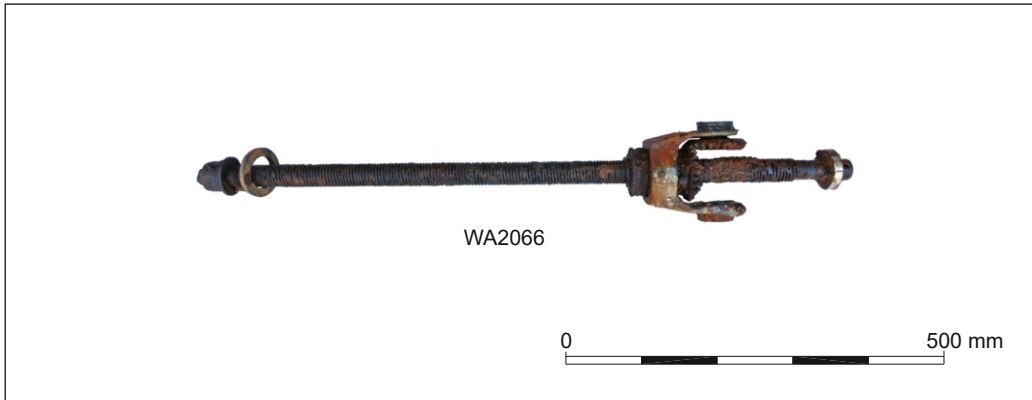
Plate 6: Tail gear retracting assembly

- 3.2.9 A threaded assembly consisting principally of a threaded screw 890 mm long with stop assemblies at each end, gears and axle were found in the upcast of Grab 2 (**Figure 3; Plate 6**). Amongst several markings stamped onto the castings is ASSY-69-1787-13. This identifies it as an American manufactured tail gear retracting screw from a B-17 (USAAF 1942: Figures 110 & 112⁷; USAAF 1943: 92⁸).

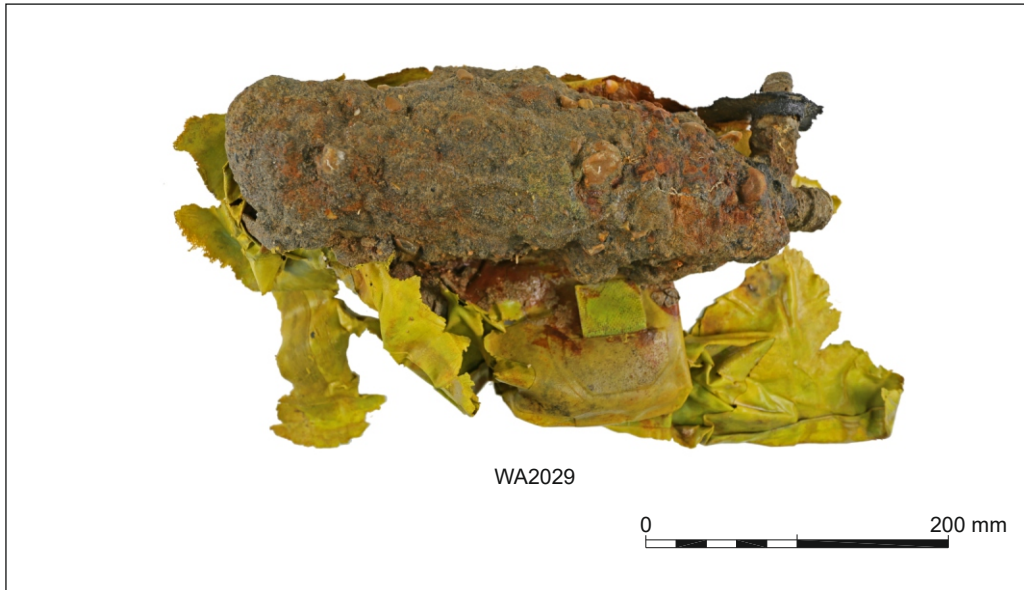
Plate 8: Life raft CO2 cylinder

- 3.2.12 A small, heavily concreted cylinder was found (**Plate 8**). This has a fabric sheath, which is a typical means of securing a cylinder to the side of a life raft and the size of the cylinder is consistent with a small, aircraft-deployed, life raft. Part of the inlet valve survives with traces of rubber fabric around it. The cylinder is very heavily concreted and no cylinder stamps can be seen as a result.

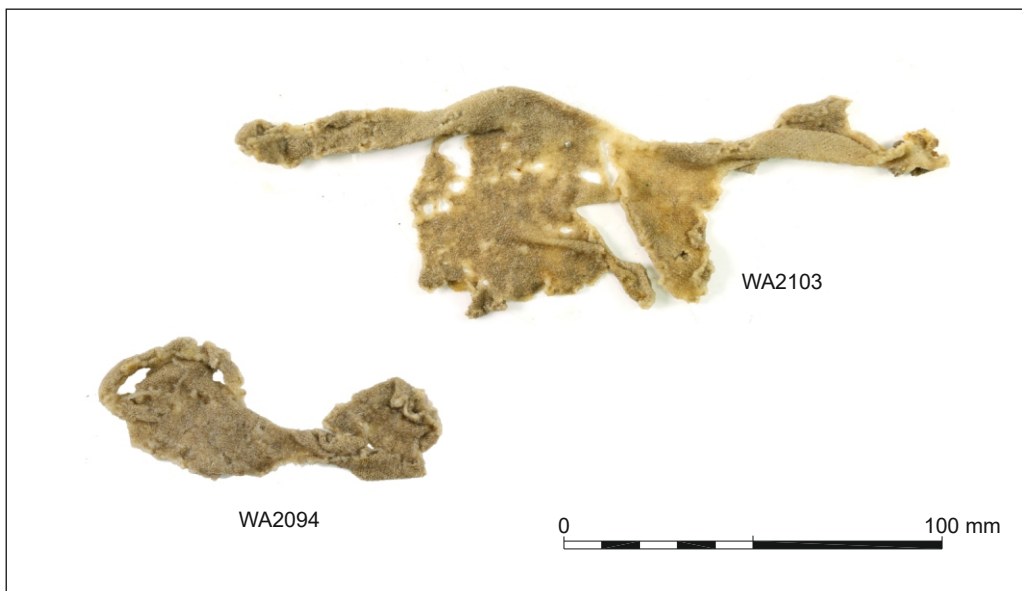
Plate 9: Clothing

- 3.2.14 Small fragments of clothing (possibly crew undergarments) and heating pads were found in the upcast of Grab 1 (**Figure 3; Plate 9 & Plate 10**).

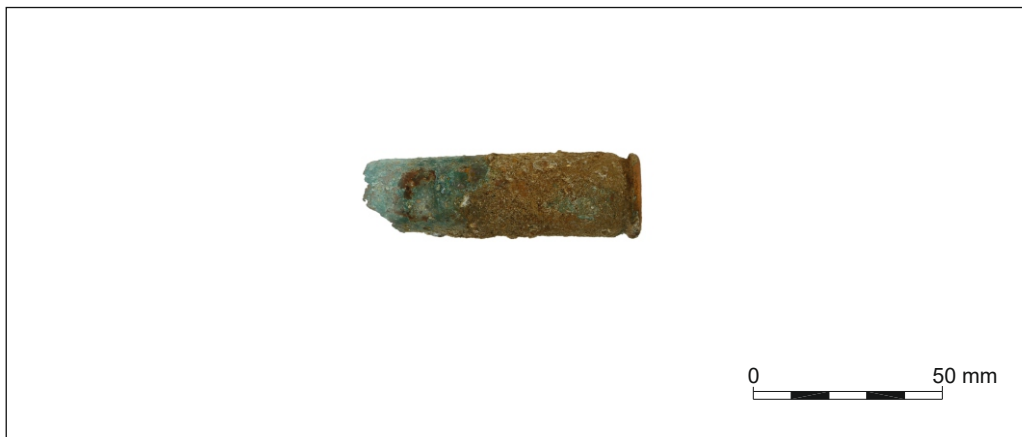
Plate 11: Round

- 3.2.16 A total of five rounds of small arms ammunition with seated bullets were recovered from WA0069 and were retained by the UXO officer, in addition to an empty cartridge casing fragment (**Plate 11**). The complete rounds had a length of approximately 138 mm and a diameter of approximately 20 mm. The rounds were 80-100% covered in marine growth and were generally damaged and/or corroded.
