# Winterbourne Court Farm Barn, Church Lane Winterbourne, South Gloucestershire

Historic Building Record

Planning Ref: PT17/5811/LB  
Ref: 116641.02  
August 2019

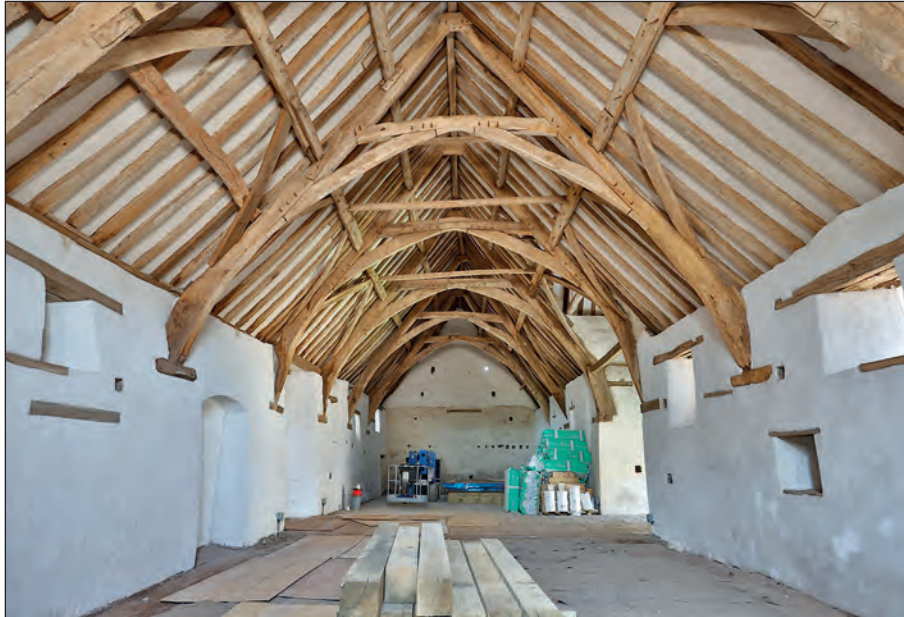
Plate 3: Main Barn interior viewed from east

- 4.2.3 The large midstrey porch on the north side is also constructed in stone and is currently fitted with large double doors with four ledge and brace elements (**Plate 3**). These doors are scheduled to be re-hung as part of the current improvements to the barn.

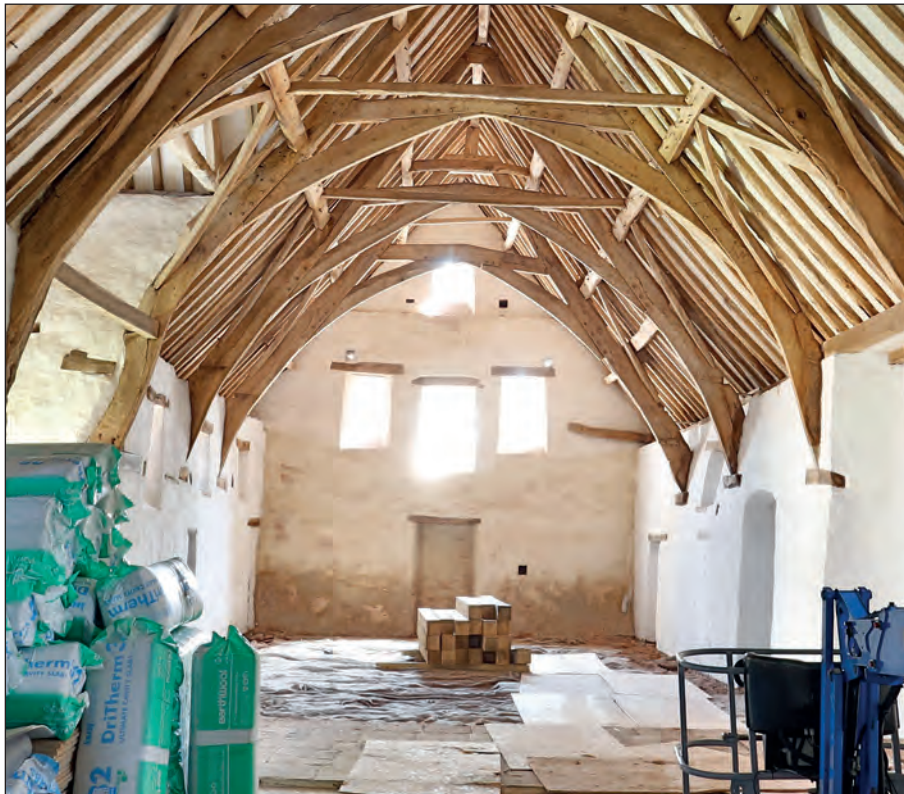
Plate 4: Main Barn interior east end

- 4.2.5 The three bays to the east side of the internal floor space (Area A) are cobbled. At the time of the survey the floor surface was covered with hessian and boarding for protection and was being used as a timber store (**Plate 4**). The 2009 survey recorded that the floor was constructed using sandstone flags, rammed earth and lime mortar. The floor is edged on three sides by deep, tabular edge-on sandstone kerbs forming a channel or 'runnel' to the outside edge. The principal feature of Area A is a complete cobbled track or 'turning circle' as part of a cider press formed from edge-on tabular sandstone setts.

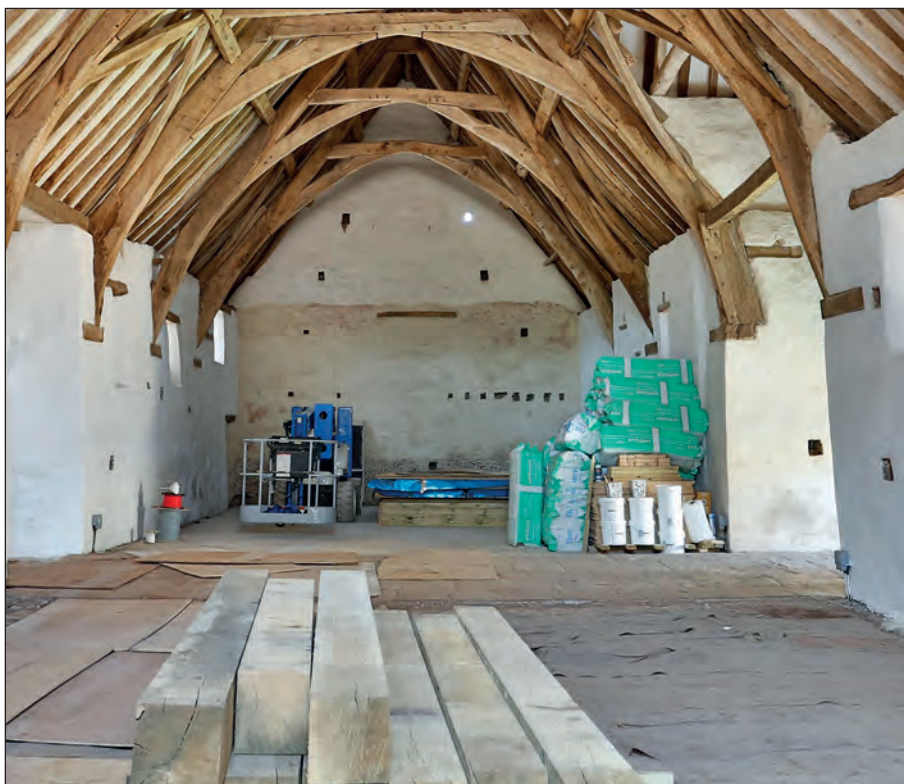
Plate 5: Main Barn interior centre and west end

- 4.2.9 It is not known at present if this floor surface was retained as, the condition survey states that the floor to the west end was being recast in limecrete during the survey (**Plate 5**). It is likely that the limecrete floor was cast directly over the earlier stone floor. The proposal here is to further level this area out and lay with stone flooring by reducing the slope from east to west. Planning consent was granted in August 2013 (ref: PT13/3152/LB) to replace the main barn floor by 'topping' the old floor with layer of limecrete.

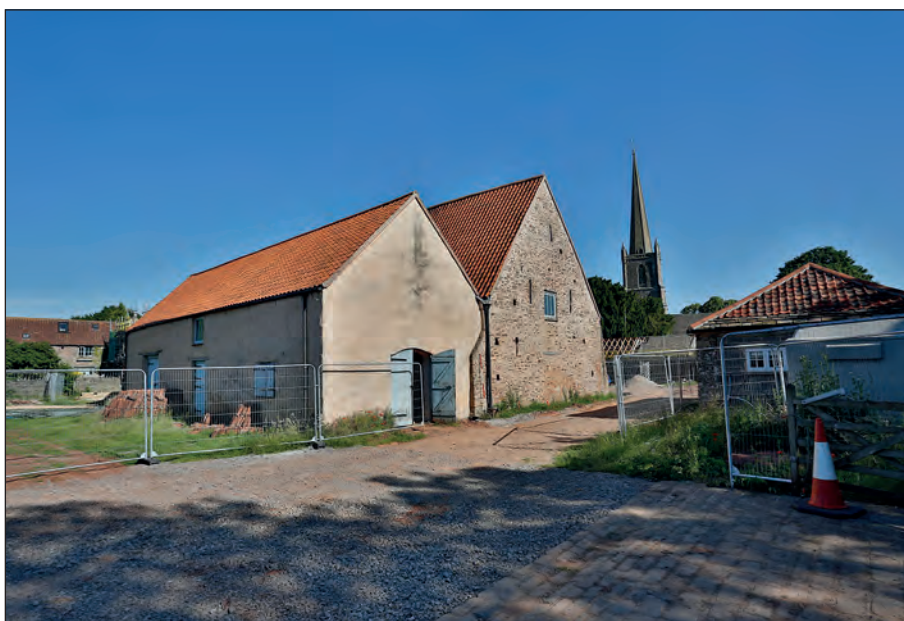
Plate 6: South Range viewed from south-east

- 4.3.1 The attached South Range (**Figure 1**) is a small rectangular building which is described in the Condition Survey as dating to the 17th century. The exterior walls are covered in lime render and the pitched roof covered in pantiles (**Plates 6-7**). The interior of this building is divided into three rooms by stone walls (**Figure 2**). Constructed in random coursed stone, the interior walls are painted white.

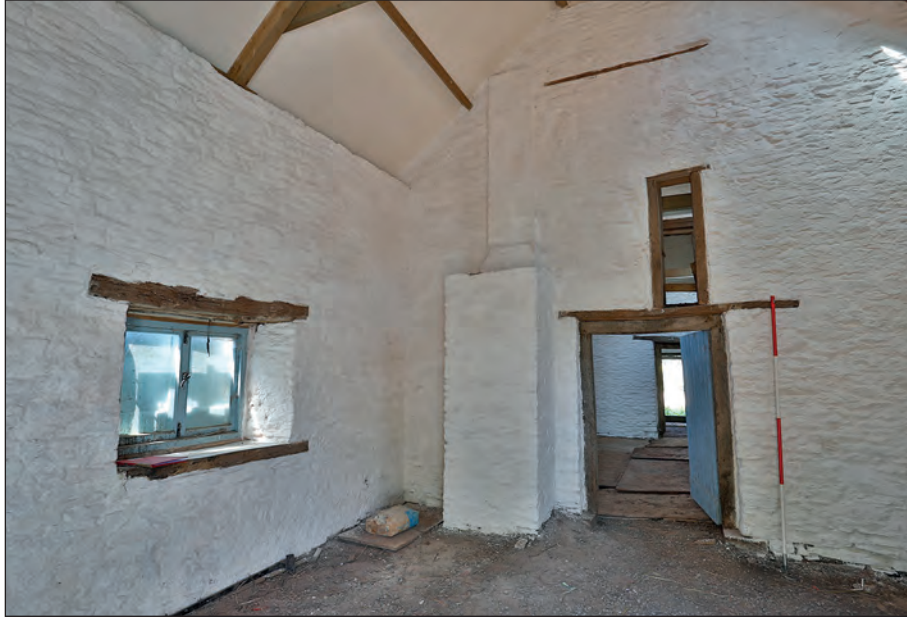
Plate 8: South Range east room interior

- 4.3.2 The east room has an external ledge and braced double door and a small timber framed casement window in the south wall. The floor is earth and gravel and there is a small sealed chimney in the south-west corner (**Plate 8**). The chimney has been sealed off at roof level and may have originally served a forge for a smithy. There is an internal doorway with wide timber lintel to the north of the chimney leading to the centre room. This is also a ledge and braced door.

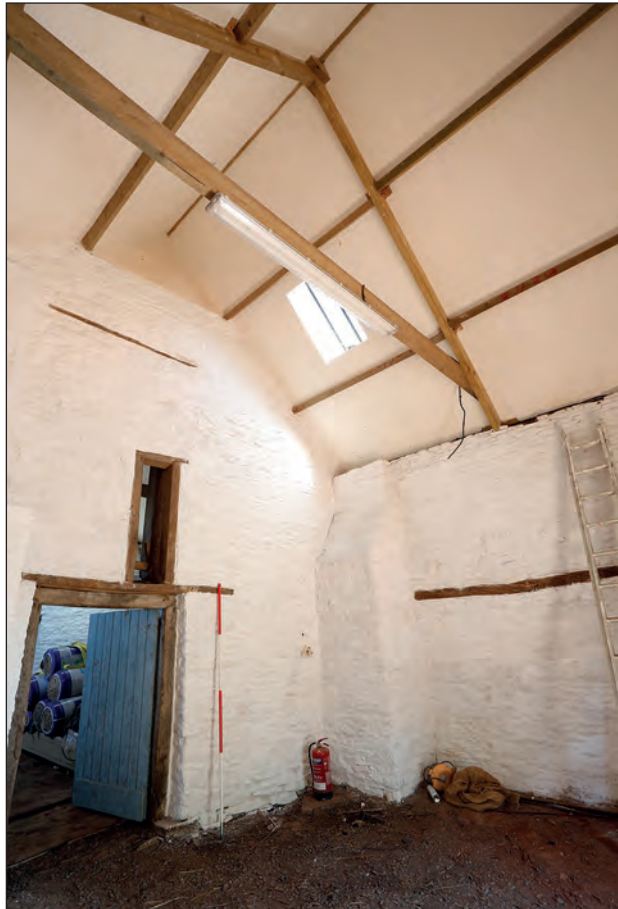
Plate 9: South Range east room roof

- 4.3.3 The roof is supported on a light weight 'A' frame and double purlins of modern appearance and is carried along the length of the building (**Plate 9**).

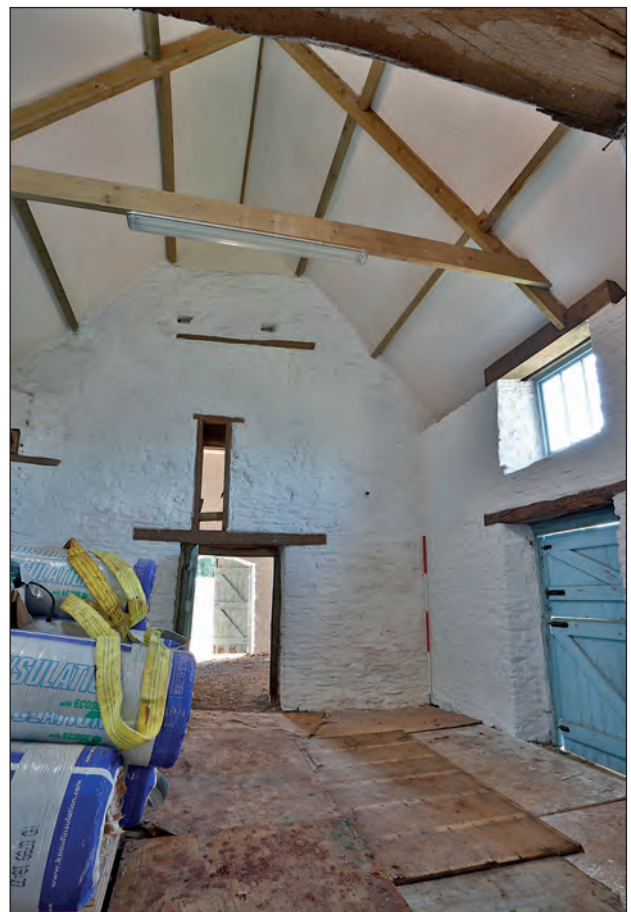
Plate 10: South Range centre room interior

- 4.3.4 During the site visit, the centre room was being used for building material storage and the floor covered in boarding. However, visible between the boards was a cobbled surface. There is some evidence to suggest that this room was a stable at some point. Along with the cobbled floor, there is a wide ledge and braced stable door with a timber framed window above (**Plate 10**). The window may have originally been a hay pitching door. Although there are no clear signs of a hayloft, the presence of hay pitching door, set above the west door into the west room, together with the window above the south door, is evidence of a use for the upper level of the building. The chimney to the east room may have served to shoe horses.

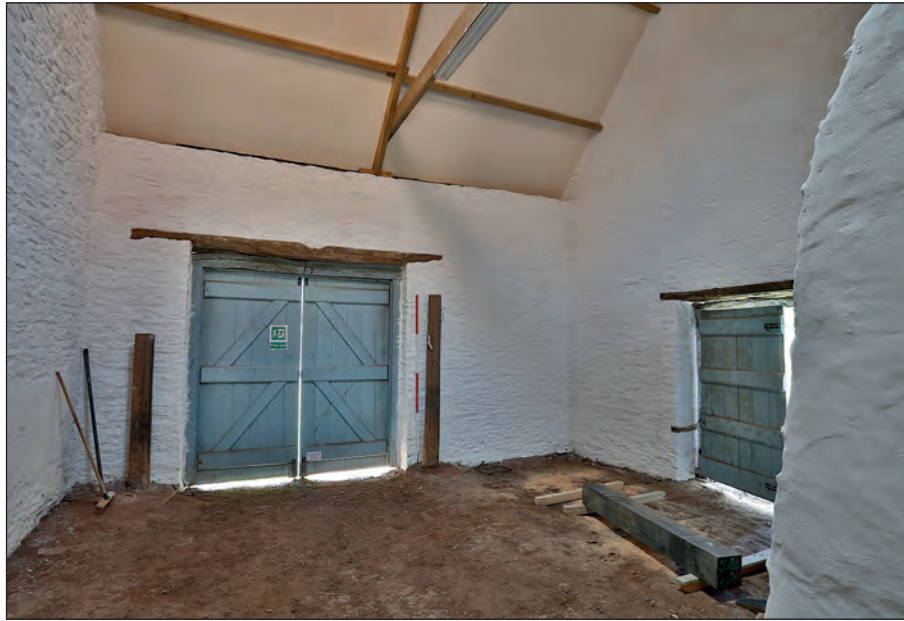
Plate 11: South Range west room interior

- 4.3.5 The west room has a double ledge and braced door in the south wall directly opposite the south main barn entrance and small plank and batten door in the west wall (**Figure 2, Plate 11**). The floor is earth and gravel, the proposal here is to resurface this floor with stone flags.

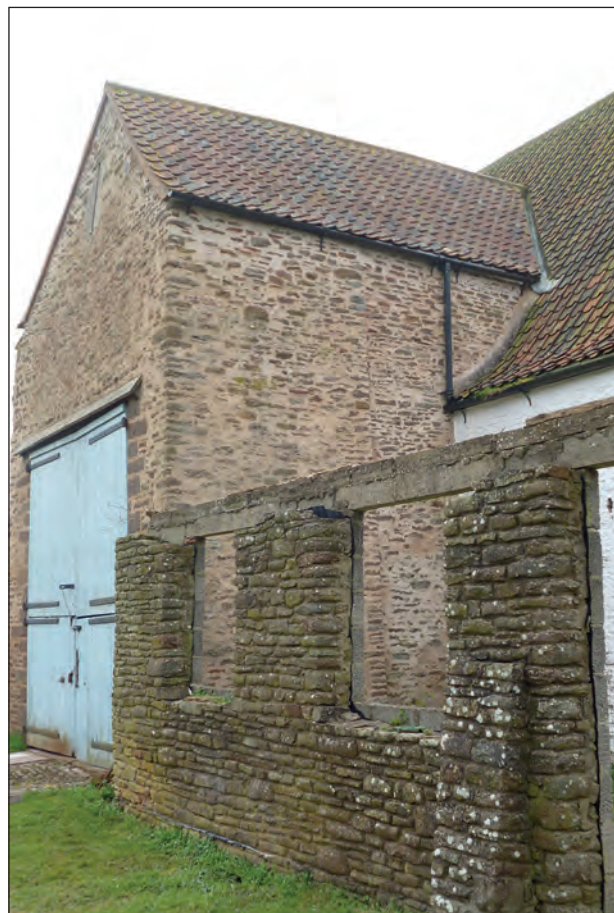
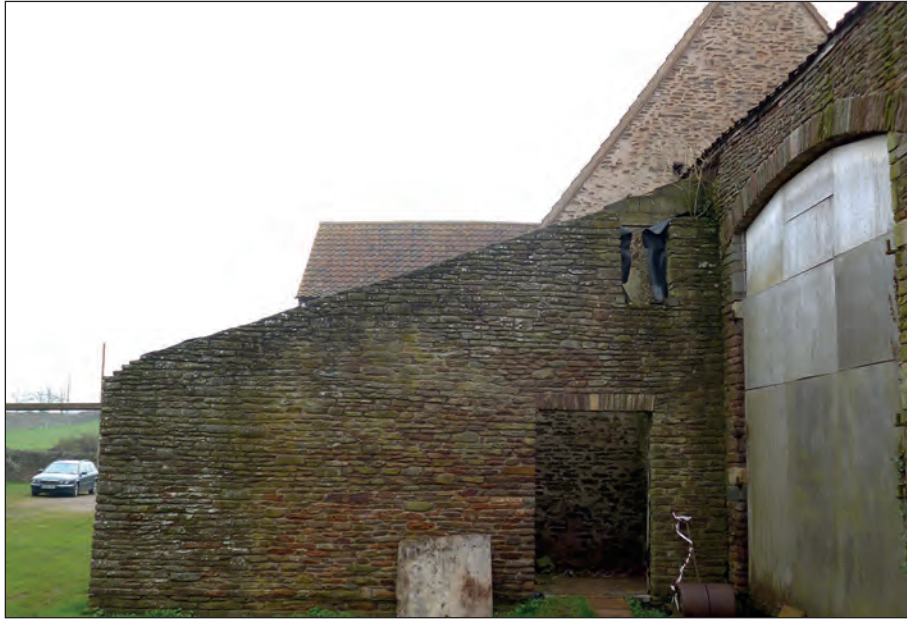
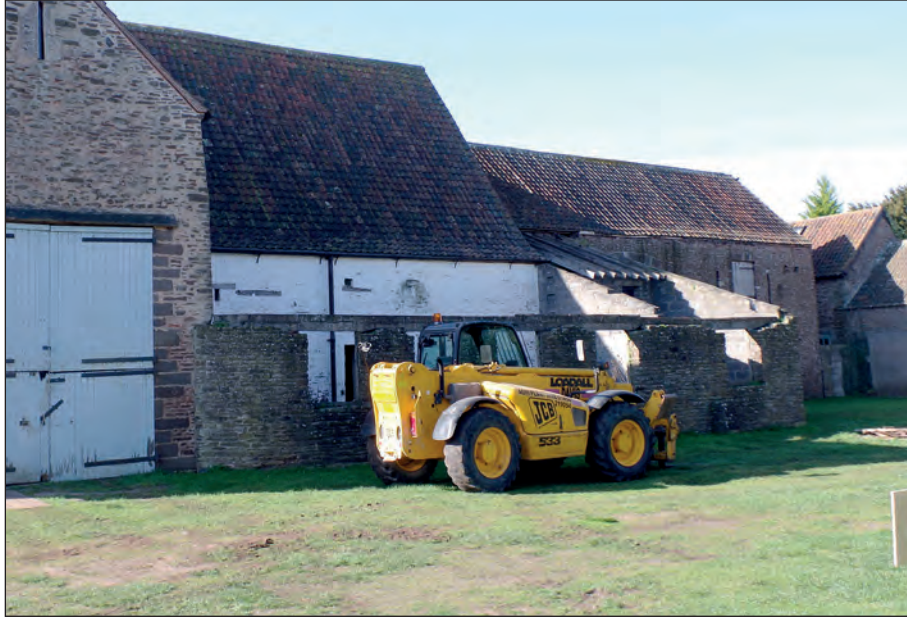
- 4.4.2 The building was located to the west of the midstrete porch of the Main Barn and extended west and partly across the north side of the West Barn (**Figure 1**). An external skin of stonework over an internal wall of concrete blockwork. Both walls had a polythene damp proof course and the door and window openings had concrete lintels. At the time of the Condition Survey the building did not have a roof (**Plates 12-14**). Internal partitions were constructed in concrete blocks.

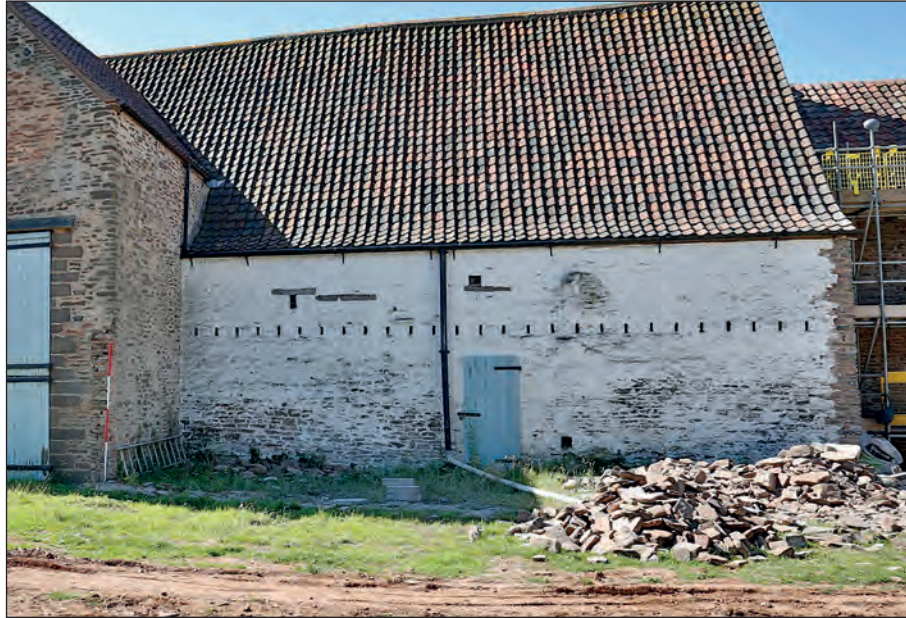
Plate 15: Main Barn north wall showing joist holes from earlier stables

- 4.4.3 A series of joist holes exposed in the north-west wall of the Main Barn are not thought to relate to the demolished building mentioned in the Design and Access Statement (**Plate 15**). The report states that 'When the Bristol and Gloucestershire Archaeological Society visited in 1880, their report noted *Between the transepts were 'Jacobean stables' with gable ends*'. These stables with gabled ends are shown in a 1913 drawing by Samuel Loxton.

- 4.4.4 These features are thought to relate to the historic stable building which previously occupied this space and was demolished later.

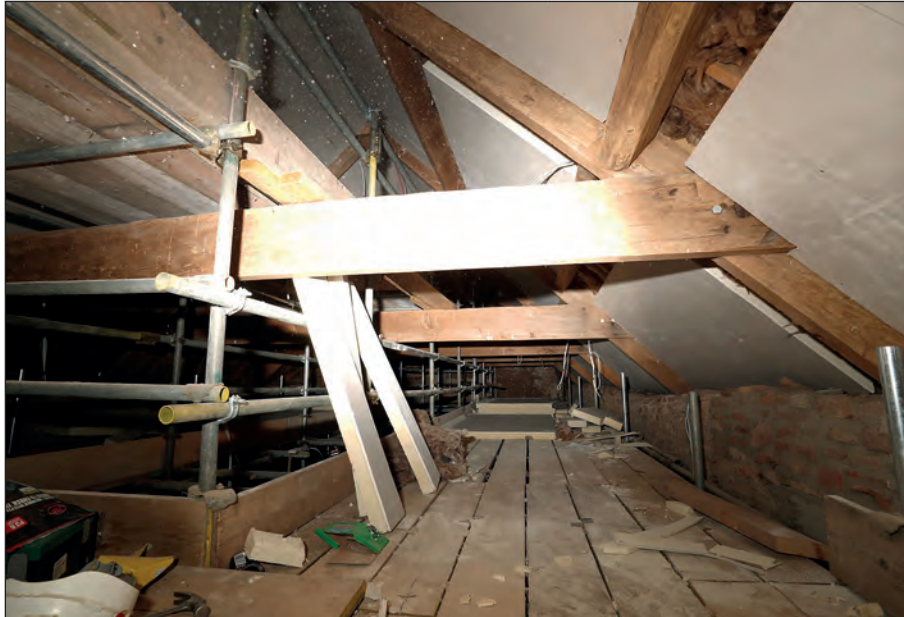
Plate 17: West Barn view of roof trusses

- 4.5.6 The roof consists of 'A' frame trusses and has been the subject of some recent work in the form of raised ties bolted to the principal trusses (**Plate 17**). The original roof elements included principal rafters possibly bridle jointed at the apex and staggered butt purlins. It was not possible to assess the common rafters as insulation sheeting had been installed between the trusses obscuring the underside of the roof. Noted on one of the principal rafters were race knife marks (**Plate 18**). A set of cut lines and at angles thought to be tally marks from the timber yards.

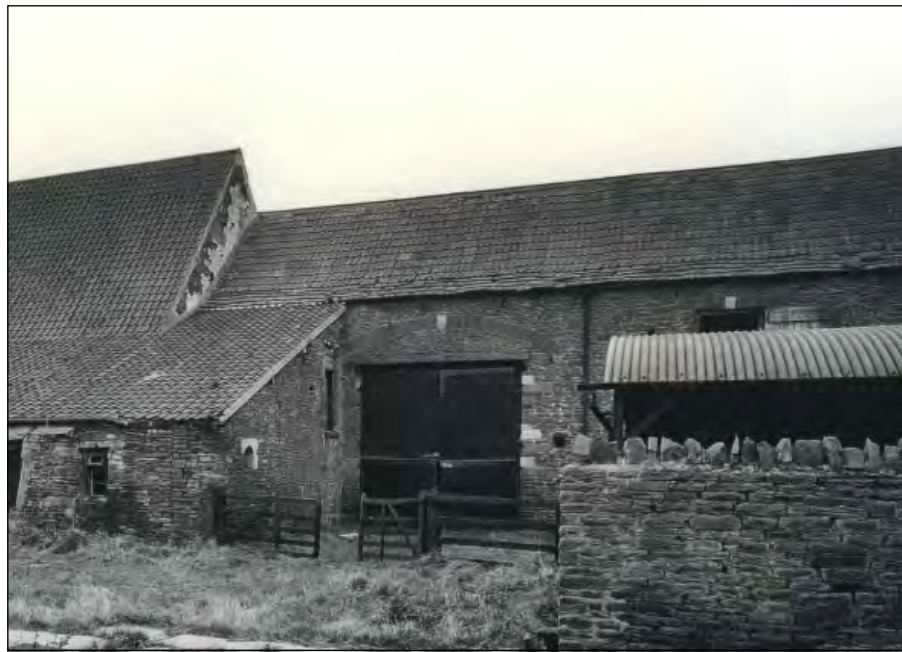
Plate 22: Undated photograph showing West Barn north elevation

- 4.5.3 On the north side of the West Barn there is a tall wide door opening with stone arch (**Plate 16**). An undated historic photograph (**Plate 22**) indicates that the stone arch was formerly a relieving arch situated above a horizontal timber lintel, although the lintel and masonry below the arch have subsequently been removed to raise the height of opening. During the site survey the door opening was blocked with boarding and the original double doors removed, although evidence remains of the original doors as either side of the opening are four surviving pintles. The location of each pindle is marked by a squared limestone block, with an upper and lower pindle and two closely spaced central pintles. The spacing of the central pintles indicates that there was originally an upper and lower door which is confirmed by the historic photograph. The earlier arrangement of this door opening is to be reflected in the design of the new glazed screen and doorway that will be installed here.
