New Emergency Access, Bishop Wordsworth's School, Exeter Street, Salisbury, Wiltshire

Historic Building Recording and
Archaeological Watching Brief Report

Planning Ref.: 18/11582/LBC and 18/11404/FUL
Museum Accession Code: SBYWM:2019.75
Document Ref.: 213981.03
April 2020

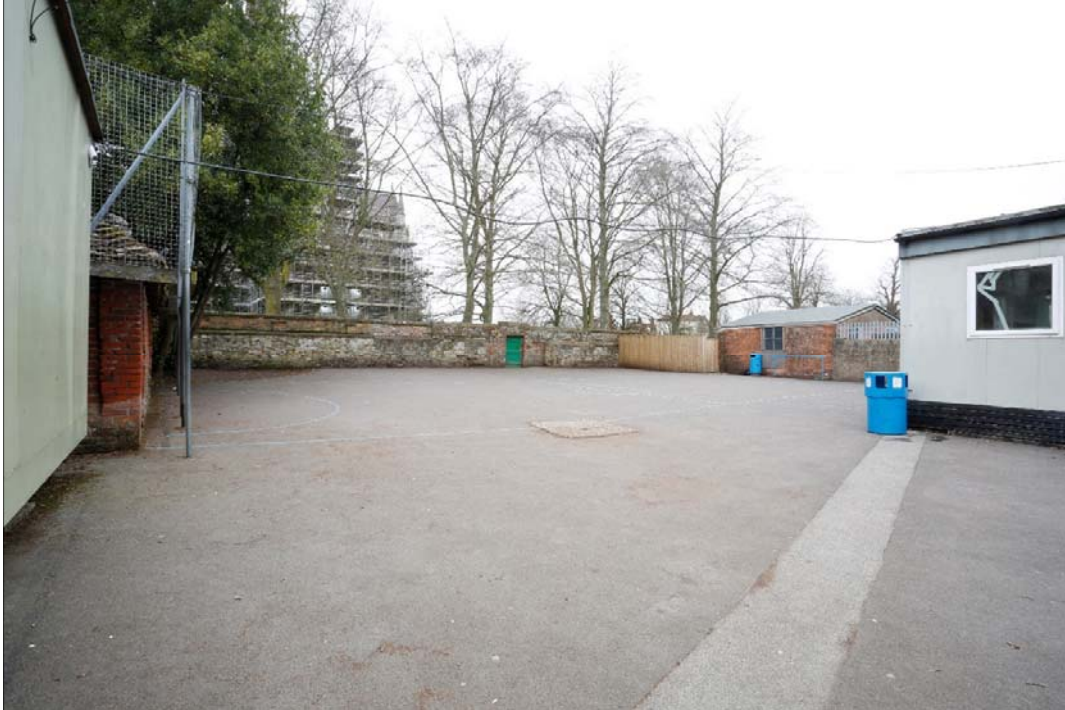
Plate 1: Wall viewed from the south-east across the school playground

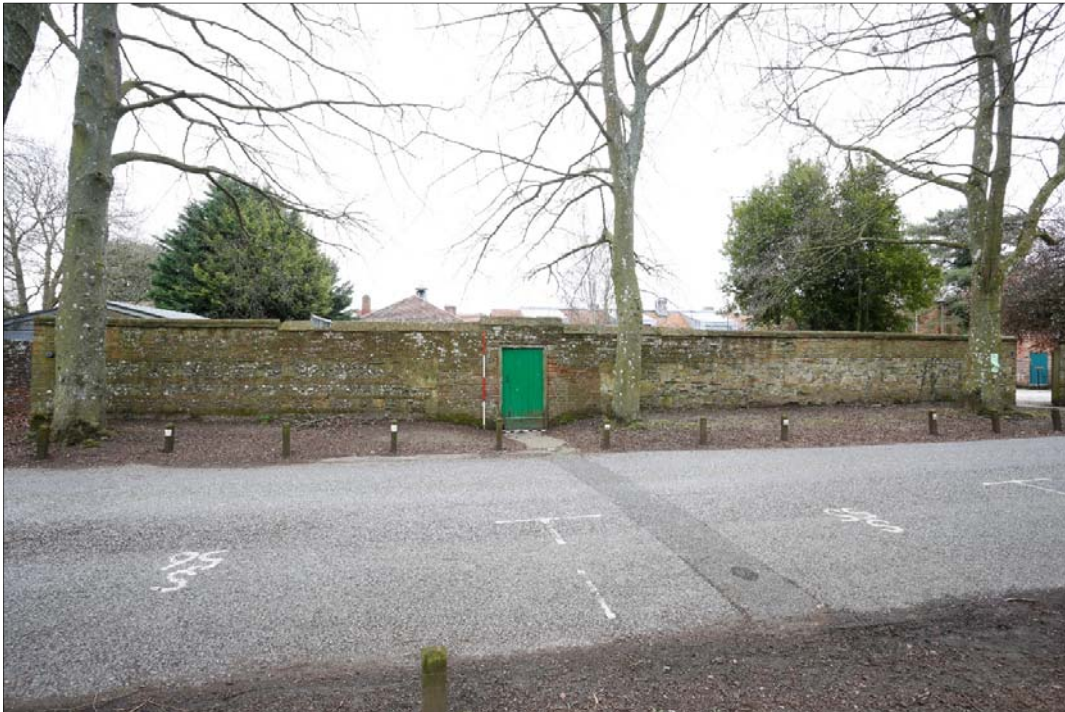
- 4.1.9 The top of the wall is capped with a series of coping stones and bricks (**Plate 2**). The majority of the wall stands approximately 2.2 m above ground level (measured on the north-west side of the new emergency access). Prior to its removal, the wall stepped up above the pedestrian doorway. It measured 2.55 m from the base of the doorway to the apex of the coping. Masonry coping stones feature(d) either side of the new emergency access and above the removed section (these have been retained by the cathedral masons for re-use elsewhere). Further along the wall in both directions, the upper (brick) part narrows and the copings change to half round bricks (**Plate 4**).

Plate 2: Wall viewed from the west

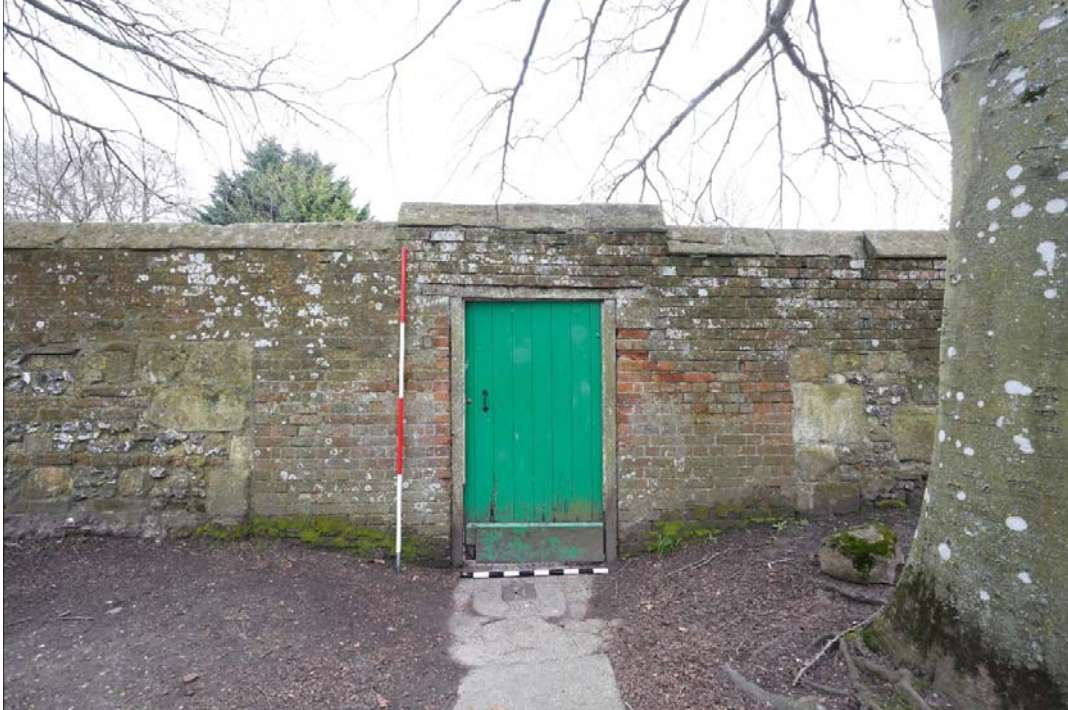
- 4.1.4 The boundary wall has been built/rebuilt in phases. The lower parts of the wall either side of the emergency access are constructed of a mix of stone rubble, flint and red brick with some occasional tile (**Plates 3-4**). The watching brief revealed evidence that the ends closest to the infill were likely rebuilt in the 18th or early 19th century (discussed below) reusing earlier material (stone rubble and flints) and red bricks. The bricks incorporated into this lower part of the wall are suggestive of rebuild and/or repair. In particular, the buttress on the north-east side of the emergency access contains a substantial amount of brickwork compared to elsewhere in the lower wall (**Plate 5**). The lower part of the wall is approximately 0.5 m in width excluding the buttress and stands 1.35 m high above ground level (measured on the north-west side of the new emergency access).

- 4.1.6 The new emergency access reinstates an earlier opening which measures 3.7 m (approximately 12 feet) in width. It replaces a brick infill section of the wall (0.375 m thick) which contained a pedestrian doorway (**Plates 3-4**). The infill brickwork was contiguous with the brickwork that forms the upper wall either side. This indicates that the increase in height, infill and creation of the pedestrian doorway was one phase of work. The alteration must have occurred before 1883 because the 1:500 scale Ordnance Survey map of Salisbury of that date shows a pedestrian-sized opening in the wall.

Plate 3: Doorway viewed from the west

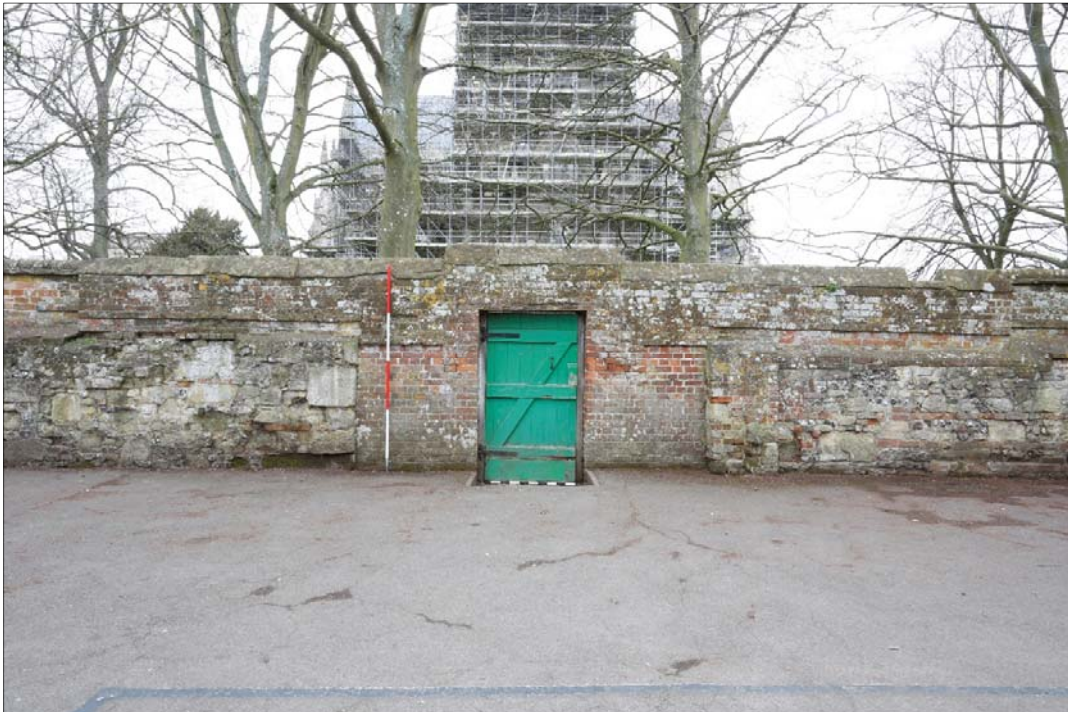
- 4.1.8 On the east side of the wall within the later raised section and infilled entrance were two protruding brick string courses laid in stretchers (**Plate 4**). The lower string course lay wholly within the brick infill and has been removed.

Plate 4: Wall and doorway viewed from the east

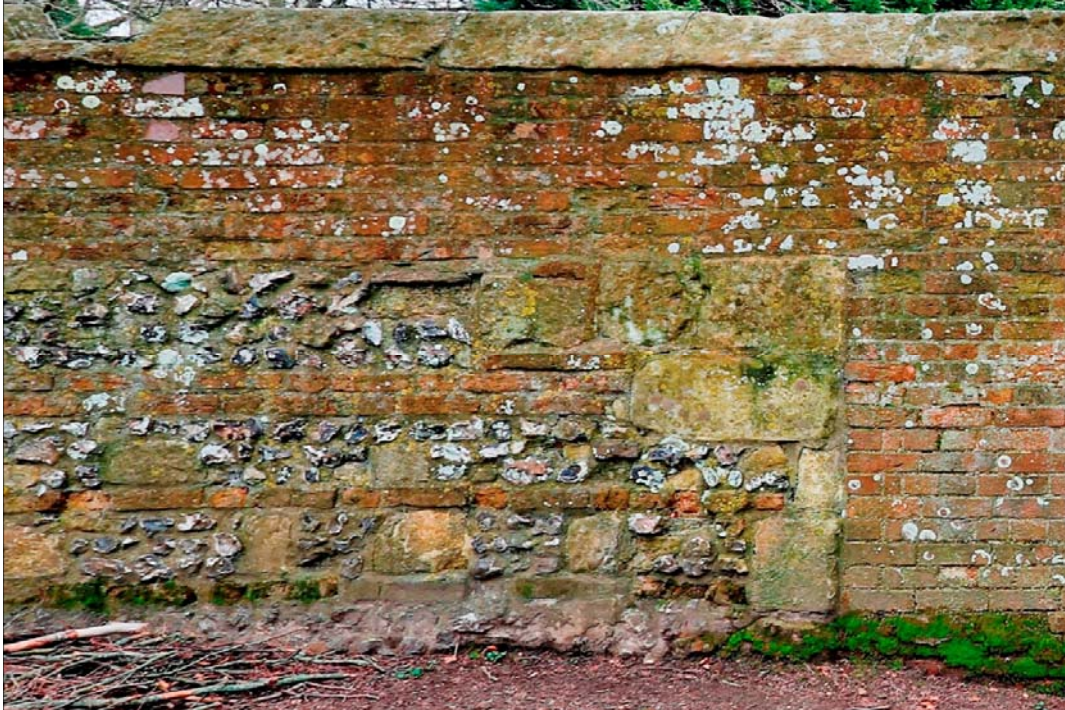
- 4.1.7 Single and double brick lacing courses feature in the lower part of the wall to the north of the new emergency access. The lacing courses on the west side are clearly defined (**Plates 2 and 6**) whereas those on the east are interrupted and untidy (**Plate 4**). The lacing course bricks are similar in size and appearance to the brickwork in the upper part of the wall and removed infill (the bricks from here being unfrogged and measuring 225 x 110 x 70 mm). rebuilt, perhaps not long before it was raised and the entrance largely infilled in probably the later 18th or early 19th century. The lacing courses are not present to the south of the new emergency access, and this part of wall was probably repaired rather than rebuilt.

Plate 5: Detail of lacing courses on the west side of the wall to the north of the new emergency access

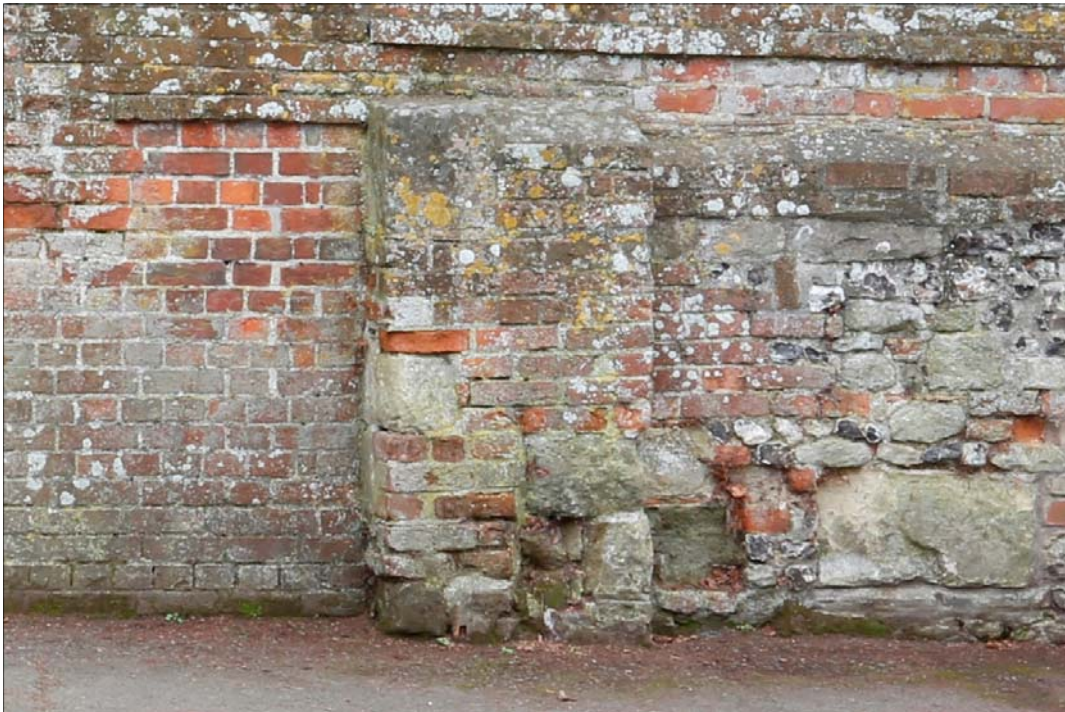
Plate 6: Detail of stone and brick buttress to the north of the doorway viewed from the east

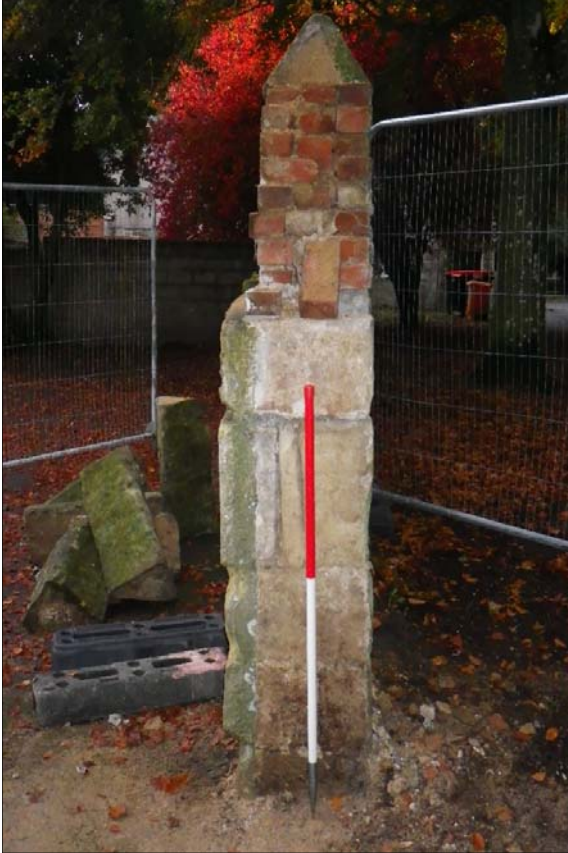
5.1.1 The areas observed are indicated on **Figure 1**. The results of the demolition of the former wall blocking are included above, this serving to re-expose the wall terminals of the earlier, wider entrance (**Plates 7 and 8**).

Plate 7: Detail of end of south section of wall following removal of blocking, viewed from the north

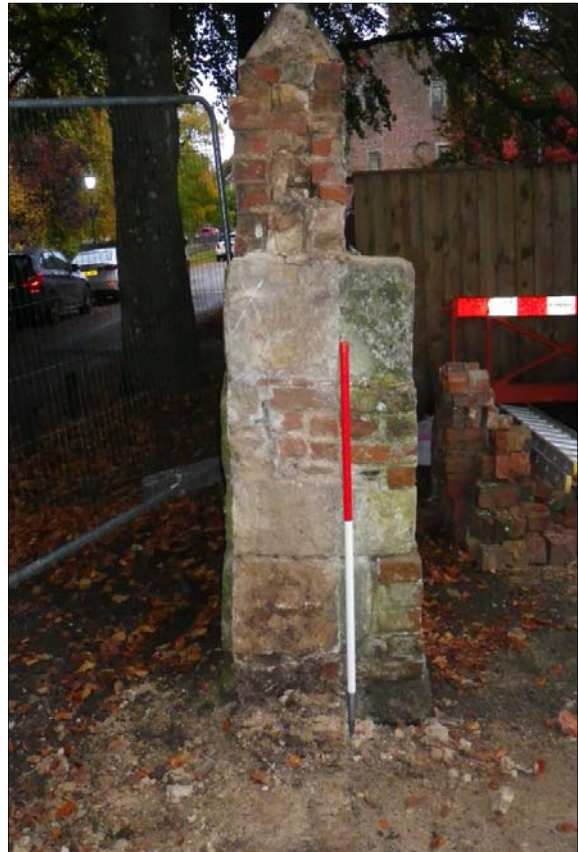
Plate 8: Detail of end of north section of wall and buttress following removal of blocking, viewed from the south

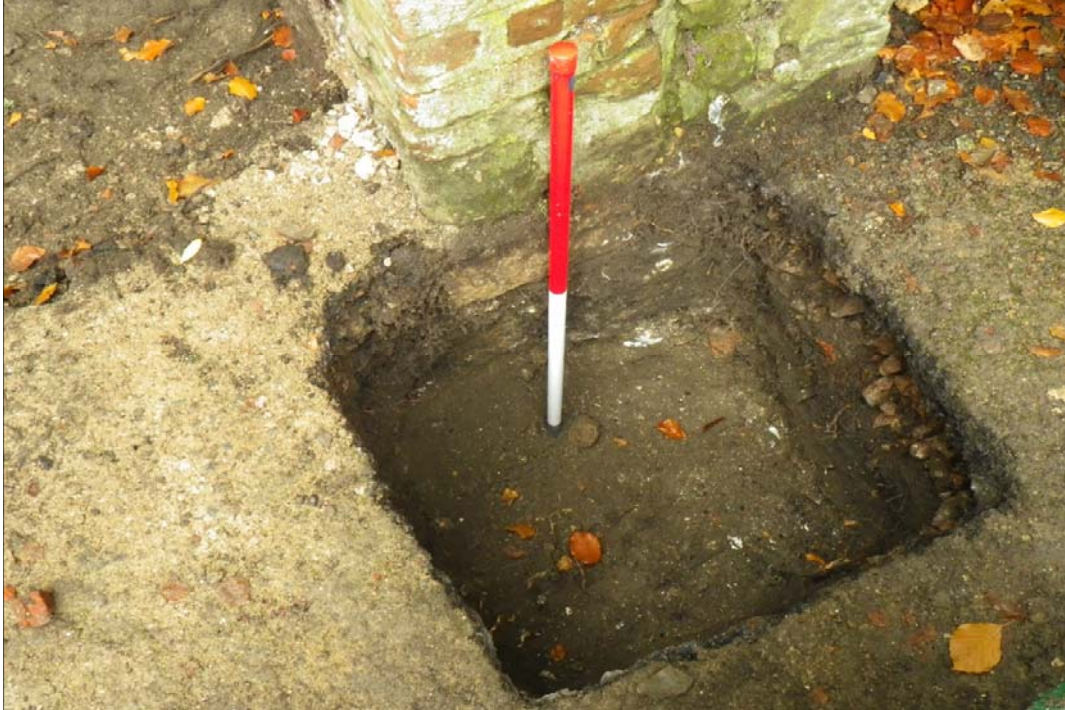
5.3.2 The holes for the gateposts measured 0.65–0.70 m square and 0.9 m deep, and both revealed similar sequences of deposits (**Plates 9 and 10**). Tarmac 0.05 m thick (layer 1) was laid over a 0.12 m layer of orange gravel sub-base (layer 2). This in turn sealed 0.35 m of dark greyish brown silty clay loam.

5.3.3 Below the buried topsoil was at least 0.35 m (base not reached) of demolition/levelling deposits (layers 5 and 6). These comprised a pale–mid greyish brown silty loam, becoming more clayey with depth, this containing common limestone and flint fragments (<0.1 m), mortar, some pieces of peg tile and a few oyster shells. These demolition/levelling deposits extended beneath the two wall terminals (no construction cut was visible).

Plate 9: Hole for north gatepost, with surface of layer 6 exposed, viewed from the east

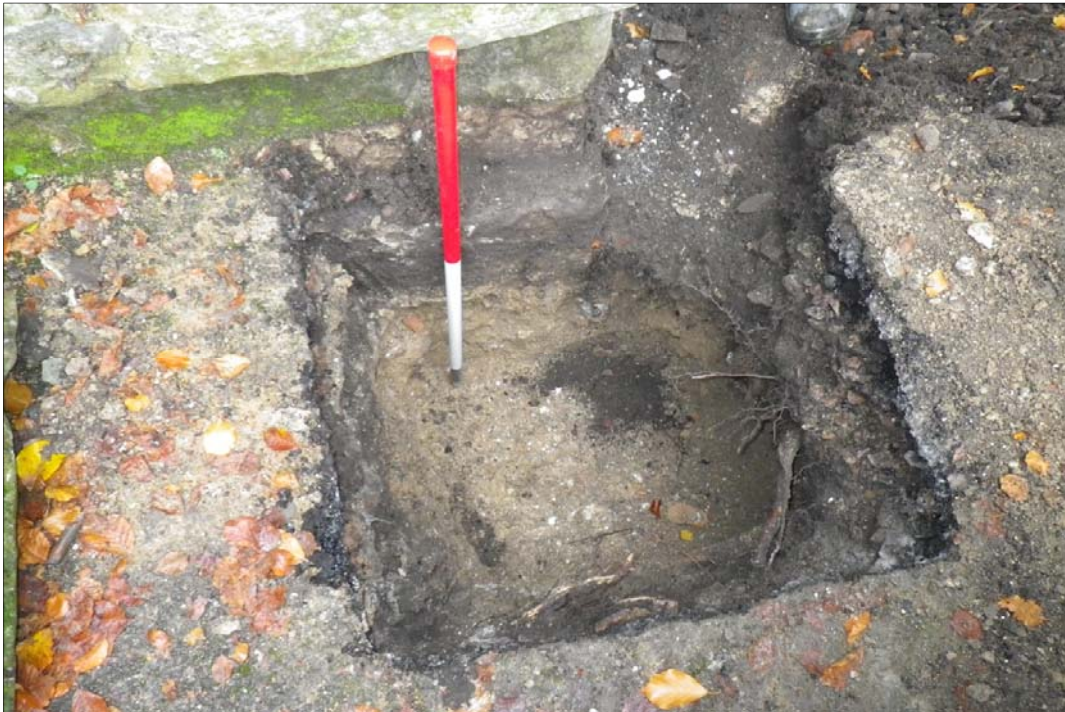
Plate 10: Hole for south gatepost, fully excavated, viewed from the east

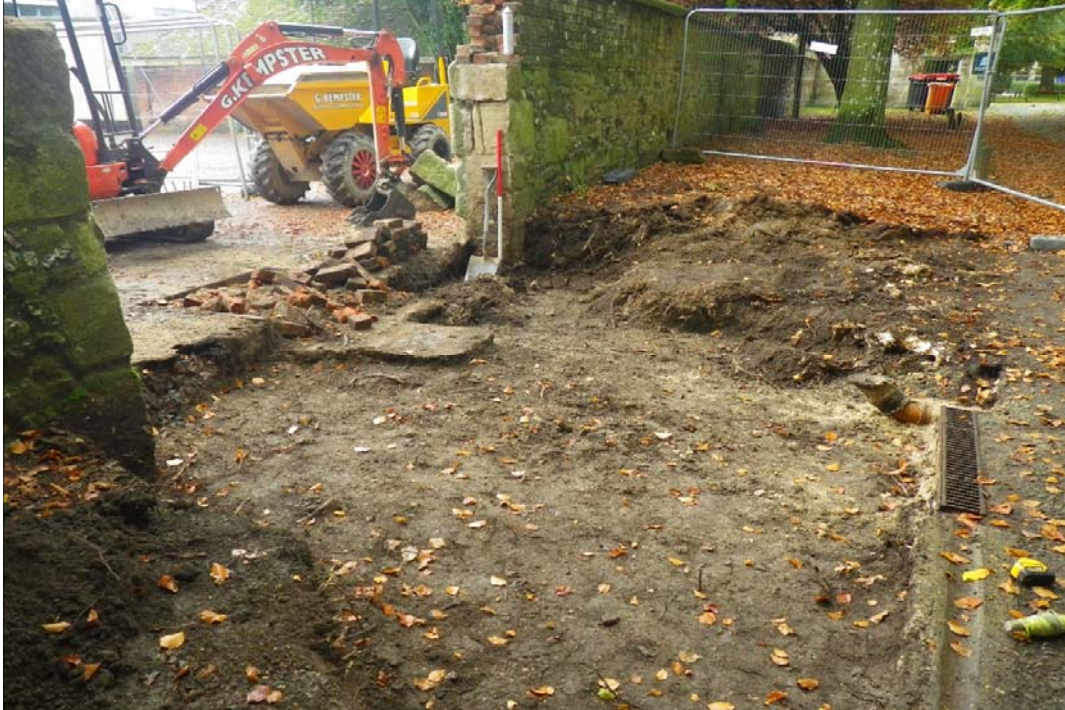
5.3.4 Ground level reduction to the west of the new emergency access, between the wall and Bishop's Walk, involved stripping turf and topsoil from an area 3.5–7 m long by 3 m wide, as well as the removal (by grinding out) of the base of a tree stump approximately 1 m in diameter on the southern edge of the area (**Plate 11**). As to the east, reduction was of insufficient depth (0.3 m) to reveal anything other than the base of the topsoil, with no pre-modern features identified or finds recovered. Two recent service trenches were present, one associated with a drain along the eastern edge of Bishop's Walk and the other, crossing the area, containing a water pipe supplying the school.

Plate 11: Ground reduction in progress to west of wall, viewed from the north
