# Race Bank Offshore Wind Farm

Preliminary Assessment of ship-timbers recovered from  
G01-H01-001 and G01-H01-014

Ref: 106942.07  
October 2017

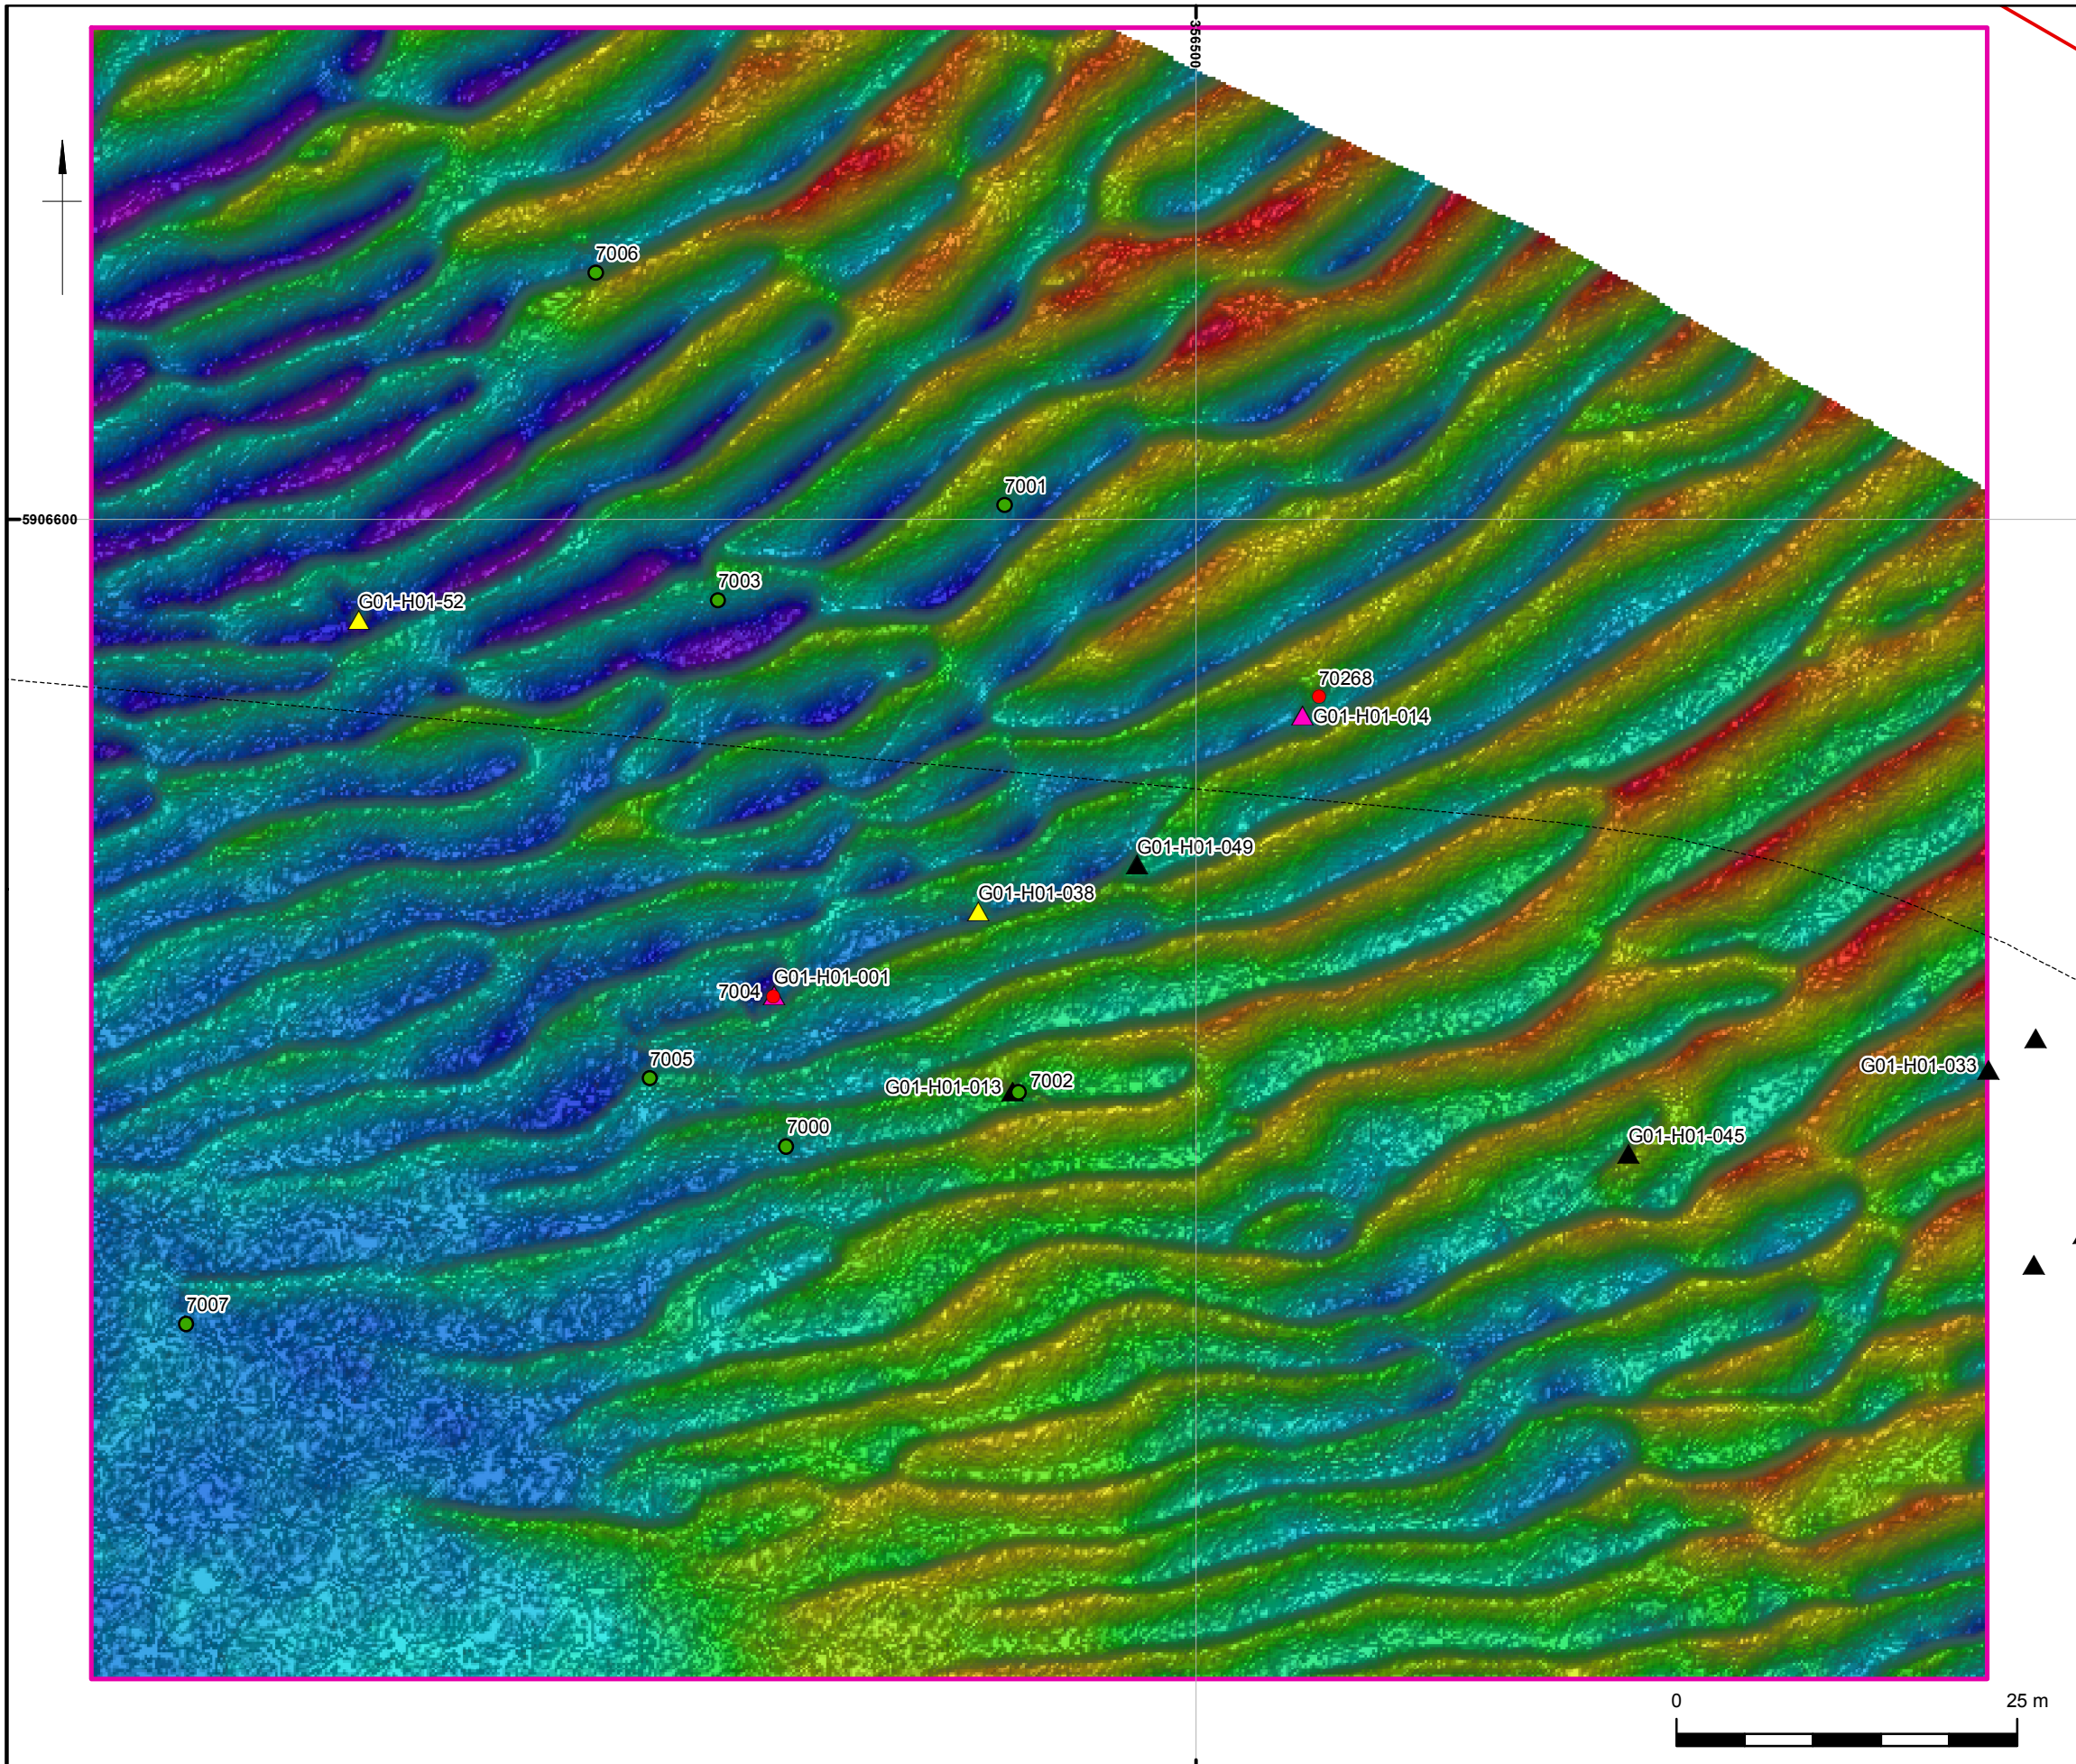
Figure 3

Seabed features of archaeological potential in study area

- 3.2.4 The 2017 multibeam bathymetry data were assessed over the study area, with particular focus on the seven targets Ørsted had identified within this area (**Figure 3**).

- 5.1.3 Two of the features were classified as A1 as they are at the locations of the targets where the timbers were recovered from. Geophysical anomaly **7004**, corresponding with **WA01**, was observed in the sidescan sonar data as an elongate feature measuring 4.4 x 1.0 x 0.3m near the edge of the sandwave area. It was also observed in the 2017 bathymetry data as a linear feature measuring 3.2 x 1.2 x 0.2m. Both these sets of dimensions are rather smaller than the actual size of the timber, which was measured to be 6.0 x 0.3 x 0.3m. This is likely

- 5.1.4 The second timber, **WA02**, came from the location of feature **70268**. This feature was also observed as an elongate object with height in the sidescan sonar data. It has dimensions of 4.1 x 0.7 x 0.4m and lies in the area of sandwaves. This feature appears in the 2017 bathymetry data to measure 4.0 x 1.2 x 0.1m. In the 2015 bathymetry data the feature was less exposed with only approximately 2m of the length visible. The measured dimensions of the recovered timber are again larger, at 7.4 x 0.3 x 0.3m, than those observed from the geophysical anomalies. Again, this suggests that the full length of the timber was not exposed at the surface at the time the data were obtained.

- 5.1.6 A single feature, **7002**, was observed in the bathymetry data only, classified as a mound and discriminated as A2. In the 2017 data it appears as a linear feature measuring 4.5 x 1.2 x 0.1m. It is not visible in the 2015 bathymetry data and the position in this dataset is located at the base of a sandwave, illustrating the mobile nature of bedforms in this area. Nothing was observed at this location on the seabed by Ørsted, using Blueview sonar, and hence no grabbing was undertaken here.

- 5.1.9 Dark reflector **7006** is an approximately triangular feature with height observed between sandwaves. It has dimensions of 2.1 x 0.9 x 0.4 m and it is possible that it may be debris.
