Tile Barn Outdoor Centre, Church Lane Brockenhurst, Hampshire

Archaeological Watching Brief Report

Ref: 108750.03
June 2015

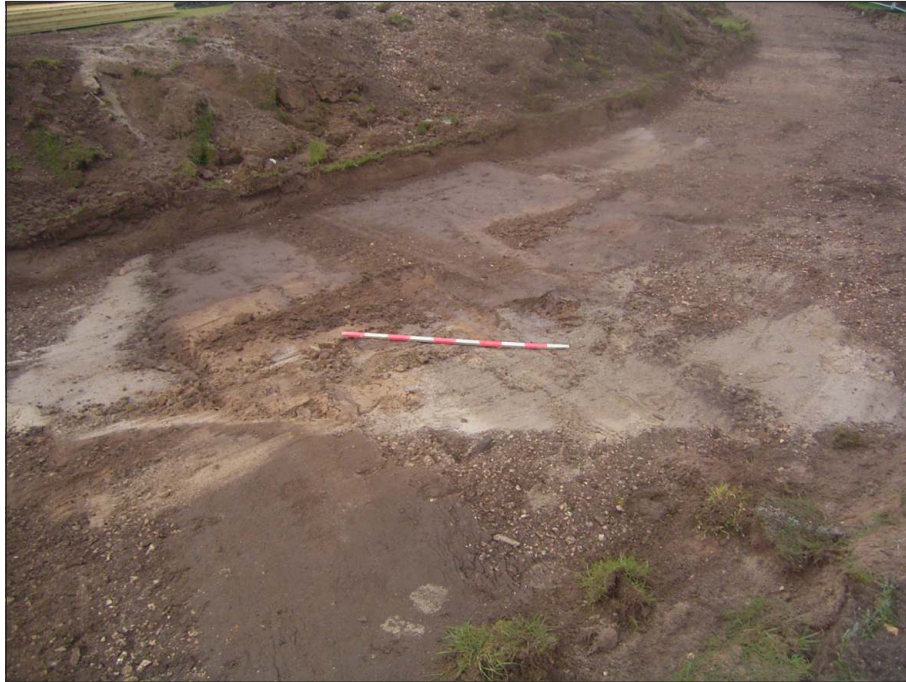
- 4.3.2 During excavation of the access road, feature **105 (Plate 1)** was identified. Rectangular in shape and measuring 5.00m in length by 3.60m wide, oriented on a north-east to south-west alignment, it was only partially exposed within the excavation area. It was initially thought to be the footprint of one of the hospital barracks which were located on the Site during WW1, as it was on the same alignment and roughly in the right location to that seen in sources from the New Forest Remembers Project. However, exploratory excavation recovered artefacts which suggest that it is of a more modern date.

Plate 1: Feature 105 viewed from the north-east

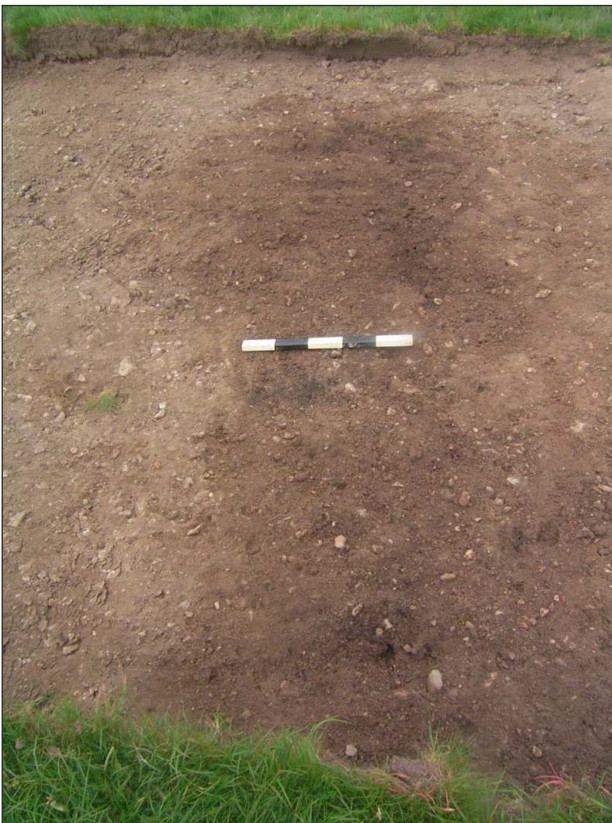
- 4.3.3 Feature **108**, metalled surface **110**, and drain **112** were encountered during the excavation of the accommodation pods and most likely date to the last 100 years. Feature **108 (Plate 2)** is most likely a spread of material that relates to the demolition of the building that is associated with rubble seen on the western edge of the Site. Metalled surface **110** was only partially visible in one of the accommodation pods and due to the limits of the works, the function and date remains unknown. Drain **112 (Plate 3)** was constructed out of ceramic building material (CBM) pipes (the same material as used for land drains) and covered by asbestos sheeting (which was safely removed and disposed of in line with the Control of Asbestos Regulations, 2012). The drain either assisted in the natural drainage of the Site, or was associated with a now demolished building.

Plate 2: Feature 108 viewed from the north

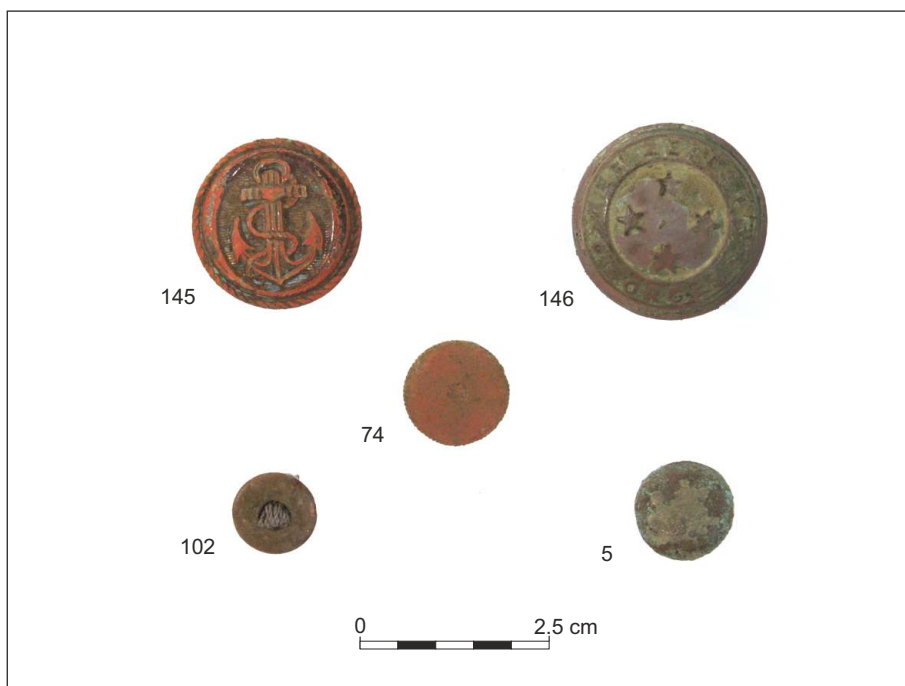
- 5.2.2 Five buttons were recovered during the metal detecting survey (Objects **5, 74, 102, 145,** and **146**) (**Plate 4**). Buttons **5, 74,** and **102** have no markings to identify them further to ascertain a date, although **102** does have threads attached which look to be khaki in colour and may be from a uniform. Button **145** was identified as being from a Merchant Navy officer's uniform, most likely a coat, and the design dates it to the 1930s.

- 5.2.3 Button **146** is of significance to the Site in its WW1 setting as it is from a New Zealand Armed Forces uniform and can be dated to the four year period from 1916 to 1919 when the Site was used as a field hospital. On the back of the button, the maker is identified as Firmin & Sons Ltd, London. Firmin & Sons are one of the 500 oldest companies in the world, being established in 1655, and are a world famous supplier of ceremonial buttons, badges, and uniforms. This evidence suggests that this button belonged to an officer in the New Zealand Armed Forces.

Plate 4: Buttons 5, 74, 102, 146, and 146

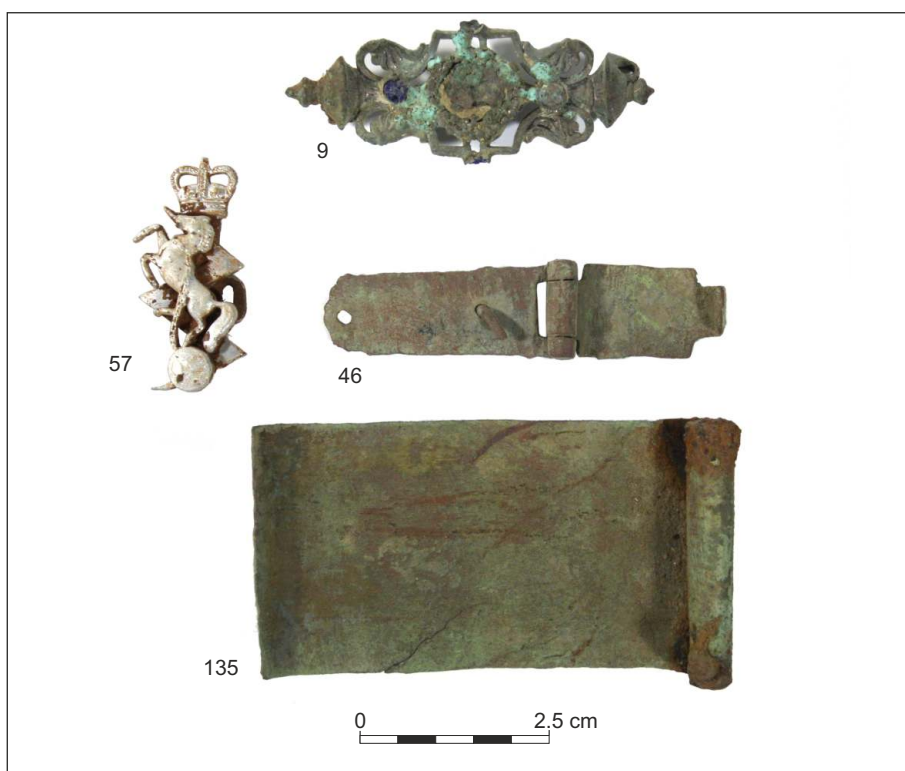
- 5.2.4 Four brooches and clasps were recovered (Objects **9, 46, 57,** and **135**) (**Plate 5**). Clasps **46** and **135** have no distinguishable features and cannot be properly identified, although **46** may be from a small book. Brooch **9** is highly stylised with some evidence of gemstone decoration, but it is unclear if this was a decorative item or part of a uniform. Brooch **57** is a cap/lapel badge from the Corps of Royal Electrical and Mechanical Engineers (REME) and can be dated to after 1947.

Plate 5: Brooches and clasps 9, 46, 57 and 135

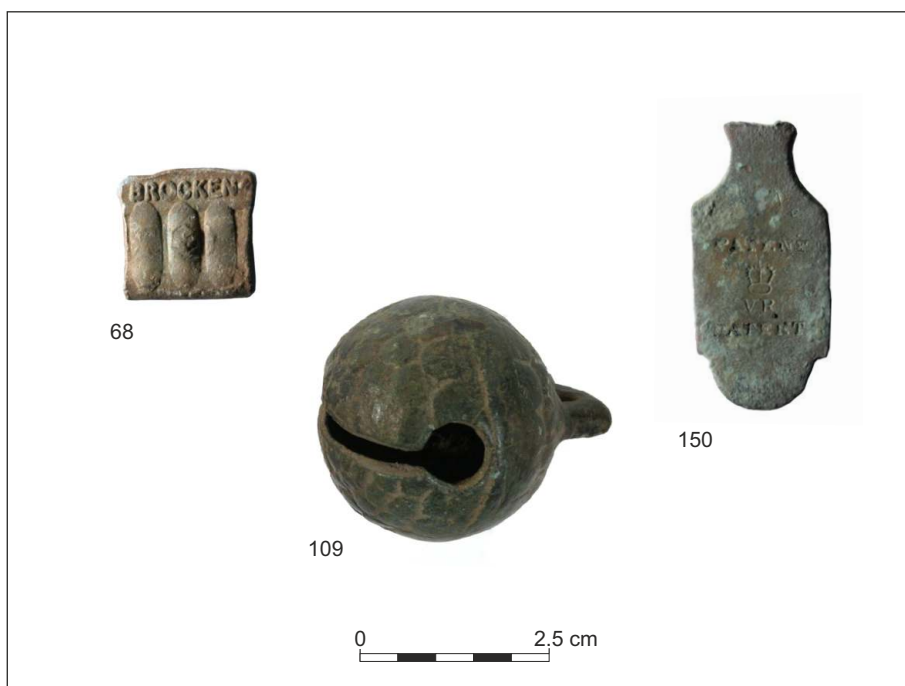
- 5.2.6 In addition, three other objects were recovered (**Plate 7**). Object **68** is a lead stamp with 'Brocken' and 'Hurst' written on either side. The date for this is unknown but obviously comes from the local area. Object **109** is a fish-scale decorated Crotal bell which dates to the 16th to 17th century. Used on horse drawn carts to warn other users of vehicles approaching, this could relate to the stables which were associated with Brockenhurst Park. Object **150** is a fragment of a larger item which has a Victorian patent mark engraved into it. It is unknown what the larger object is (cutlery?) or if it relates to the WW1 use of the Site.

Plate 7: Objects 68, 109, and 150
