# Bishop's Waltham Palace, Test Pit Monitoring Bishop's Waltham, Hampshire

Archaeological Watching Brief

Ref: 233190  
August 2020

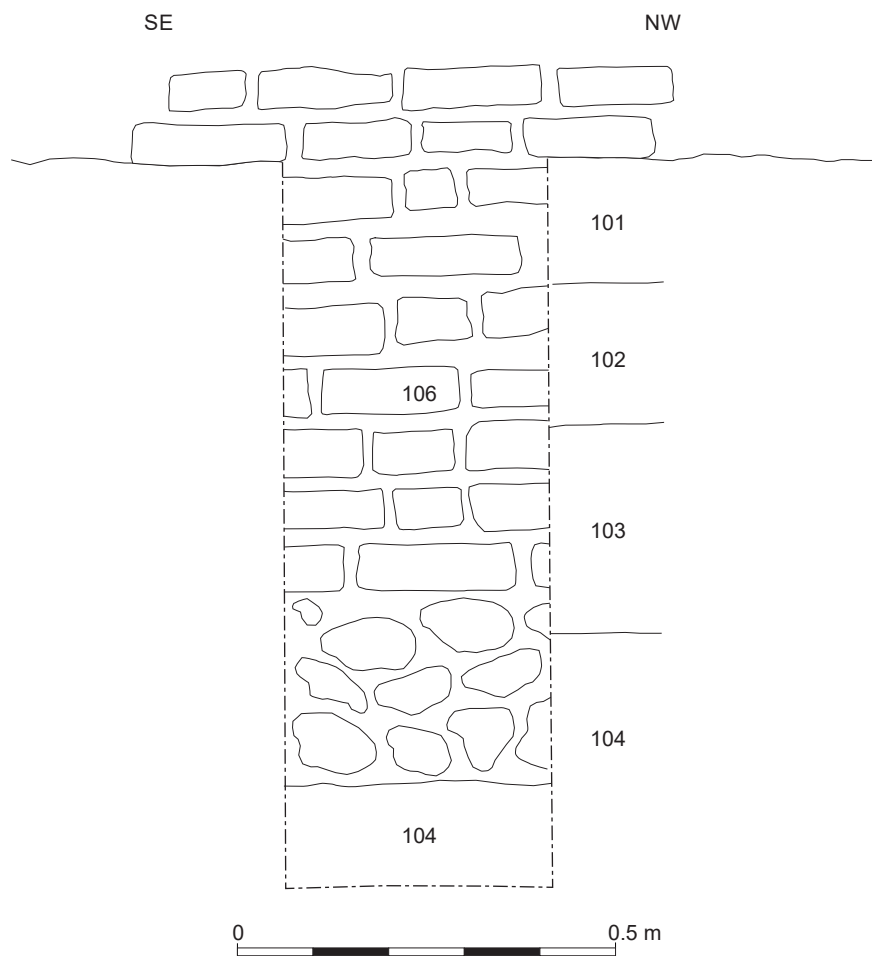
- 5.2.2 The tower wall (106) continued for 0.82 m bgl in its entirety and consisted of 0.56 m of wall and 0.26 m of foundation (**Plate 1; Figure 2a**). As was common throughout the works no specific bond could be determined. The face of the wall and foundation was vertical, and it was not possible to determine where the foundation cut began, the brickwork continuing without noticeable variation to the foundation itself. Nevertheless, the foundation was definitely cut into 104, and its physical relationship to 103 – with the upper part of the foundation being in contact with 100-120 mm of that deposit – suggests that it was cut through 103 as well. Three courses of sub-surface brick to the top of 103 would be unremarkable, and this suggests that the external ground surface at construction was there, or thereabouts. The bonding agent of 106 was observed to be a pale whitish red sand with very small fragments of flint, which acted as a temper, and the jointing was seen to be thick

and irregular measuring on average 0.02 m in thickness. The bricks all corresponded to the dimensions of nine inch bricks, all being within handmade variation of nine by four by three inches. The foundation of 106 was seen to consist of a pale whitish brown mortar with moderate flint nodules (0.15 m+) to act as stabilisation.

A: North-east facing section of Test Pit 1

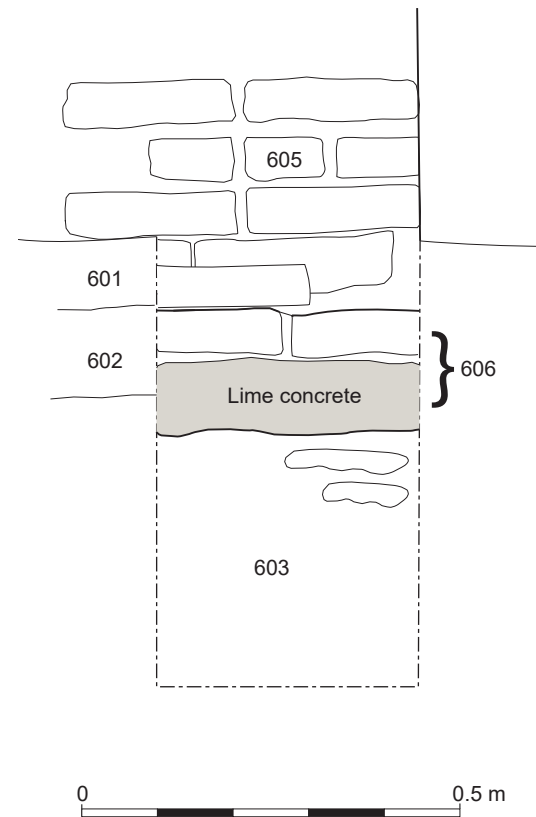
- 5.5.2 The structural sequence observed here was rather more complex than that seen in Test Pit 1. The upstanding section of perimeter wall 605 consisted of nine inch brickwork in no continuous bond. This sat (at 100 – 120 mm BGL) on a plinth of dark red hand-made bricks bonded to a lime concrete foundation. These bricks were noticeably larger than the nine inch bricks. The two examples seen were nearer to eight inches wide than four, and marginally less than three inches thick, although that may have been a result of the wear apparent on their surfaces. Lengths could not be determined, and it remains possible that they represent eight-inch tiles rather than bricks. (**Plate 5; Figure 2b**). This structure was cut into 603.

B: North-north-east facing section of Test Pit 6 and Wall 605

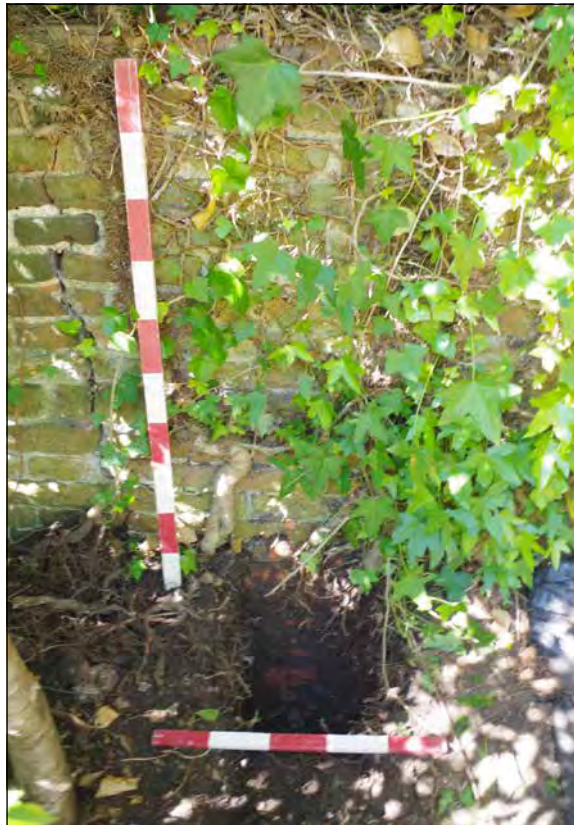
- 5.2.1 Test Pit 1 (WS01/HP01) was located on the exterior side of the north-east tower within a hedge border in the car park belonging to The Crown Inn (**Figure 1; Plate 1**). The test pit measured 0.40 m in length by 0.35 m and was stopped at 0.95 m bgl. The soil sequence within the test pit consisted of a 0.16 m thick modern topsoil/bedding which overlaid a sequence of three deposits which continued to the base of the test pit (**Figure 2a**). The upper two subsoil deposits contained fragments of red brick and white mortar, as well as tile fragments.

Plate 1: North-east facing view of extant wall and Test Pit 1

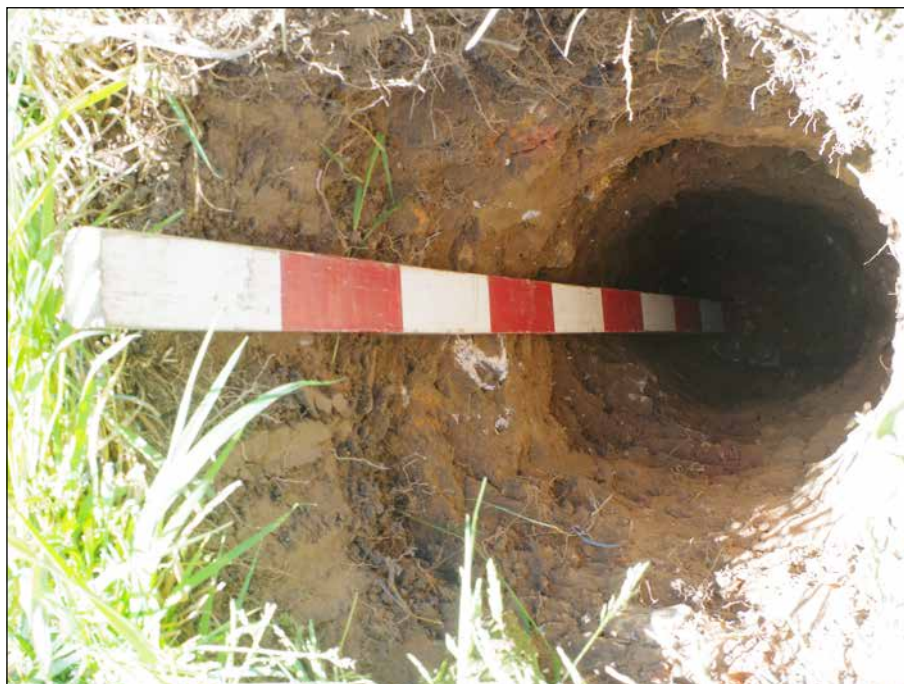
- 5.3.1 Test Pits 2 (HP04) and 3 (HP02/WS03) were located immediately west of the steel footbridge within The Lord's Garden and measured 0.35 m by 0.35 m (**Plate 2**). During the hand excavation of the test pits it was observed that the soil sequences were broadly similar; a deposit of topsoil which ranged in thickness from 0.09 m – 0.12 m, which overlaid a layer of material which contained occasional to red brick and flint fragments (<0.06 m) Measuring between 0.13 m and 0.26 m in thickness, overlaid two deposits of possible subsoil, and the natural geology of a mid-greyish brown to brown silty clay was observed at a depth of 0.89 m bgl. This also corresponds with the non-structural sequence seen in Test Pit 1.

Plate 2: South facing view of Test Pit 2

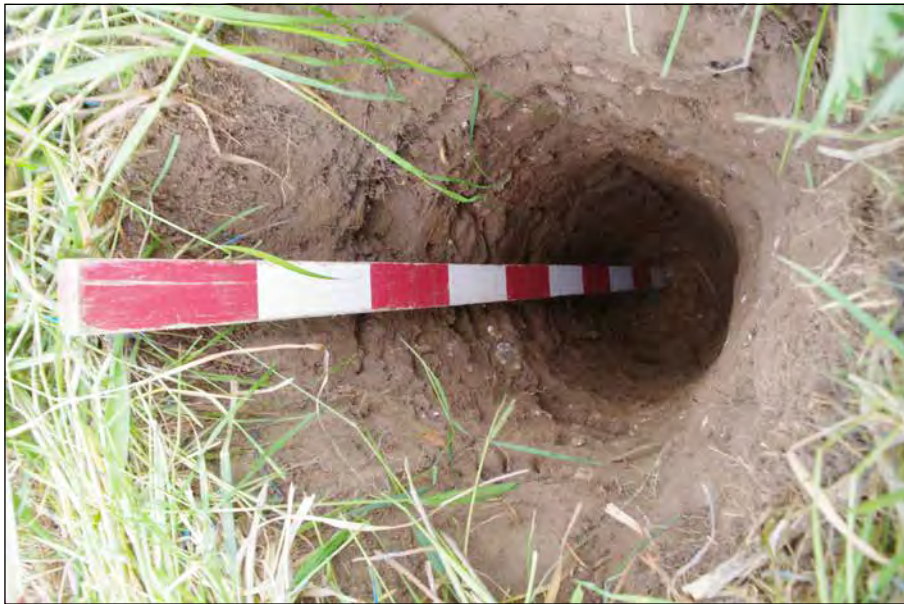
- 5.4.1 Test Pits 4 (HP05) and 5 (HP03/WS04) were located immediately to the east of the footbridge and measured 0.35 m by 0.35 m. The corresponding soil sequence as that in Test Pits 1 – 3 was observed, except that the brick/tile flecked deposit was not seen in Test Pit 5 (**Plate 3**).

Plate 3: South facing view of Test Pit 5

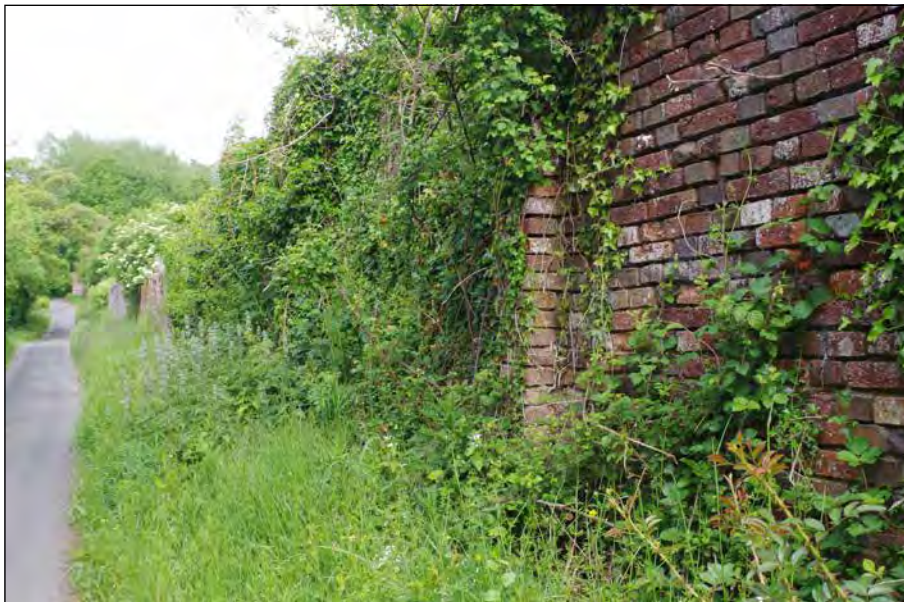
- 5.5.4 Further investigation of the exterior of the wall showed that this section was inset from the outer face (**Plate 4**). This, coupled with the wear on the upper surface of 606 and the compacted nature of 603, suggests that rather than a buttress (as at first thought) this section may represent a second, blocked, gate in the southern perimeter wall. In this

interpretation 606 is believed to represent a threshold, while the compacting of 606 may hint at the otherwise invisible presence of a path.

Plate 4: Exterior view of southern precinct wall (view from south)

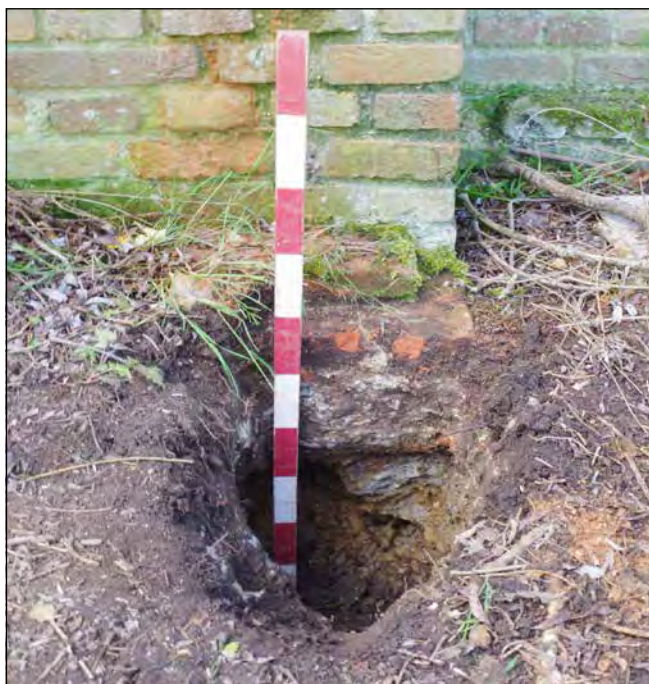
- 5.5.1 Test Pit 6 (HP06) was located on the interior on the southern precinct wall towards the junction between Botley Road and Bishop's Lane (**Figure 1; Plate 4**). The test pit measured 0.40 m in length by 0.35 m and was stopped at a depth of 0.60 m after the base of the wall's foundation was established. The soil sequence of the test pit showed a 0.16 m thick layer of topsoil 601, which overlaid 0.24 m of subsoil 602 which contained occasional mortar and brick fragments, along with sparse flint nodules. Below this subsoil was a compact mid-brown clay 603 which contained common flint nodules (**Plate 5; Figure 2b**).

Plate 5: North-north-east facing section of Test Pit 6

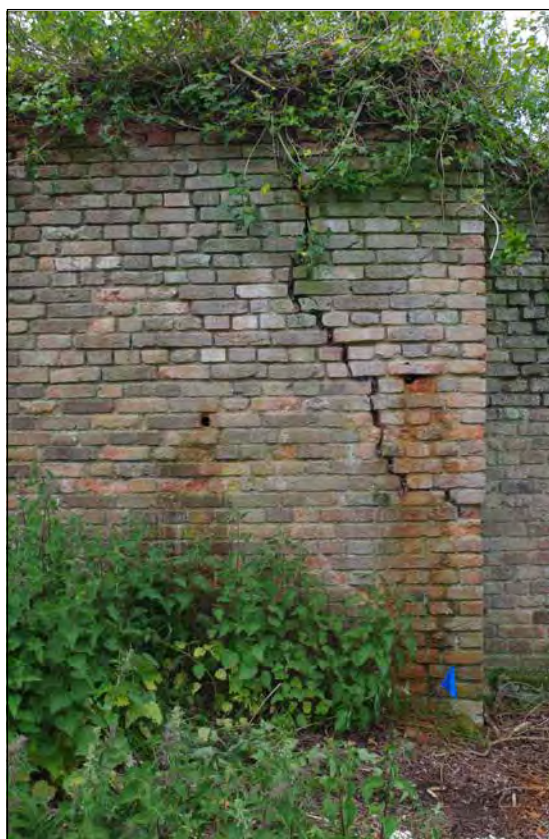
- 5.5.3 In addition to Test Pit 6, two small cores were drilled through the extant wall in order to establish the makeup of the wall (**Plate 6**). The western most core seen in **Plate 6** was located 0.35 m east of the corner of the wall, and the wall was seen to measure 0.73 m in thickness with red brick present throughout, although it was more fragmentary in the middle. The second core was 1.28 m east of the corner and drilling established that the wall was 0.38 m thick.

Plate 6: Location of core samples taken from the interior of the southern precinct wall (view from north-north-east)
