Colworth Park Sharnbrook

Archaeological Evaluation

Ref: 238602.03

January 2021

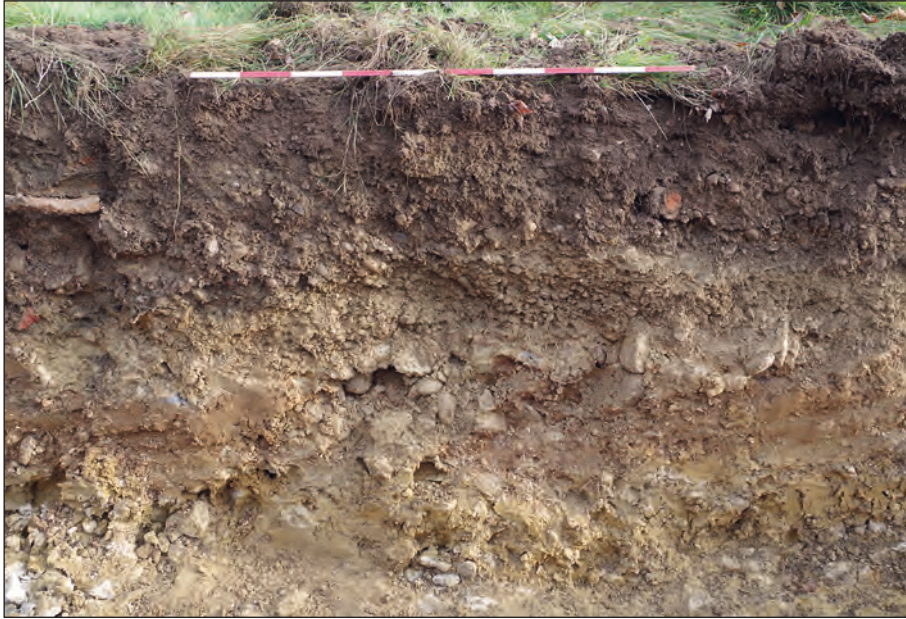
Plate 1: South-west facing representative section at north-west end of Trench 1

- 5.3.1 Trench 1 was the northern most trench and was situated in an area of manicured grass. The topsoil (101) was of a dark greyish brown silty clay loam with sub-angular and sub-round stones.
- 5.3.2 This overlain three layers of made ground (102, 103, 104) at the north-west end of trench 1 which were uncovered from 0.20-0.65m below ground level (BGL). These layers are likely derived from the demolition of the previous structures as they contained fragments of ceramic building material (CBM); this material was used to build up the ground surface (**Plate 1**).
- 5.3.3 At the south-east end of trench 1, beneath the topsoil, layer 107 (0.30-0.66m BGL) may have been some sort of hard standing or yard associated with previous structures suggested by its tight compaction, layer 108 (0.60-0.86m BGL) may have been bedding for this (**Plate 2**).

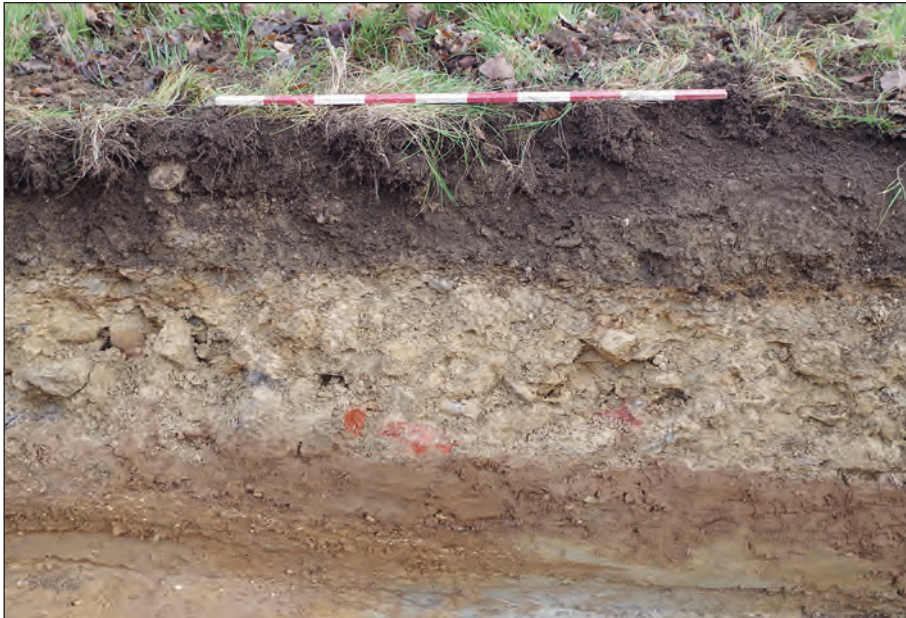
Plate 2: South-west facing representative section at south-east end of Trench 1

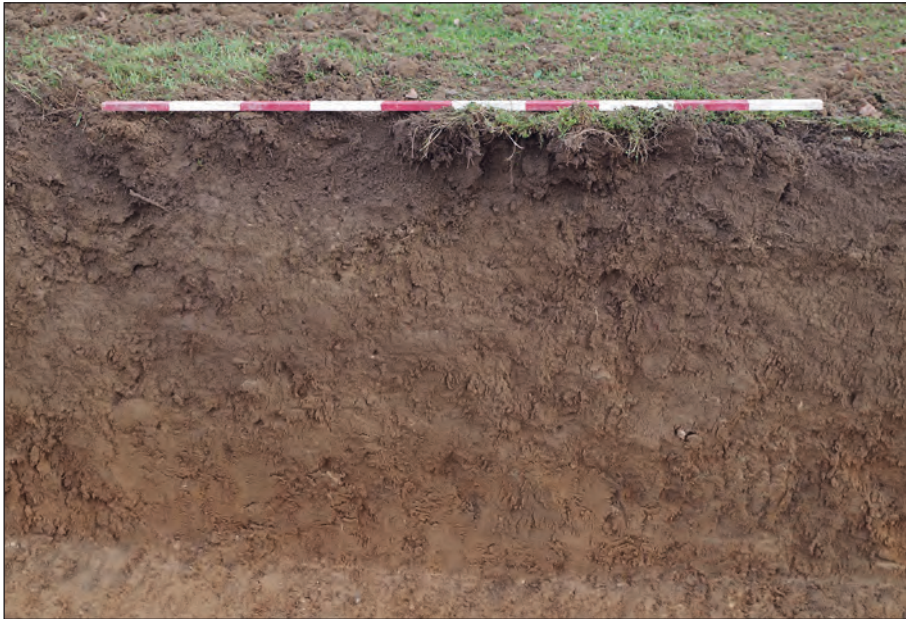
Plate 3: East facing representative section of Trench 3

5.4.1 Trench 3 was excavated in an area of manicured grass towards the western edge of the site. This area did not appear to have been heavily disturbed. Two north east – south west aligned land drains were revealed towards the northern end of the trench and a water pipe on the same alignment toward the southern end. The stratigraphy comprised of a dark greyish brown silty clay loam topsoil (301, 0-0.15m BGL), greyish brown silty clay subsoil (302, 0.15-0.045m BGL), and brown clay natural (303 0.40m+ BGL) with a pale variation at the southern end (**Plate 3**).

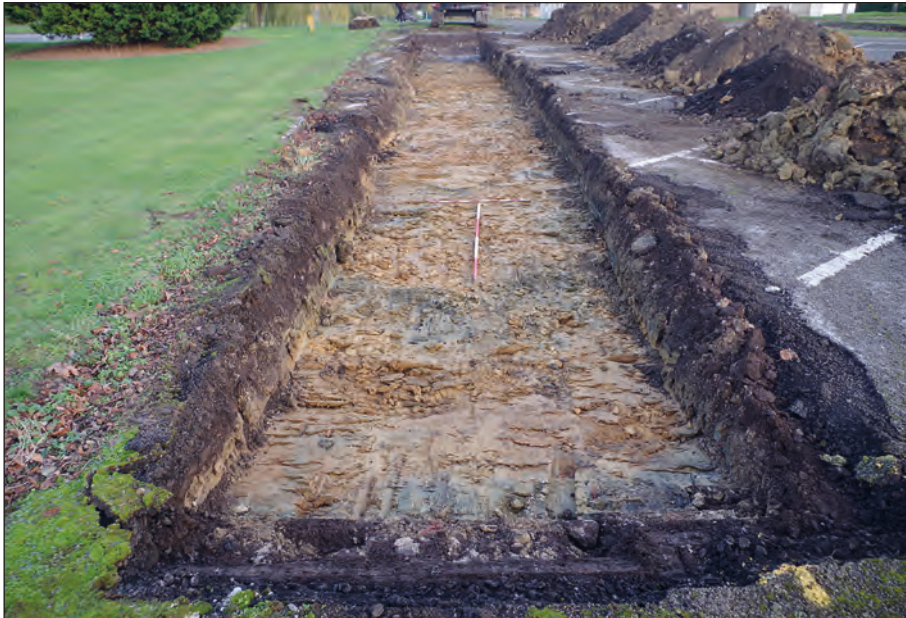
Plate 4: Trench 4 (view from the west)

5.5.1 Trench 4 located towards the southern limit of the site was dug through the current tarmac carpark surface (401) and its bedding of sand (402) to reveal a layer of made ground (403, 0.20-0.36m BGL). This comprised of various CBM, mortar and stone fragments likely derived from the demolished buildings and used to build up the area from the carpark. This overlain disturbed clay natural (404, 0.36-0.43m BGL) containing fragments of tarmac and CBM. The natural (405, 0.43m+ BGL) revealed in the base of the trench was reddish brown clay with mudstone fragments (**Plates 20 and 21**).

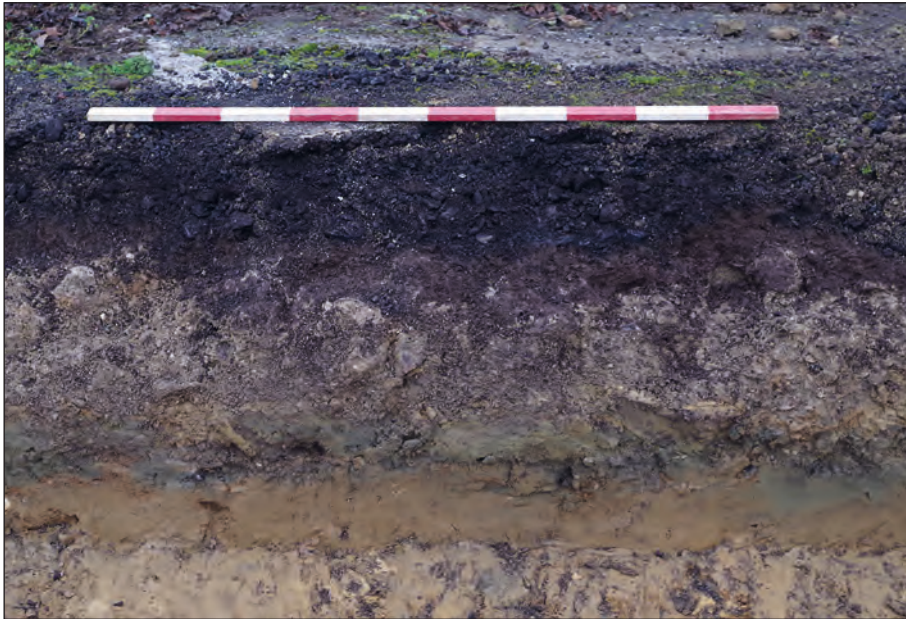
Plate 5: South facing representative section of Trench 4

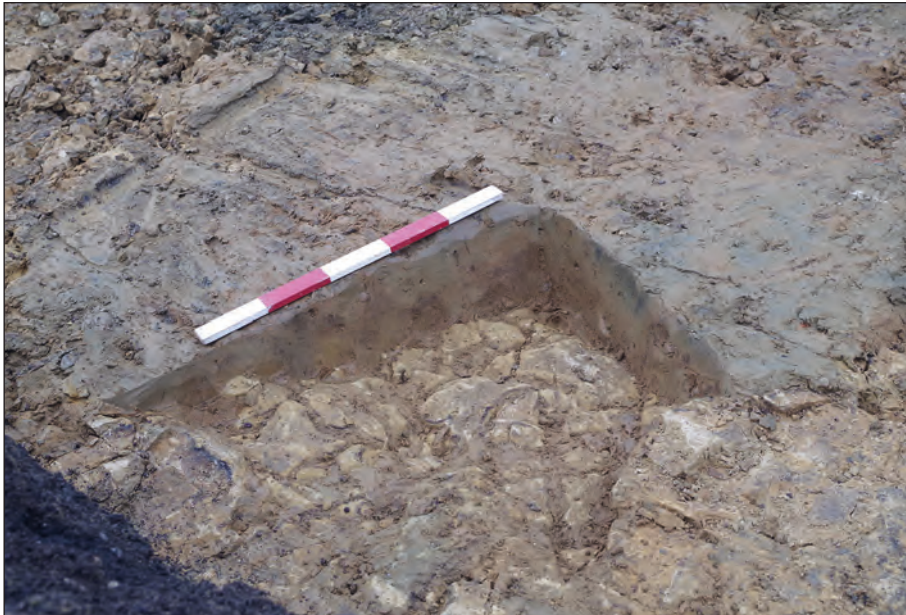
- 5.1.1 No archaeological features or deposits were found during the archaeological evaluation. Trench 4 contained one feature which on investigation was determined as natural geology (**Plate 6**).

5.5.2 A feature was uncovered at the eastern end of trench 4 (**Plate 6**), excavation of the feature confirmed it to be of natural origin, not of archaeological derivation.

Plate 6: South-east facing section of natural feature in Trench 4 (view from the south-east)

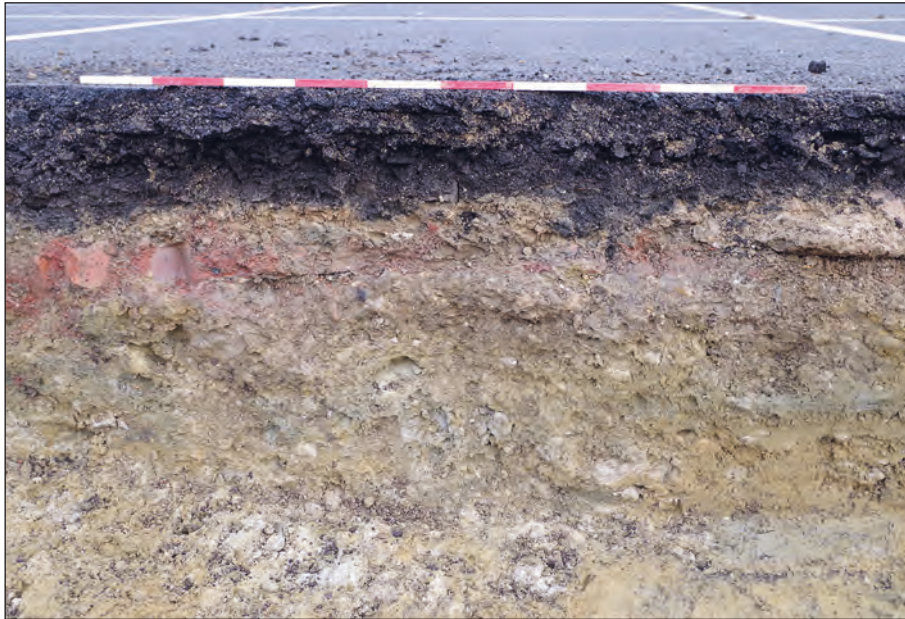
5.6.2 At the northern end a layer of concrete (503, 0.12-0.22m BGL) was revealed which had a bedding of blackish grey clay (504, 0.19-0.30m BGL). Beneath this was a layer of reddish-brown sandy silt made ground (505, 0.30-0.40m BGL) (**Plate 7**).

Plate 7: West facing representative section of Trench 5

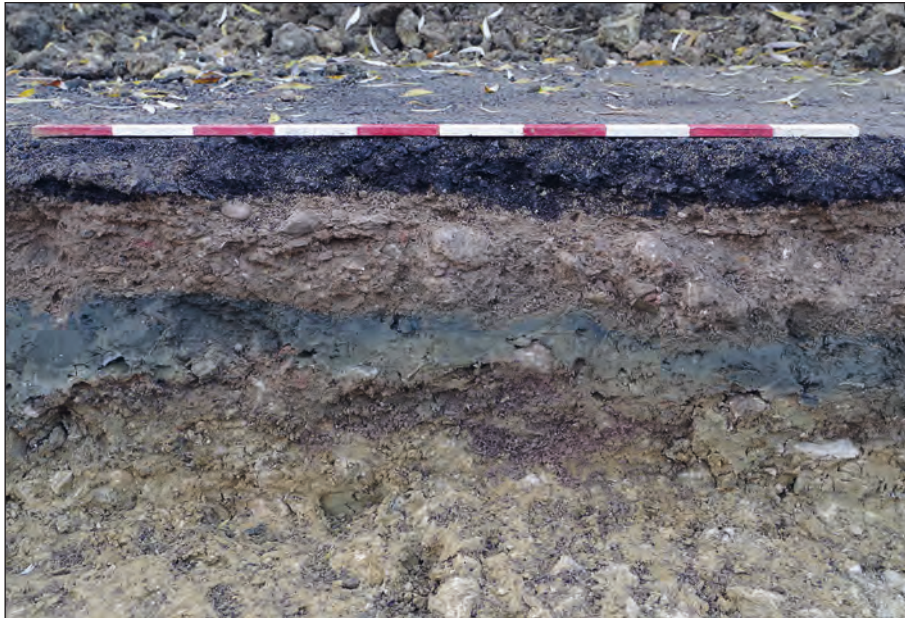
5.6.3 At the southern end of the trench beneath the tarmac and bedding was a layer of black coarse gravel loose tarmac fragments used as bedding material (507, 0.08-0.18m BGL), this overlain another layer of sand bedding (508, 0.15-0.22m BGL). Beneath this was a layer of demolition rubble (509, 0.19-0.37m BGL) comprising of concrete with stone and brick embedded. This overlain a greyish brown sandy clay made ground (510, 0.33-0.46m BGL) (**Plate 8**).

Plate 8: East facing representative section of Trench 5

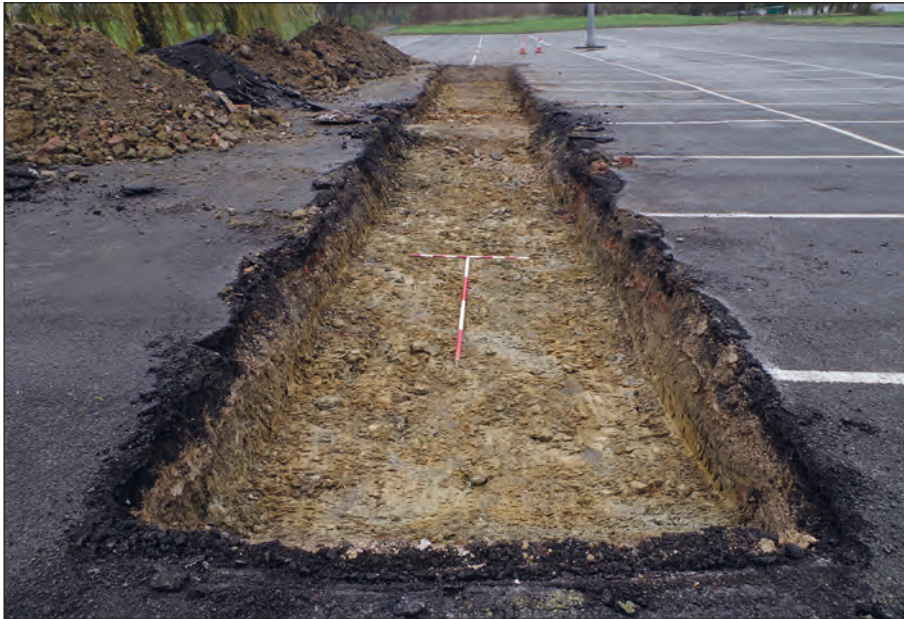
5.6.5 Located in approximately the middle of the trench was an east – west aligned concrete culvert (**Plate 9**). On its northern side redeposited natural that most likely part of the instalment of the culvert. From the northern end of the trench a north - south aligned French land drain (filled with stone pebbles) enters the trench and is cut by the culvert. The drain appears on the southern side of the culvert and turns eastwards.

Plate 9: Trench 5 (view from the south)

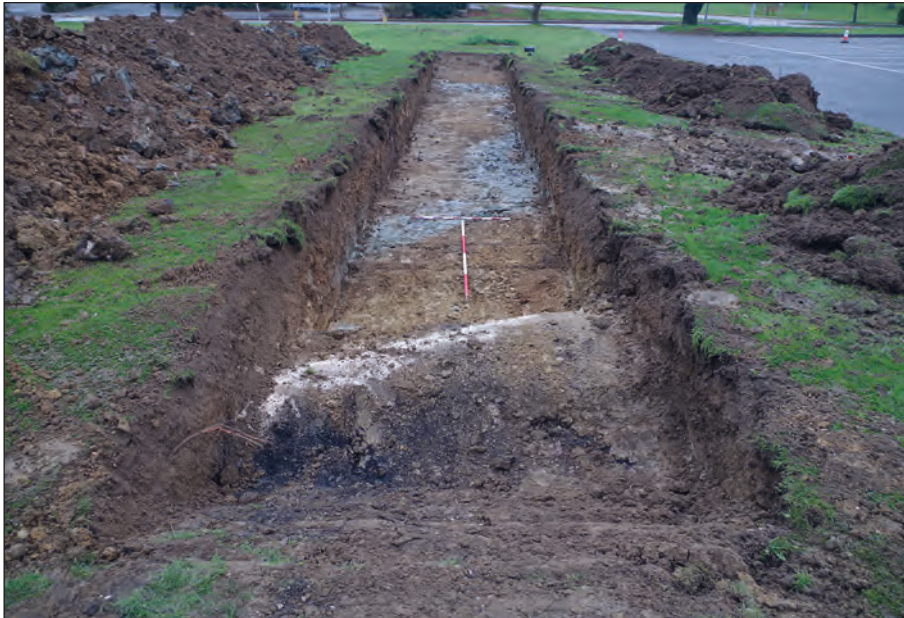
- 5.7.1 Trench 6 was dug in an area of manicured grass towards the south east corner of site. The stratigraphy comprised of a greyish brown silty clay loam topsoil (601, 0-0.25m BGL), followed by a made ground consisting of redeposited natural and demolition rubble (602, 0.25-0.40m BGL). This overlain a buried soil (603, 0.40-0.65m BGL), possibly the original ground before the previous buildings were demolished and the ground was built up, this comprised of greyish brown silty clay loam (**Plate 10**)
- 5.7.2 The natural within this trench varied from a greyish brown clay (504 0.65m+ BGL) to a blueish grey clay (605, 0.75m+ BGL), and contained sub-angular mudstone fragments.

Plate 10: Trench 6 (view from the south)
