# Queen Elizabeth Class Capital Dredge Project Her Majesty's Naval Base, Portsmouth

Archaeological Assessment Report

Ref: 111320.05  
January 2018

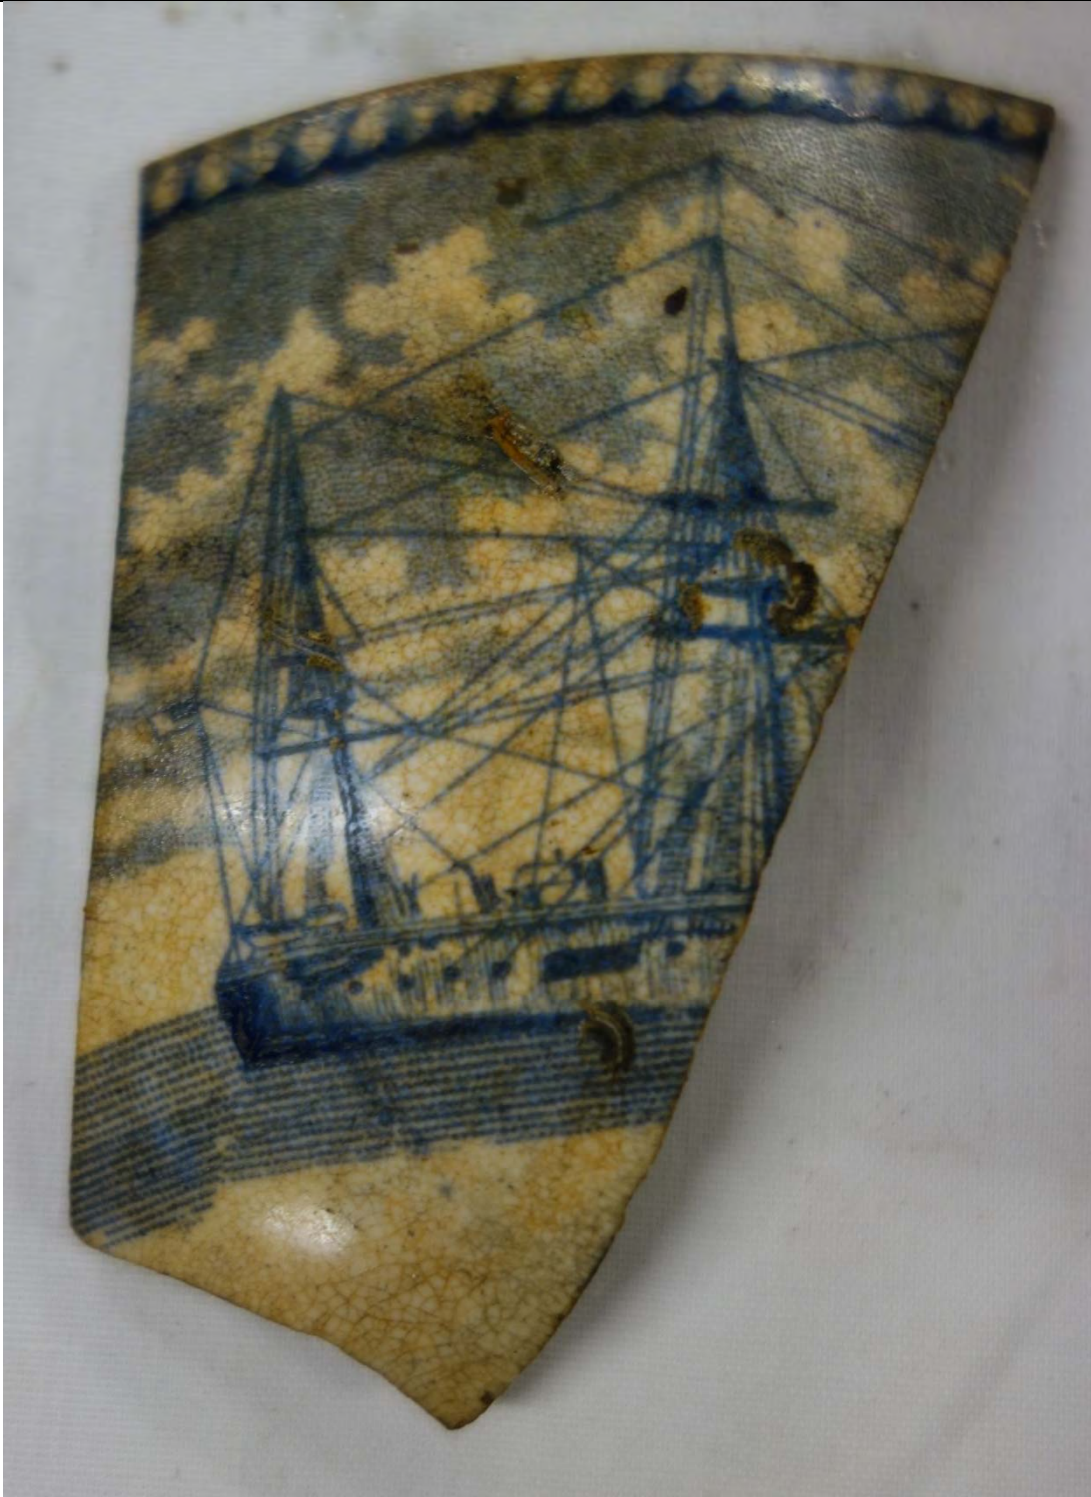
Detail from BWL1\_0014

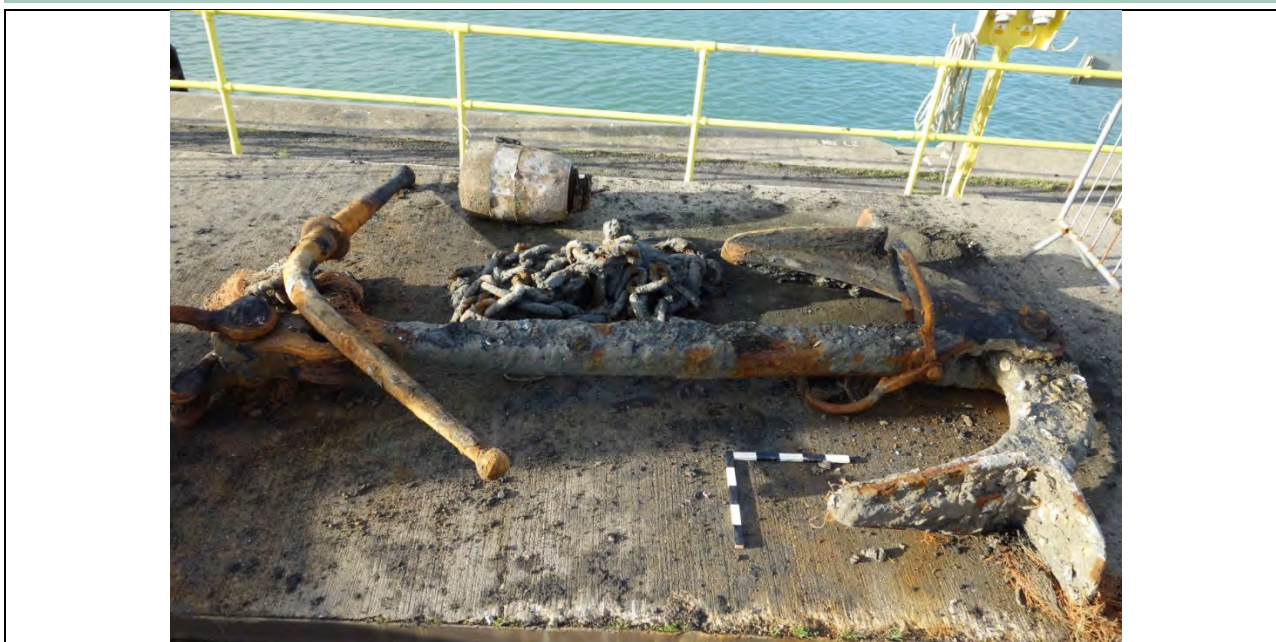
An exemplar of Trotman's anchor (circa 1860), improved from Porter's design.

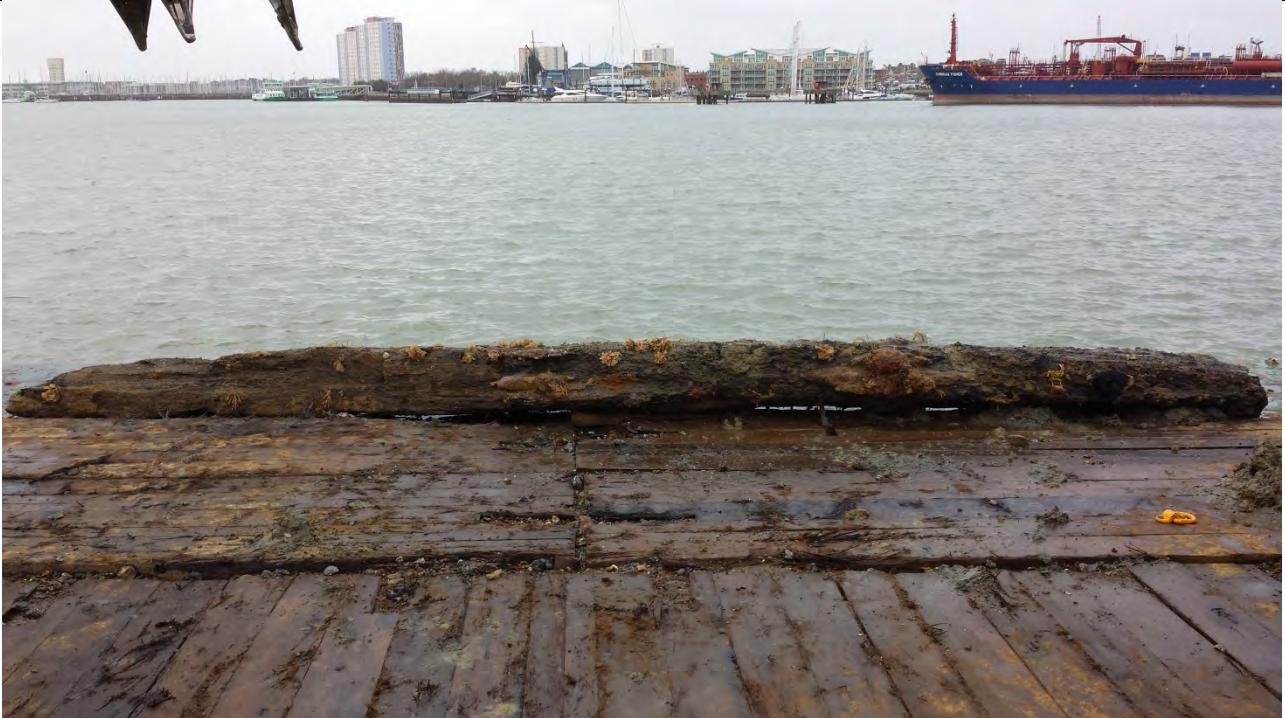
BWL1\_0019 on board *Strekker* after recovery

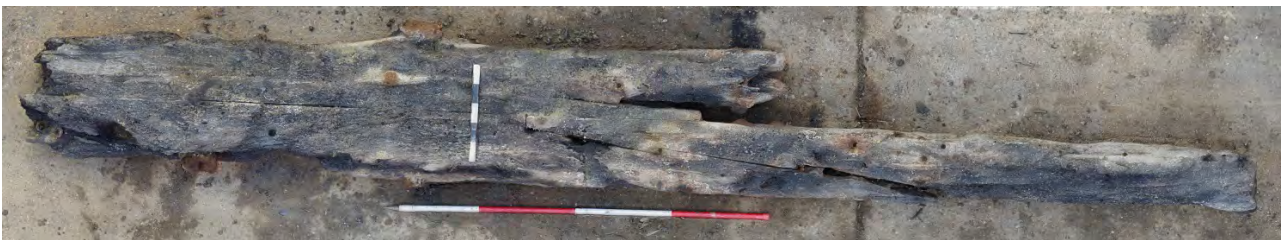
Face view (2D image of photogrammetry model)

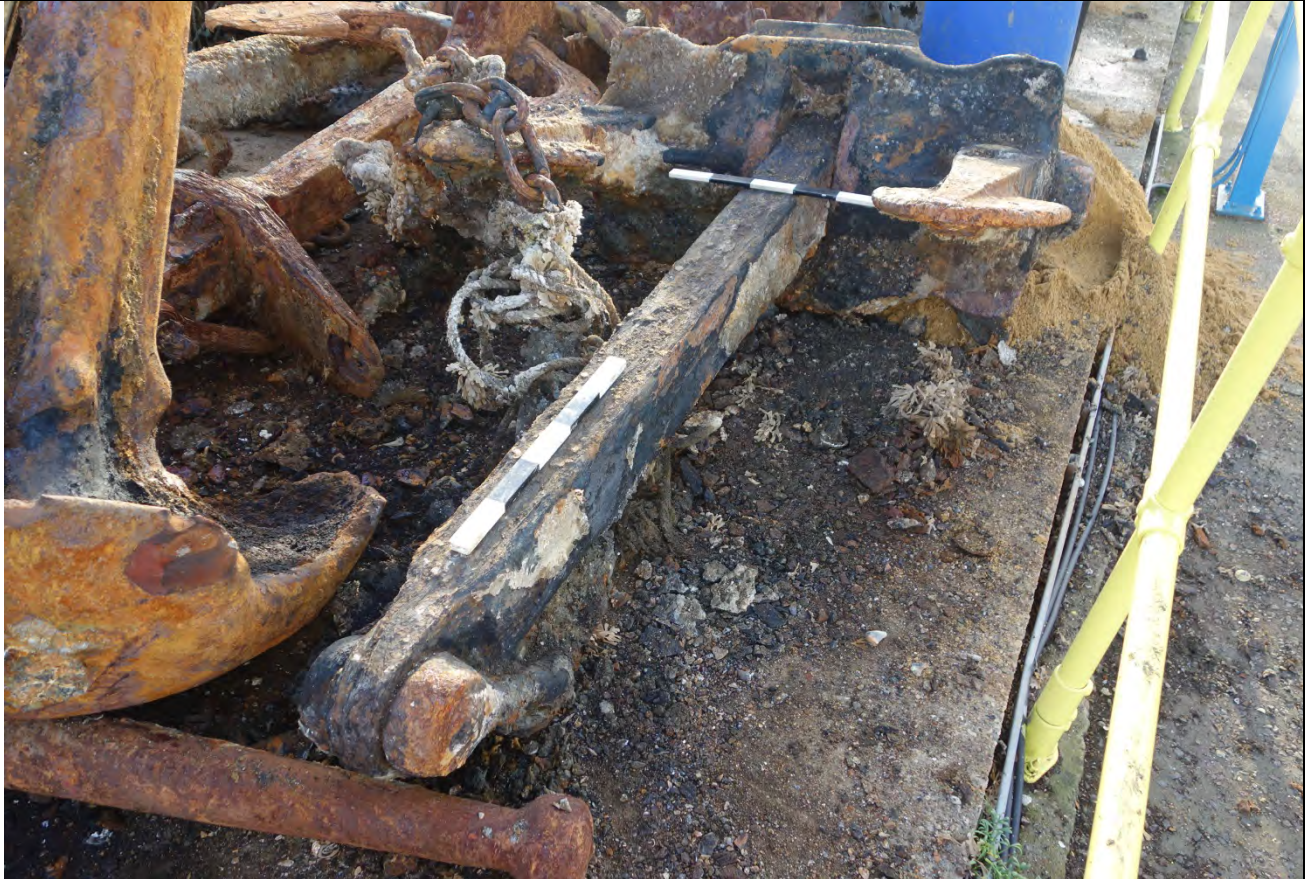
View looking along shank towards crown (0.5m scales)

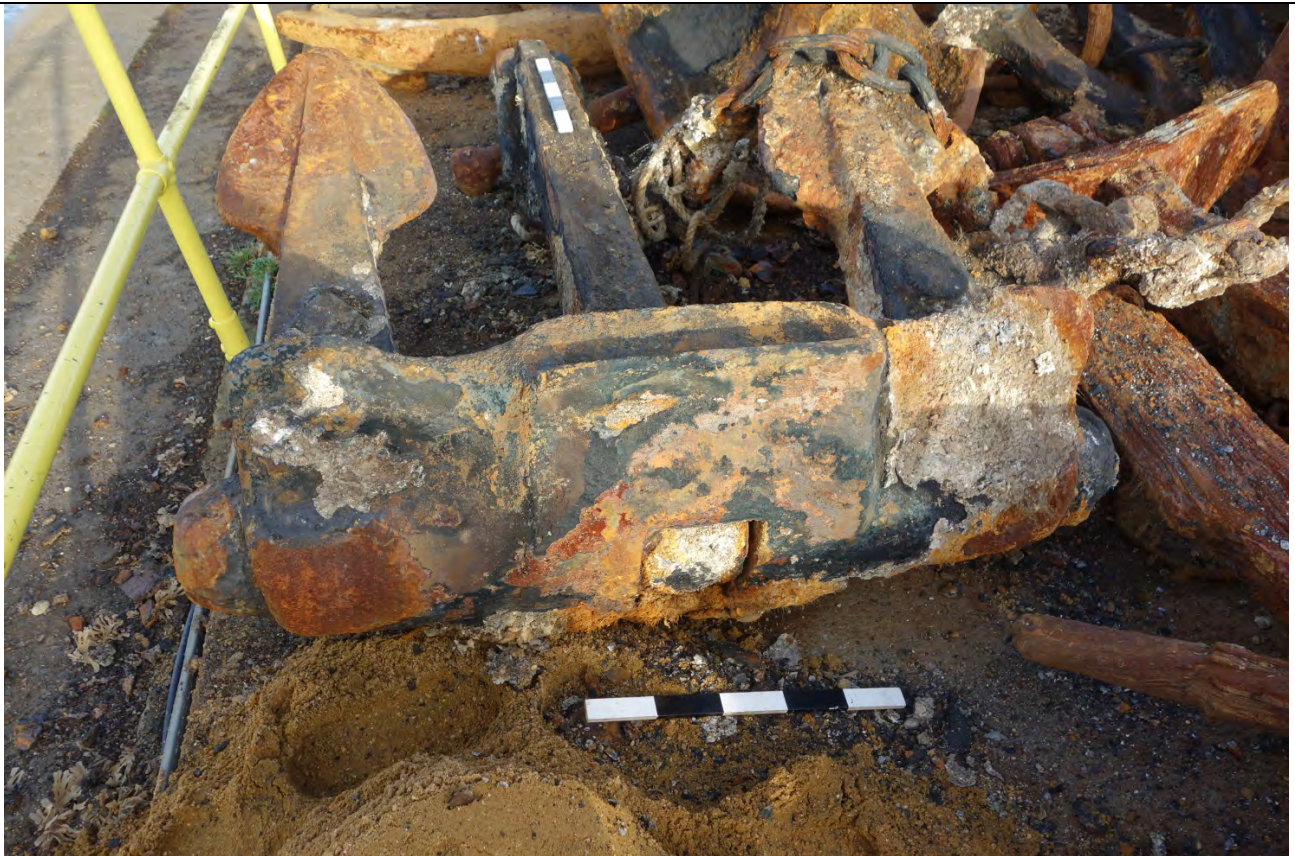
Crown and blades of anchor with retaining pins and head of shank

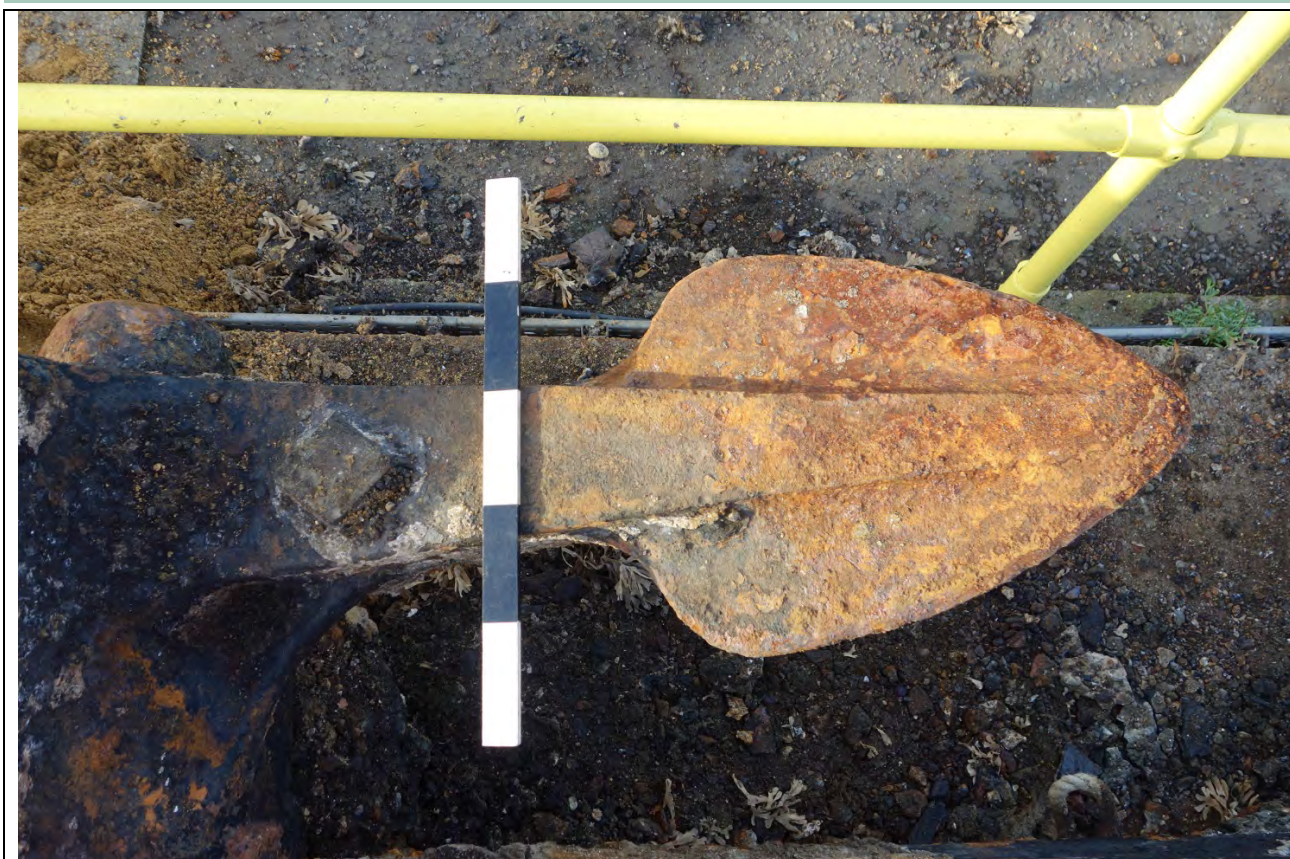
Left arm and palm/fluke with diamond boss

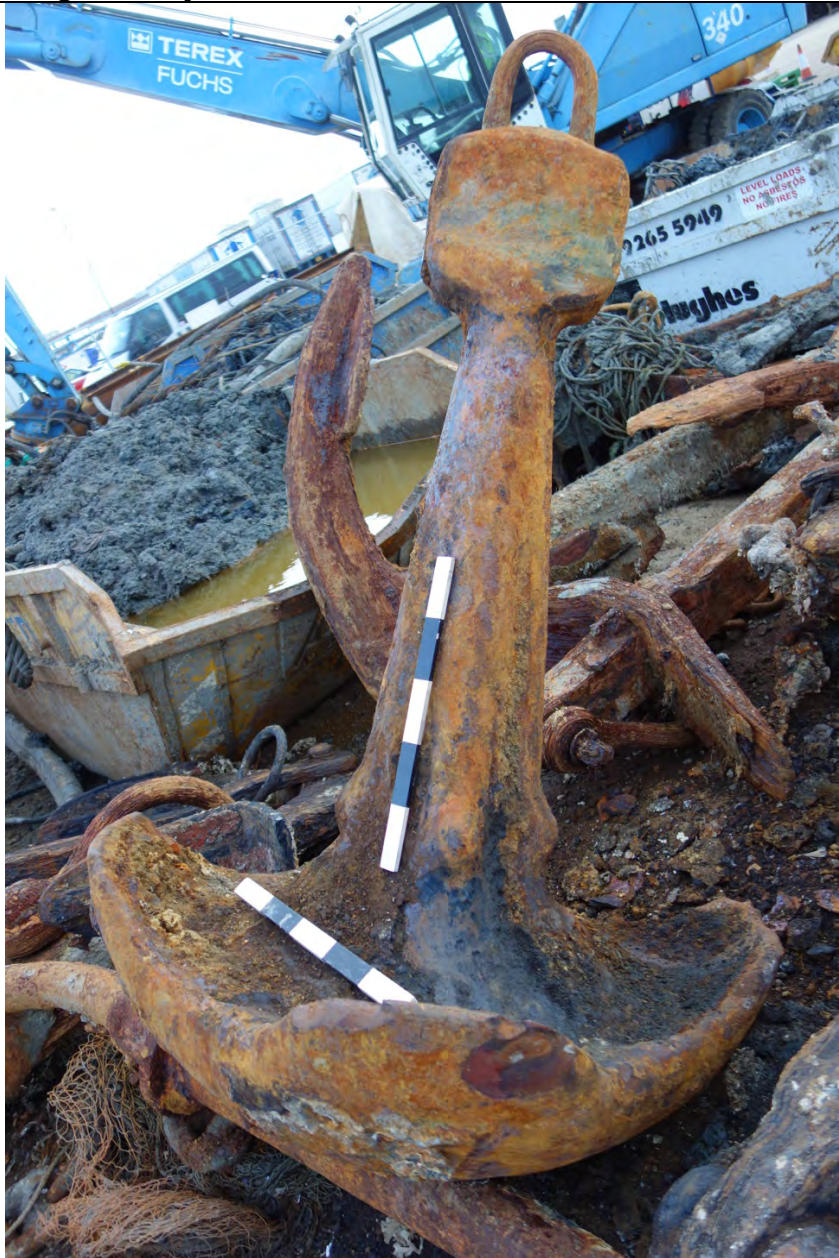
Side profile

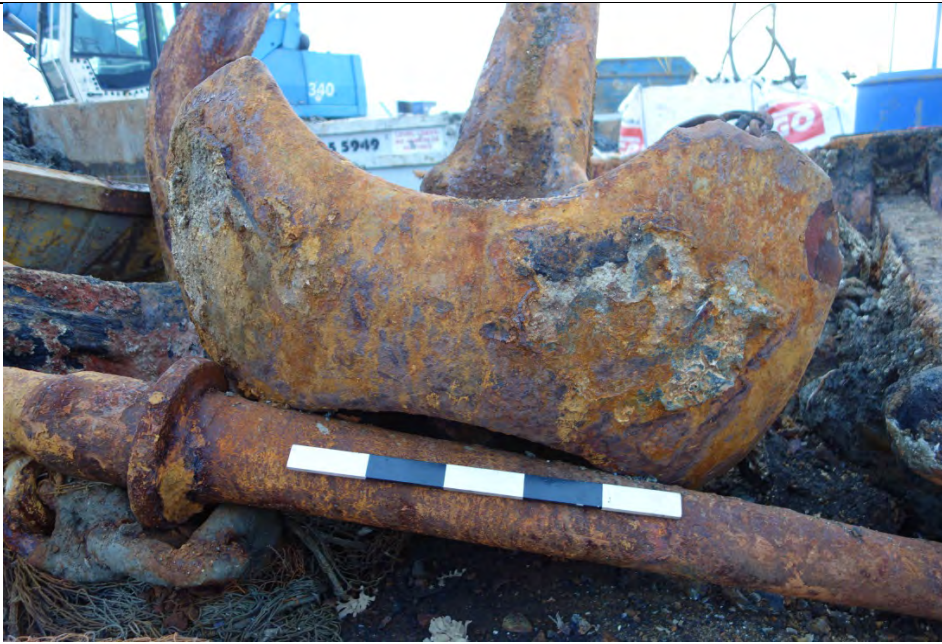
Detail of base/crown, showing concavity in the crown (stock is from another anchor)

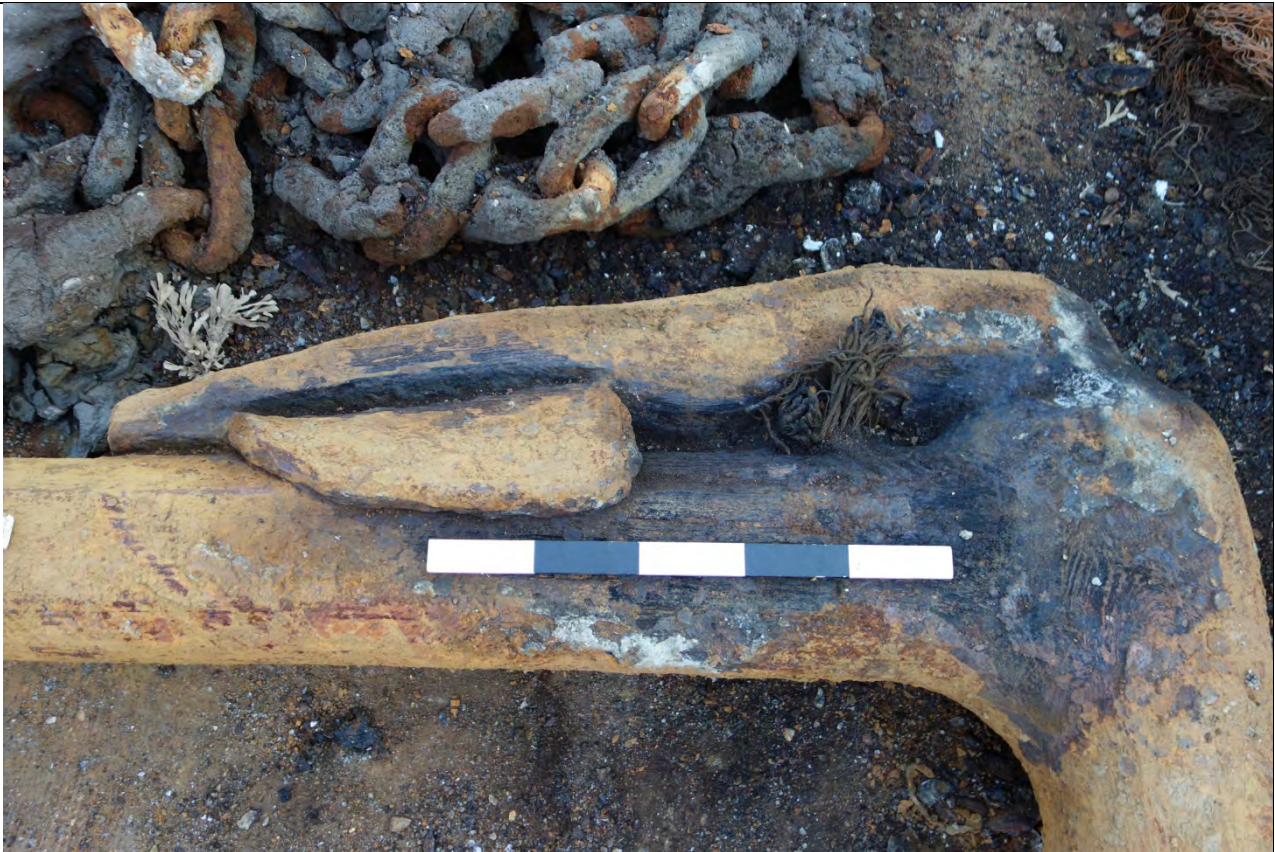
Reforged arm bent onto shank during conversion to a mooring anchor

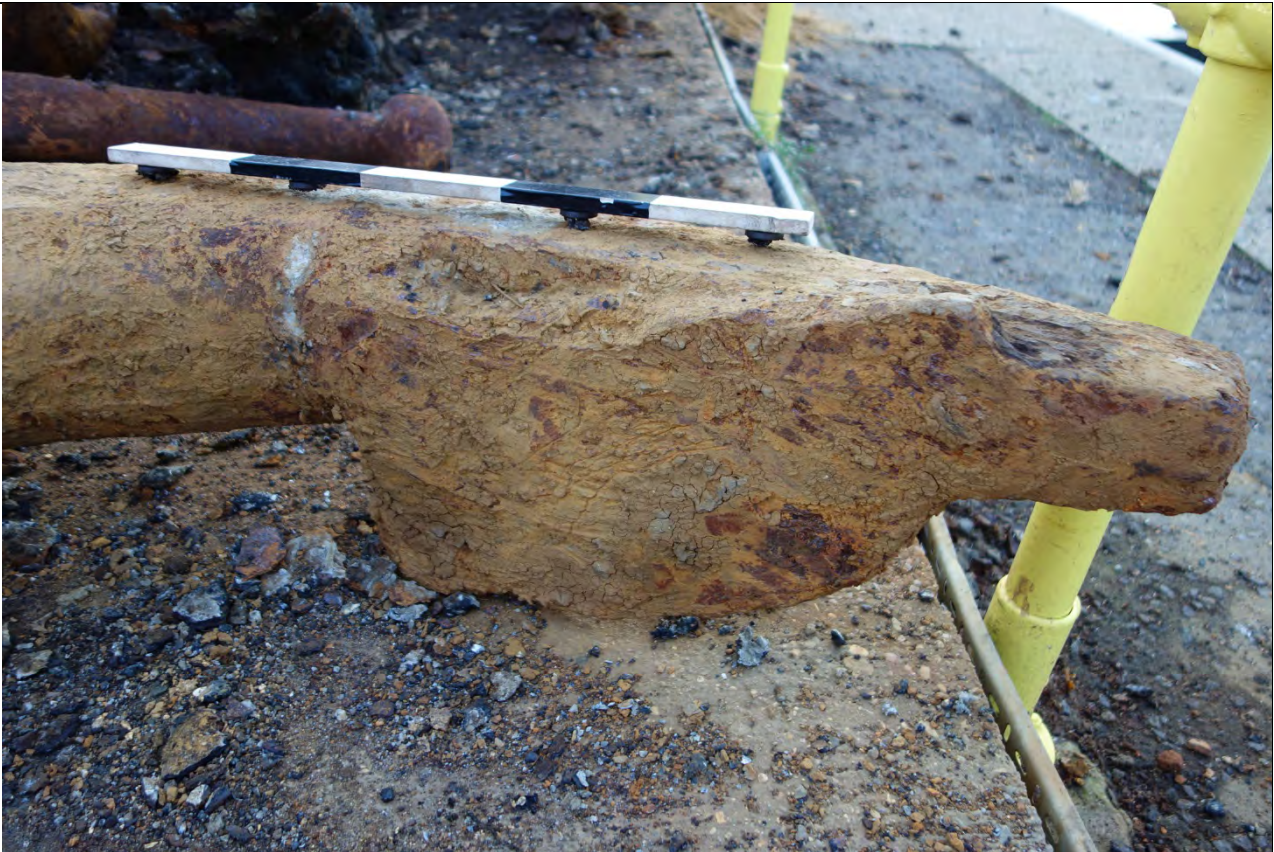
Broken palm/fluke

(See also separate 3D pdf model attached)

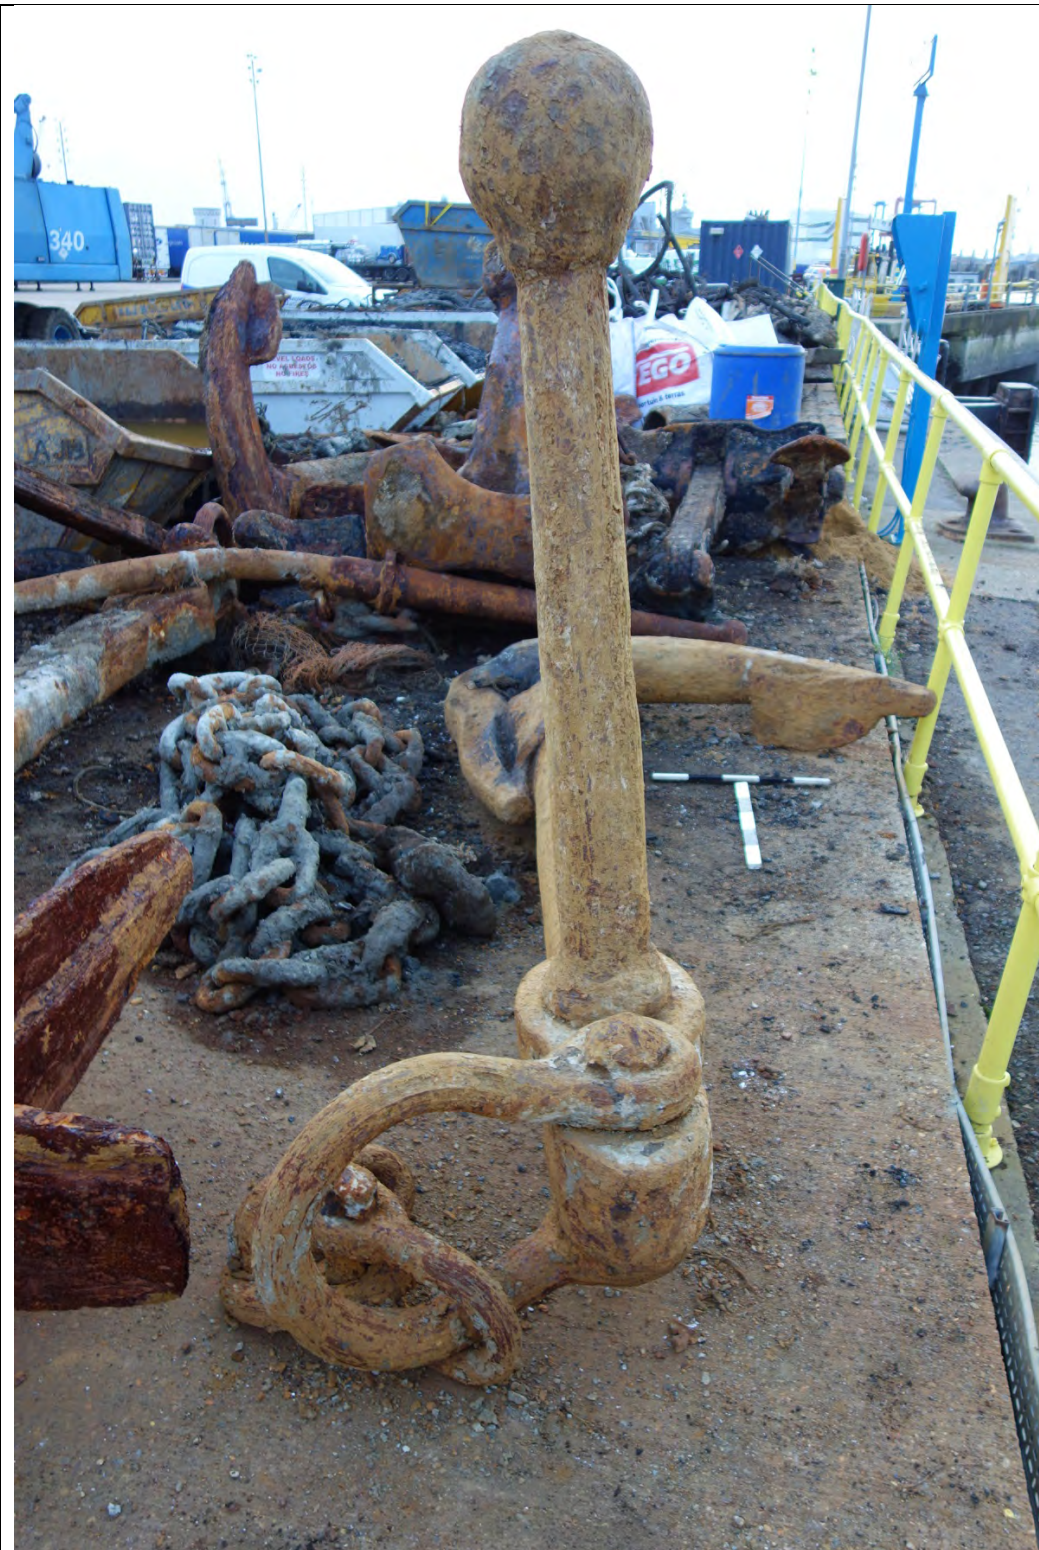
Anchor shackles and iron stock

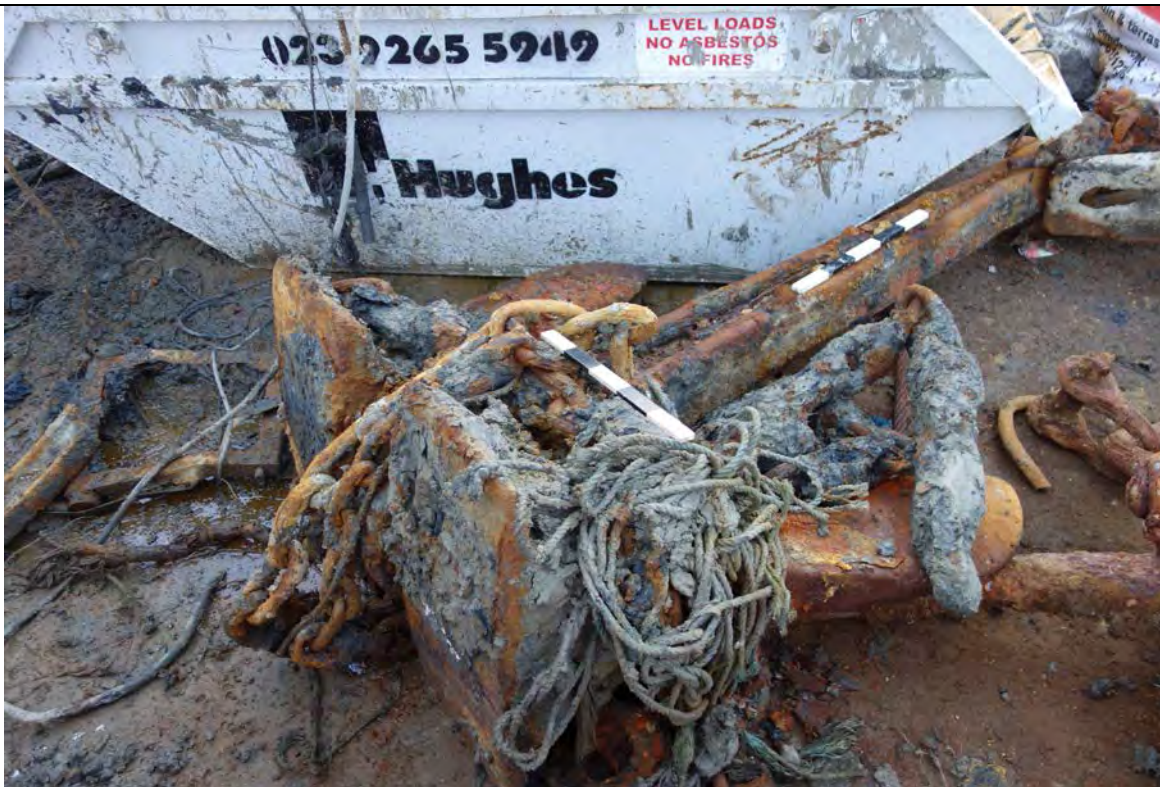
Side view showing the tripping palms and double plate girder shank

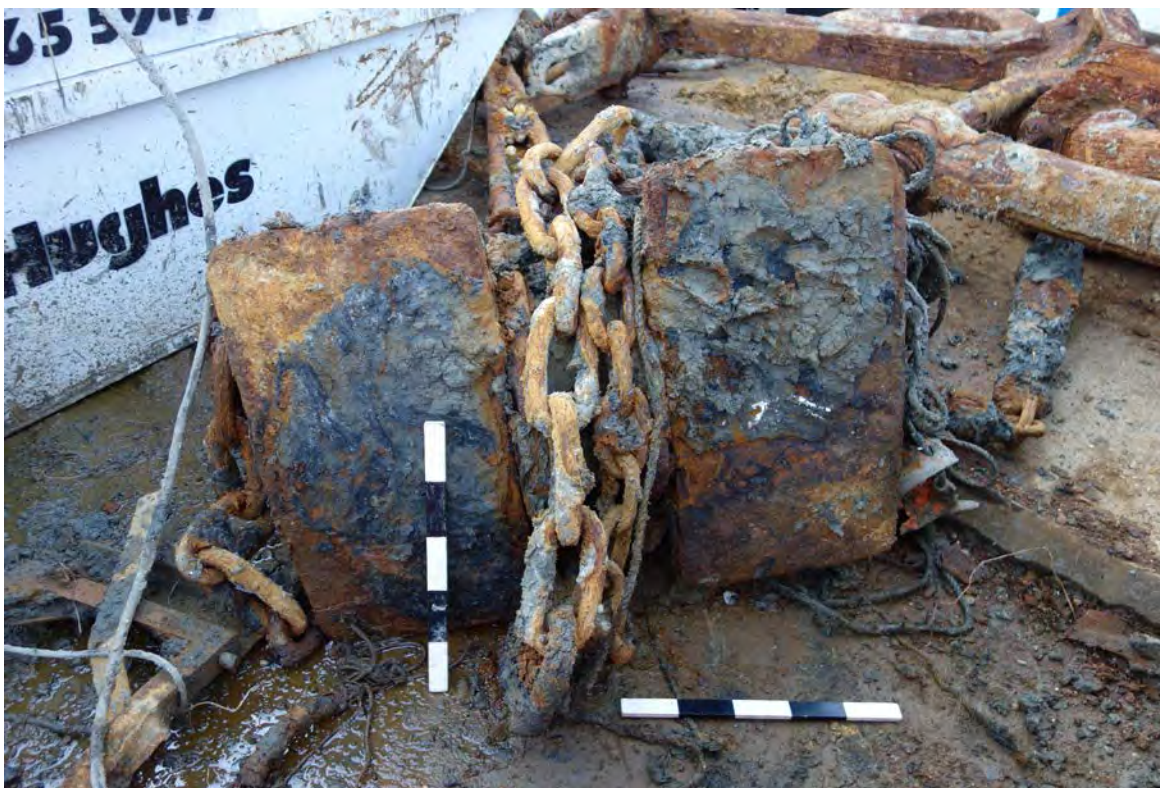
Tripping palms. The crown and head of the shank are obscured by the chain.

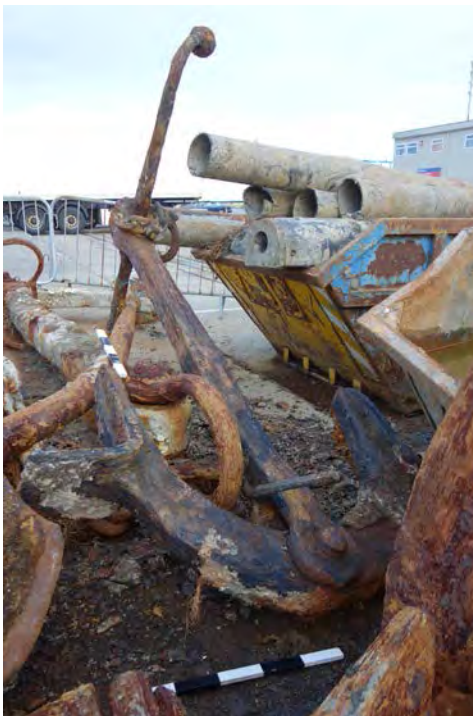
Anchor post-recovery, note chain is wrapped around the base of the stock

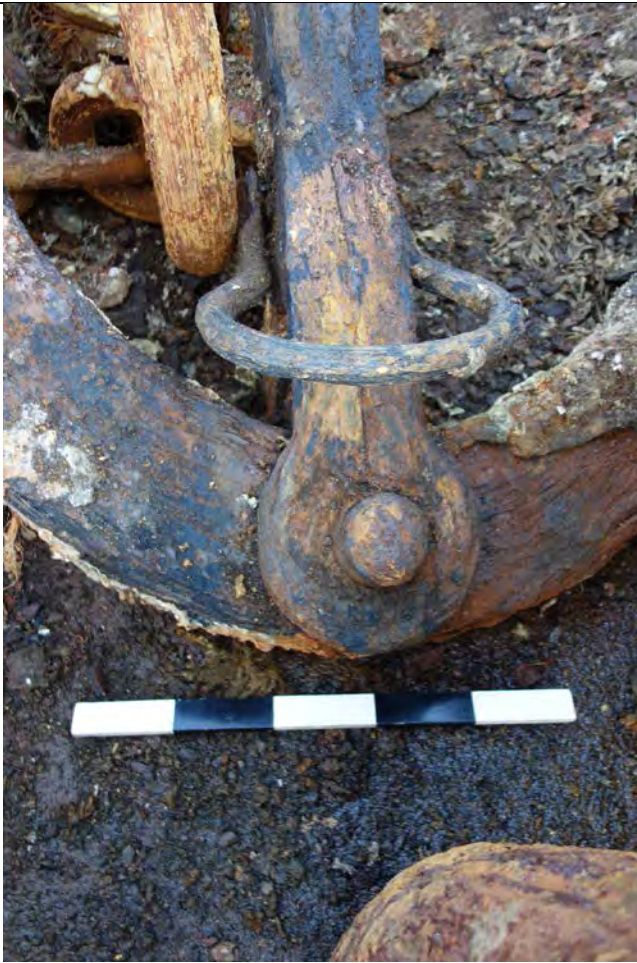
Detail of crown and balancing band

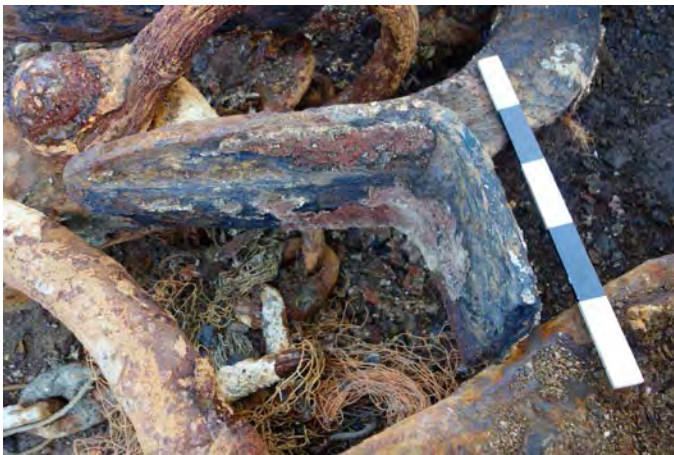
Detail of palm/fluke

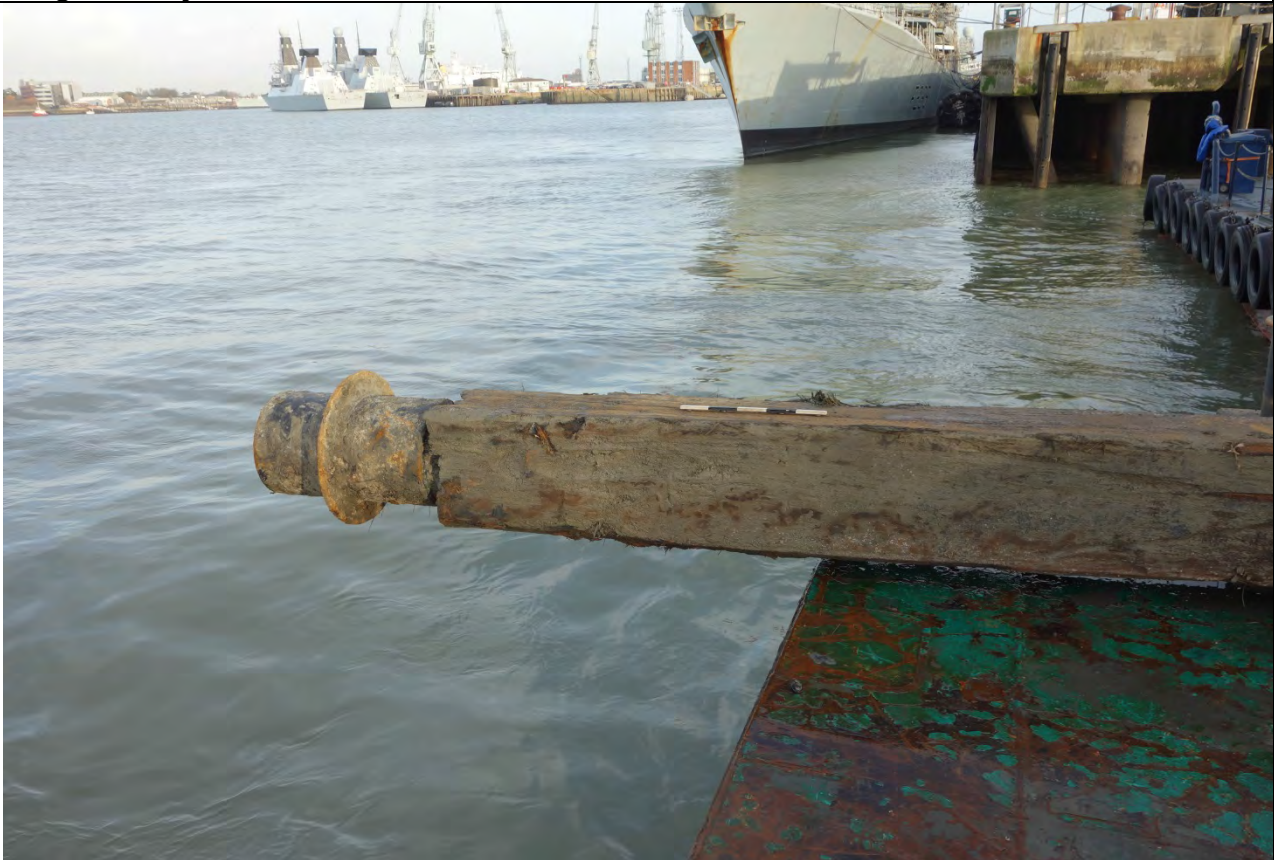
Head of pile with cylindrical flanged steel fitting

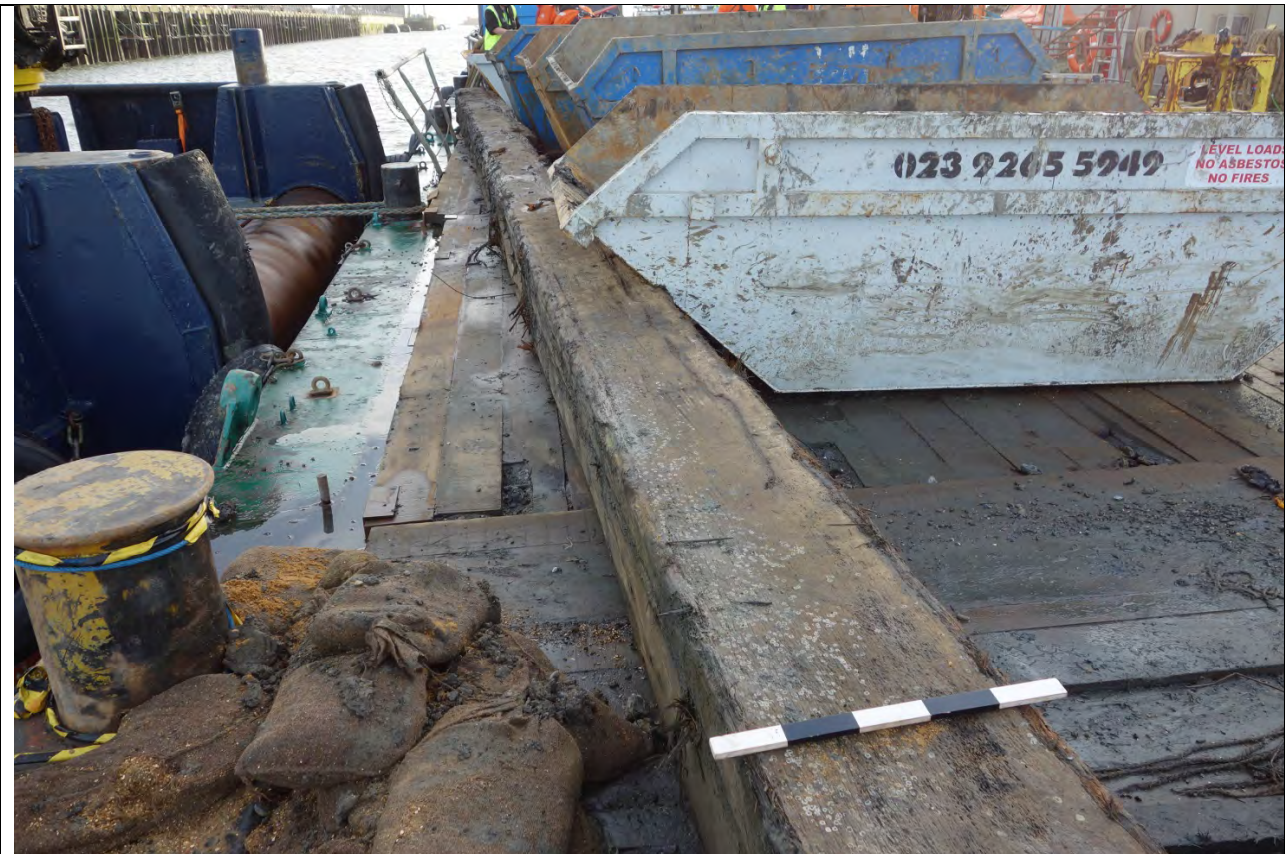
Looking along pile towards heel

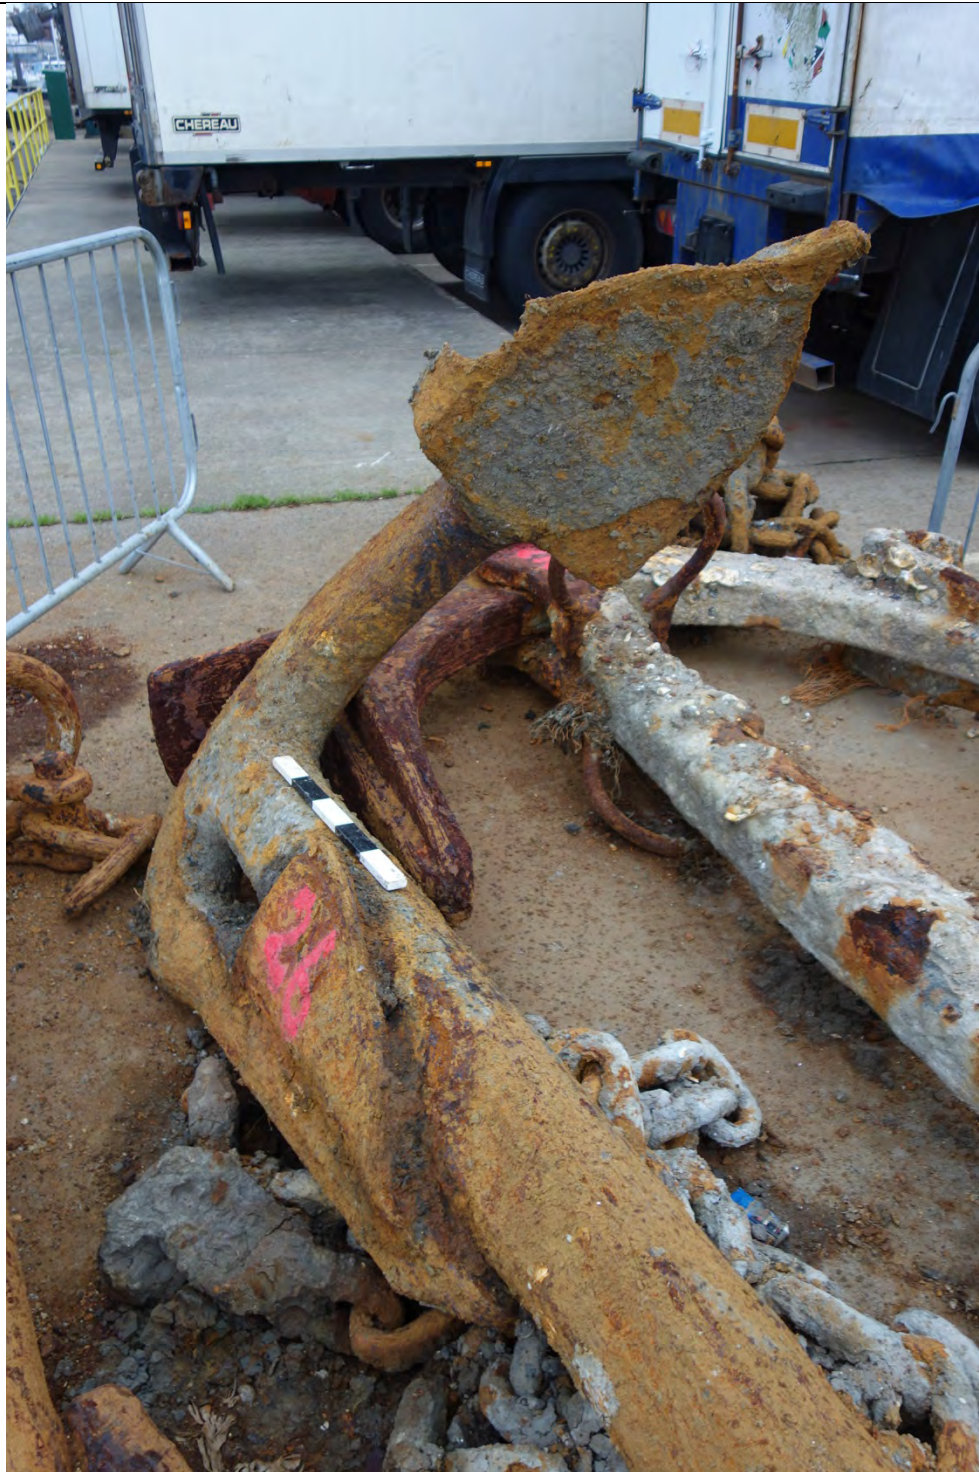
Head of the anchor, showing reformed arm and damaged palm

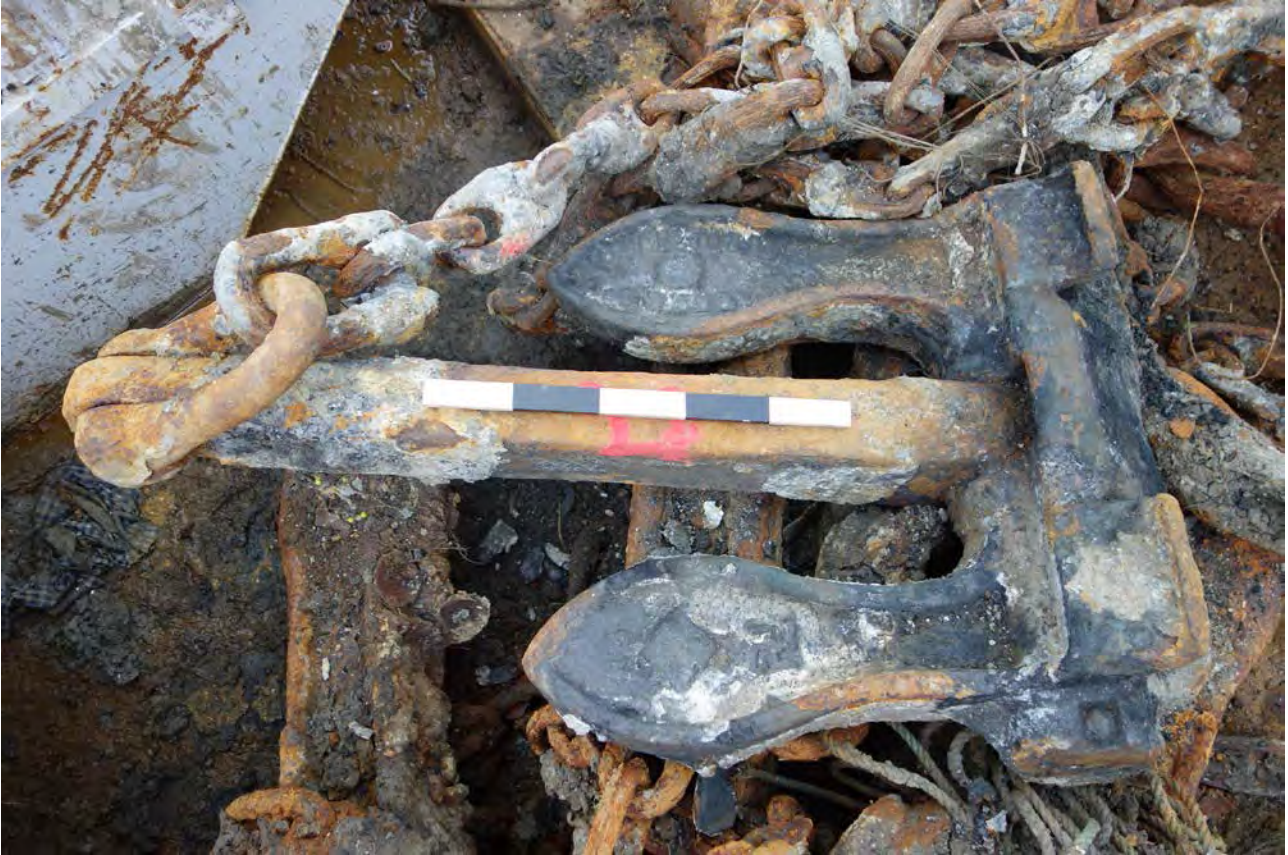
BWL1\_0027 on quayside following recovery; some concretion removed

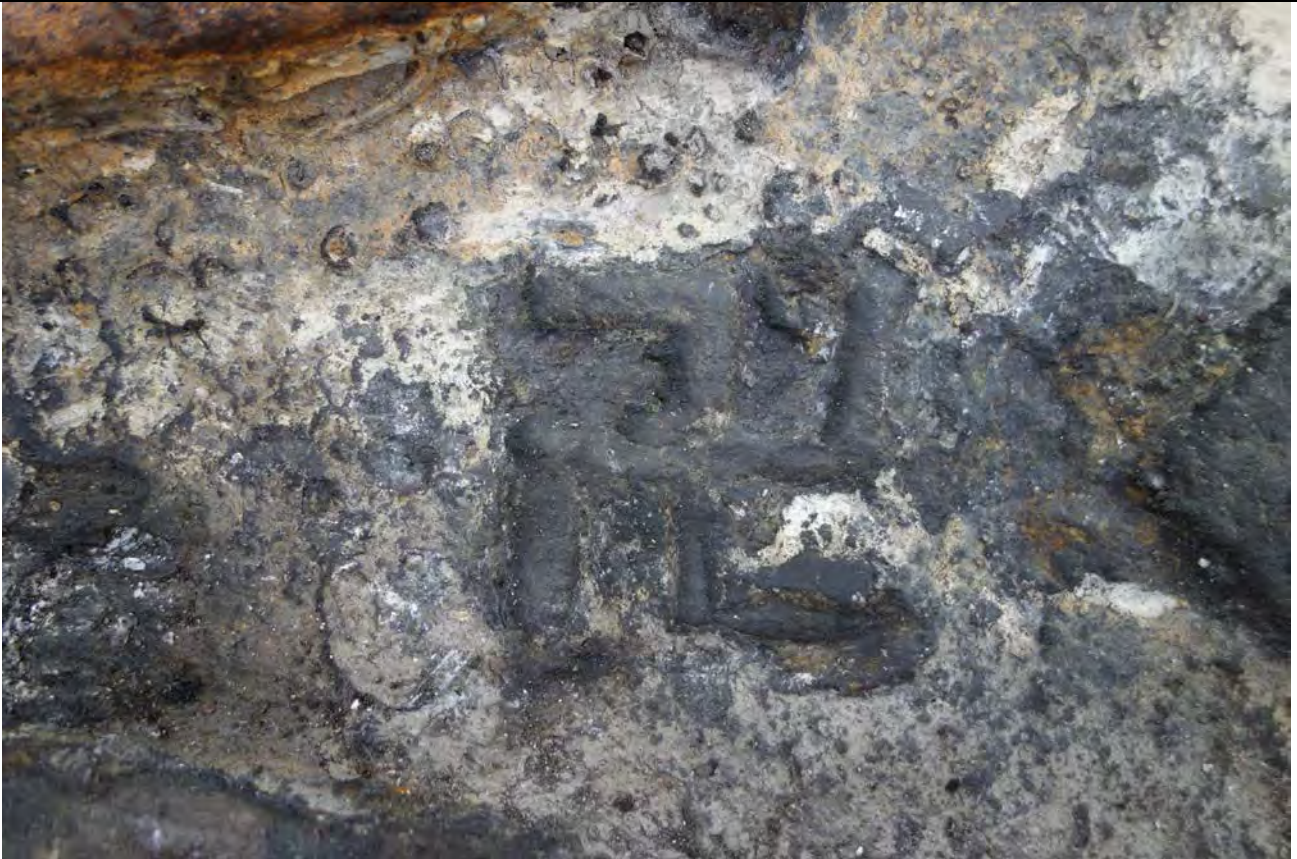
Left-handed swastika on the left fluke

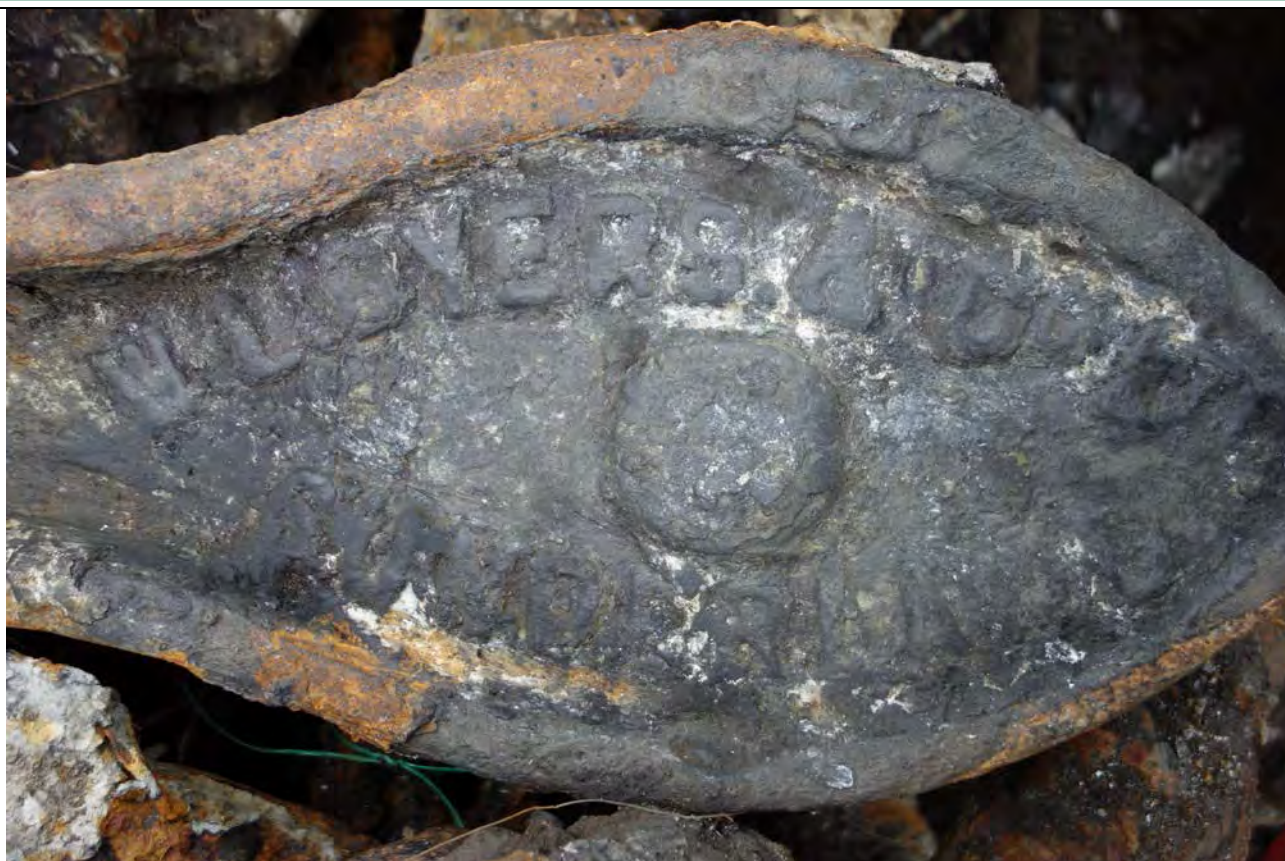
Makers name and circular boss on the right fluke
