# Queen Elizabeth Class Capital Dredge Project Her Majesty's Naval Base, Portsmouth

Archaeological Assessment Report

Ref: 111320.05  
January 2018

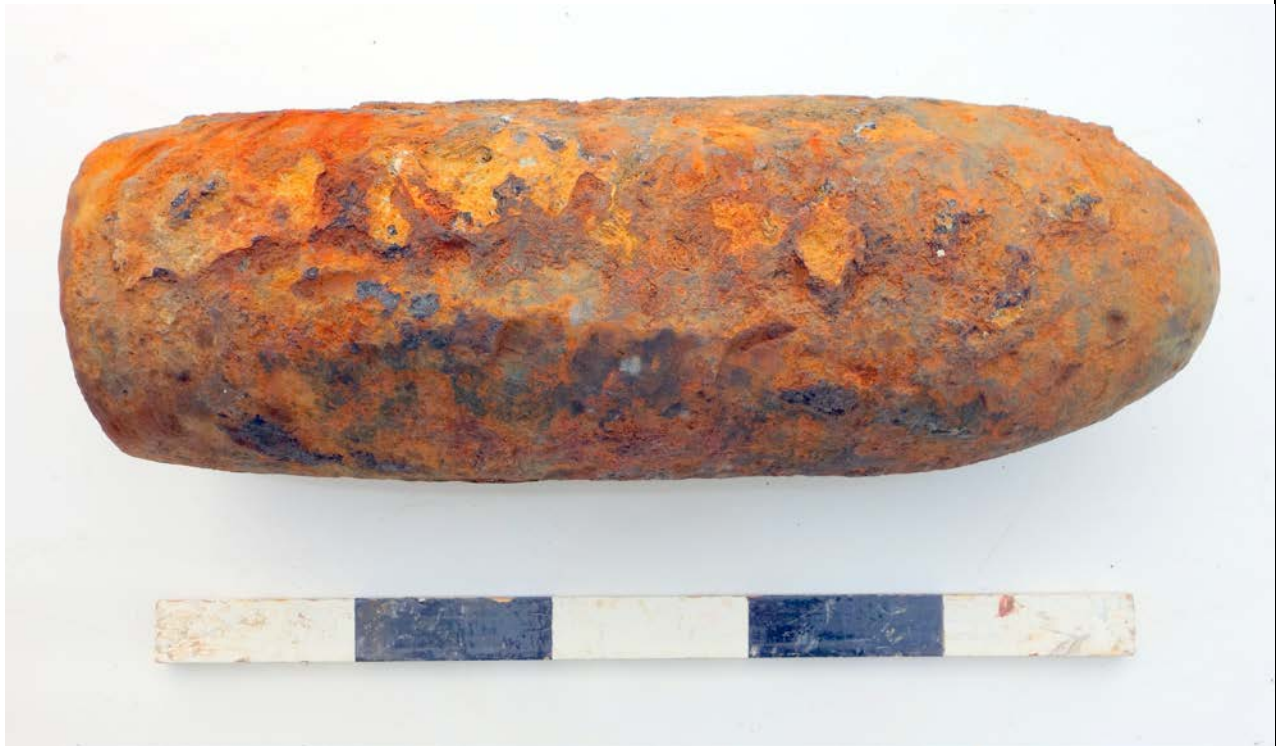
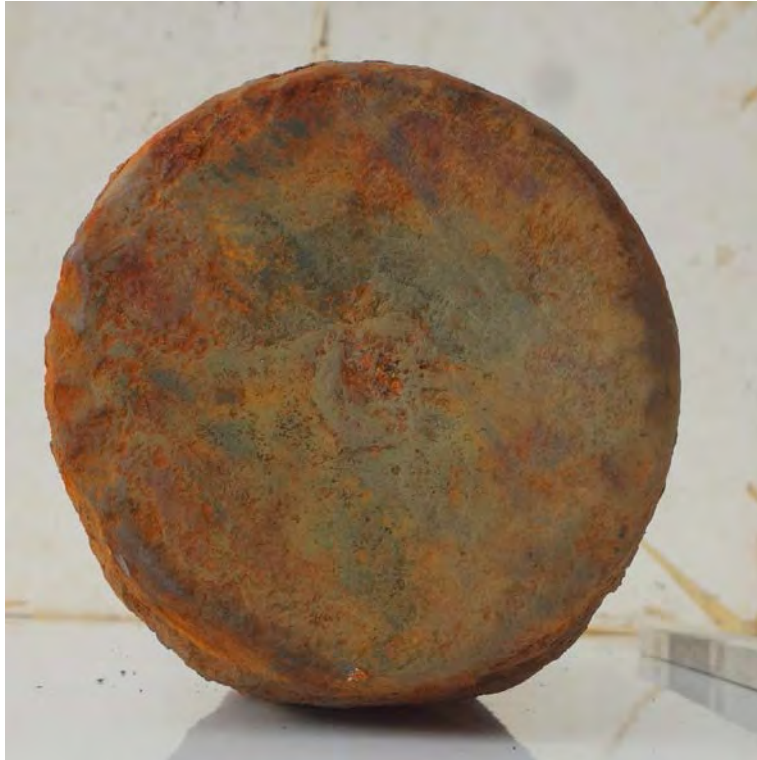
Metal solid shot with six flat sides in a spiral arrangement and hexagonal cross section with rounded corners. Calibre is 145mm and the shot is 500mm long. The original surfaces suffered from corrosion and it is uncertain whether the shot was fired or unspent when it reached the seabed. The calibre is close to a 70-pounder gun.

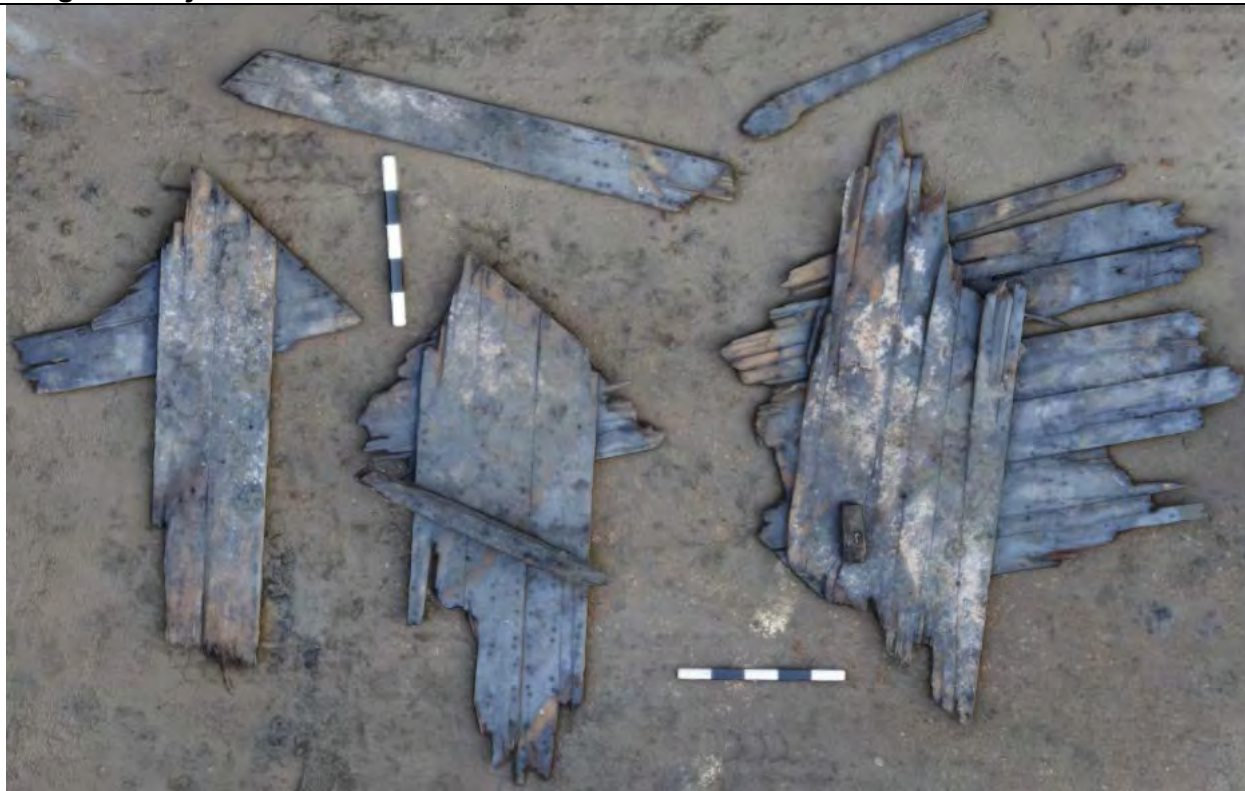
BWL1\_0029 on quayside following recovery

Fragmented wooden planks with nails with washer and clenched nail, all of cuprous materials. The planks were related to the same structure as suggested by similarities in the condition, general dimensions and typology and arrangement of fasteners. All the planks seem to be of the same wood specie and have similar thickness (c. 12mm) and width (c. 180mm). The most complete plank is c. 1.4m long and the planks end with an angle of c. 45 degrees along the width.

The nails found on the planks are of different dimensions (15mm to c. 140mm) and different heads but all have squared section. They are disposed in an alternated pattern with some variations.

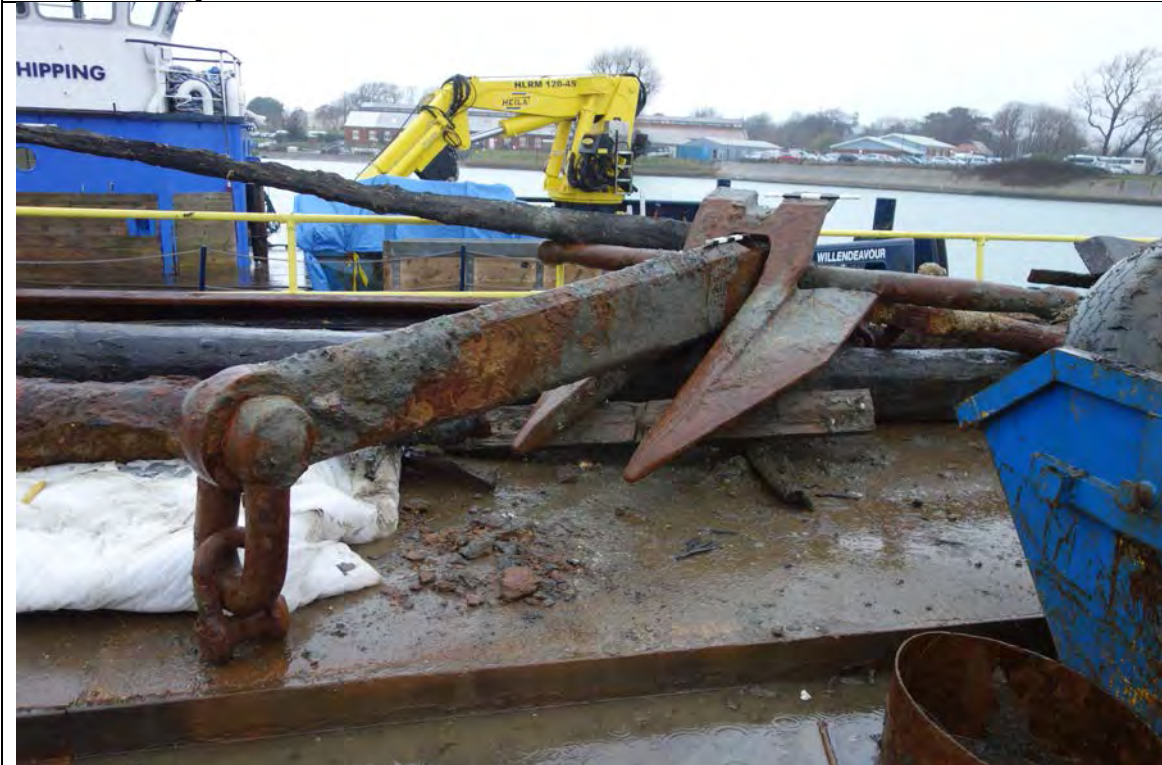
This is a Dantforth Anchor, which was patented in the 1940s and was approved as a High Holding Power anchor by Lloyd's register of Shipping in 1964. According to the Admiralty Manual of Seamanship issued in 1995 (2-10) it was fitted in some older minor war vessels. A D-ring shackle but no chain was attached to this anchor when it was recovered. The weight of the anchor is estimated as approximately 3 ton.

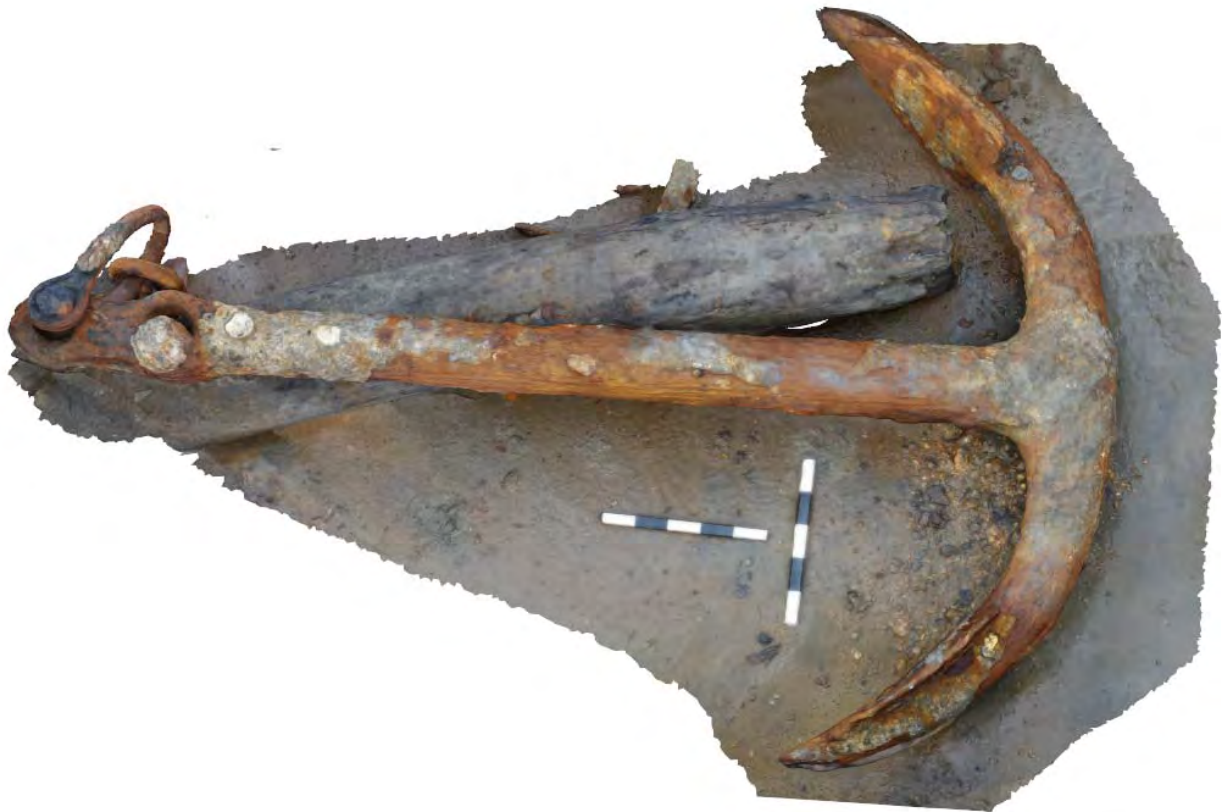
BWL1\_0031 on quayside

Side view showing the shackles and the broken iron stock

The overall length of the anchor is 3.18 m and the shank is 2.84 m long with a rectangular section with rounded sides. The section of the shank has a diameter of 0.20 m at the crown tapering to 0.17 m at the ring. At the ring the shank tapers into a square section with sides of 0.17 m. The distance between the bills is 2.19 m; the maximum dimensions of the palms are 0.51 m wide and 0.57 m not including the bill. The iron stock is broken and only a partial arm with ball is present. The remaining part of the arm measures 0.52 m in length and 0.125 m in diameter and the pinned ball diameter is c. 0.15 m. Two large shackles are attached to the anchor connecting a un-studded and the studded chain with rings 0.3 m long and 0.50 mm thick. The weight of the anchor estimated from the length of the shank is around 546 kg, which is almost 11 cwt.

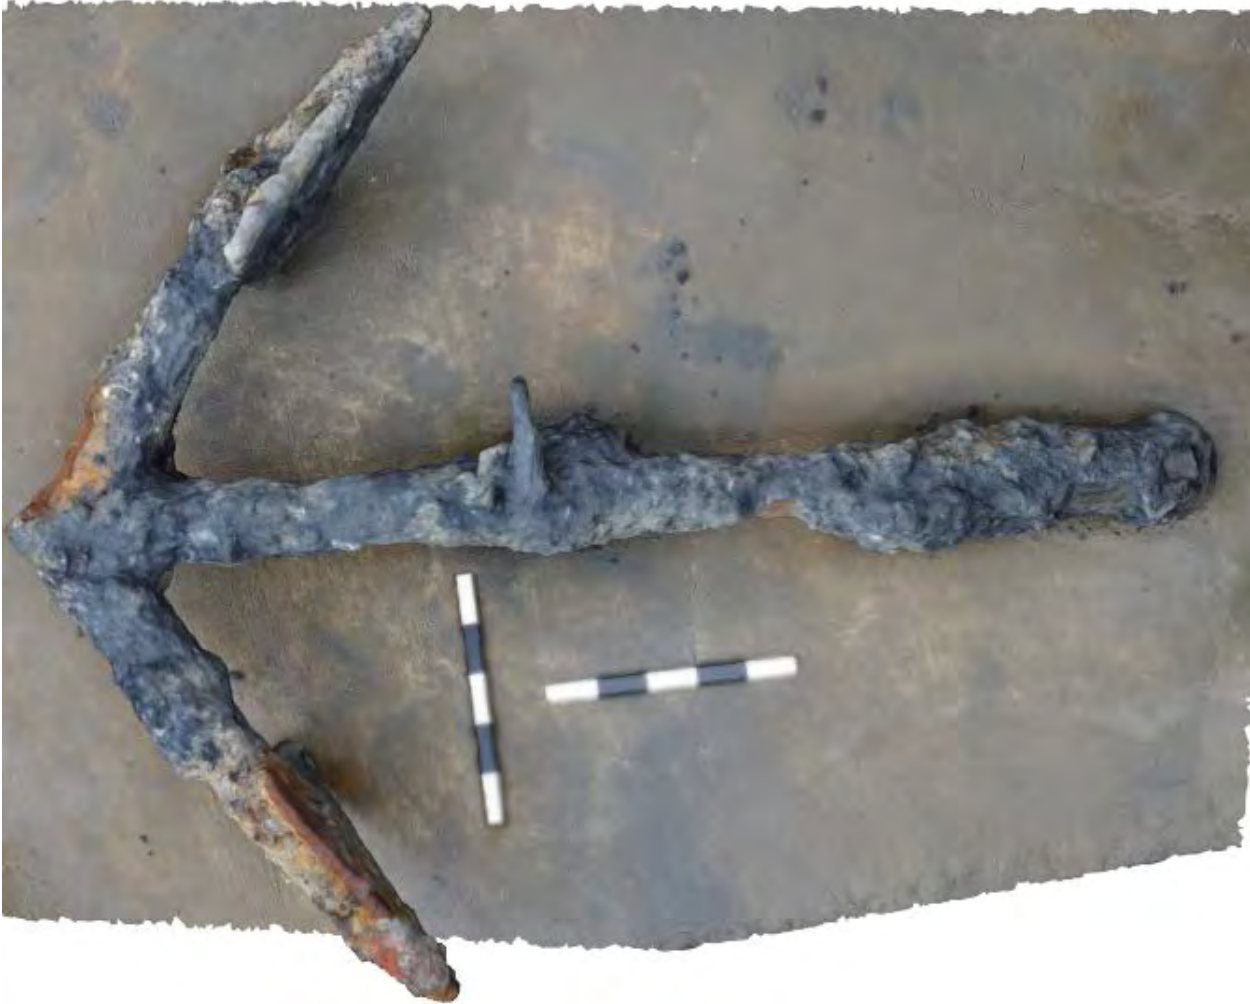
BWL1\_0032

Detail of broken shank and flukes shape.

Admiralty long shank anchor possibly of wrought iron. The shank 2.27 m long with rounded section tapering away from the crown from 0.15 m to 0.75 m in diameter. The stock end of the shank is broken and reveals a rounded shank underneath the thick layer of concretion. The arms are covered by concretions but appear to be straight or very slightly rounded. The arms are 1.2 m long and come to a point at the crown and the flukes have large prominent palms. The palms are triangular (0.46 m long and 0.47 width) and 0.25 m thick and present pronounced bill (0.09 m long). The bill to bill measurement is 1.82 m. A small piece of wood protrudes the concretion in the middle of shank.

As the damaged area is covered by concretion it is very likely that the damage is not recent and could have occurred during the weighting of the anchor. This seemed to be a frequent problem for this type of anchor that was obviated in the beginning of the 19<sup>th</sup> century by the introduction of the curved arm<sup>1</sup>.

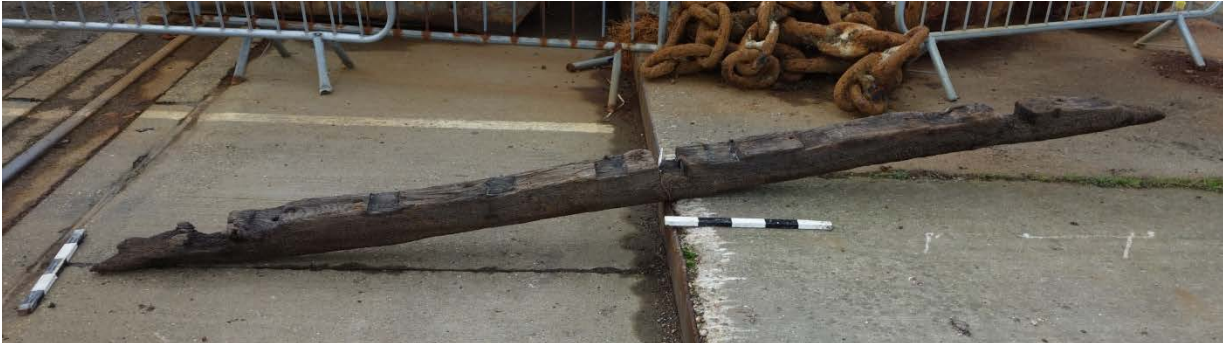
Figure 1 BWL1-0034 on the quayside after recovery

The timber was fastened with 18 through treenails, of which two are missing and only the holes are visible and the remaining 16 still retain the treenails *in situ*. The diameter of the treenails holes is on average 26 mm. Some of the treenails are wedged and all the holes were augured in a single direction, perpendicular to the run of the grain of the timber. The wood used for the treenails is different from the one used for the timber and has a more red colour. The pattern of the fastening is not clear but seems to correspond to a double fastening in the spaces between the recesses with some exceptions.

The ARIS image shows that this timber was stray and not associated with other material on the seabed. It is possible that it was lost at sea in an accident that may or may not have caused a vessel to sink and then floated to its current position, or it could have redeposited from a nearby wreck by the action of tide and currents.

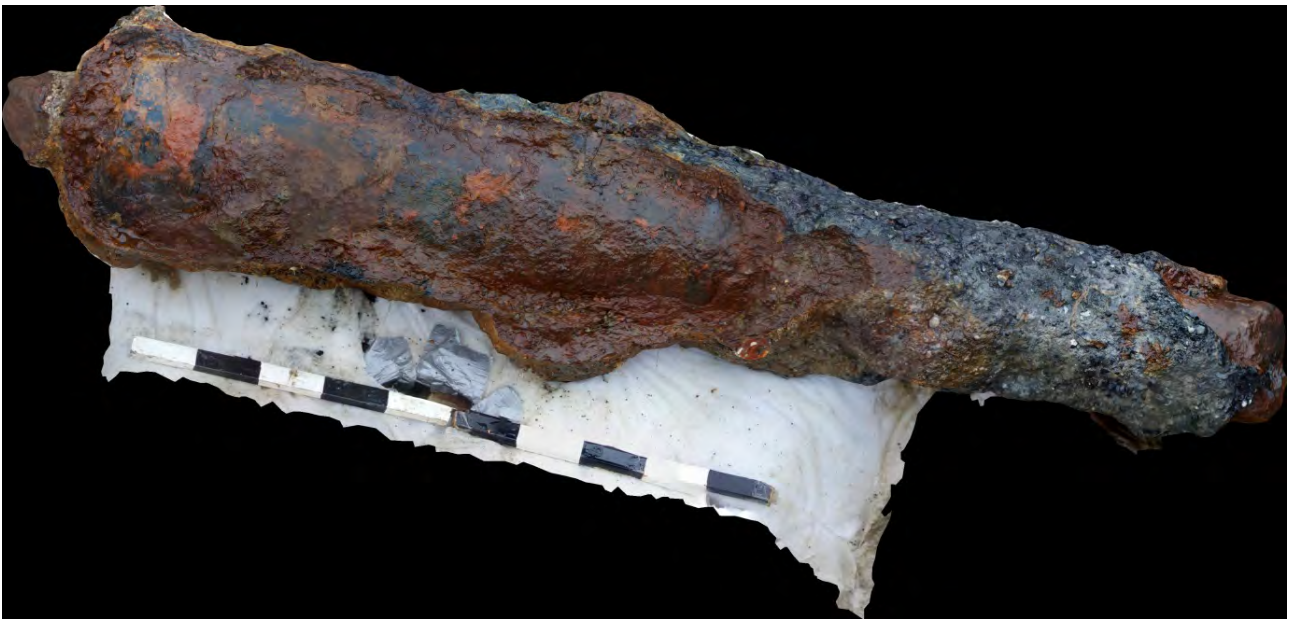
**Figure 1:** Orto-photo of BWL1-0035 taken from 3d model and drawing with rings visible on the surface of the cannon (scale increments are 100mm each)

The cannon is a cast iron smooth bore gun. It is very concreted (30 to 90 mm in places) and the muzzle suffered some minor damage when the some concretion was removed in order to expose the bore. No trunnions are visible but at least part of them may be covered by the concretion. Similarly, no mouldings are visible except for the 2nd reinforce ring and two mouldings of the base ring on the breech side.

From the ARIS image it appears that the cannon was exposed on the seabed and was not associated to any other material on the seabed. The cannon was found c.150 m E of the floating breakwater of Gosport Marina, and c. 60 m from another cannon (**BWL1\_0036**) that was recovered a week later. At the present there is no evidence of further archaeological material in this area and the cannon is assessed as an isolated find.

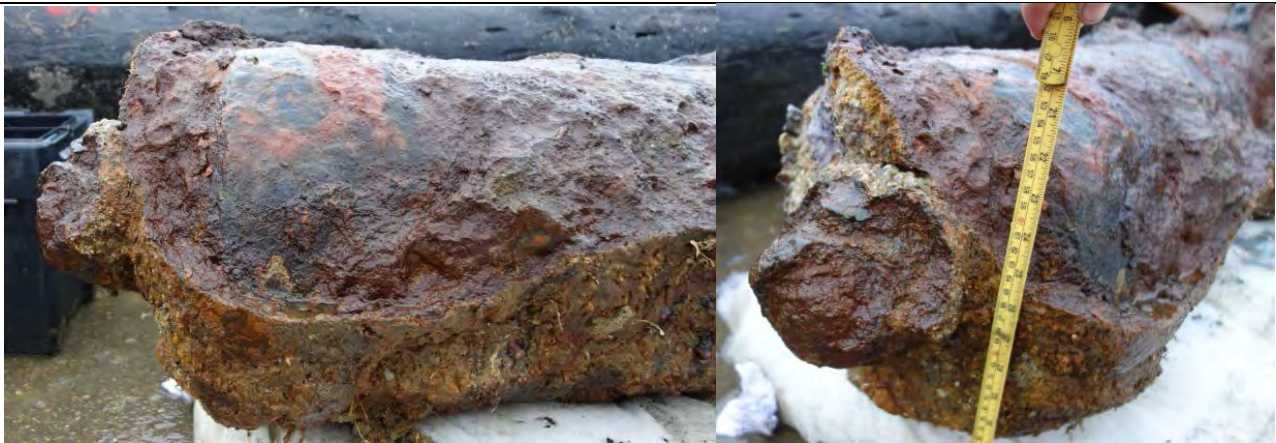
Figure 2 Profile and detail of cascabel

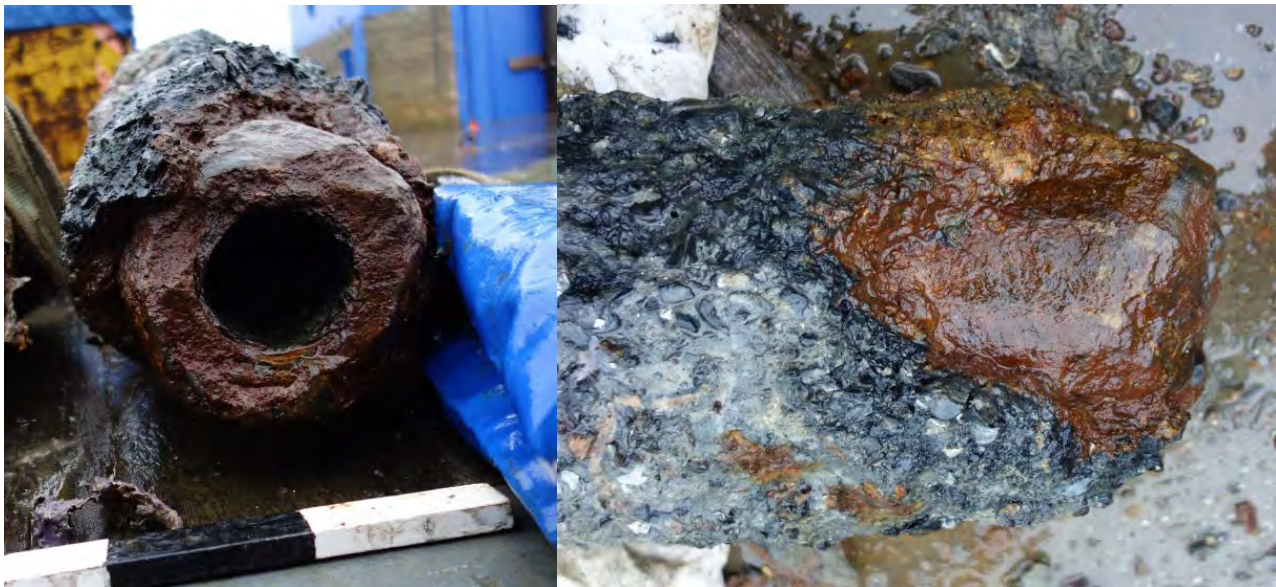
Figure 3 Bore and muzzle swell

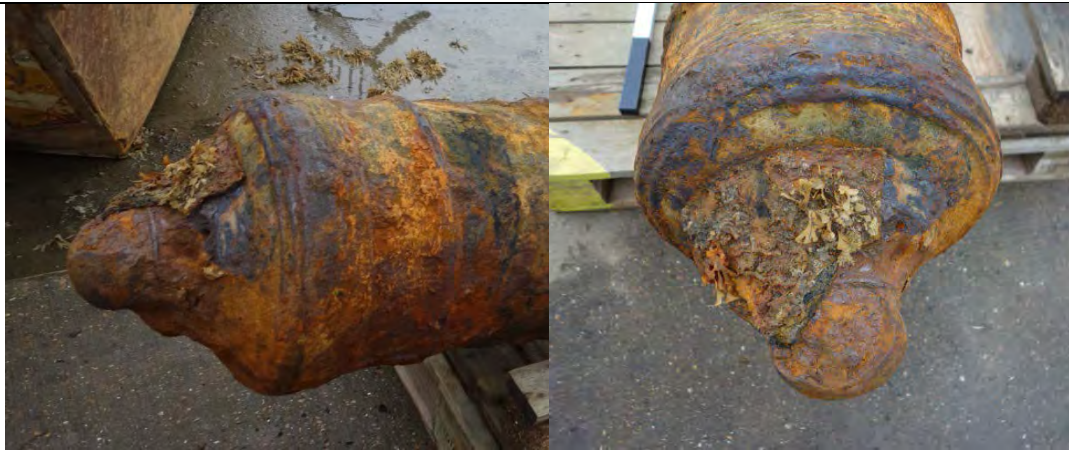
Figure 2 Profile and detail of cascabel

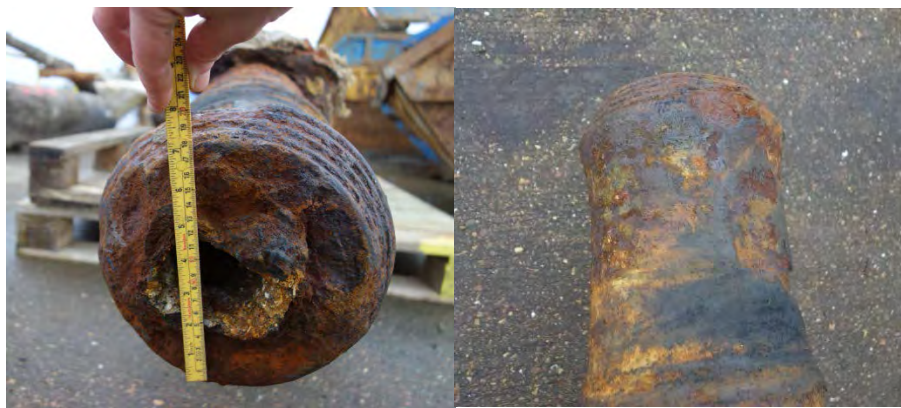
Figure 3 Bore and muzzle swell

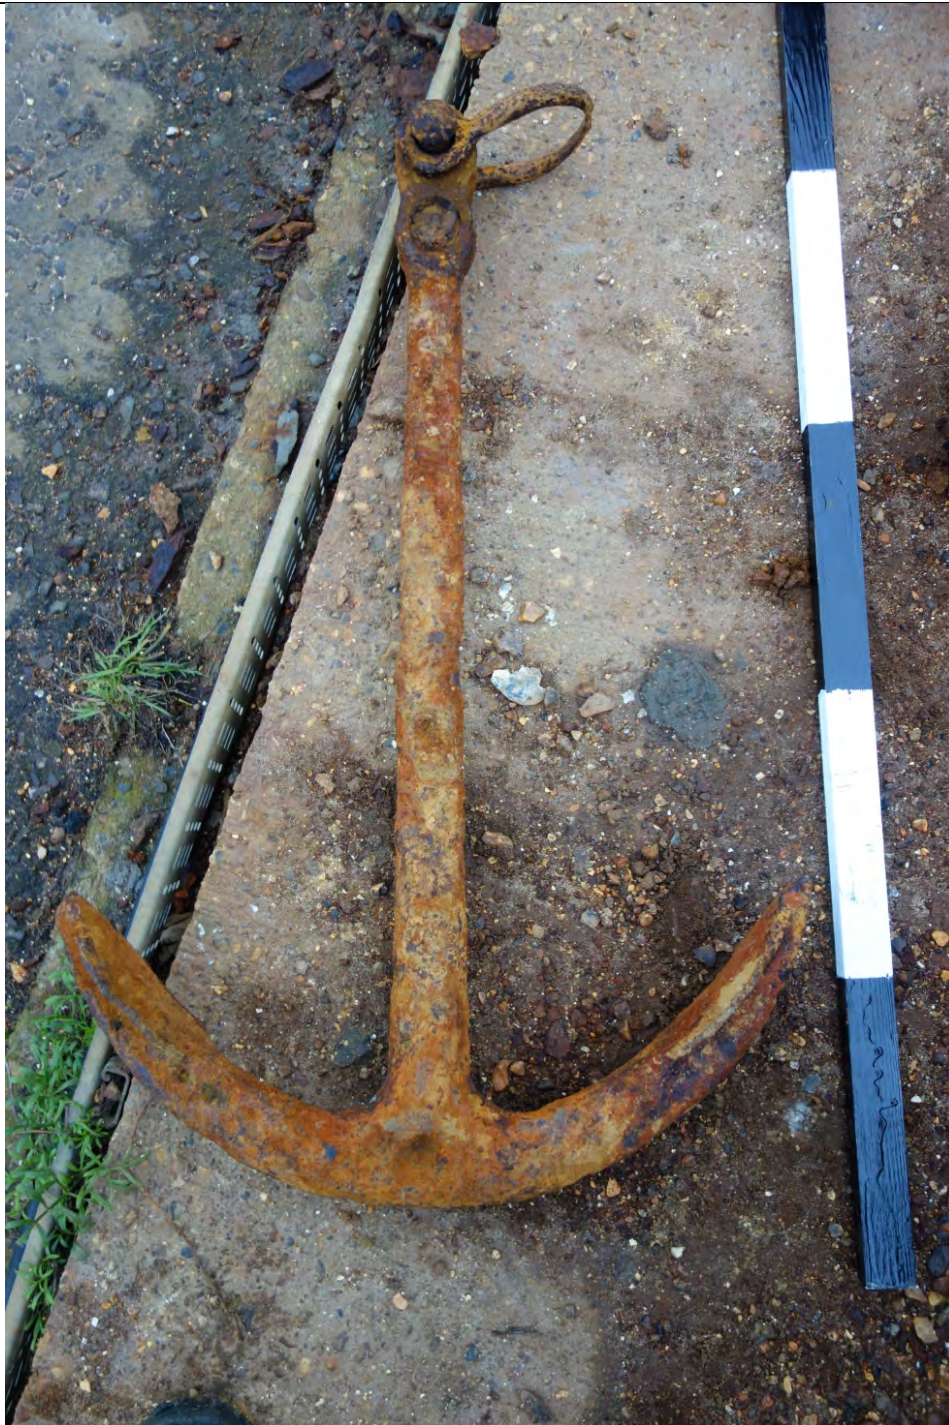
Figure 1 BWL1\_0026 on the quay side

Small iron anchor. The shank is 700 mm long and has rounded section that tapers slightly from the crown to the stock eye (34 mm). The stock is missing and a shackle is attached to the anchor by a large pin. The palms are 90 mm wide and 120 mm long and are leaf shaped with rounded lower corners and a pronounced bill, the edges of the flukes are corroded. The width of the anchor bill to bill is 470 mm.

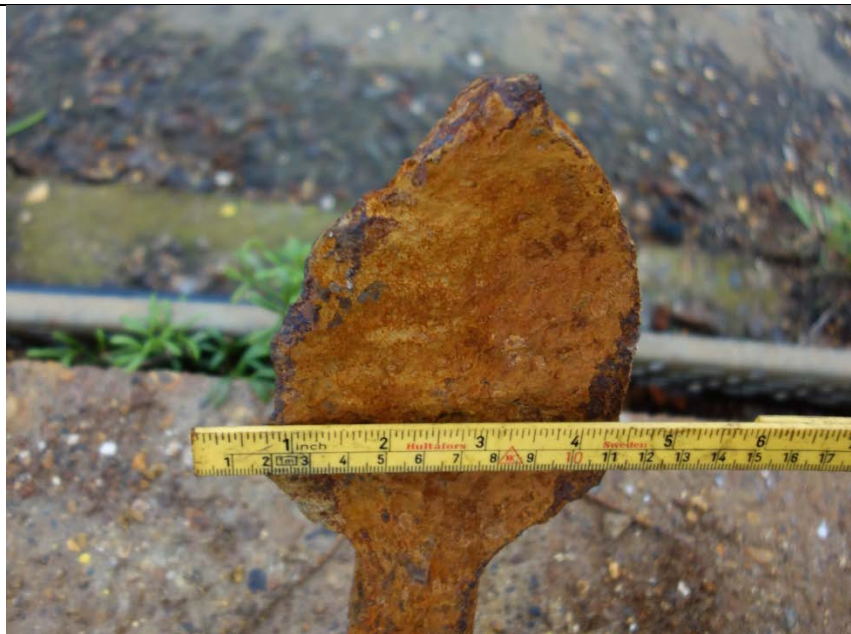
**Figure 2:** Fluke shape

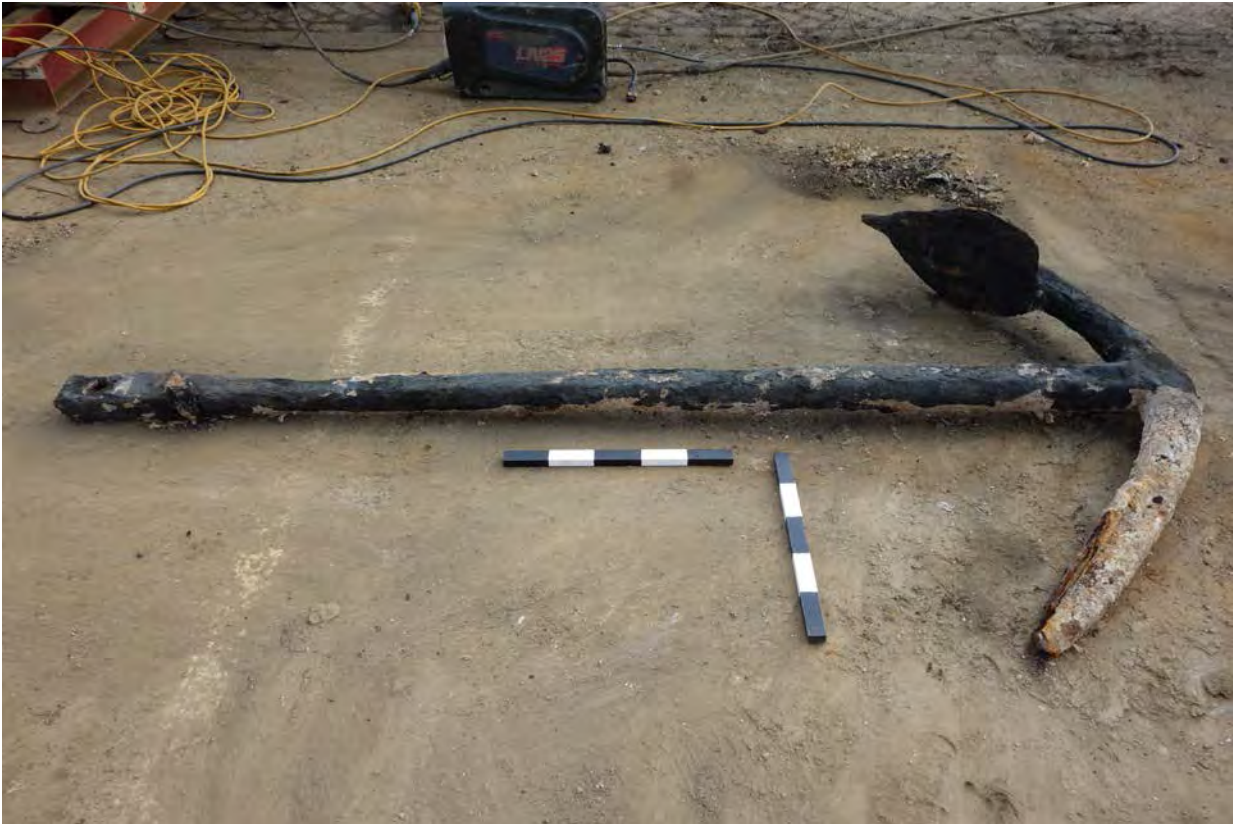
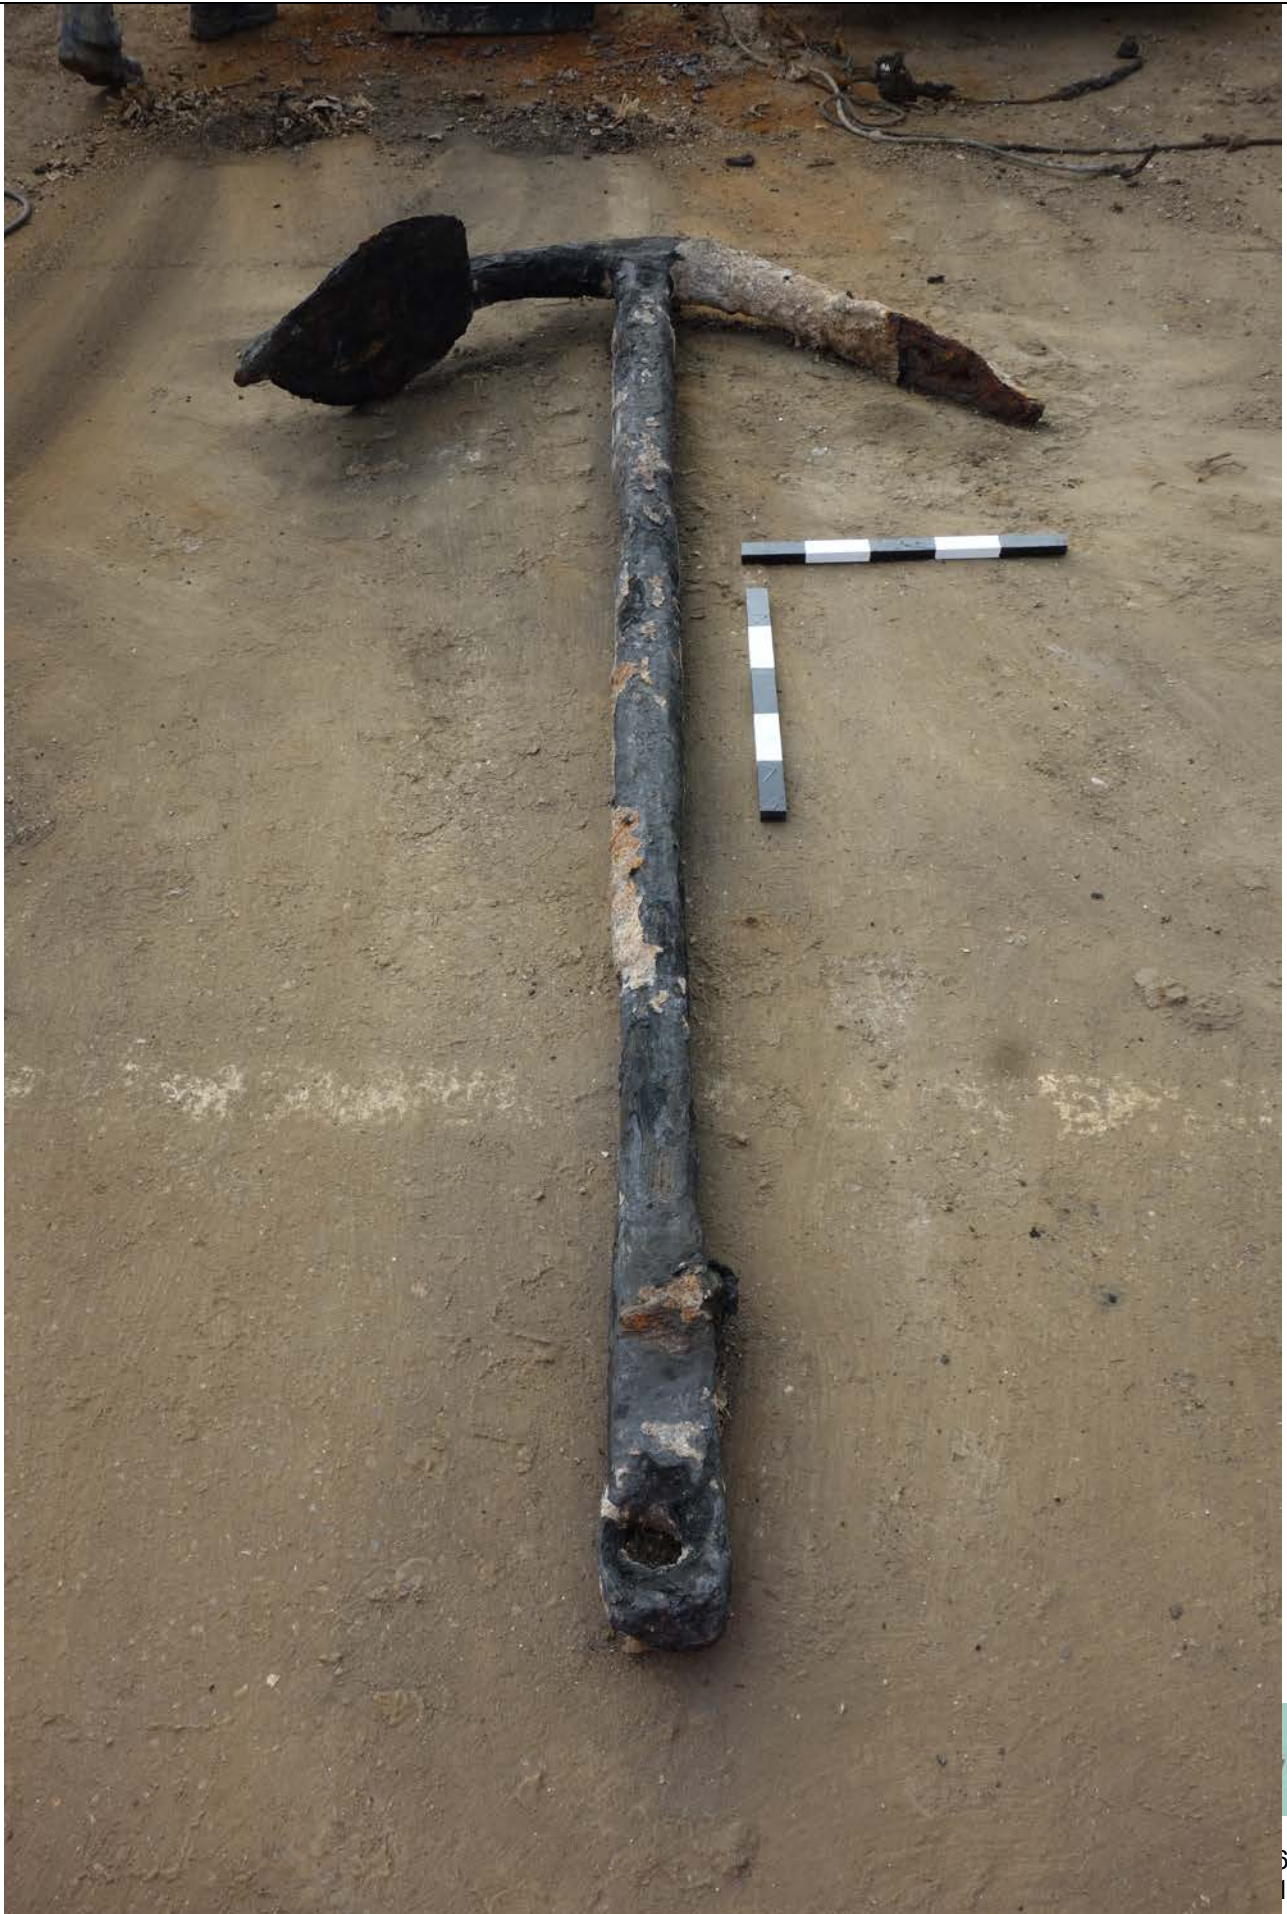
Small stocked wrought iron anchor. Concreted to a minimum/maximum depth of c. 2/10 mm prior to recovery. Overall length is 2570 mm. The anchor is heavily corroded and the original metal surface has been lost. The shank section is 90 mm wide along its length. Although the shape is obscured by loss of surface, it appears to have been faceted. The head of the shank is squared off with a small parallel stock key (24 mm wide and deep) on each side to accept a wooden stock, now missing. There is an anchor ring eye of 50 mm diameter but the ring is missing. The arms are of shallow angled section form and the crown has a very shallow point. One arm is damaged and is missing most of the fluke and bill, but the undamaged arm has a length of 940 mm. Distance bill to bill is estimated to have been 1365 mm, with an amplitude of 975 mm and a bill height of approximately 600 mm. The surviving fluke has a tipped spade shape, 515 mm long by 310 mm wide. Weight is estimated to be 4-5 cwt.

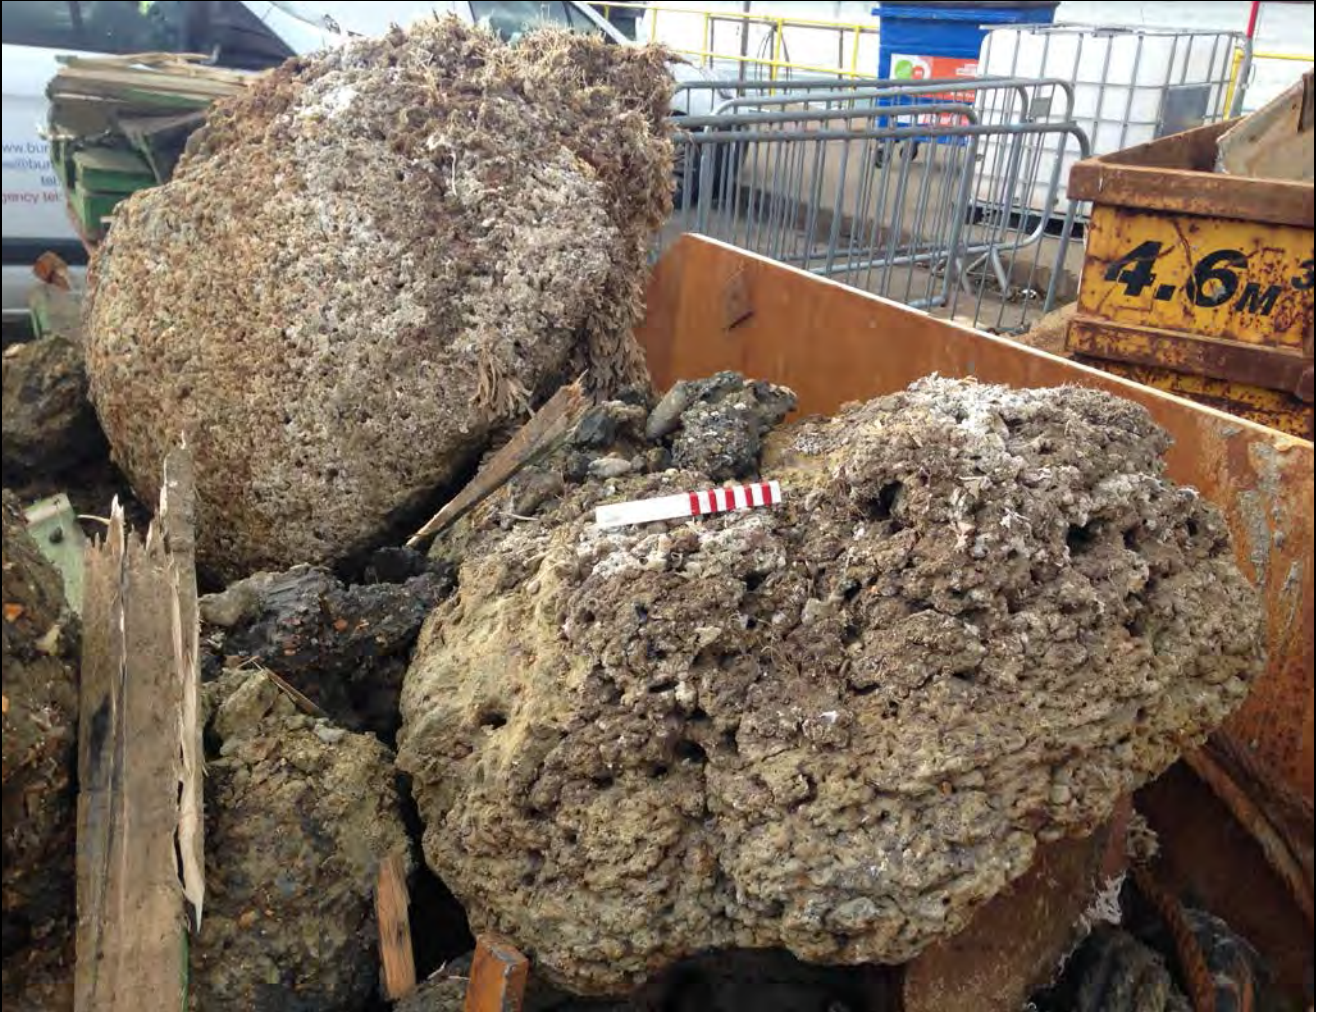
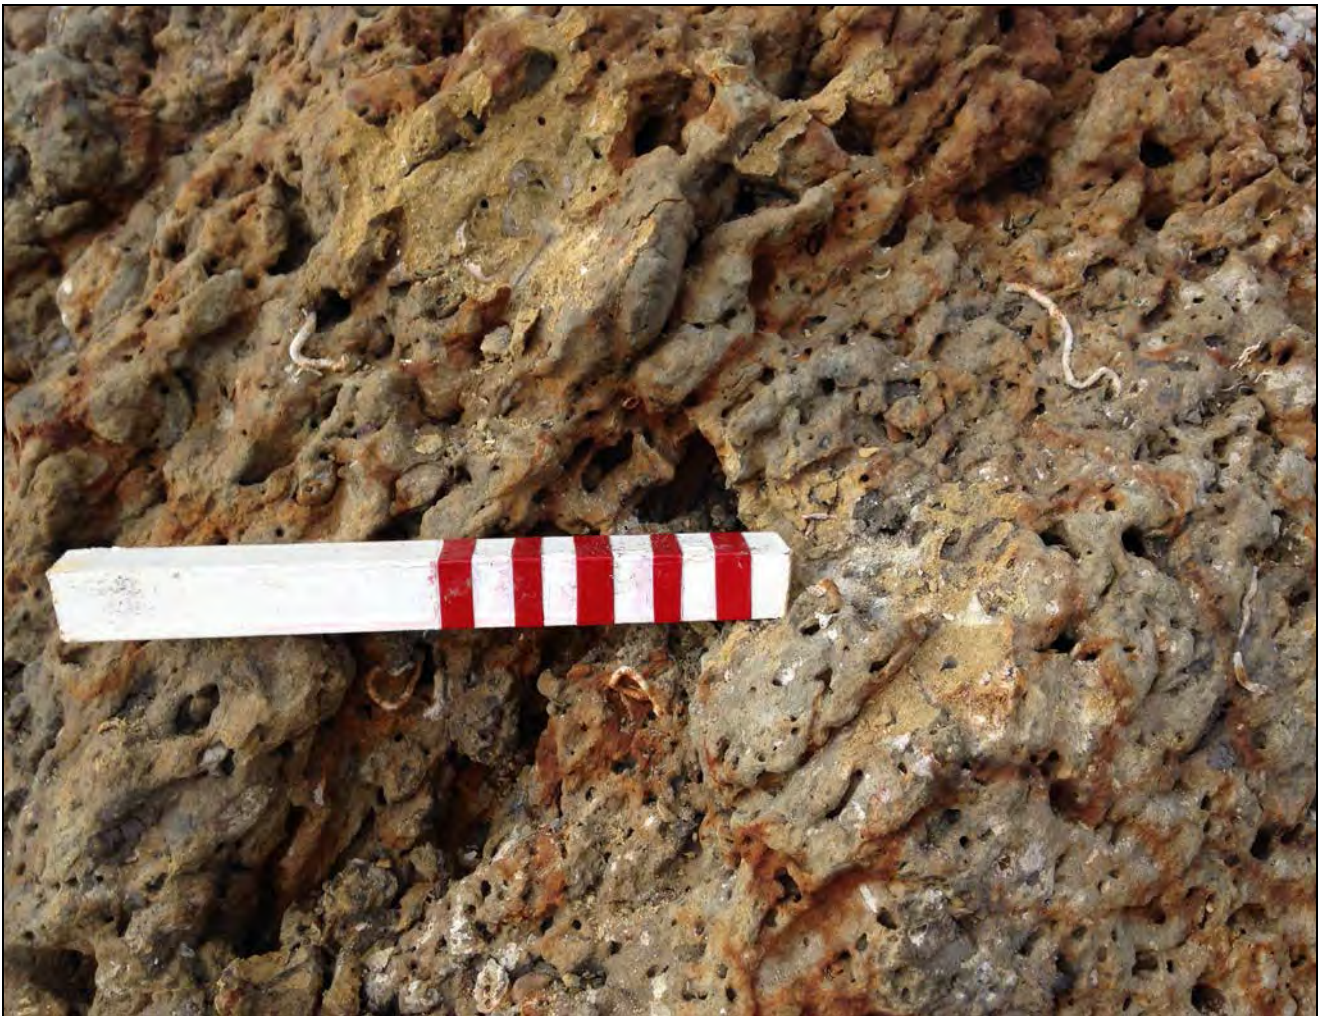
Three irregularly shaped fine grained sandstone boulders up to 2m in diameter and 4-5 tons weight. Partially covered in marine growth. The sandstone is fossiliferous, including bivalve molluscs. No evidence that the boulder surfaces have been worked.

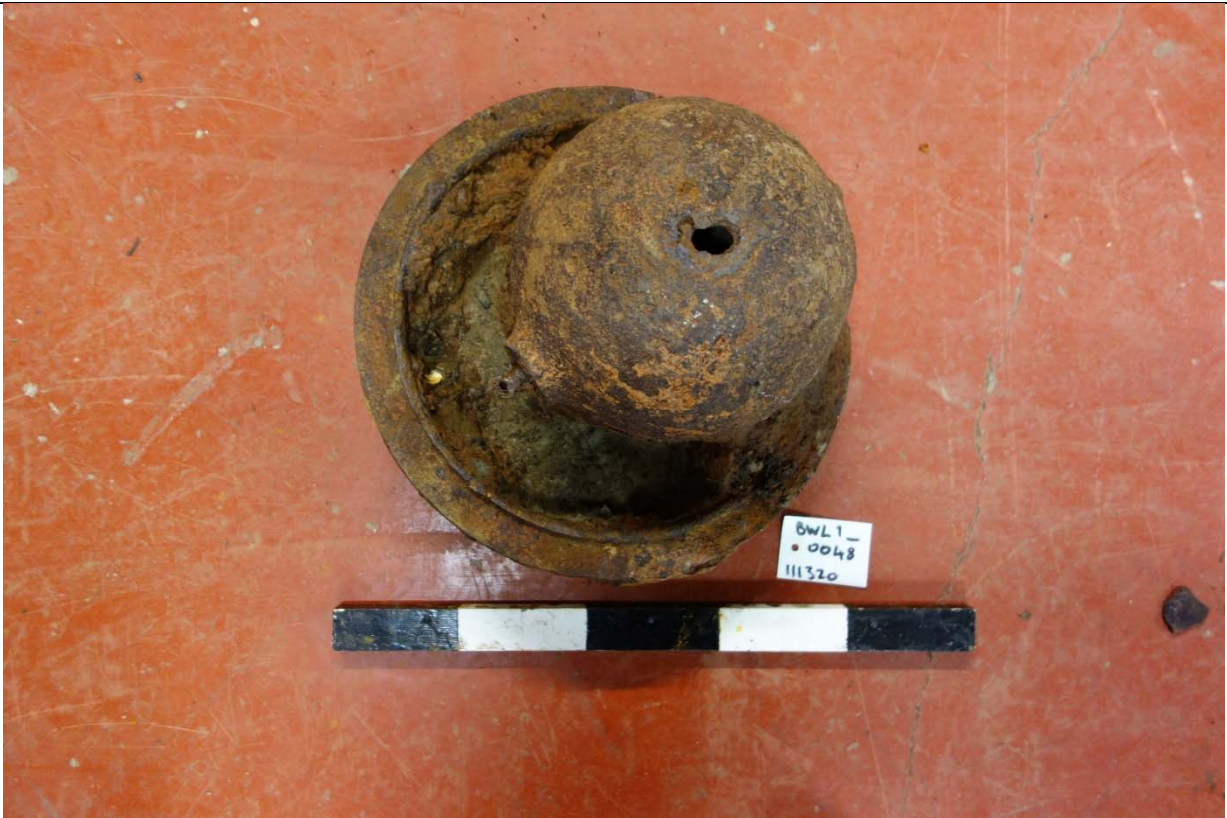
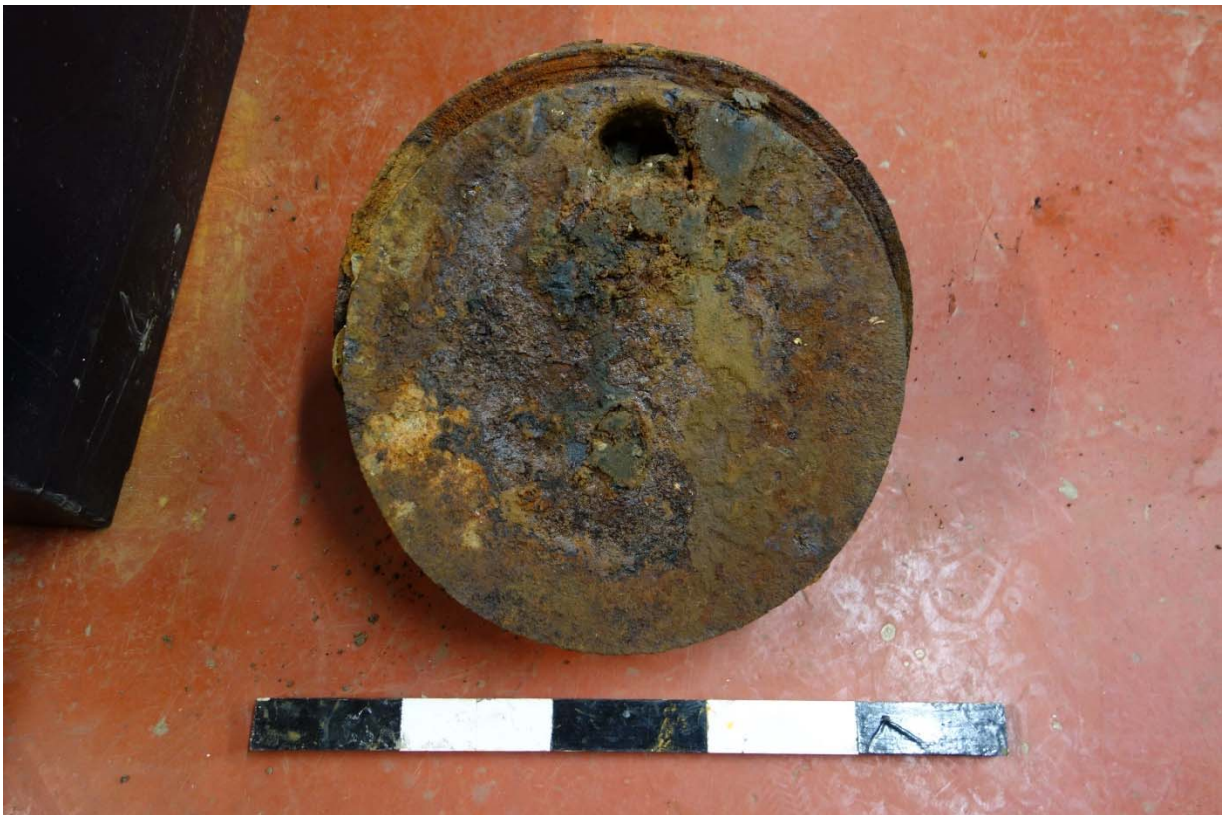
The object has been identified as a condensing bulb for a steam pressure transmitter. The condensing bulb would have been attached to the side of a ship's boiler with the steel base facing the boiler. Steam from the boiler would pass through the small hole in the base and into the sphere. In the sphere the steam would be condensed into water, this would feed through the protruding feature found on the sphere and into a pressure gauge. This would be used for monitoring the pressure within the ship's boiler. This object would have been located well within the ship's hull and as it is an isolated find, it may indicate that it was lost or discarded during ship breaking.

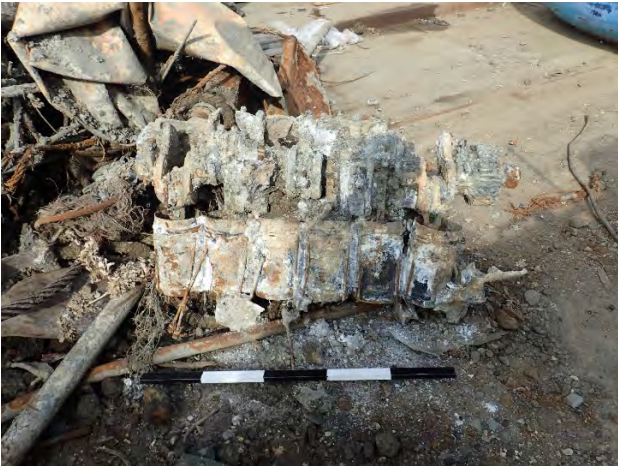
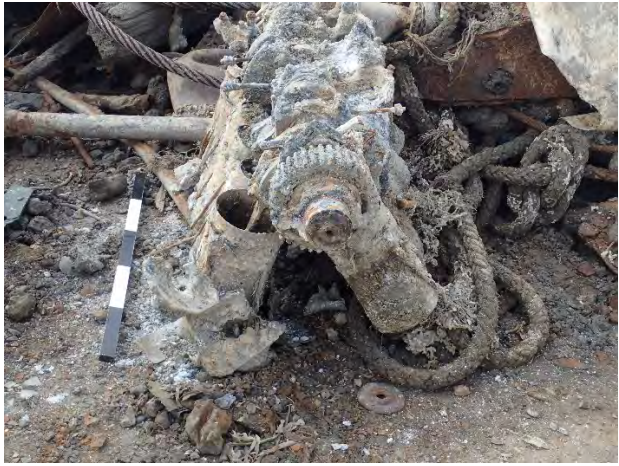
Side view (Wessex Archaeology)	End view (Wessex Archaeology)

The engine is a V-12 steel and aluminium composite. It is very heavily corroded and damaged and is only partially intact. Surviving elements include: pistons, cylinder liners (sleeves) and connecting rods; flywheels and crankshaft and an engine mount fixture 1.27 m long and has twelve cylinders of 0.15 m diameter and 0.27 m height. The cylinder O-rings are still in place. The gear at one end of engine is 0.2 m diameter (addendum circle) and 70 mm wide, with a circular pitch of approximately 15 mm.

The available information suggests that the engine is a Jumo 211, an inverted V-12 German aero engine. This engine was used to power a number of Luftwaffe bomber types during the Second World War, including the Junkers Ju 87 and Ju 88 and the Heinkel He 111. The aircraft that it belonged to has not yet been identified. Ju-88 A1 of 8/KG51 shot down over Portsmouth Harbour by anti-aircraft fire on 12 August 1940 can be discounted on the basis that wreckage associated with this loss has been found north of Whale Island and the character of that material suggests that the aircraft concerned dived steeply into the harbour (NRHE Monument No. 1400101; Steve Vizard, pers. comm.).

During the quayside inspection, fragments of fishing net were found entangled with the cylinder liners. A heavy rope was also coiled around part of the engine, although it was not clear when the latter entanglement occurred. The fact that the engine was detected as a sidescan sonar anomaly with height indicates that the likelihood of some entanglement having occurred on the seabed is high. It is possible that this could indicate that the engine has been moved from the original aircraft crash site, as it has been informally reported that aircraft wreckage recovered in nets from as far afield as the Isle of Wight has occasionally been dumped by fishing vessels in the approaches to Portsmouth (Steve Vizard, pers. comm.).

1. the anomaly location should be treated as a probable military aircraft crash site and therefore protected under the Protection of Military Remains Act 1986;
2. the 100m Temporary Exclusion Zone (TEZ) should be retained around the anomaly location pending the results of recommendations 3 & 4;
3. further investigations to confirm the identification of the engine and of the aircraft it came from should be undertaken; and
4. further investigations to determine whether the engine is an isolated find or part of a wider crash site in the vicinity should be undertaken.

In order for recommendation 4 to be carried out, it is strongly advised that Wessex Archaeology should: be provided with and review any existing geophysical survey datasets for the anomaly location, including sidescan sonar, magnetometer, multibeam bathymetry and sub-bottom profiler; be provided with any sector scanning or similar sonar data acquired immediately before and during the recovery; and interview the supervisor and any divers involved.
