# Queen Elizabeth Class Capital Dredge Project Her Majesty's Naval Base, Portsmouth

Archaeological Assessment Report

Ref: 111320.05  
January 2018

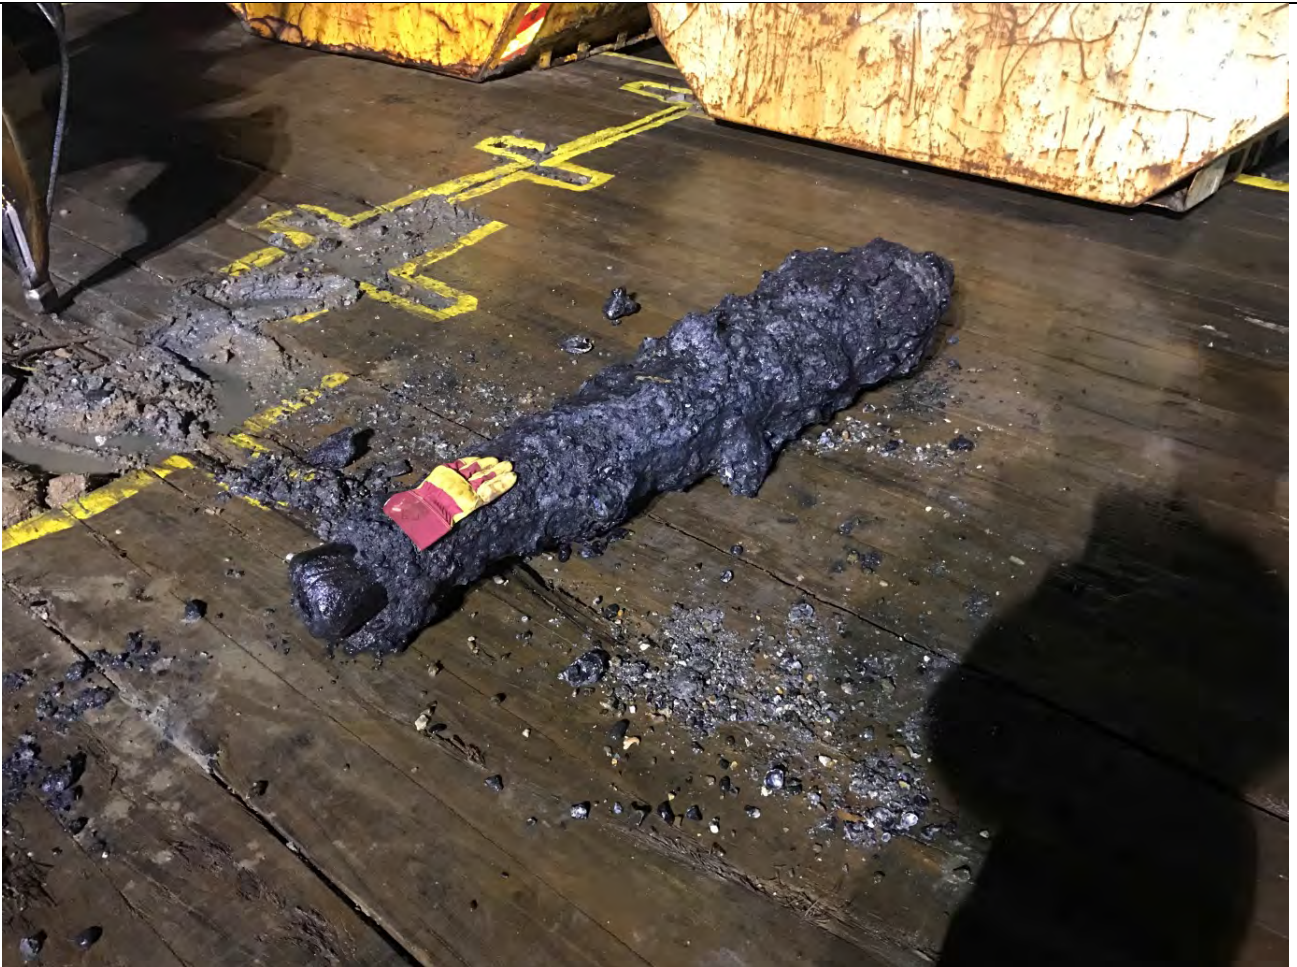
BWL1\_0051 on deck following recovery

Small cast iron cannon. The gun when recovered was largely covered in concretion. However, most of this was missing when subsequently inspected by Wessex Archaeology.

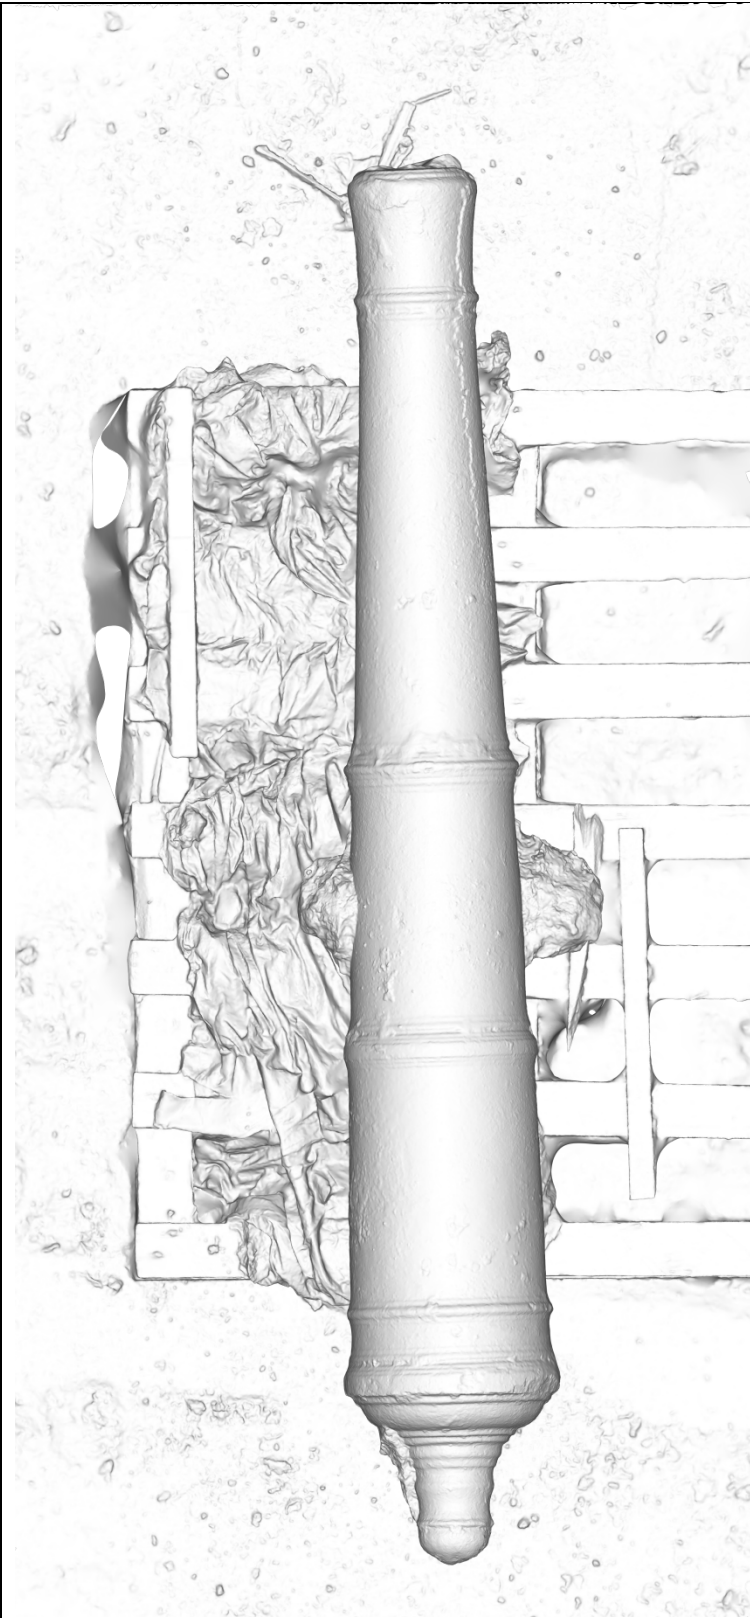
2D representation of 3D photogrammetry model (rectangular bars on either side are 0.5 m scales)

The gun has two muzzle mouldings. The swell is not very pronounced and is curved rather than straight. The muzzle astragal has a fillet on either side; the one towards the breech is separate. The second reinforcement ring has six or seven fillets/ogee; the first has four, with a separate ring forward and separated by a few millimetres. The vent field astragal has two fillets; the base ring has several, which are very worn. The vent is plain and slightly oval. The cascabel mouldings are complicated and best appreciated by looking at the model. One trunnion is worn and corroded; the other is covered with concretion. The trunnions are offset and are positioned at about 40% of the length of the gun.

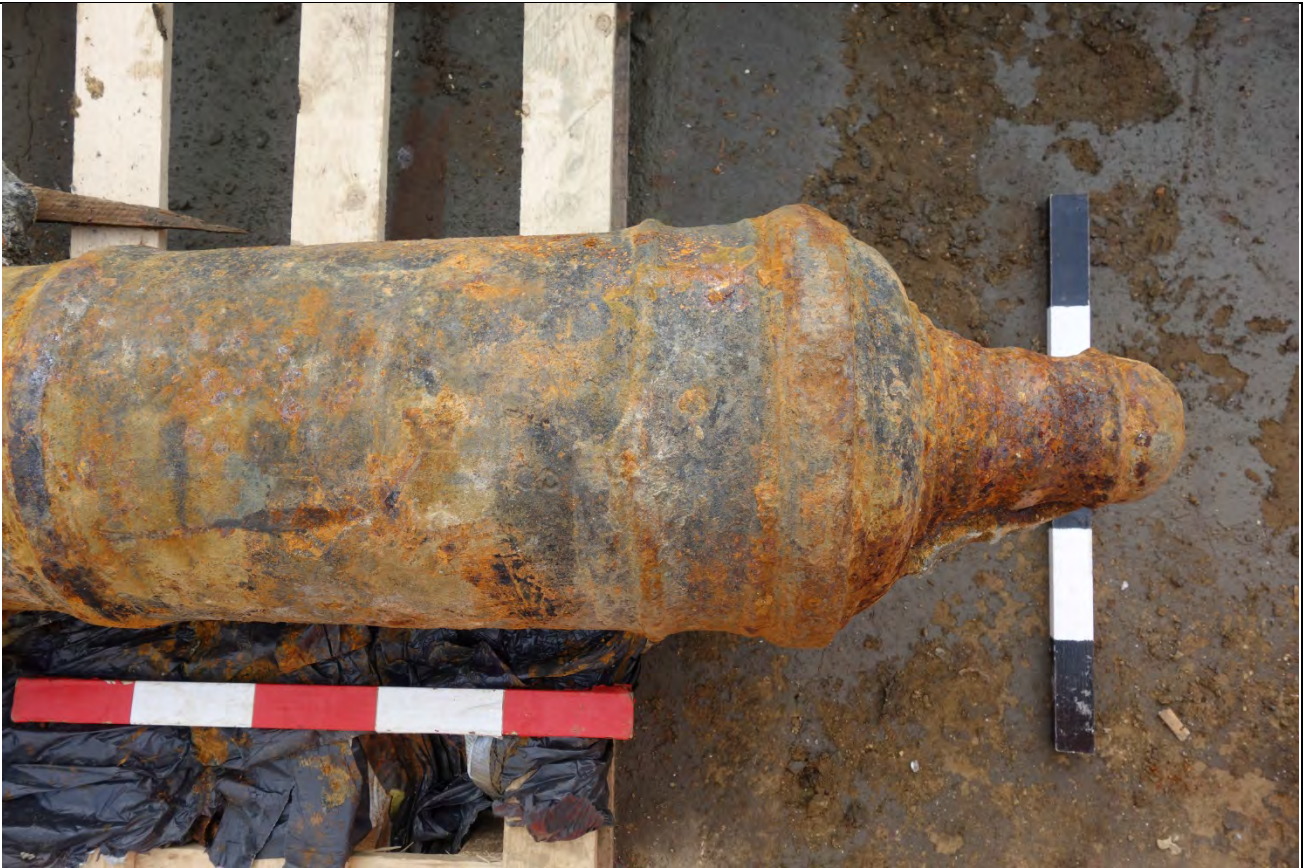
Detail of breech and cascable (0.5 m scales)

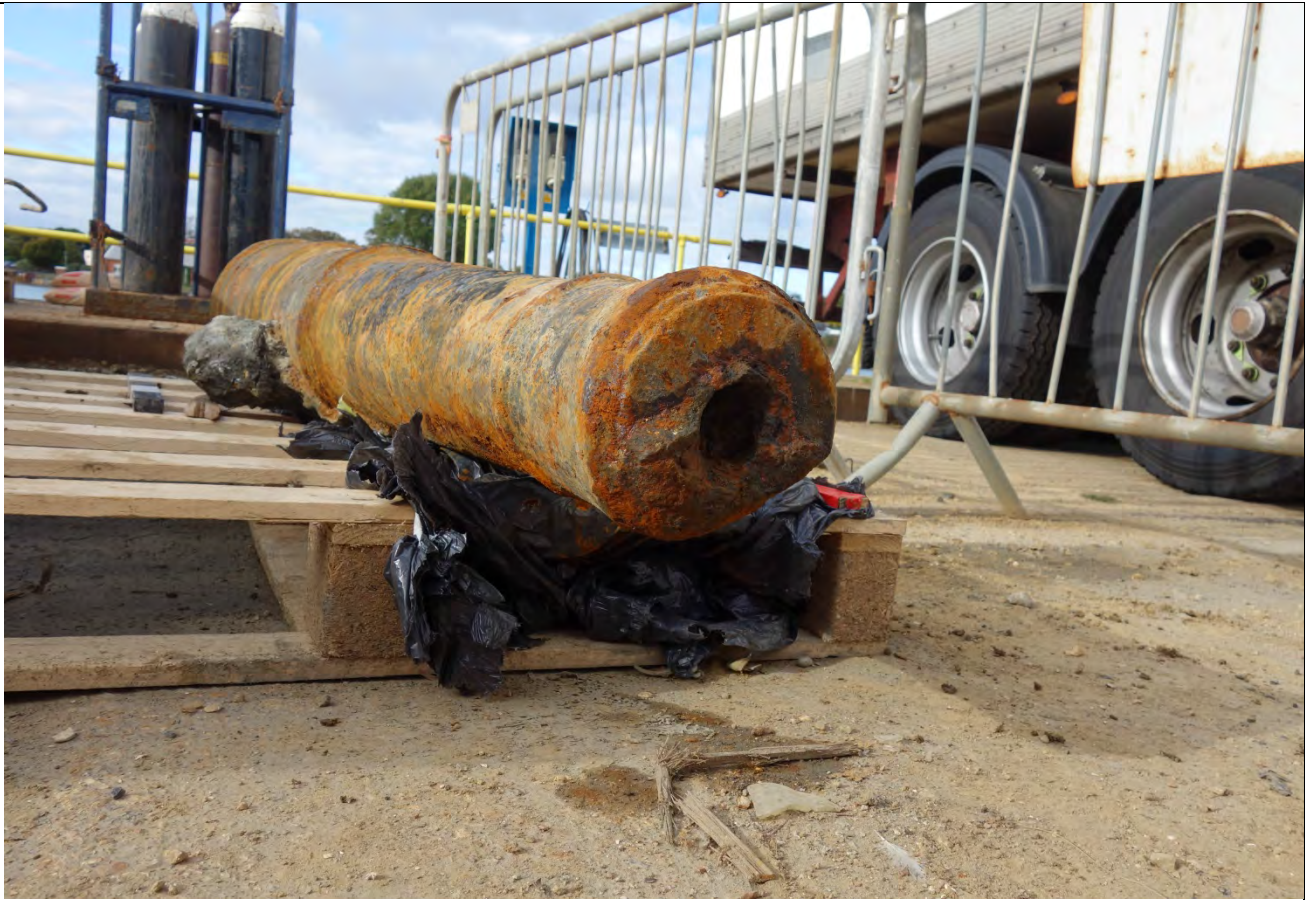
Detail of muzzle

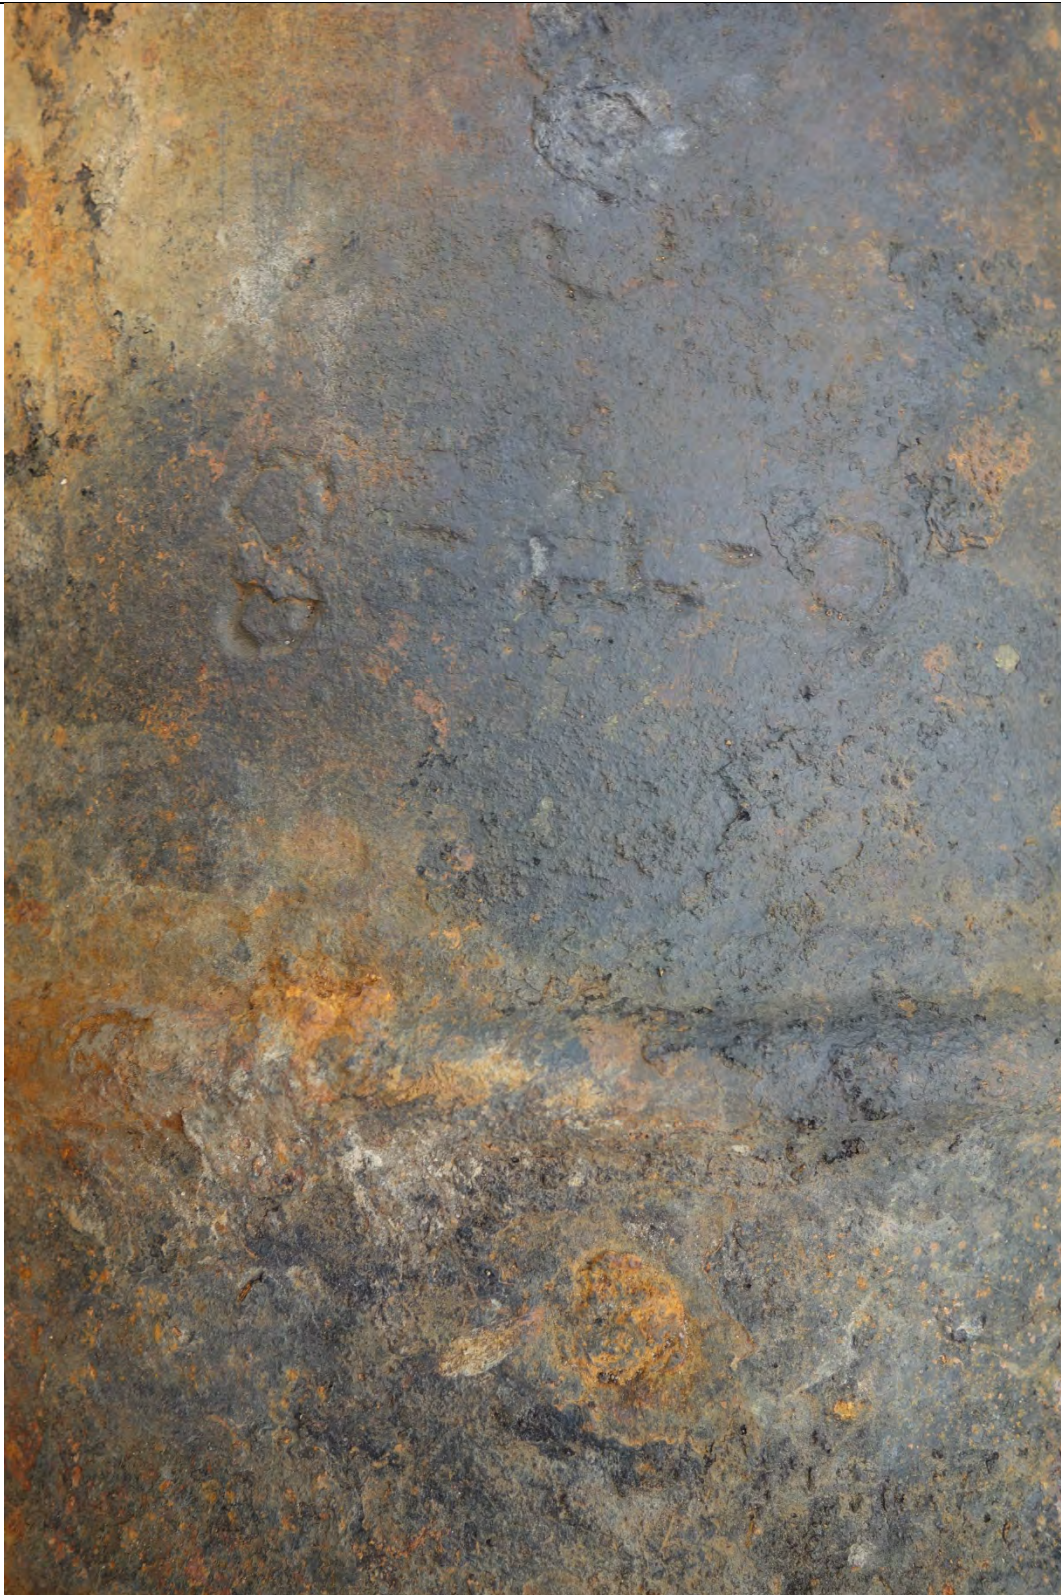
Weight and gunfounder markings on First Reinforce (vent bottom centre)

There are no markings on the base ring or vent field. Neither trunnion is in good condition and no markings are apparent. The weight is inscribed on the first reinforce (8 – 1 (?) – 0). Forward of that is inscribed the letter 'S', the maker's mark.

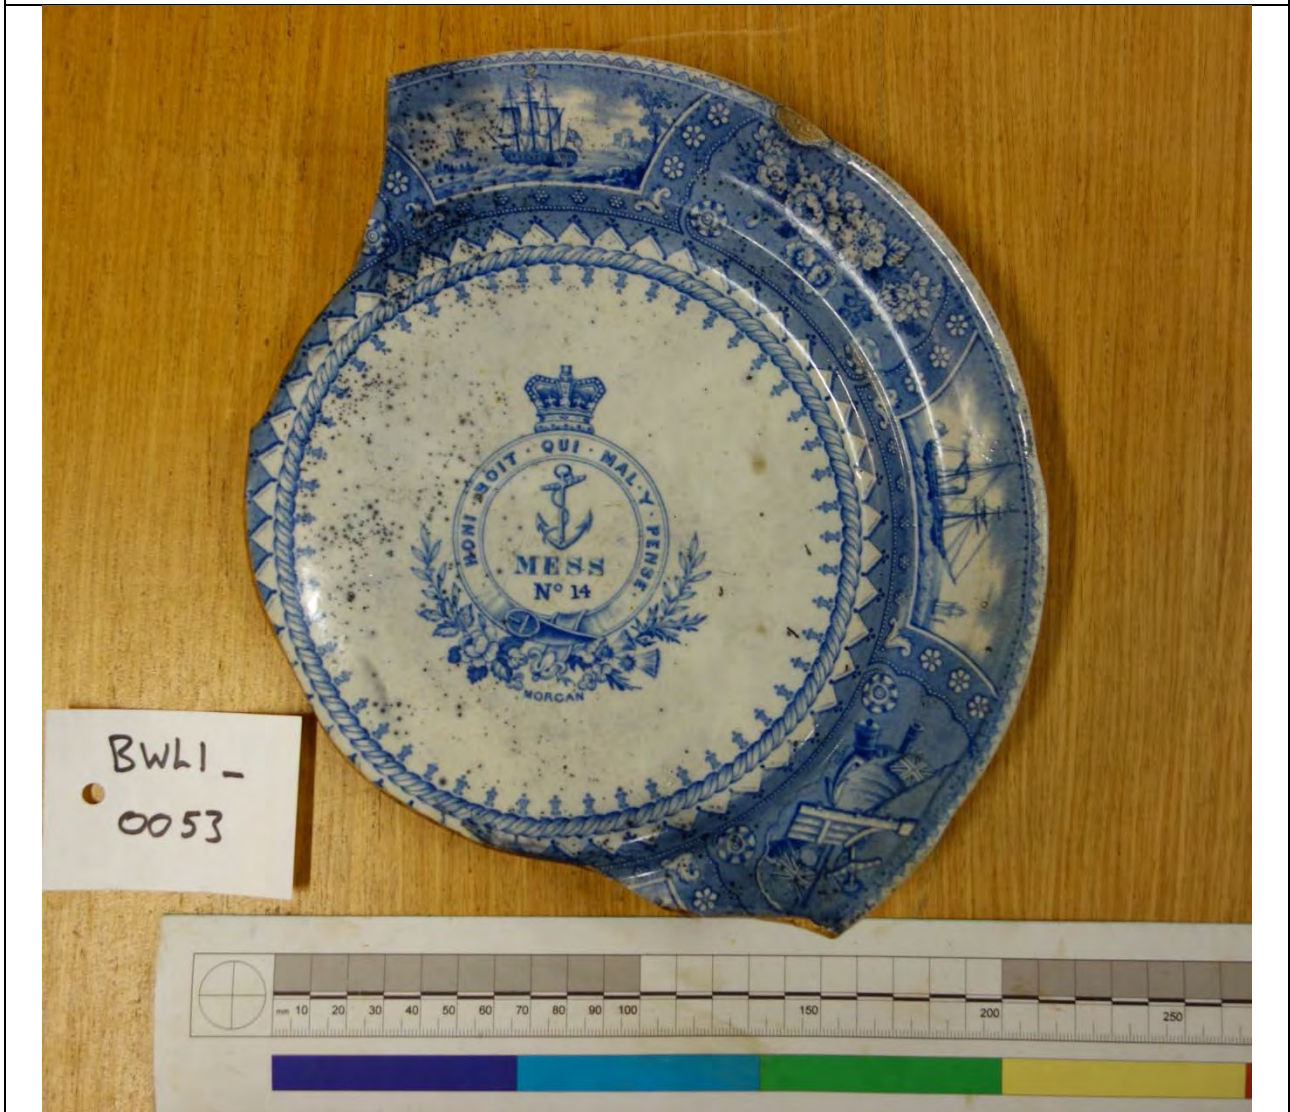
A Royal Navy mess plate with approximately half of the rim missing. The plate is a ceramic known as pearl ware. The plate has an approximate diameter of 248 mm and is 4 mm thick. The central design is a French inscription that reads 'HONI SOIT QUI MAL Y PENSE', which translates roughly to 'shame on him who thinks evil of it'. The inscription surrounds a fouled anchor with the words 'MESS No 14'. A crown surrounds the inscription and anchor. Below is an arrangement of flowers, likely to consist of roses, laurel and thistles, representing England, Scotland, Wales and Ireland. Similar floral designs are found around the rim of the plate, while in-between these there are depictions of naval scenes.

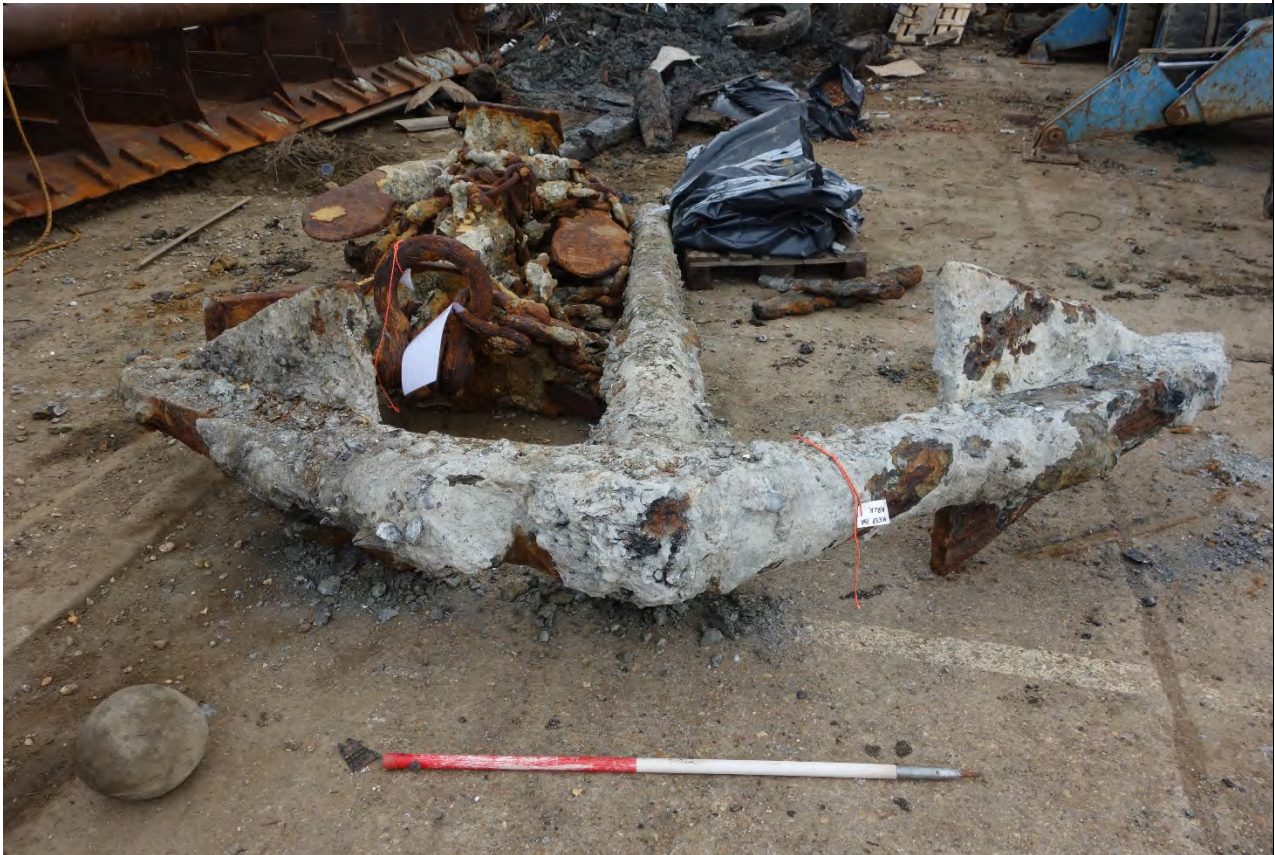
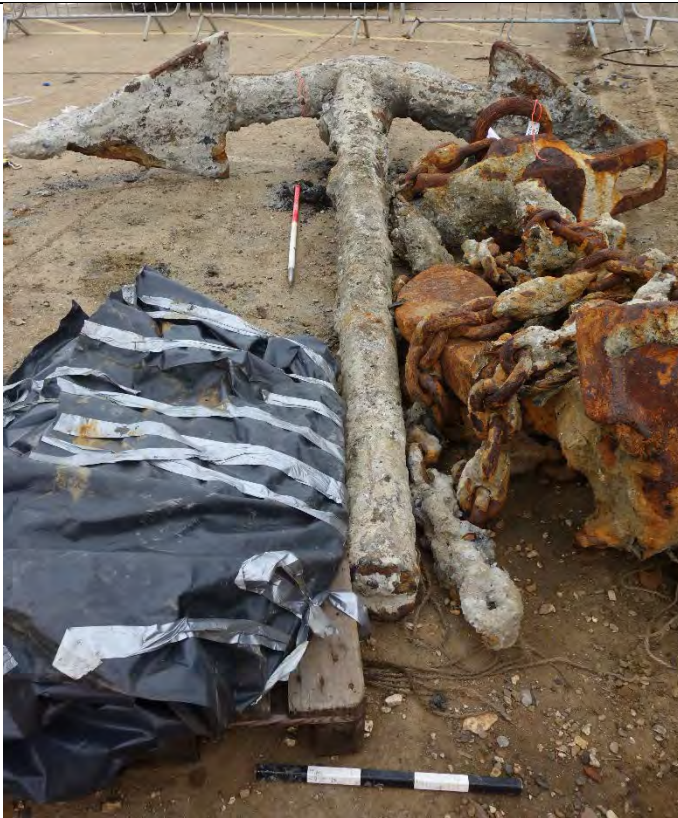
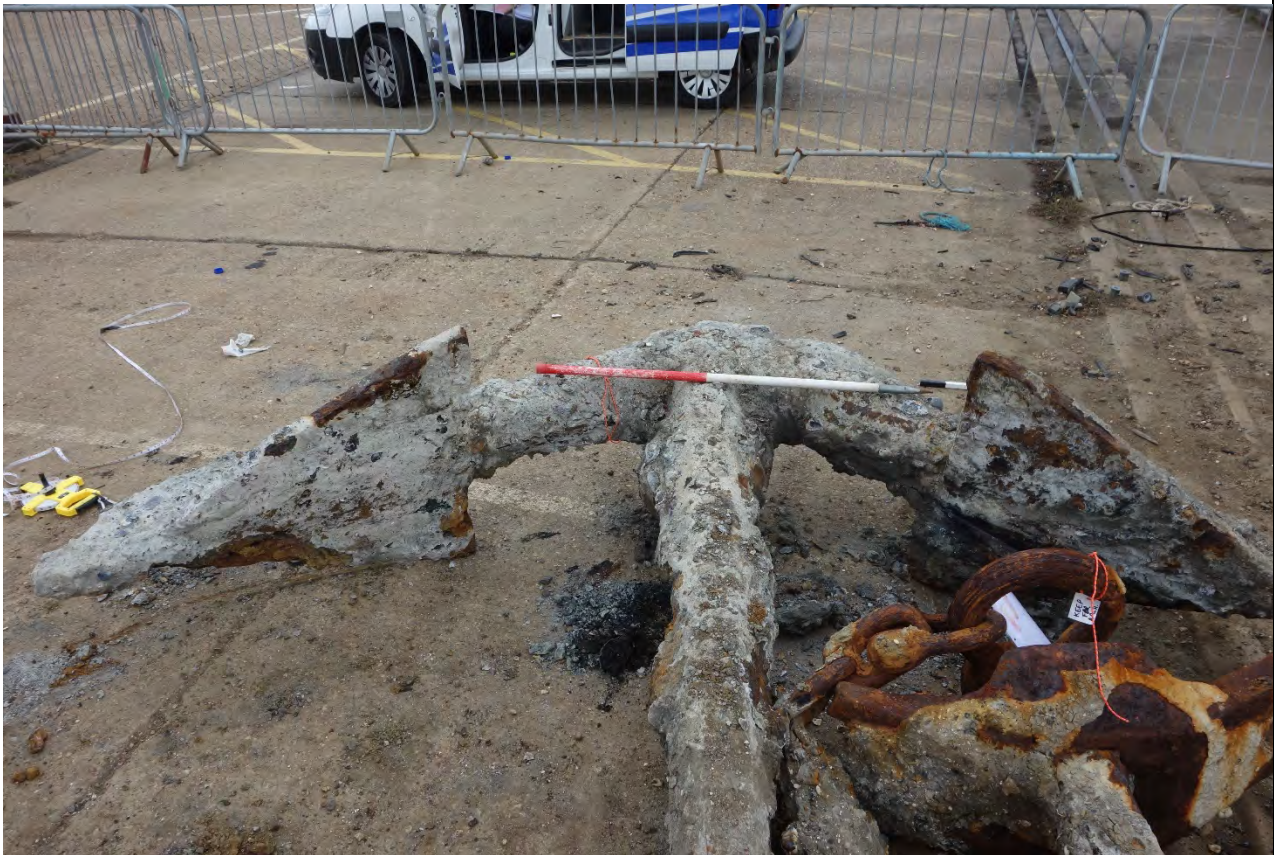
<b>Description</b>			
<p>The anchor's shank has a remaining length of 3300 mm. The shank has a rounded section and a diameter of 200 mm at towards the crown, tapering to 170 mm towards where the ring would have been. The distance between the bills is 3160 mm and the palms have maximum dimensions of 800 mm wide and 840 mm in length, with very pronounced bills measuring 240 mm long. The anchor shank appears to be broken at the ring end, losing the remains of the stock and ring.</p>			
<b>Interpretation</b>			
<p>This anchor is possibly one of two anchor types. The first possibility is an Old Pattern Long Shank anchor which was common from the late 18th century to the early 19th century, and has become one of the most memorable anchor shapes in the public eye. The design was eventually replaced by the Improved Admiralty design in 1841 with more curving arms, and this anchor could relate to the improved design. The angled arms caused issues with the strength of the anchor and many were broken and repaired. The anchor was an isolated find and it is likely that the anchor was lost or abandoned.</p>

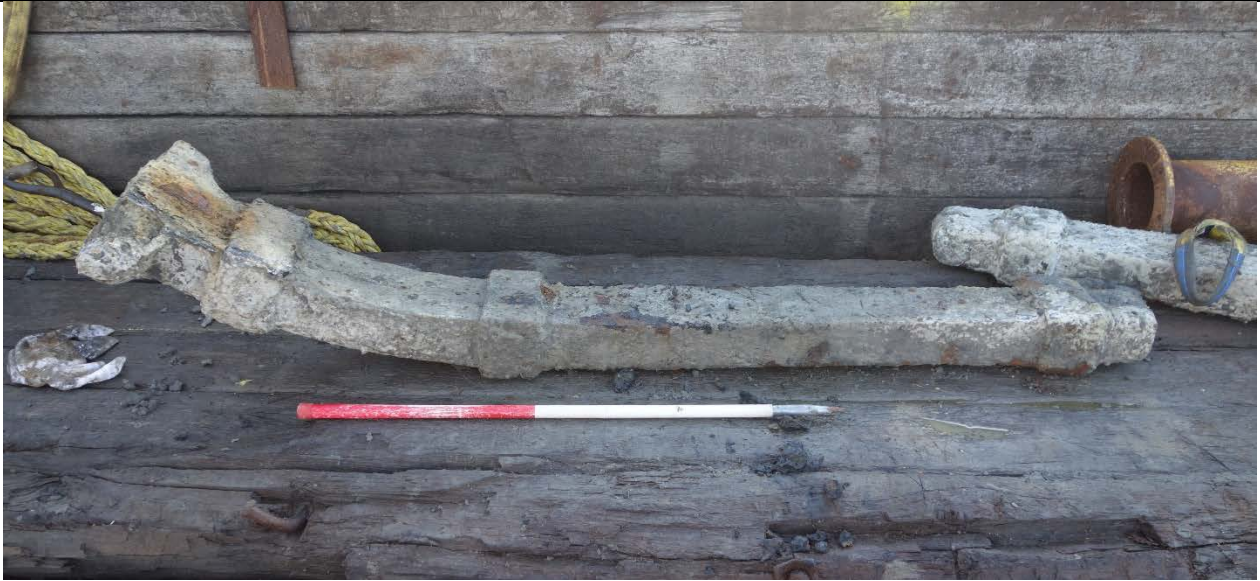
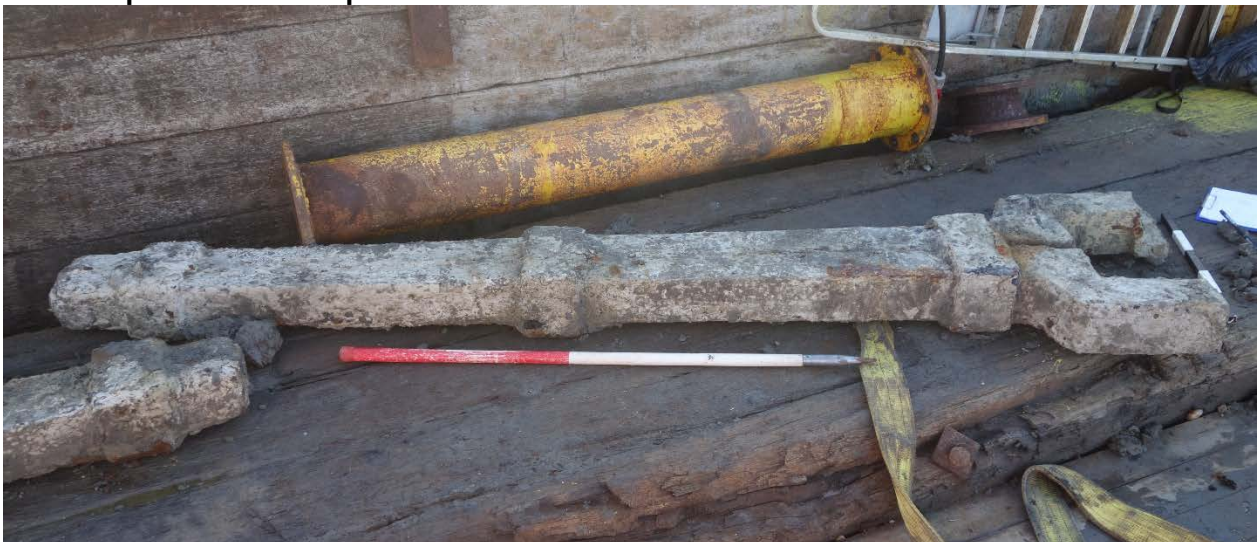
Above – part A. Below – part B.

The second piece, part B, is 2650 mm long and 470 mm at its widest. The broken end that connects to part A has two protruding arms which when connected to the after half creates a square socket in the centre of the object measuring approximately 320 x 270 mm. There is a split clearly visible in this end that looks to form a seam for the socket end to approximately half way along its length. A similar seam can be seen in the other part; this would suggest that two halves are banded together. The first of the bands measures the same as the corresponding band on part A, 120 x 270 mm. The gap to the second band is a long 820 mm and 200 mm wide. The second band is 130 x 230 mm, then a 770 x 180 mm gap to the third band. The third and final band is 130 x 210 mm with the end measuring 180 x 160 mm.

The metal anchor stock has clearly broken in two at the socket, and this is why the two parts were on the seabed.

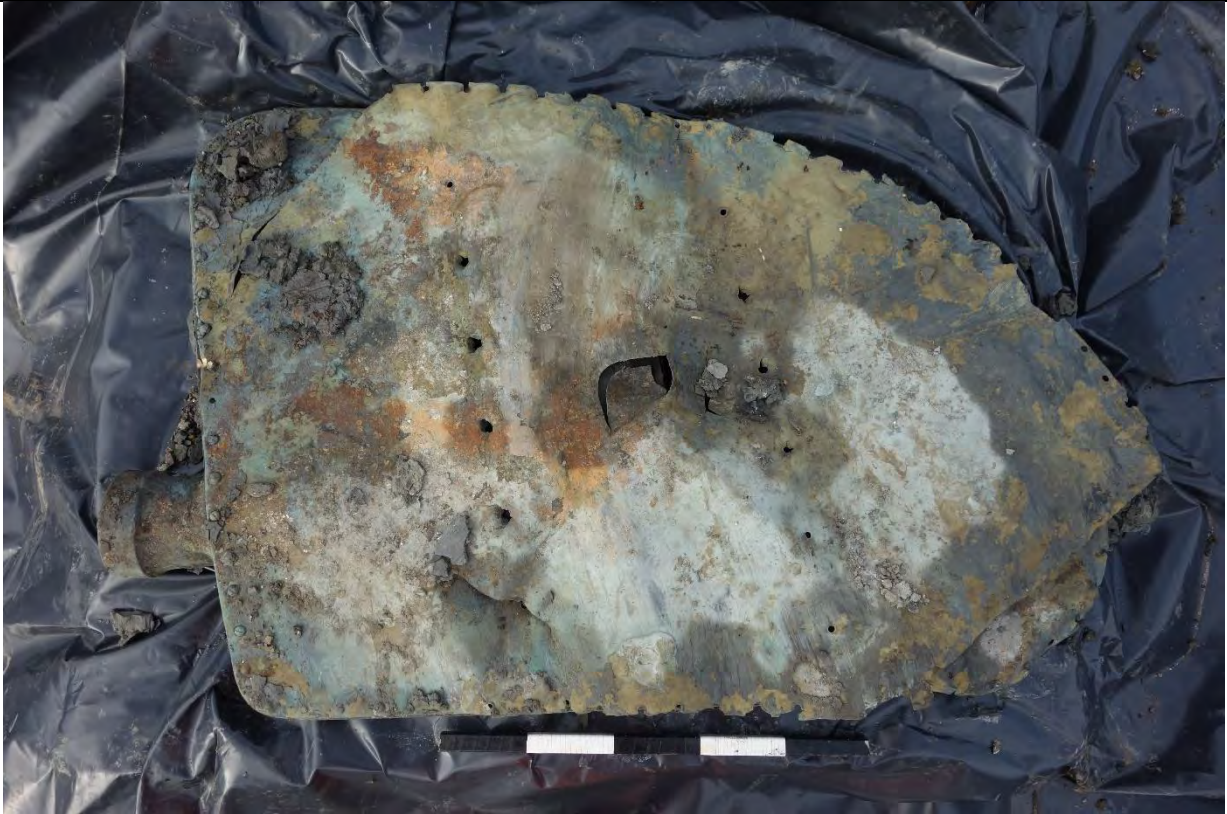
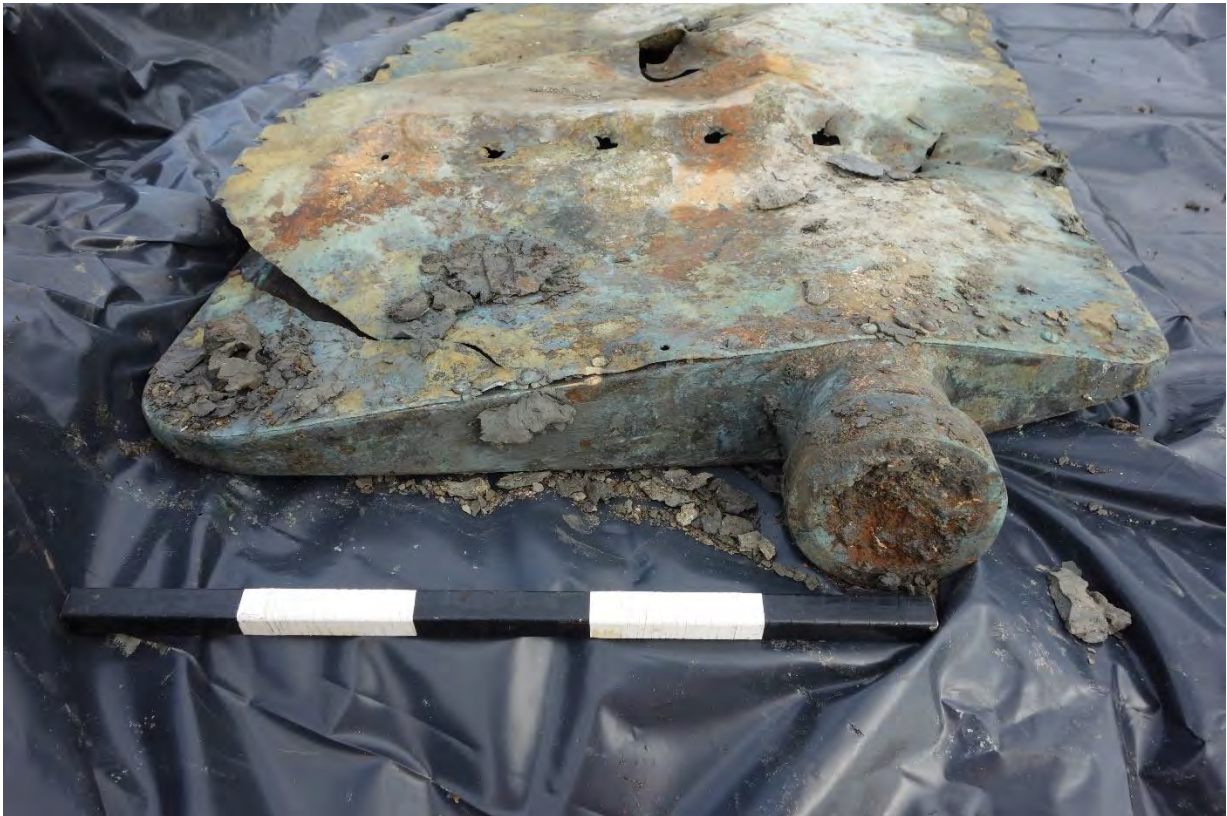
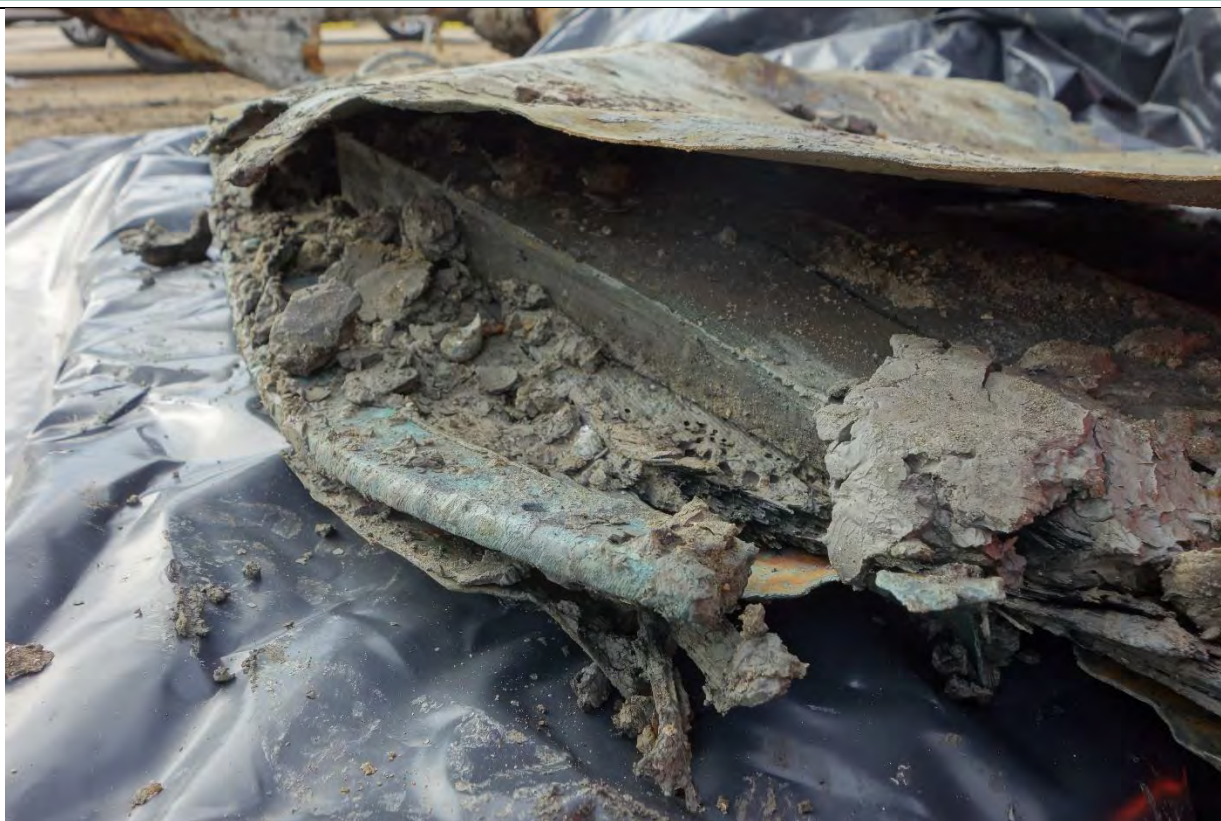
The wooden core of the rudder

The rudder blade is a balanced spade rudder, only being attached via the rudder stock at the top of the blade. The balanced rudder refers to the position of the stock in relation to its width. The balanced position reduced the energy required to move the rudders position, additionally the absence of a skeg reduces the drag associated with turning, in turn this reduces fuel consumption and can increase speed. The down side to the spade rudder is that it is more susceptible to damage compared to other designs. With only the rudder stock holding the blade to the boat it becomes more likely to become damaged in strong seas or through making contact with the sea floor, quaysides and tangling with fishing gear. Commonly this type of rudder can be found on inshore cruising yachts and boats, it is used commonly by racing yachts for its advantages of reduced drag and energy requirements.

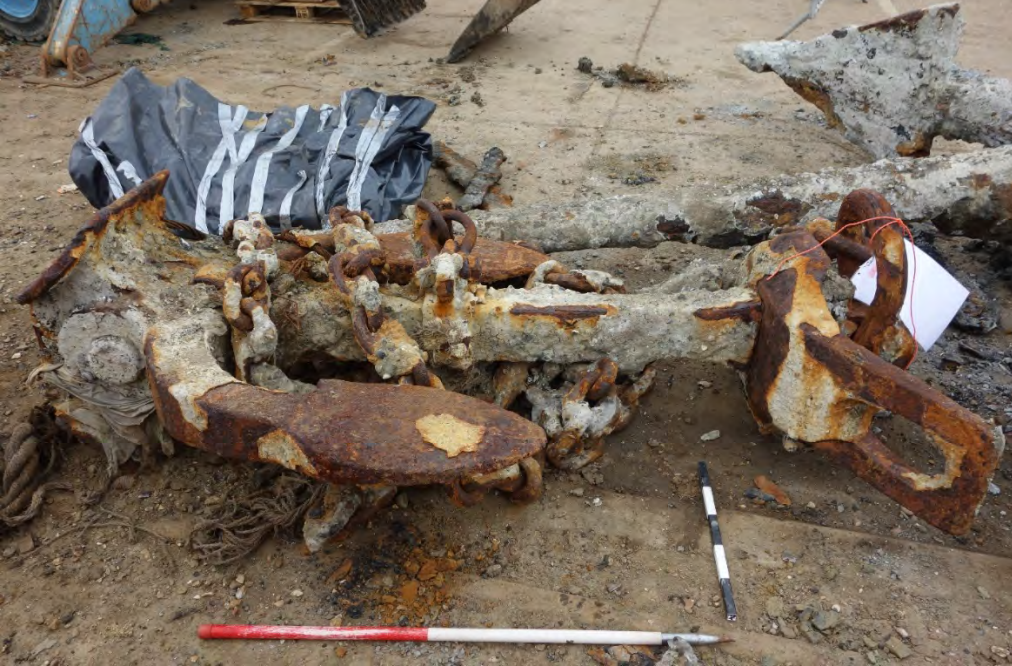
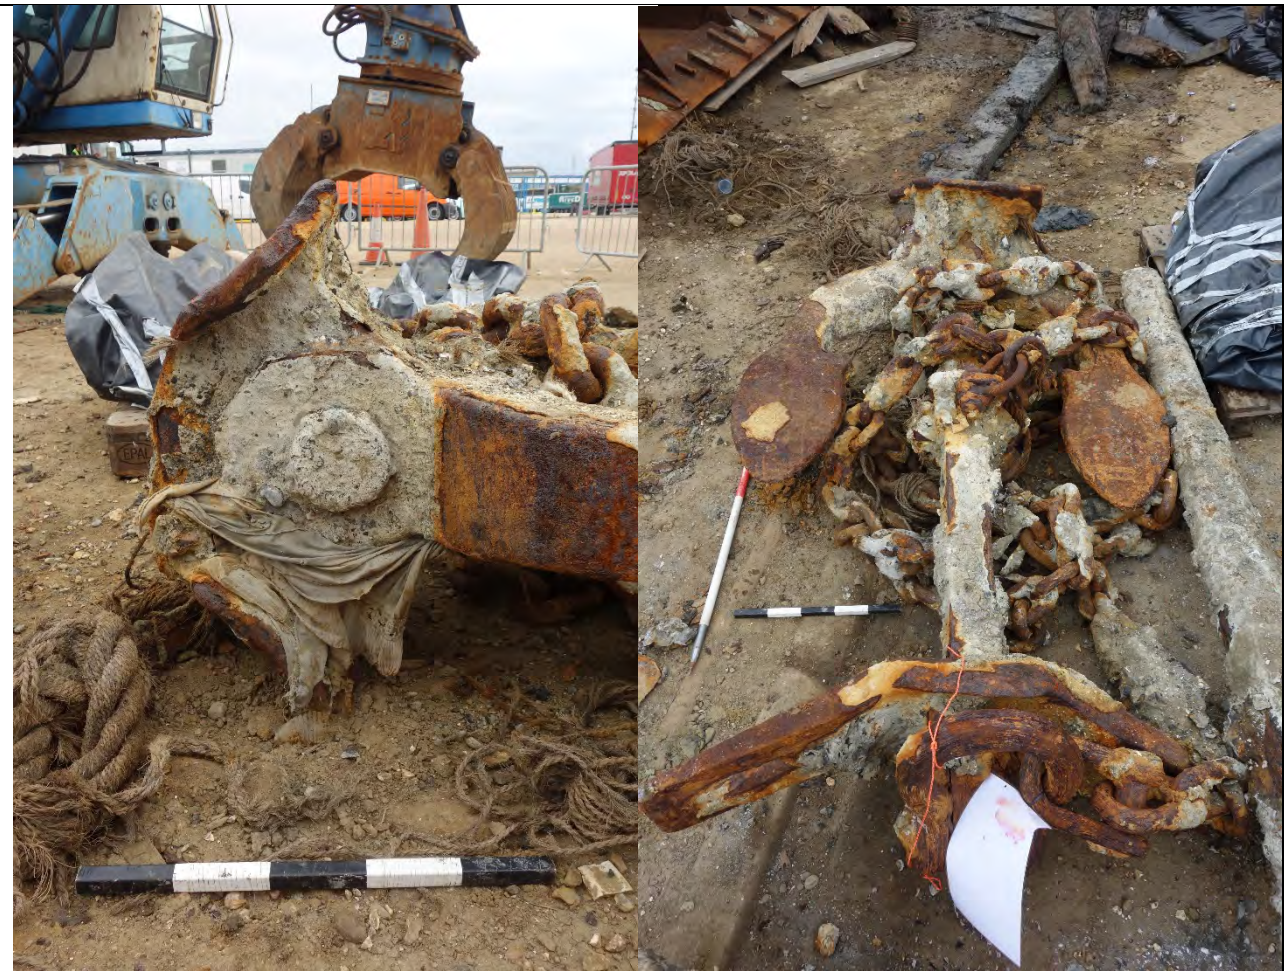
This is the second anchor of this type to have been found during these works (the first was BWL1\_0001). The anchor is likely to have been made by Brown, Lenox & Co. Ltd, who were based originally in Pontypridd, Glamorgan. The design was approved by Lloyds in 1892, so it is probable it was made after this date. The company manufactured chains, cables, anchors, and moorings for the Admiralty and for others. They were the main supplier of chain to the Admiralty until 1916, although the factory did not close until 2000. No markings were found on the anchor and it may have been lost or abandoned, although it is just as likely that it was used as a mooring.

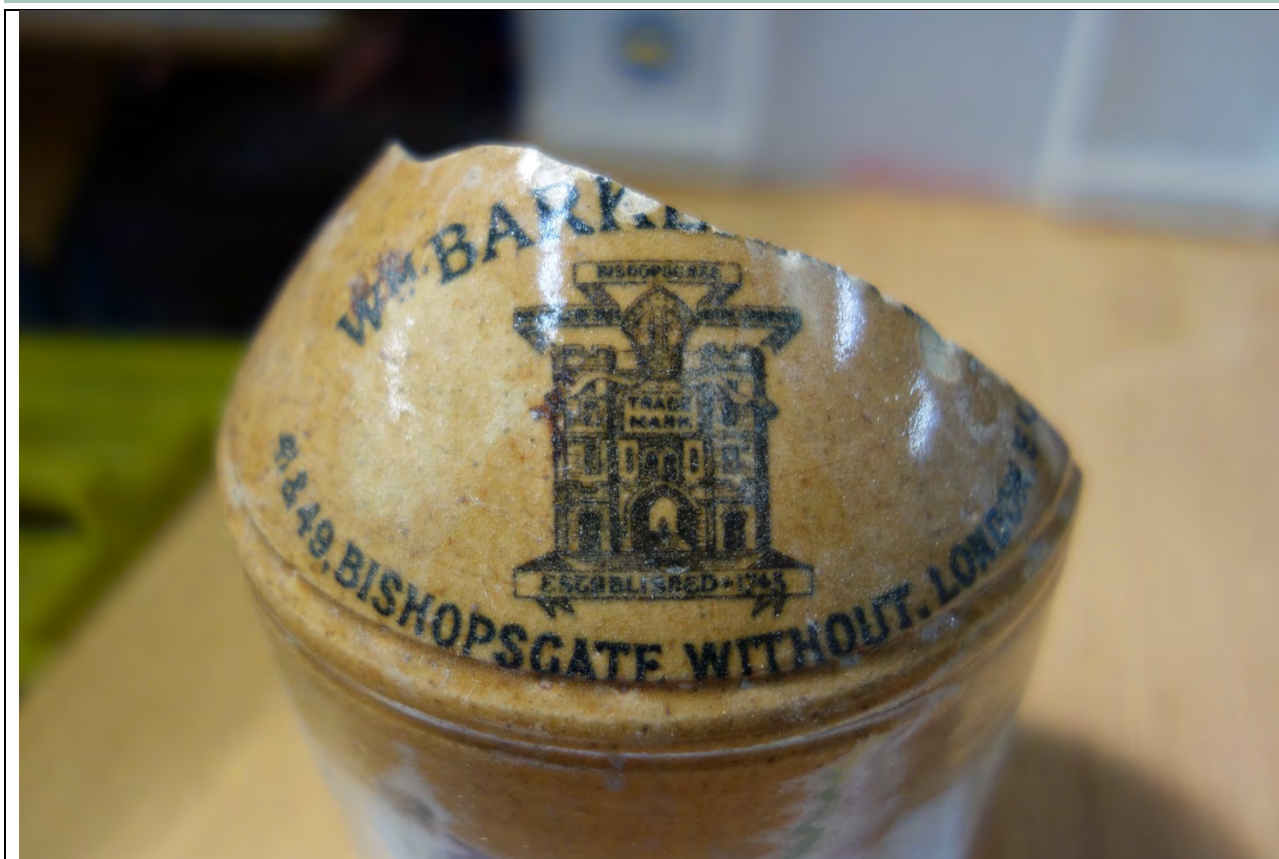
The jug is made of a ceramic known as stoneware. It measures 197 mm in height with a diameter of 124 mm. The remains of a handle are visible just below the missing section, and the ceramic measures 7 mm thick in this area. On the shoulder of the jug there is writing for W.M. Barker 41 & 49 Bishopsgate Without, London, and a logo of a large gateway with a bishop's mitre.

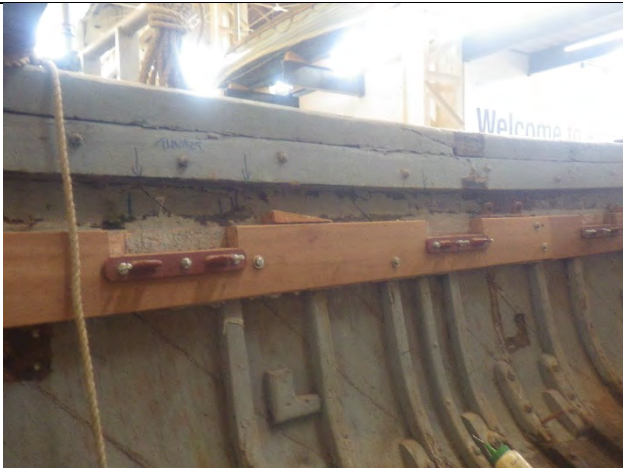
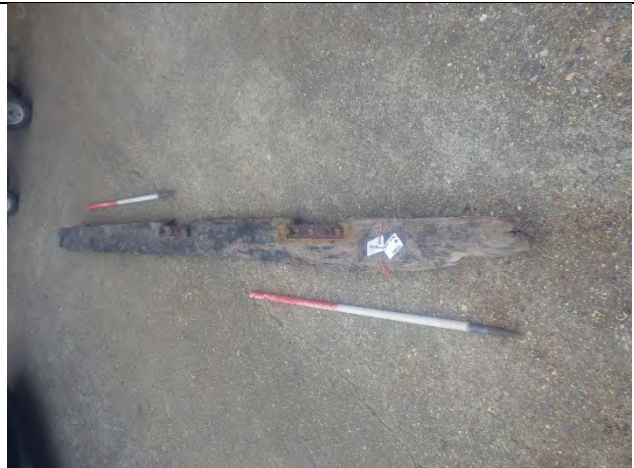
**Rising timber. As seen (left) sits on top of the framing and is also the end of the internal frames.**

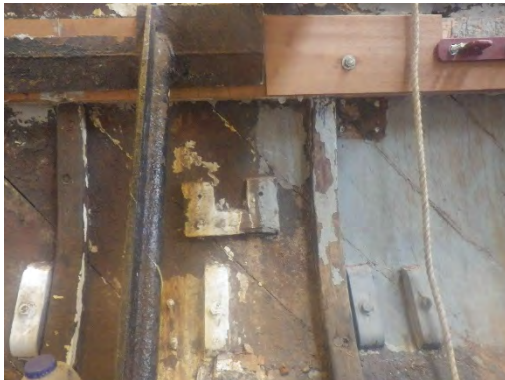
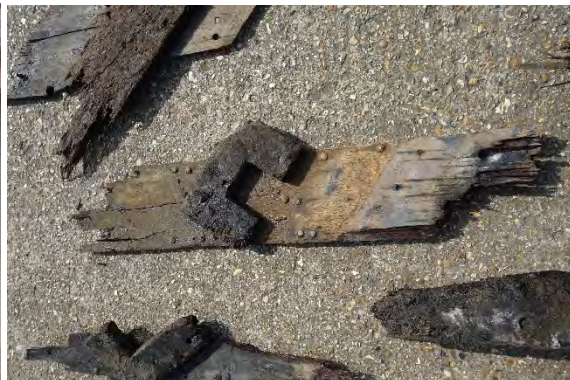
**Stretcher bracket.**

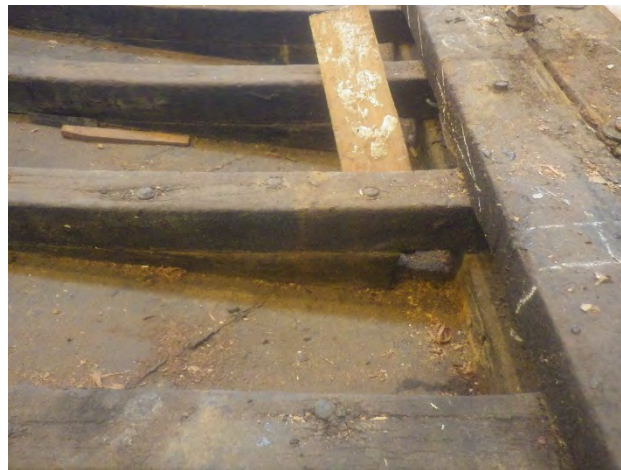
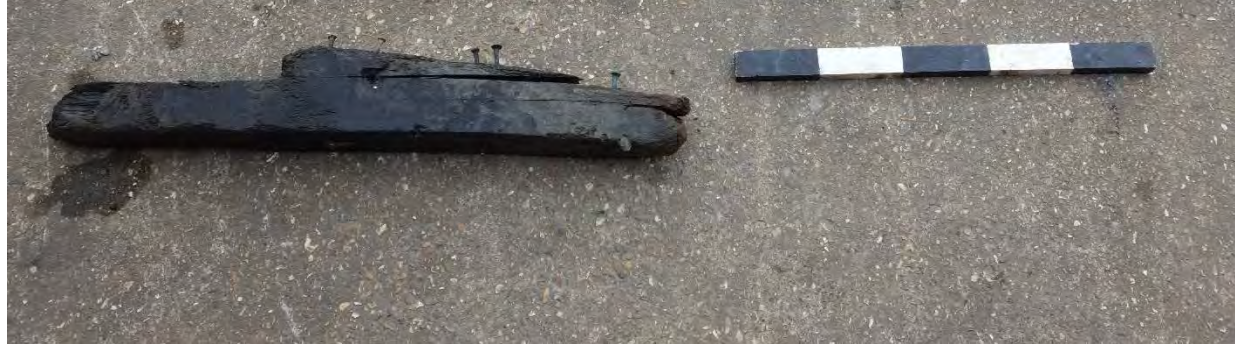
Frame and sliver seen on Cyclops and example recovered from BWL9\_0057

A partial and fragmented wooden wreck site was located during pre-dredge clearance and recovered by grab. The remains of the vessel are timber with copper fastenings. The wreck is incomplete with no confirmed timbers from the bow or the stern. The vessel may have been more complete on the seabed but due to the type of recovery the remaining structure has become disarticulated.

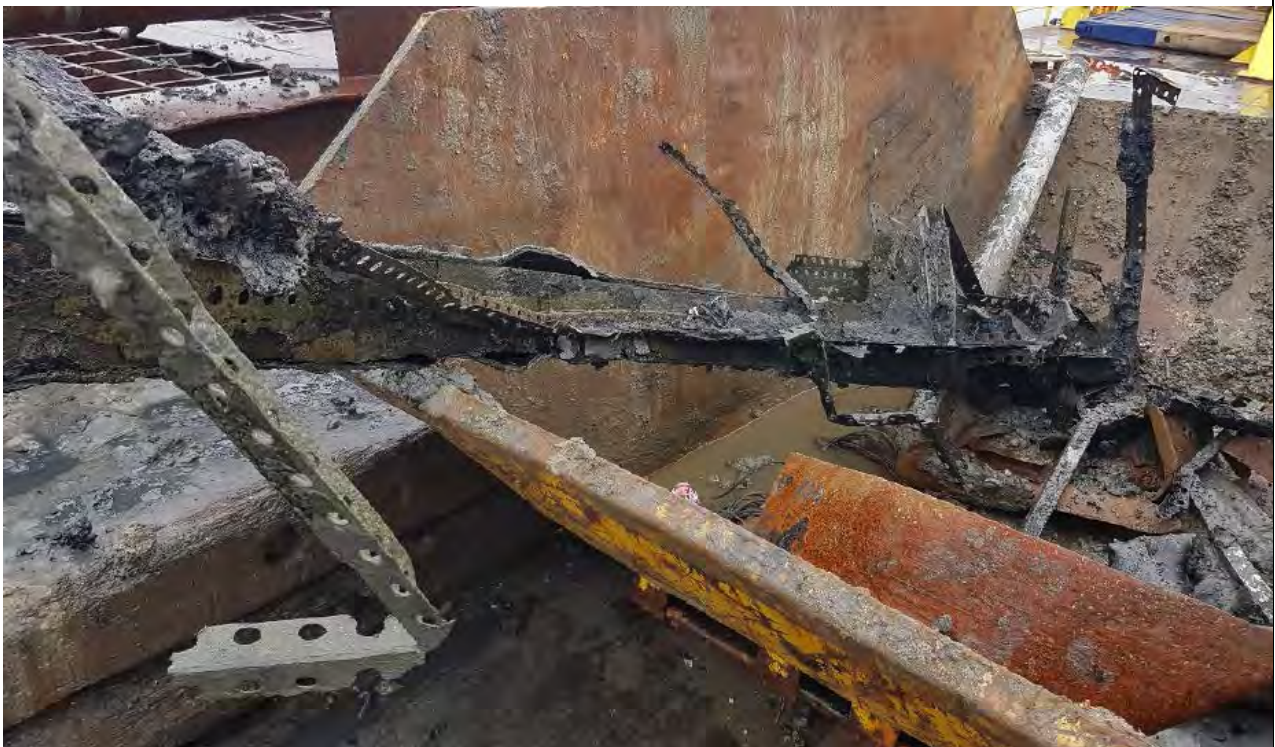
<b>UID</b> BWL1_0071	Metal structure	
<b>Date of Discovery</b>	19/12/2016	
<b>How Discovered</b>	Recovered by grab on board <i>Stemat 87</i>	
<b>Position of Discovery (British National Grid)</b>	..... E	..... N
<b>Location Map</b>	<b>Anomaly Image</b>	
N/A	N/A

Without being able to examine the object, interpretation becomes difficult. It is possible that this is a piece of a small boat, possibly a keel with framing. The use of regular rivets to hold the structure together with some larger bolts visible running horizontally through the main part of the structure. There is also the possibility that this is a piece from a small iron or steel vessel, likely the keel. This may have been from a small lightly built vessel but the loss of this structure would have resulted in sinking. There is no sign of a wreck site has been found which may suggest that the wreckage is from elsewhere, having been dragged in by a fishing trawler or similar marine activity. Another possibility is the MoD, who may have used a small vessel for firing practice. The area should be reviewed closely during further dredging work in case any additional wreckage is found in the area.
