# Queen Elizabeth Class Capital Dredge Project Her Majesty's Naval Base, Portsmouth

Archaeological Assessment Report

Ref: 111320.05  
January 2018

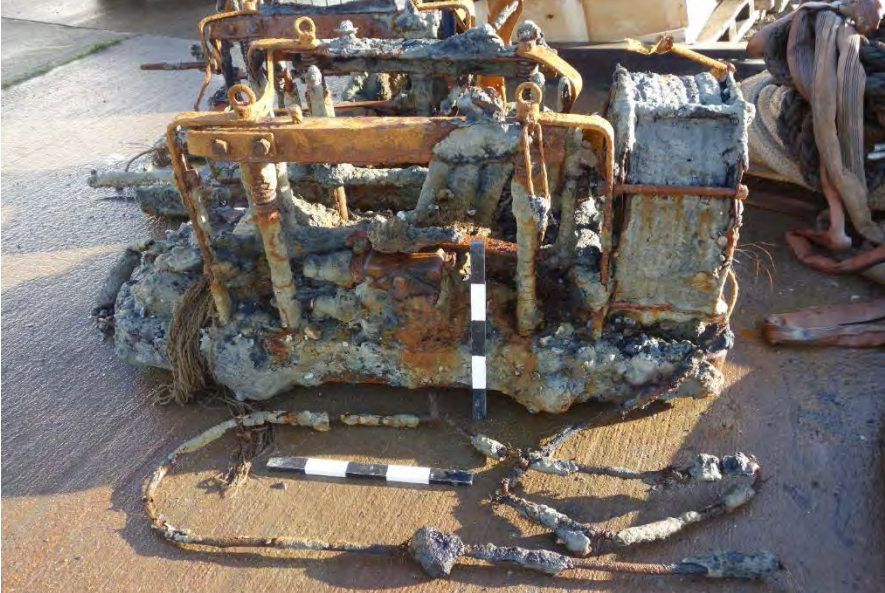
Two near identical objects recovered close to one another. The base of the objects measures 1660 x 620 mm; the overall height of the objects is 720 mm. One of the objects has a cable drum in place, while the other is visibly damaged at the mountings and the drum is missing. The cable drum contains 19 mm steel cable and the drum itself measures 620 mm in diameter with a depth of 260 mm.

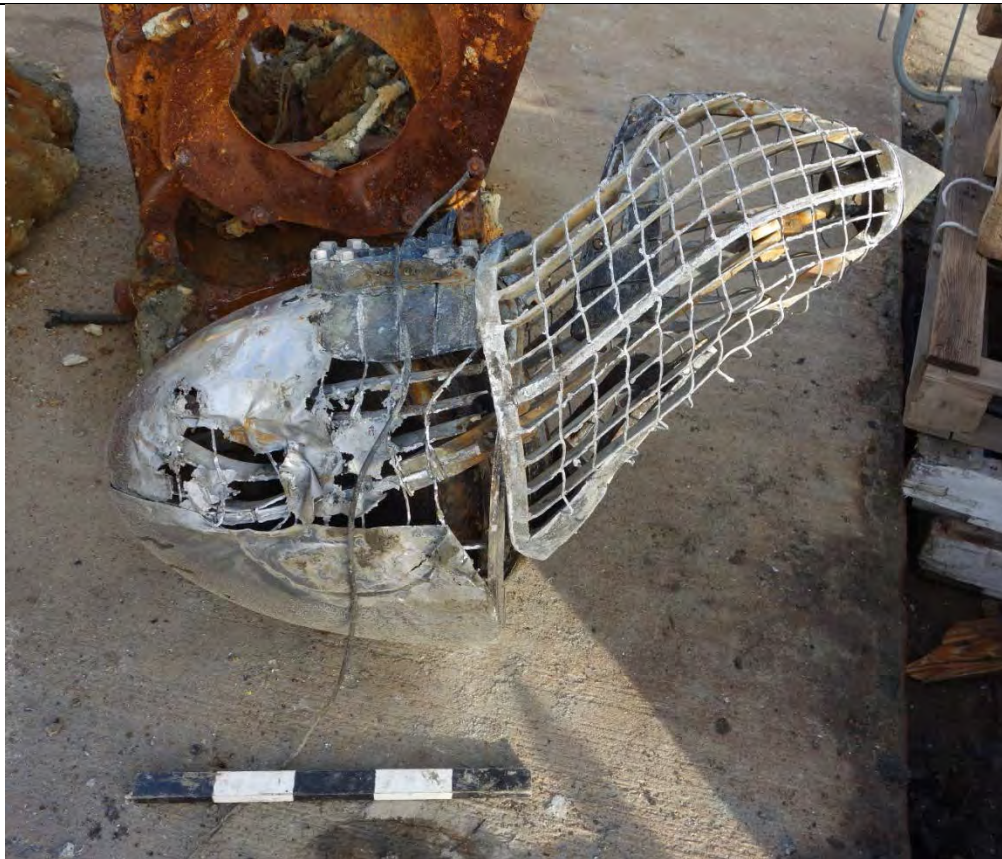
<b>UID</b> BWL1_0076	Aircraft Automatic Direction Finder	
<b>Date of Discovery</b>	31/12/2016	
<b>How Discovered</b>	Recovered by grab during clearance by <i>Stemat 87</i> barge.	
<b>Position of Discovery (British National Grid)</b>	..... E	..... N
<b>Location Map</b>	<b>Anomaly Image</b>	
N/A	N/A

An aluminium object with a cone shape on one end and a domed end. The cone has been bent and crushed to mis-shape the object. The inner frame can be seen on the coned end where the aluminium coating has been lost. On the top of the object there is a mounting bracket that looks to have sheared off. From the top of the mounting there are two wires that would have connected the object to the inside. Inside the centre of the object there is a large disc that fills the diameter of the object. The disc does not spin in its current condition, but looks to have been mobile when in working order.

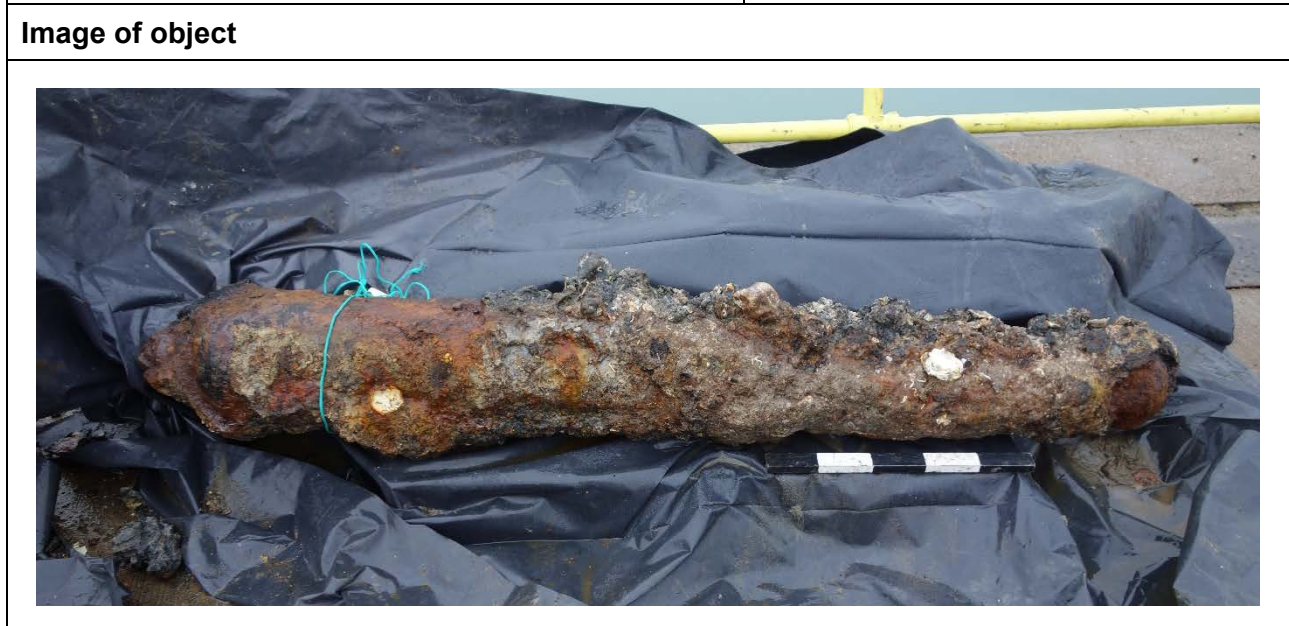
<b>UID</b> BWL1_0078	Cannon	
<b>Date of Discovery</b>	26/01/17	
<b>How Discovered</b>	Recovered by grab on board <i>Stemat 87</i> during pre-dredge clearance.	
<b>Position of Discovery (British National Grid)</b>	<b>462434.17 E</b>	<b>100298.29 N</b>

Small smooth bore cast iron cannon. This gun is largely covered in concretion and its dimensions are obscured by this. Estimated length from the unconcreted muzzle face to the estimated position of the base ring is 2.02 m, which suggests that this is a 6 foot 6 inch gun. The gun is largely covered with concretion, obscuring features such as mouldings. Areas which are exposed are well worn and the trunnions are partially intact being worn to stubs.

The tampion is in place, which suggests that the gun was still in service when it came to be deposited on the harbour bed, although the surface of the gun is worn and the trunnions survive only as stubs. The cannon may have been used as ballast or possibly as a mooring anchor once the gun came to the end of its working life. The area in which it was recovered is a historic anchorage during the 19th century and may have been used as such prior to this.

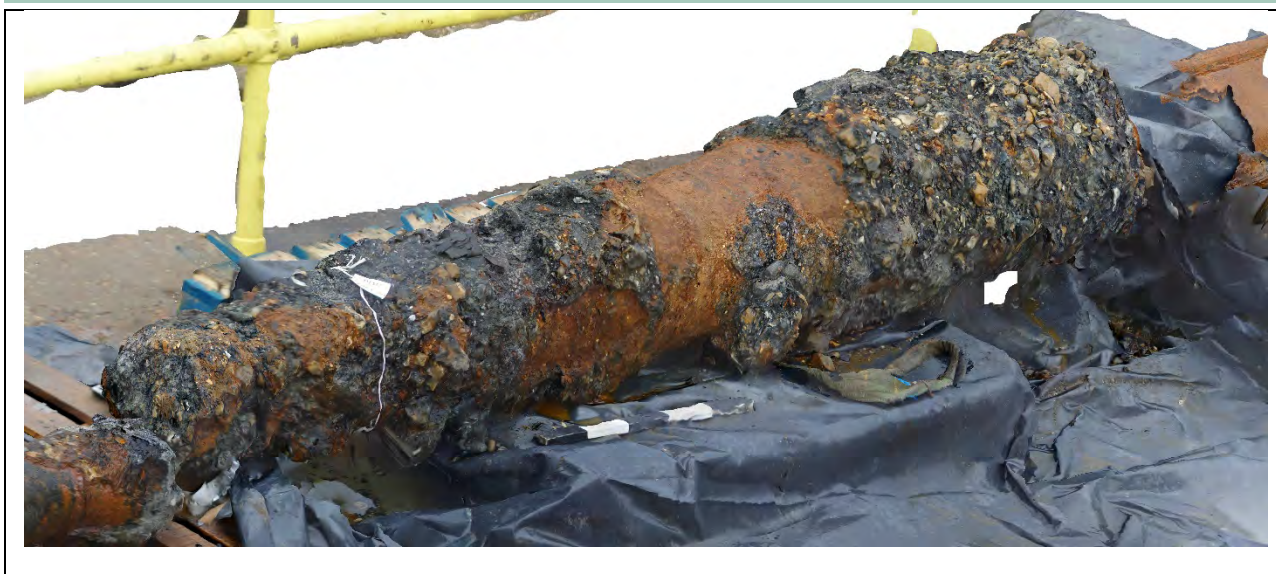
Smooth bore cast iron cannon. This gun is largely covered in concretion. Total length is 2.63 m, although the length by which guns are compared (muzzle face to base ring) is 2.485 m. The gun is largely covered with concretion, obscuring features such as mouldings and the muzzle head and face. Areas which are exposed are well worn, both trunnions are intact, one is covered by concretion.

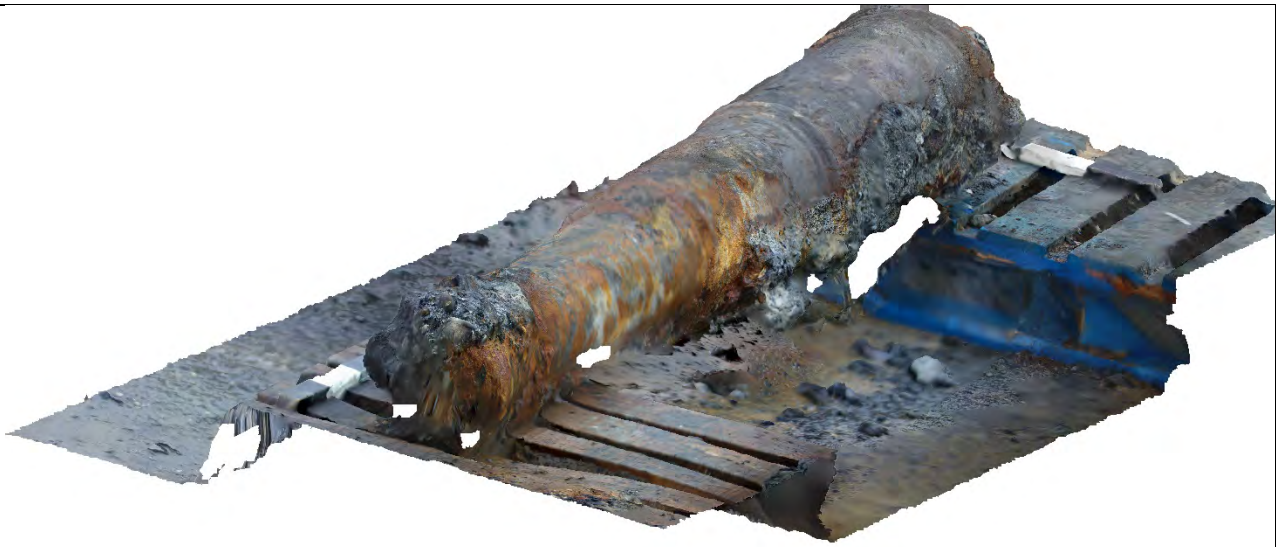
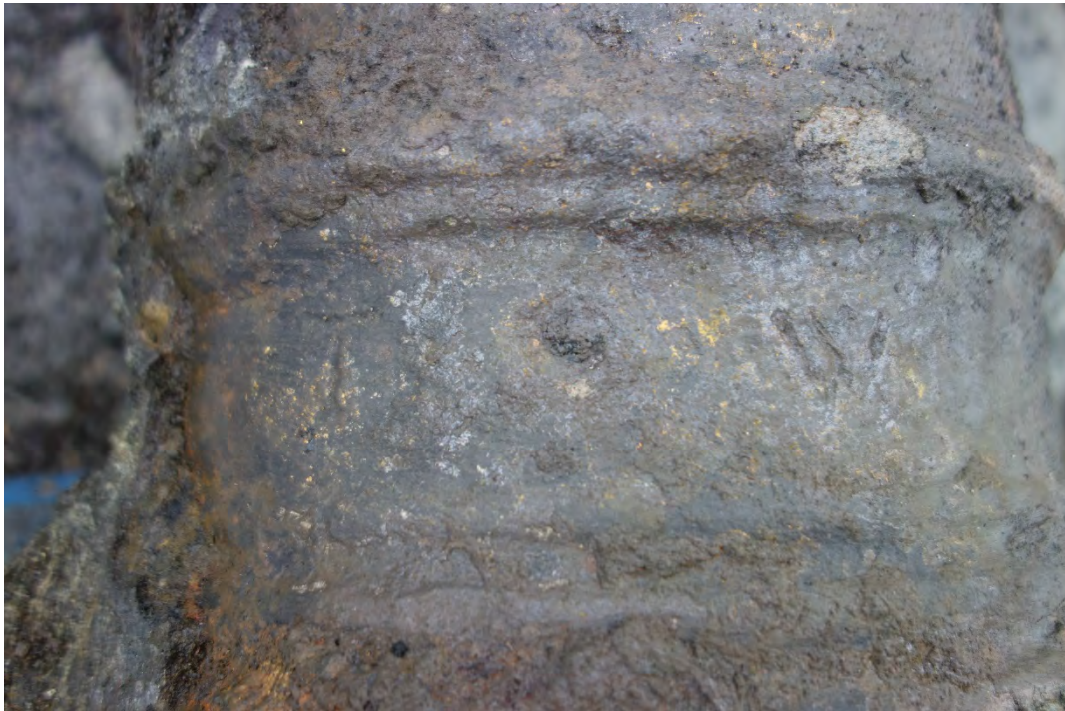
The markers mark "TW" positioned either side of the touch hole

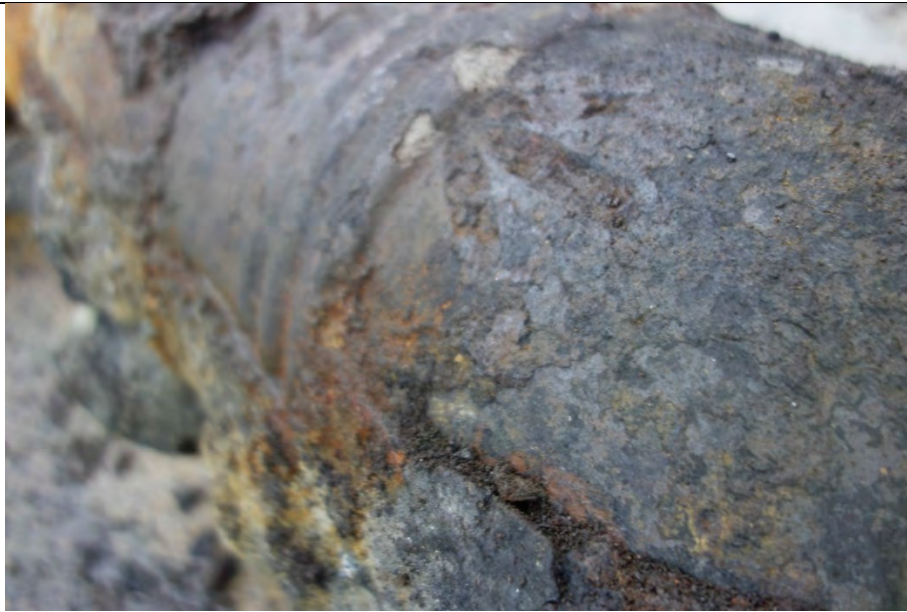
Royal Navy Broad arrow

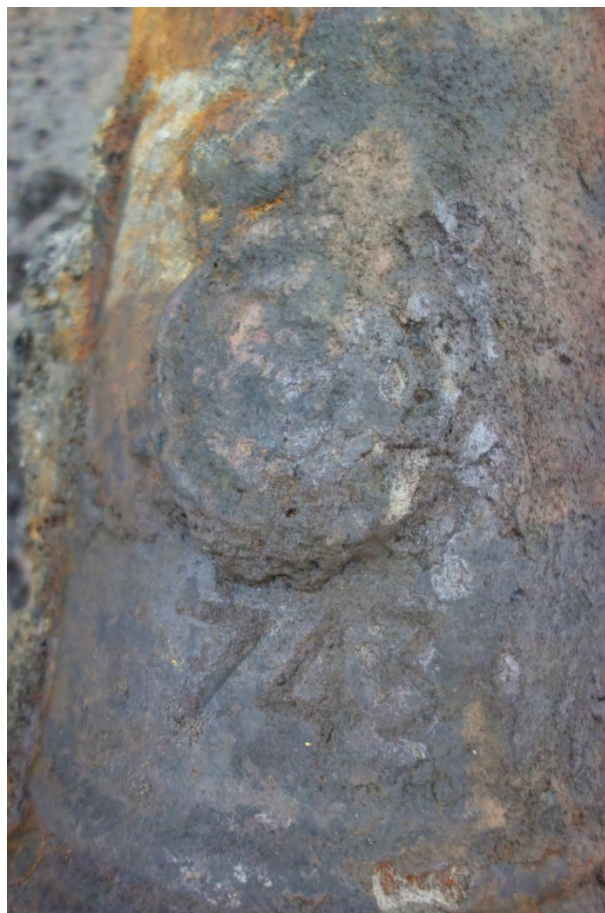
The Royal monogram possible of Queen Anne (rose and crown) and the Board of Ordnance number below "743"

There is a Royal monogram on the second reinforce. Too concreted to be readable, this would require careful cleaning by a specialist to remove the concretion, although it also looks quite worn. The outline looks vaguely like that of Queen Anne (1702-14). This would narrow the date range for the gun.

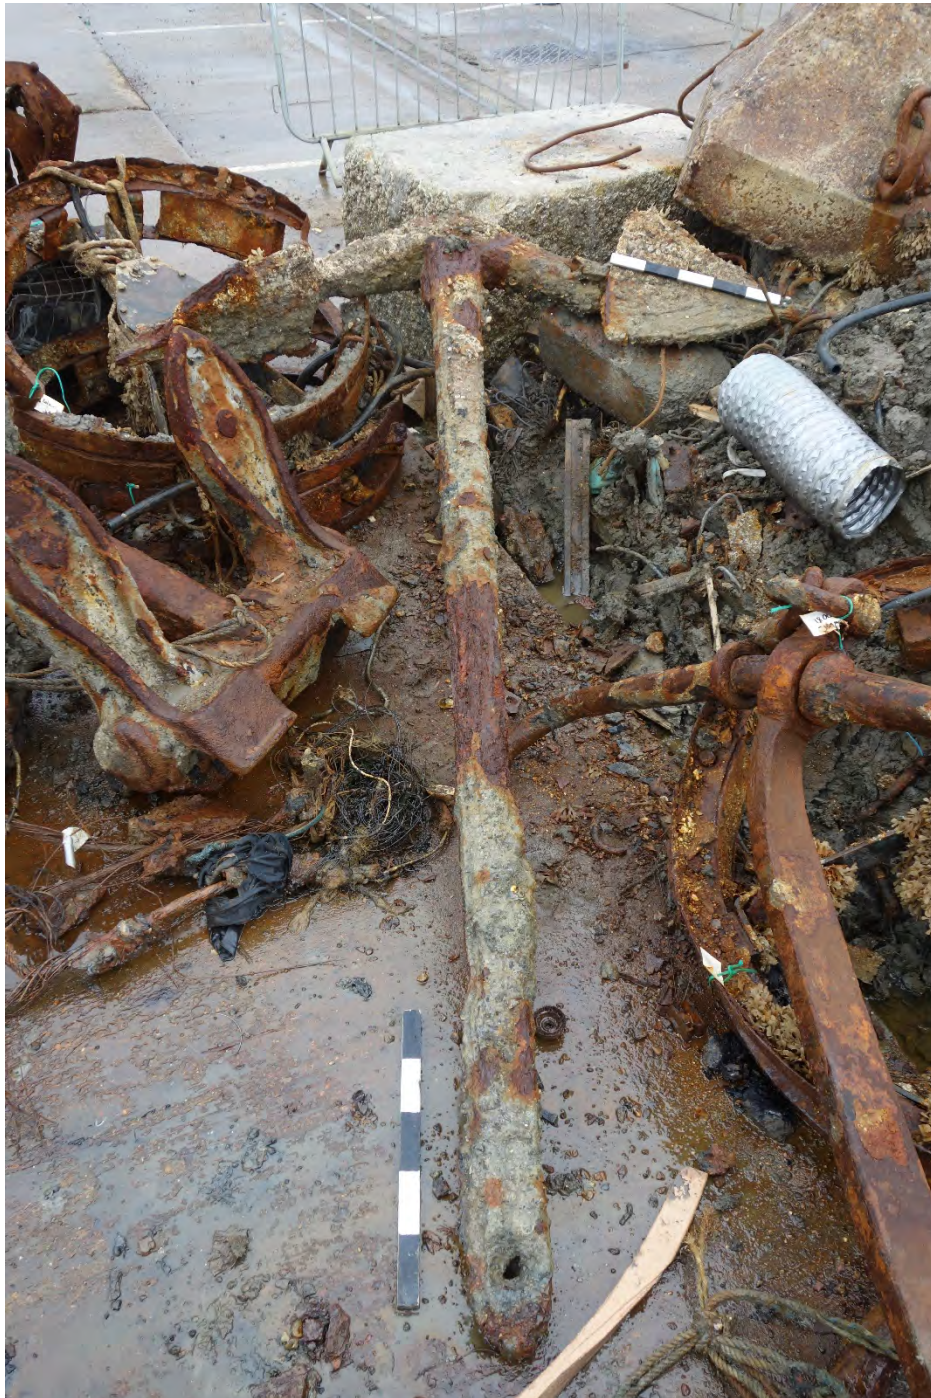
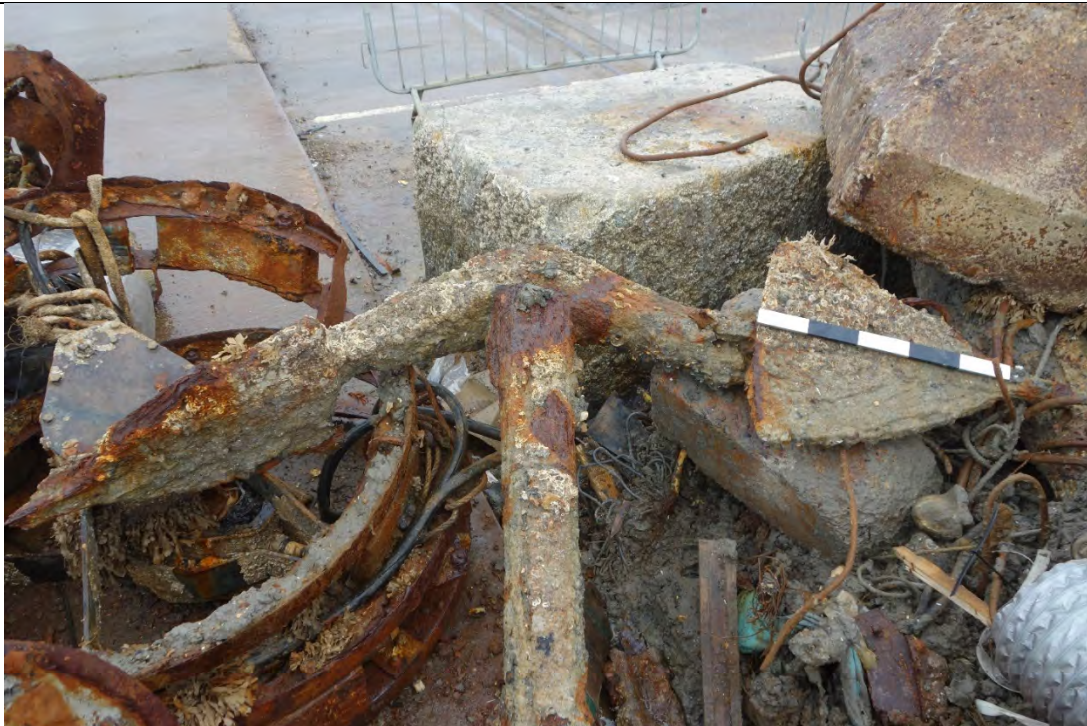
The anchor is made of iron and would have had a wooden stock which has been lost. The shank is 2810 mm in length with a rounded square profile. The ring has a diameter of 40 mm. The area of the shank where the stock would have attached is rectangular in section measuring 100 x 90 mm. At the midpoint of the shank it measures 120 x 100 mm and at the crown the shank is 170 x 140 mm. The crown is angular and has a depth of 210 mm. From the crown to bill, the arms measure 1160 mm long. The bill to centre measurement is 920 mm and the height of the bills is 660 mm, the tipped spade flukes measure 490 x 450 mm, while the bills extend out 120 mm and are 50 mm wide. One of the fluke has bent round into a right angle from its original position.

The anchor is an old pattern angle crown admiralty long shank. It would have been fitted with a wooden stock. These types of anchors were commonly used in the late 18th century until the middle of the 19th century. The design was replaced by the Improved Admiralty long shank which used curved arms in c.1840.

The straight arms of the old pattern anchor were a common issue, causing many anchors to be damaged while attempting to weigh anchor. This issue was solved with the introduction of curved arms on the Improved Admiralty anchor.

This anchor is likely to have belonged to the Royal Navy and has been discarded after becoming damaged.

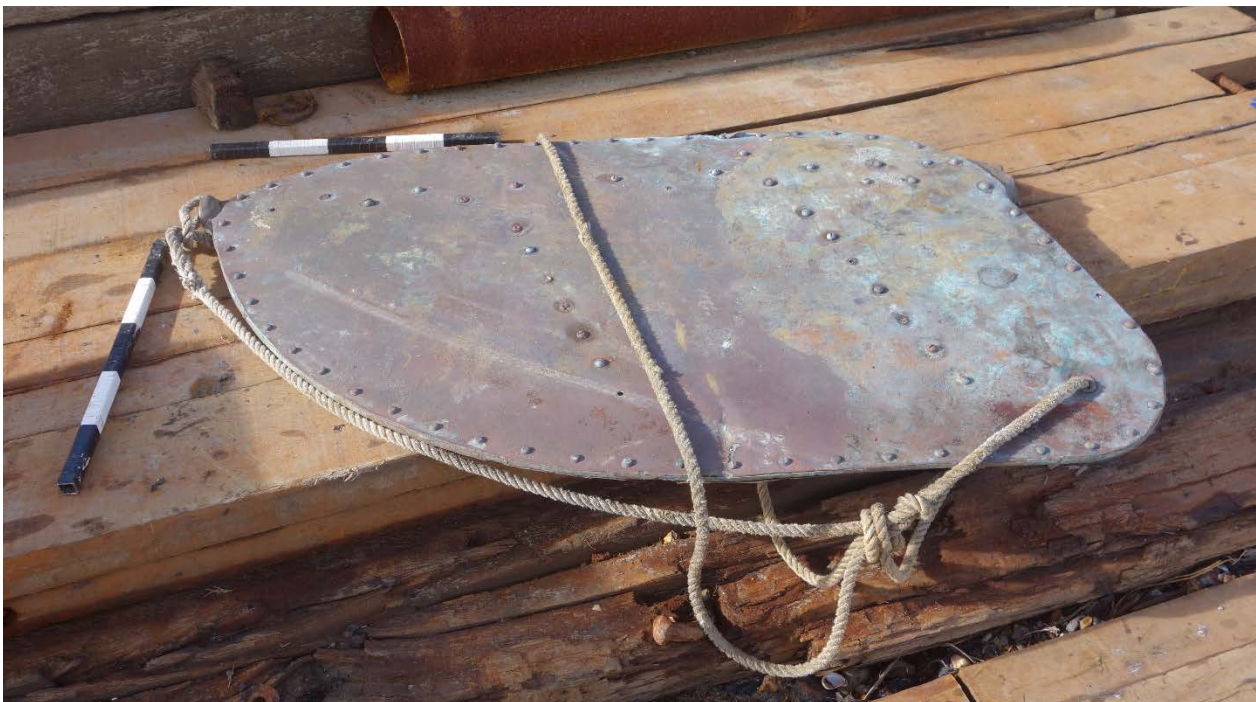
<b>UID</b> BWL1_0083	Balanced Spade Rudder	
<b>Date of Discovery</b>	11/02/17	
<b>How Discovered</b>	Recovered by grab on board <i>Stemat 87</i>	
<b>Position of Discovery (British National Grid)</b>	<b>462634.93 E</b>	<b>100545.11 N</b>
<b>Location Map</b>	<b>Anomaly Image</b>	
N/A	N/A

**Note:** The rope in the picture was from the recovery of the object.

This is a balanced spade rudder, it would have attached via a stock at the top of the blade and again at the base. Balanced spade rudders have a reduced drag compared to the skeg mounted rudder. The balance of the rudder is referring to the position of the stock in relation to the width of the rudder, by placing it  $\frac{3}{4}$  back creates a more balanced and efficient rudder movement. It is a common construction type with a wooden core, copper alloy frame and then plated in a copper alloy, this would have been to protect the rudder from wood borers and salt water corrosion. This is the third of this type of rudder to have been found during the dredging of Portsmouth harbour (BWL1\_0057 and BWL1\_0070) both of which were similar in construction and more interestingly very similar in size. They may have come from very similar vessels. This may suggest that these rudders became damaged and were replaced with the harbour.

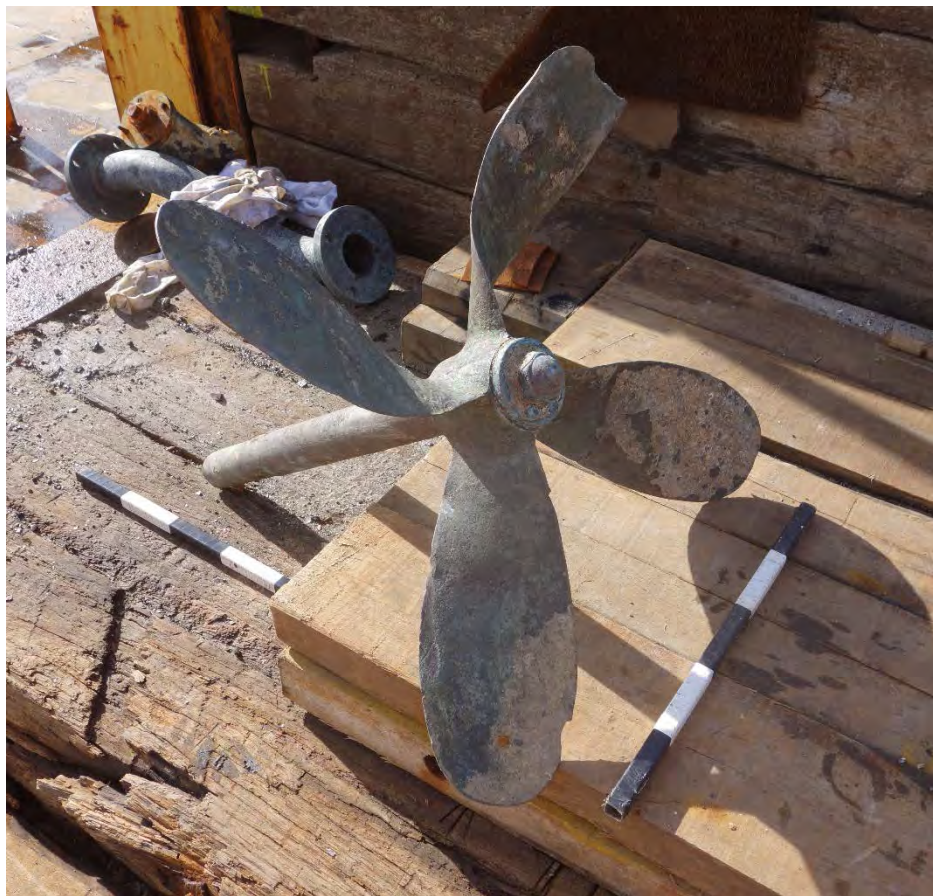
<b>UID</b> BWL1_0084	Boat propeller	
<b>Date of Discovery</b>	11/02/2017	
<b>How Discovered</b>	Recovered by grab and found during Quayside Archaeological Monitoring.	
<b>Position of Discovery (British National Grid)</b>	..... E	..... N
<b>Location Map</b>	<b>Anomaly Image</b>	
N/A	N/A

<b>Description</b>			
Copper or brass fixed pitch propeller. One of the blades has been damaged, becoming bent and losing its tip. The prop shaft has been broken at the forward end. The prop shaft measures 560 mm in length and 62 mm in diameter. The propeller itself measures 815 mm across with each blade measuring 362 mm and a maximum width of 165 mm. The central bolt has a diameter of 50 mm.			
<b>Interpretation</b>			
The propeller may have come from several vessel types, possibly relating to fishing, or judging by the find location, possibly military. The propeller looks although it has been in a collision, possible with the seabed or upstanding rocks, bending one of the blades. The propeller was likely replaced and the old one has been discarded in to the harbour. It is also possible that a boat has lost the propeller whilst motoring within the harbour.			
<b>Period</b>	Modern	<b>Date Range</b>	20th Century

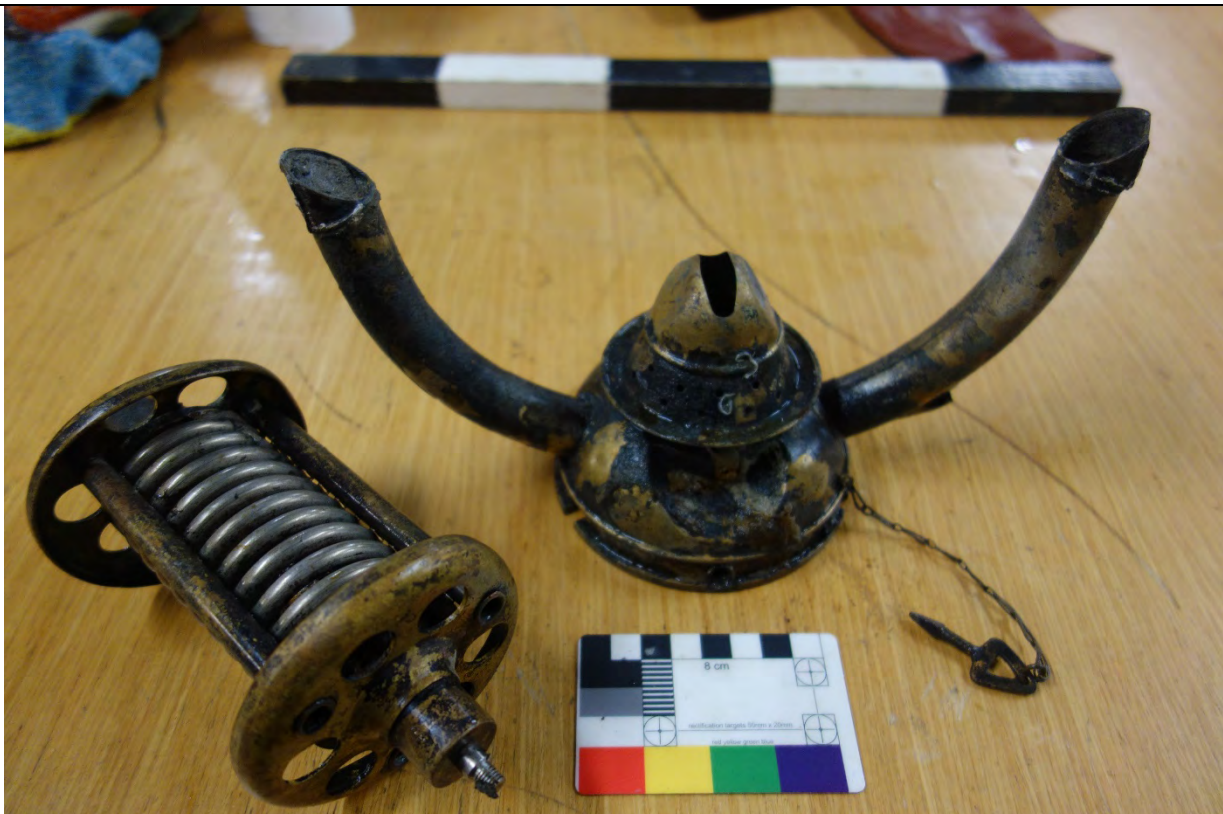
The top section of an oil lamp burner, consisting of the collar, wick raiser, burner and shade holders. The object has a maximum width of 260 mm and a height of 150 mm.

The function of the other object is unclear but it has been suggested that it is a buffer spring similar to what is found within a clutch plate used for shock absorption, but again the machinery it would be from is unclear.

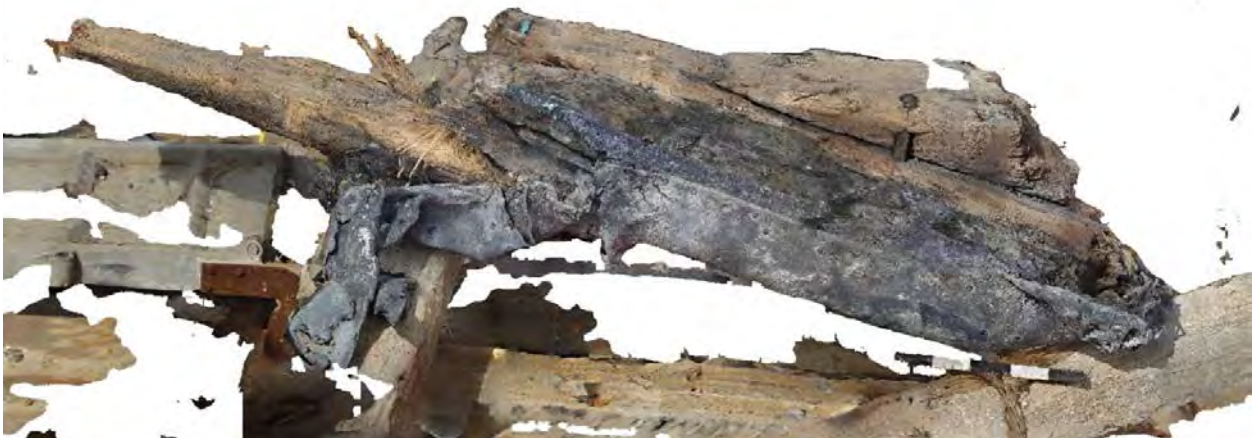
Photogrammetry model of BWL1\_0092 from the opposite side, showing the additional lead sheathing or hawse pipe to the bottom left

There are several possible interpretations for this timber, none of which are conclusive, the condition and limited evidence prevent a conclusive interpretation.

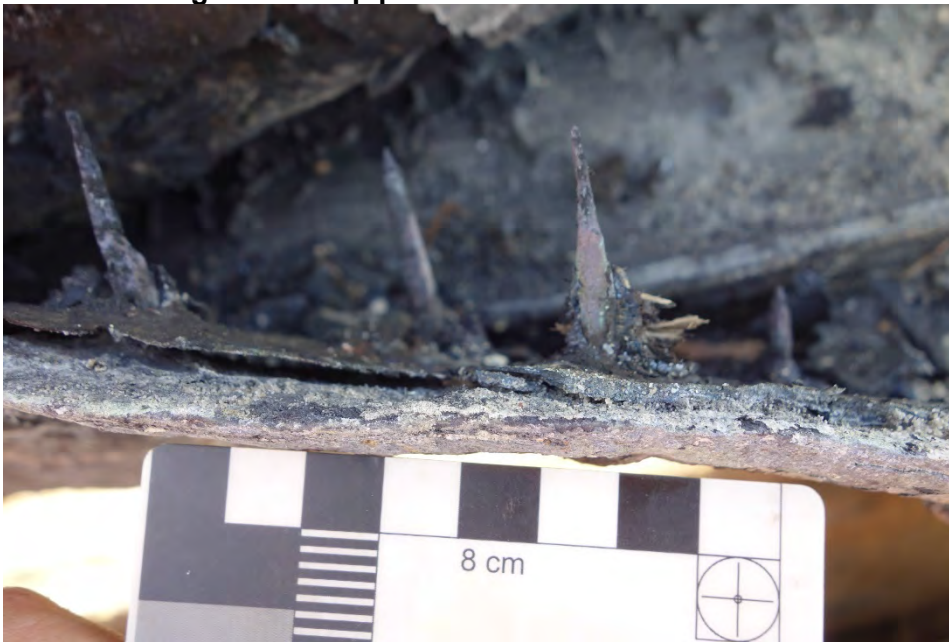
Lead sheathing profile and a thin layer of copper sheathing in between the lead and the timber.

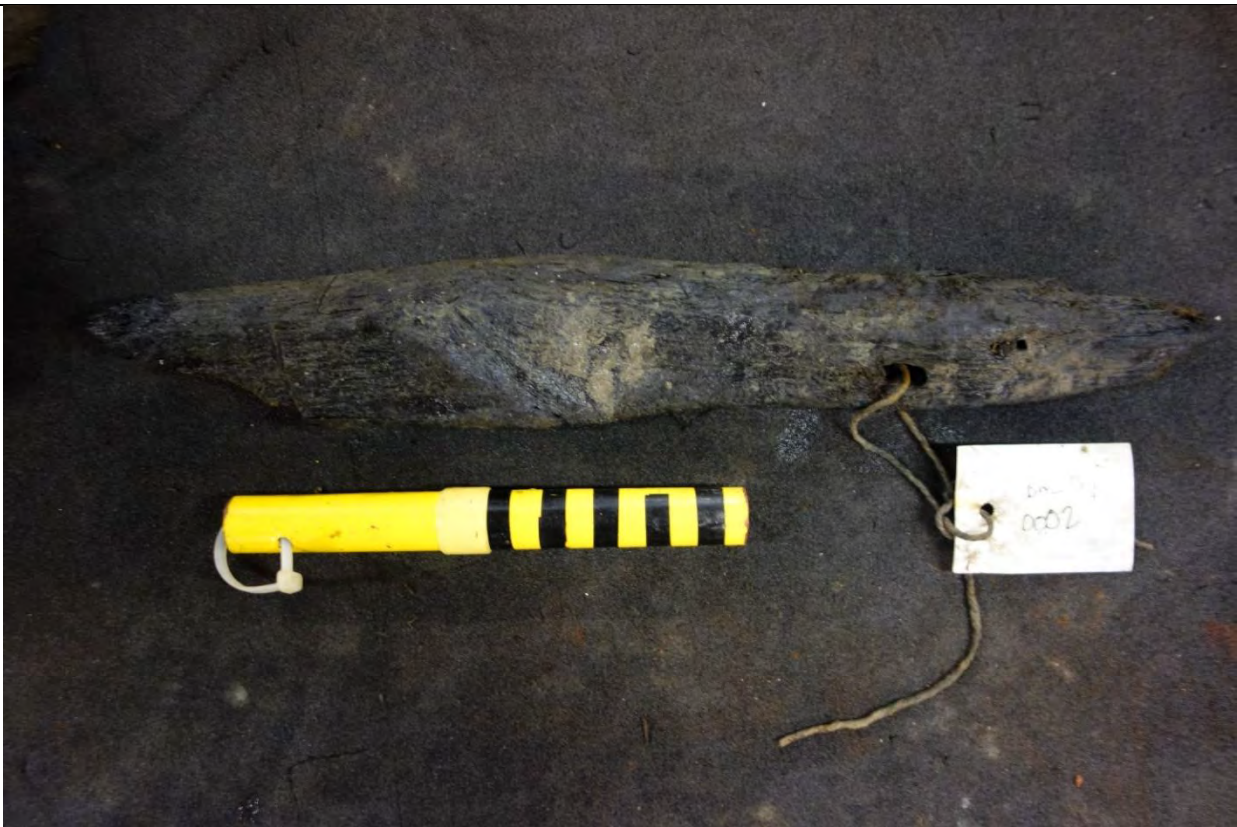
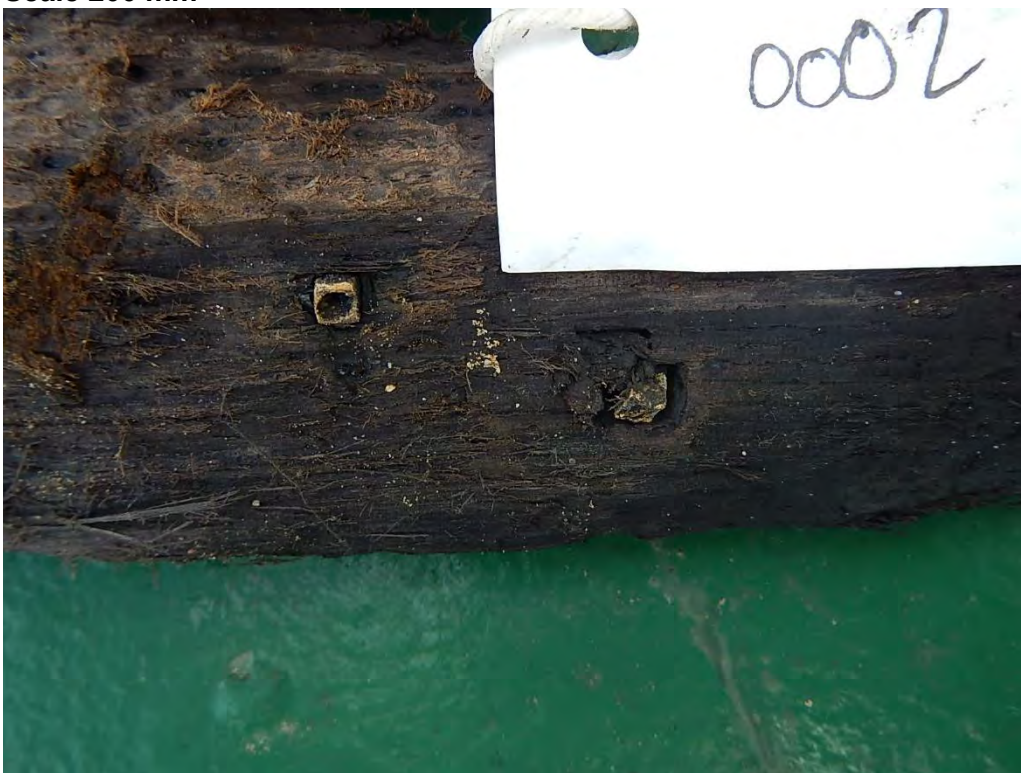
Scale 200 mm

This timber is a maximum of 420 mm long, 65 mm wide and 45 mm high. It is in very poor condition with evidence of wood borer activity. There is one brass nail through the cross section of the timber and treenail holes at various locations along the length of the timber.

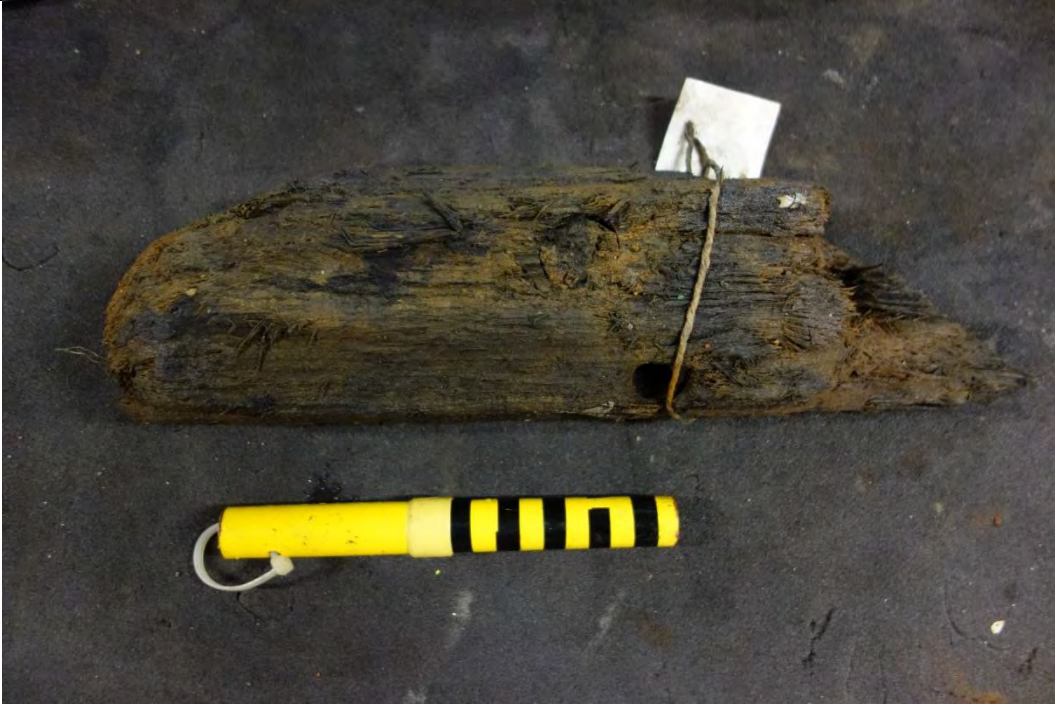
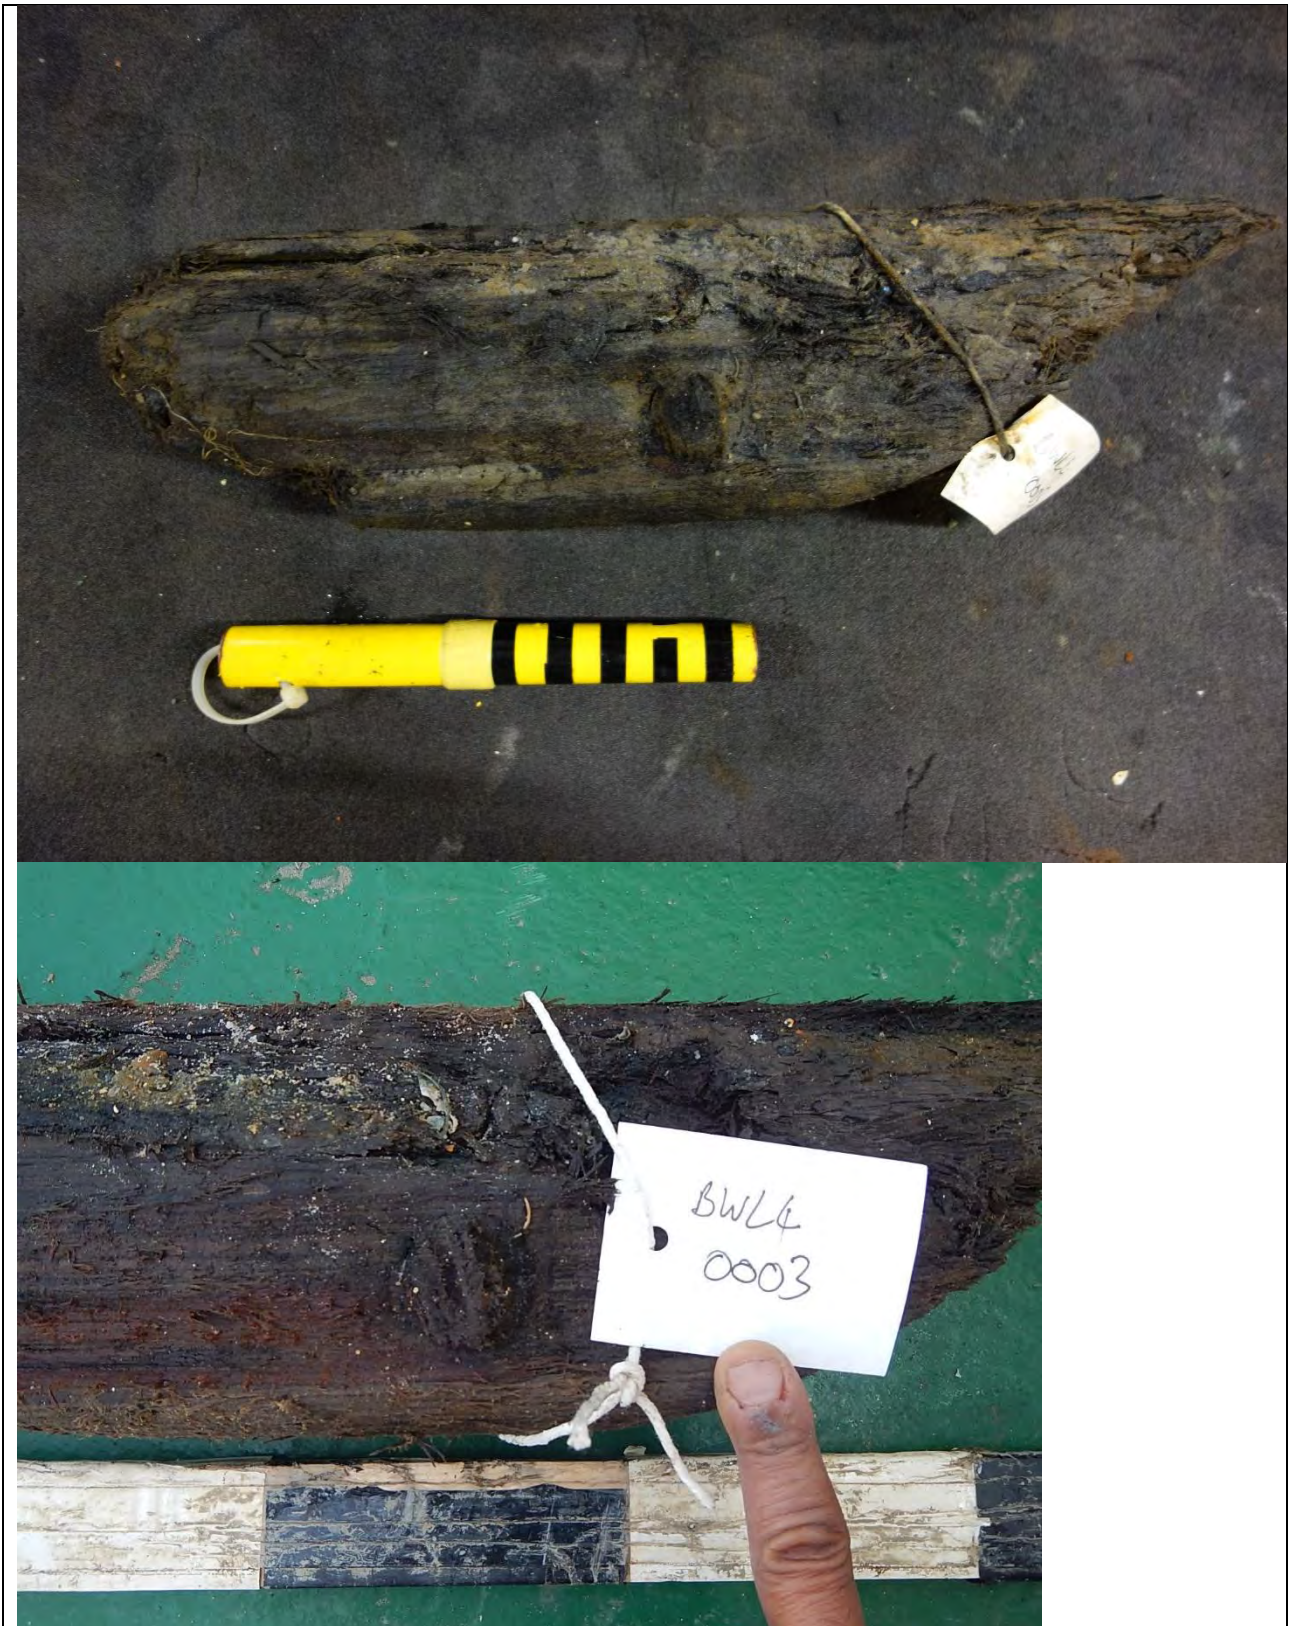
<b>UID</b> BWL4_0003	Worked Wood with treenail	
<b>Date of Discovery</b>	05/08/2016	
<b>How Discovered</b>	Retrieved from drag head during dredging	
<b>Position of Discovery (British National Grid)</b>	..... E	..... N
<b>Location Map</b>	<b>Anomaly Image</b>	
N/A	N/A	
<b>Images of object</b>

This timber is a maximum of 405 mm long, 80 mm wide and 75 mm high. It has a 30 mm diameter treenail towards the edge of the shortest remaining side and a 16 mm treenail hole very close to the longest edge. It is straight grained with no tree rings or marks and is in very poor condition.

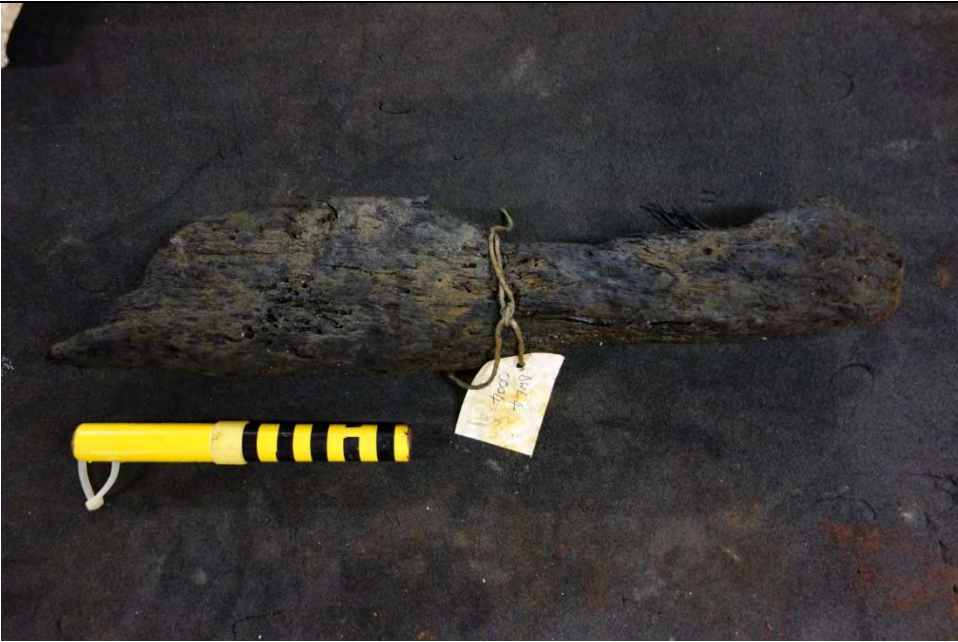
<b>UID</b> BWL4_0004	Worked Wood with treenail	
<b>Date of Discovery</b>	05/08/2016	
<b>How Discovered</b>	Retrieved from drag head during dredging	
<b>Position of Discovery (British National Grid)</b>	..... E	..... N
<b>Location Map</b>	<b>Anomaly Image</b>	
N/A	N/A	
<b>Images of object</b>

This timber is a maximum of 500 mm long, 70 mm wide and 86 mm high. It has a 28 mm diameter treenail towards the edge of the shortest remaining side and a partial treenail hole towards what would have been the middle of the timber prior to weathering. It is straight grained with no tree rings or tool marks or original surfaces and is in very poor condition.

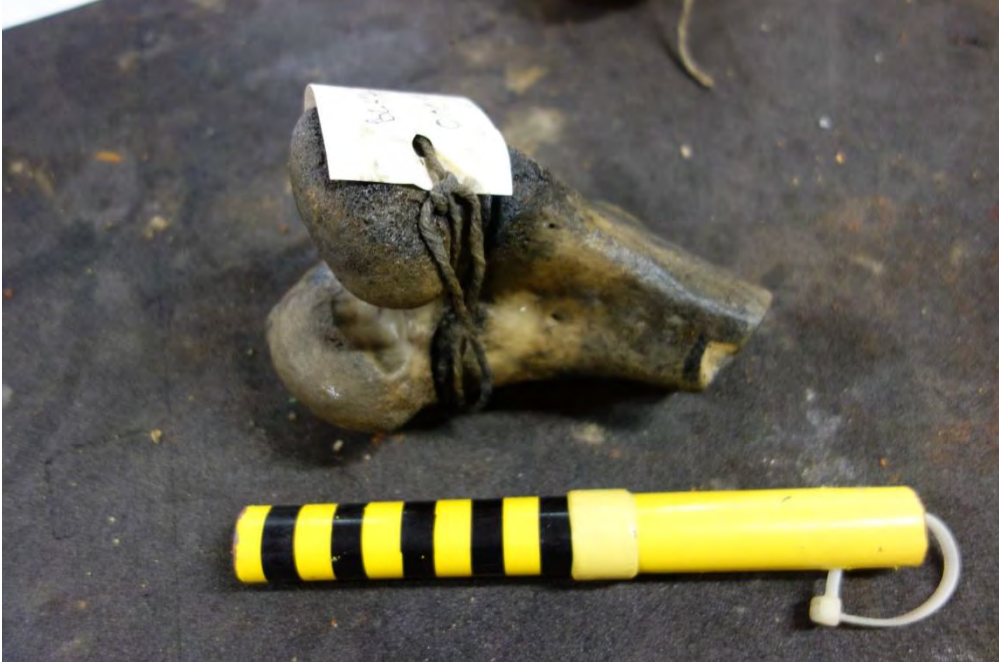
<b>UID</b> BWL4_0009	Cut bone	
<b>Date of Discovery</b>	27/08/2016	
<b>How Discovered</b>	Retrieved from drag head during dredging	
<b>Position of Discovery (British National Grid)</b>	..... E	..... N
<b>Location Map</b>	<b>Anomaly Image</b>	
N/A	N/A	
<b>Image of object</b>

<b>Description</b>			
This is the distal end of a femur from a large mammal, probably cattle, that has been purposely cut. It has a maximum length of 135 mm and is 100 mm wide and 47 mm thick at the cut end which is also broken. There are no other butchery marks.			
<b>Interpretation</b>			
Remains of a long bone from a large mammal that was either part of a shipboard meal or cargo.			
<b>Period</b>	Unknown	<b>Date Range</b>	Unknown

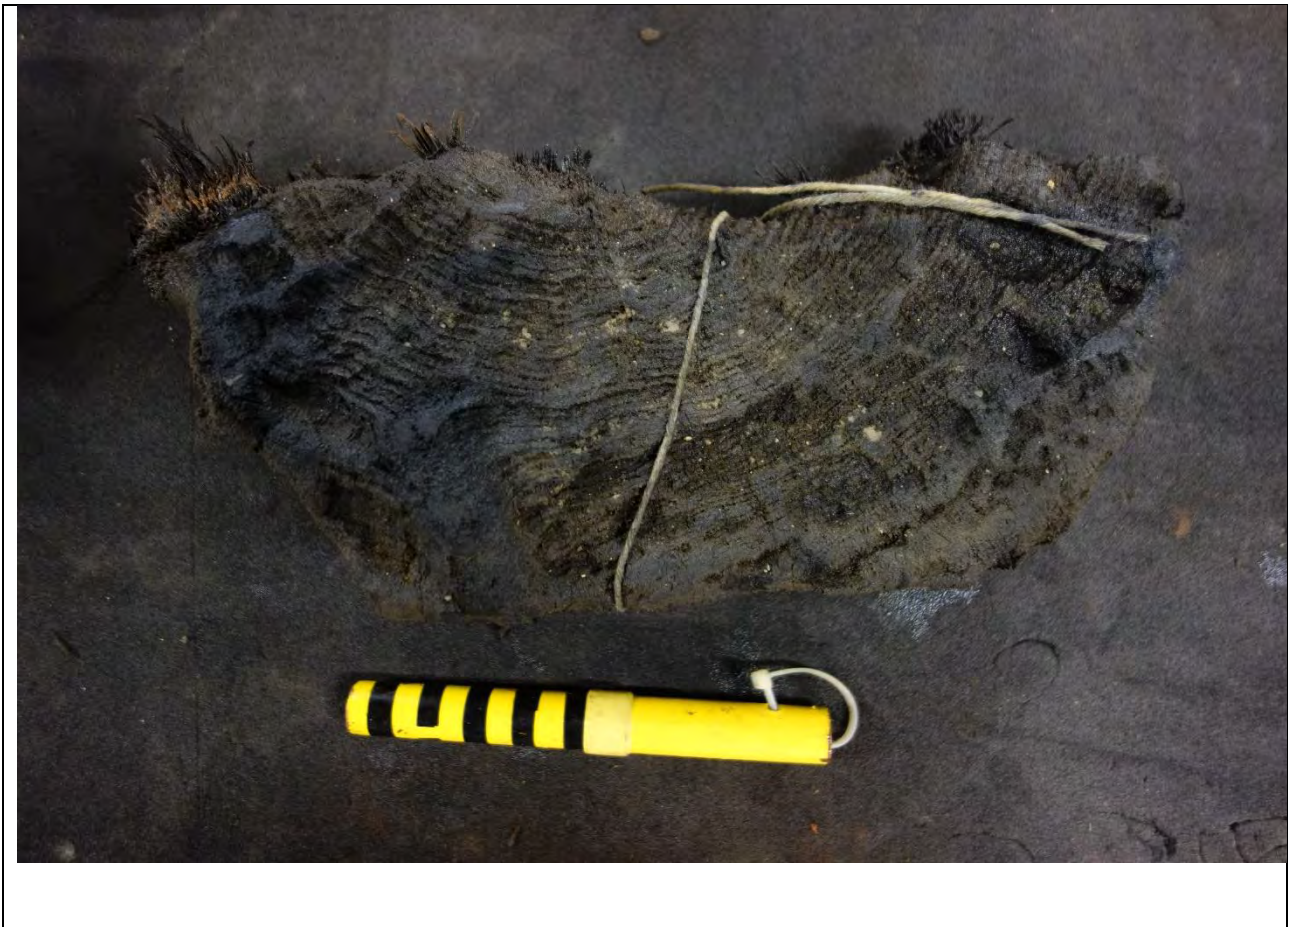
Section of worked timber with maximum length of 390 mm with a maximum width of 150 mm and thickness of 130 mm. Overall it is somewhat trapezoidal in shape and roughly represents half of the cross section of a tree trunk. The tree rings that are visible on the cross section of the timber show that the longest face of this find is just on the outside of the heartwood. The three shorter sides of the trapezoid show signs of being sawn. There are also saw marks evident on two sides perpendicular to the tree rings. In total there are seven sides of this find that show saw marks. There is no evidence of treenails or nails. The top and the bottom of this find are badly worn.

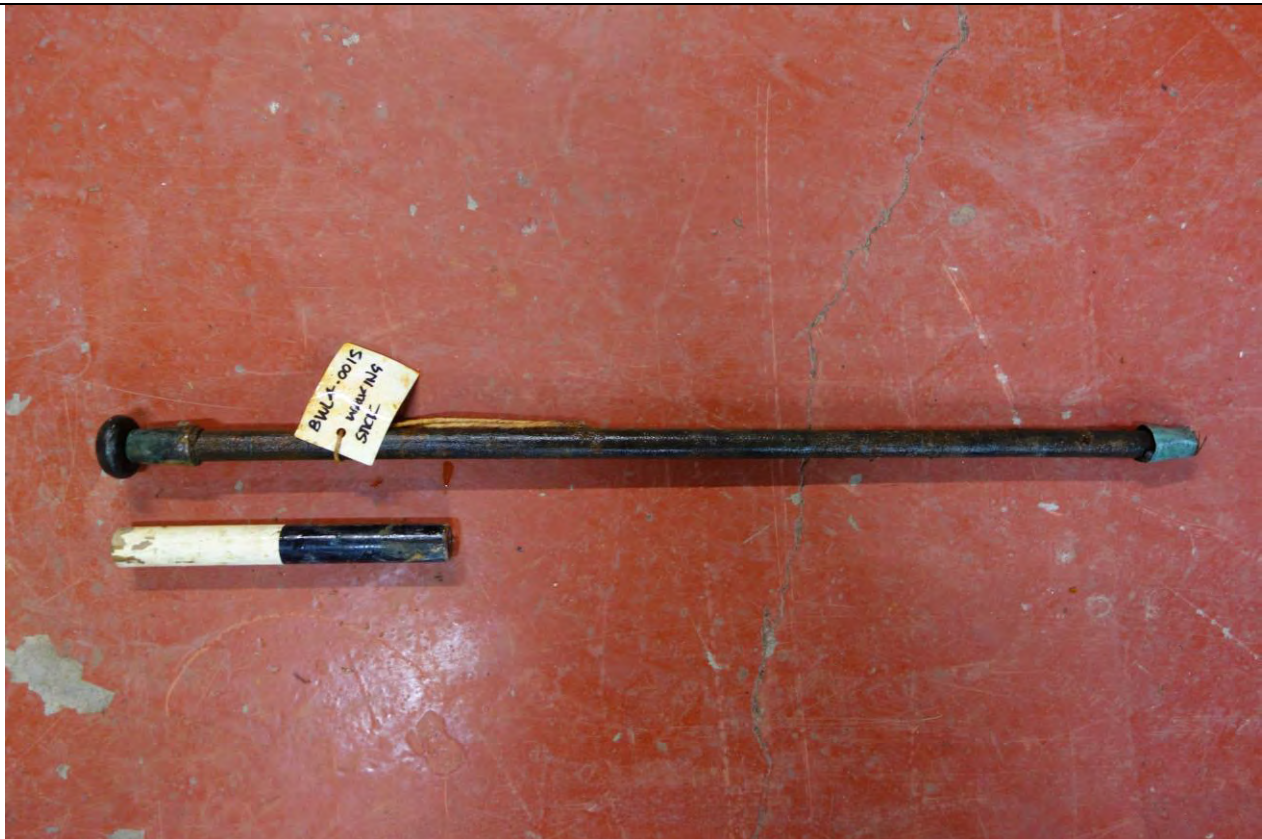
<b>UID</b> BWL4_0015	Flag pole	
<b>Date of Discovery</b>	04/09/2016	
<b>How Discovered</b>	Retrieved from drag head during dredging	
<b>Position of Discovery (British National Grid)</b>	..... E	..... N
<b>Location Map</b>	<b>Anomaly Image</b>	
N/A	N/A

The object is made from both wood and copper. It measures 660 mm in length, the shaft is 17 mm in diameter and the top end is 38 mm in diameter. The shaft is wooden as is the end, which has a two ring design etched into the top. There are two collars, both made of copper and have a single ring and a double ring design etched into both. There is a ring of pale green staining roughly two thirds the way down the shaft, which may suggest a third copper hoop was present.

A possible interpretation for the object is that it is a small flag pole that would have been positioned over the stern of a vessel. These are often found on motor launch vessels, and a commonly seen on modern day yachts. The original interpretation of the object was a walking stick, although this may still be the case, the length of the object is too short, although the end of it is clearly broken.
