# Queen Elizabeth Class Capital Dredge Project Her Majesty's Naval Base, Portsmouth

Archaeological Assessment Report

Ref: 111320.05  
January 2018

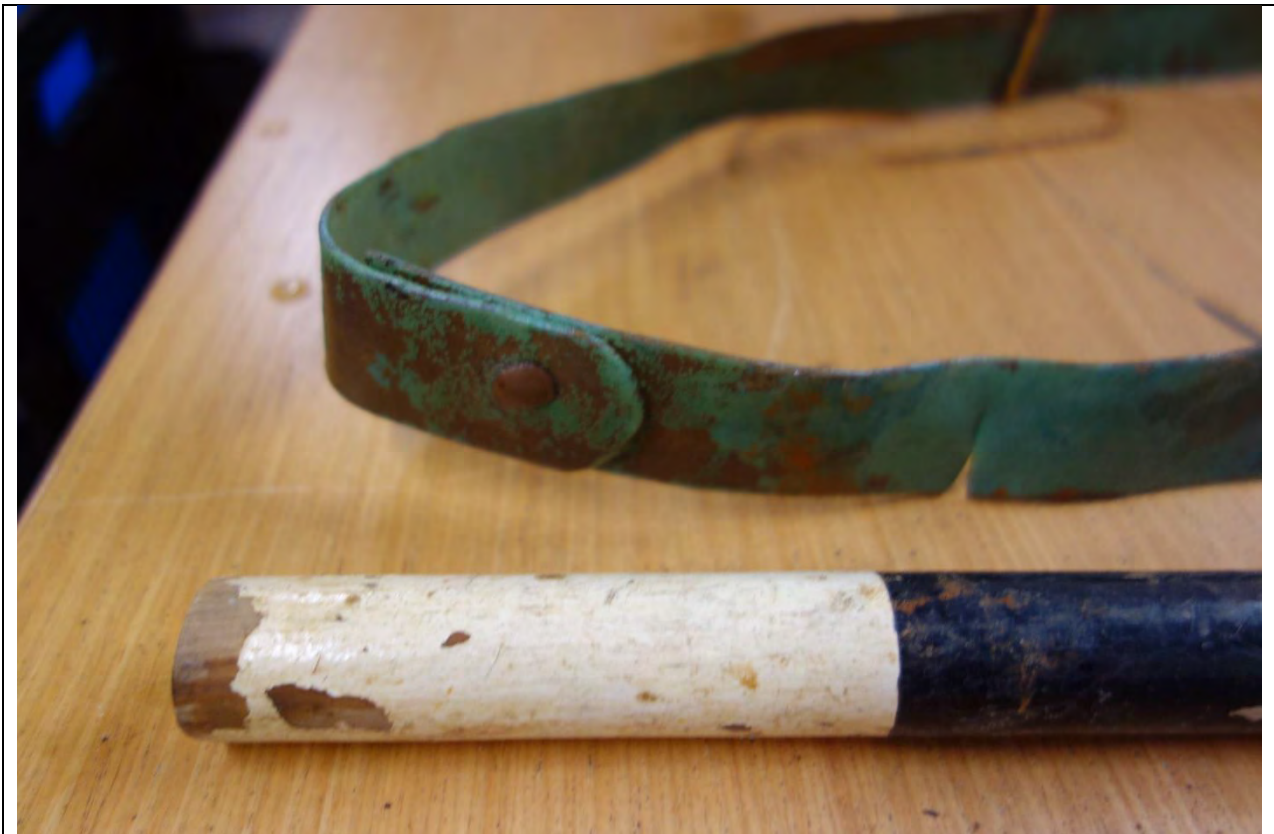
The object is likely to be made from copper. The hoop has a circumference of 1063 mm, a width of 31 mm and a thickness of around 1 to 1.5 mm. Where the two ends meet there is a single rivet holding them together.

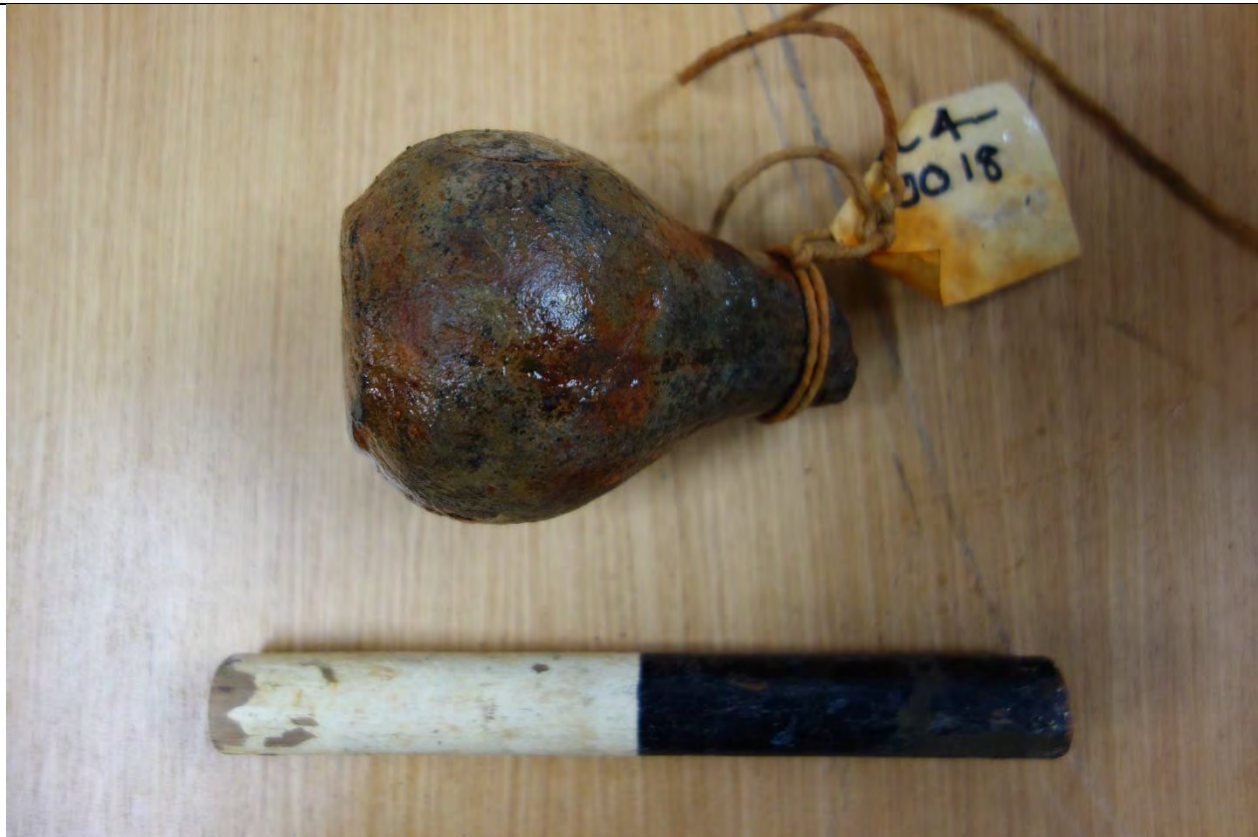
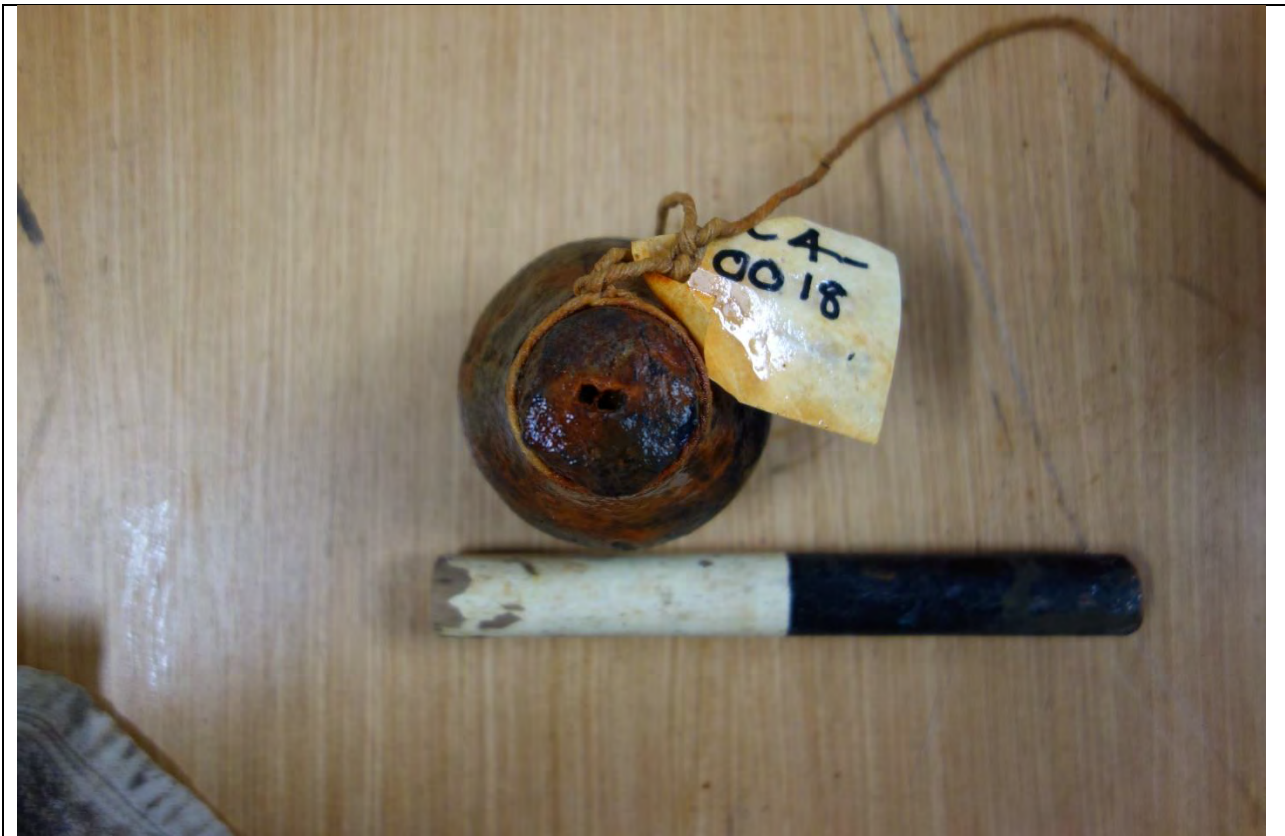
<b>UID</b> BWL4_0018	Balance weight	
<b>Date of Discovery</b>	04/09/2016	
<b>How Discovered</b>	Retrieved from drag head during dredging	
<b>Position of Discovery (British National Grid)</b>	..... E	..... N
<b>Location Map</b>	<b>Anomaly Image</b>	
N/A	N/A

This object is made from cast iron. It measures 111 mm in height, 83 mm at its widest diameter and weighs 6 pounds or 2.7 kg. The base is flattened and is 45 mm in diameter. The teardrop shape narrows to 36 mm in diameter at the top, in which there is a hole, which appears like two holes joined together.

A possible interpretation for this object is that it is a counter balance weight from a hanging slide balance scale. The weight would be attached to the balance arm using a small chain with a hoop around the balance arm to allow it to slide up and down. Along the balance arm there would be units of weight. On the other end of the balance arm would be a hook, from this, goods could be hung and weighed. This sort of scale was common on board all merchant ships and would be found at the docks, shops and manufactures to ensure that they were getting a fair deal. The use of scales is not new, but dates back to before 2000 BC. A common image from Egyptian hieroglyphics is one of a pan balance scale, symbolising justice. All scales in use up until the seventeenth century would have been a variation of the balance scale.

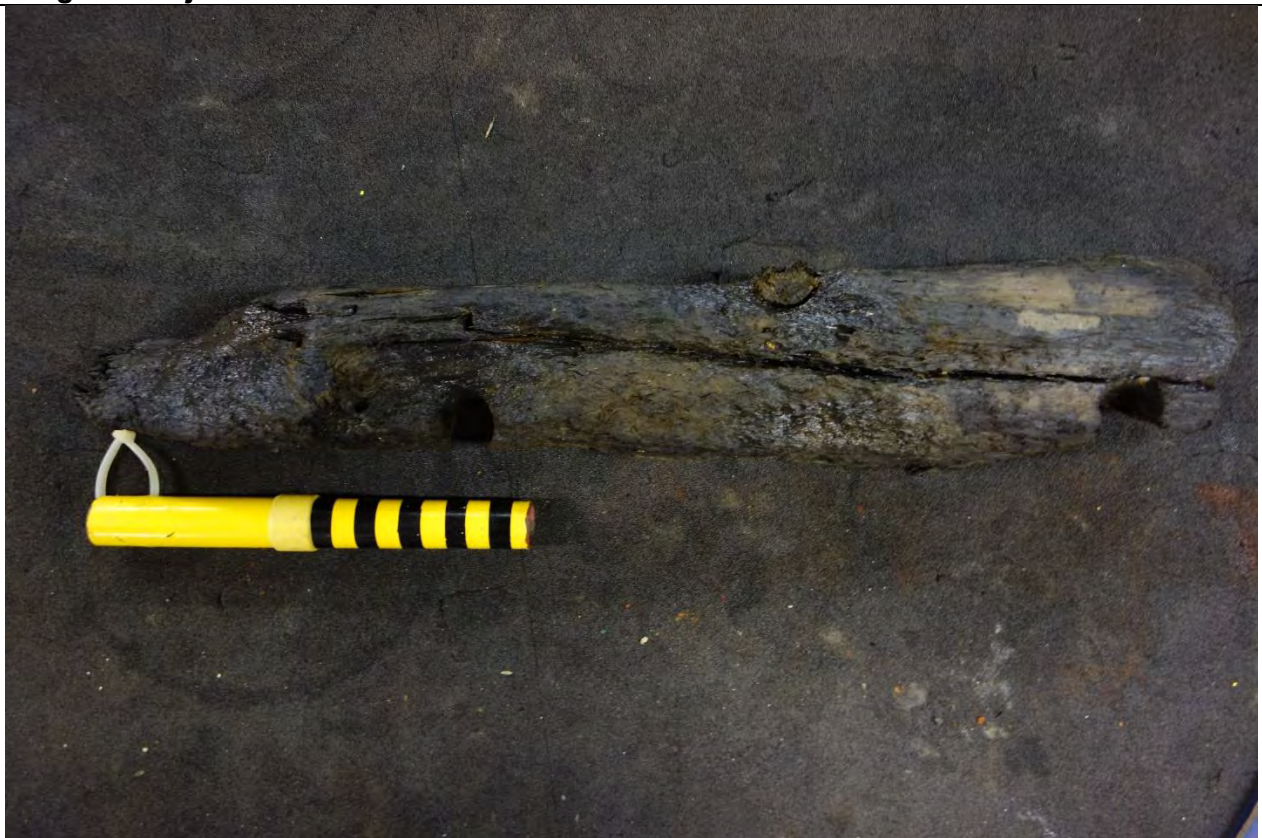
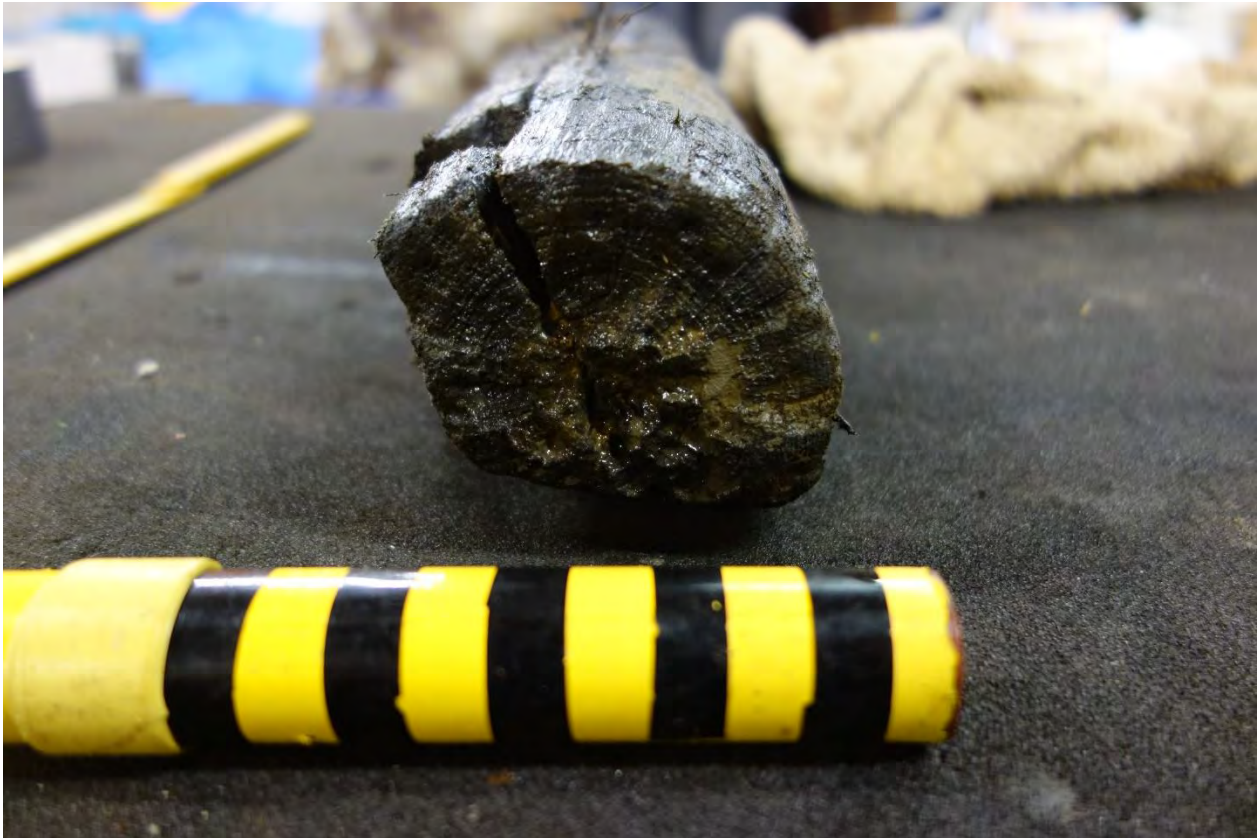
<b>UID</b> <b>BWL4_0022</b>	Worked timber	
<b>Date of Discovery</b>	28/08/2016	
<b>How Discovered</b>	Retrieved from drag head during dredging	
<b>Position of Discovery (British National Grid)</b>	.... E	.... N
<b>Location Map</b>	<b>Anomaly Image</b>	
N/A	N/A

This timber has a maximum length of 490 mm, 82 mm wide and 70 mm high. It has two partial treenail holes measuring 24 mm and 25 mm in diameter, with one further treenail *in situ* measuring 24 mm. All of the treenails are positioned on the edge of the timber. The profile of the timber is partially rounded, this may be natural or evidence of working, the timbers surface is in poor condition and exposure has led to attacks by wood boring organisms.

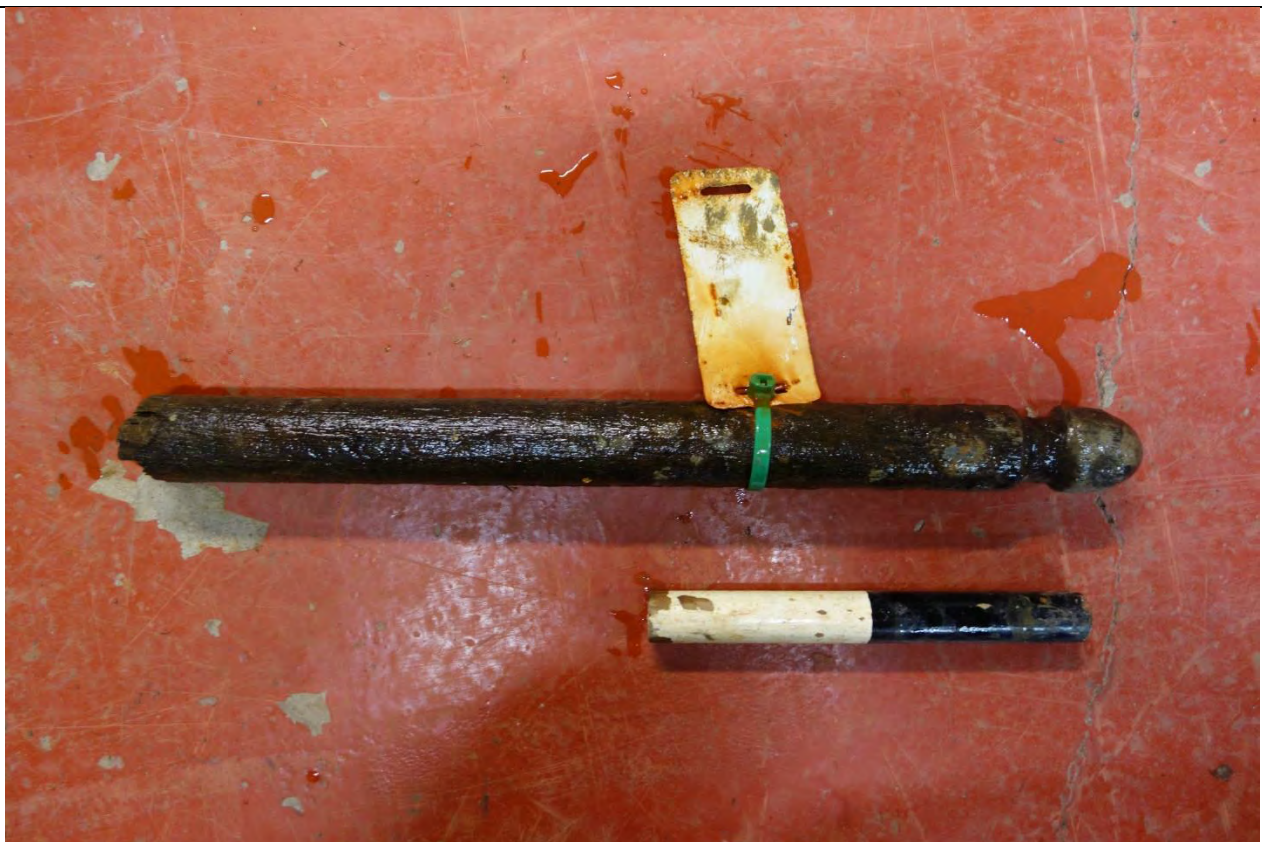
<b>UID</b> BWL4_0025	Worked wood	
<b>Date of Discovery</b>	04/10/2016	
<b>How Discovered</b>	Retrieved from drag head during dredging	
<b>Position of Discovery (British National Grid)</b>	..... E	..... N
<b>Location Map</b>	<b>Anomaly Image</b>	
N/A	N/A

<b>Description</b>			
The object is a length of straight grained wood, it has been rounded and smoothed. It measures 450 mm in length and a diameter of 40 mm. One end is broken, and the other end has been worked into a smooth, rounded end. The rounded end is 33 mm long and then there is a groove cut into the wood. The groove is equally worn, and possibly cut on a form of lathe.			
<b>Interpretation</b>			
This piece of worked wood has no distinguishing marks or features along it. With exception of the rounded end. Possible interpretations for its use have been a rolling pin or a piece of furniture, possibly a chair or table leg that has broken and been discarded.			
<b>Period</b>	Post-medieval - modern	<b>Date Range</b>	Post-medieval - modern

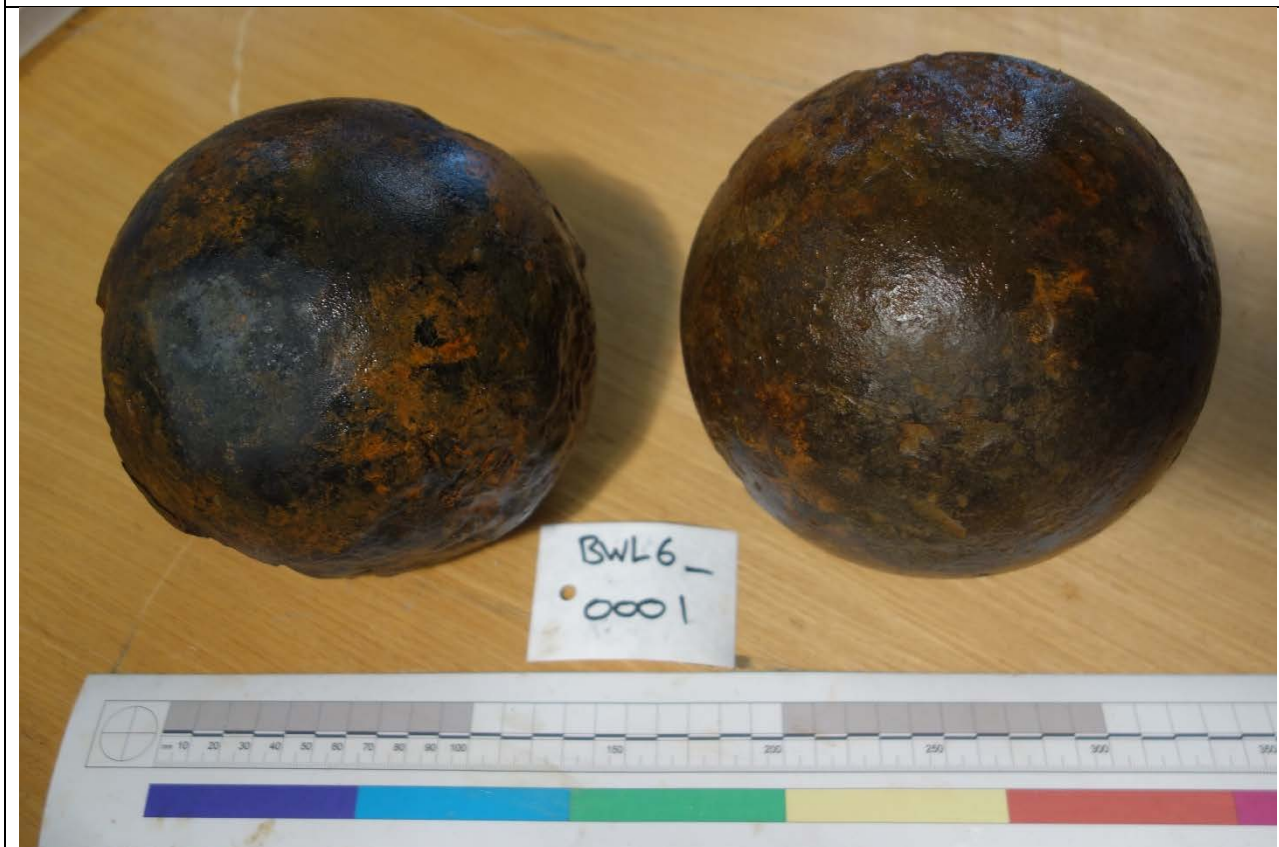
<b>UID</b> BWL6_0001	Two cannonballs	
<b>Date of Discovery</b>	19/10/2016	
<b>How Discovered</b>	Recovered from the drag head aboard the dredger <i>Reynaert</i>	
<b>Position of Discovery (British National Grid)</b>	..... E	..... N
<b>Location Map</b>	<b>Anomaly Image</b>	
N/A	N/A

Both cannonballs are iron. One has a diameter of 144 mm and weighs 28.5 lb or 12.9 kg. The other has a diameter of 146 mm and weighs 31 lb or 14 kg. Both are damaged with the smaller of the two showing more damage than the other.

These two cannonballs are likely to be from 30 and 32 pounder cannon. 30 pounder cannon were commonly used by the French, while 32 pounders were often British and Spanish sizes, although this does vary. With Portsmouth's naval history there are a number of reasons for them to be found, such as being fired during training or battle, lost or discarded.

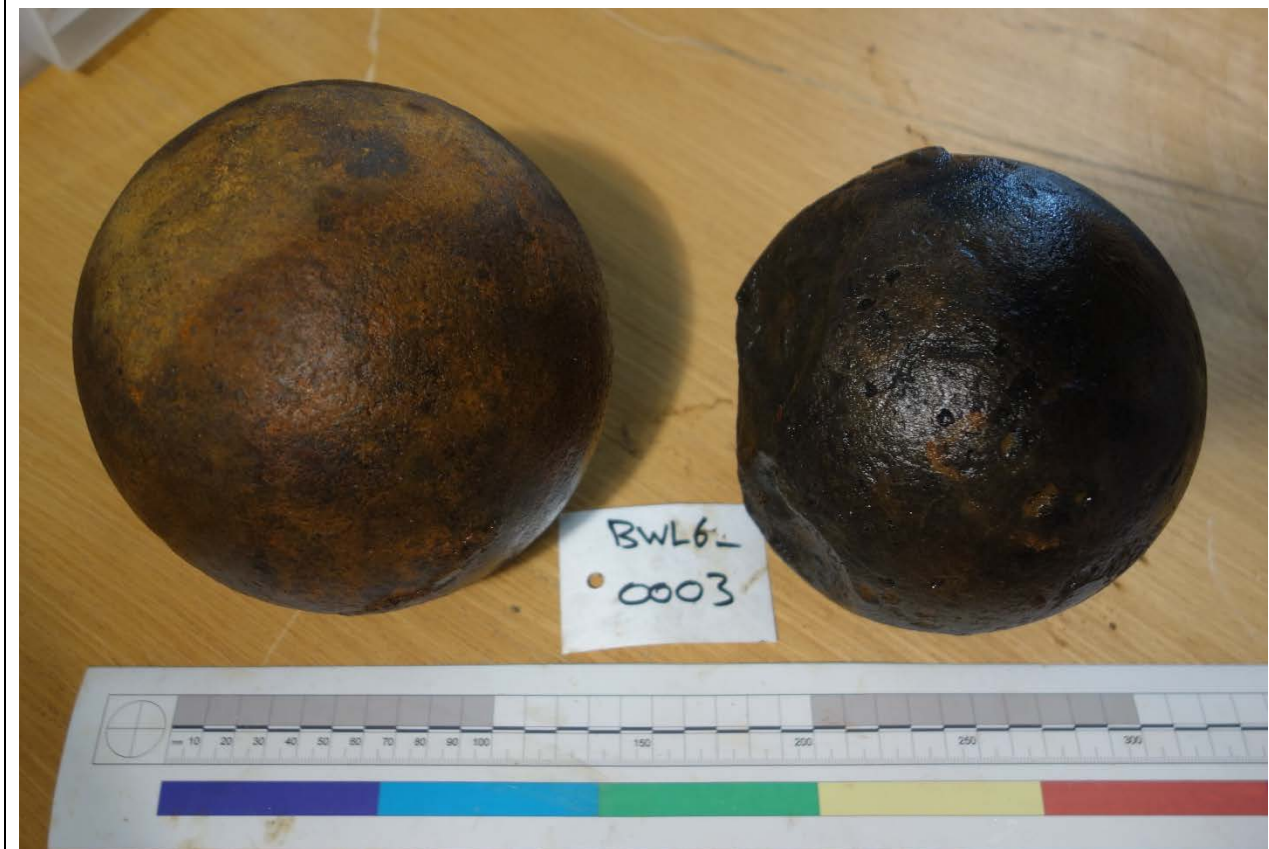
<b>UID</b> BWL6_0003	Two cannonballs	
<b>Date of Discovery</b>	22/10/2016	
<b>How Discovered</b>	Recovered from the drag head aboard the dredger <i>Reynaert</i>	
<b>Position of Discovery (British National Grid)</b>	..... E	..... N
<b>Location Map</b>	<b>Anomaly Image</b>	
N/A	N/A

<b>Description</b>			
Two cannonballs made from iron. The larger of the two has a diameter of 146 mm and weighs 31 lb or 14 kg. The other has a diameter of 130 mm and weighs 20 lb or 9 kg, and has some damage which suggests it would have originally weighed more.			
<b>Interpretation</b>			
These two cannonballs are likely to be from a 32 pounder cannon and a 24 pounder. Both are common sizes of gun, and probably would have been used on warships, as the size and weight of the guns would have limited the amount of cargo that could be carried by a merchant ship.			
<b>Period</b>	16th – 17th century	<b>Date Range</b>	16th – 17th century

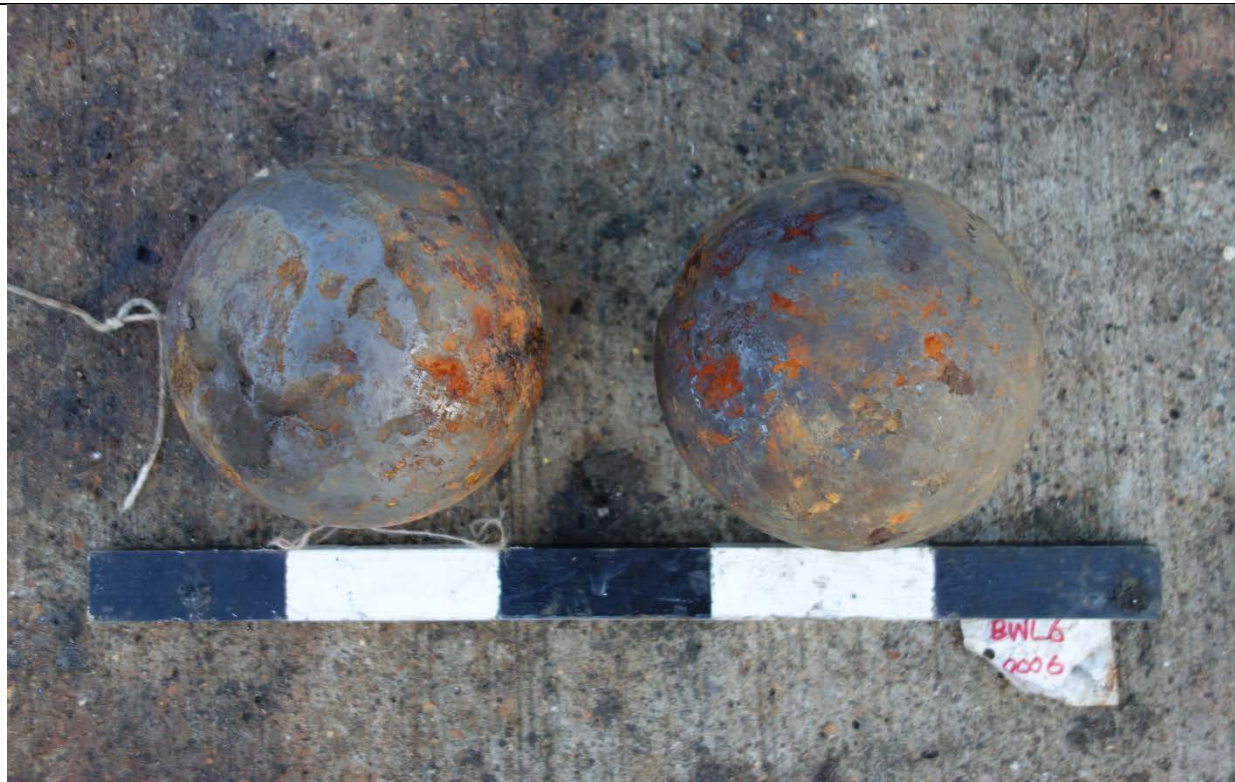
<b>UID</b> BWL6_0006	Two cannonballs	
<b>Date of Discovery</b>	22/12/2016	
<b>How Discovered</b>	Recovered during dredging by <i>Reyneart</i>	
<b>Position of Discovery (British National Grid)</b>	..... E	..... N
<b>Location Map</b>	<b>Anomaly Image</b>	
N/A	N/A

<b>Description</b>			
Both cannonballs measure 154 mm in diameter.			
<b>Interpretation</b>			
The diameter of the cannonball converts to approximately 30 pounds.			
A relatively large shot weight, this is more likely to have been used by a naval vessel, with a 30-pounder cannon being used on the main gun deck on larger warships. Large numbers of cannonballs are being found within Portsmouth harbour which shows the long running history of naval presence in the area. It is likely to have been discarded or possibly fired.			
<b>Period</b>	Post medieval	<b>Date Range</b>	16th – 19th century

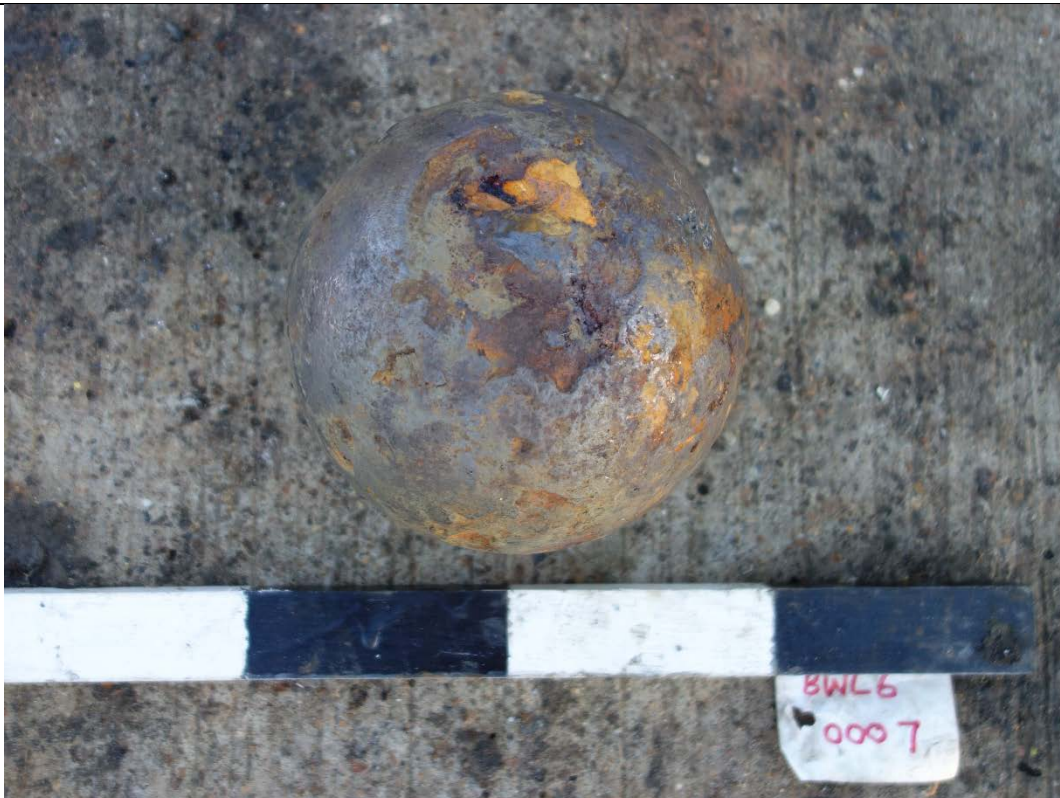
<b>UID</b> BWL6_0007	Cannonball	
<b>Date of Discovery</b>	22/12/2016	
<b>How Discovered</b>	Recovered during dredging by <i>Reyneart</i>	
<b>Position of Discovery (British National Grid)</b>	..... E	..... N
<b>Location Map</b>	<b>Anomaly Image</b>	
N/A	N/A

<b>Description</b>			
Cast iron cannonball measuring 152 mm in diameter.			
<b>Interpretation</b>			
The cannonball's diameter suggests that it would have been used in a cannon rated 30 or 32 pound. This is a large sized cannon, commonly found on larger warships, although some smaller military vessels may have carried small numbers. It is probable that this cannonball was either discarded or it may have been fired.			
<b>Period</b>	Post medieval	<b>Date Range</b>	16th – 19th century

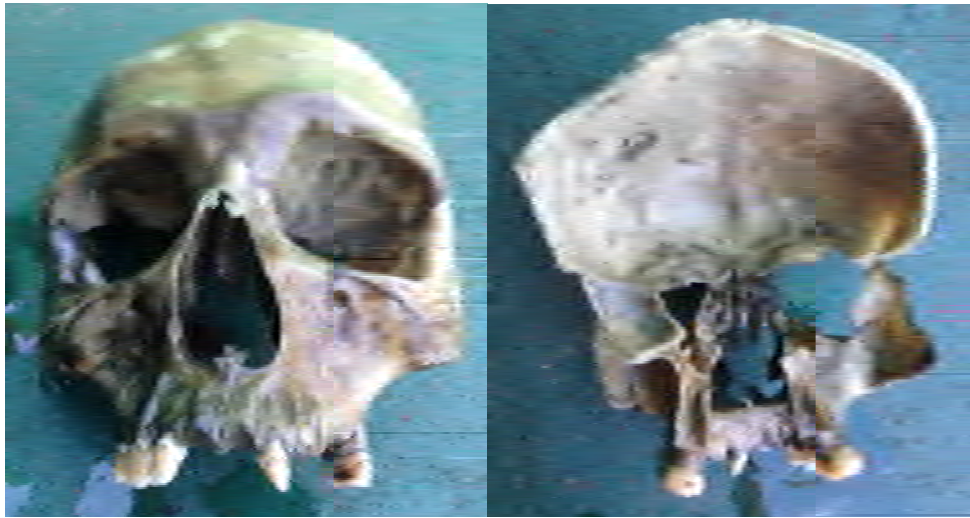
<b>UID</b> BWL6_0008	Human bone
<b>Date of Discovery</b>	02/11/2016
<b>How Discovered</b>	Recovered from the draghead of <i>Reynaert</i> .
<b>Position of Discovery (British National Grid)</b>	n/a see image below

Facial bones (maxilla, malars, nasal bones) and frontal vault (all articulated) of an adult male.

Most of teeth are missing but eruption and level of wear suggests the individual aged around 25-35 yr. There are the remnants of moderate calculus deposits (calcified plaque) on the remaining teeth, and evidence for dental caries in the cervical area of one molar. The lesions suggest a lack of dental hygiene and a high carbohydrate diet (e.g. stews, pottages, bread). There are no visible indications of dental interventions (though the photographs are slightly out of focus and not all angles are covered). The individual had a very distinctively shaped face with large, squared eye sockets and a very broad nasal aperture. On current evidence it is unlikely to be a modern skull; possibly Post-medieval or earlier.

It is also recommended, subject to the investigations of the Hampshire Constabulary, that the skull be transferred to Wessex Archaeology where it can be properly inspected.

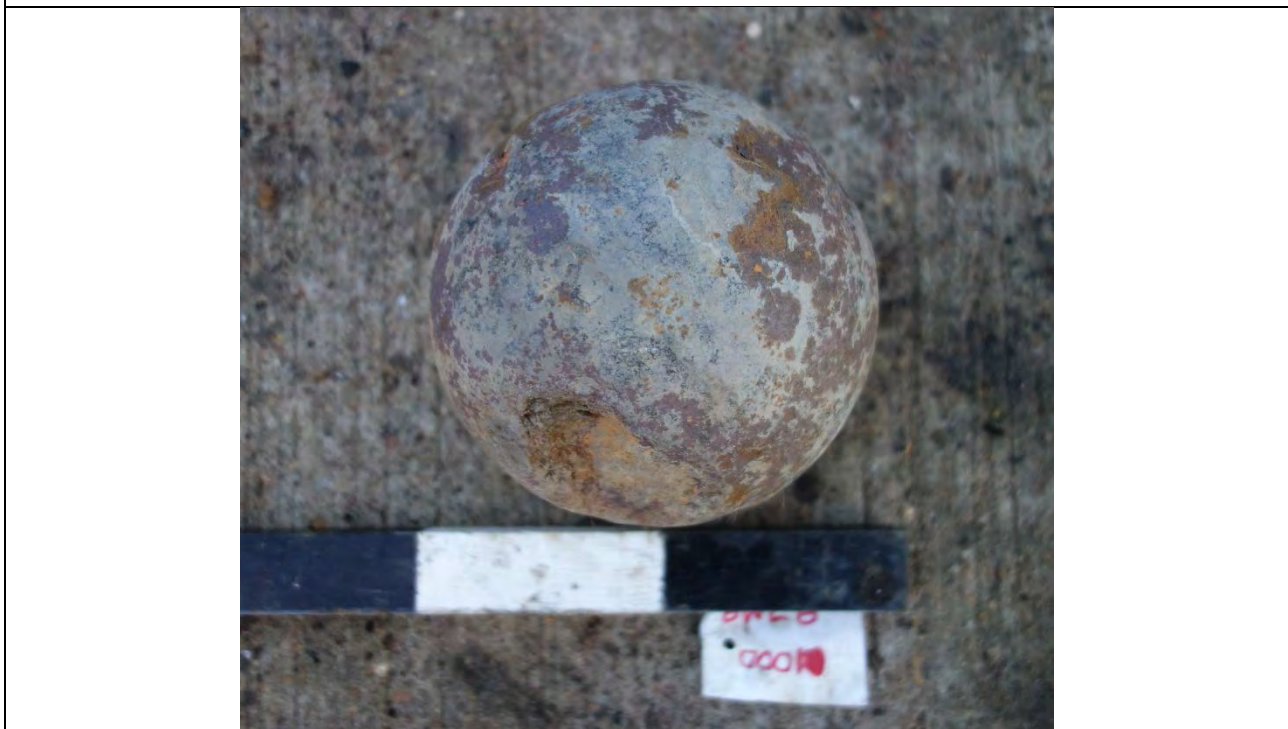
<b>UID</b> BWL6_0010	Cannonball	
<b>Date of Discovery</b>	22/12/2016	
<b>How Discovered</b>	Recovered during dredging by <i>Reyneart</i>	
<b>Position of Discovery</b> (British National Grid)	..... E	..... N
<b>Location Map</b>	<b>Anomaly Image</b>	
N/A	N/A

<b>Description</b>			
The cannonball measures 155 mm in diameter.			
<b>Interpretation</b>			
The diameter of the cannonball converts to approximately 31-32 pounds.			
A 32 pounder represents a larger size of cannon, and is likely to have been a naval gun, guns of such size are unlikely to be used by merchants due to the excessive size and weight of the guns. Large warships would often use 32 pounders throughout the main gun deck. Large numbers of cannonball are being found within Portsmouth harbour which shows the long running history of naval presence in the area. It is likely to have been discarded or possibly fired.			
<b>Period</b>	Post medieval	<b>Date Range</b>	16th – 19th century

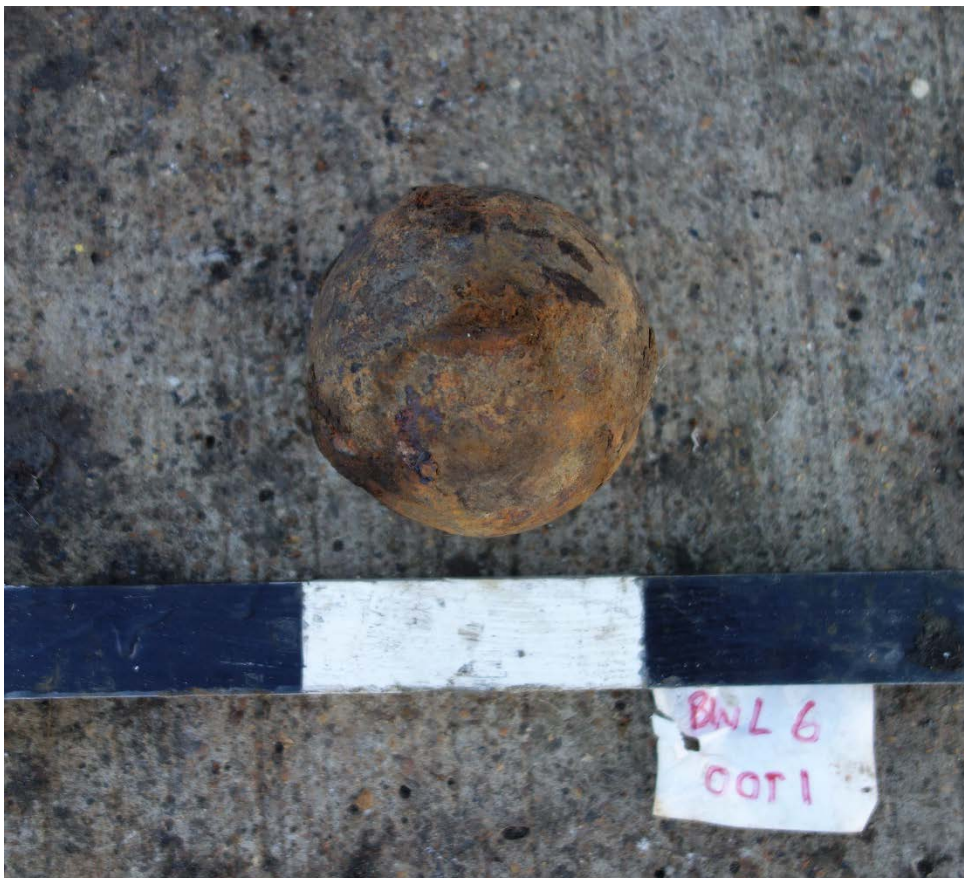
<b>UID</b> BWL6_0011	Cannonball	
<b>Date of Discovery</b>	22/12/2016	
<b>How Discovered</b>	Recovered during dredging by <i>Reyneart</i>	
<b>Position of Discovery (British National Grid)</b>	..... E	..... N
<b>Location Map</b>	<b>Anomaly Image</b>	
N/A	N/A

<b>Description</b>			
This cannonball measures 94 mm in diameter.			
<b>Interpretation</b>			
The diameter of the cannonball converts to approximately 7 pounds.			
A relatively small shot weight, this is more likely to have been used by a merchant vessel, although larger warships may also have carried smaller cannon on deck. Large numbers of cannonballs have been found within Portsmouth harbour which shows the long running history of naval presence in the area.			
The cannonball is likely to have been discarded or possibly fired.			
<b>Period</b>	Post medieval	<b>Date Range</b>	16th – 19th century

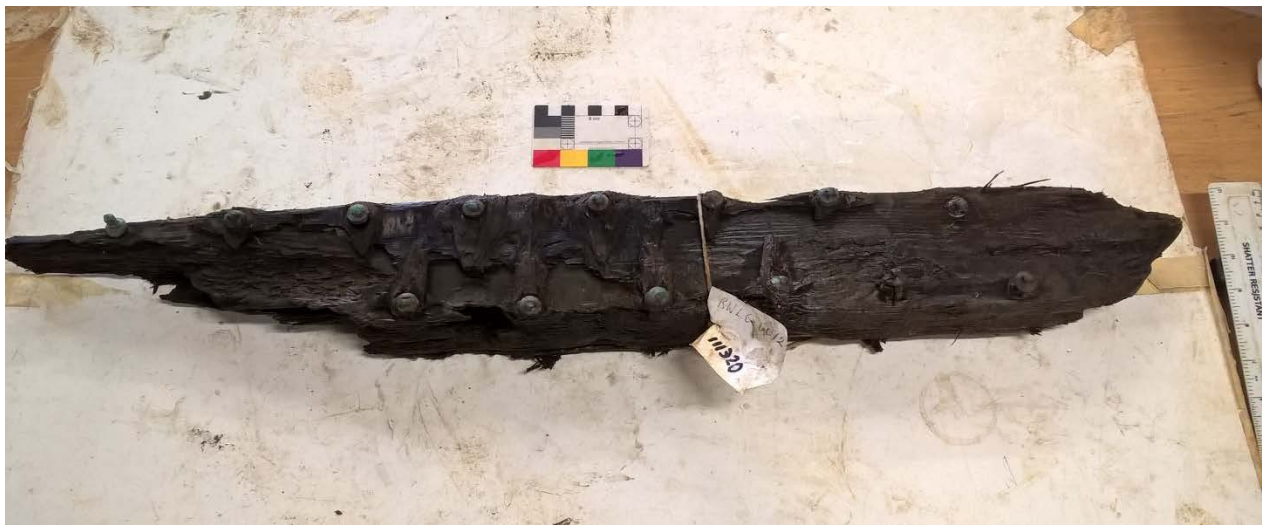
<b>UID</b> BWL6_0012	Ship's timber	
<b>Date of Discovery</b>	22/12/2016	
<b>How Discovered</b>	Recovered during dredging by <i>Reynaert</i> .	
<b>Position of Discovery (British National Grid)</b>	..... E	..... N
<b>Location Map</b>	<b>Anomaly Image</b>	
N/A	N/A

<b>Description</b>			
A worked timber measuring 1330 mm in length with a maximum width of 200 mm. The timber is in very poor condition with much of one end being badly damaged and frayed. There are two patches of iron staining along one edge, but no evidence of iron fastenings. At the damaged end, there is a treenail hole, this extends through the whole of the timber and part of the treenail remains, blocking the other side of the hole, it has a diameter of 30 mm.			
<b>Interpretation</b>			
The timber is worked and could possibly be a ship's timber or alternatively part of a quayside structure such as piling. However, the damage to the timber prevents any positive identification. The only remaining evidence of timber working is the treenail hole found at one end, and the iron staining may suggest that it was joined or banded with iron. The timber may have been removed from a ship or quayside structure and discarded. With the condition of the timber being so bad any dating is very speculative.

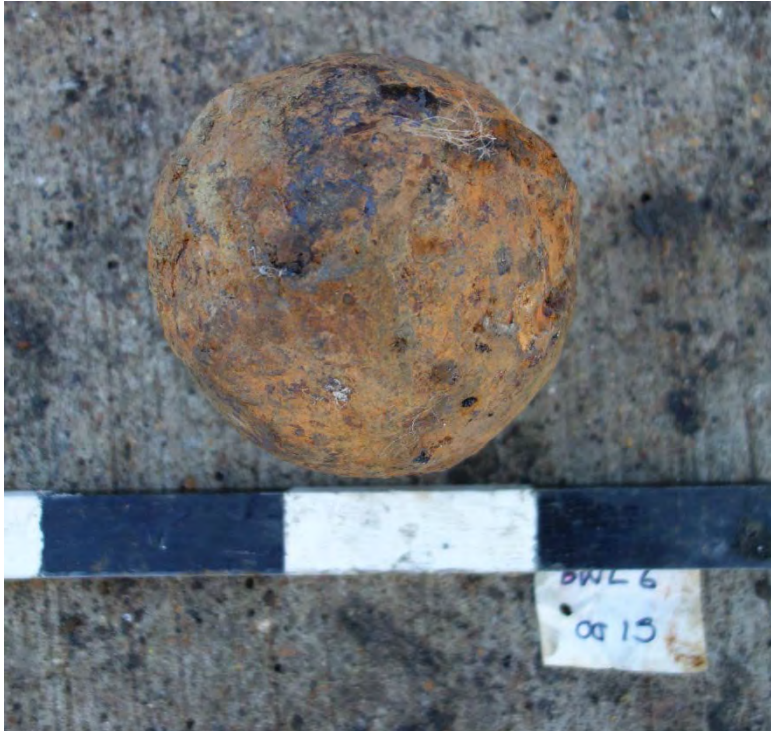
<b>UID</b> BWL6_0015	Cannonball	
<b>Date of Discovery</b>	22/12/2016	
<b>How Discovered</b>	Recovered during dredging by <i>Reyneart</i>	
<b>Position of Discovery</b> (British National Grid)	..... E	..... N
<b>Location Map</b>	<b>Anomaly Image</b>	
N/A	N/A	
<b>Images of object</b>

<b>Description</b>			
The cannonball measures 139 mm in diameter.			
<b>Interpretation</b>			
The diameter of the cannonball converts to approximately 22 pounds.			
A cannon of this size could have been fitted to a number of ships, it may have been used as a larger gun on board a merchant vessel, or equally it may have been used on a naval vessel. Large numbers of cannonball are being found within Portsmouth harbour which shows the long running history of naval presence in the area. It is likely to have been discarded or possibly fired.			
<b>Period</b>	Post-medieval	<b>Date Range</b>	16th – 19th century

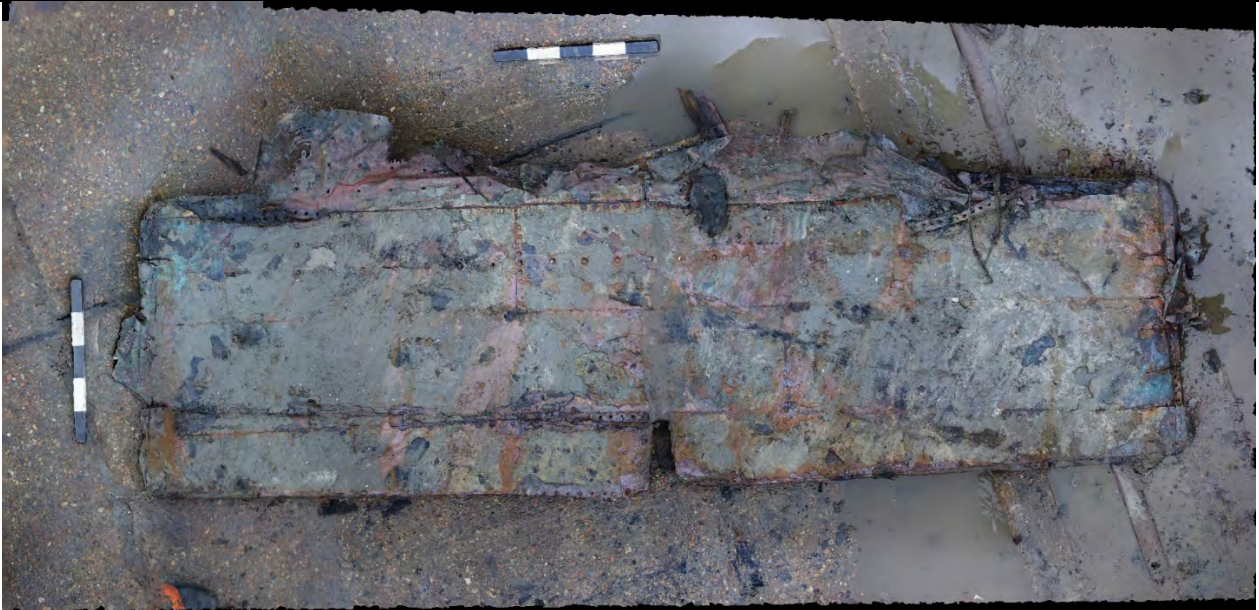
Section of the planking or staves, showing the copper sheathed outer surface

As this was a particularly large Royal Navy buoy, it is likely to have been a navigational marker in the approaches to Portsmouth or a mooring within the harbour itself. The markings on the timbers provide a huge amount of information of the object as a whole. The marked date on the timbers arriving in Portsmouth is 1811 and 1823, so it would have been built sometime after 1823 – unless it was repaired. However, the date 1811 is not clear and is suggestive, the gap between the two dates is 12 years, which is a large time period for seasoning timbers, it is possible that some of the markings have been lost and obscured the date of this timber. Alternatively the timber marked with 1823 may have been a later timber used for repair. The Broad arrow shows that they belonged to the Royal Navy and the syntax shows it was processed and likely manufactured in the Royal dockyard at Portsmouth. With so few buoys in England by 1818, it possibly makes this one of the earliest examples of a hollow wooden buoy in England. It is likely that the buoy went into disrepair, its position well within the harbour may suggest that it was brought back into the harbour for repair or discard. With its date being so close to use of iron buoys it may have been later replaced by iron.

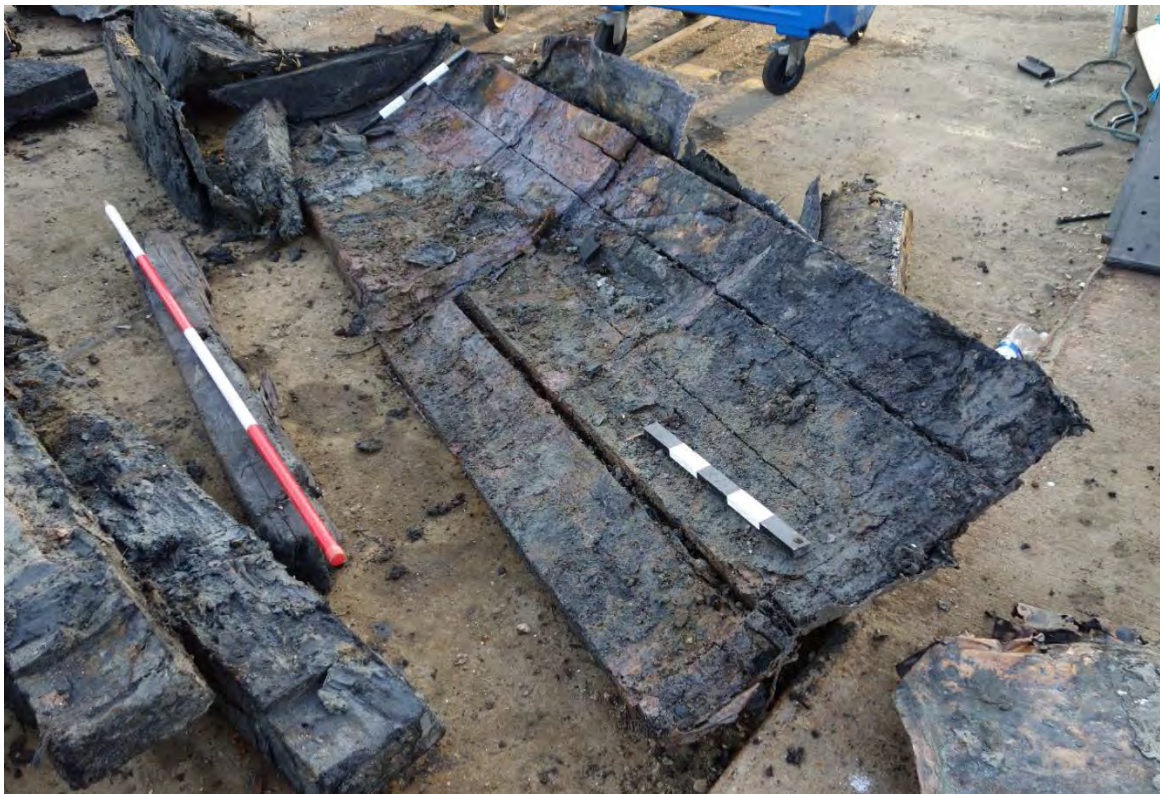
Showing the inside of the planking. Note the semi-circular timber still in situ to the top left of the image and the deep groove for the larger central iron hoop in the centre of the image.

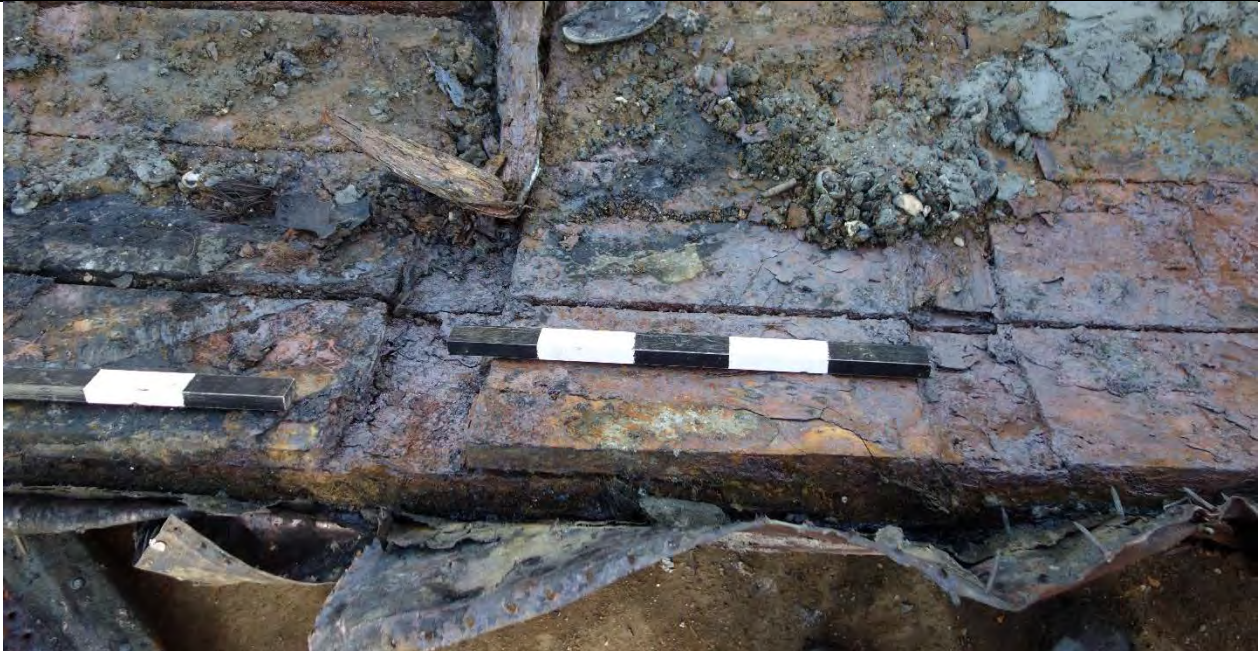
Internal view of the planking showing two of the iron hoop grooves and overhanging copper sheathing at the bottom of the image

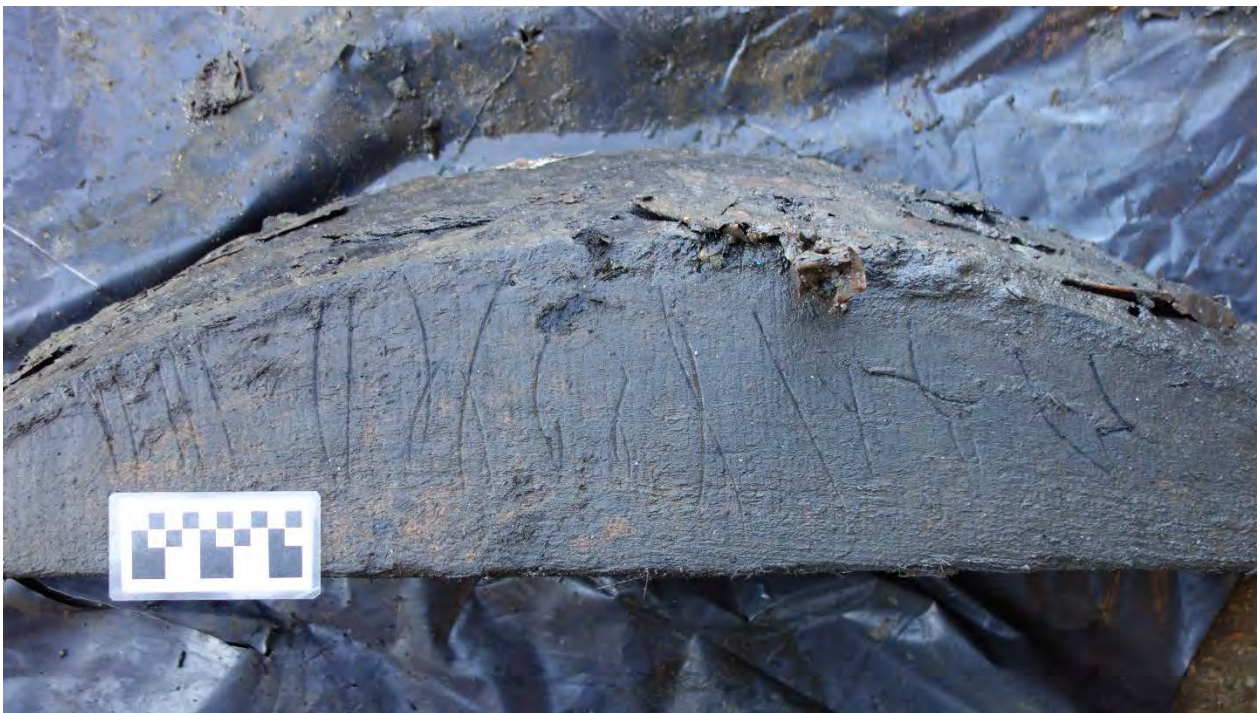
Rase marks seen on one of the semi-circular timbers

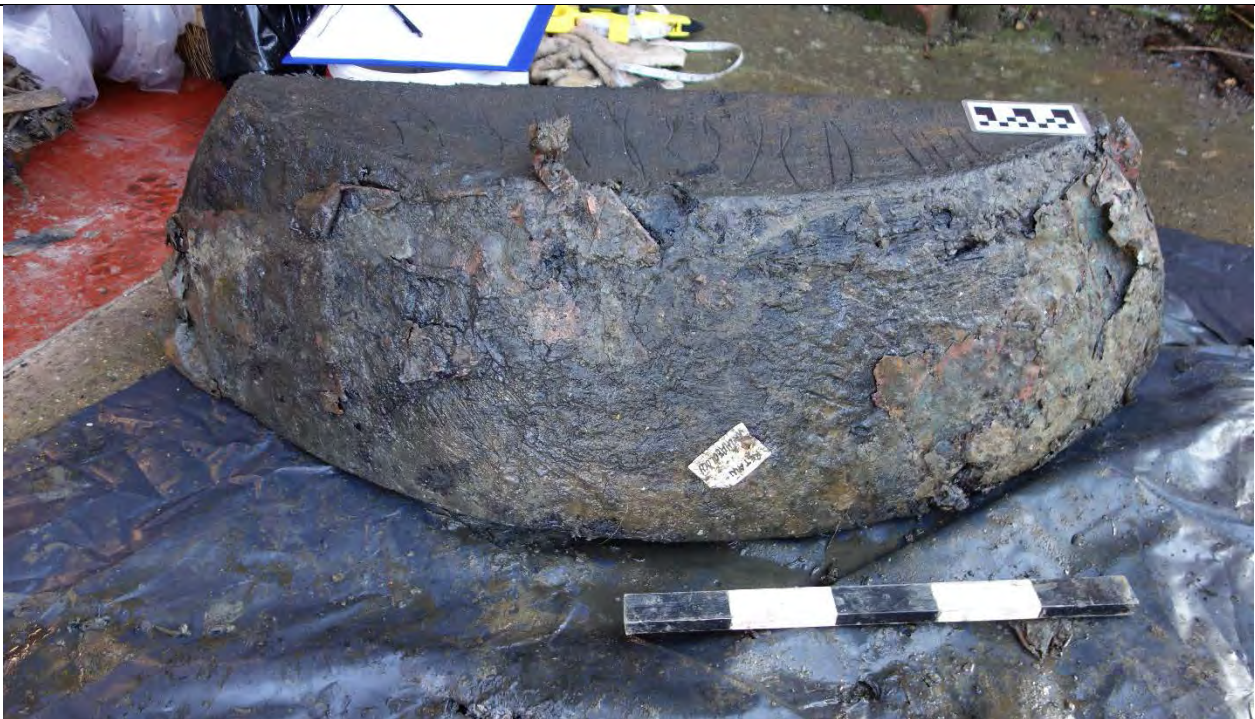
Copper sheathed outer face of one of the semi-circular timbers
