# Queen Elizabeth Class Capital Dredge Project Her Majesty's Naval Base, Portsmouth

Archaeological Assessment Report

Ref: 111320.05  
January 2018

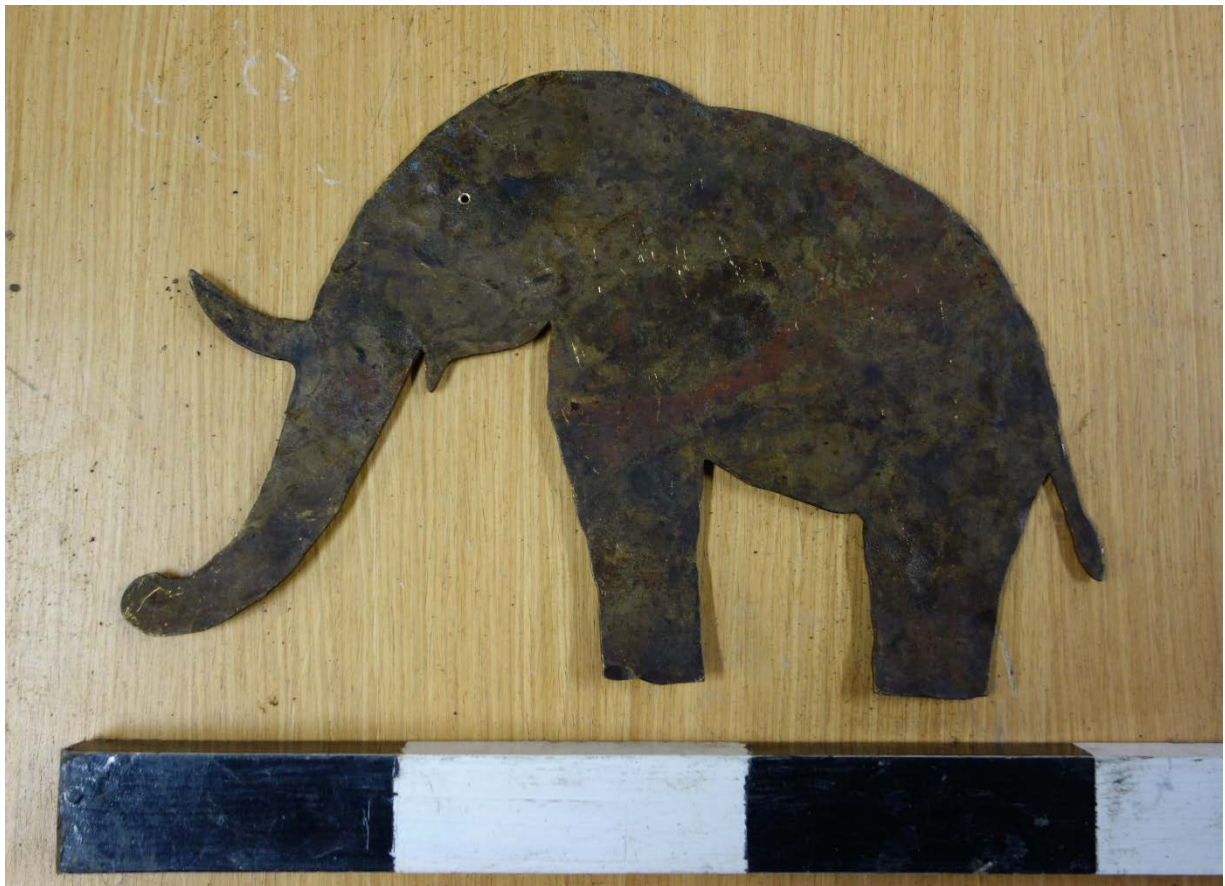
The elephant is likely to have been made for decorative purposes and may have been hung on a wall, but there is only one hole through which it could be attached to anything. The eye hole appears a lot cleaner than the rest of the metal, which may suggest that it was drilled out at a later date. Another depiction of an elephant has already been found during the Portsmouth dredging operations, BWL1\_0042, was a plaque from the HMS Ganges shore establishment. The two finds were made approximately 200 m apart and it is possible that the two finds may be related but no conclusions can be drawn.

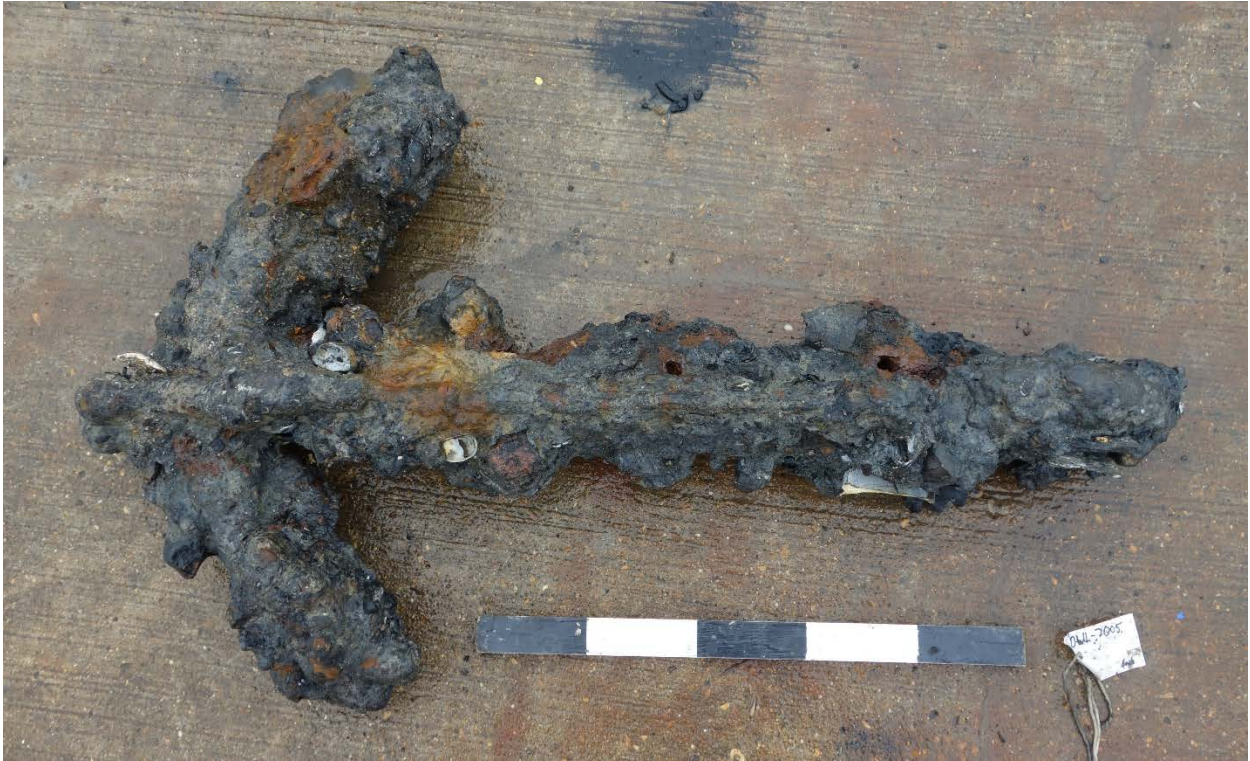
Anchor before and after concretion removal

<b>Description</b>			
<p>The anchor was fully covered in concretion when found, however the concretion was removed for recording.</p> <p>The total length of the anchor is 730 mm, with the shank measuring 670 mm and 48 mm in diameter which tapers to 45 mm towards the ring. The ring measure 70 mm. The distance between the bills is 510 mm and the maximum dimensions of the palms are 170 x 105 mm. The stock measures 710 mm long and 36 mm in diameter.</p>			
<b>Interpretation</b>			
<p>This type of anchor is known as a fisherman's anchor. Fisherman anchors are designed for use in reefs, rocks and weed to enable to fisherman to anchor within the areas with most fish. The small flukes are ideal for a rocky bottom, but will drag if used in sand or mud. To counteract the small flukes, the weight of the anchor is increased to help provide an adequate holding. The anchor also has a folding stock, this allows for the anchor to be stored flat on the deck, as this design will not store in a hawse pipe. This design of anchor has remained basically unchanged since the move to iron stocks in the 1840s.</p> <p>Overall the condition of the anchor is good, which may suggest that the anchor was lost rather than discarded.</p>

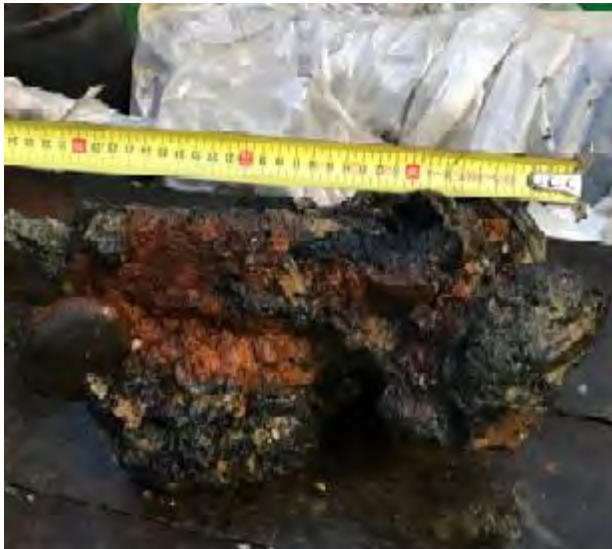
Object as recovered

Concretions are commonly found in marine environments; they are the result of corroding ferrous metals such as iron. The reaction that takes place creates corrosion by-products, which will engulf objects around them creating a conglomerate of materials, often this will be stones and shells from the sea floor, but also other objects. Concretions are often removed from shipwreck sites as they hold a high potential for preservation compared to the sea floor, and will contain objects such as ships fixture and fittings, armaments, personal items and cargo.

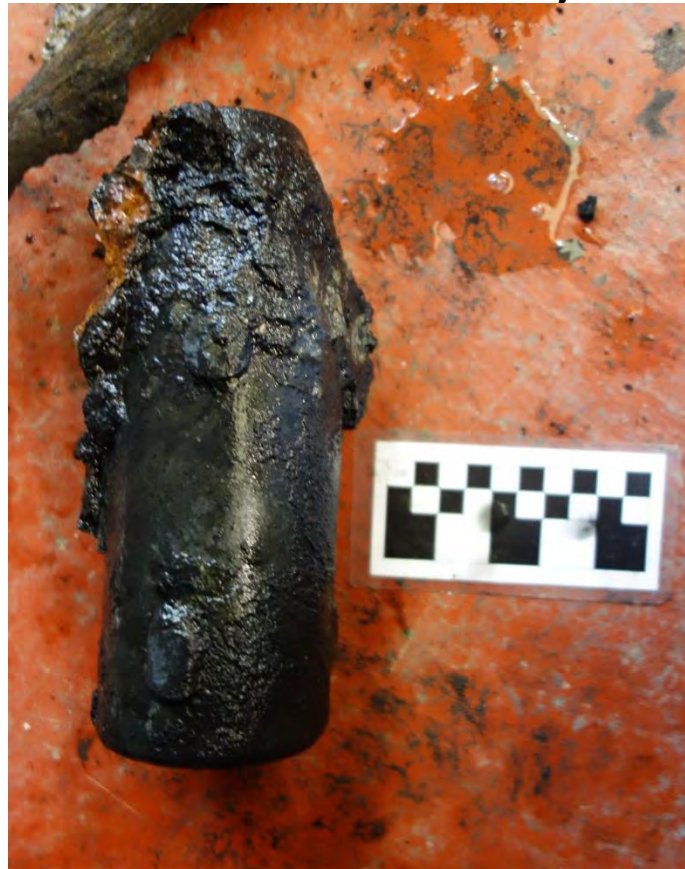
Projectile found within the concretion

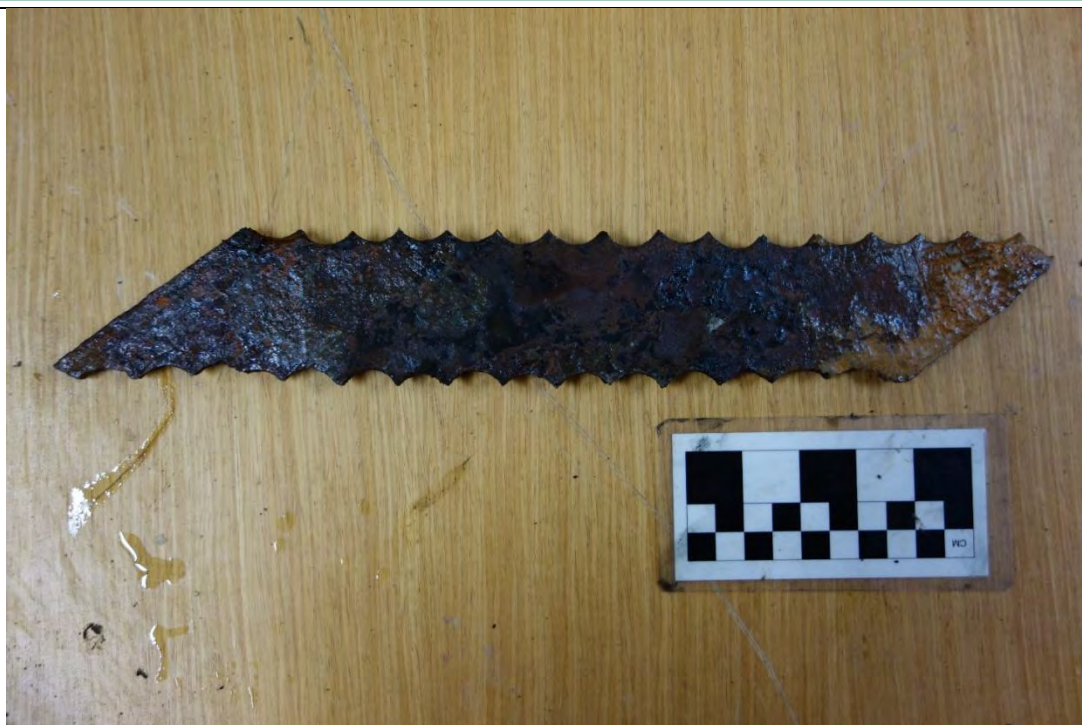
Possible saw blade found within concretion

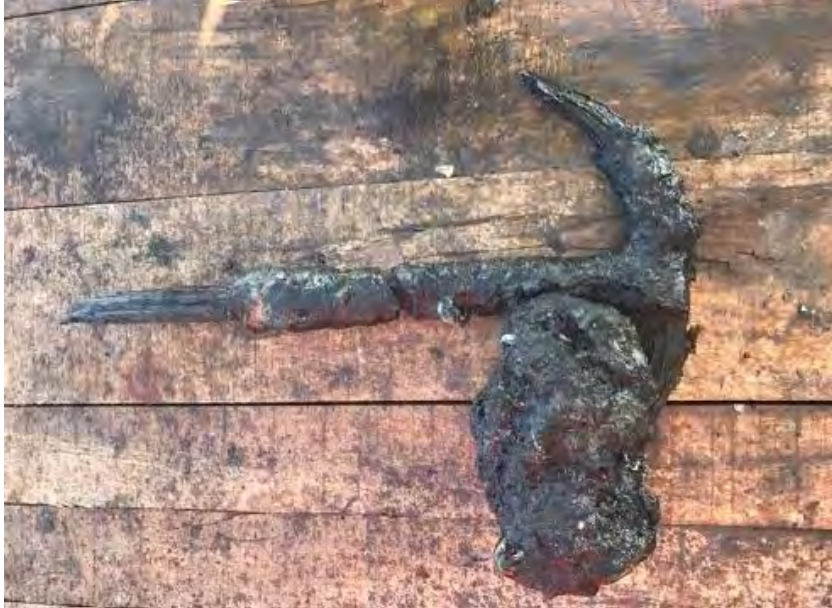
<b>Description</b>			
An anchor recovered from opposite Victory jetty. The anchor was not seen during quay side archaeological monitoring, and the photograph taken immediately after recovery does not include a scale. Judging by the size of the planks in the photograph, this is a relatively small anchor, likely to be under one meter in length.			
<b>Interpretation</b>			
Although the anchor is broken at the ring and concreted it is a recognisable anchor, this type of anchor is known as a fisherman's anchor. Fisherman anchors are designed for use in reefs, rocks and weed to enable to fisherman to anchor within the areas with most fish. The small flukes are ideal for a rocky bottom, but will drag if used in sand or mud. To counteract the small flukes, the weight of the anchor is increased to help provide an adequate holding. This anchor is likely to have also had a folding stock, this allows for the anchor to be stored flat on the deck, as this design will not store in a hawse pipe. This design of anchor has remained basically unchanged since the move to iron stocks in the 1840s.

The anchor is in poor condition and the shank is broken before the stock, this may be the reason for losing the anchor or for discarding.			
<b>Period</b>	Modern	<b>Date Range</b>	c. 20th century

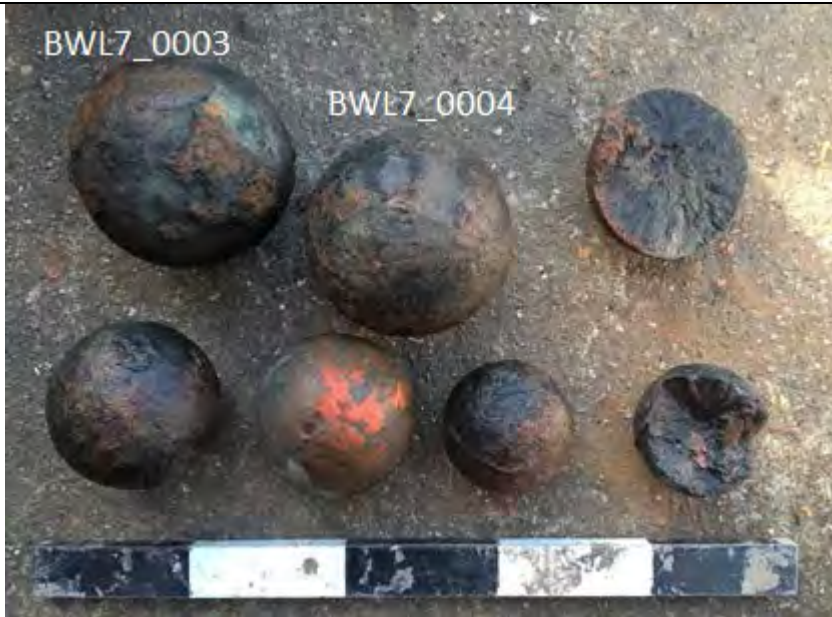
**Note:** in this photo, the top left cannonball is recorded as BWL7\_0003 and the top middle is recorded as BWL7\_0004.

<b>Description</b>			
A total of 65 cannonballs recovered from within Portsmouth Harbour. The assemblage contains cannonballs ranging from 52 mm in diameter up to 209 mm. Their condition varies, with some being broken, some concreted and others in excellent condition. Within the group there are examples of standard shot, bar shot and hollow shells.			
<b>Interpretation</b>			
This group of cannonballs shows the large variety in sizes of naval armaments, ships would carry a variety of different sized cannon, and a variety of shot types.			
<p>The smallest of the cannonballs would have been used in small signalling guns, others for swivel guns positioned around the ship's rails. Larger shot would have been used in the main armament. Particularly in larger ships with multiple gun decks, each deck will contain different sized guns, with the largest close to the water line. HMS <i>Victory</i> for example carried at least six different sizes of gun in its main armament, while the <i>Mary Rose</i> carried nearly double this. Some of the shot is more specialised. The bar shot for example consisted of two cannonballs joined together by an iron bar. Once the bar shot leaves the cannon the weight at either end will cause the shot to spin in the air. The purpose of the bar shot was to immobilise an enemy ship by targeting the masts and rigging. Another type of shot represented here are shells, these were hollow cannonballs that would be filled with black powder. There were several types used, impact fuses, timed fuses and occasionally shrapnel.</p> <p>This large group of cannonballs was found within the harbour and is likely to represent multiple events rather than a single deposit, most likely having been discarded overboard.</p>

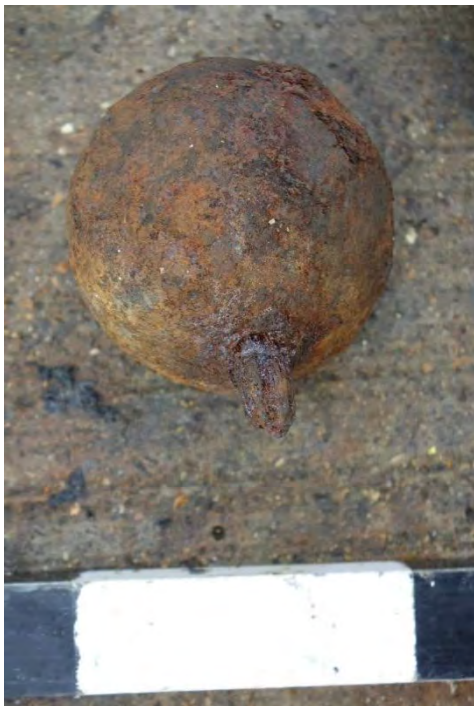
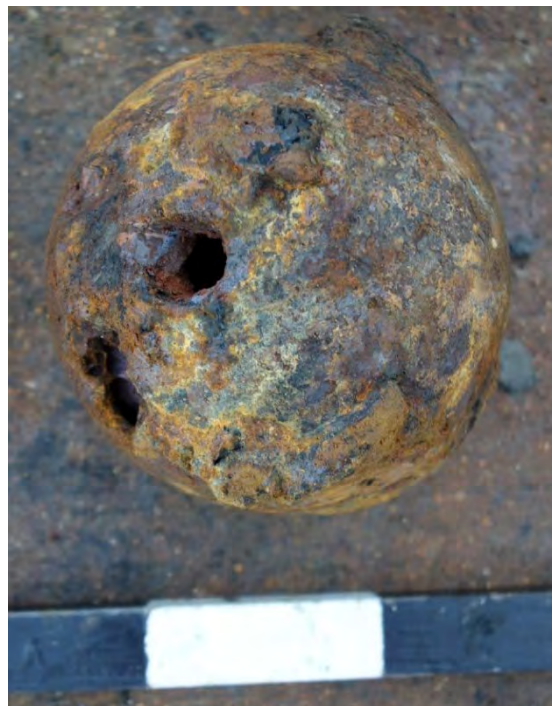
**Left: Broken  
barshot  
Right:  
Hollow shell**

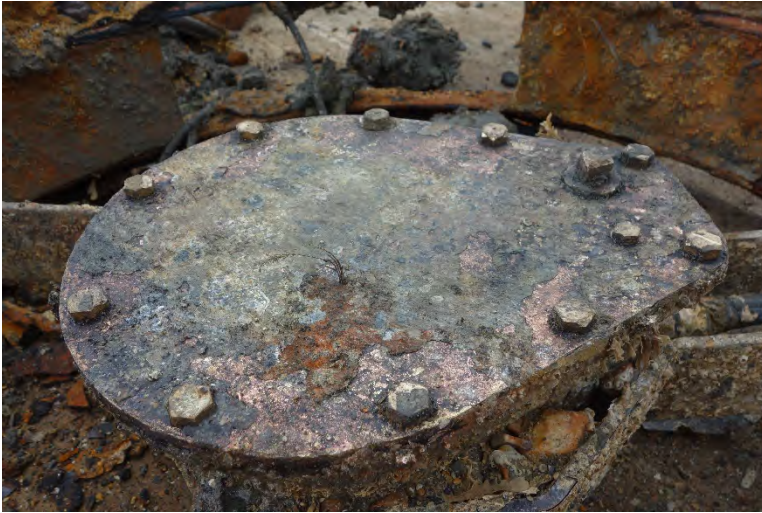
Central brass unit

Unit contains a sealed lead container surrounded by bitumen

The four identical wheel-like objects are actually degaussing units. Degaussing ranges were set up to help protect shipping from magnetic sea mines. During the Second World War the introduction of magnetic mines caused catastrophic results to Allied shipping. Steel hulled ships create a magnetic signature as they travel which disturbs the earth's magnetic field as it moves. This disturbance in the magnetic field is what is detected by the mines. The mines would be anchored to the bottom and positioned within the water column, unlike contact mines, the ships would only need to pass nearby to activate the mine. The resulting explosion would cause great damage to the hull of the ship, tearing out plating, rivets and would be capable of breaking the back of a ship. As British shipping suffered heavily, a solution was needed. It was found that by inducing a small field to the ship, this could offset the effect that it had on the earth's magnetic field. Some ships were fitted with their own degaussing units, electromagnetic coils, which would allow them to consistently offset the effect. This was expensive so another method had to be devised, one method involved dragging the cable around the ship's hull or by using specially designed ranges. As the effect would gradually wear off, several degaussing ranges existed for merchant and naval shipping. Within Portsmouth there are several versions of the degaussing range, all very similar variations using the same equipment. The unit itself, the central box with the copper coil, was used on all of the Portsmouth ranges. The unit could be positioned at different angles and with multiple other unit to increase the effectiveness and sensitivity of the degaussing range. In Portsmouth there was single axis, two axis and three axis ranges, with this

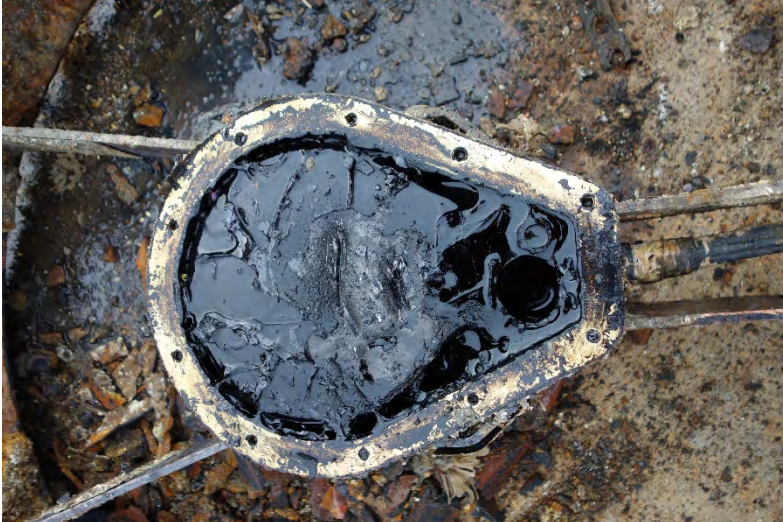
Inside the lead container is capped by a metal plate (possibly steel)

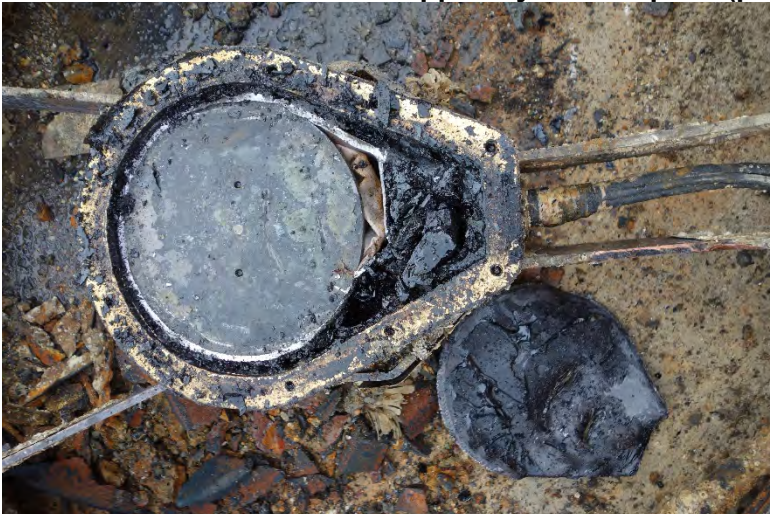
Underneath the metal disc there is a thin cardboard disc

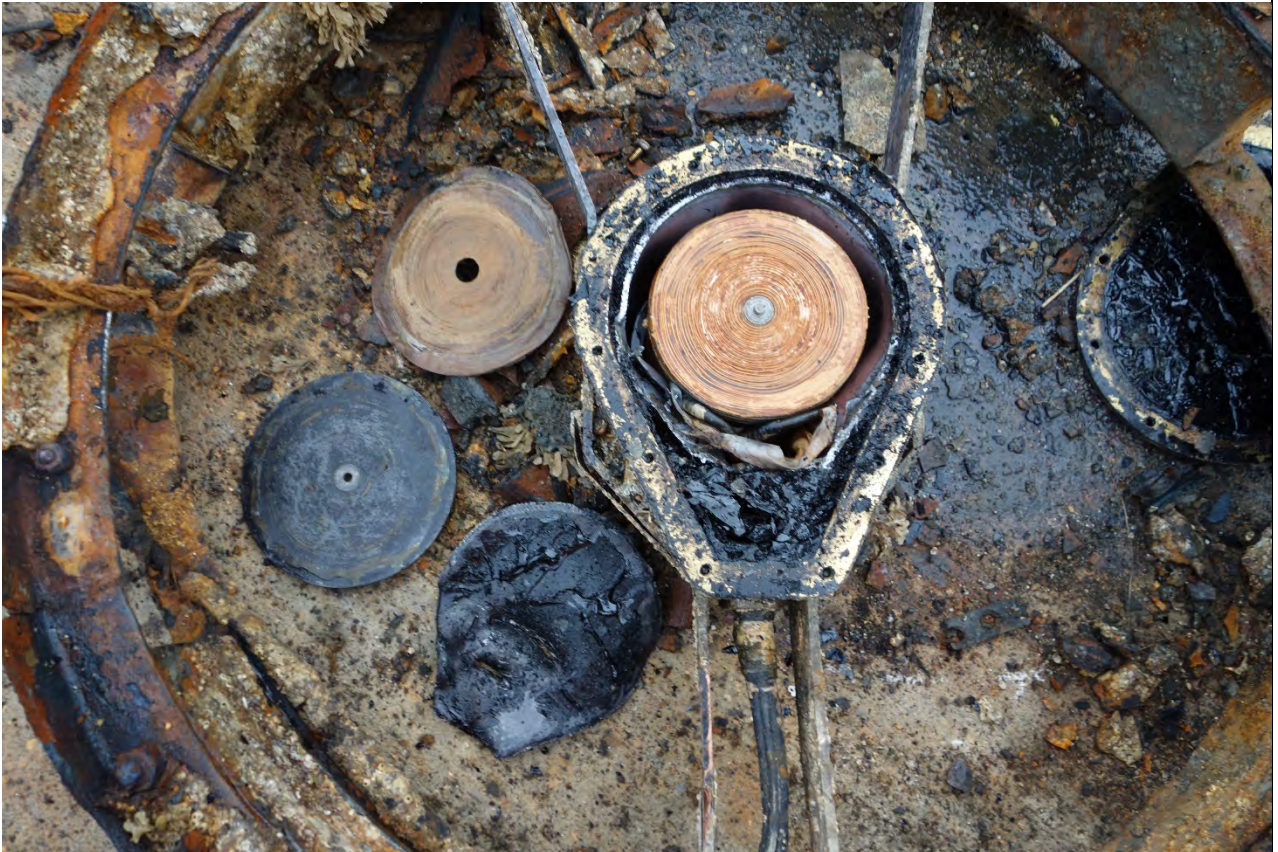
Inside of the central unit there is a copper coil that is connected to wires leading outside of the unit

particular example coming from a single axis range. The two and three axis ranges mounted the unit onto large frames along with 20 – 40 other units, these were developed in the 1950s for use with coastal minesweepers. Single axis units would likely be related to others, such as the four found together here, but instead of being mounted into a single frame, each was built in to its own anchor and would have been individually positioned to create a range area. The units are likely to have no longer been required as technology improved. The units may have been discarded (abandoned) by the Navy after they became obsolete, or alternatively lost, although this is unlikely.

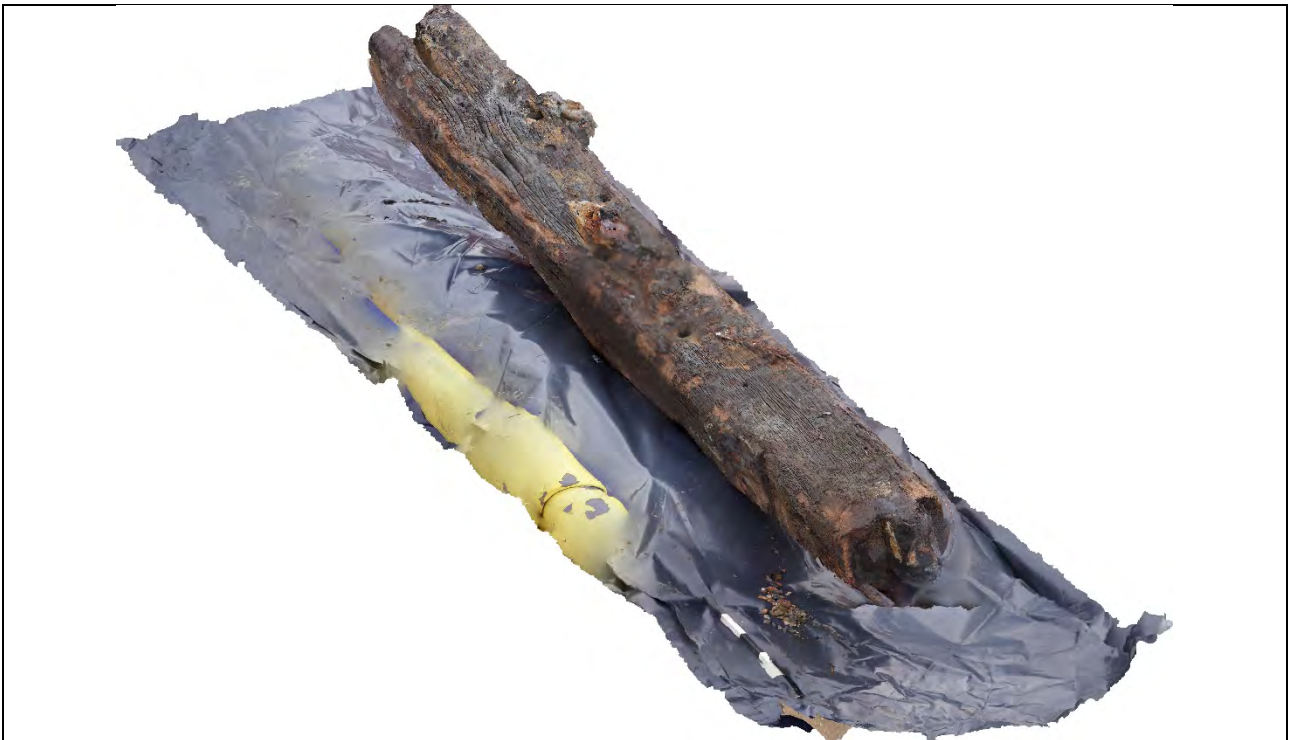
The timber measures 2650 mm in length and 270 x 290 mm in width. A large number of treenails remains *in situ* throughout the timber and an equal number of empty holes are also noted. The treenails range between 10 and 45 mm, with the majority being 40 mm. There is a slight curve to the timber and one end has a tenon joint. There is also evidence of two iron fitting with the presence of concretion material.

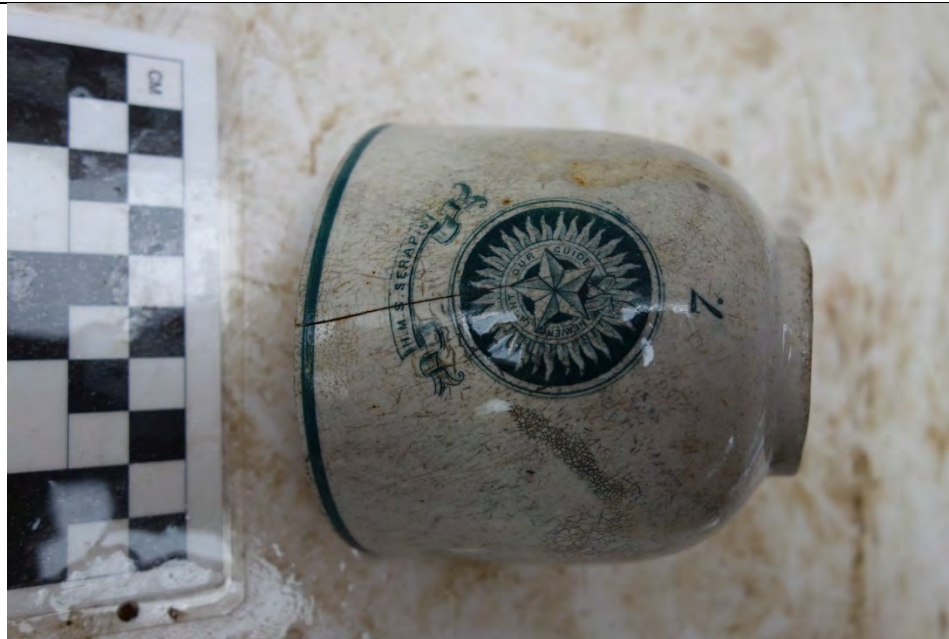
Detail on the Navy mess mug

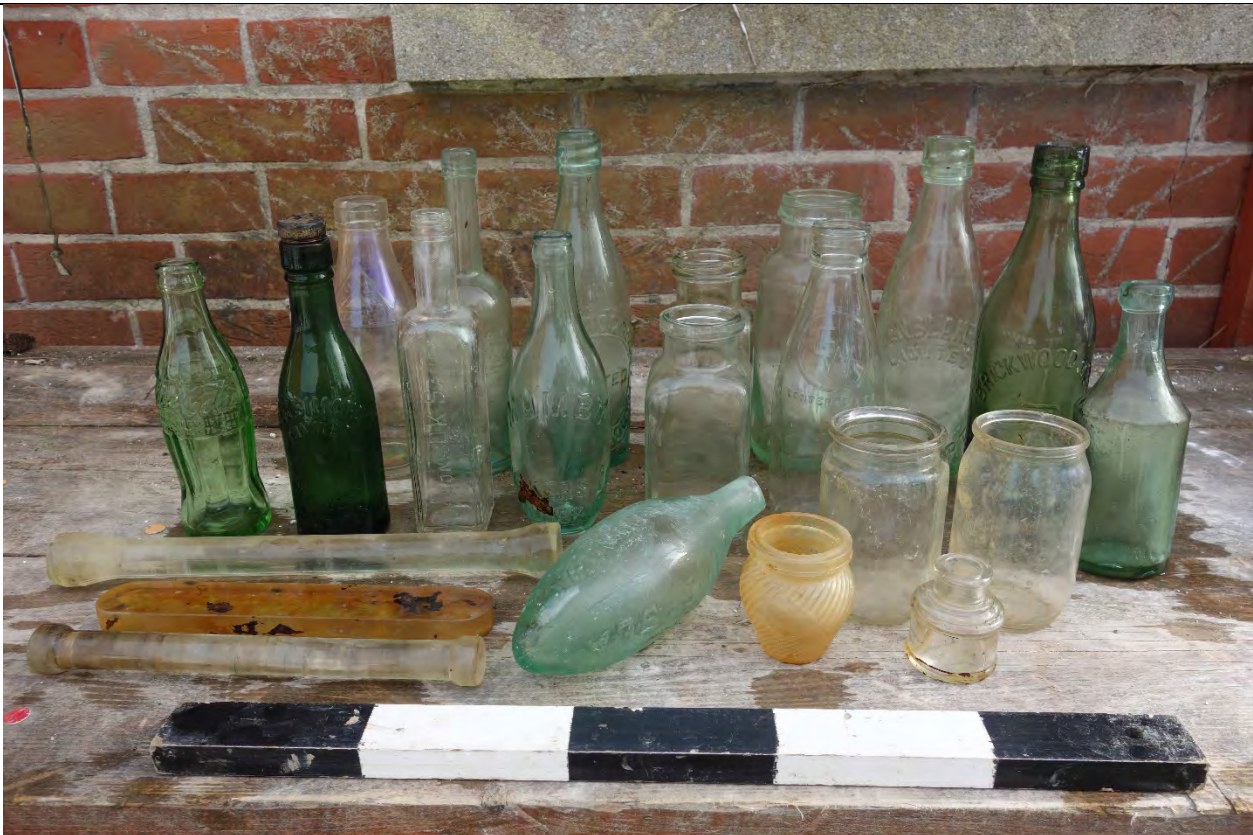
<b>UID</b> BWL7_0019	19x glass bottles, 3x sight glasses	
<b>Date of Discovery</b>	17/02/17	
<b>How Discovered</b>	Recovered by grab on board <i>Manu Pekka</i> during obstruction clearance.	
<b>Position of Discovery (British National Grid)</b>	..... E	..... N
<b>Location Map</b>	<b>Anomaly Image</b>	
N/A	N/A

- Clear glass bottle (stained orange), spiral decoration, marked with "MM 50" on the base, 75 mm tall.
- Clear glass ink well, unmarked, 60mm tall.
- Clear glass jar, marked with "FMF" on the base, 120 mm tall.

- Clear glass jar, marked with "FMF" on the base, 120 mm tall.
- Clear sight glass (stained orange), unmarked, 240 x 40 mm.
- Clear sight glass, marked with "Pyrex" "3658", 325 x 35 mm.

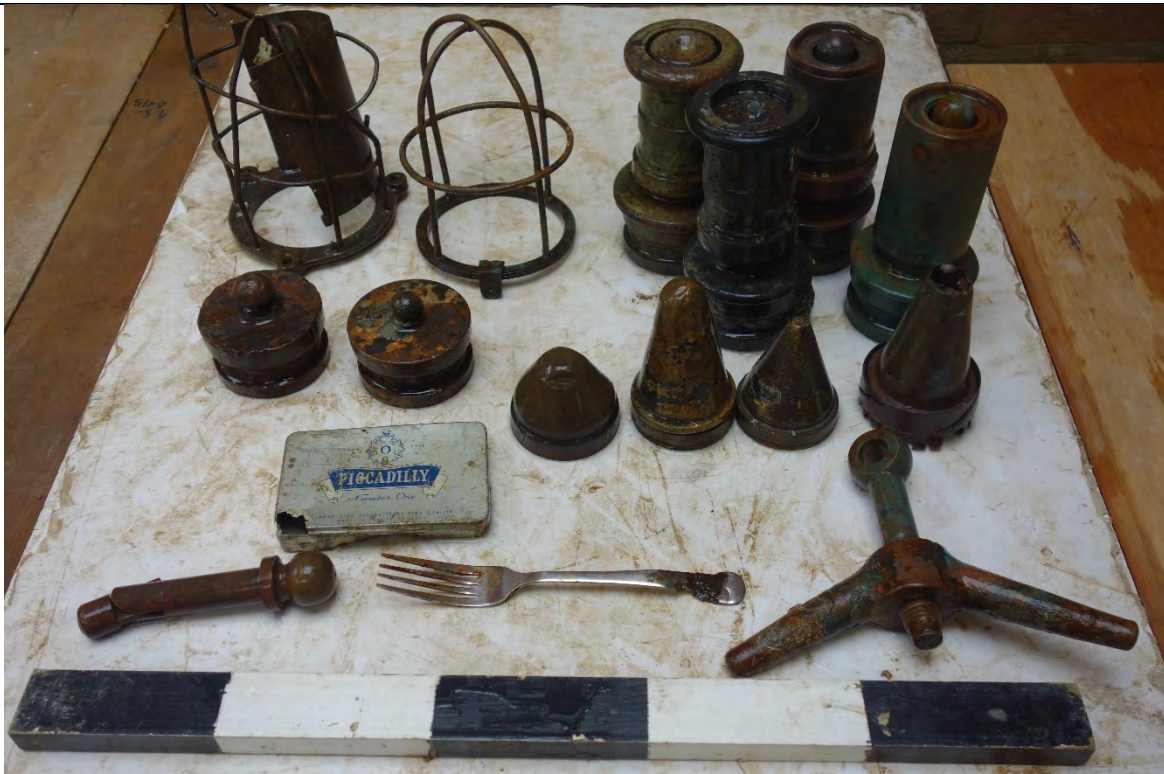
<b>UID</b> BWL7_0020	Twelve metal objects	
<b>Date of Discovery</b>	04/02/17	
<b>How Discovered</b>	Recovered by grab on board <i>Manu Pekka</i> during pre-dredge clearance.	
<b>Position of Discovery (British National Grid)</b>	..... E	..... N
<b>Location Map</b>	<b>Anomaly Image</b>	
N/A	N/A

- Two brass ship's light cages measuring 160 mm tall and 110 mm in diameter.
- A stainless-steel fork measuring 195 mm and marked with "2009 Arthur Price 1324644".
- Brass locking pin measuring 130 mm and 20 mm diameter.
- Aluminium Piccadilly cigarette tin measuring 115 x 75 mm.
- Brass locking 'dog' from a porthole or hatch.
- Two brass fire hose plugs measuring 70 mm in diameter.
- Two brass fire hose couplings measuring 150 x 70 mm.
- Two brass industrial fire hose nozzles measuring 150 x 70 mm.

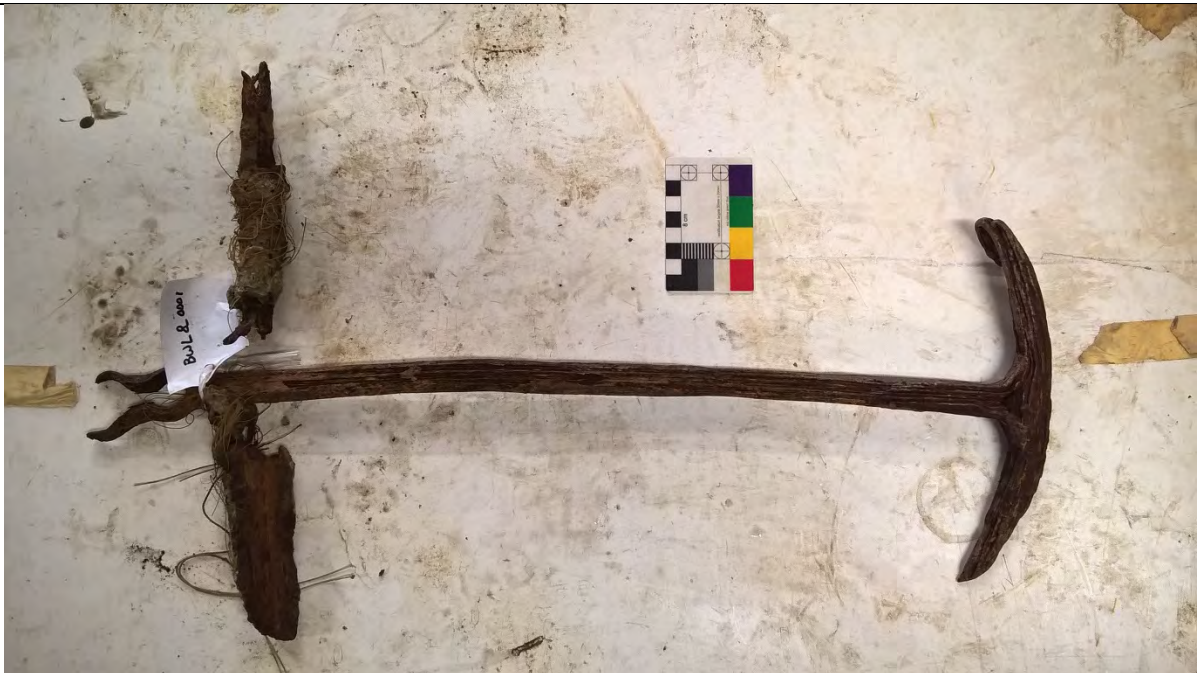
<b>UID</b> BWL8_0001	Small anchor	
<b>Date of Discovery</b>	29/03/17	
<b>How Discovered</b>	Recovered from the draghead on board <i>Causeway</i>	
<b>Position of Discovery (British National Grid)</b>	..... E	..... N
<b>Location Map</b>	<b>Anomaly Image</b>	
N/A	N/A

<b>Description</b>			
The anchor has a total length of 570 mm and the shank is rounded with a diameter of 20 mm. The flukes have been lost and the remaining bill to bill is 220 mm. Each of the arms are 113 mm long and 20 mm in diameter. The stock is fragmented and mostly remains only as concretion, the stock had a diameter of 20 mm.			
<b>Interpretation</b>			
This is a small fisherman's type anchor that would likely had a folding stock. This is one of the most easily recognisable shapes of anchor and popular in the latter half of the 19th century. This example is in a very poor condition. It may have been lost during use or discarded after being damaged.			
<b>Period</b>	Modern	<b>Date Range</b>	19th century

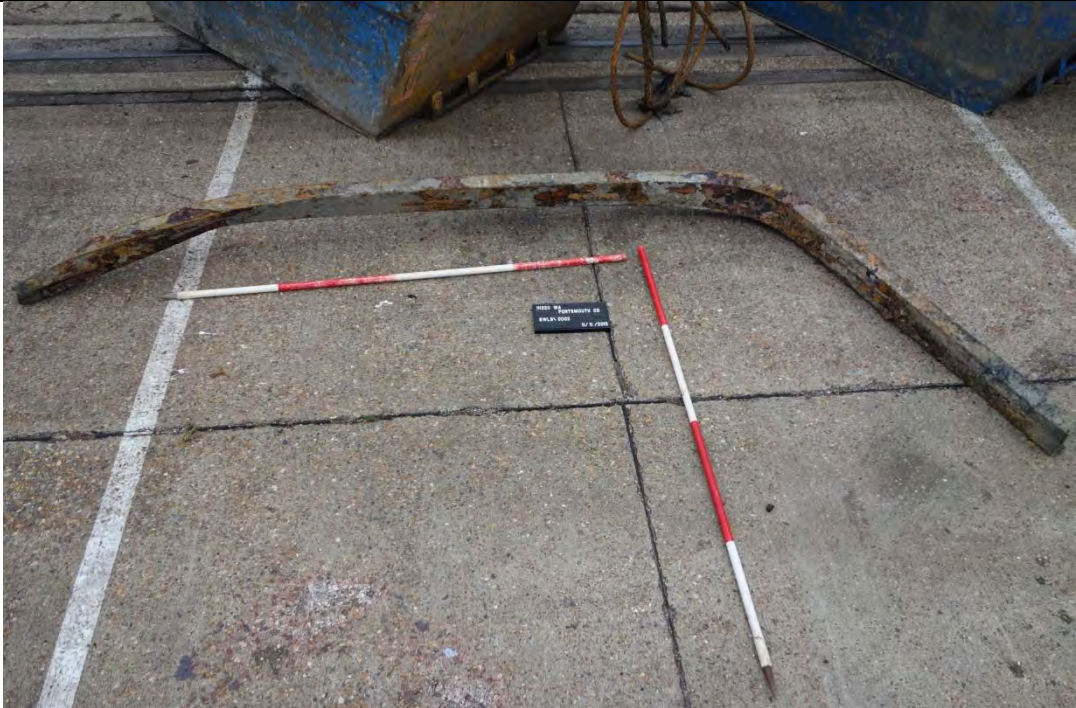
<b>UID</b> BWL9_0002	Steel Bar	
<b>Date of Discovery</b>	11/11/2015	
<b>How Discovered</b>	Recovered by grab by <i>Strekker</i> . Found during quay side archaeological Monitoring.	
<b>Position of Discovery (British National Grid)</b>	-	-
<b>Location Map</b>	<b>Anomaly Image</b>	
-	-	
<b>Images of object</b>

<b>Description</b>			
Steel channel bar with seven rectangular openings on the upper face.			
<b>Interpretation</b>			
This channel bar is probably construction material and likely to have been dumped or lost from a ship. Its condition suggests that the time of the deposition is relatively recent.			
<b>Period</b>	20th century	<b>Date Range</b>	1950-2000

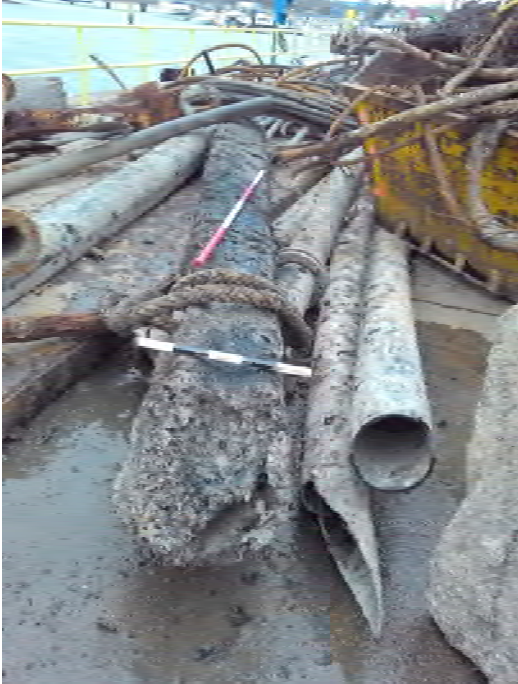
<b>UID</b> BWL9_0003	Dock or pile timber	
<b>Date of Discovery</b>	18/11/2015	
<b>How Discovered</b>	Retrieved by grab by <i>Strekker</i> – found during quay side Archaeological Monitoring	
<b>Position of Discovery (British National Grid)</b>	-	-
<b>Location Map</b>	<b>Anomaly Image</b>	
-	-	
<b>Images of object</b>

<b>Interpretation</b>			
<p>This timber might have been part of a dock structure or similar marine infrastructure that may have been discarded at sea. There is no indication of a potential date although the poor condition would suggest that it has been in the water for some time.</p>			
<b>Period</b>	Unknown	<b>Date Range</b>	Unknown

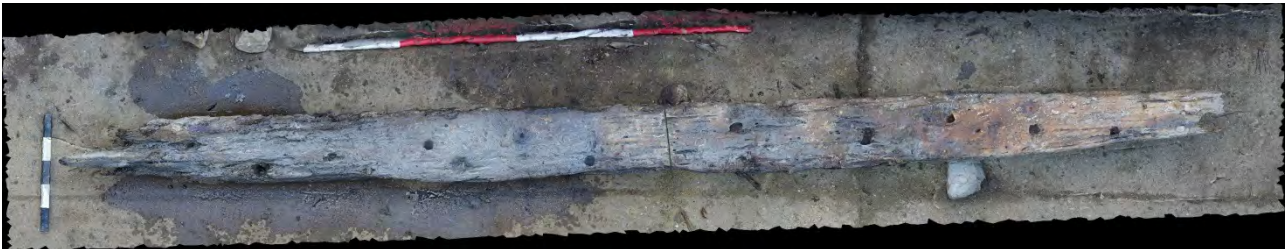
**BWL9\_0005 Face 1** (2D projection of 3D model; cut line across is for sampling)

Worked, plank-like timber object. Original dimensions truncated by erosion but maximum dimensions are 5.07m long, 0.27 wide and 0.17m thick. Face 2 significantly more eroded, but below surface the tight grained light coloured timber is in good condition with no evidence of marine borers. Box halved conversion. Twelve drilled through fastening holes of 24-55mm diameter, plus square headed ferrous nail holes. Partial survival of two drilled holes for through fastenings through the thickness axis. No obvious curve along long axis.

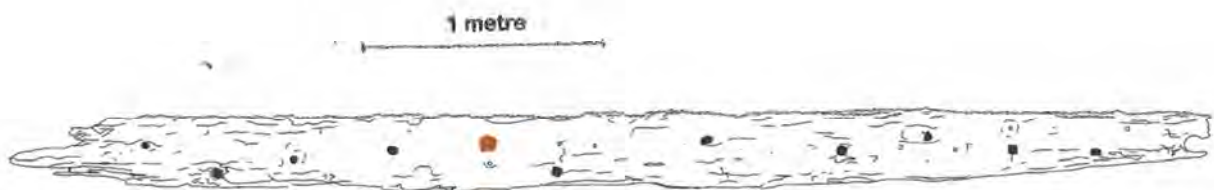
**BWL9\_0005 Face 1** (concretion and ferrous nails in red brown; empty fastener holes in dark grey)

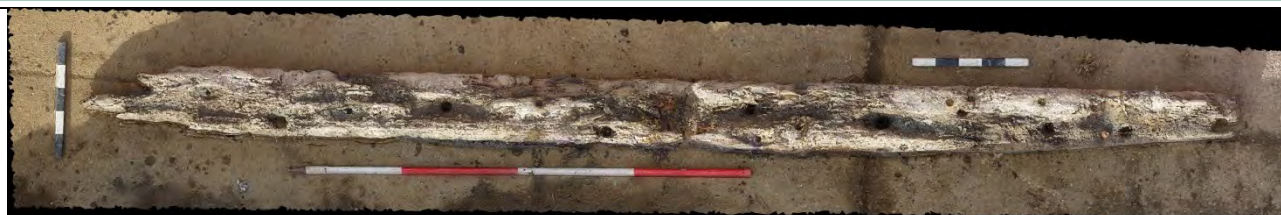
**BWL9\_005 Face 2** (2D projection of 3D model)

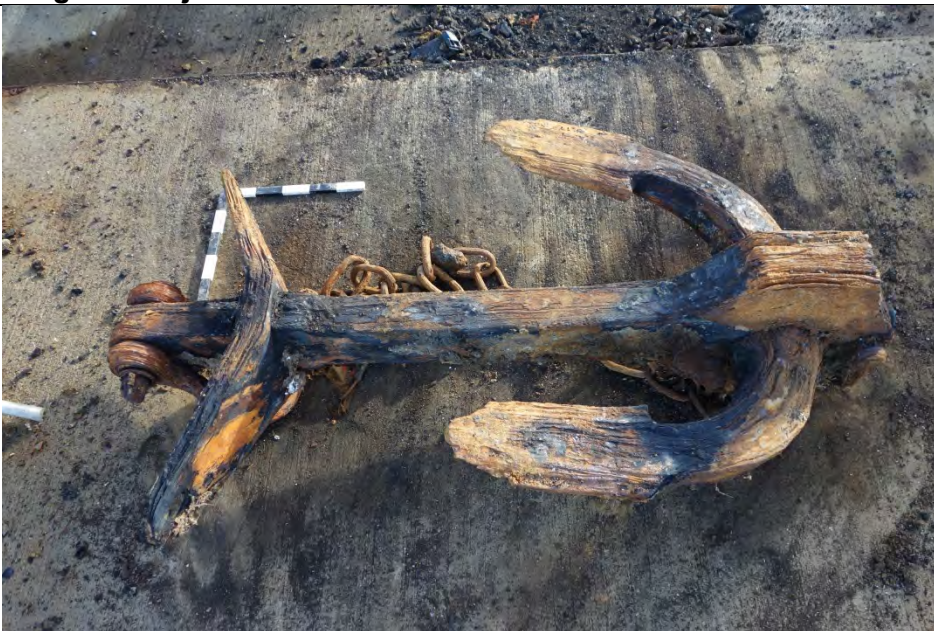
**BWL9\_0006 (0.5m scales)**

<b>UID</b> <b>BWL9_0006</b>	Martin self-canting anchor	
<b>Date of Discovery</b>	c.04/12/2015	
<b>How Discovered</b>	Recovered by crane pontoon <i>Strekker</i>	
<b>Position of Discovery (British National Grid)</b>	Not known	Not known
<b>Location Map</b>	<b>Anomaly Image</b>	
n/a	Anomaly number unknown

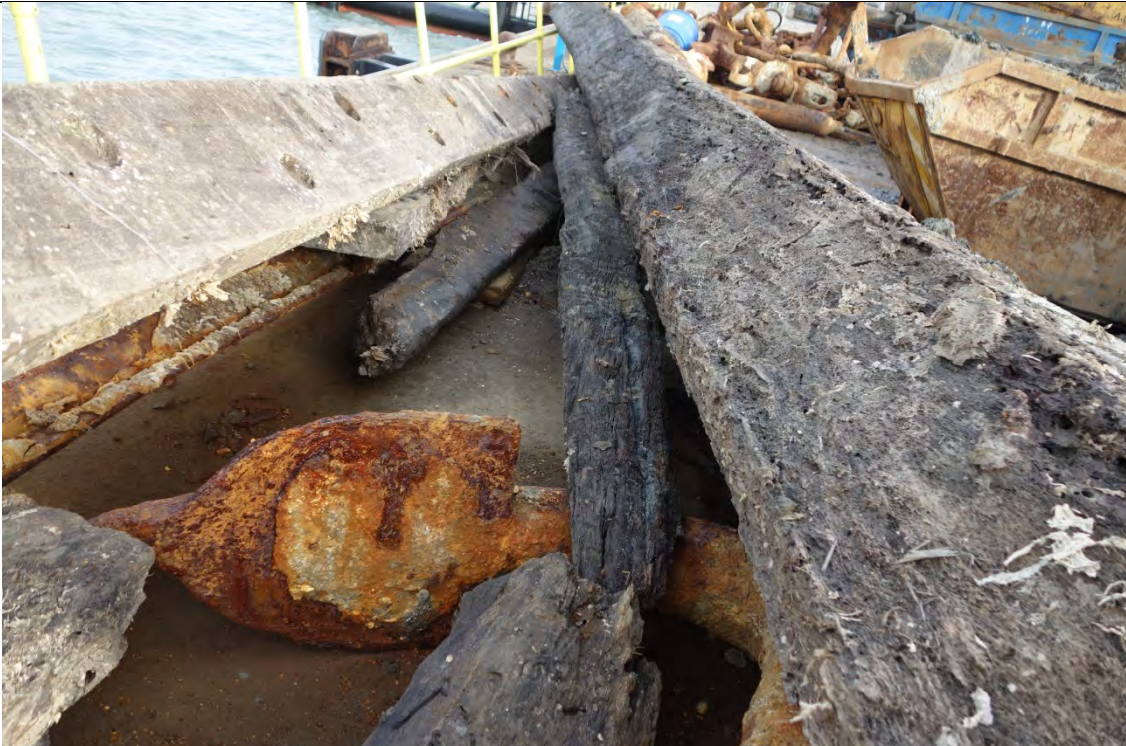
<b>UID</b> <b>BWL9_0008</b> <b>BWL_0009</b>	Dockyard piles and timbers	
<b>Date of Discovery</b>	30/12/2016	
<b>How Discovered</b>	<b>BWL9_0008:</b> Retrieved by grab and inspected on <i>Strekker</i> during Archaeological Monitoring. <b>BWL_0009:</b> Retrieved by grab and found on the quayside during Archaeological Monitoring.	
<b>Position of Discovery (British National Grid)</b>	-	-
<b>Location Map</b>	<b>Anomaly Image</b>	
-	-	
<b>Images of object</b>

<b>Description</b>			
<p><b>BWL9_0008:</b> Dockyard piles and other timbers of various sizes including planks. These timbers have square or rectangular sections and measure up to c. 5 m in length. Most of them are very eroded. They are fastened with iron bolts, plates and very simple scarf but no treenails or small nails were observed suggesting that they were more likely to be dockyard timbers and not obviously ship timbers.</p> <p><b>BWL9_0009:</b> Wooden strake of softwood of tapering circular section (max c. 0.15 m) with one end sharpened. It is c. 2.27 m long and one the upper end is broken.</p>			
<b>Interpretation</b>			
<p>The timbers probably related to a former dockyard or pier and may have been washed away by the sea or actively discarded at sea because of their conditions. As the location of recovery is not known it is impossible to associate them with any former or existing structure.</p>

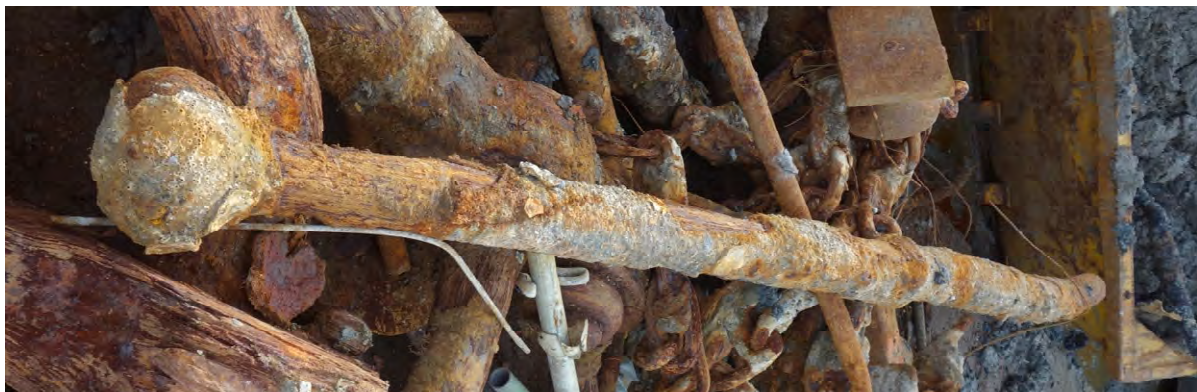
<b>UID</b> <b>BWL9_0010</b>	Admiralty iron stock	
<b>Date of Discovery</b>	06/01/2016	
<b>How Discovered</b>	Recovered by grab of crane barge <i>Strekker</i> and found during on the Quay Side Archaeological Monitoring.	
<b>Position of Discovery (British National Grid)</b>	-	-
<b>Location Map</b>	<b>Anomaly Image</b>	
-	-

Anchor stock made of wrought iron. The curved arm of the stock is broken while the straight arm is complete and still has the ball attached. The stock is identified as admiralty stock from the shoulder piece that held it in place.

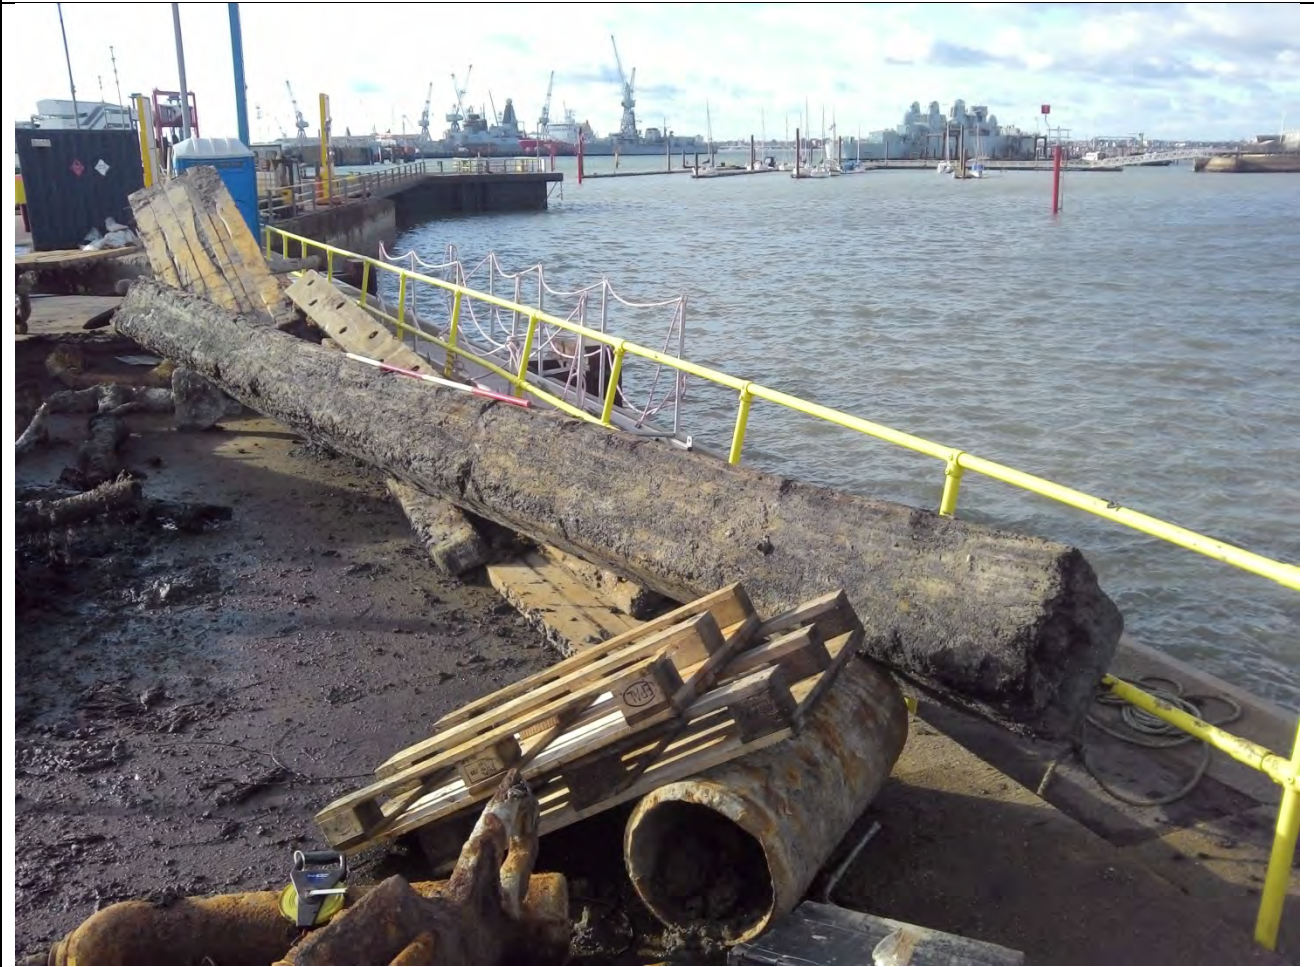
<b>UID</b> BWL1_0011	Wooden pile	
<b>Date of Discovery</b>	14/01/2016	
<b>How Discovered</b>	Recovered by grab and found during quay side archaeological Monitoring	
<b>Position of Discovery (British National Grid)</b>	-	-
<b>Location Map</b>	<b>Anomaly Image</b>	
-	-

<b>Description</b>			
<p>This timber is 9.50 m long and has a roughly squared section of 0.45 by 0.48 m. Both ends are eaten by marine borers and the all surfaces are worn, particularly on the upper side. The corners and edges appear to have been smoothed. The timber presents a slight curve along its main axis. No fastening was observed and there are no apparent tool-marks.</p>			
<b>Interpretation</b>			
<p>The timber could be a pile used in marine construction.</p>			
<b>Period</b>	Unknown	<b>Date Range</b>	Unknown

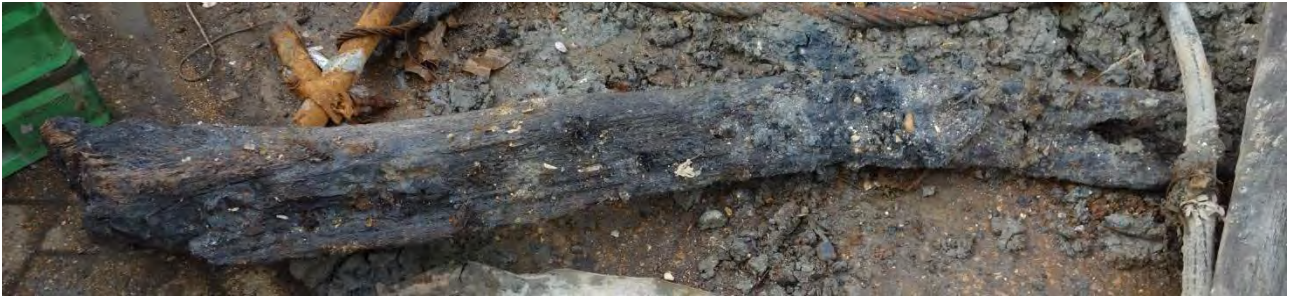
Figure 1 BWL9-0014 on the quayside after recovery

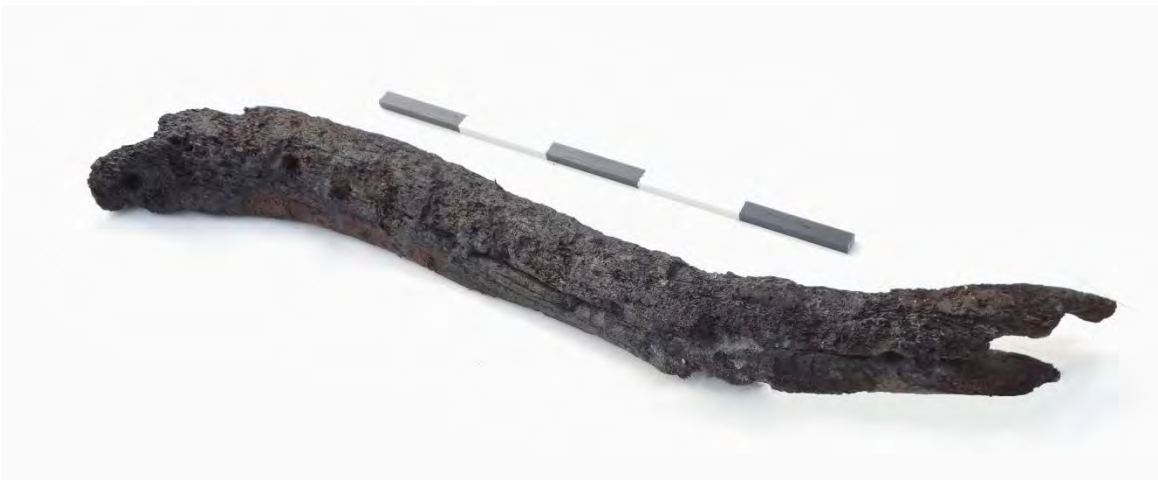
Figure 2 Isometric view (scale increment 200mm) – rear / outer face view
