# Queen Elizabeth Class Capital Dredge Project Her Majesty's Naval Base, Portsmouth

Archaeological Assessment Report

Ref: 111320.05  
January 2018

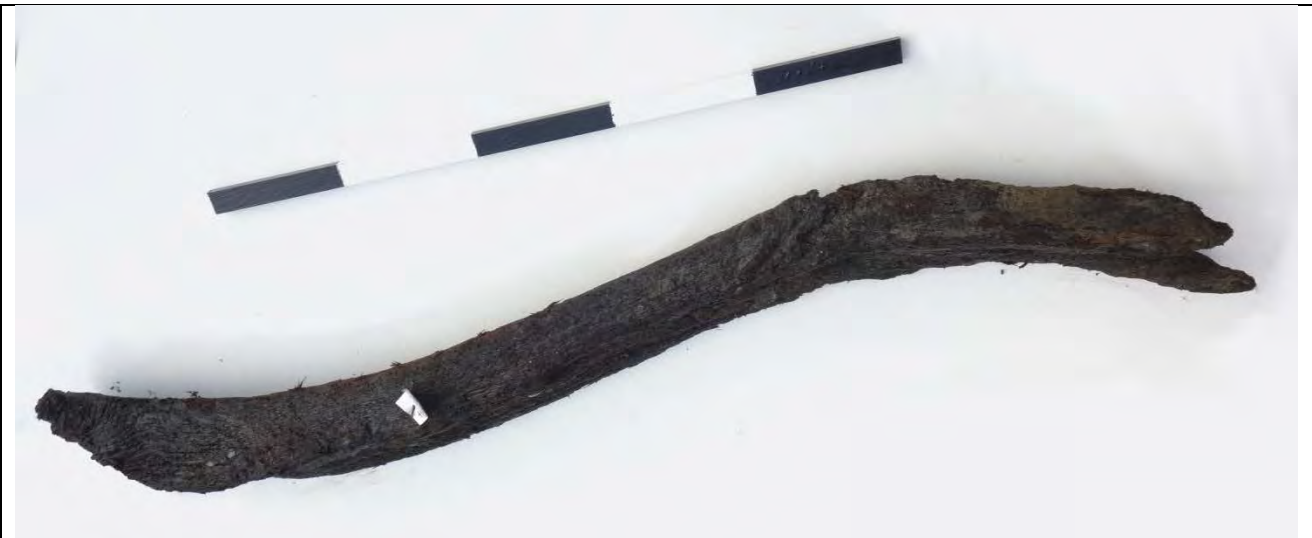
Figure 4 Front view/ outer face is on top

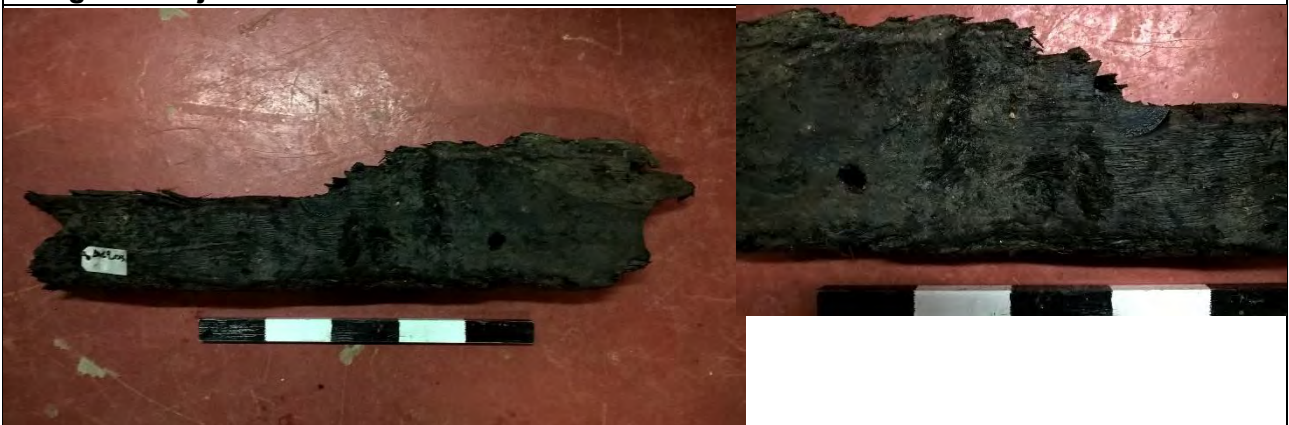
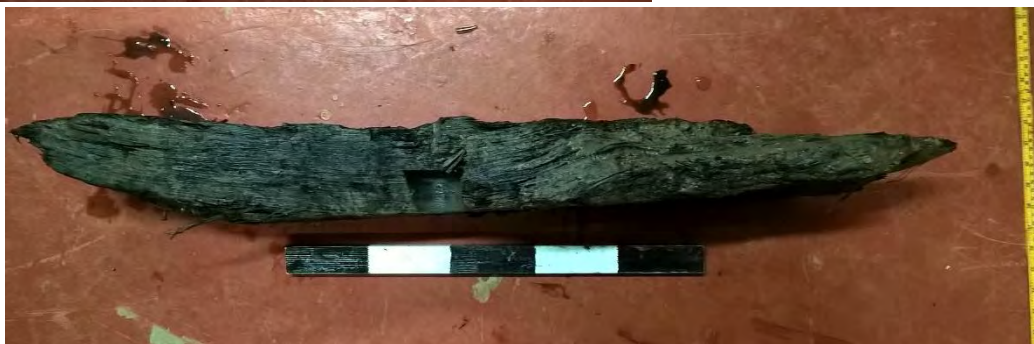
Scales = 100 mm sections

<b>UID</b> <b>BWL9_0015</b>	Timber	
<b>Date of Discovery</b>	22/04/2016	
<b>How Discovered</b>	Recovered by grab and found during Quay Side Archaeological Monitoring.	
<b>Position of Discovery (British National Grid)</b>	-	-
<b>Location Map</b>	<b>Anomaly Image</b>	
N/A	N/A

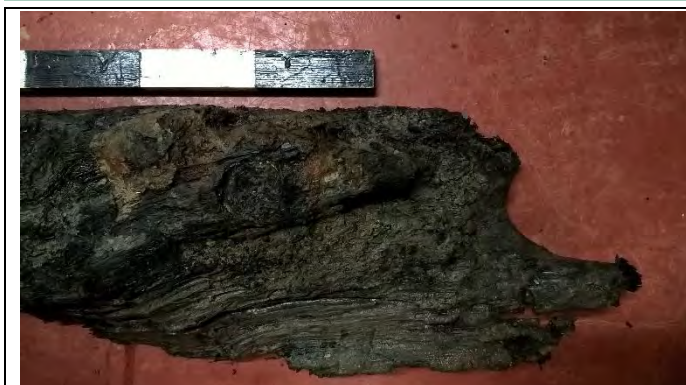
A one meter long timber with a width between 120 and 217mm and a thickness of 88 mm. The timber has a half cut groove about halfway along its length, resembling a seat for a trunnion. Closer inspection after recovery and cleaning suggests that this circular cut is more modern, likely to have been cut out using modern tools. The addition of a 10 mm dowel hole running to its centre makes this more unlikely. There is a 23 x 22 mm hole on one side and a small concretion in a relating position on the other. The other end of the timber displays a slight curve. Both ends of the timber are barely worn and no tool marks or other markings are surviving in the timbers surface.

Due to the condition of the timber, interpretation is difficult, but it has been suggested that this is part of a ship's framing. Possibly forming part of the decking, the most likely candidate has been suggested as being a carling timber. Carling timbers were used as short lengths that were placed horizontally between the beams of the ship's deck(s) forming longitudinal support to the ship's decks, which would suggest the small size of this particular timber. This would explain the curve to the timber, as decking timbers are cambered, to allow for water movement. Often these carling timbers would be found around the boundaries of hatchways and found in more numbers as the deck weight is increased. Carling timbers were each slotted in between the beams with their upper side flush to the deck, and then secured by nails (Goodwin 1987 p73 + p159, Greenhill1988 p134).

The interpretation of this being a carling timber is speculative due to the poor condition of the timber, but it can be suggested that this timber did come from a ship's structure, which may suggest a wreck in the area, although it would be very broken up and in poor condition judging by this particular find.

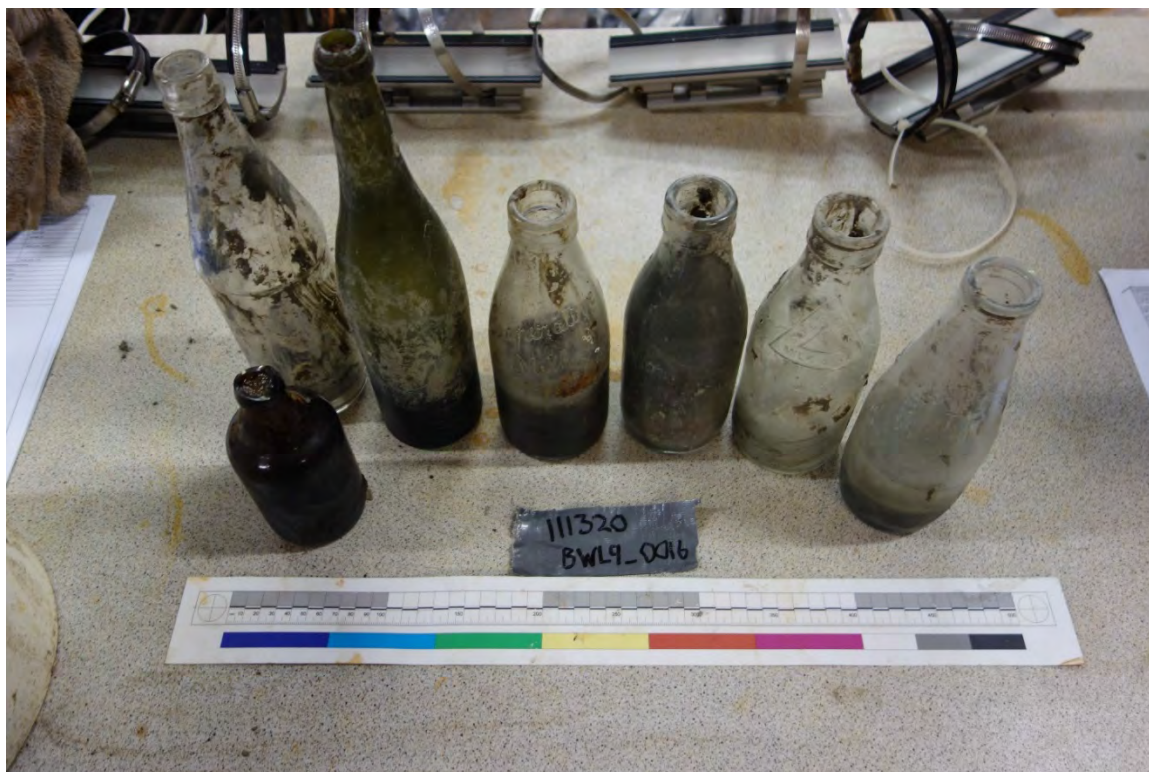
- A group of seven glass bottles were collected from a small area on the quay side. (From left to right)
- Small dark brown glass bottle, unmarked. The top is slightly broken away.
  - Tall clear glass bottle, unmarked.
  - Tall green glass bottle, unmarked, likely to have been a wine bottle.
  - Clear glass bottle marked with "Portsmouth" on one side and "Cooperative milk" on the other side.
  - 2x Clear glass bottles marked with a equilateral triangle with the word "Safety" "First" and "Milk Assn" around the borders of the triangle.
  - The Clear glass bottle on the right is marked with "Tom Parker Davies" "Fareham".

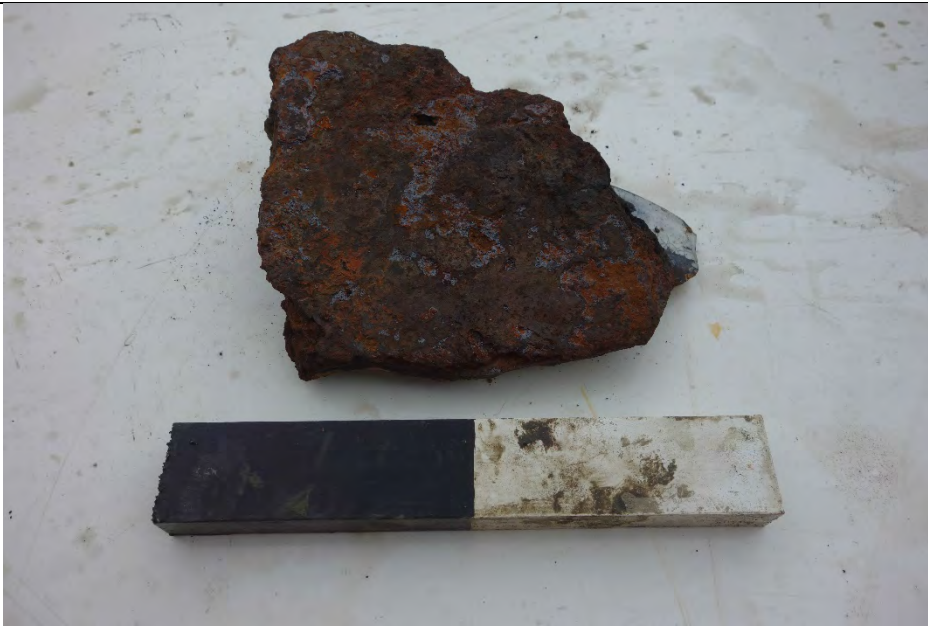
The ceramic sherd measures 160 mm across and represents only a small fragment of what was likely to have been a plate. Identified by members of the finds department at Wessex Archaeology, the style of the ceramic is known as Refined Whiteware and was in use from the 18th Century to the early 20th Century. This particular example is believed to date from the late 18th to the 19th century. An early style of white and blue ceramics are from the Chinese, but demand and influences lead to the reproduction of many similar designs in Europe.

A small sherd such as this may have been broken on board a vessel and discarded overboard, but as it is attached to an iron concretions it is possible that multiple objects went in at once. This could indicate the location of a shipwreck or an area which has seen higher levels of dumping.

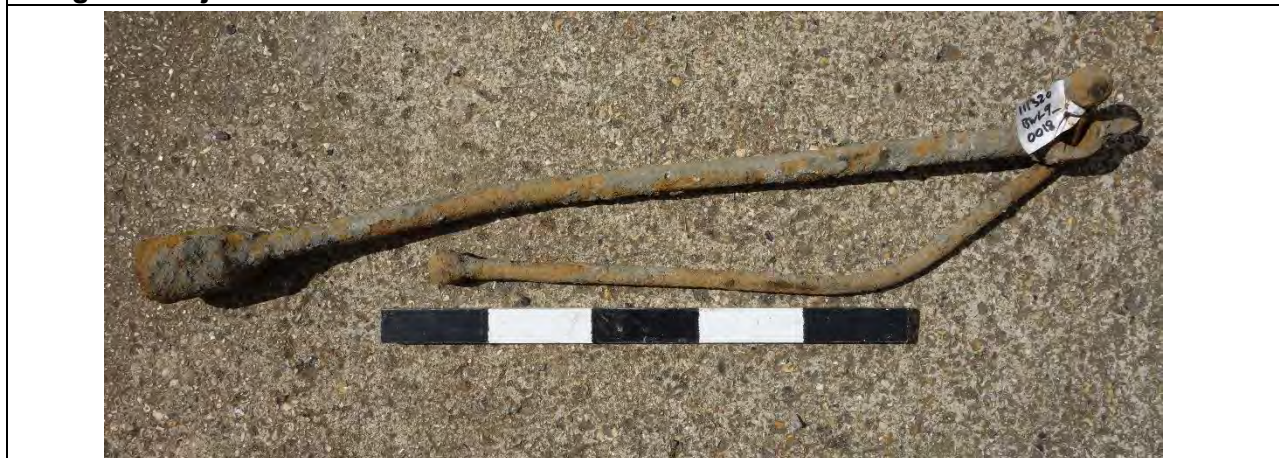
The object is made from iron and consists of two interlinked parts. Measuring just over 900 mm in length and with a general diameter of around 28 mm. At one end of the main shaft there is a large hexagonal shaped block. Measuring 60 mm wide and 73 mm in length, the overall shape and depth of this would suggest that it is a socket for the tightening and untightening of large bolts. The other end of the main shaft is a hoop, measuring 30 mm in size, through which the second component, which has an average diameter of 17 mm, is able to freely move through the hoop, with bulbous ends act as stoppers, both ends measure 32 mm and 35 mm in diameter. While the second component is bent, it measures approximately 700 mm, this second component is suggested to be the handle of the tool.

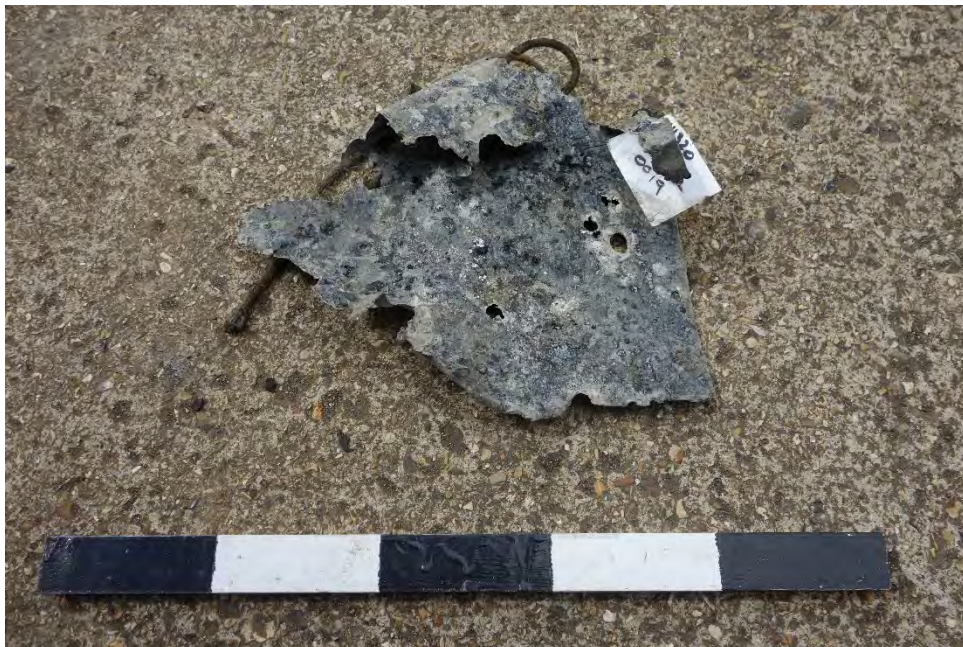
BWL9\_0019

- The smallest fragment recovered, measuring 310 x 260 mm in its crumpled condition.
- The metal itself is painted black, and has a thin, but extensive covering of marine growth.
- On this example a total of five possible rivet holes can be counted amongst the holes caused by corrosion.
- A length of thin rope is caught between one of the folds, but this is likely to have become entrapped in the fold at a later date.

Should these be aircraft remains, this would suggest that a crash site may lie within Portsmouth Harbour and this would be a protected war grave under the Protection of Military Remains Act 1986. It is recommended that those working in the area are vigilant to further possible aircraft remains.

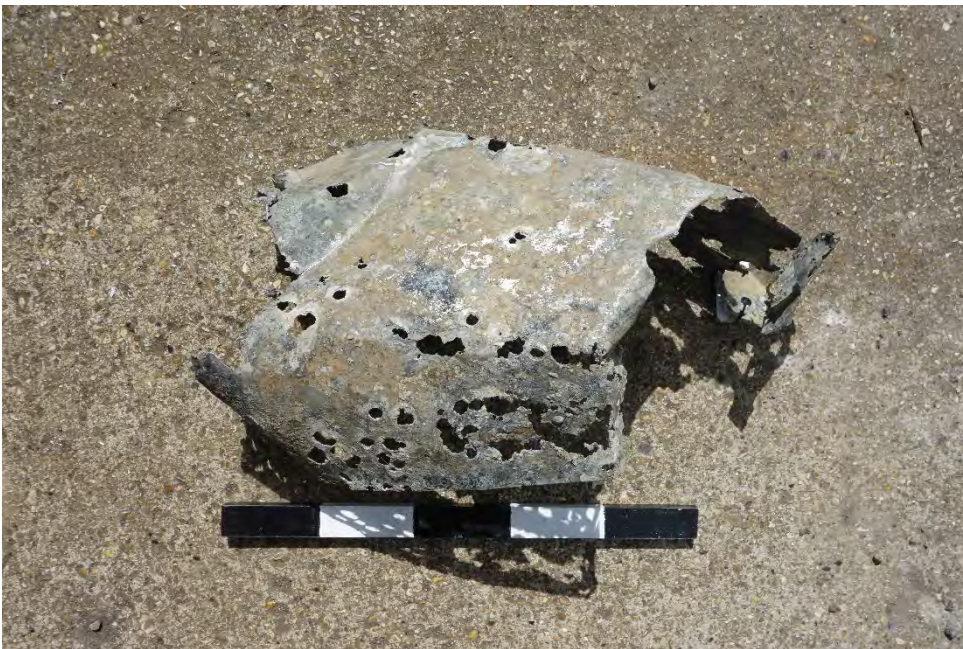
BWL9\_0020

- The middle sized fragment measures roughly 530 x 362 mm, although due to the irregular shape, some further measurements of the intentional folds were made.
- The metal itself is painted black, and has a thin, but extensive covering of marine growth.
- This piece contains at least five intentional folds in the metal, although it had been shaped for a larger object.
- Although this is a larger piece and contains more intentional folds, only five possible rivet holes could be accounted for. Yet this piece has been more affected by corrosion.

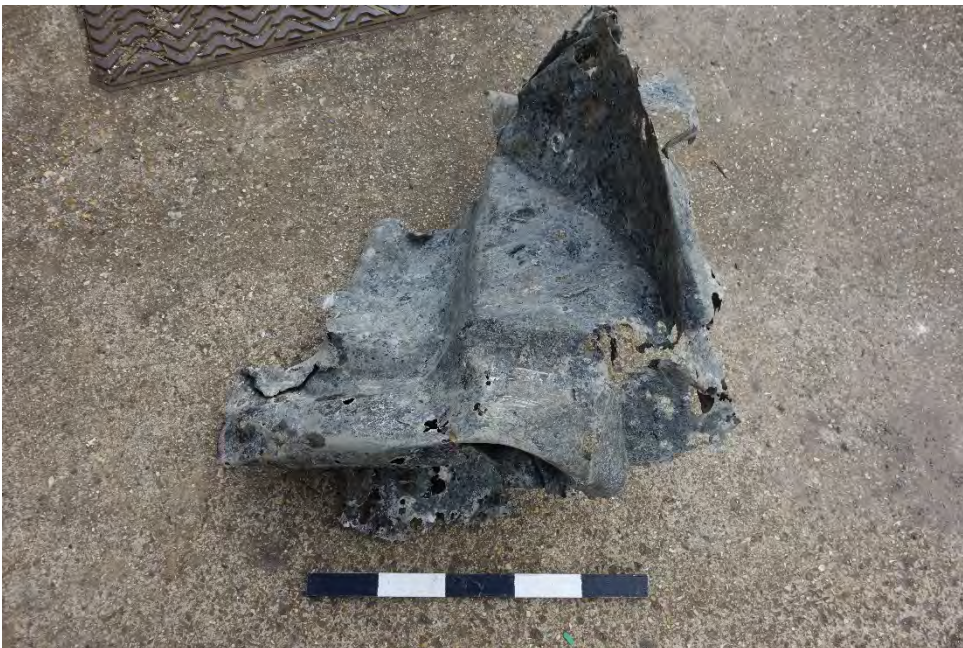
BWL9\_0021

- The largest and most damaged from this series of three finds measures up to 885 x 620 mm.
- The metal itself is painted black, and has a thin, but extensive covering of marine growth.
- Only two intentional folds in the metal could be observed on this piece and a total of ten possible rivet holes.

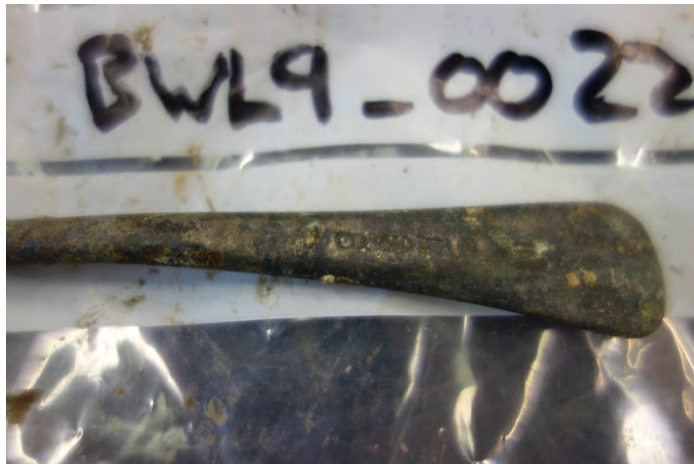
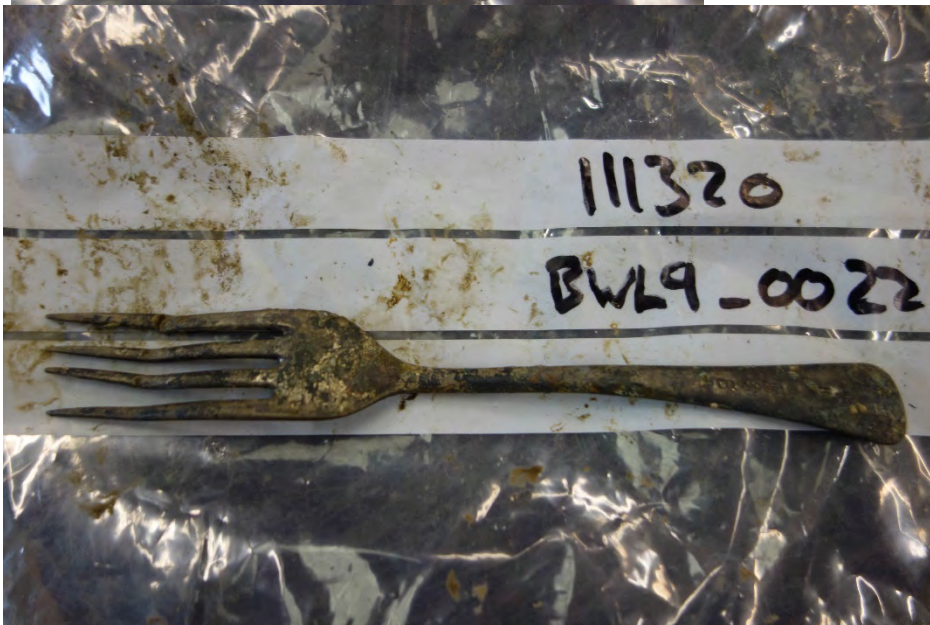
This silver four pronged fork measures 175 mm in total length, while the handle is 100 mm and the prongs themselves 50 mm in length. The prongs of the fork have been damaged which may have been caused by the dredging or be the reason for discard. The back of the fork displays a hallmark which is difficult to make out, but part possibly reads "NOX10"? The blackened colour of the fork would suggest that it has been submerged for quite a while.

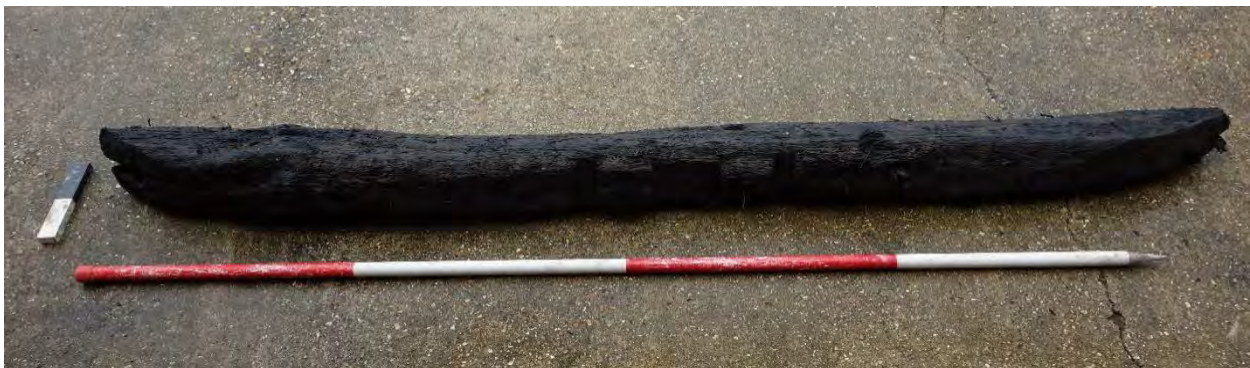
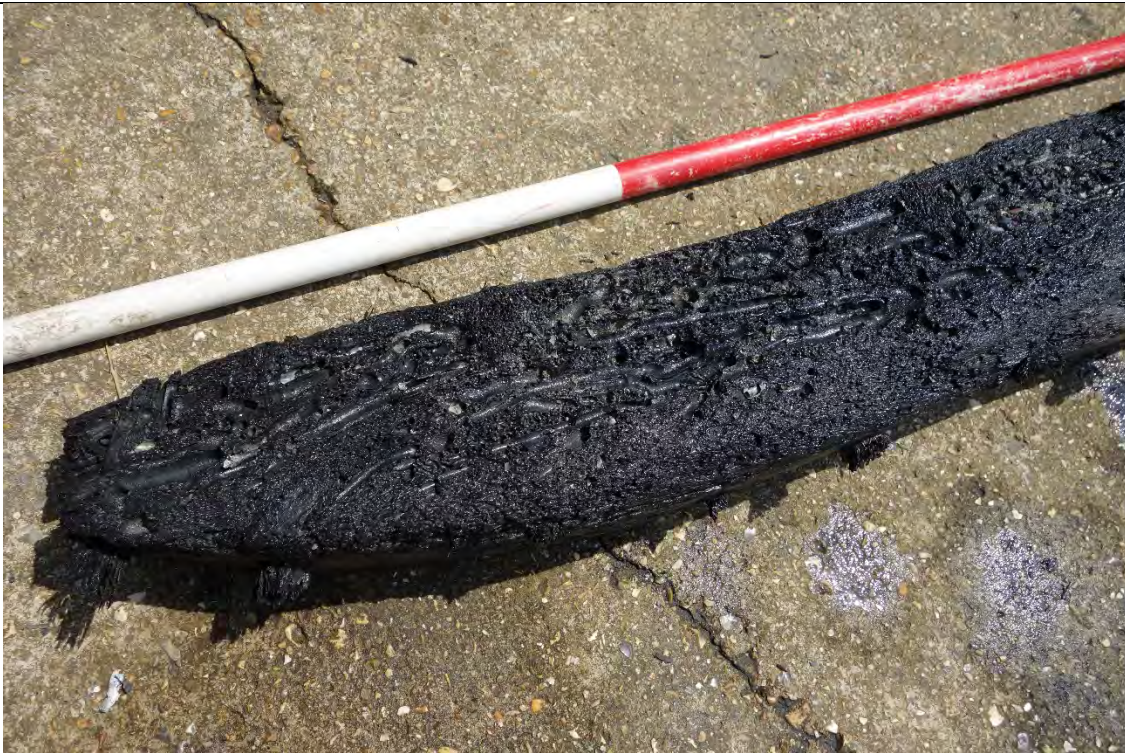
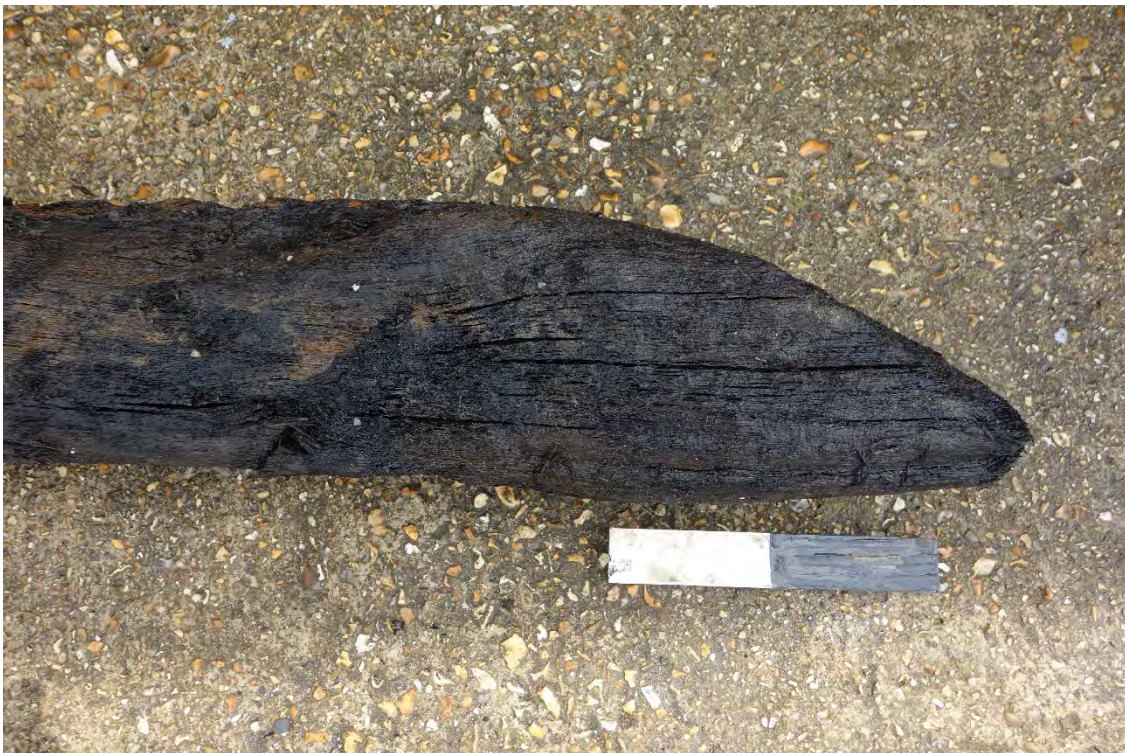
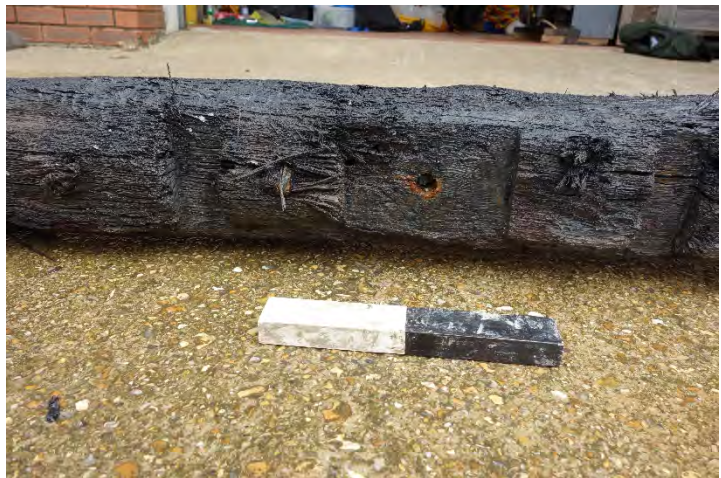
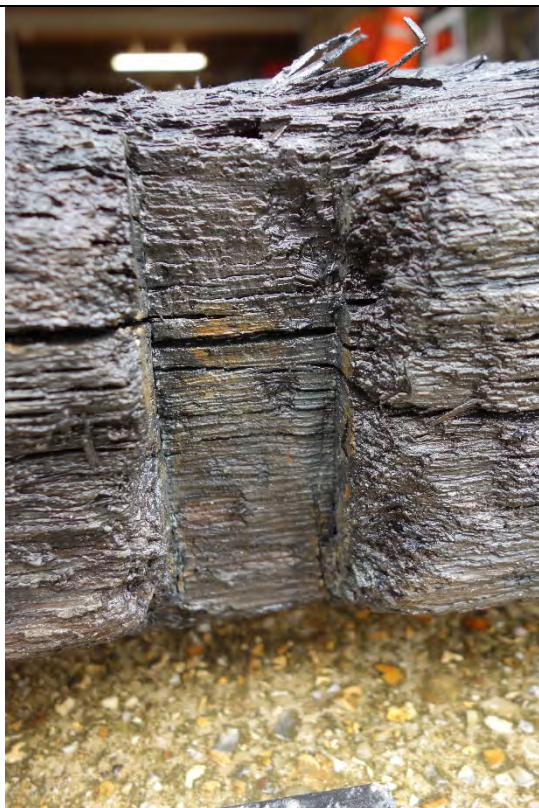
Scarf joint from either end of the timber.

The timber measures a total length of 2100 mm with a width of 150 mm at the top and 130 mm on its underside; and a depth of 150 mm at around the mid-point. Its overall shape is slightly rounded to the base, with the topside width being 150 mm and the underside width of 130 mm. The keel rabbet does not sit exactly at the mid-point with the floor timbers arms extending 940 mm on one side and 880 mm on the other, both of these being measured from the respective watercourse. The keel rabbet measures 130 mm in length, 100 mm in width and a depth of 15 mm, the keel rabbet has a smaller, possibly iron bolt hole measuring 20 mm. Either side of the keel rabbet, at a spacing of 100 mm are the two watercourses. Each watercourse measures 40 mm in width, 100 mm in length and 20 mm in depth. At each extent of the timber is a scarf joint. These are plain scarfs joined by two treenails and measure 280 mm and 300 mm in length. The scarf joints extend up at an angle of 22 degrees on the longer side and 20 degrees on the shorter.

There are 20 treenails visible in the top of the timber, yet only 16 proceed out through the bottom. There are however four sets of treenails that are touching at the entry point but only have one exit, suggesting that one does not pass the whole way through. None of the treenails have been wedged. These additional treenails that do not pass through the whole timber may have been in relation to the ceiling planking. Although there is no noticeable evidence for any timbers crossing the floor timber, either a keelson or ceiling planking. The underside of the timber does not show any obvious evidence for external planking. The treenails are spaced inconsistently, making an estimation of the width of any planking difficult, but general spacing varies between 70 – 200 mm. But without evidence for any clinker joinery, it is likely that this was a carvel built vessel, with planks joining end to end and not overlapping.

One of the treenails suggests a possible later repair, with an iron bolt or nail running through the middle of it. Other than this there is only one other possible iron bolt, and that is to connect the floor timber to the keel, although the bolt is not *in-situ*.

The timber has some tool marks found with the watercourse recesses, both of these show the chisel marks. The outer surface of the timber revealed little in the way of markings although a close inspection was undertaken. One end of the timber has also been quite heavily attacked by wood borers and this has affected the timbers shape at that particular end.

No other timbers that may relate to this floor timber were recovered and this can be considered an isolated find. The angle at which it appears to have been exposed, looking at the wood borer damage, would suggest that the timber was lying on its side with one side partially exposed from the sea bed.

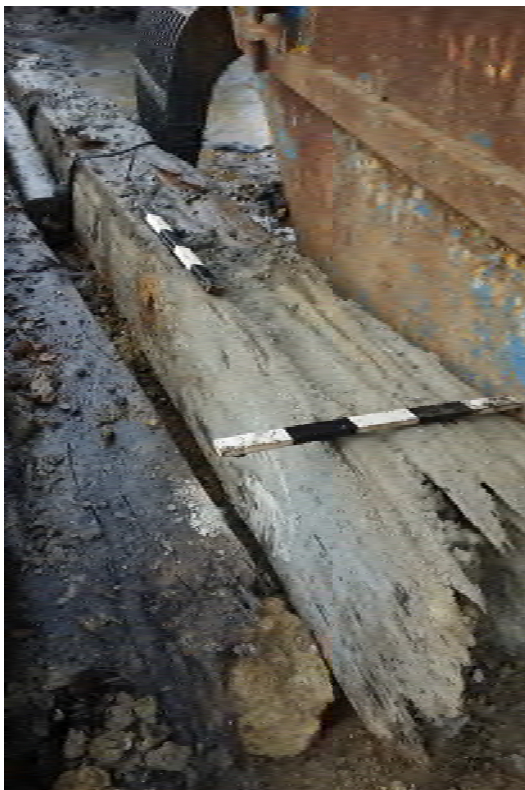
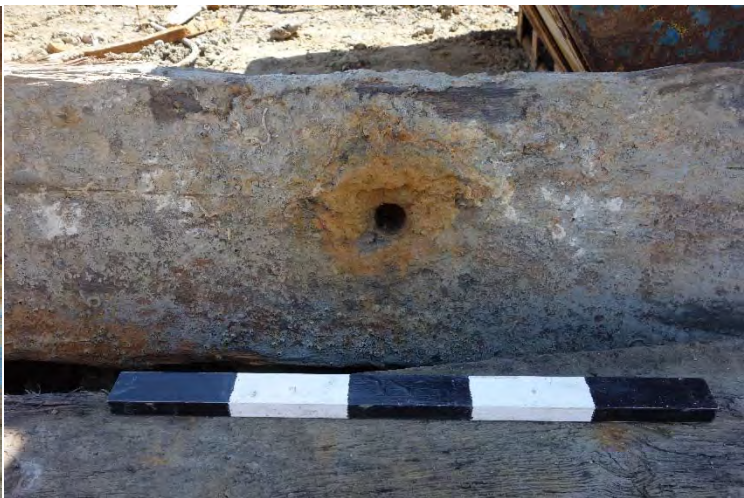
This timber measures approximately 3500 mm and originally looks to of had a square section of around 350 x 350 mm. The timber is well prepared and likely to have been done by machine, there were no visible tool marks along its length, although the timber was in poor condition. The timber's inner structure was almost gone. There are two bolt holes along its length, and one of these shows evidence around the holes to suggest that it was bolted using iron. The overall length and thickness of the timber along with the positioning of the fixing holes would suggest that this is a vertical timber from a wooden harbour/quay side.

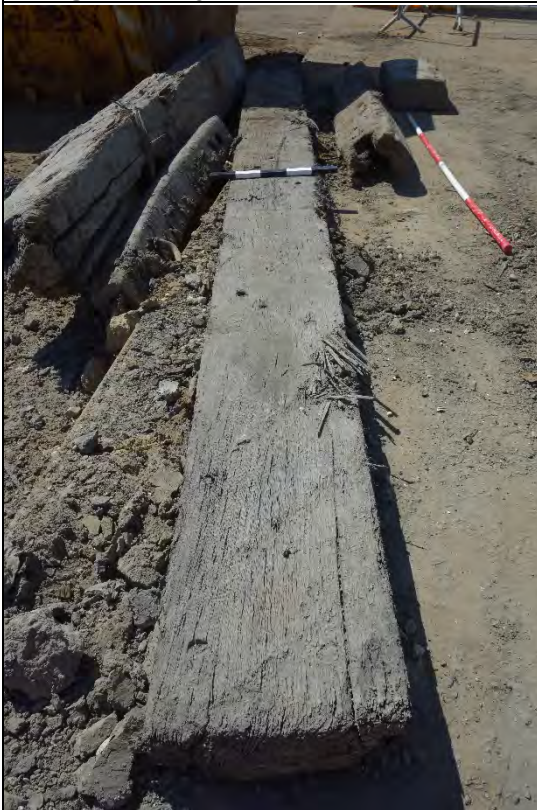
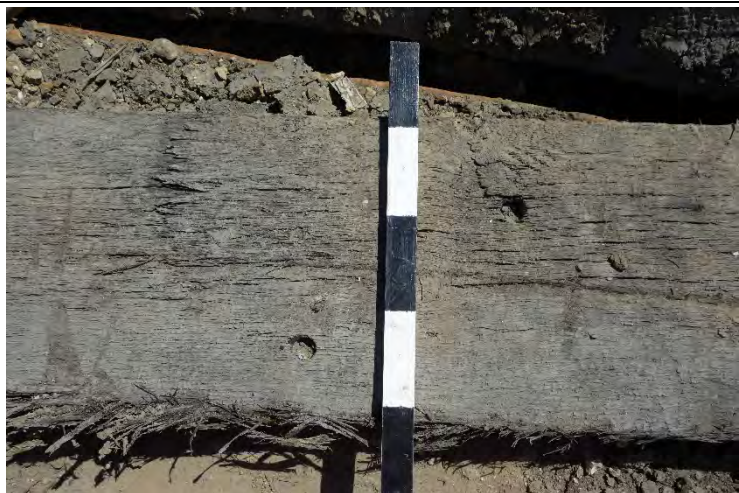
This timber measures approximately 5000 mm and originally looks to of had a rectangular section of around 300 x 100 mm. The timber is well prepared and likely to have been done by machine, there were no visible tool marks along its length, despite its relatively good condition. There are several sets of treenail or bolt holes along its length, in sets of two and spaced around a meter between each set. There was no evidence around the holes to suggest whether they were treenails, iron, or copper. The overall length and thickness of the timber along with the positioning of the fixing holes would suggest that this is a horizontal timber from a wooden harbour/quay side.

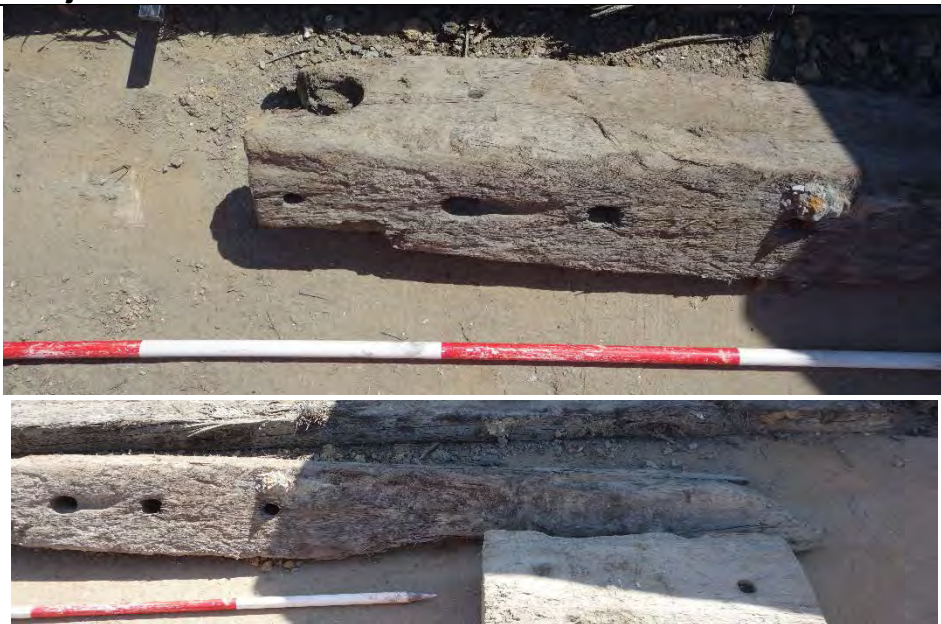
This timber measures approximately 2500 mm and although in very poor condition, originally looks to of had a square section of around 300 x 300 mm. One end (bottom picture to the right) is much more decayed than the other, this end also has no features to report on. The other end is in much better condition and has a series of four large bolt holes running through. On the other face, right at the end of the timber there is a larger circular cut that overlaps the edge to leave an opening.

This timber is likely to relate to a wooden harbour/quay side. Being a vertical pile, the more degraded end of which would have likely been positioned at the bottom, while the uppermost section, received the least in terms of degradation. The series of holes are likely to have supported the horizontal timbers.

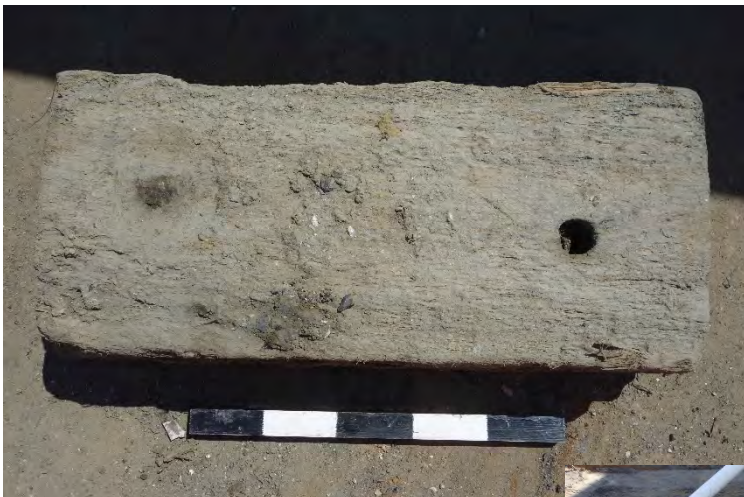
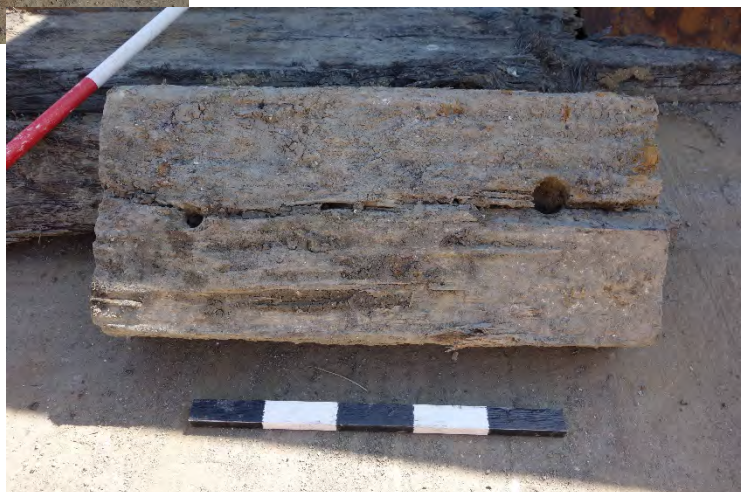
This timber is likely to have been a part for a wooden harbour/quay side. Wear to the timber would suggest that this is of a modern date.

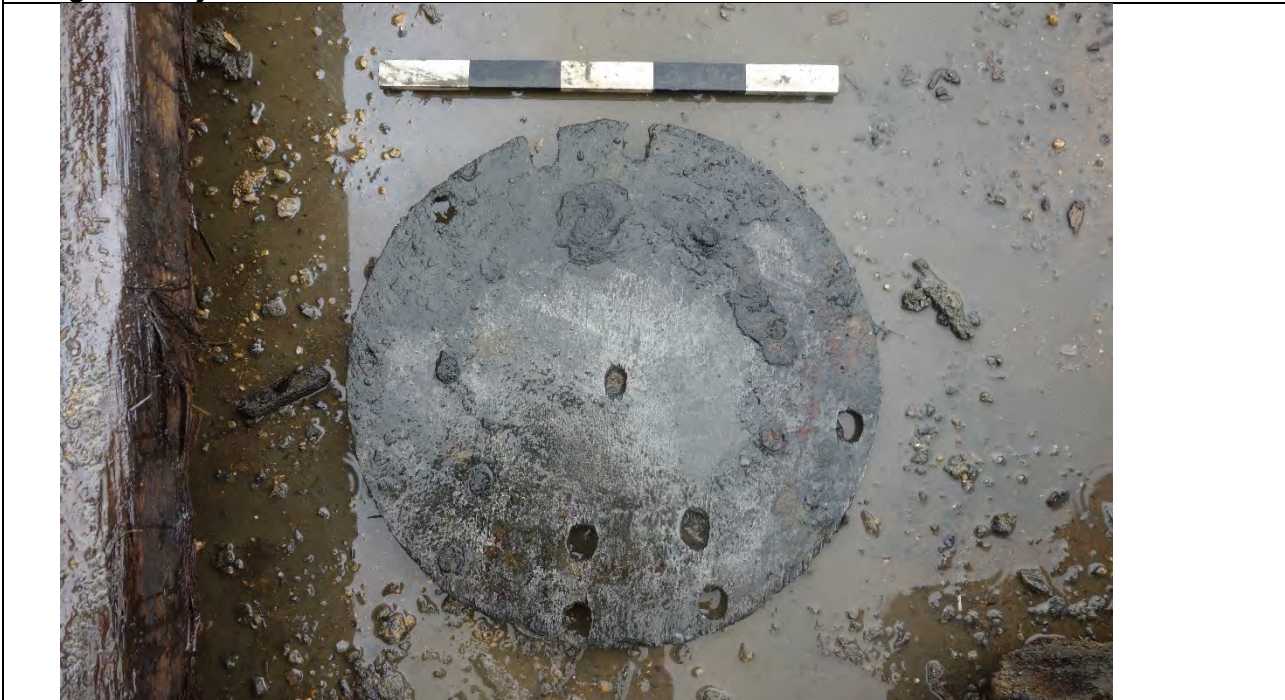
Circular metal object measuring 550 mm in diameter. There are a total of nine holes of slightly varying sizes positioned around the object. The four close together and the two holes found opposite that break the borders of the object, together suggest a hinge and handle setup. This may be a cover from on board a vessel of some kind, possibly a service hatch, or to be part of the harbour side itself.

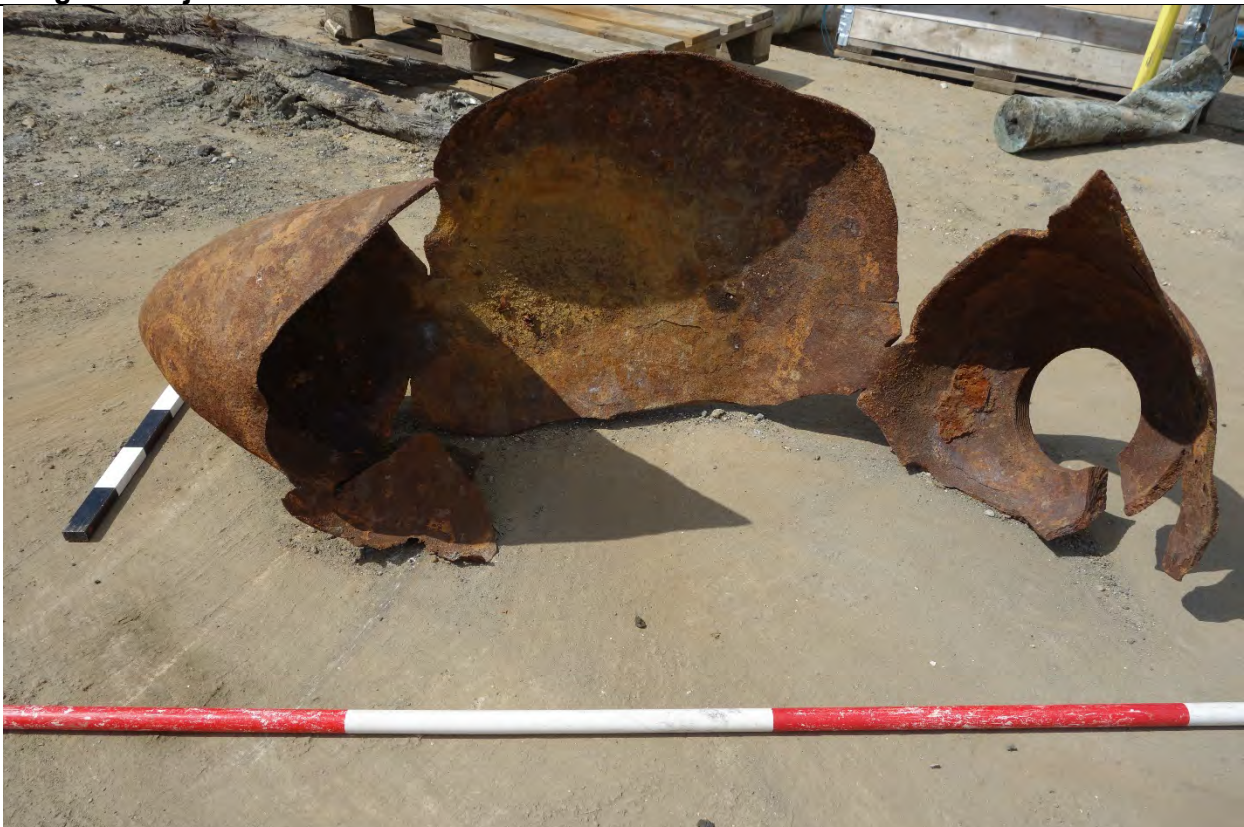
The nose cone is attached to approximately a quarter of the main body, this has been spread out by the force of the explosion. Similarly, the tail end is barely attached but displays the full base of the bomb which has a diameter of 300 mm. The thread into with the cavity of the bomb would be filled and tail fins attached was cracked through in one spot, measuring 175 mm in diameter and a thread depth of approximately 45 mm, demonstrating the force of the explosion.

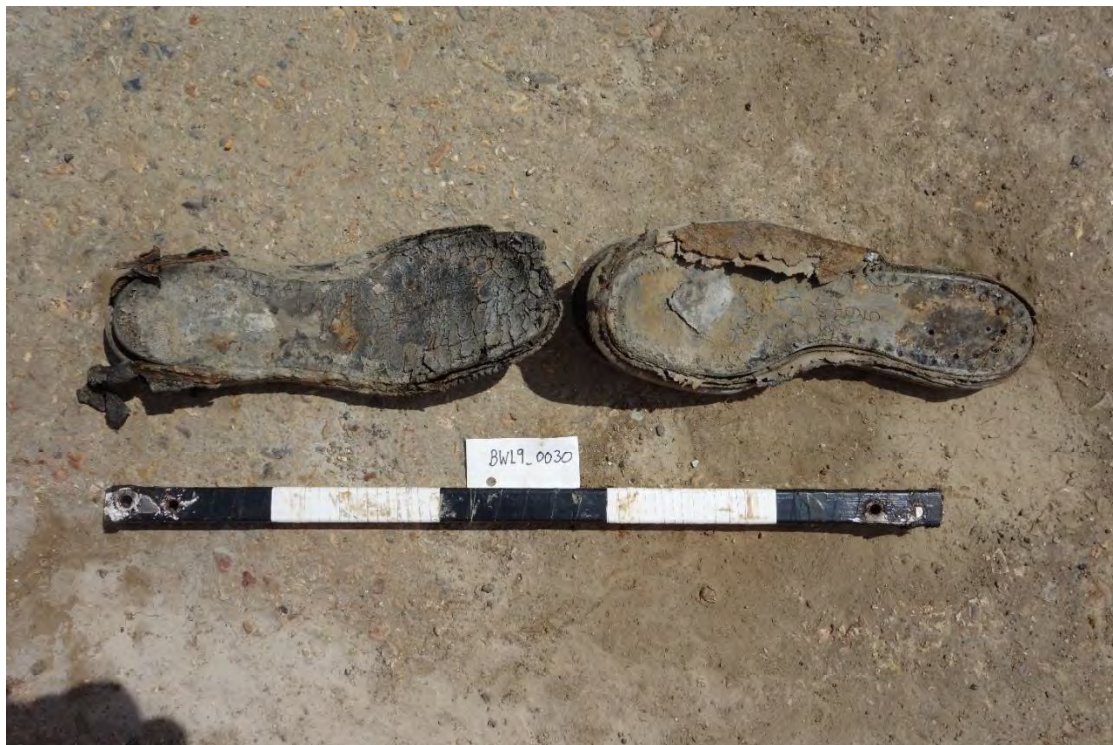
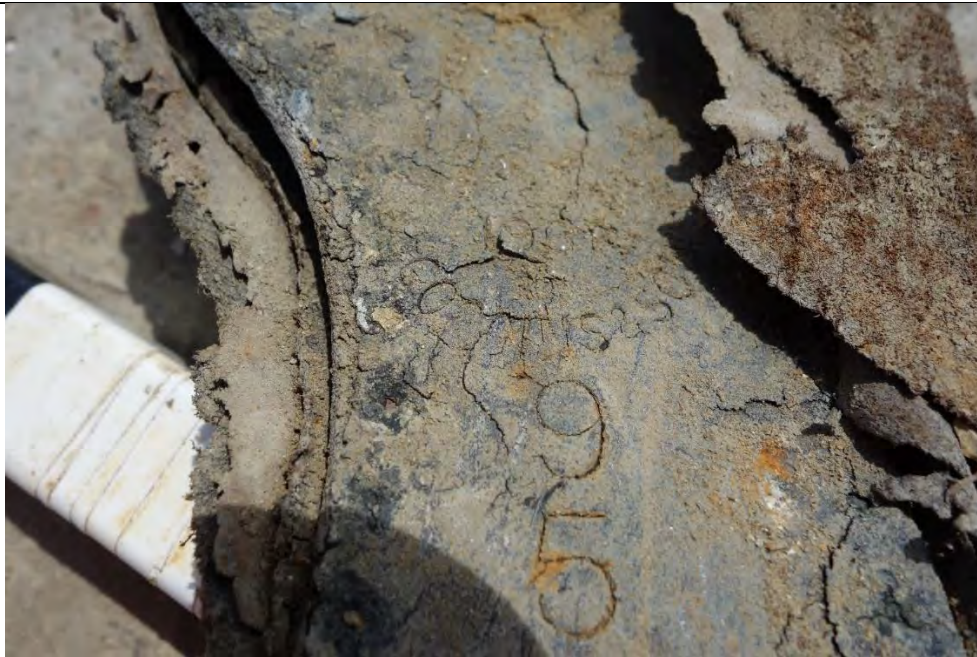
Two similarly sized and designed shoe soles.

The first measures 275 mm in length, where it is broken at the toe. The leather is in very poor condition. It is constructed using pins and also possibly glue. There is a possible partial date on the sole of the shoe ending in "...918". The shoe is likely to have been either a size 9 or 9.5 in UK sizing.

The second of the two shoe soles measures 285 mm in length. This is in slightly better condition with some of the upper shoe still remaining, which shows that the shoe would have been made of suede leather. The construction is similar except for a second internal row of stitching holes. On the sole of the shoe are the numbers "9" and "5" positioned one above the other, this is likely to be the shoe size 9.5 in UK sizing, which measures 280-285 mm in length. Above this is the partial date of "195..." and below this the partial makers name of "CO...INS & SONS". This is believed to be a Northamptonshire based shoe maker, Coggins Shoes. Founded in 1892, they were mostly commonly known for their production of Army and Navy work wear for the First World War.

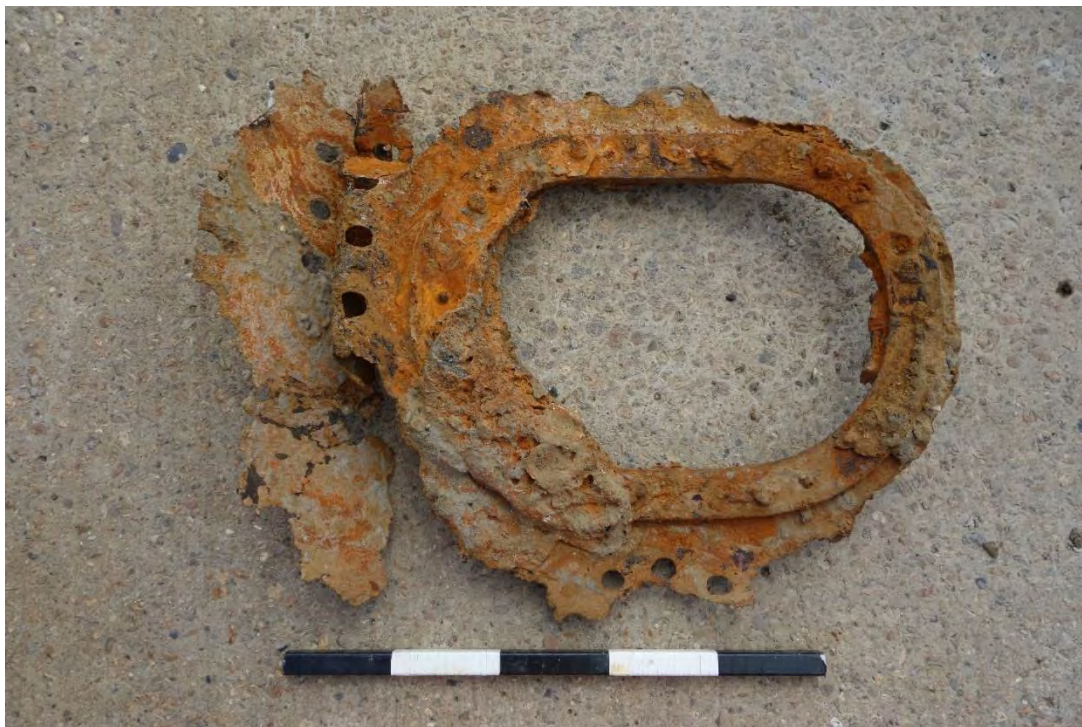
The porthole is likely to have been discarded into the sea, possibly during repair work. It is unlikely to have fallen from a ship or to relate to the site of a shipwreck as no other material or obstructions were recovered with it.

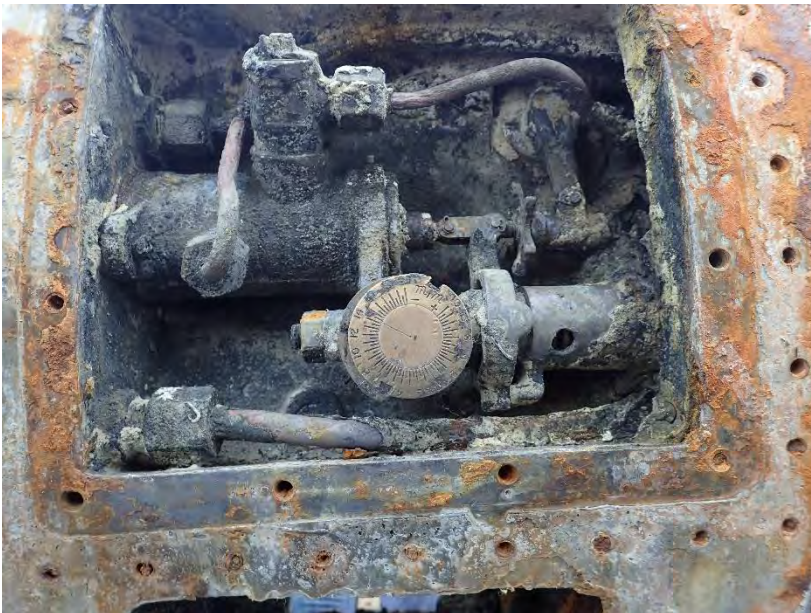
The steering engine or depth mechanism

The hatch is 200 mm wide and 160 mm high with a bolt in each of the four corners. It is made from a different type of metal to the rest of the engine and is still grey and not rusted. It appears to be an access hatch for up to two controls along one of the long edges.

The two fuel tanks would suggest that this is a Brotherhood burner-cycle engine. Used by the British from the First World War and throughout the Second World War in both the 18 inch and 21 inch torpedoes. Effectively this was a semi-diesel engine, with one cylinder filled with air and the other filled with a kerosene fuel. The air in the cylinder would be pressurised and heated to around 1,000 degrees. Injecting the hot gas into the engine mixed with a small amount of kerosene fuel created the combustion required to power the engine. The diameter of the engine would be from a 21 inch torpedo, commonly used by submarines, motor torpedo boats, cruisers and destroyers. The open circular hatch seen on the top is possibly the top of the gyro clamp plate and cover. The gyro mechanism would be responsible for controlling the steering rudders. Close by this is what is either the depth or steering engine, featuring a small dial. Both of these are found on either side of the gyro as they each connect to the torpedoes' rudders, one to the depth rudders, the other to the steering rudders. All three components are closely grouped as all three work with the rudders.
