# Queen Elizabeth Class Capital Dredge Project Her Majesty's Naval Base, Portsmouth

Archaeological Assessment Report

Ref: 111320.05  
January 2018

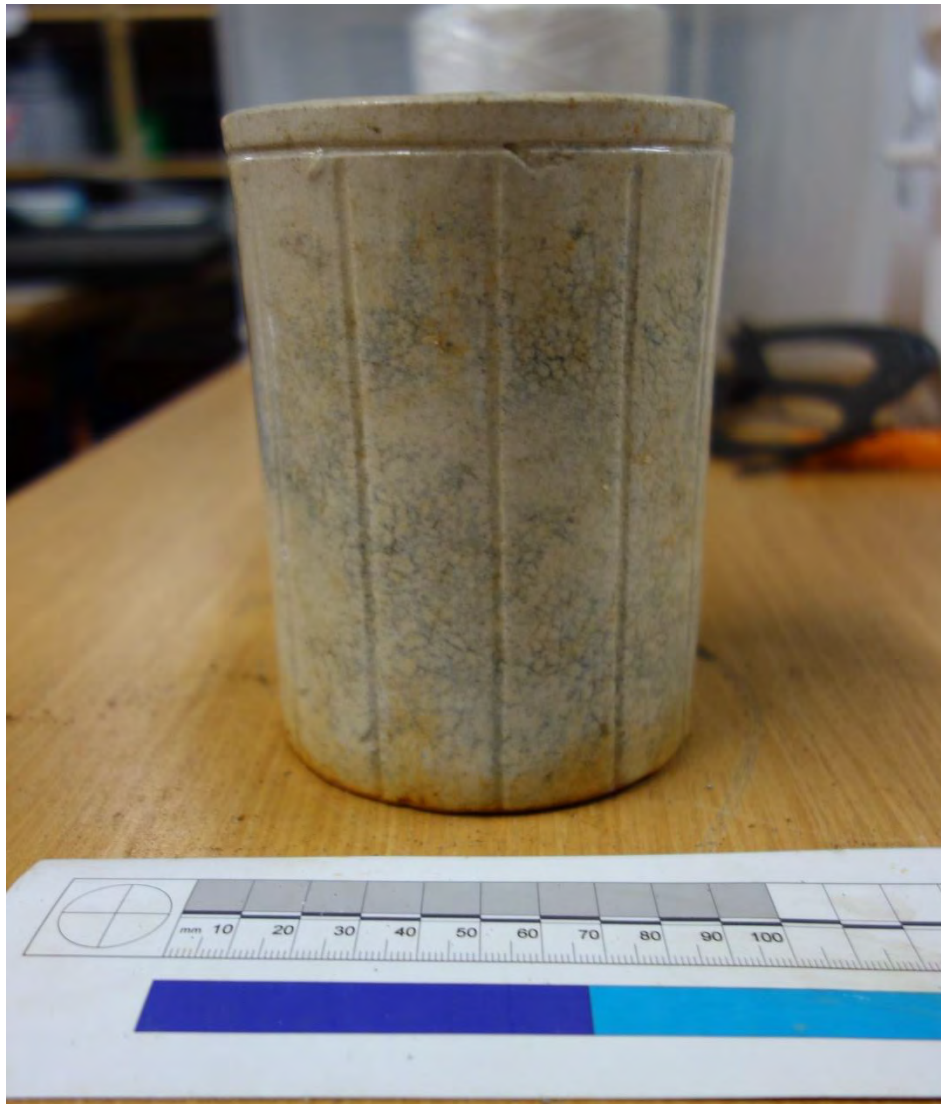
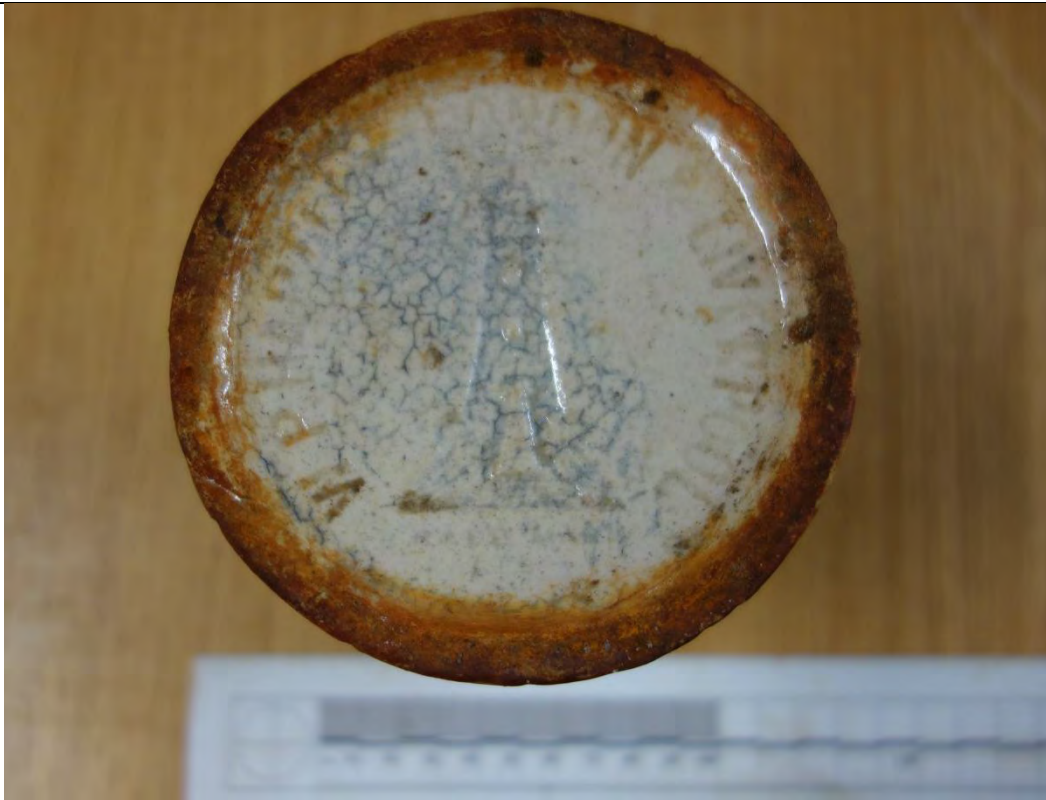
The jar is made of a stoneware ceramic with a feldspathic glaze. It measures 134 mm tall with a diameter at the base of 95 mm which increases to 100 mm at the mouth. The jar is 5 mm thick, giving an internal opening at the mouth of 90 mm. On the base it is inscribed with "W.P. Hartley. London. Liverpool" with an image of a light house.

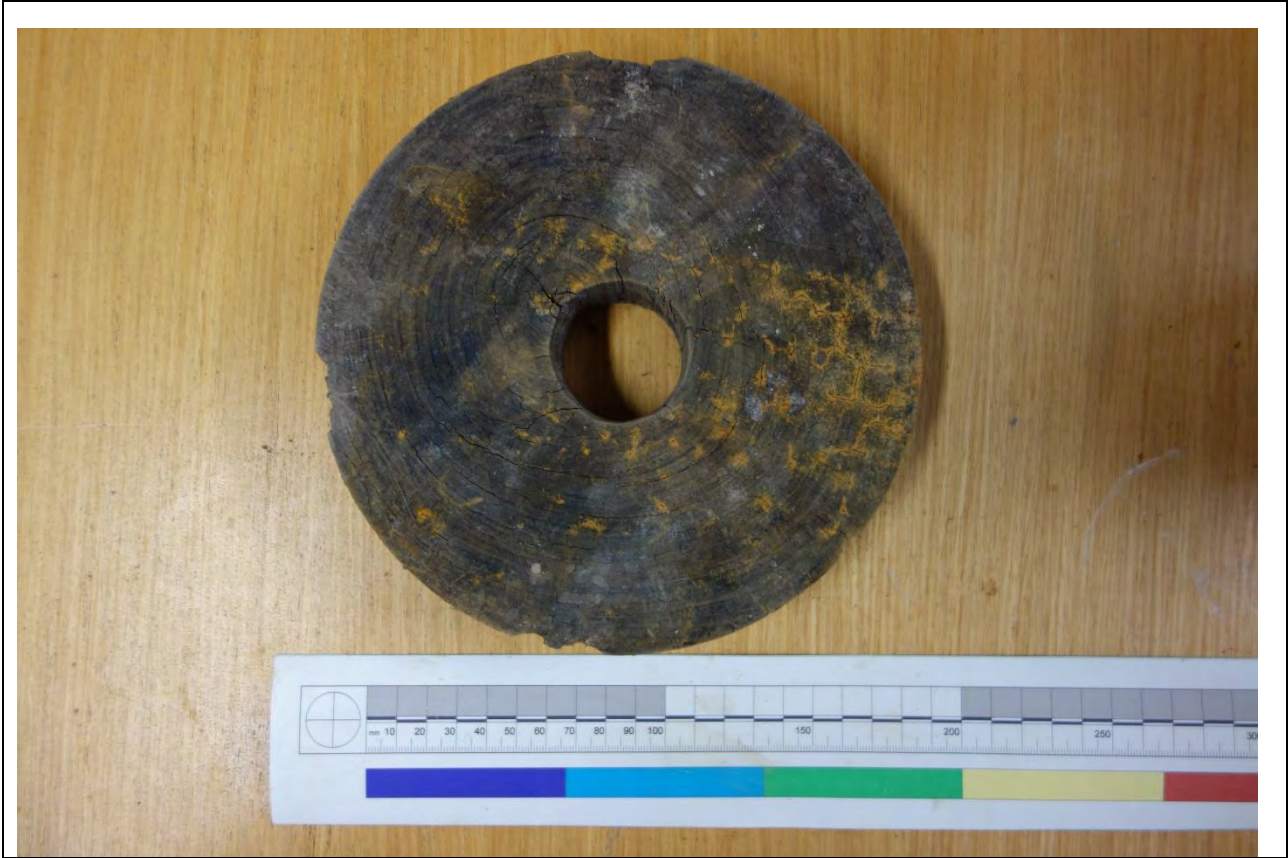
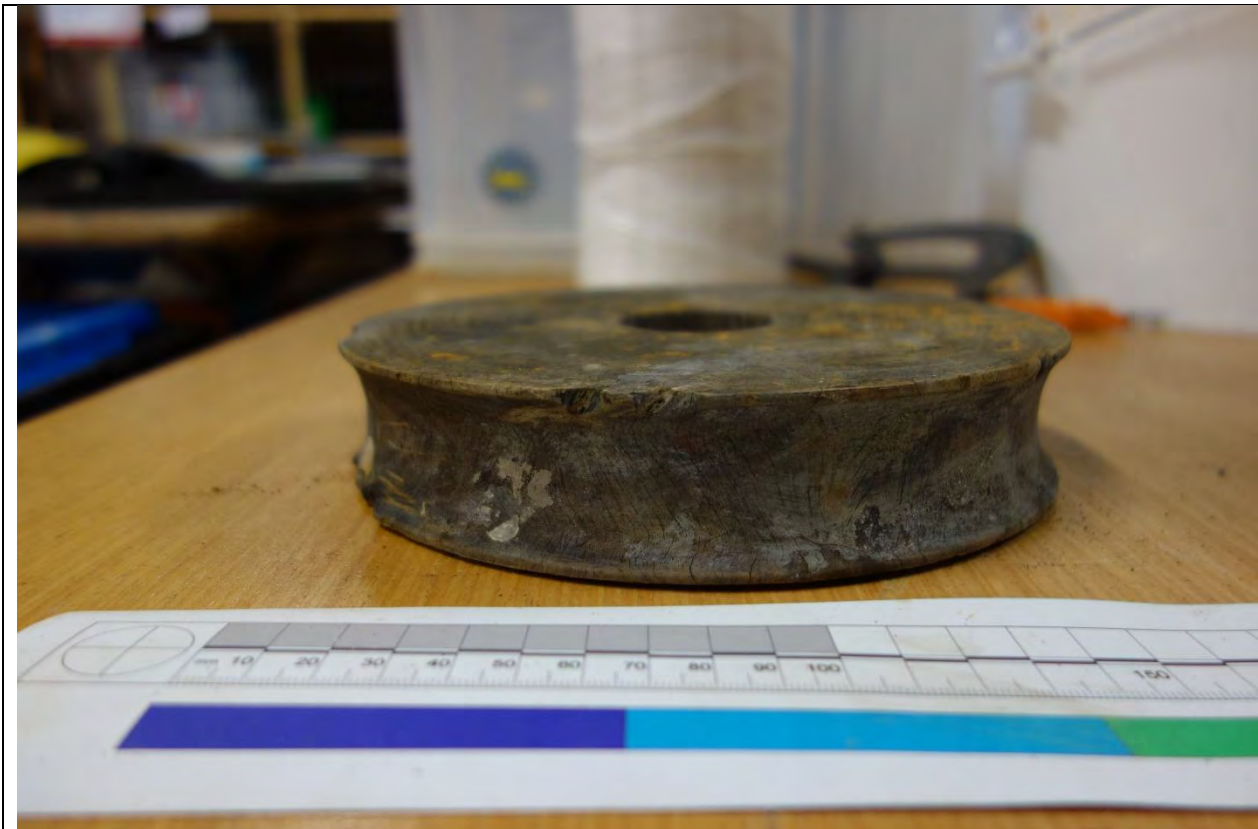
The object is made of wood, with a central hole and a curved groove cut around its circumference. It has a diameter of 185 mm and the inner hole has a diameter of 42 mm. It has a thickness of 36 mm and the groove is 32 mm wide.

The object is a pulley wheel, and would have had many uses on board ships as well as in the harbour. It is likely to have been used for the loading and unloading of goods being transported overseas and around the coasts of Britain. Pulley wheels are difficult to date, the pulley has been in use for hundreds of years and wooden wheels can still be found today. It may have broken off while in use within Portsmouth harbour or have been discarded or lost.

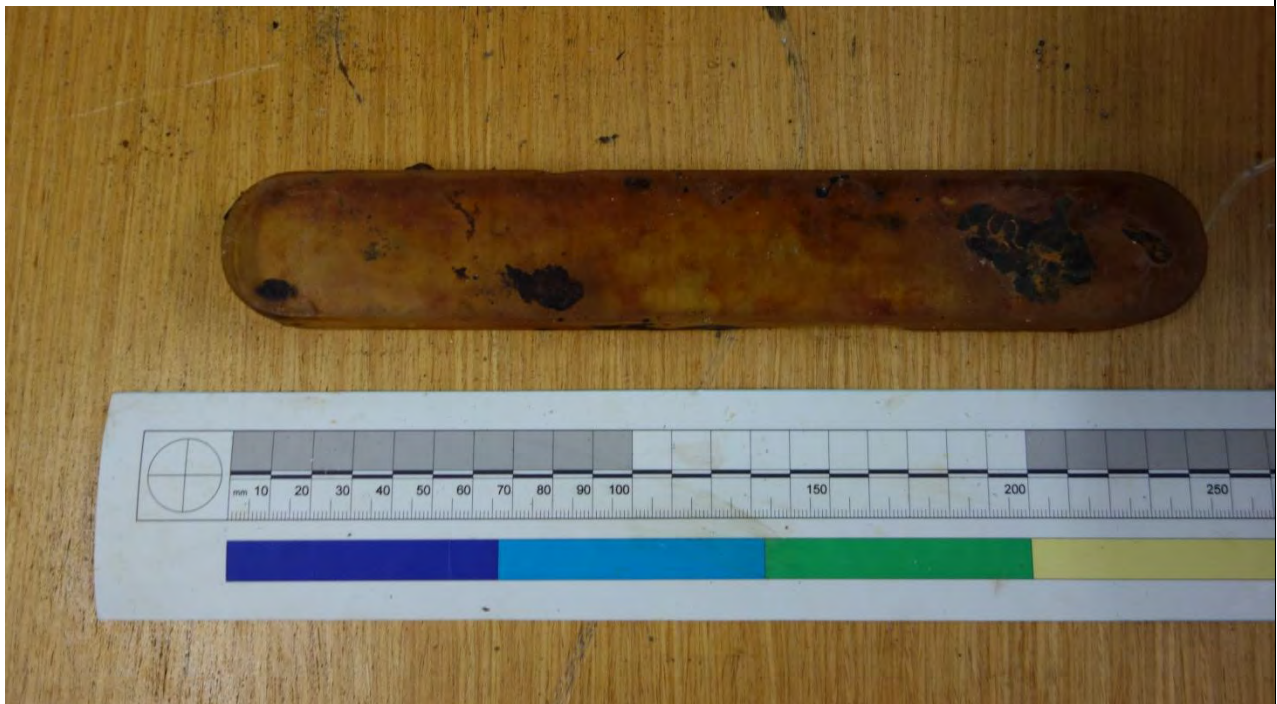
<b>Description</b>			
The object is made of clear glass. It is an elongated shape and measures 242 mm in length, 38 mm wide and 15 mm thick.			
<b>Interpretation</b>			
This object may be a part of a deck light from a vessel. The glass would have covered the light bulb, protecting it from damage and also diffusing the light beam. The fitting may have come loose and lost over board or possibly may have been discarded during a refit.			
<b>Period</b>	Modern	<b>Date Range</b>	Modern

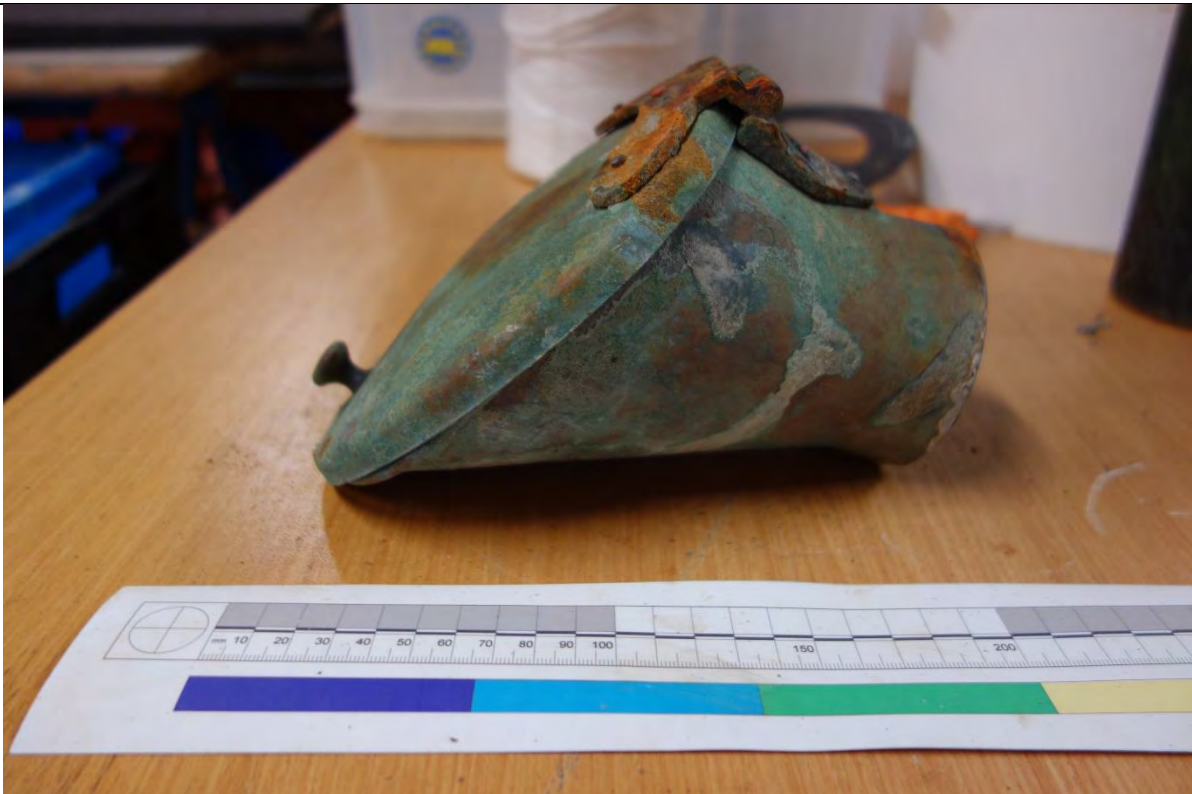
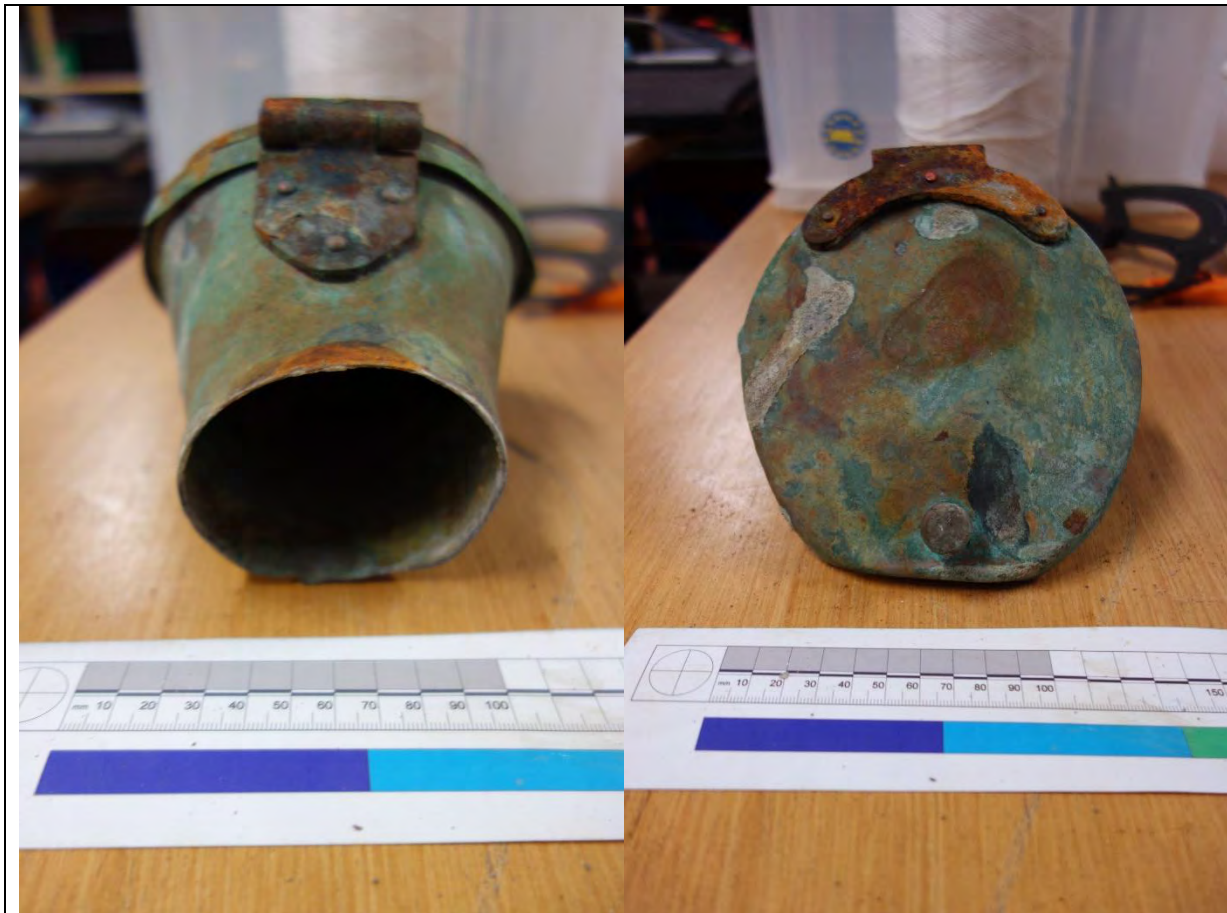
The object is the end of a tube with a hinged lid on one end, it is made of copper. The object measures 180 mm long and the open hole is 80 mm in diameter. The lid is 150 mm wide and 160 mm high.

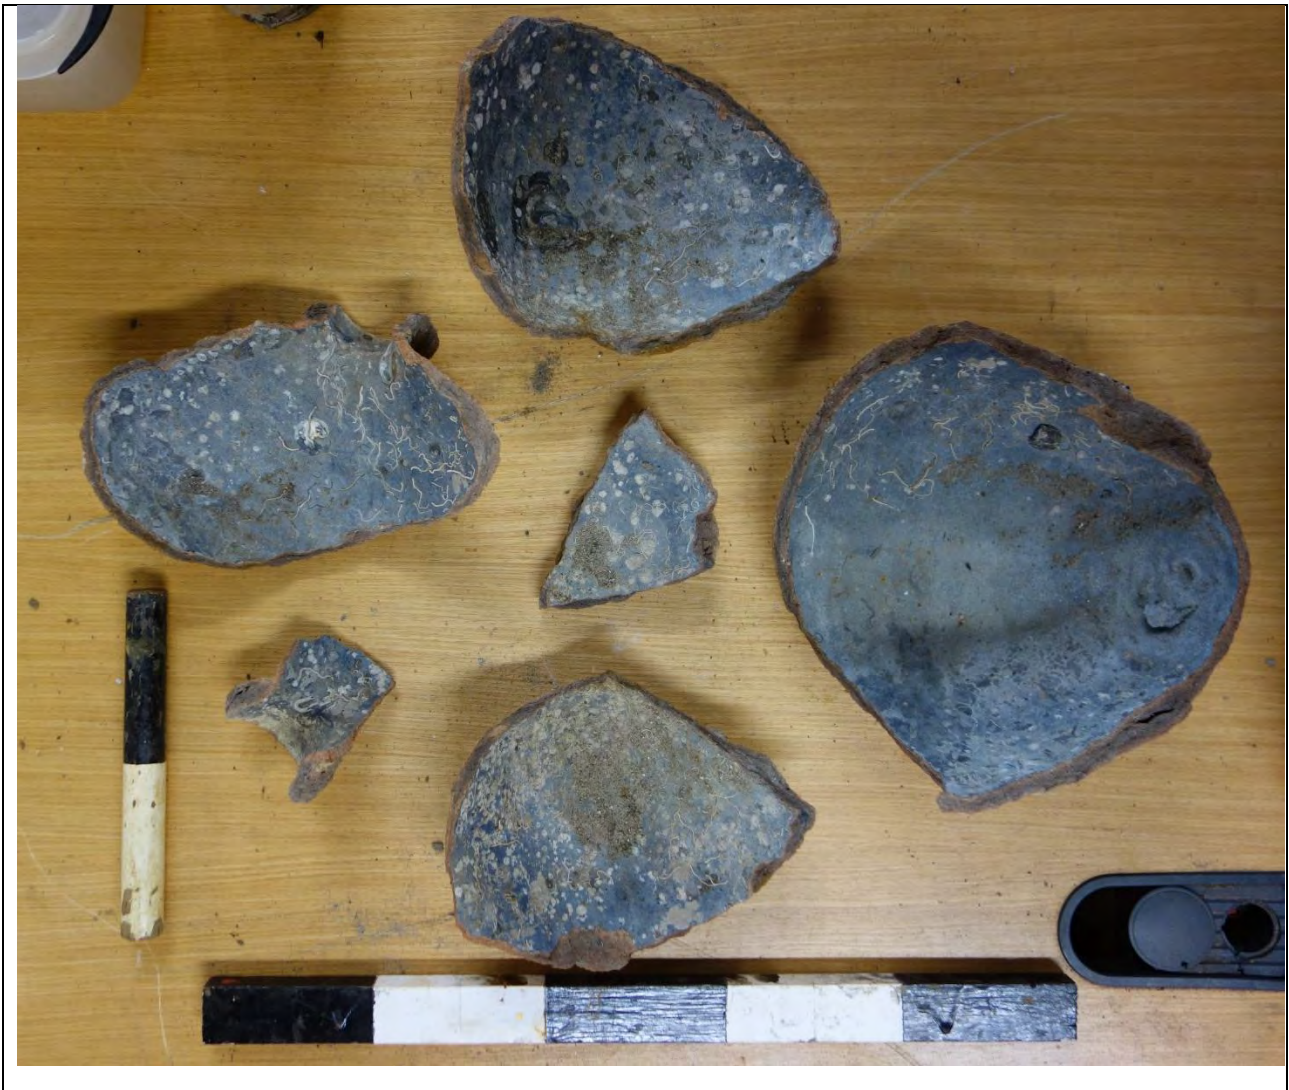
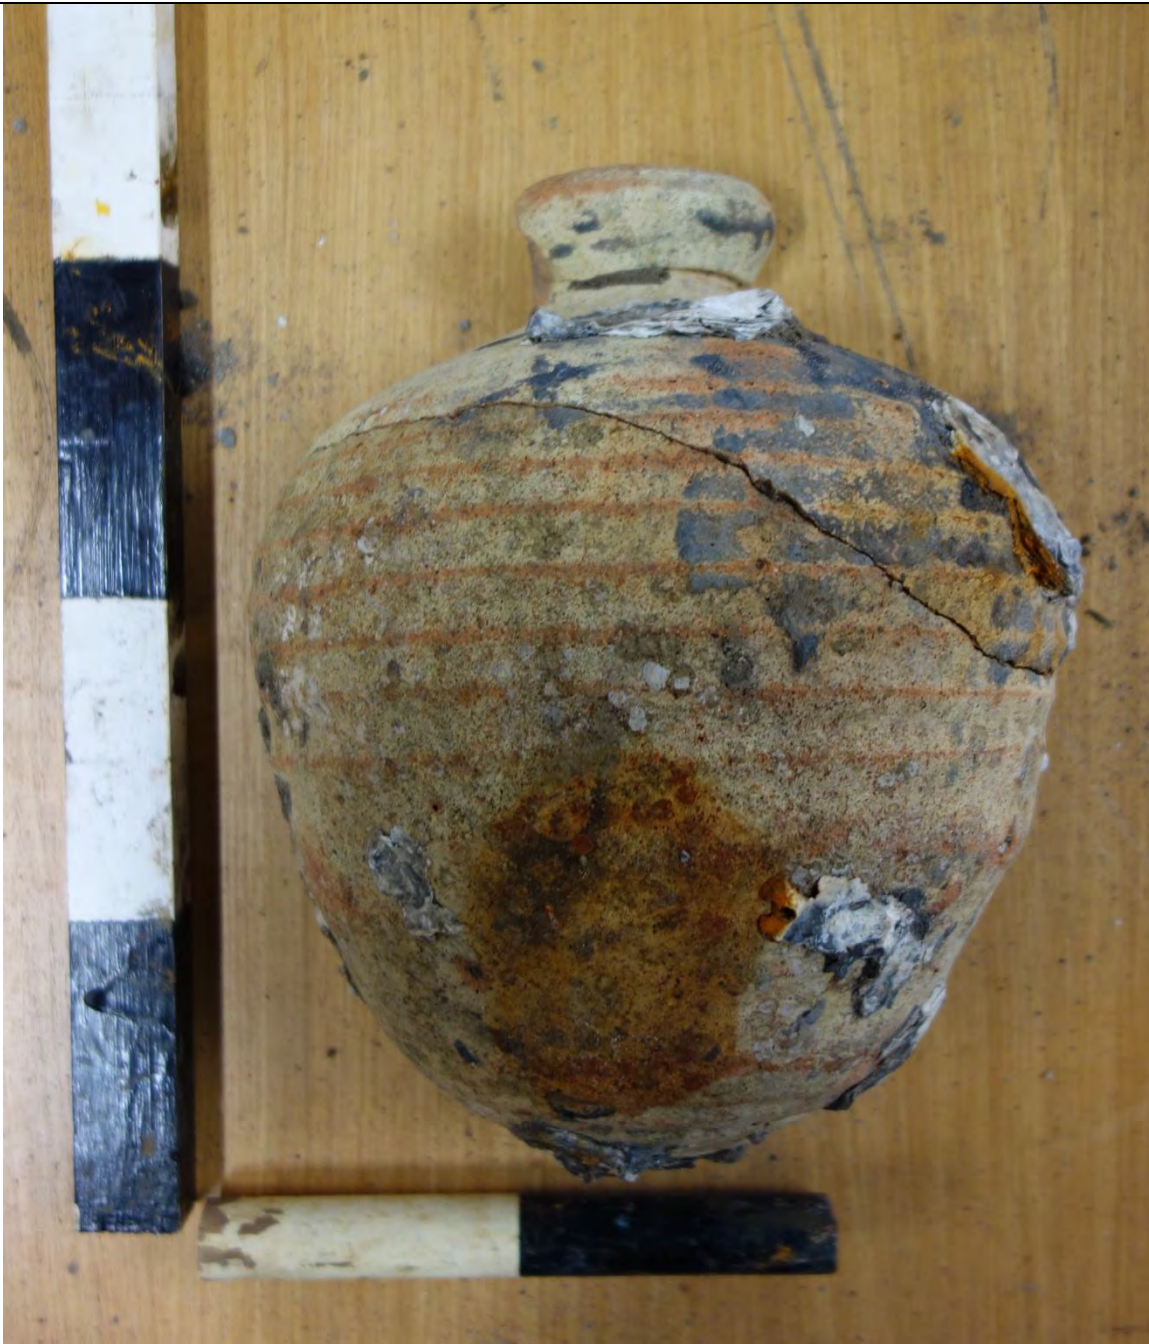
Scale 100 mm sections

The jar was unfortunately found in six pieces, but does fit together to form a complete jar. The breaks are relatively fresh which would suggest that the jar was complete on the seabed and was broken during recovery by the dredger. The height of the complete jar is 280 mm and is 240 mm across at its widest point. The base is rounded and has a thickness of 15 mm. The rim is 90 mm in diameter with an interior diameter at the mouth of 62 mm. The rim is 14 mm wide and 30 mm high and the neck of the vessel is 6 mm thick.

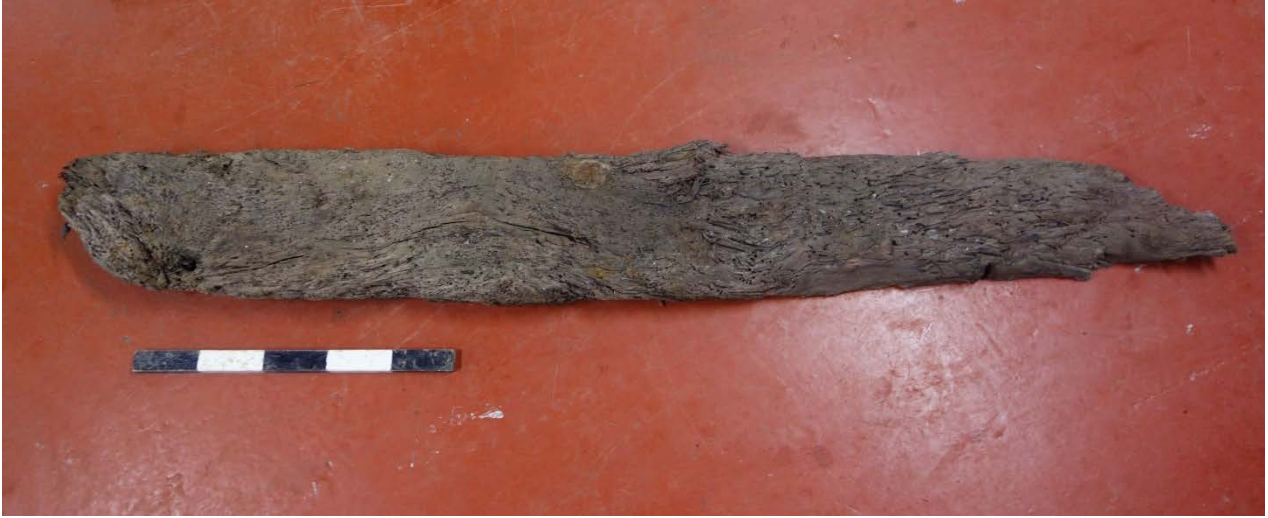
<b>Description</b>			
<p>A timber measuring 1860 mm in length with a maximum width of 240 mm and a thickness of 100 mm. The timber is in very poor condition being largely eroded and subject to a heavy attack from wood boring organisms such as gribble and shipworm. At one end, there is a possible treenail hole measuring 18 mm in diameter, towards the centre there is a circular concretion measuring 60 mm in diameter and at the other end there is a second possible treenail hole measuring 14 mm in diameter.</p>			
<b>Interpretation</b>			
<p>The timber has a relatively consistent thickness of around 100 mm that is likely to suggest that it has been worked into a plank. The evidence of two possible treenails and a small concretion would also support that this is a worked timber. The concretion does not appear to cover any fastenings. The timber is in a very poor condition which obscures any positive identification of the timber's source. However, it may be that the timber relates to a quayside structure such as pilings and it being a ship's timber cannot be ruled out.</p> <p>The timber was not recovered with any relating material and is likely to have been an isolated object. The dating of a timber in this condition is very difficult and only a speculative date range can be given.</p>

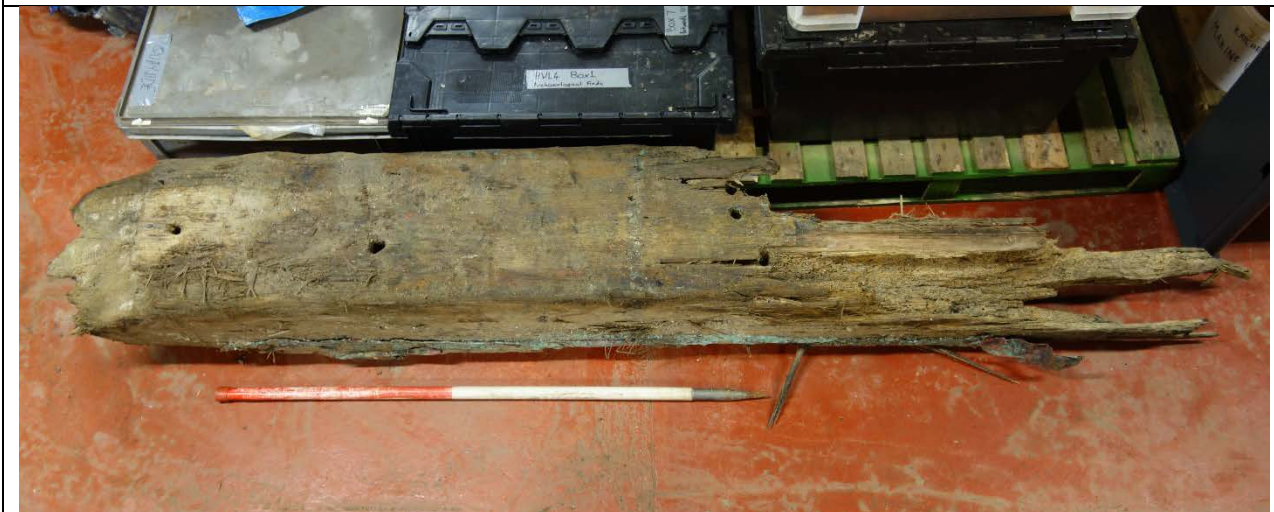
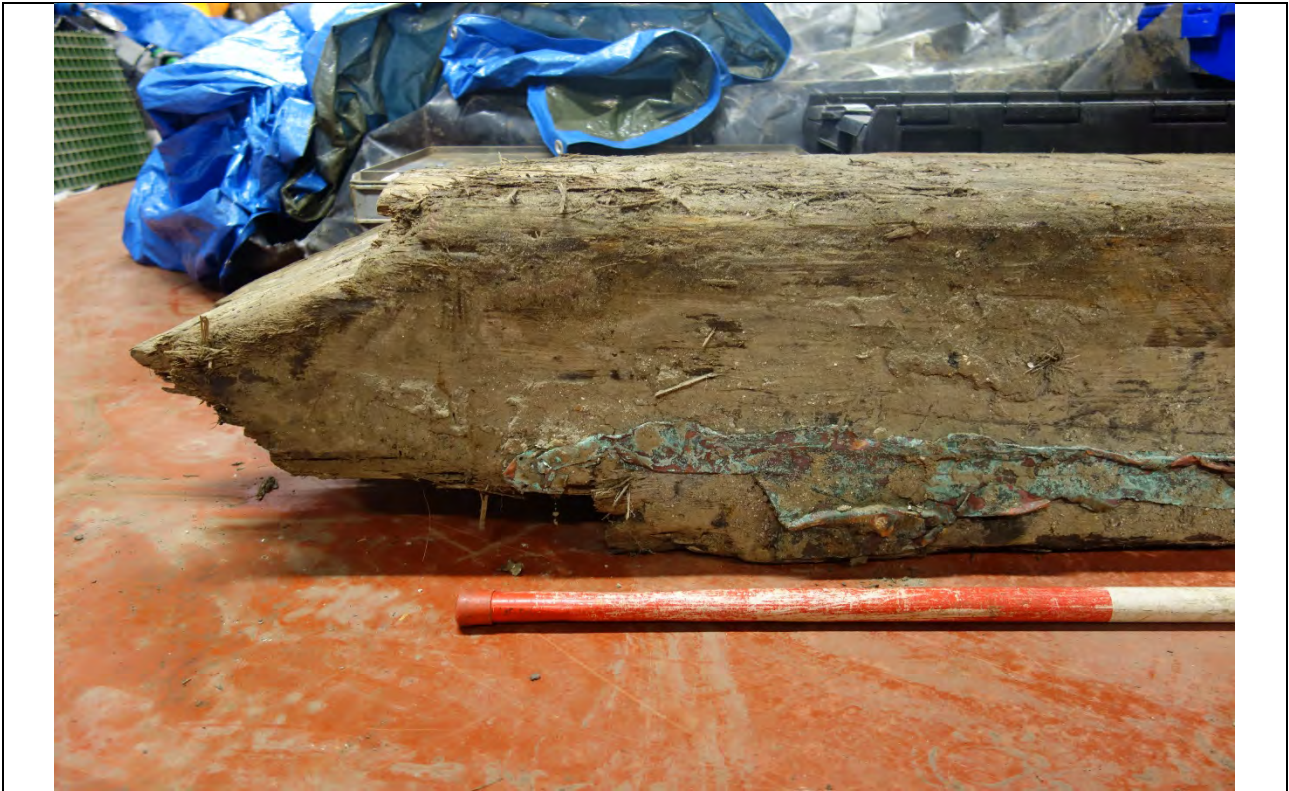
The timber measures 2520 mm in length and has a square profile with maximum dimensions of 336 x 316 mm. The timber itself is in very poor condition with approximately half of the timber having been lost to wood borers such as shipworm and gribble as well as other damage. There are several tubes of calcium carbonate visible which are left by the boring shipworm. There is evidence on all four faces of the timber of copper sheathing, which would have covered the majority of the timber's surface. There is also indication of the joinery used on the timber, at one end there is an angled face that would have been a scarf joint. The join is damaged, but the remains of two treenail holes are visible in the break. In the centre of the timber there is a raised section on one face running at a slight angle across the timber, this may be where it attached to horizontal timbers, although there are no treenails holes relating to this area.

This timber is likely to have been used as a dock pile. Although the timber is badly damaged, this conclusion is made due to the presence of copper sheathing on all four faces, which would suggest that all sides were exposed to salt water. Copper sheathing was developed by the Royal Navy during the 18th century and was used to protect the wood from wood boring organisms. The timber has become exposed and affected by the presence of wood borers in the surrounding waters. The scarf joint at one end would have attached to another timber in order to extend the overall length. While the horizontal join may have been for crossing timbers used to support the structure giving it additional strength.

The timber is likely to have been part of a harbour structure and may have been discarded after having been replaced or lost due to excessive damage from wood borers.

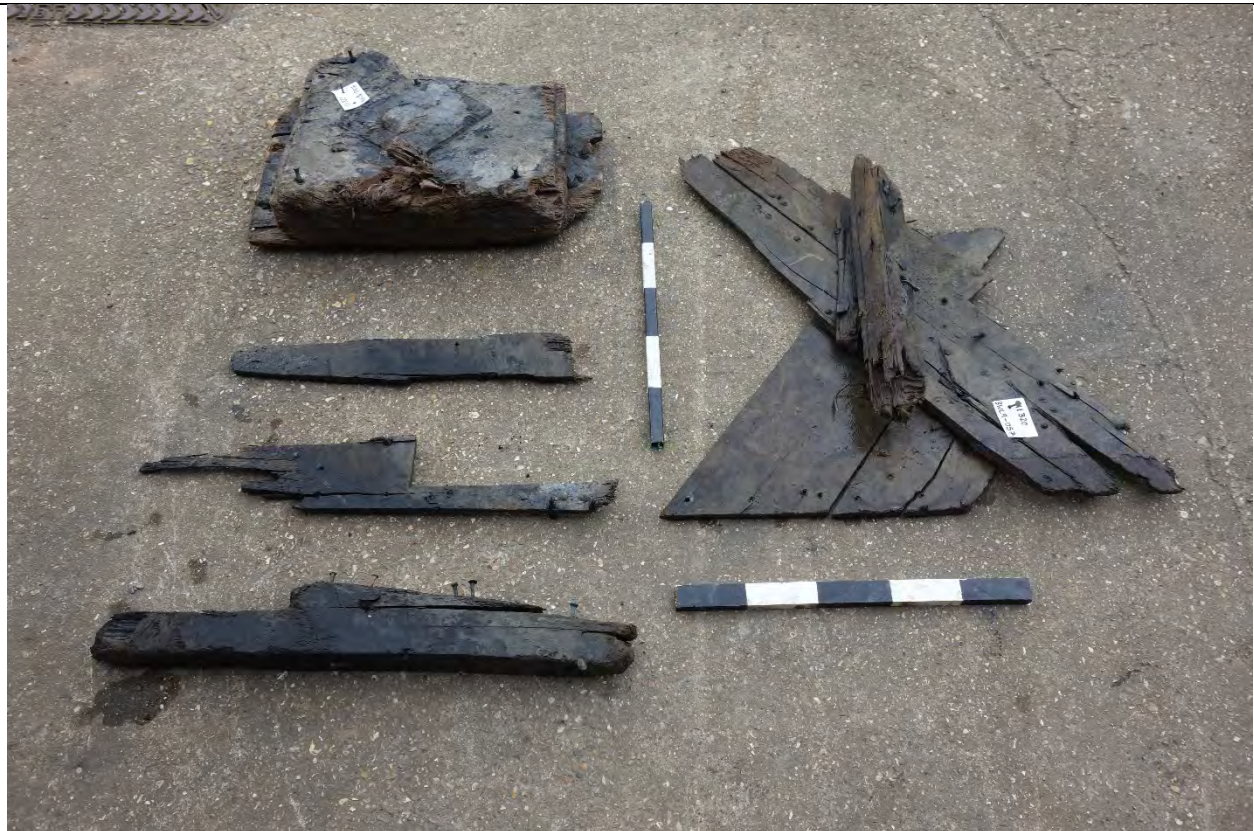
<b>Description</b>			
Five loose fragments from BWL1_0069 collected from the quayside: <ul style="list-style-type: none"> <li>• Two disarticulated planks;</li> <li>• One floor timber frame and attached sliver;</li> <li>• A section of double diagonal planking and frame; and</li> <li>• An unidentified timber wedge.</li> </ul>			
<b>Interpretation</b>			
<p>These are parts relating to a 42 ft ship's launch dating to around 1898 discussed in more detail in report <b>BWL1_0069</b>. The wreck was discovered during clearance within the harbour and recovered by grab on board <i>Stemat 87</i>, these remains were later collected from the quayside.</p> <p>The only object that cannot be positively identified to the launch is the wedge. This may have been part of the launch but its purpose and position within the boat cannot be identified. Visits to boat house #4 at Portsmouth Dockyard have been undertaken to compare to <i>Cyclops</i>, an almost identical 1915 dated 42 ft launch, and no similar timber could be seen and the shipwrights involved could not identify its purpose. It looks to have been placed between two large timbers which would have sat over the lip on either side of the wedge. The upper side has a raised diamond which may have seated a fitting or sat between diagonal planks. In the centre of the diamond there is a circular plug which extends through the timber into a larger octagon shape. This may have been a later repair, plugging up a hole, possibly from a removed bilge pump.</p>

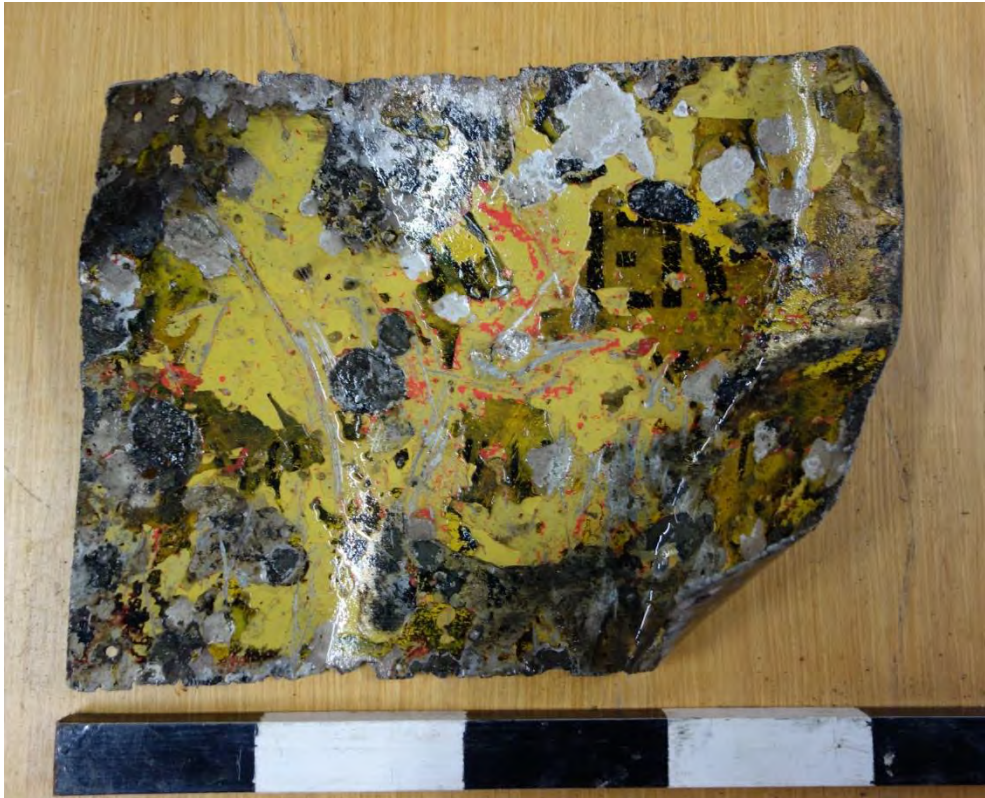
- 5.2.17 The final sign (**BWL9\_0059**) dates to the 20th century and was painted yellow with black lettering, which suggests it was a warning sign. Lettering visible on the sign implies it originally said the word 'DANGER', and due to its poor condition, it was most likely discarded at sea.

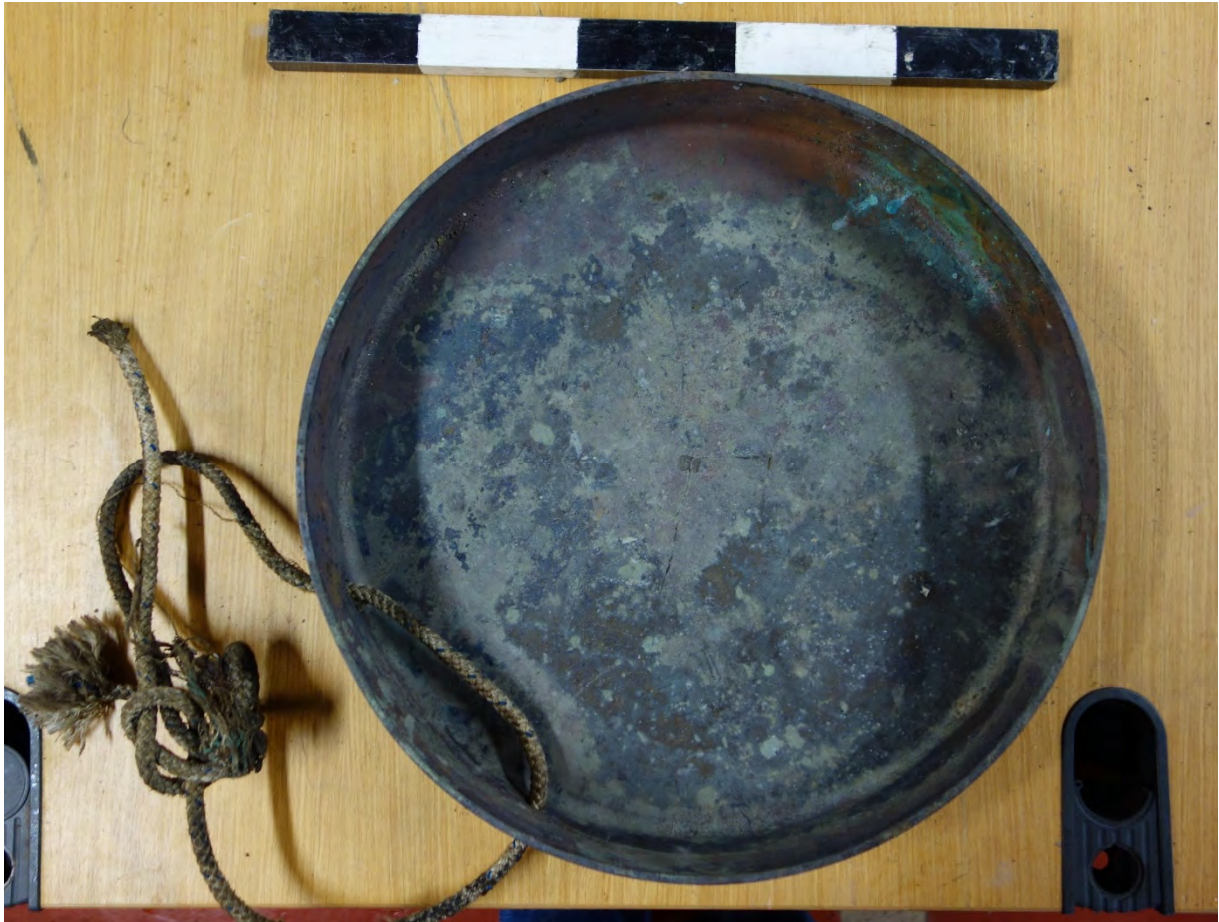
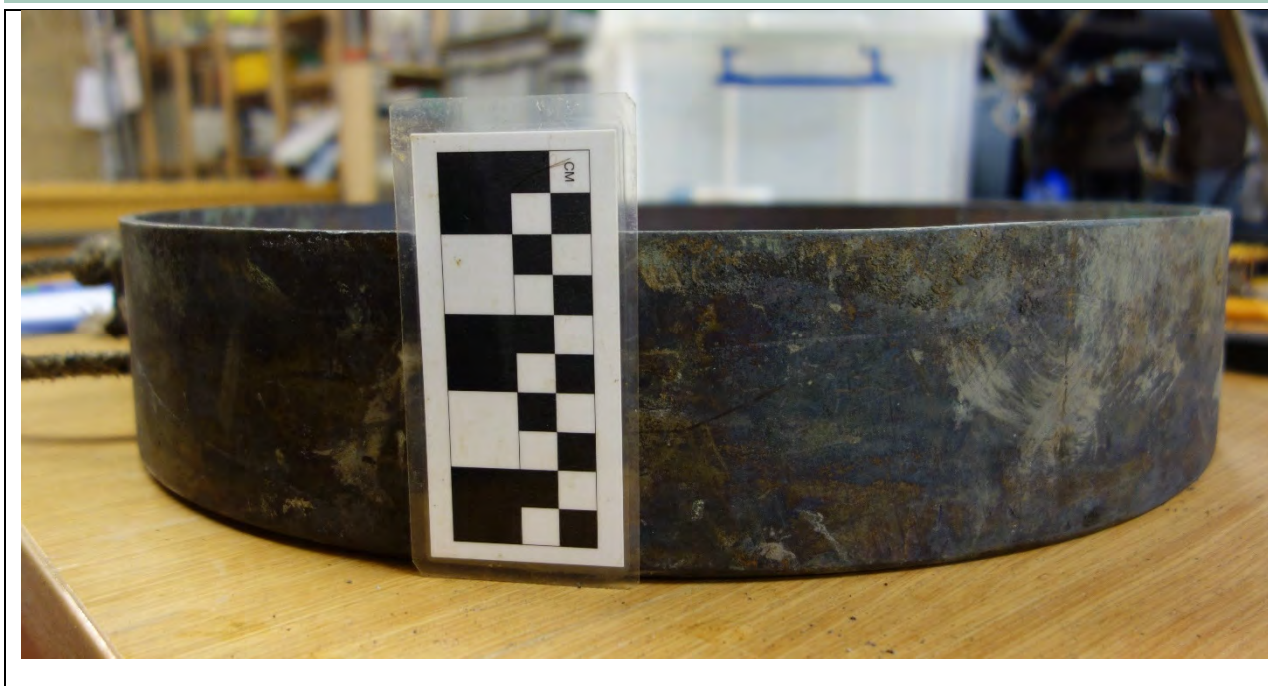
A large dish-shaped object made from copper, with two holes at a length of rope attached. The dish has a diameter of 454 mm and a height of 88 mm. The two holes are positioned closely and are both 12 mm in diameter. In the centre of the dish there is a "51" in raised numbers. The object weighs 32 lb or 14.5 kg.

The two holes in the side of the dish would suggest that it was either hung or fitted with a handle. It is likely that the rope in the picture was a later addition due to its condition. The most likely explanation is that it was a gong, although it has also been suggested that it could be a large skillet or baking tray. If related to cooking, the large size, especially its weight at 14.5 kg, could suggest that it is a copper cooking pan such as those found on ships, and its large size would help to accommodate cooking for a large crew. If this was the case, then the two holes would help to accommodate cooking for a large crew. If this was the case, then the two holes would have attached to a handle. More likely, if the object is hung from rope or wire, then the position of the holes would cause it to hang vertically. This way, it could have been used to make noise, as a gong. The object is more likely to have been lost, as a large piece of copper such as this would likely have been kept and repaired.

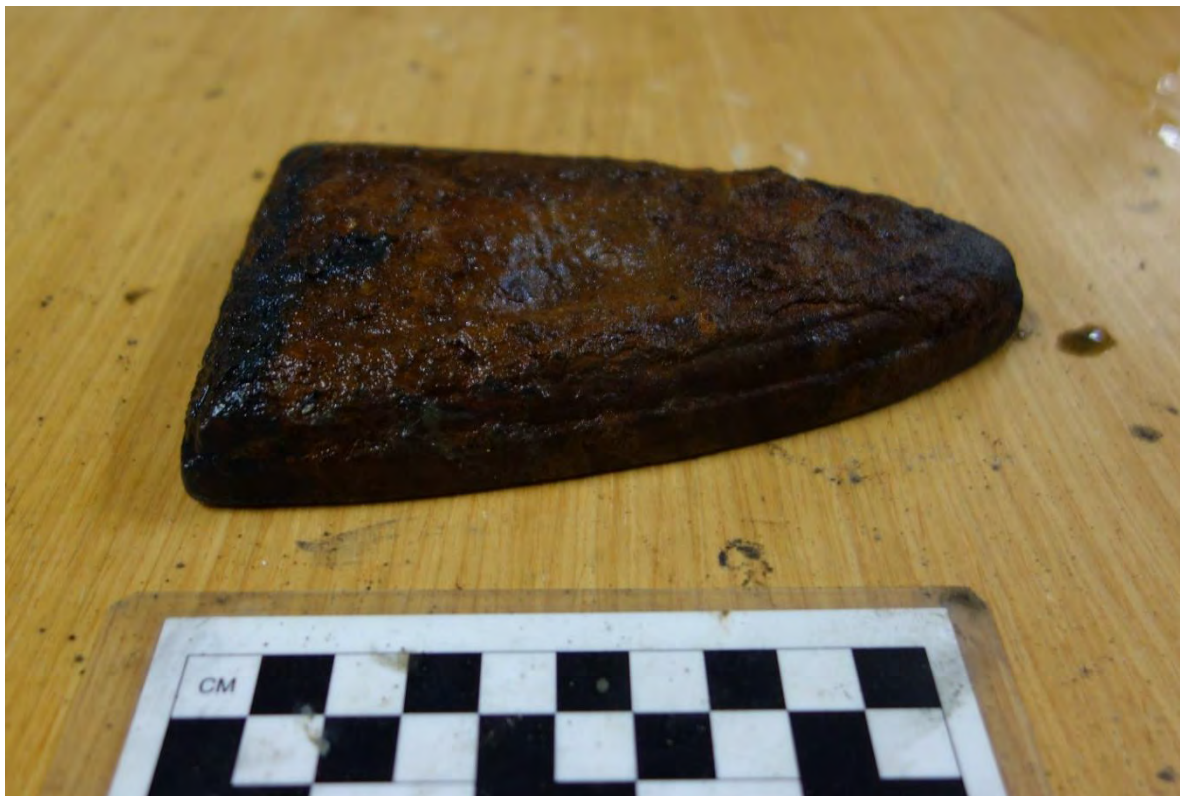
<b>Description</b>			
This is the base to a flat iron. It measures 142 mm in length with a maximum width of 88 mm. The base of the object is very smooth and flat, while the top (shown) is slightly concreted where the handle has broken off.			
<b>Interpretation</b>			
The flat iron, or pressing iron, was developed in the 17th century and was in common use through the 17th and 18th centuries. Flat irons comprise slabs of solid iron with a handle attached. The iron would be heated in the fire and then it could be used for the ironing of clothes. As the metal would gradually cool during use, often more than one iron was needed to keep a constant work flow as one was heated another was in use. These were later replaced by the charcoal iron, which had a box of hot coals the maintain heat in the iron.			
This flat iron is likely to have been discarded in a terrestrial context and dumped at sea as part of a larger cargo.

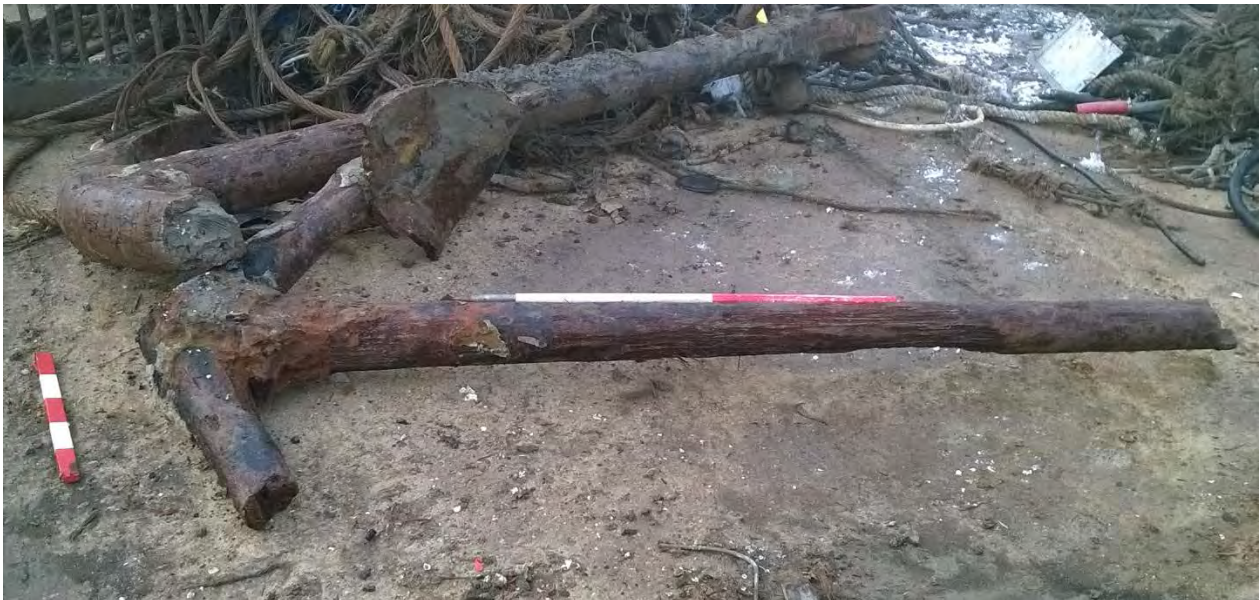
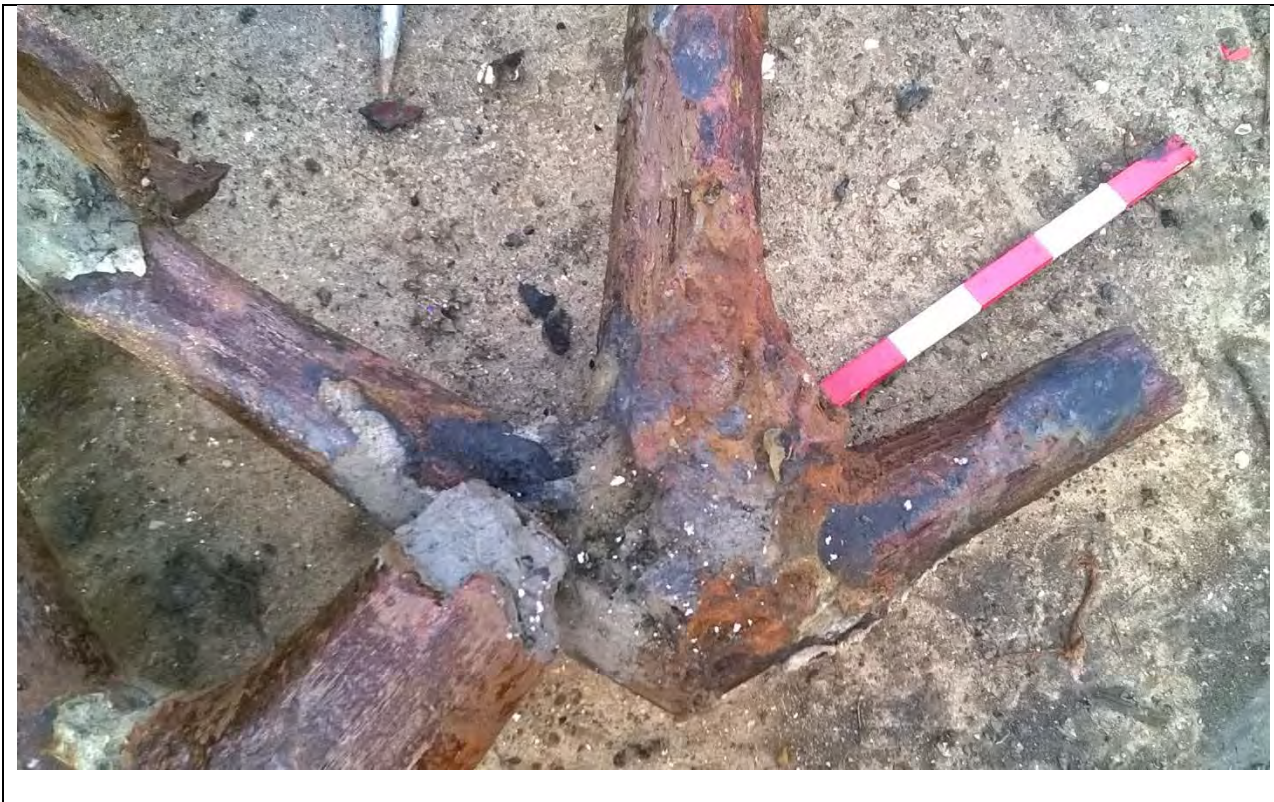
<b>UID</b> BWL9_0072	Old Pattern Admiralty Long Shank anchor	
<b>Date of Discovery</b>	30/12/2016	
<b>How Discovered</b>	Recovered during dredging on board <i>Manu Pekka</i> .	
<b>Position of Discovery (British National Grid)</b>	..... E	..... N
<b>Location Map</b>	<b>Anomaly Image</b>	
N/A	N/A

The remaining length of the anchor is 2420 mm, with the shank is rounded in section and measures 150 mm in diameter which tapers to 110 mm towards the ring. The shank is broken before the ring and before where there may have been the hole for a stock to pass through. The distance between the bills is 2200 mm and the arms are 1400 mm long. The palms have a maximum dimension of 550 x 520 mm.

The sharp angle between the arms and the shank at the crown and the size of the palms would suggest that this anchor is an Old Pattern Admiralty Long Shank anchor, commonly used from the late 18th century by the Royal Navy up until c.1840 when the Improved Admiralty design gradually took its place. Damage to the shank is a frequent problem with this style of anchor and is likely to have occurred during the weighing of the anchor, an issue that was corrected in the early 19th century with the introduction of curved arms.

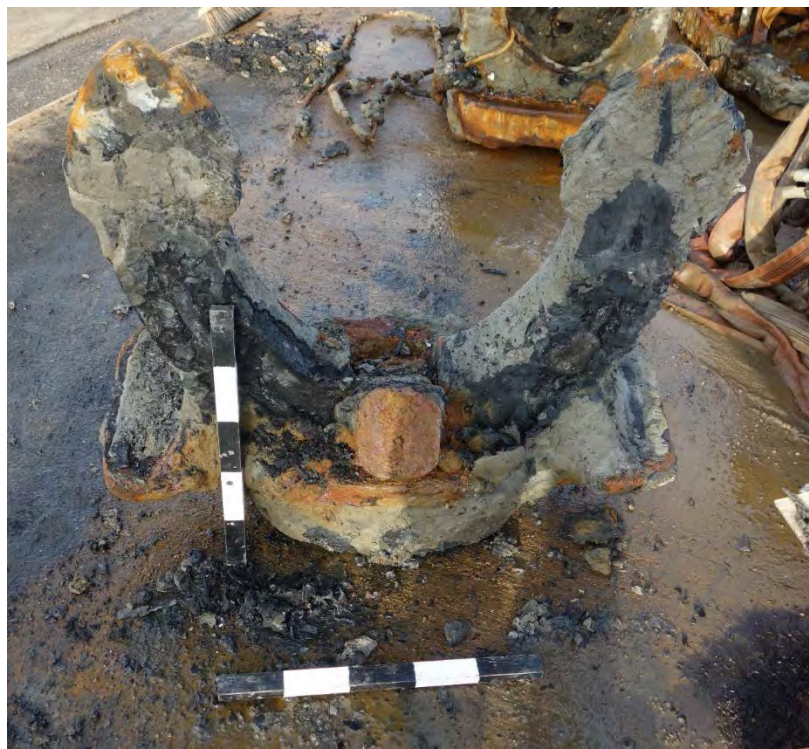
<b>UID</b> BWL9_0073	Hall's stockless anchor	
<b>Date of Discovery</b>	30/12/2016	
<b>How Discovered</b>	Recovered by grab and found during Quay Side Archaeological Monitoring.	
<b>Position of Discovery (British National Grid)</b>	..... E	..... N
<b>Location Map</b>	<b>Anomaly Image</b>	
N/A	N/A

<b>Description</b>			
Stockless anchor. The shank has been lost close to the crown with approximately 250 mm remaining, it has a square section measuring 120 x 130 mm. The distance between the bills is 700 mm and the palms have a maximum dimension of 250 x 220 mm.			
<b>Interpretation</b>			
<p>The anchor is likely to be an example of Hall's stockless anchor, sanctioned by Lloyds in 1888. The anchor was designed to be stockless with tripping palms that would secure to the seabed. The shank of this anchor has broken away close to the crown. The condition of the break would suggest that it was broken later, with concretion building up over the rest of the crown. Although the break is not fresh enough to have occurred during recovery. This may suggest that the anchor was reused multiple times, possibly as a mooring.</p> <p>The location of the anchor within the harbour and the break in the shank mean it is likely to have been discarded or used as a mooring.</p>
