# Queen Elizabeth Class Capital Dredge Project Her Majesty's Naval Base, Portsmouth

Archaeological Assessment Report

Ref: 111320.05  
January 2018

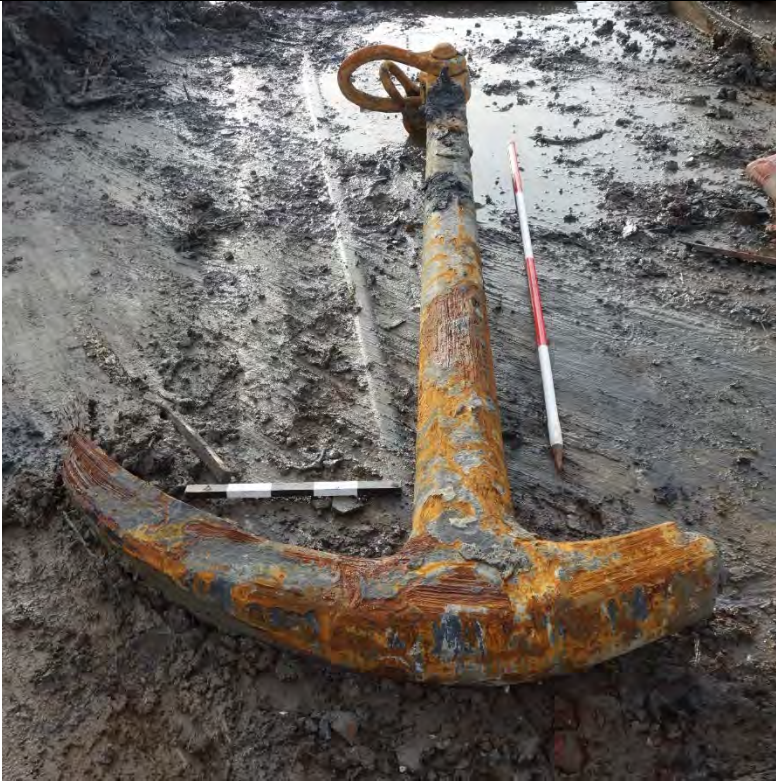
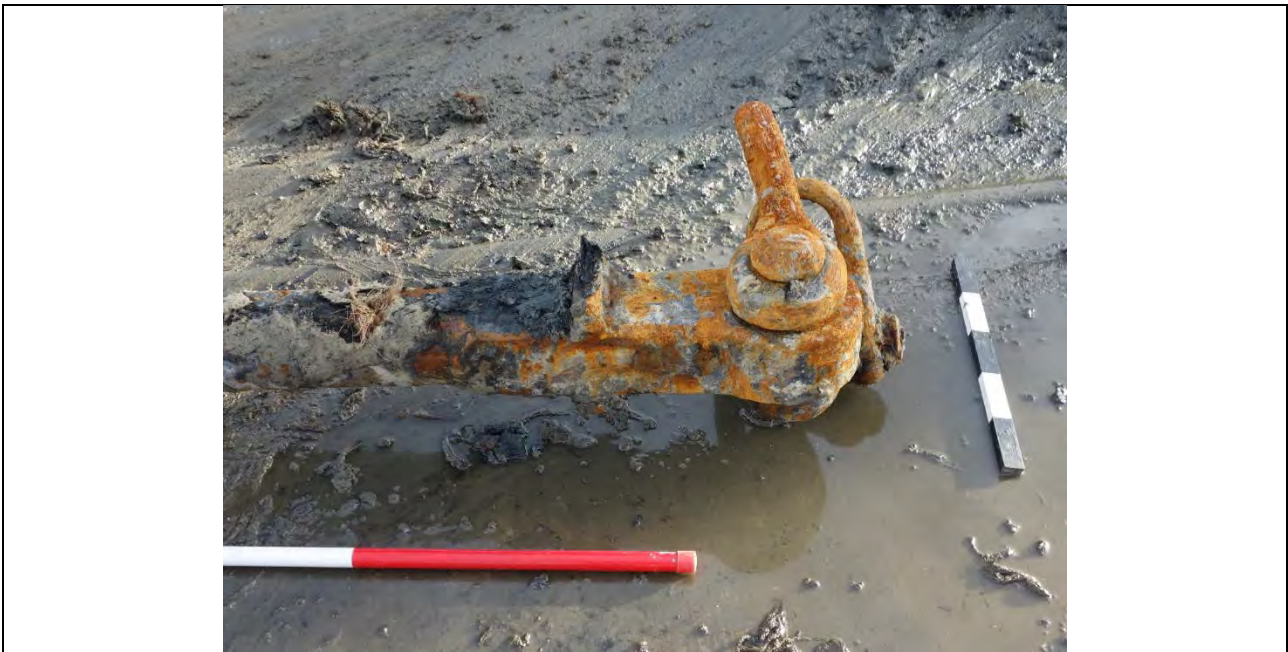
One of the anchor's arms has broken off and the fluke is missing from the other arm. The anchor is also missing its wooden stock. The total length of the anchor is 2860 mm and the remaining arm measures 1289 mm from the crown and is 160 mm wide. From bill to centre measures 920 mm, the length of the missing fluke is approximately 580 mm. The shank is oval in section and measures 200 x 180 mm towards the crown and 150 x 120 mm towards the ring. Close to the ring there are two protruding plates, these would have been for the wooden stock which is now missing. At the ring, there is a D shackle 430 mm long and 210 mm wide.

The anchor is broken which may have been the reason for its loss or discard.

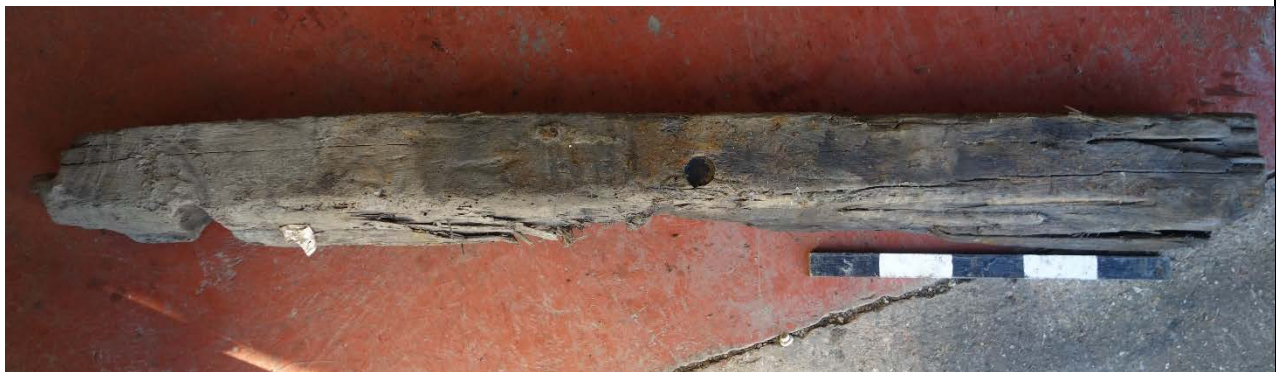
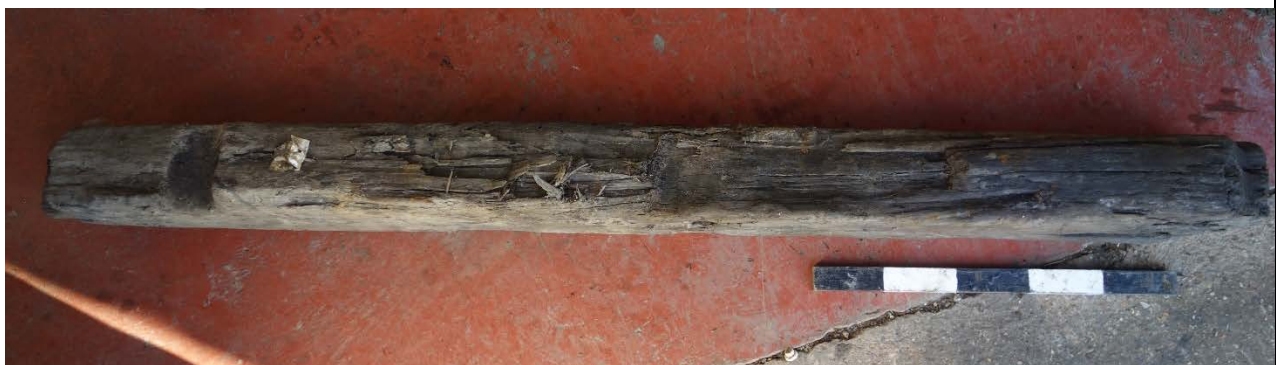
<b>UID</b> BWL9_0075	Possible ship's timber	
<b>Date of Discovery</b>	14/12/2016	
<b>How Discovered</b>	Recovered by grab and found during Quay Side Archaeological Monitoring.	
<b>Position of Discovery (British National Grid)</b>	..... E	..... N
<b>Location Map</b>	<b>Anomaly Image</b>	
N/A	N/A

The timber is clearly worked, and the presence of treenails shows that it was part of a larger structure. There is no evidence of any scarf joints, previously attached timber or sheathing. It is difficult to be conclusive about the structure that the timber belonged to as there is so little evidence available. It may have been a beam within a ship or part of a structure within the harbour such as timber piling. The timber is in reasonably good condition, although one edge is uneven and some of the wood is frayed, as the half sectioned treenail holes are on the same face the timber may have split along its length, which may have been a reason for its discard. The timber is also likely to be broken at both ends.

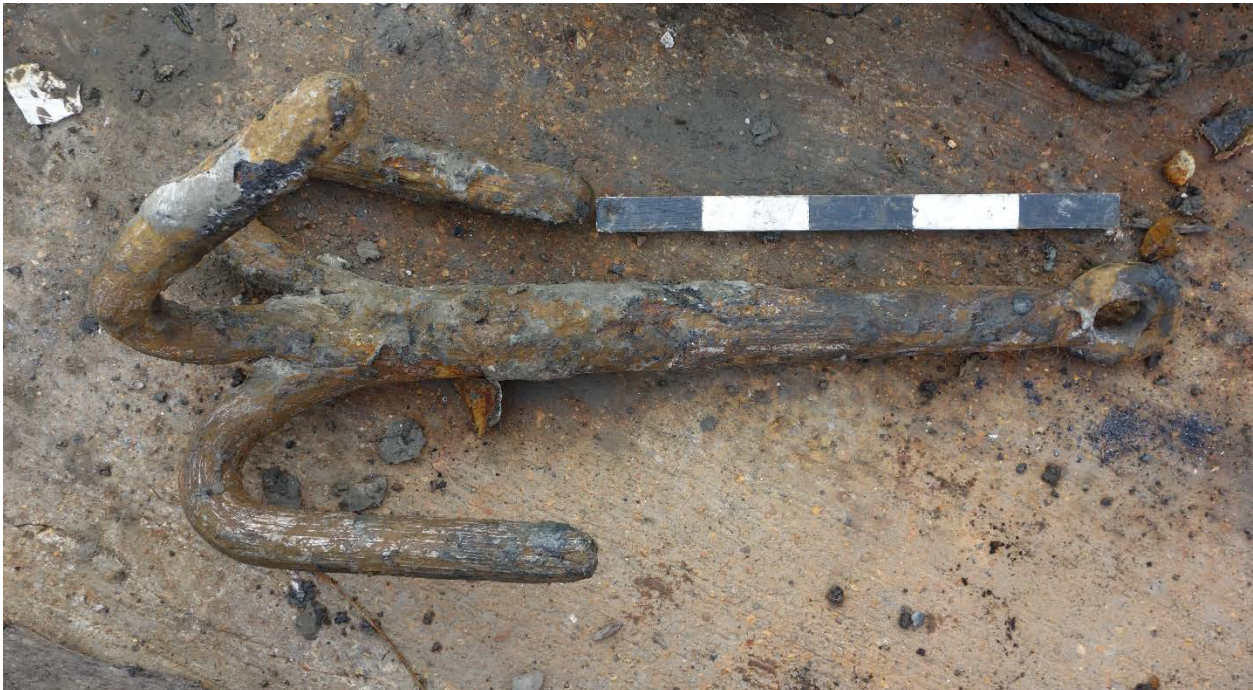
<b>UID</b> BWL9_0076	Grapnel	
<b>Date of Discovery</b>	06/01/2017	
<b>How Discovered</b>	Recovered by grab and found during Quay Side Archaeological Monitoring.	
<b>Position of Discovery (British National Grid)</b>	..... E	..... N
<b>Location Map</b>	<b>Anomaly Image</b>	
N/A	N/A

<b>Description</b>			
A three arm grapnel made from iron. It measures 970 mm in length with a diameter around the shaft of 100 mm at the crown that tapers off to 60 mm at the ring. The ring has a diameter of 100 mm and the eye has a diameter of 40 mm. The arms measure 370 mm with a diameter of 50 mm.			
<b>Interpretation</b>			
Grapnels have been in use for several hundred years, and the design has remained relatively unchanged, however, newer designs having folding arms for easier storage. Grapnels work very well in anchorages with a rock or reef seabed, in other conditions they do not hold well. Grapnels are commonly found in smaller boats, such as a dinghy, a ship's boat or small fishing boat, where space is limited. This grapnel is damaged which may be the reason for discard, alternatively I could have been lost.			
<b>Period</b>	Modern	<b>Date Range</b>	c.19th century - 20th century

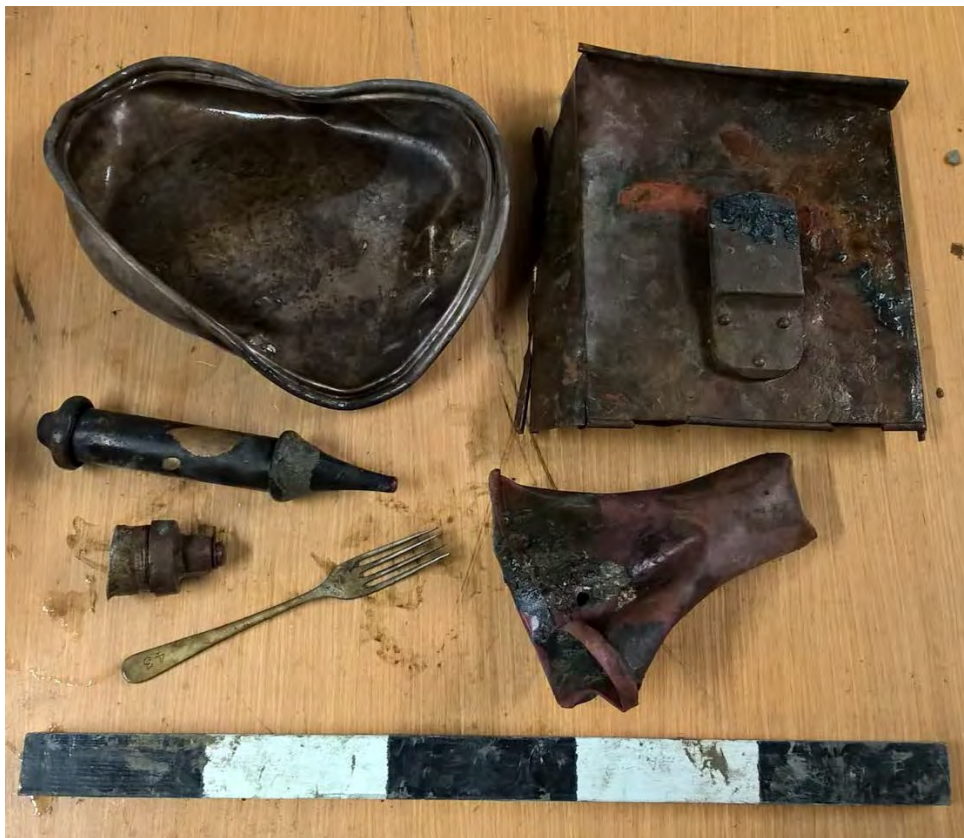
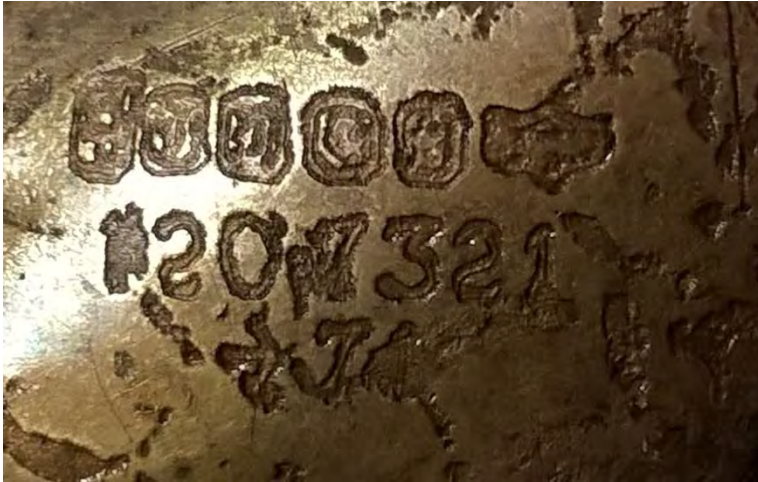
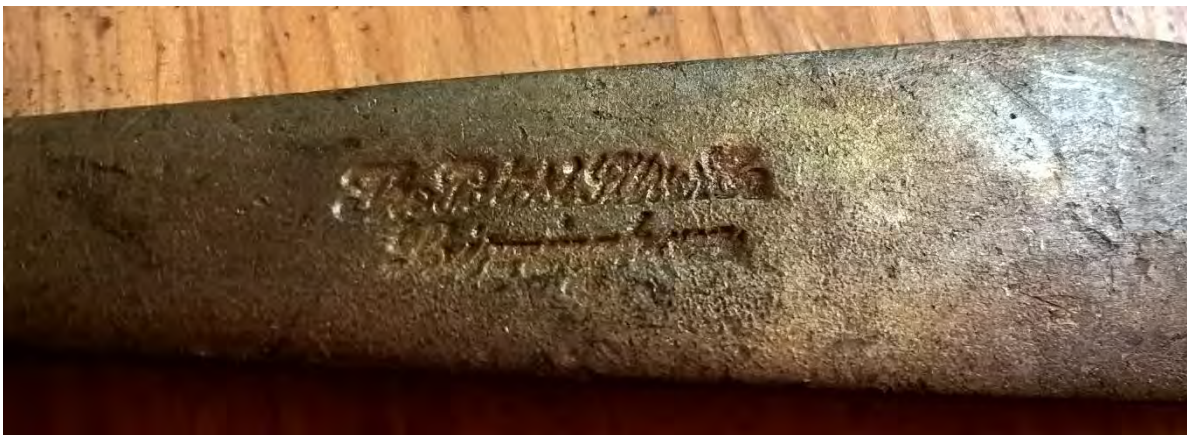
<b>UID</b> BWL9_0077	Assorted metal objects	
<b>Date of Discovery</b>	22/11/2016	
<b>How Discovered</b>	Recovered by grab and found during Quay Side Archaeological Monitoring.	
<b>Position of Discovery (British National Grid)</b>	..... E	..... N
<b>Location Map</b>	<b>Anomaly Image</b>	
N/A	N/A

Marking on the base of the dish

Inscription on the back of the fork handle

- A four pronged stainless steel fork, measuring 193 mm in length. At the base of the handle it is inscribed with the number "43", and a maker's name is visible of the back on the handle, which is difficult to read but the second line reads "Birmingham".

- A brass grease gun, measuring 210 mm in length and a maximum diameter of 42 mm.
- Brass fitting which appears to have broken away, inside the centre there is a layer of wood blocking a through route. It also has a thread below the central ring. c.50 mm high and 43 mm wide.

Speaking tubes are a form of communication used on-board ships since the early 1800s, it was also used to communicate between the decks, engine room and wheelhouse as well as other areas that must work together. Other uses for speaking tubes has been on trains, aircraft and in buildings. The two holes show that the lid is missing, this would have a plaque to say where was on the other end and would be used to keep water from entering, so it is likely that this speaking tube was used on deck. This is the second speaking tube to be discovered during the project, the first is recorded as BWL9\_0049.

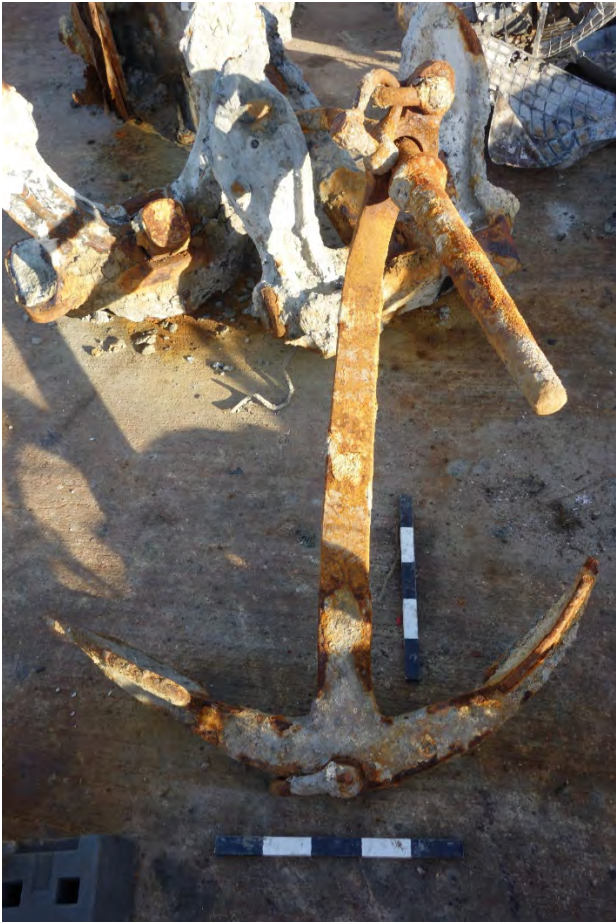
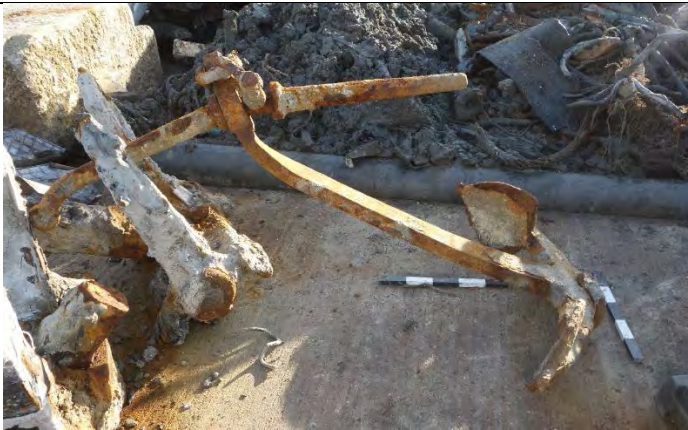
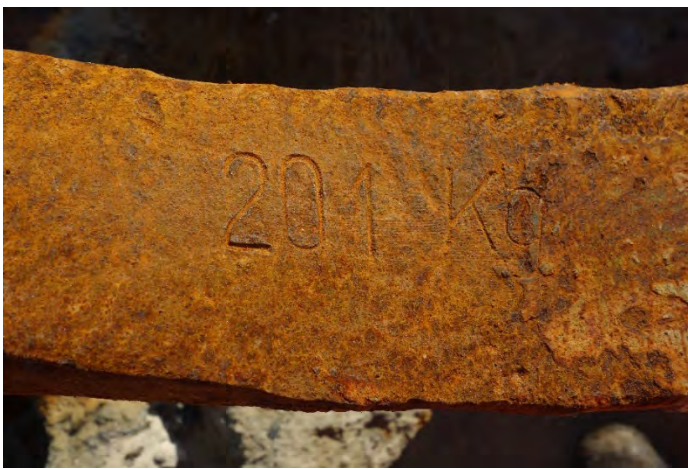
Anchor weight on the shank

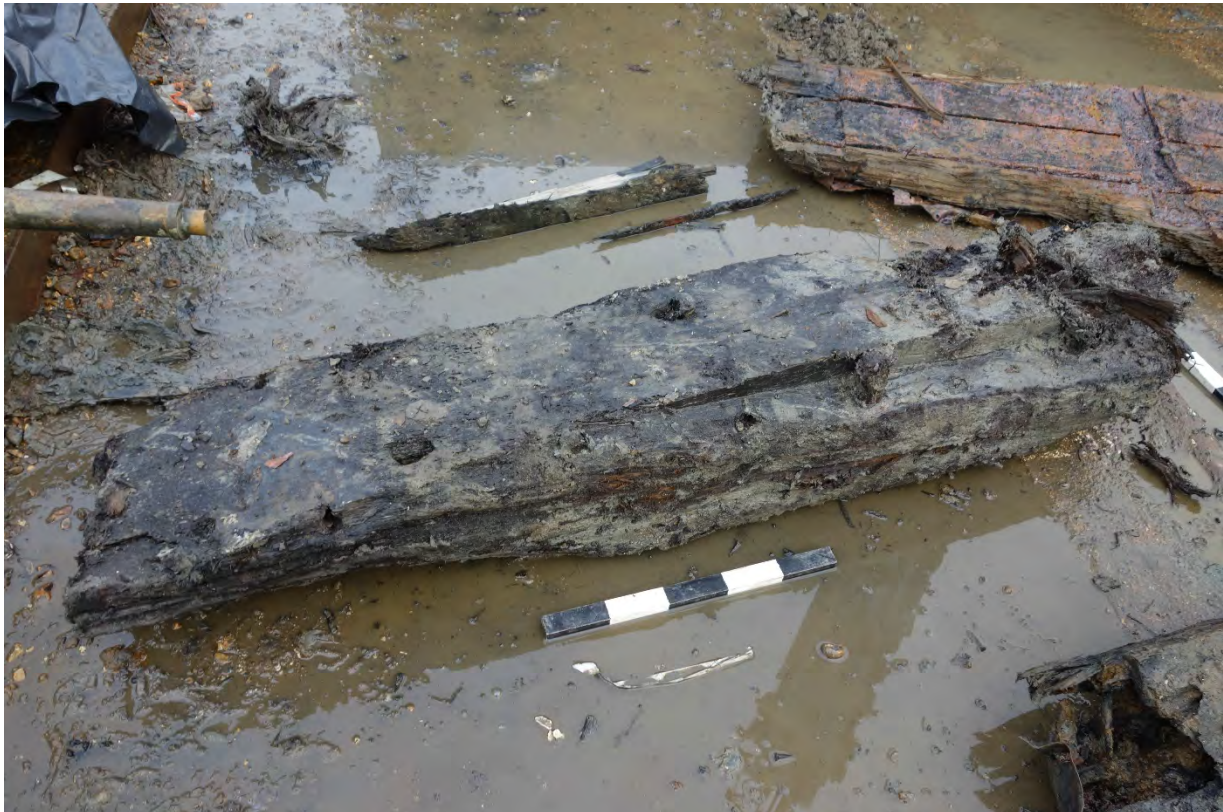
<b>UID</b> BWL9_0083	Possible ship's timber	
<b>Date of Discovery</b>	13/12/2016	
<b>How Discovered</b>	Recovered by grab and found during Quay Side Archaeological Monitoring.	
<b>Position of Discovery (British National Grid)</b>	..... E	..... N
<b>Location Map</b>	<b>Anomaly Image</b>	
N/A	N/A

<b>Description</b>			
<p>The timber measures 2080 mm in length with a maximum width of 358 mm. At both ends of the timber it begins to taper down, which may have been two scarf joints to increase the timbers overall length. On the opposite surface of the timber there is a recess cut 100 mm into the timber and 70 mm deep, this runs the majority of the length and there are four treenails present within this recess. Five other treenail holes are visible on the same surface of the timber, none of which extend through the whole of the timbers width. The timber is also damaged at both ends.</p>			
<b>Interpretation</b>			
<p>This timber may have come from a ship, but equally may have been part of a quayside structure such as piling. The large profile of the timber would suggest that it came from a large vessel if it was from a ship. The wood has a dark patina which would suggest that it is relatively old and the lack of any wood borer attacks would suggest that it has remained buried for the majority of this time. As the timber was found with the harbour it is unlikely to represent a shipwreck but more likely to have been discarded during repairs to a ship or quayside structure.</p>

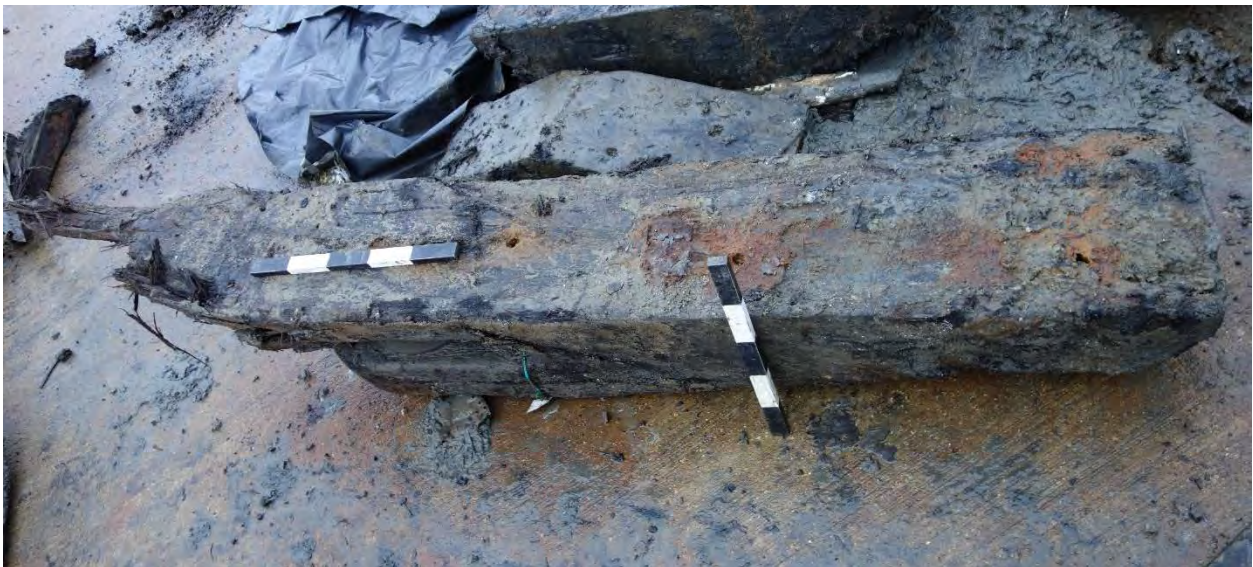
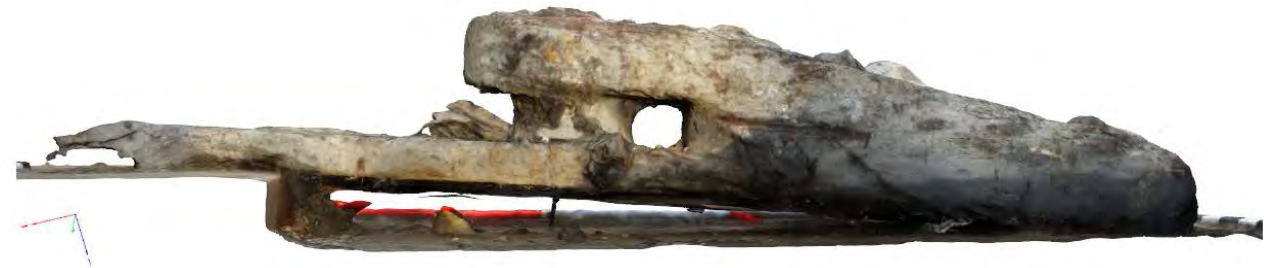
<b>UID</b> BWL9_0084	Timber with snatch block	
<b>Date of Discovery</b>	13/12/2016	
<b>How Discovered</b>	Recovered by grab and found during Quay Side Archaeological Monitoring.	
<b>Position of Discovery (British National Grid)</b>	..... E	..... N
<b>Location Map</b>	<b>Anomaly Image</b>	
N/A	N/A

The timber measures a maximum of 2770 mm in length with a width of 375 mm. One end of the timber is damaged and may have had a scarf joint, although there is no evidence of any fixings such as tree nails. The other end of the timber splits into two with a central recess, in which there is a wooden pulley wheel. The pulley wheel is made of wood and measures 300 mm in diameter with a width of 100 mm. The timber to one side of the pulley wheel is undamaged and extends just past the wheel and is rounded at the end. The other side of the pulley wheel the timber extends further out and is damaged.

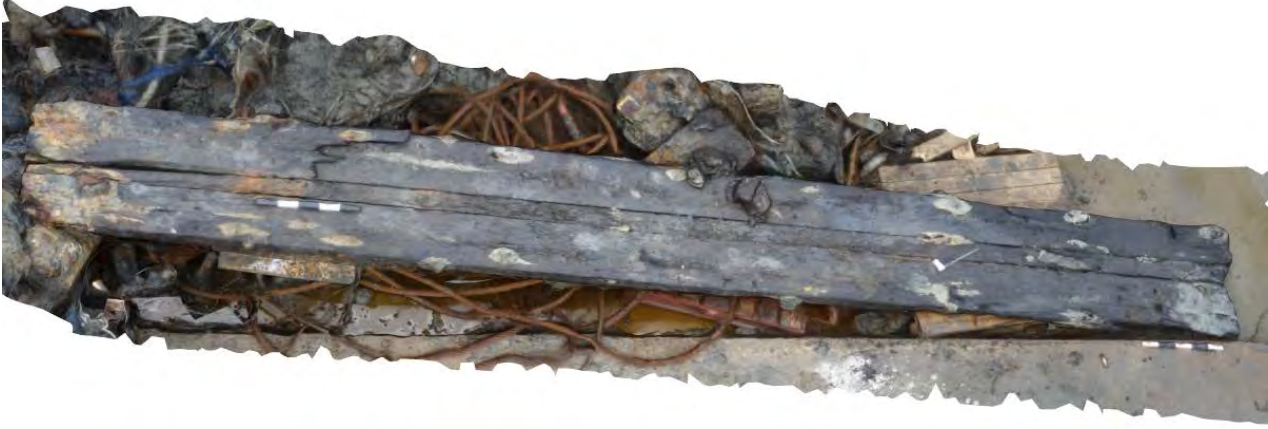
2D representation of 3D photogrammetry model (0.5 m scales)

This section of joined timbers is likely to be a section of either hull or deck planking. The timbers appear to be flat, which may make deck planking a more likely interpretation. The use of ferrous nails for the fixing would suggest that this is an earlier construction or it may have been a cheaper build. The timbers look to have some age but a specific date range is difficult to apply in this case. The timbers were found well with the harbour and close to shore, this would suggest that these were possibly removed from a vessel either during maintenance or breaking and they have been discarded on site, or possibly dropped in to the water and never recovered. Their size and location do not look to indicate the presence of a shipwreck.

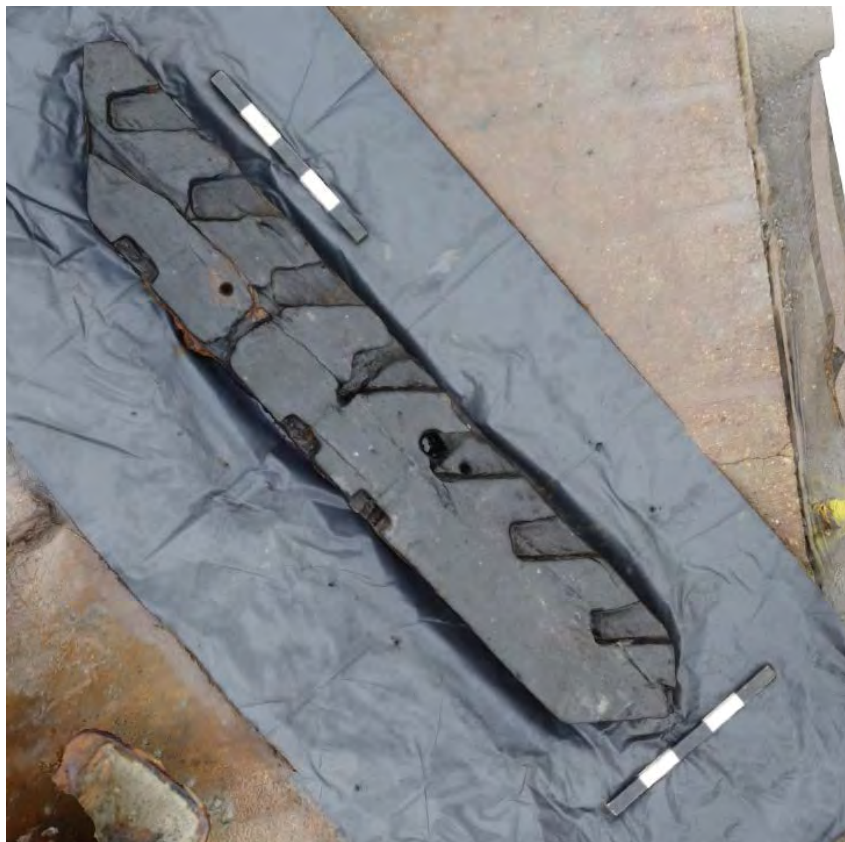
2D representation of 3D photogrammetry model (0.5 m scales)

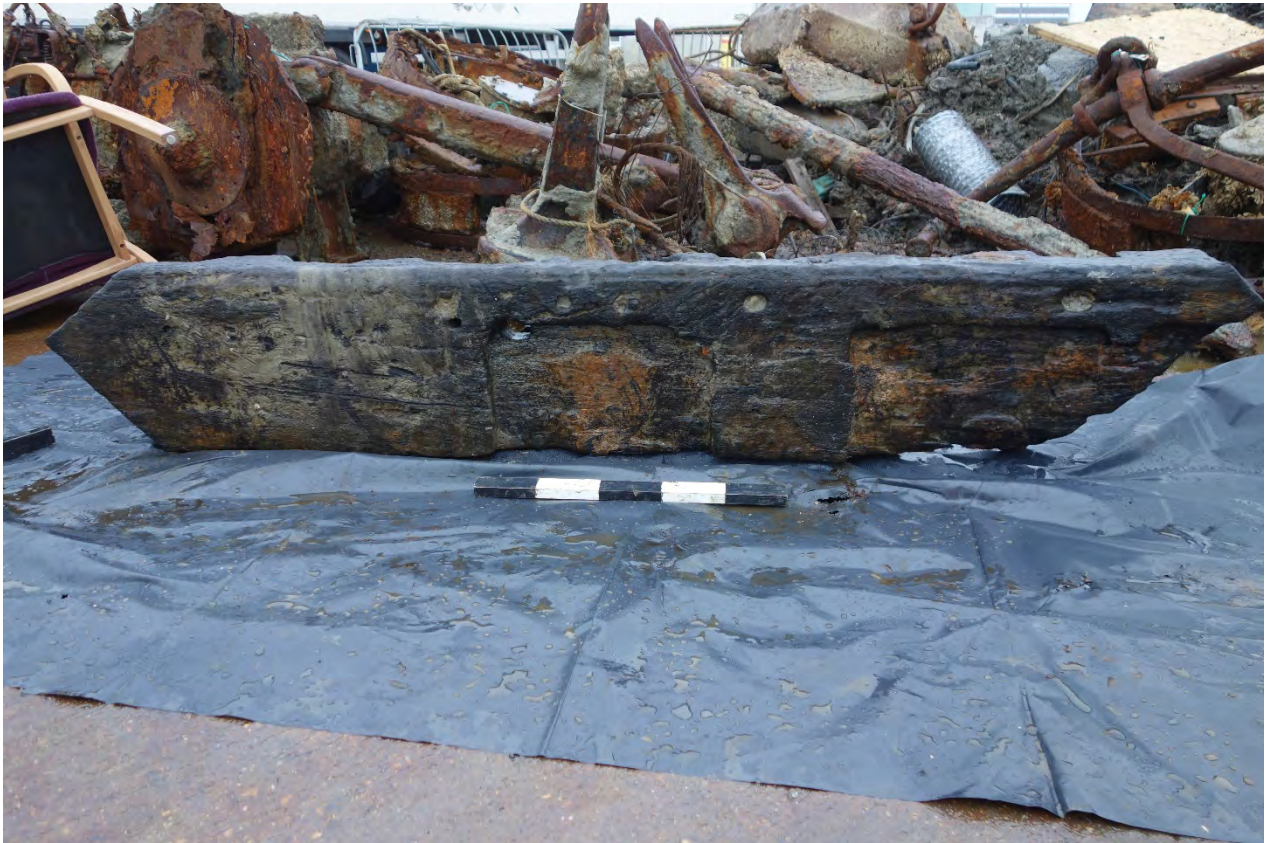
<b>UID</b> BWL9_0086	Ships timber - stringer	
<b>Date of Discovery</b>	30/01/2017	
<b>How Discovered</b>	Recovered by grab and found during Quayside Archaeological Monitoring.	
<b>Position of Discovery (British National Grid)</b>	..... E	..... N
<b>Location Map</b>	<b>Anomaly Image</b>	
N/A	N/A

Underside of the timber. The two large recesses may have joined to the side of the ship.

The timber is a stringer for a set of stairs also known as a companion ladder, these would have been found on wooden ships and would have been a feature of many different vessel types. The stringer would have supported the stairs, possibly up to the quarter deck or within the hold moving from deck to deck. The first photograph has been positioned as it would have been used. The base would sit on the deck, then a small step up to the first of the seven steps. At the top end of the timber the long flat face would have joined onto the wall close to the next floor level.

The timber is a substantial size and made of oak which may suggest it was from a larger, more expensive ship build. The dating of the timber is very difficult due to the long running and largely unchanged use of stairs on ships, although the dark staining would suggest some age to the timber, but a date range cannot be confidently applied.

It is probable that this timber was either replaced or part of a ship that was dismantled and the stringer was discarded.

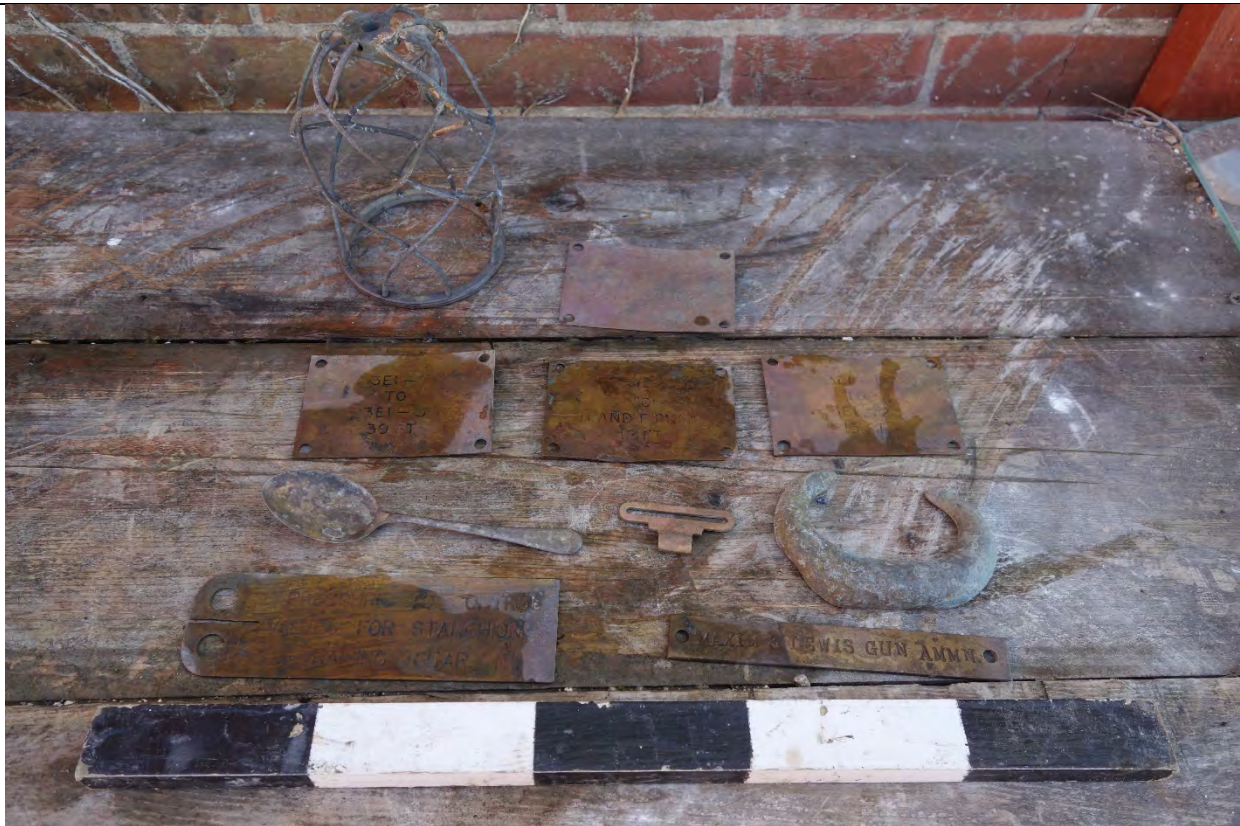
<b>UID</b> BWL9_0093	10x Metal objects	
<b>Date of Discovery</b>	04/02/17	
<b>How Discovered</b>	Recovered by grab and recovered during Quayside Archaeological Monitoring.	
<b>Position of Discovery (British National Grid)</b>	..... E	..... N
<b>Location Map</b>	<b>Anomaly Image</b>	
N/A	N/A

- Brass light cage measuring 170 x 110 mm
- 'U' shaped brass object measuring 120 x 30 mm
- Stainless steel spoon measuring 165 mm and marked "1957" "W.S.Ltd"
- Brass military belt buckle measuring 63 x 30 mm
- Brass plaque measuring 110 x 76 mm and marked with "6D1-1 To Hand F-pump 15 FT"
- Brass plaque measuring 110 x 76 mm and marked with "3E1-1 To 3E1-2 15 FT"
- Brass plaque measuring 110 x 76 mm and marked with "6F1-6 To Hand F-pump 18 FT"
- Brass plaque measuring 110 x 76 mm and marked with "3E1-1 To 3E1-5 39 FT"
- Brass plaque measuring 185 x 55 mm and marked with "Pressure to control values for stanchion raising gear NI"
- Brass plaque measuring 172 x 23 and marked with "Maxim & Lewis gun Ammn"

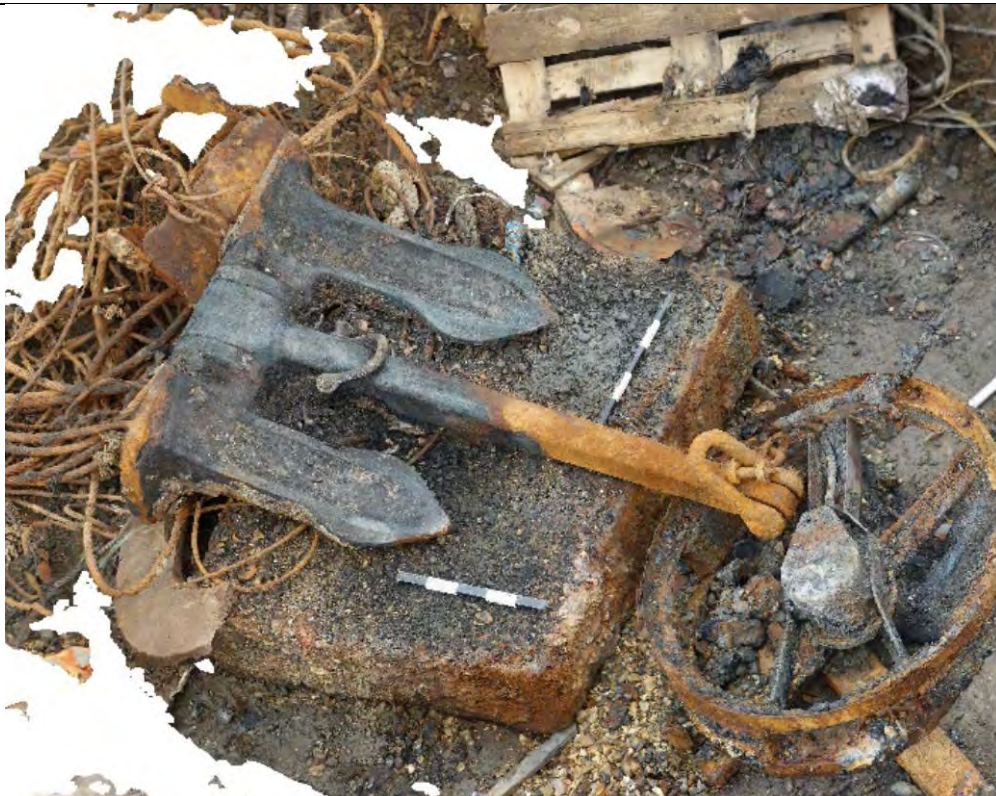
**Photogrammetry model of BWL9\_0098**

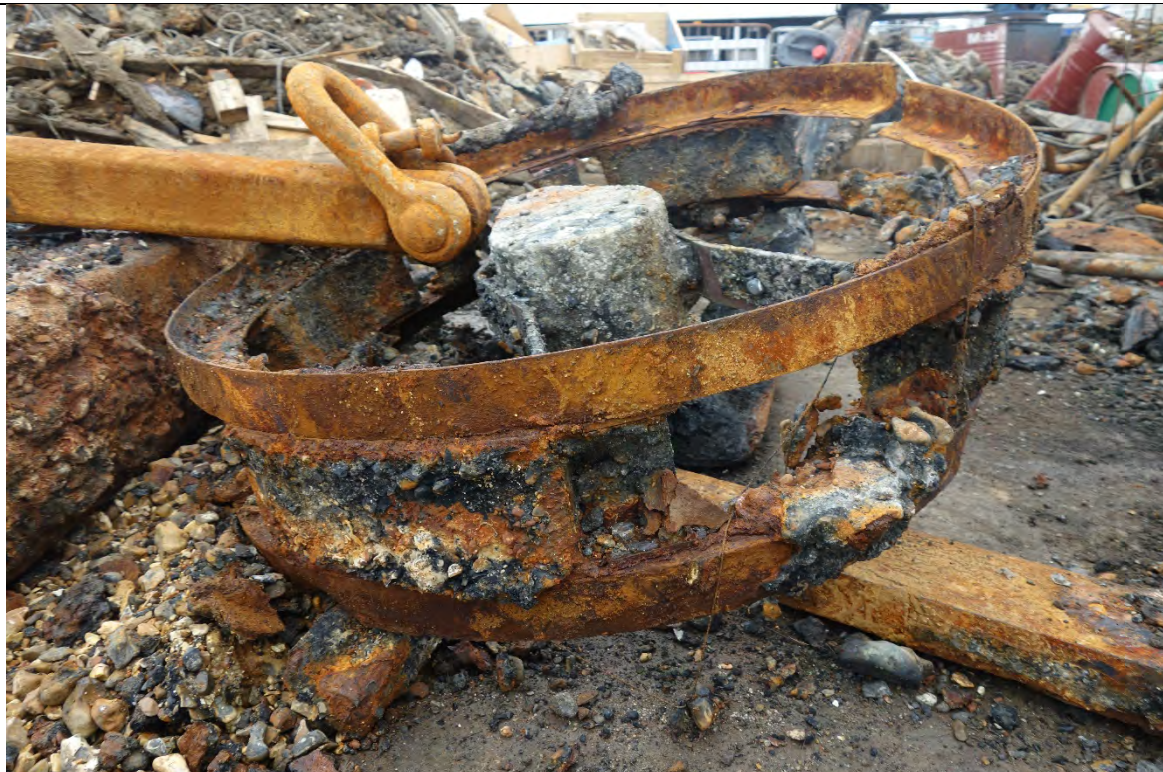
<b>UID</b> BWL9_0099	Degaussing unit	
<b>Date of Discovery</b>	29/03/17	
<b>How Discovered</b>	Recovered by grab and recovered during quay side archaeological monitoring.	
<b>Position of Discovery (British National Grid)</b>	..... E	..... N
<b>Location Map</b>	<b>Anomaly Image</b>	
N/A	N/A

The degaussing unit would have been part of a series making up a degaussing range. Degaussing ranges were set up to help protect shipping from magnetic sea mines. During the Second World War the introduction of magnetic mines caused catastrophic results to Allied shipping. Steel hulled ships create a magnetic signature as they travel which disturbs the Earth's magnetic field as it moves. This disturbance in the magnetic field is what is detected by the mines. It was found that by inducing a small field to the ship, they could offset the effect that it had on the Earth's magnetic field. Some ships were fitted with their own degaussing units, electromagnetic coils, which would allow them to consistently offset the effect. This was expensive so other method had to be devised, one method involved dragging the cable around the ship's hull or by using specially designed ranges. As the effects would gradually wear off, several degaussing ranges existed for merchant and naval shipping.

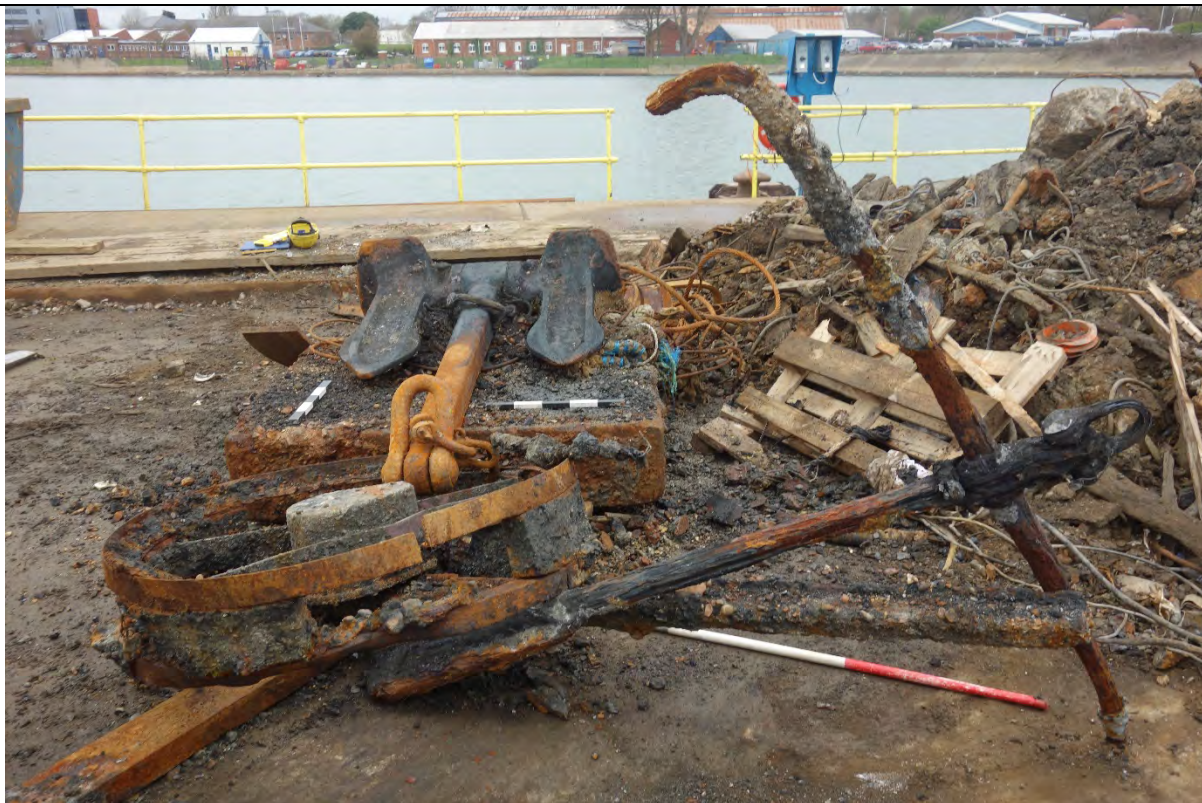
<b>UID</b> BWL9_0100	Stocked mooring anchor	
<b>Date of Discovery</b>	29/03/2017	
<b>How Discovered</b>	Recovered by grab and recovered during quay side archaeological monitoring.	
<b>Position of Discovery (British National Grid)</b>	..... E	..... N
<b>Location Map</b>	<b>Anomaly Image</b>	
N/A	N/A

BWL9\_0100 – The bent over arm can be seen facing the camera. An example of a stockless anchor can be seen in the background.

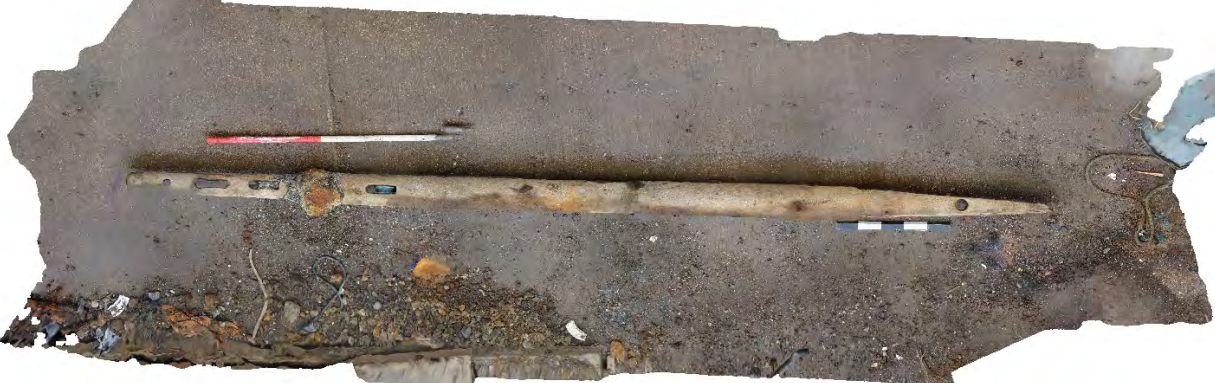
Mast booms are commonly made of wood, and the wear and decay on this object are not high, so this would suggest a more modern date. It is unlikely to be from a wreck as no other related material has been recovered to suggest this. It may have been discarded or lost during a refit within the harbour.

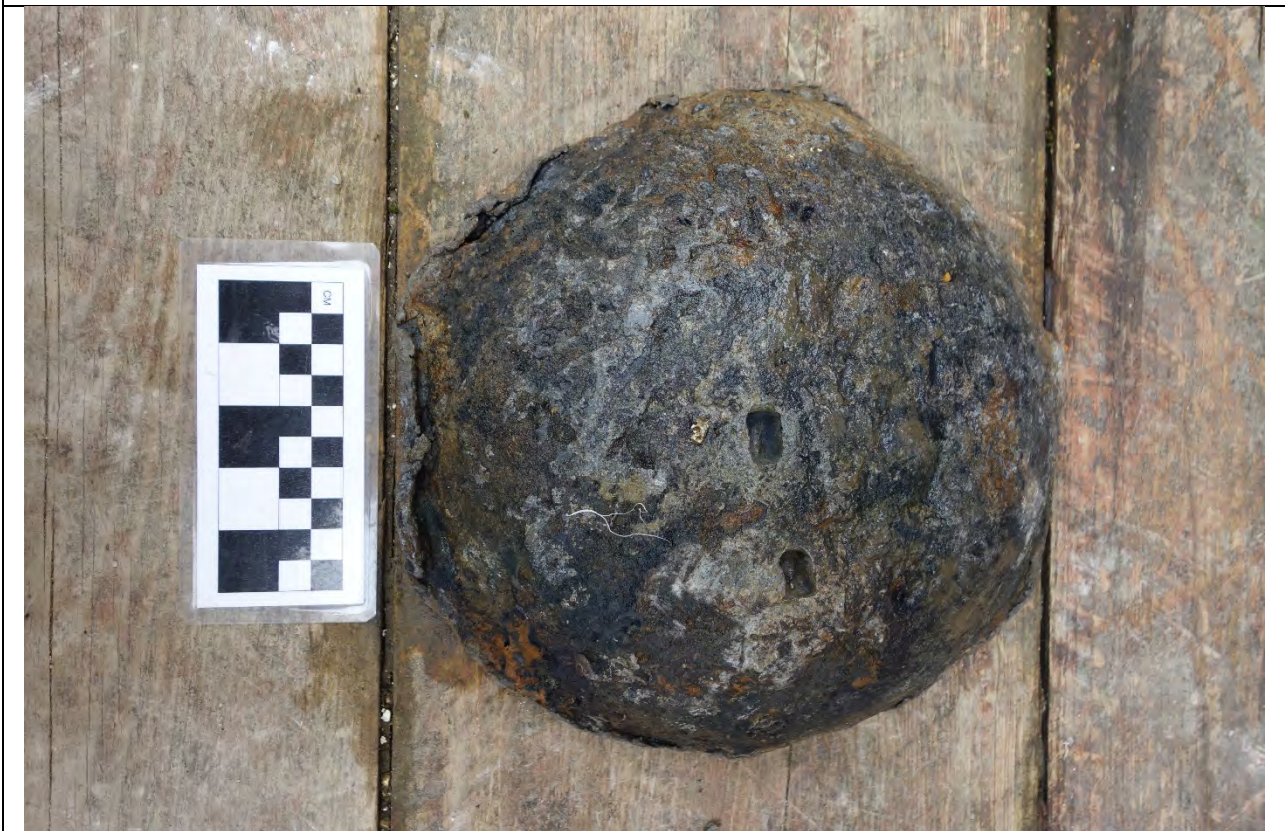
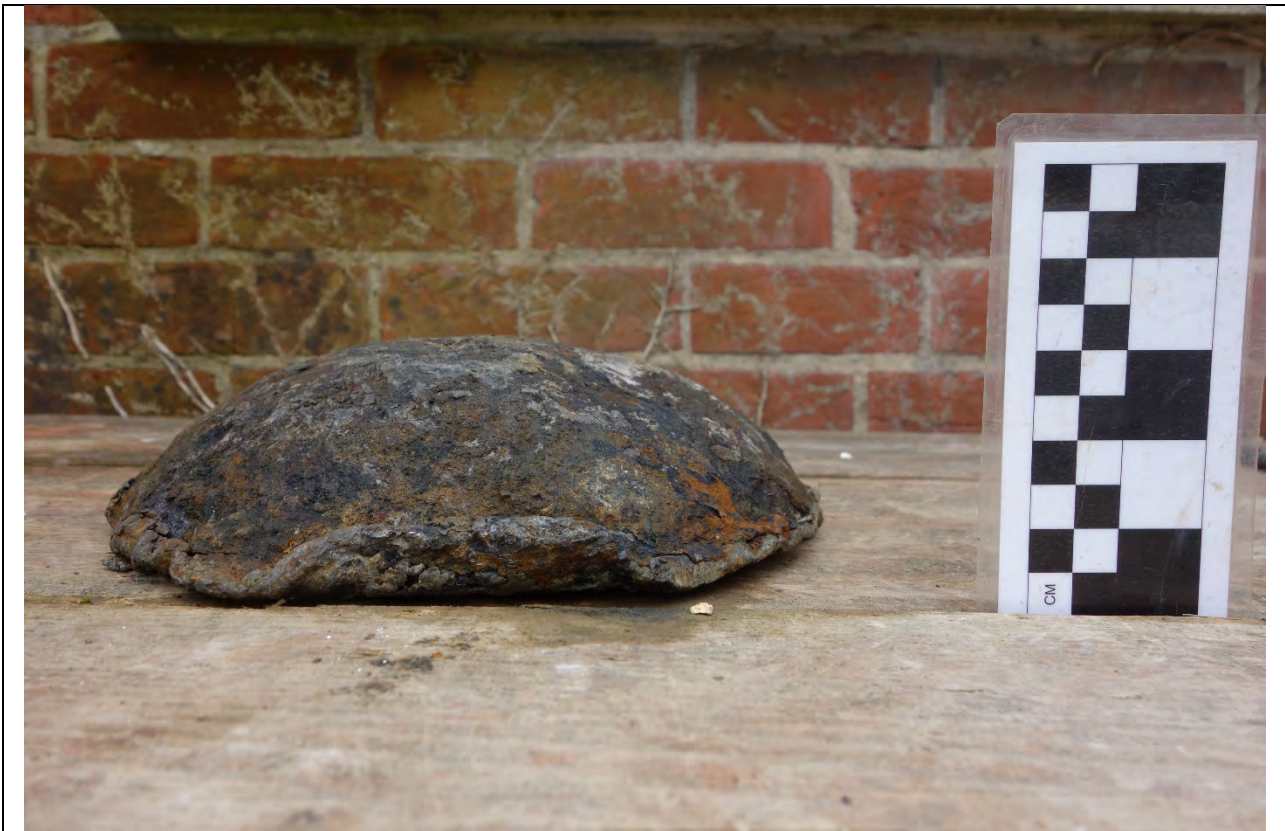
<b>UID</b> BWL9_0102	Lead ingot	
<b>Date of Discovery</b>	30/12/2016	
<b>How Discovered</b>	Recovered by grab and recovered during quay side archaeological monitoring.	
<b>Position of Discovery (British National Grid)</b>	..... E	..... N
<b>Location Map</b>	<b>Anomaly Image</b>	
N/A	N/A

A domed shaped lead ingot weighing 14.1 kg or 31 lbs, it has a diameter of 230 mm and a height of 60 mm. There are two indentations of the top of the ingot, 15 and 20 mm in depth.

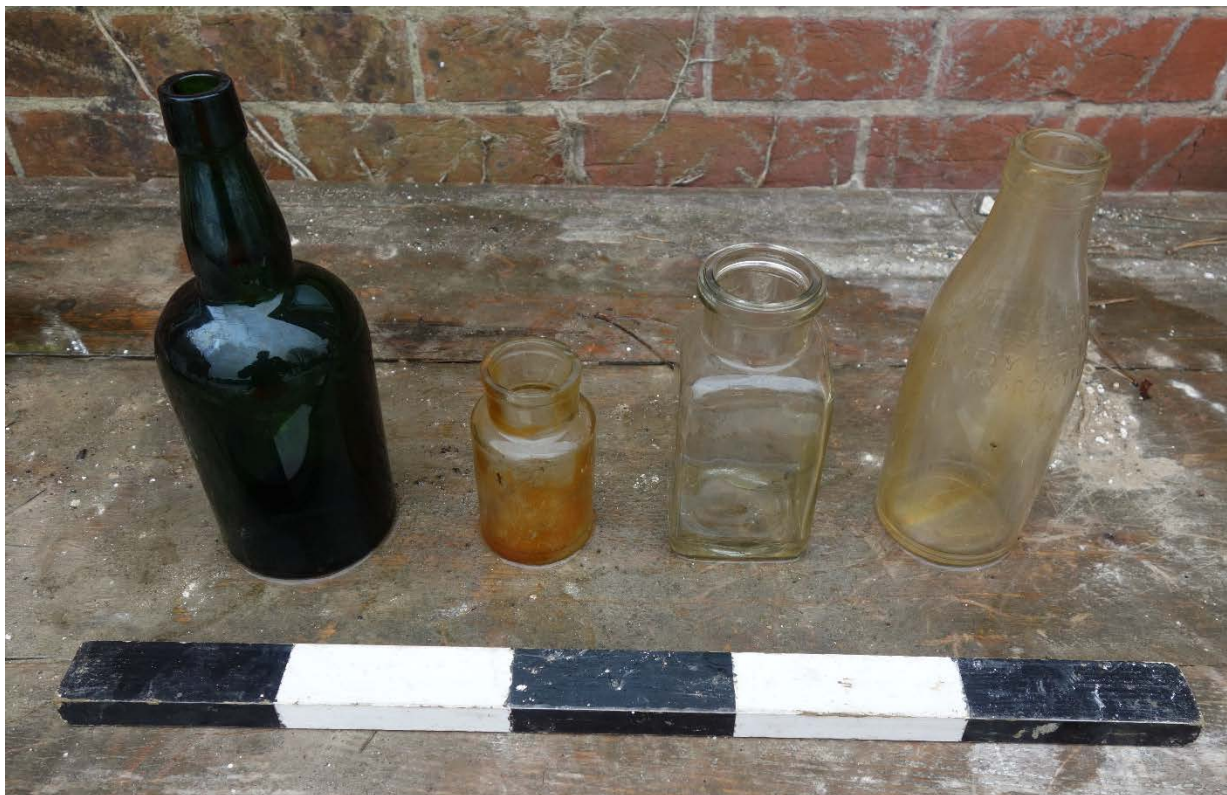
<b>UID</b> BWL9_0104	Four glass bottles	
<b>Date of Discovery</b>	29/03/2017	
<b>How Discovered</b>	Recovered by grab and recovered during quay side archaeological monitoring.	
<b>Position of Discovery (British National Grid)</b>	..... E	..... N
<b>Location Map</b>	<b>Anomaly Image</b>	
N/A	N/A

- Large dark green glass bottle measuring 240 mm in height and 85 mm diameter. There are no markings.
- Small clear glass jar with yellow staining. Measuring 110 mm in height and 60 mm in diameter. There are no markings.
- Clear glass jar measuring 150 mm in height and 70 mm in diameter, there are no markings.
- Clear glass bottle measuring 210 mm in height and 75 mm in diameter. The bottle is marked with a triangle with "Safety First" on one side and "Bottled by members of the Safety First Milk Association" on the other.
