# Queen Elizabeth Class Capital Dredge Project Her Majesty's Naval Base, Portsmouth

Archaeological Assessment Report

Ref: 111320.05  
January 2018

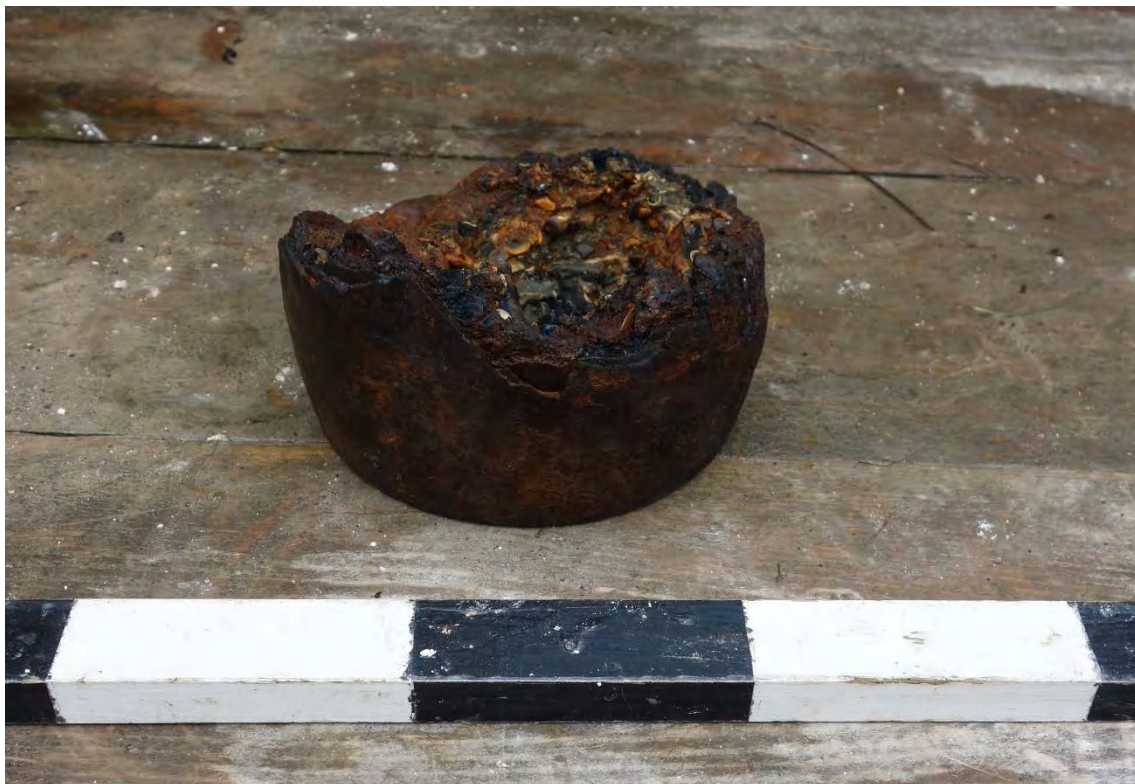
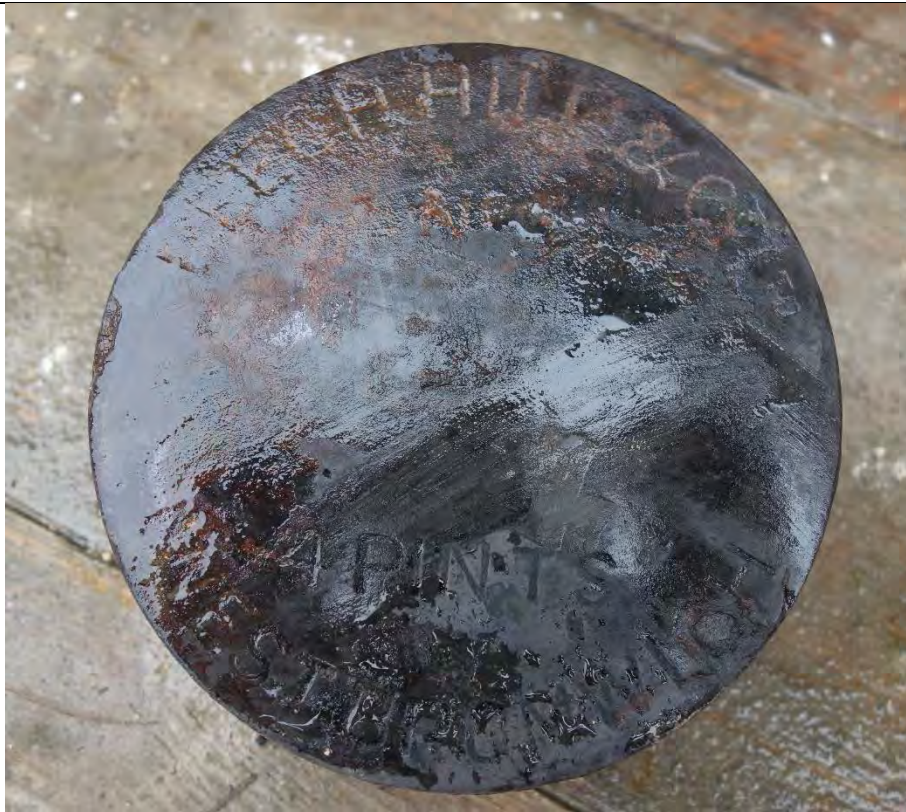
A cast iron circular object with a flat base. The inside of the object is filled with concreted material. The object remains to a height of 80 mm and has a diameter of 170 mm. On the base it has:

This is the base of a cast iron cooking pot or a similar form of kitchen ware. The '4 pints' will refer to its contents once complete. It was made by Beech Hill & Co Ltd of West Bromwich, an iron founders established in 1903, specialising in cast iron hollow ware.

The object may have been discarded or lost and it is unclear if the item was broken prior to discard or not.

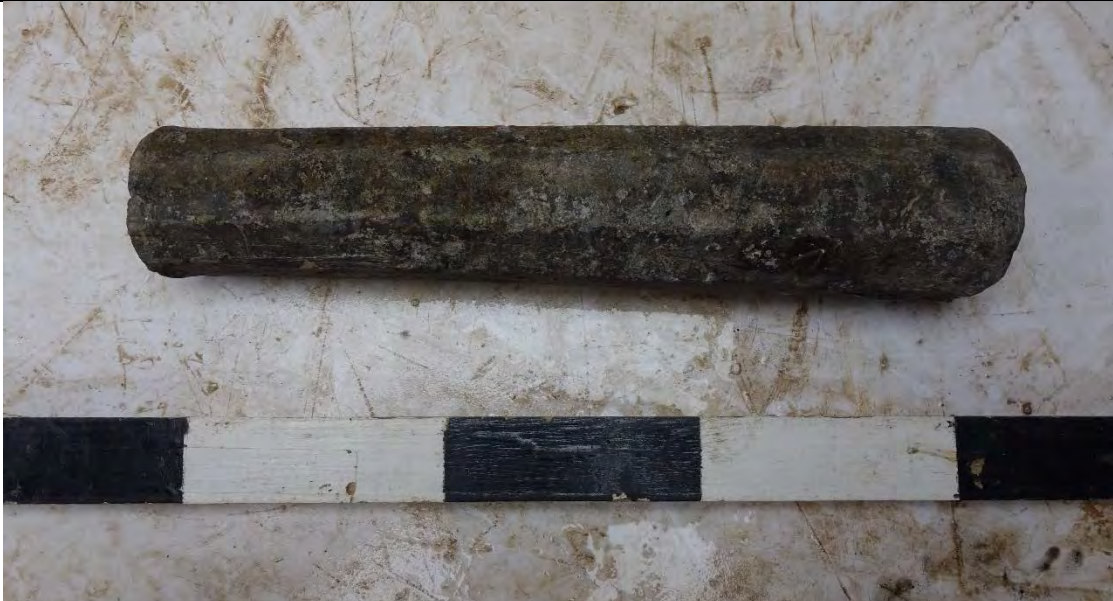
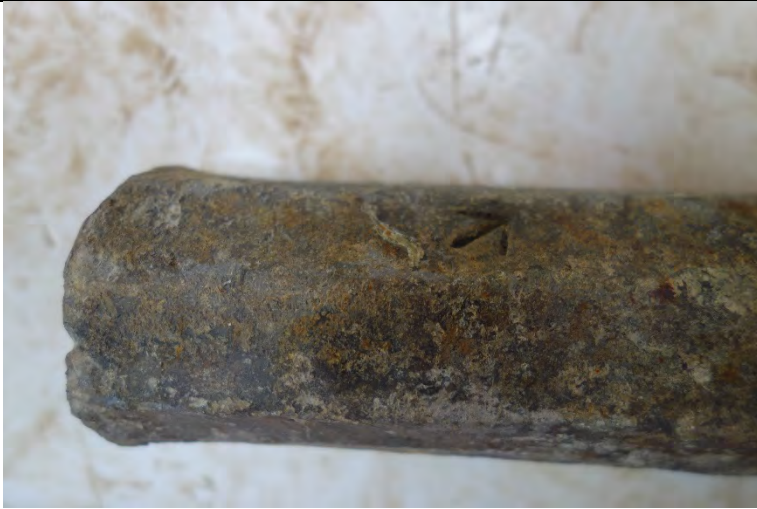
**Royal Navy Broad Arrow**

A lead sound weight incised with a broad arrow. The top of the lead has broken and it is missing the hole where a line would be attached. The lead measures 325 mm in length and between 55 and 60 mm in width. The weight of the object is 10.4 kg or 22.9 lbs.

Sounding leads had two purposes, to measure the depth of water and to identify the composition of the seabed. The lead would be attached to a line and the line would have marks tied in intervals so that the depth could be quickly identified. The base of the sounding lead is concaved and would be filled with tallow, this was so that once the lead was retrieved a sample of the seabed could be observed. This information could be used to aid in navigation and whether the area is suitable to anchor.

It is likely that the lead was either broken and discarded or broken during use and was lost.

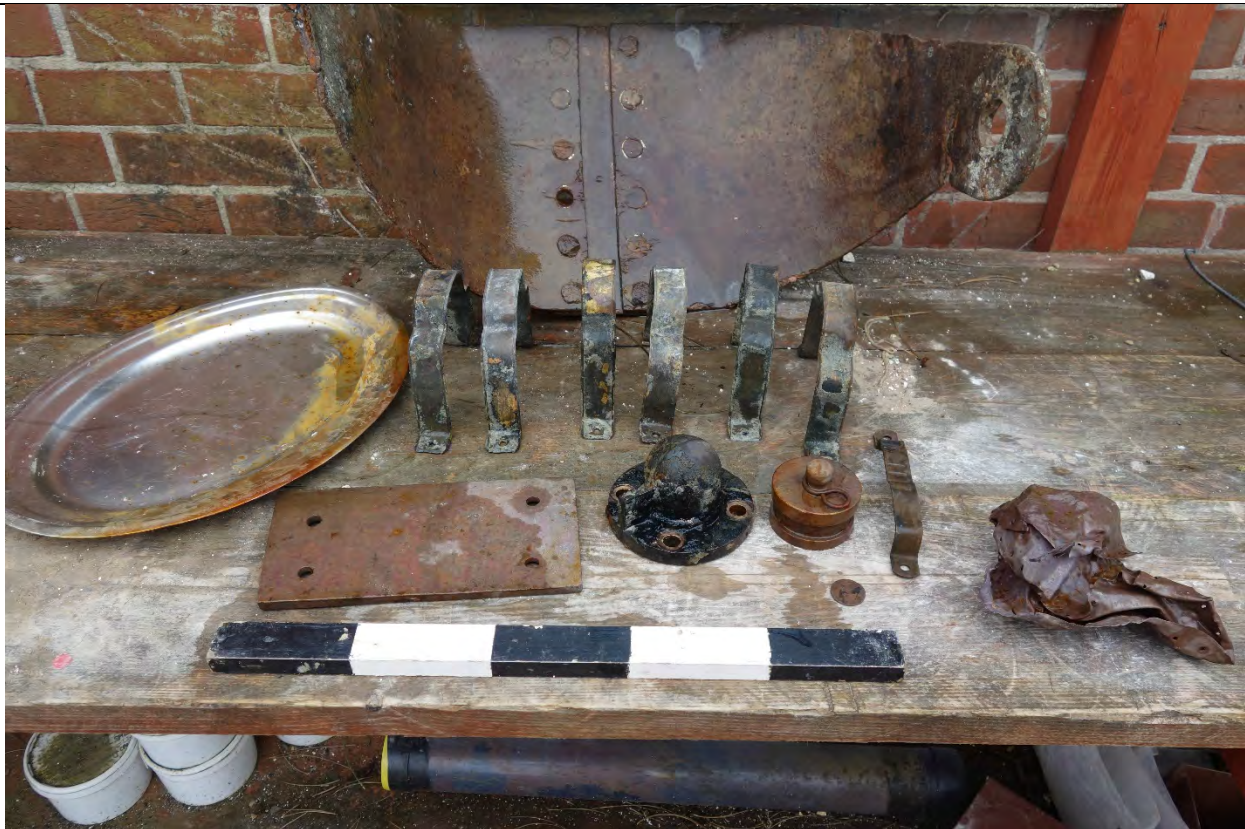
<b>UID</b> BWL9_0107	Assorted metal objects	
<b>Date of Discovery</b>	04/02/17	
<b>How Discovered</b>	Recovered by grab and recovered during quay side archaeological monitoring.	
<b>Position of Discovery (British National Grid)</b>	..... E	..... N
<b>Location Map</b>	<b>Anomaly Image</b>	
N/A	N/A

- Stainless steel platter measuring 410 x 320 mm and marked on the underside with "S.G. 1979" "129-1178"
- Six brass brackets measuring 180 x 125 mm in a "U" shape
- Brass bracket measuring 180 x 25 mm
- Steel plate with four fixing holes measuring 250 x 130 mm
- Brass nozzle cap measuring 75 x 45 mm
- Brass flange with domed top measuring 120 x 90 mm
- Steel riveted shoot or grab plate measuring 640 x 330 mm
- Copper alloy coin with 27 mm diameter, all markings have been lost.
- Crumpled copper alloy sheet with rivet holes.

The stainless steel platter would have been used for food service, and therefore it is more likely to have come from a ferry or similar passenger ship as MoD material would usually be identified by a broad arrow.

The copper alloy coin is very worn and is now very thin. All of the design has been lost and is now a smooth surface. It is unclear what sort of coin it is, it is 1 mm wider in diameter than a modern two pence coin ruling out this possibility.

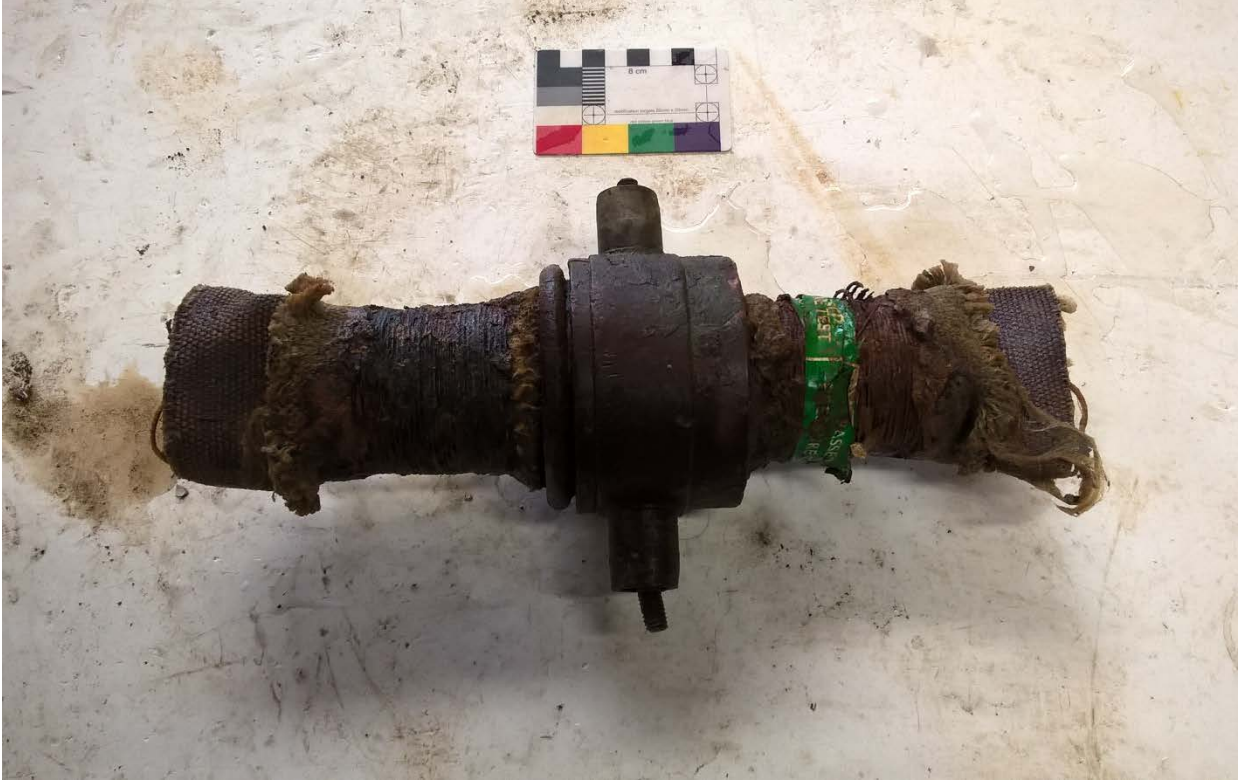
This may date to the 1950s or later judging by other components found, although this design has remained relatively unchanged.
