# Southsea Castle Portsea Island, Hampshire

GI Works Archaeological Watching Brief

Document Ref.: 118666.03  
March 2021

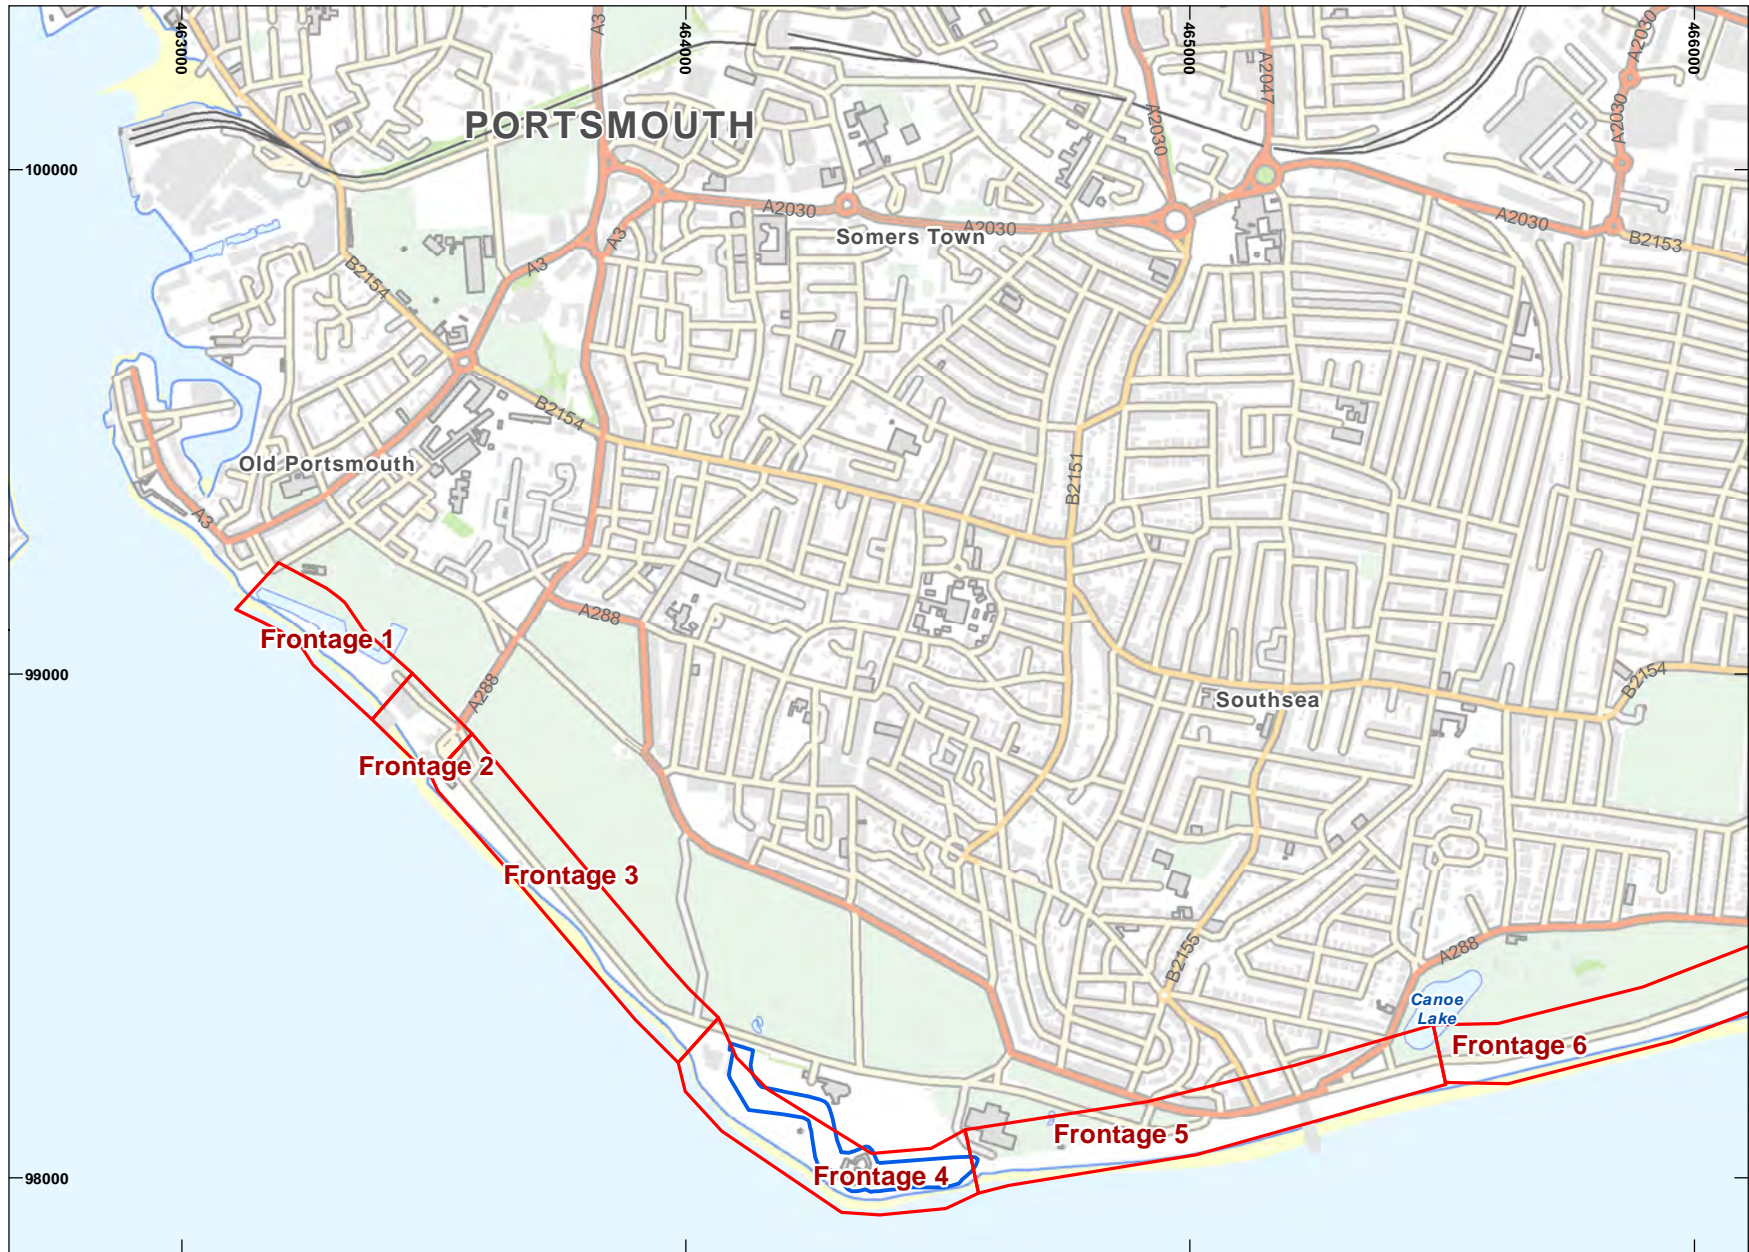
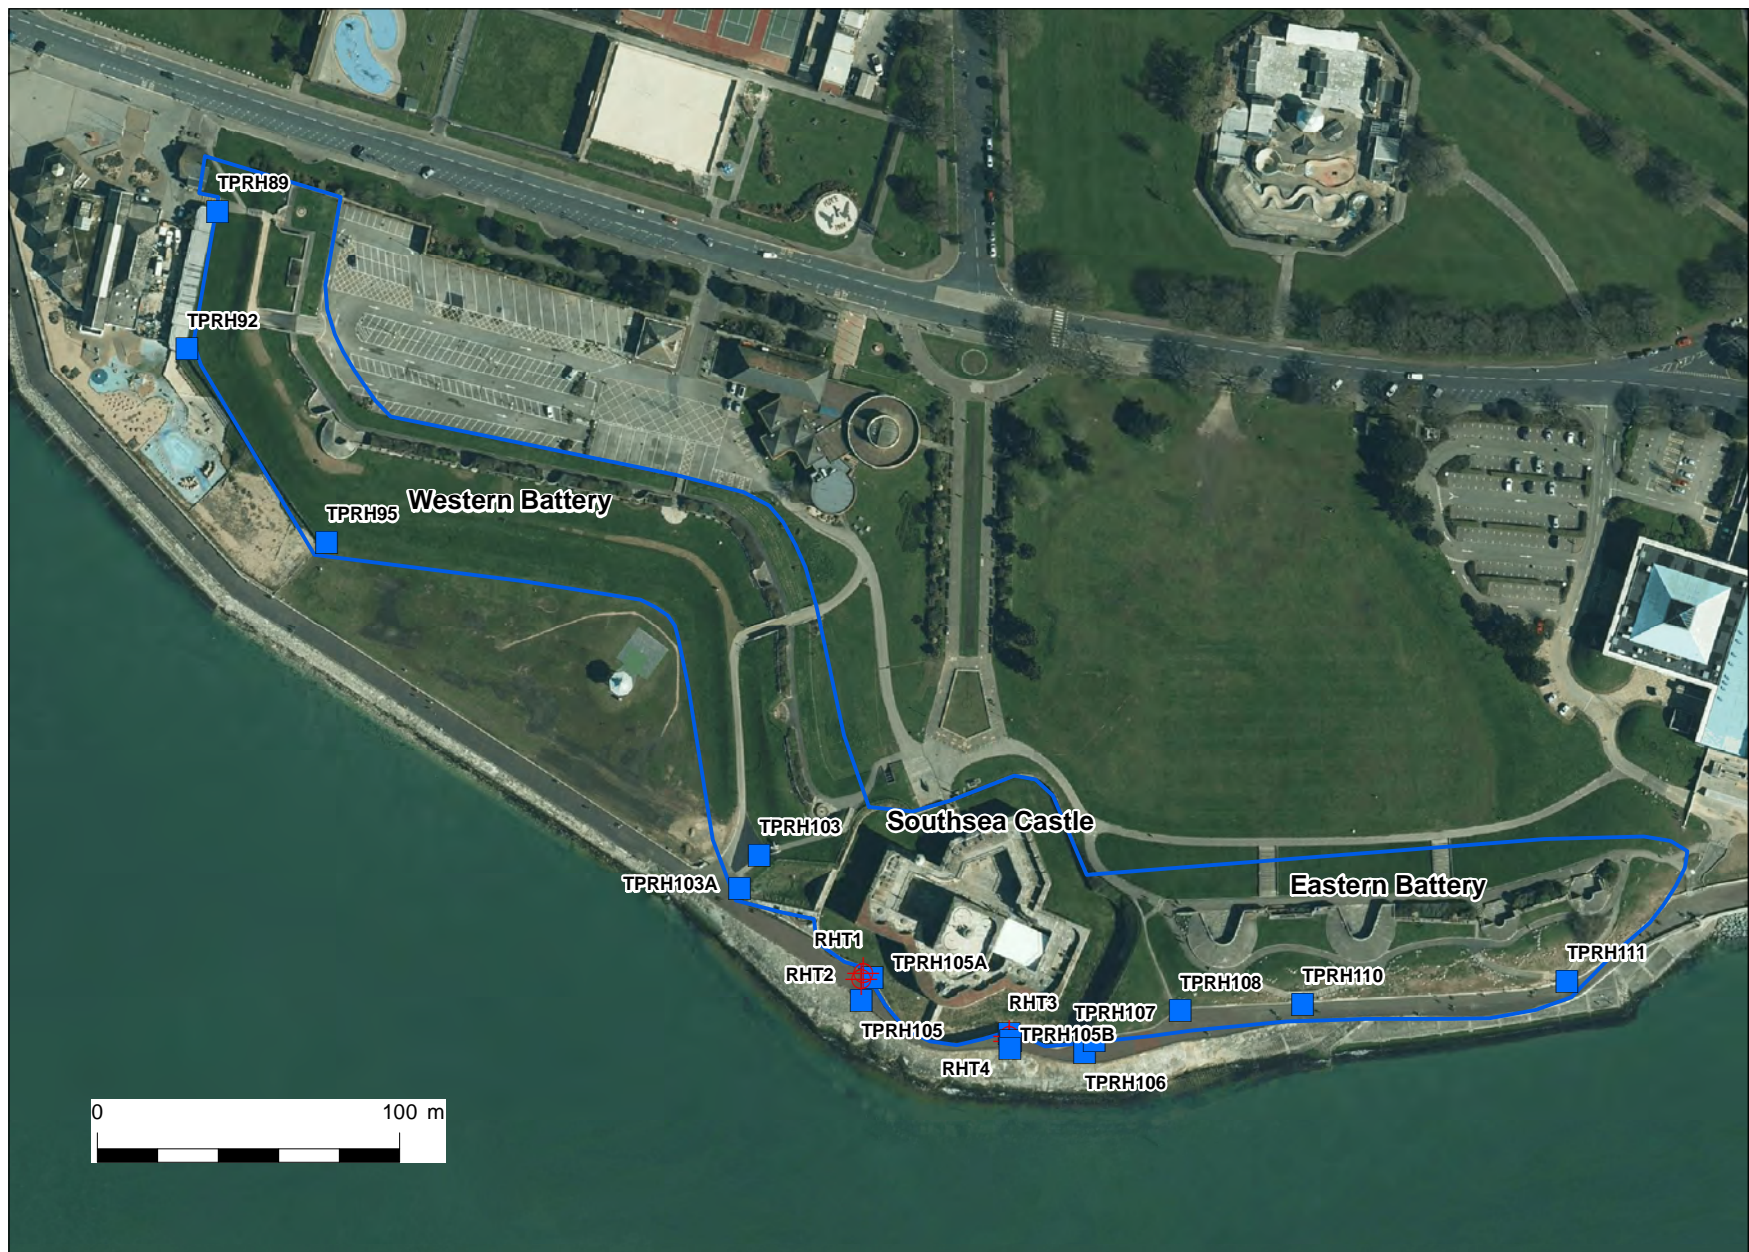
Figure 1

- 1.1.3 These additional GI works are within or adjacent to the Scheduled Monument Boundary of Southsea Castle (list entry 1001869) within Frontage 4 of the scheme (**Figure 1**).

Southsea Castle, trial pits and core locations

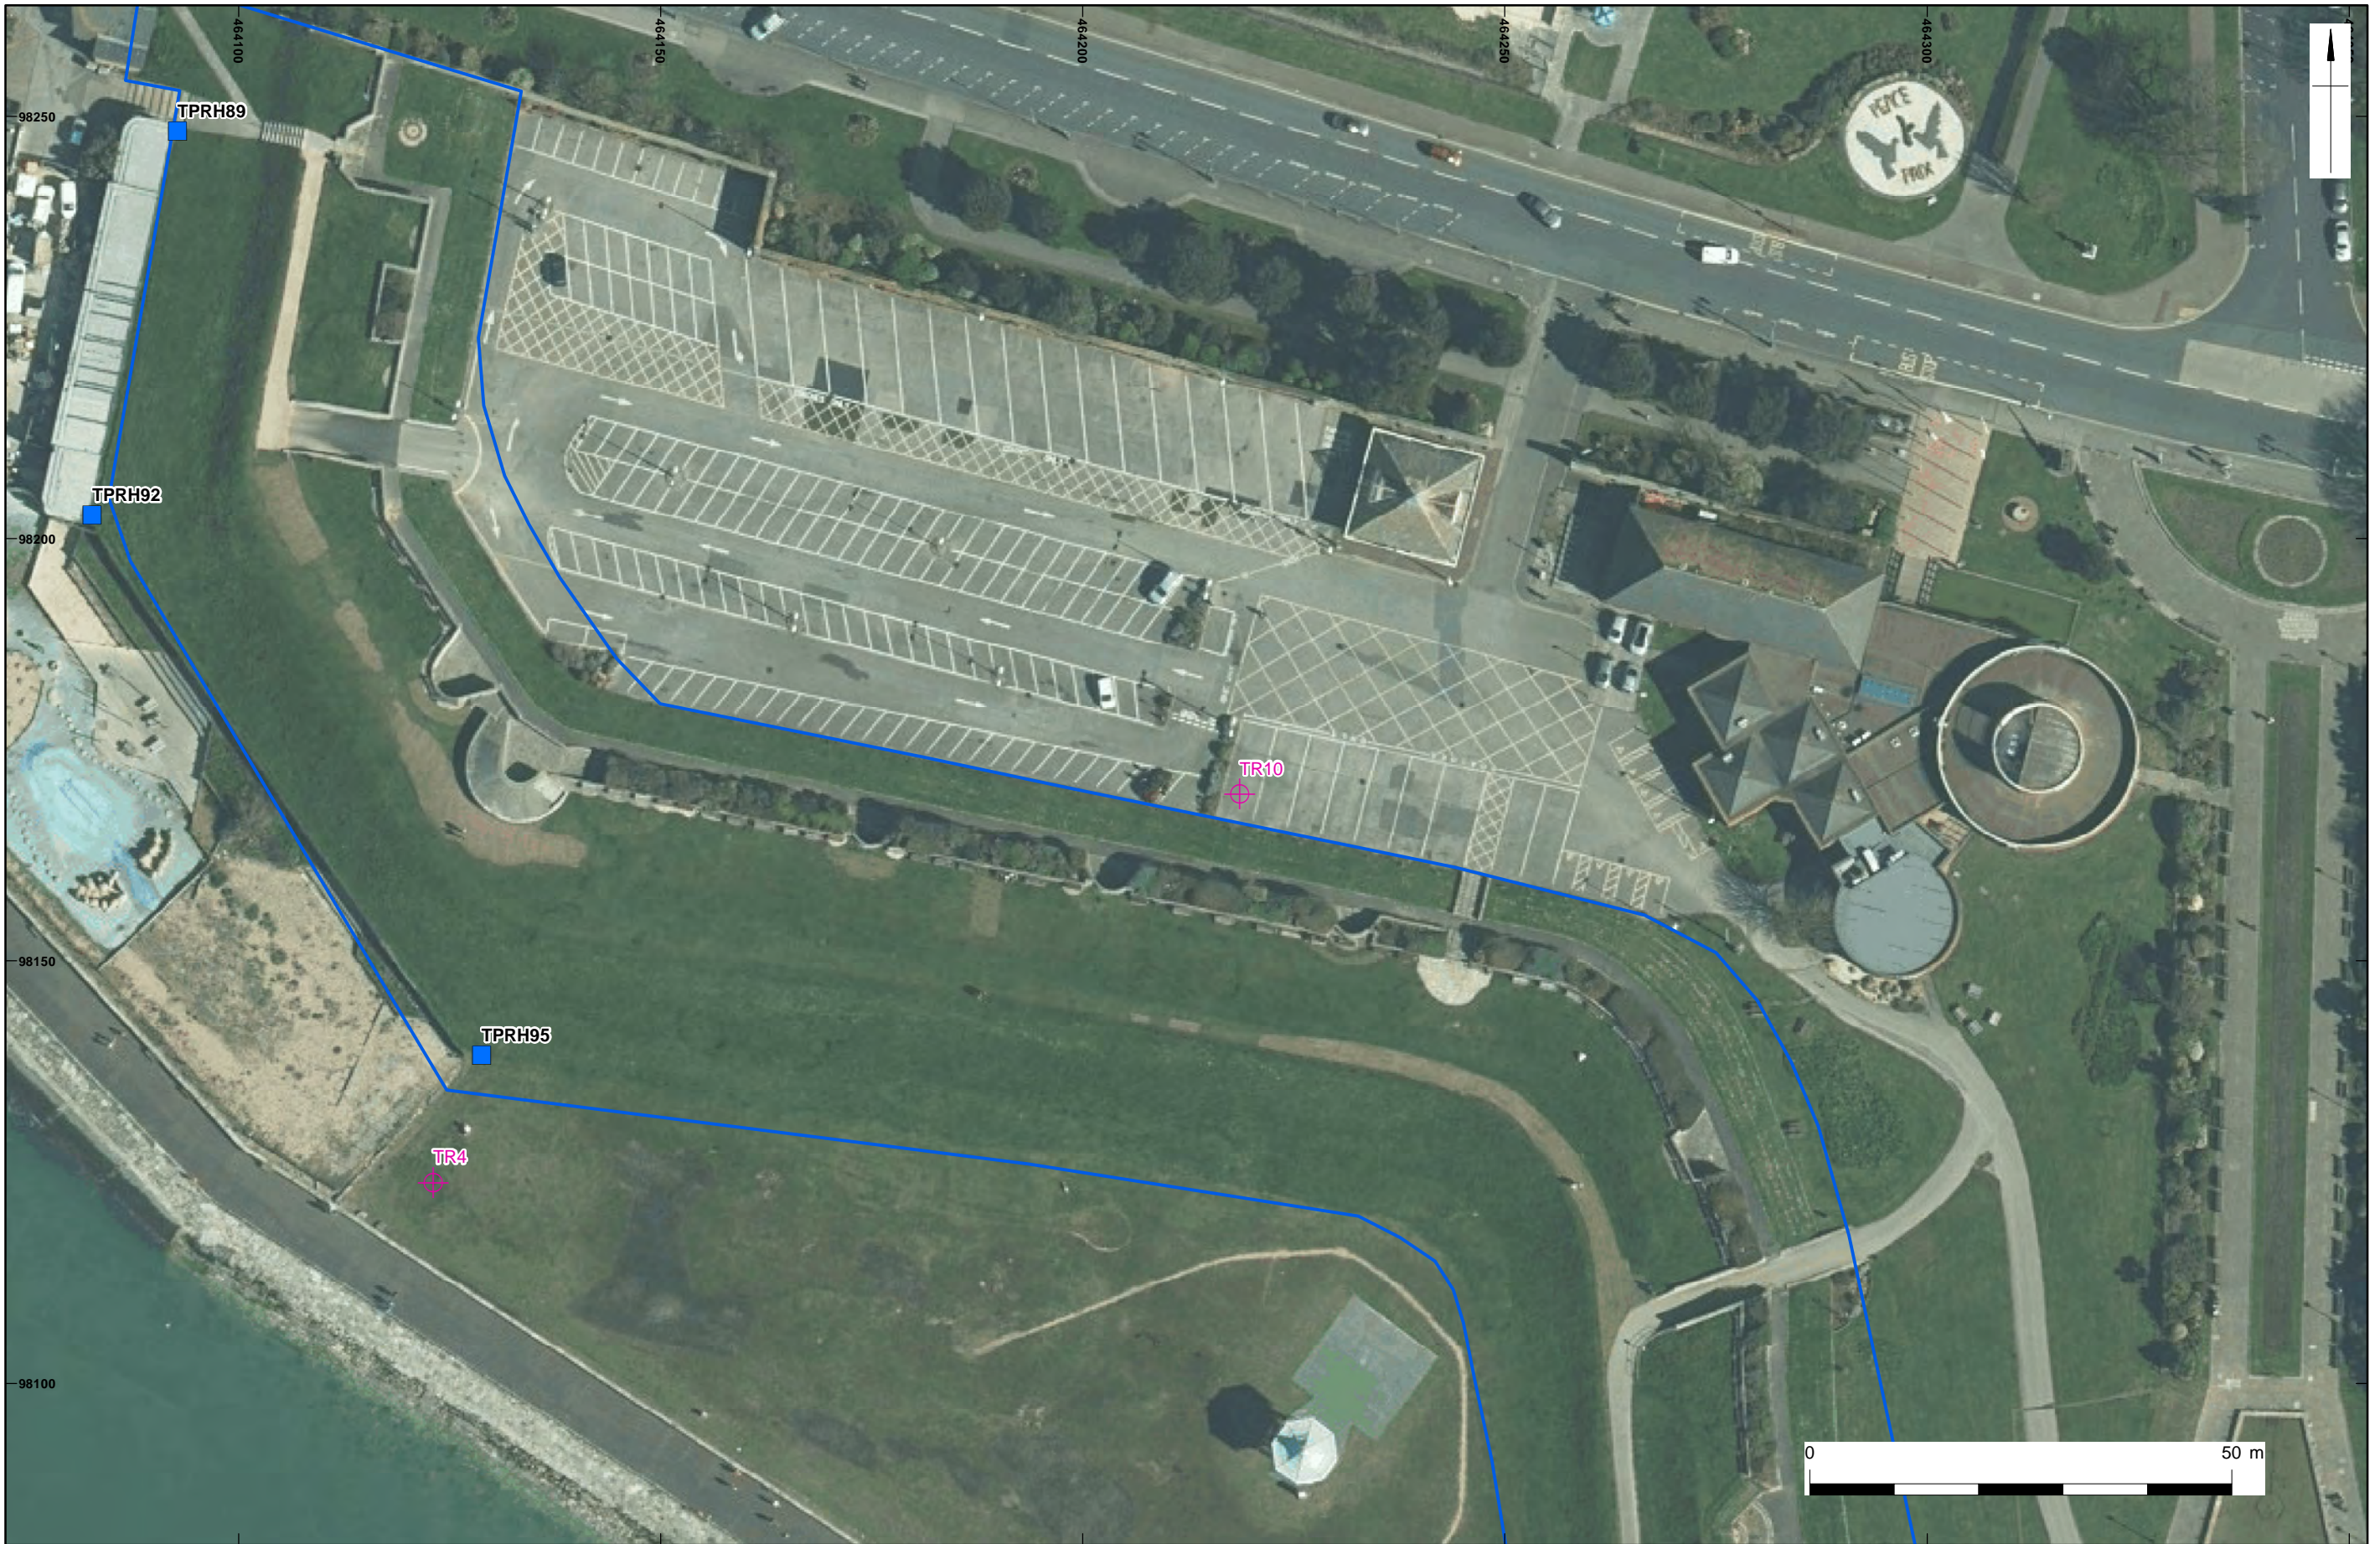
Figure 2

- 5.2.1 Trial pits TPRH89, TPRH92, TPRH95 (**Figure 2**) and TPRH103 (**Figure 3**) were all situated within the area of the Western Battery. While they had the potential to provide further information on this late 19th century structure and later landscaping works, they were all located either off or on the outskirts of the main earthworks. These trial pits were targeted on specific structures to inform the detailed design of the secondary defence retaining wall.
- 5.2.2 In general, around 0.15 m of topsoil was found to overlie up to 0.80 m of modern made ground which included fragments of brick and concrete (**Plates 1-4**). No substantive topsoil

Investigations within the Western Battery

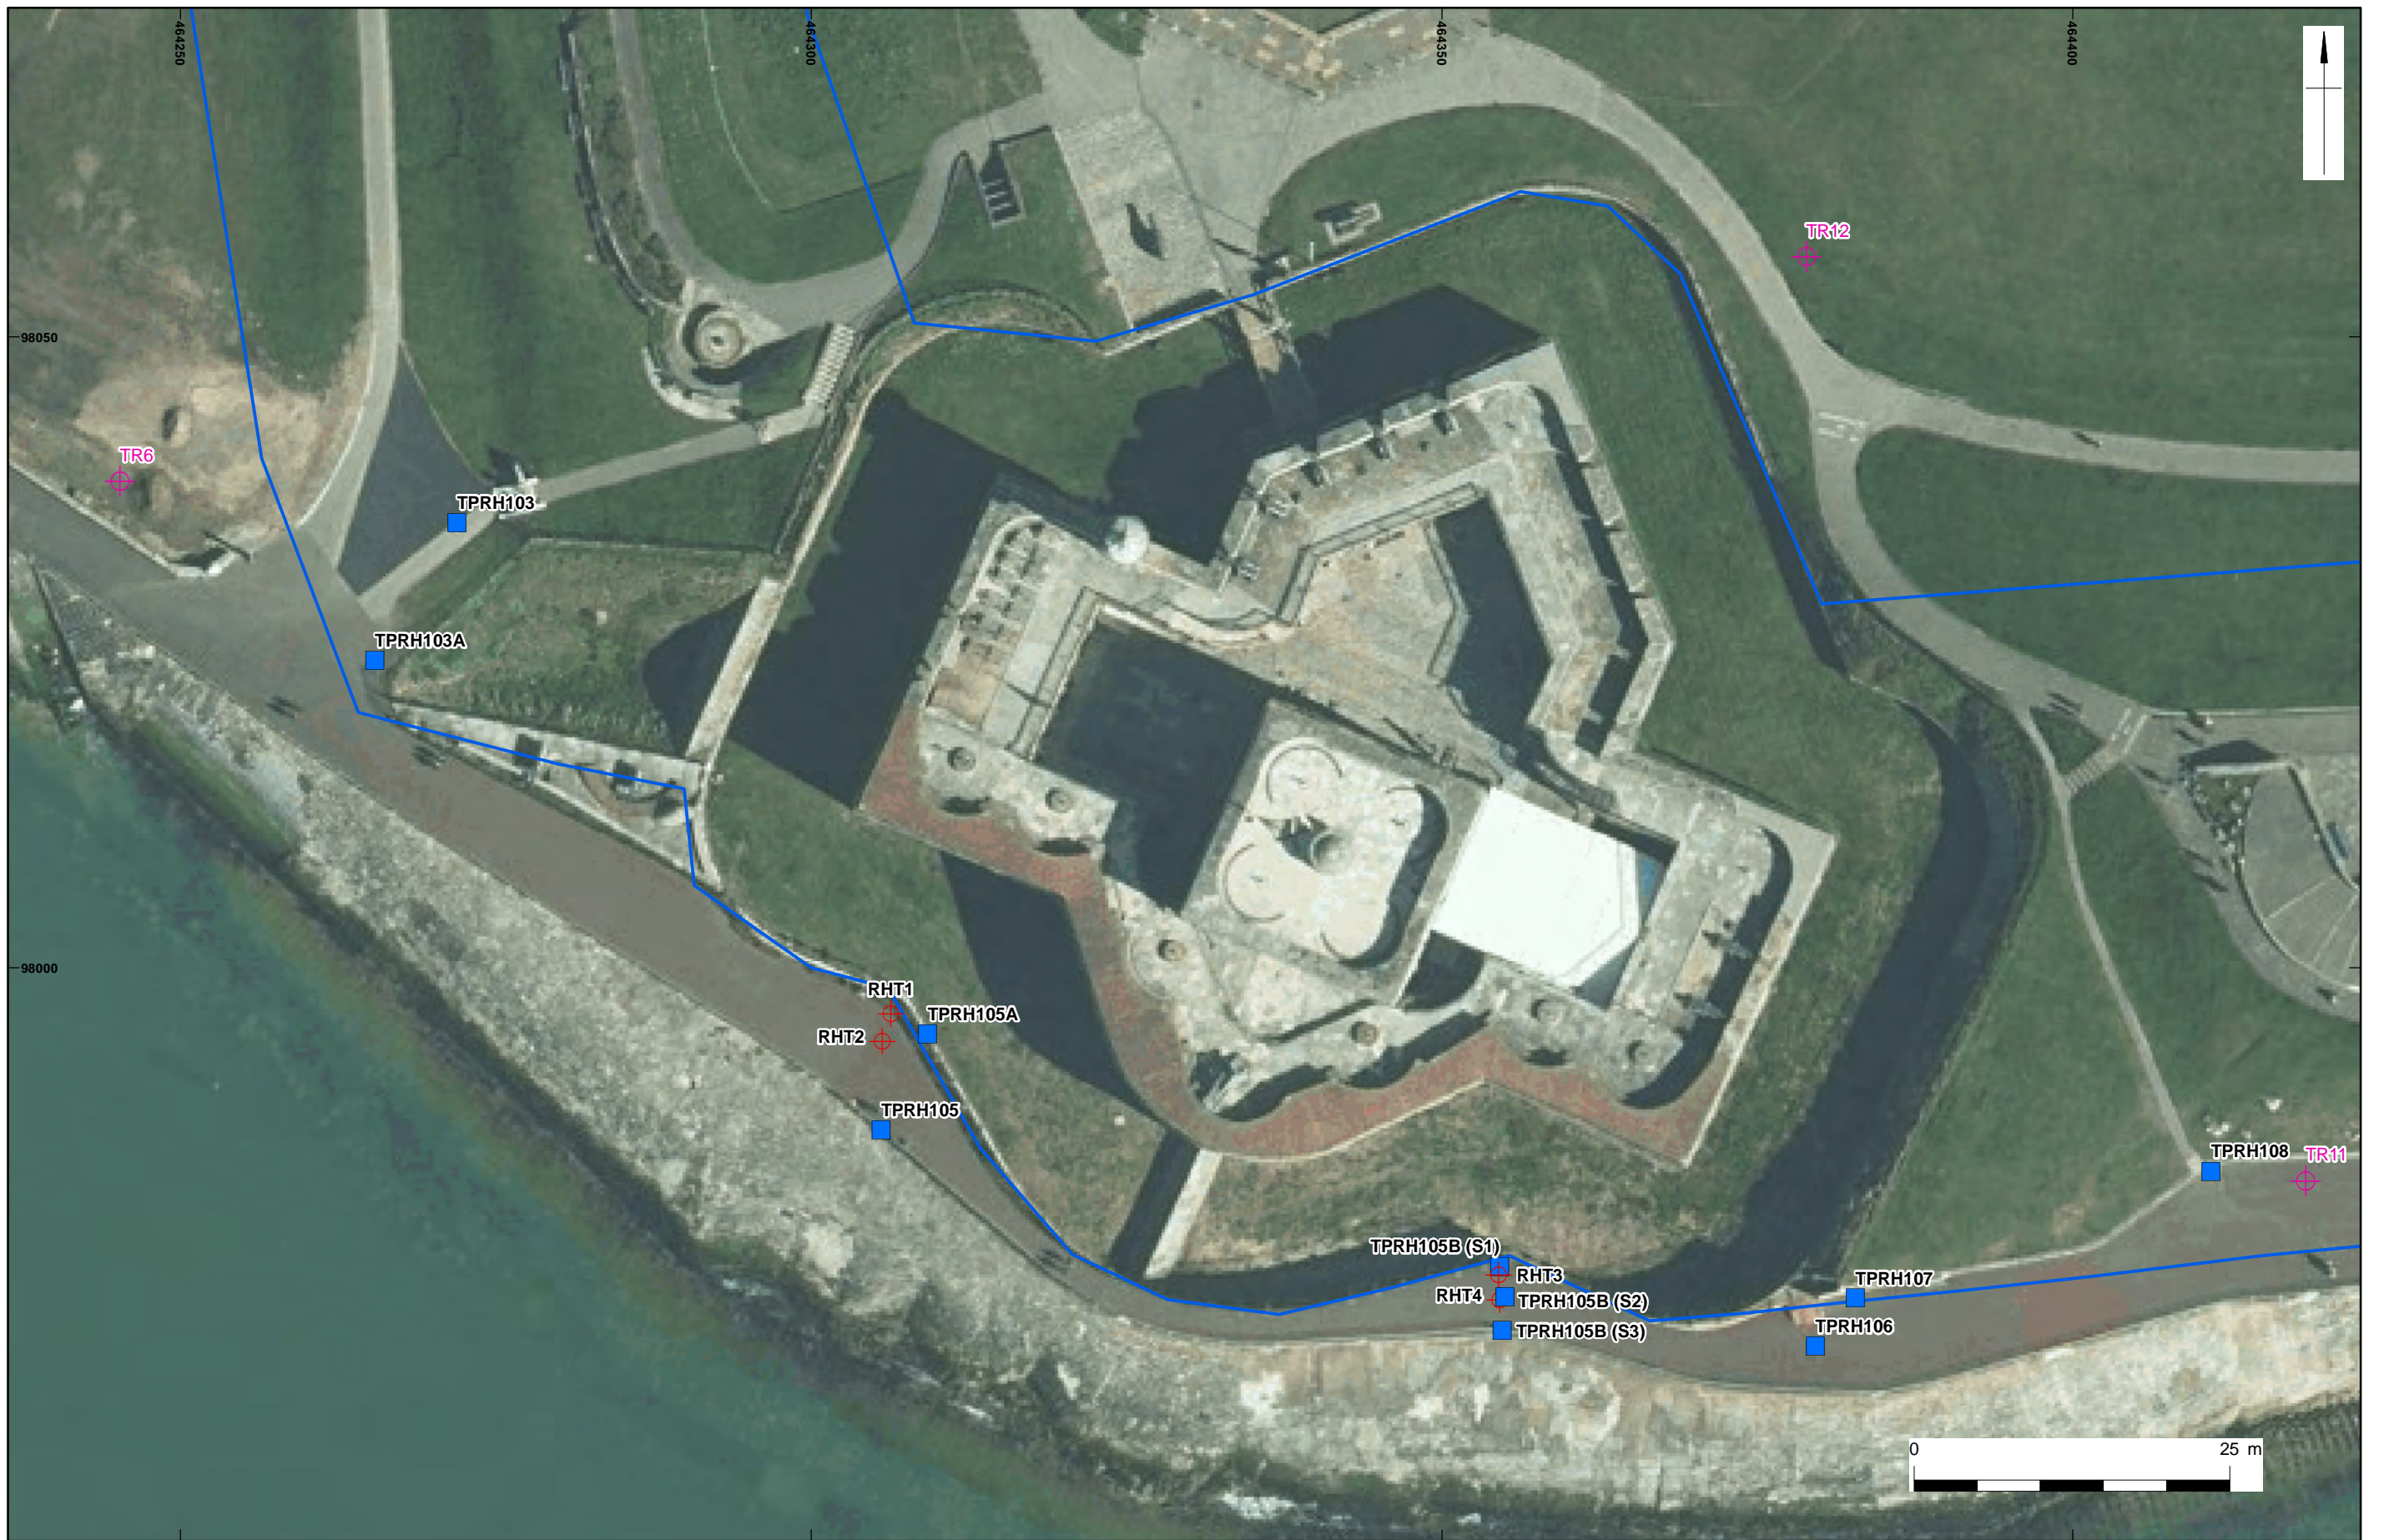
Figure 3

- 5.3.1 Trial pits TPRH103A, TPRH105, TPRH105A, TPRH105B, TPRH106 and TPRH107 were all situated within the promenade seaward of the castle, with TPRH105, TPRH105A, TPRH105B, TPRH106 and TPRH107 in the area above the counterscarp tunnels (**Figure 3**).

Investigations in the vicinity of the castle

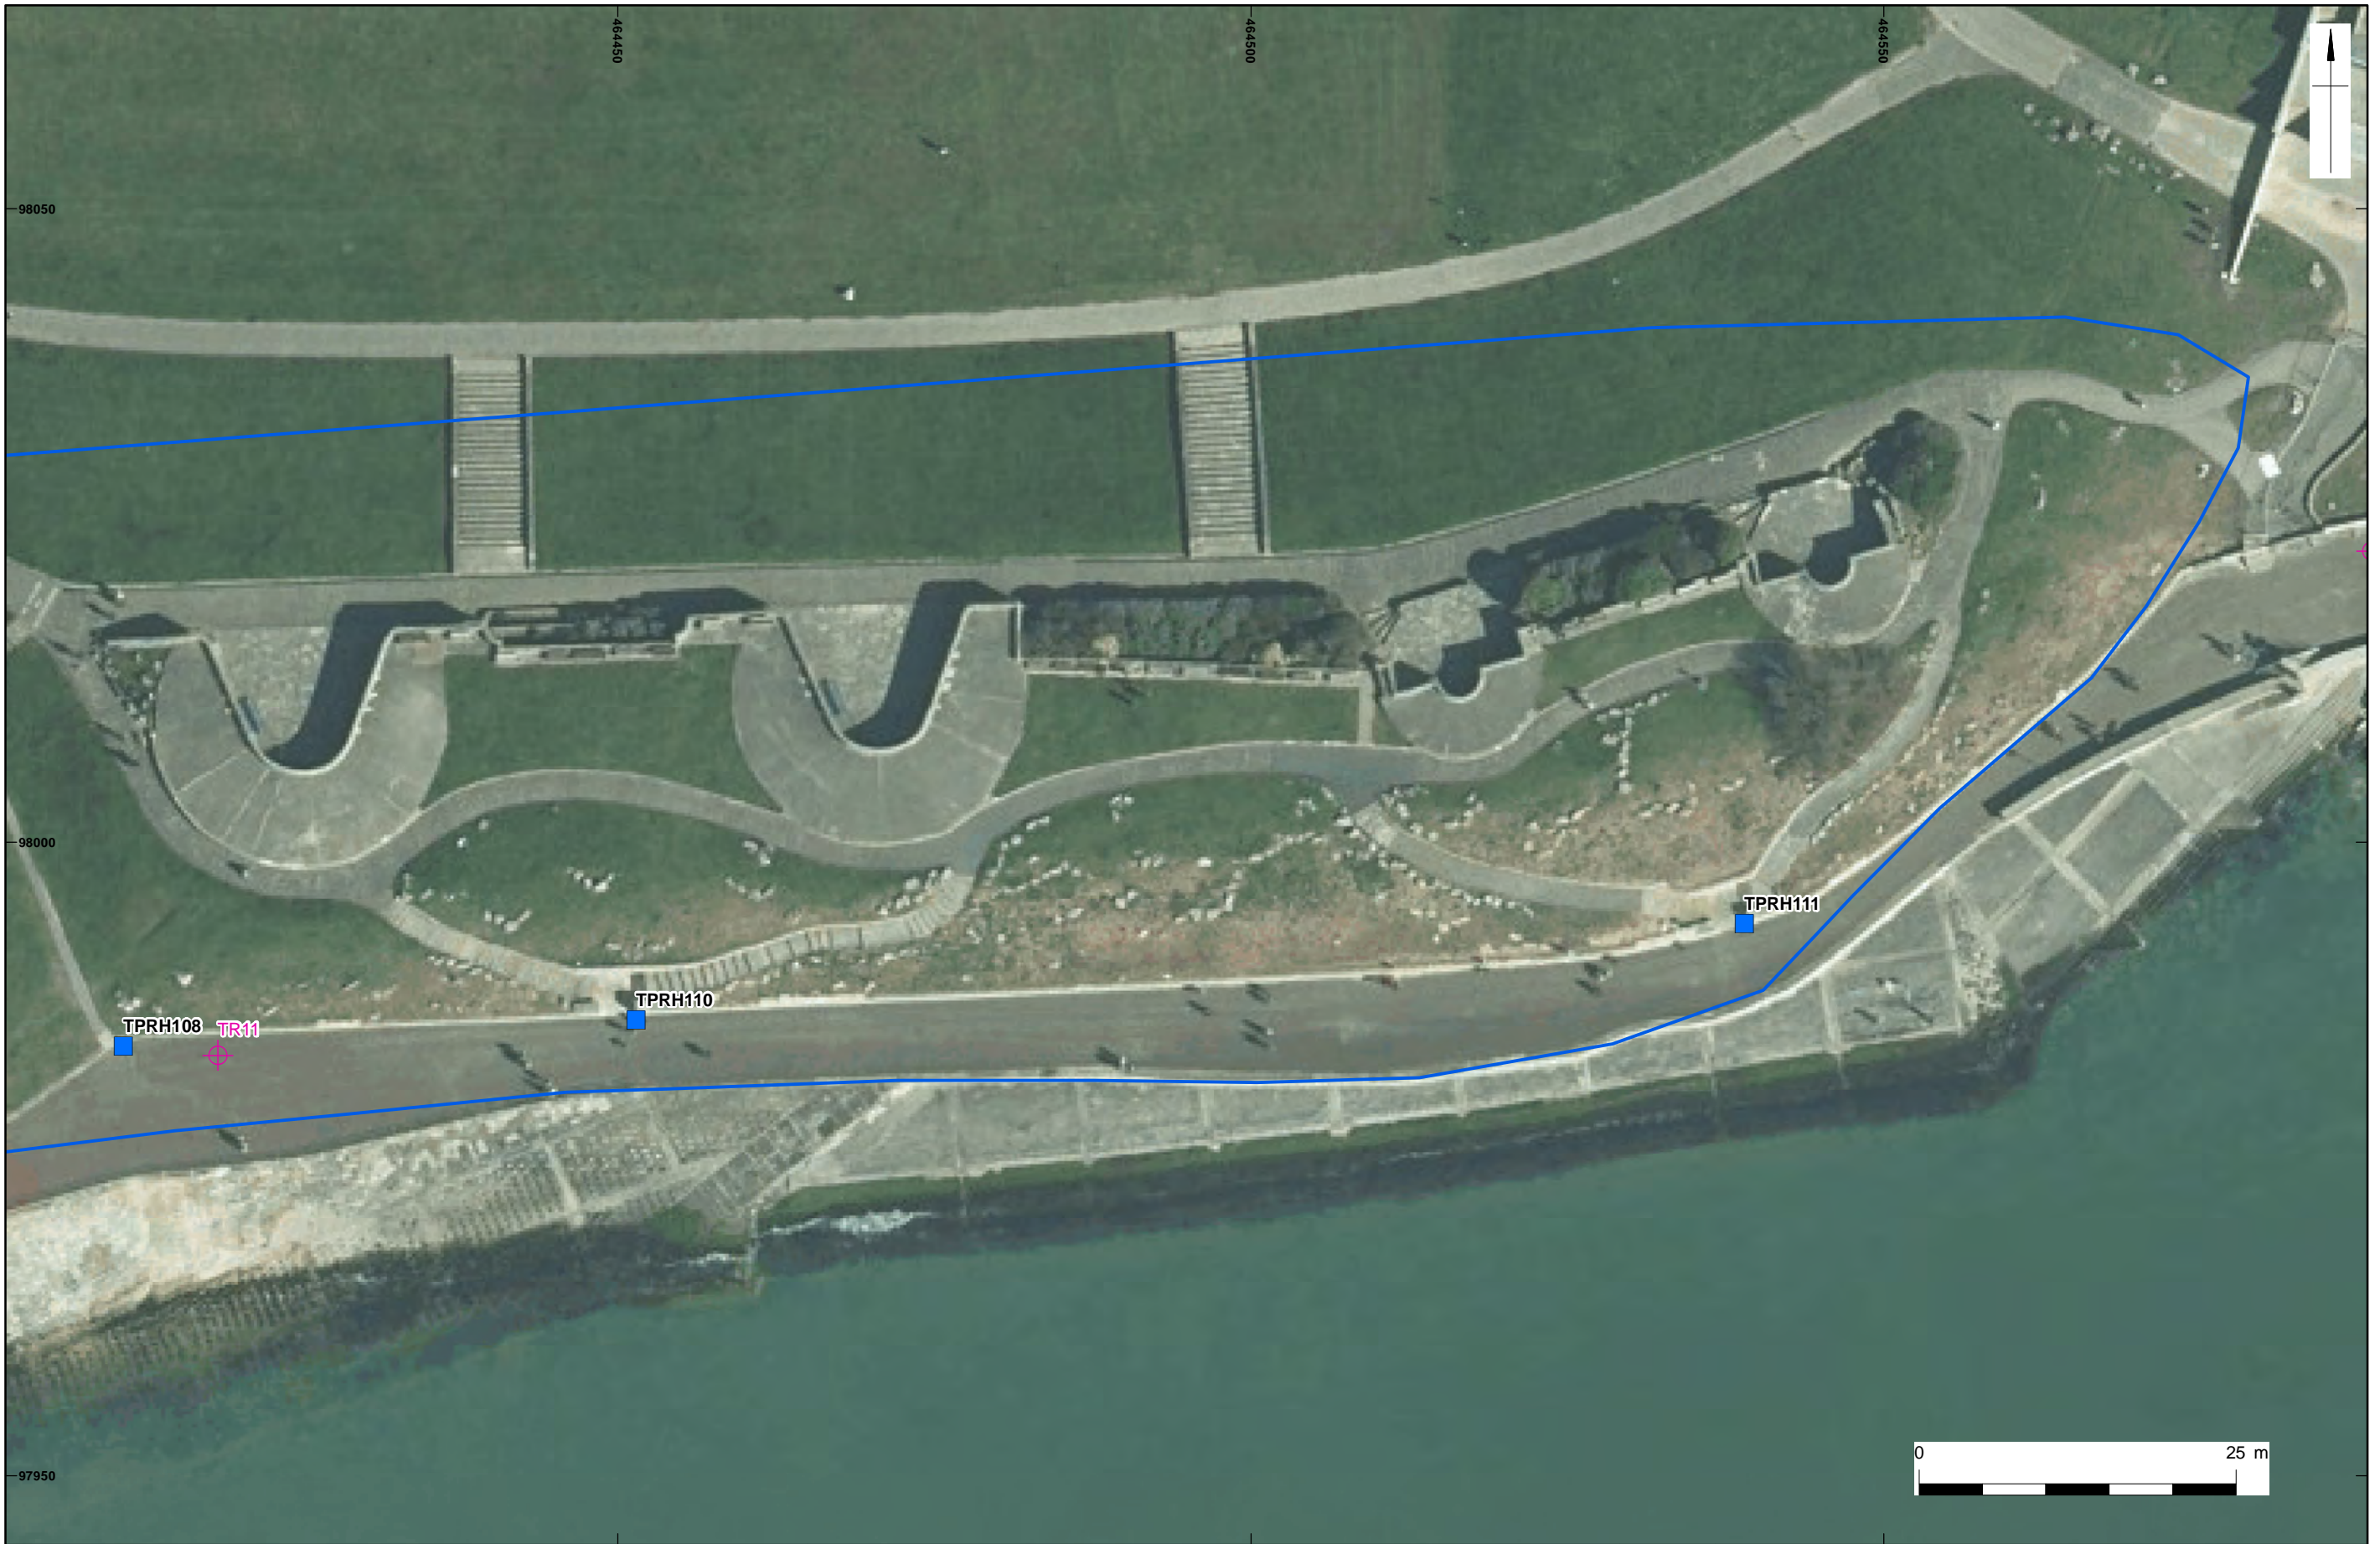
Figure 4

- 5.4.1 Trial pits TPRH108, TPRH110 and TPRH111 were all situated seaward of the Eastern Battery adjacent to the wall at the edge of the promenade (**Figure 4; Plates 17-20**).
- 5.4.2 Beneath the surfacing of the tarmac and the concrete foundation of the wall, a silty sandy clay gravel was encountered which appeared to be predominantly redeposited storm beach deposits, however inclusion of brick and concrete within this confirmed it as modern made ground. The full depth of this deposit was not confirmed within the confines of these investigations but extended to at least 0.80 m below current ground level. A previous borehole within this area (Trench 11/ BHRH08) located made ground to a depth of 1.00 m below ground level overlying storm beach deposits and the sands and clays of the underlying bedrock.

Investigations adjacent to the Eastern Battery

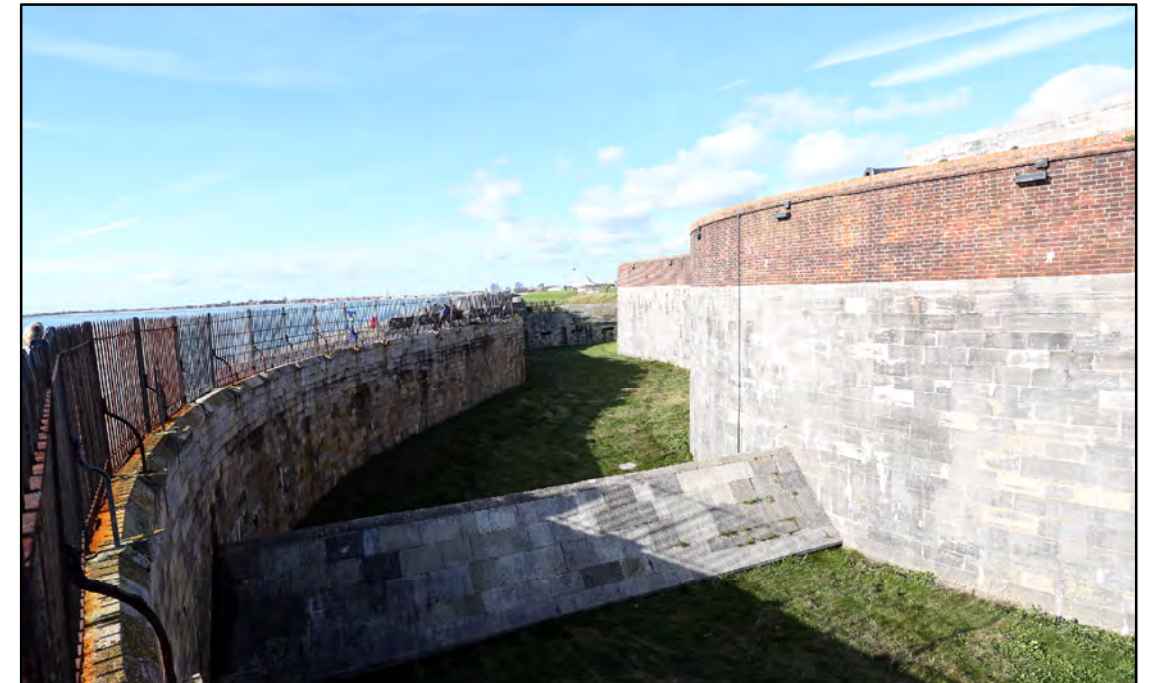
The moat, counterscarp gallery and caponier

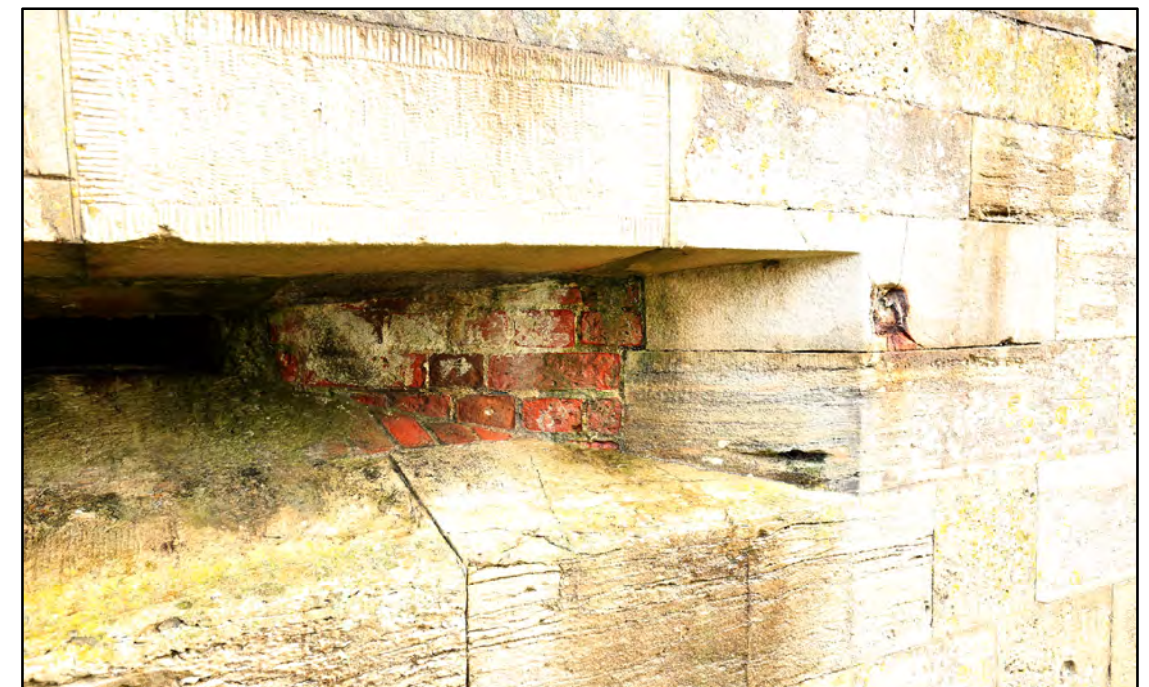
Gun embrasure within wall of counterscarp tunnel showing brick and stone construction

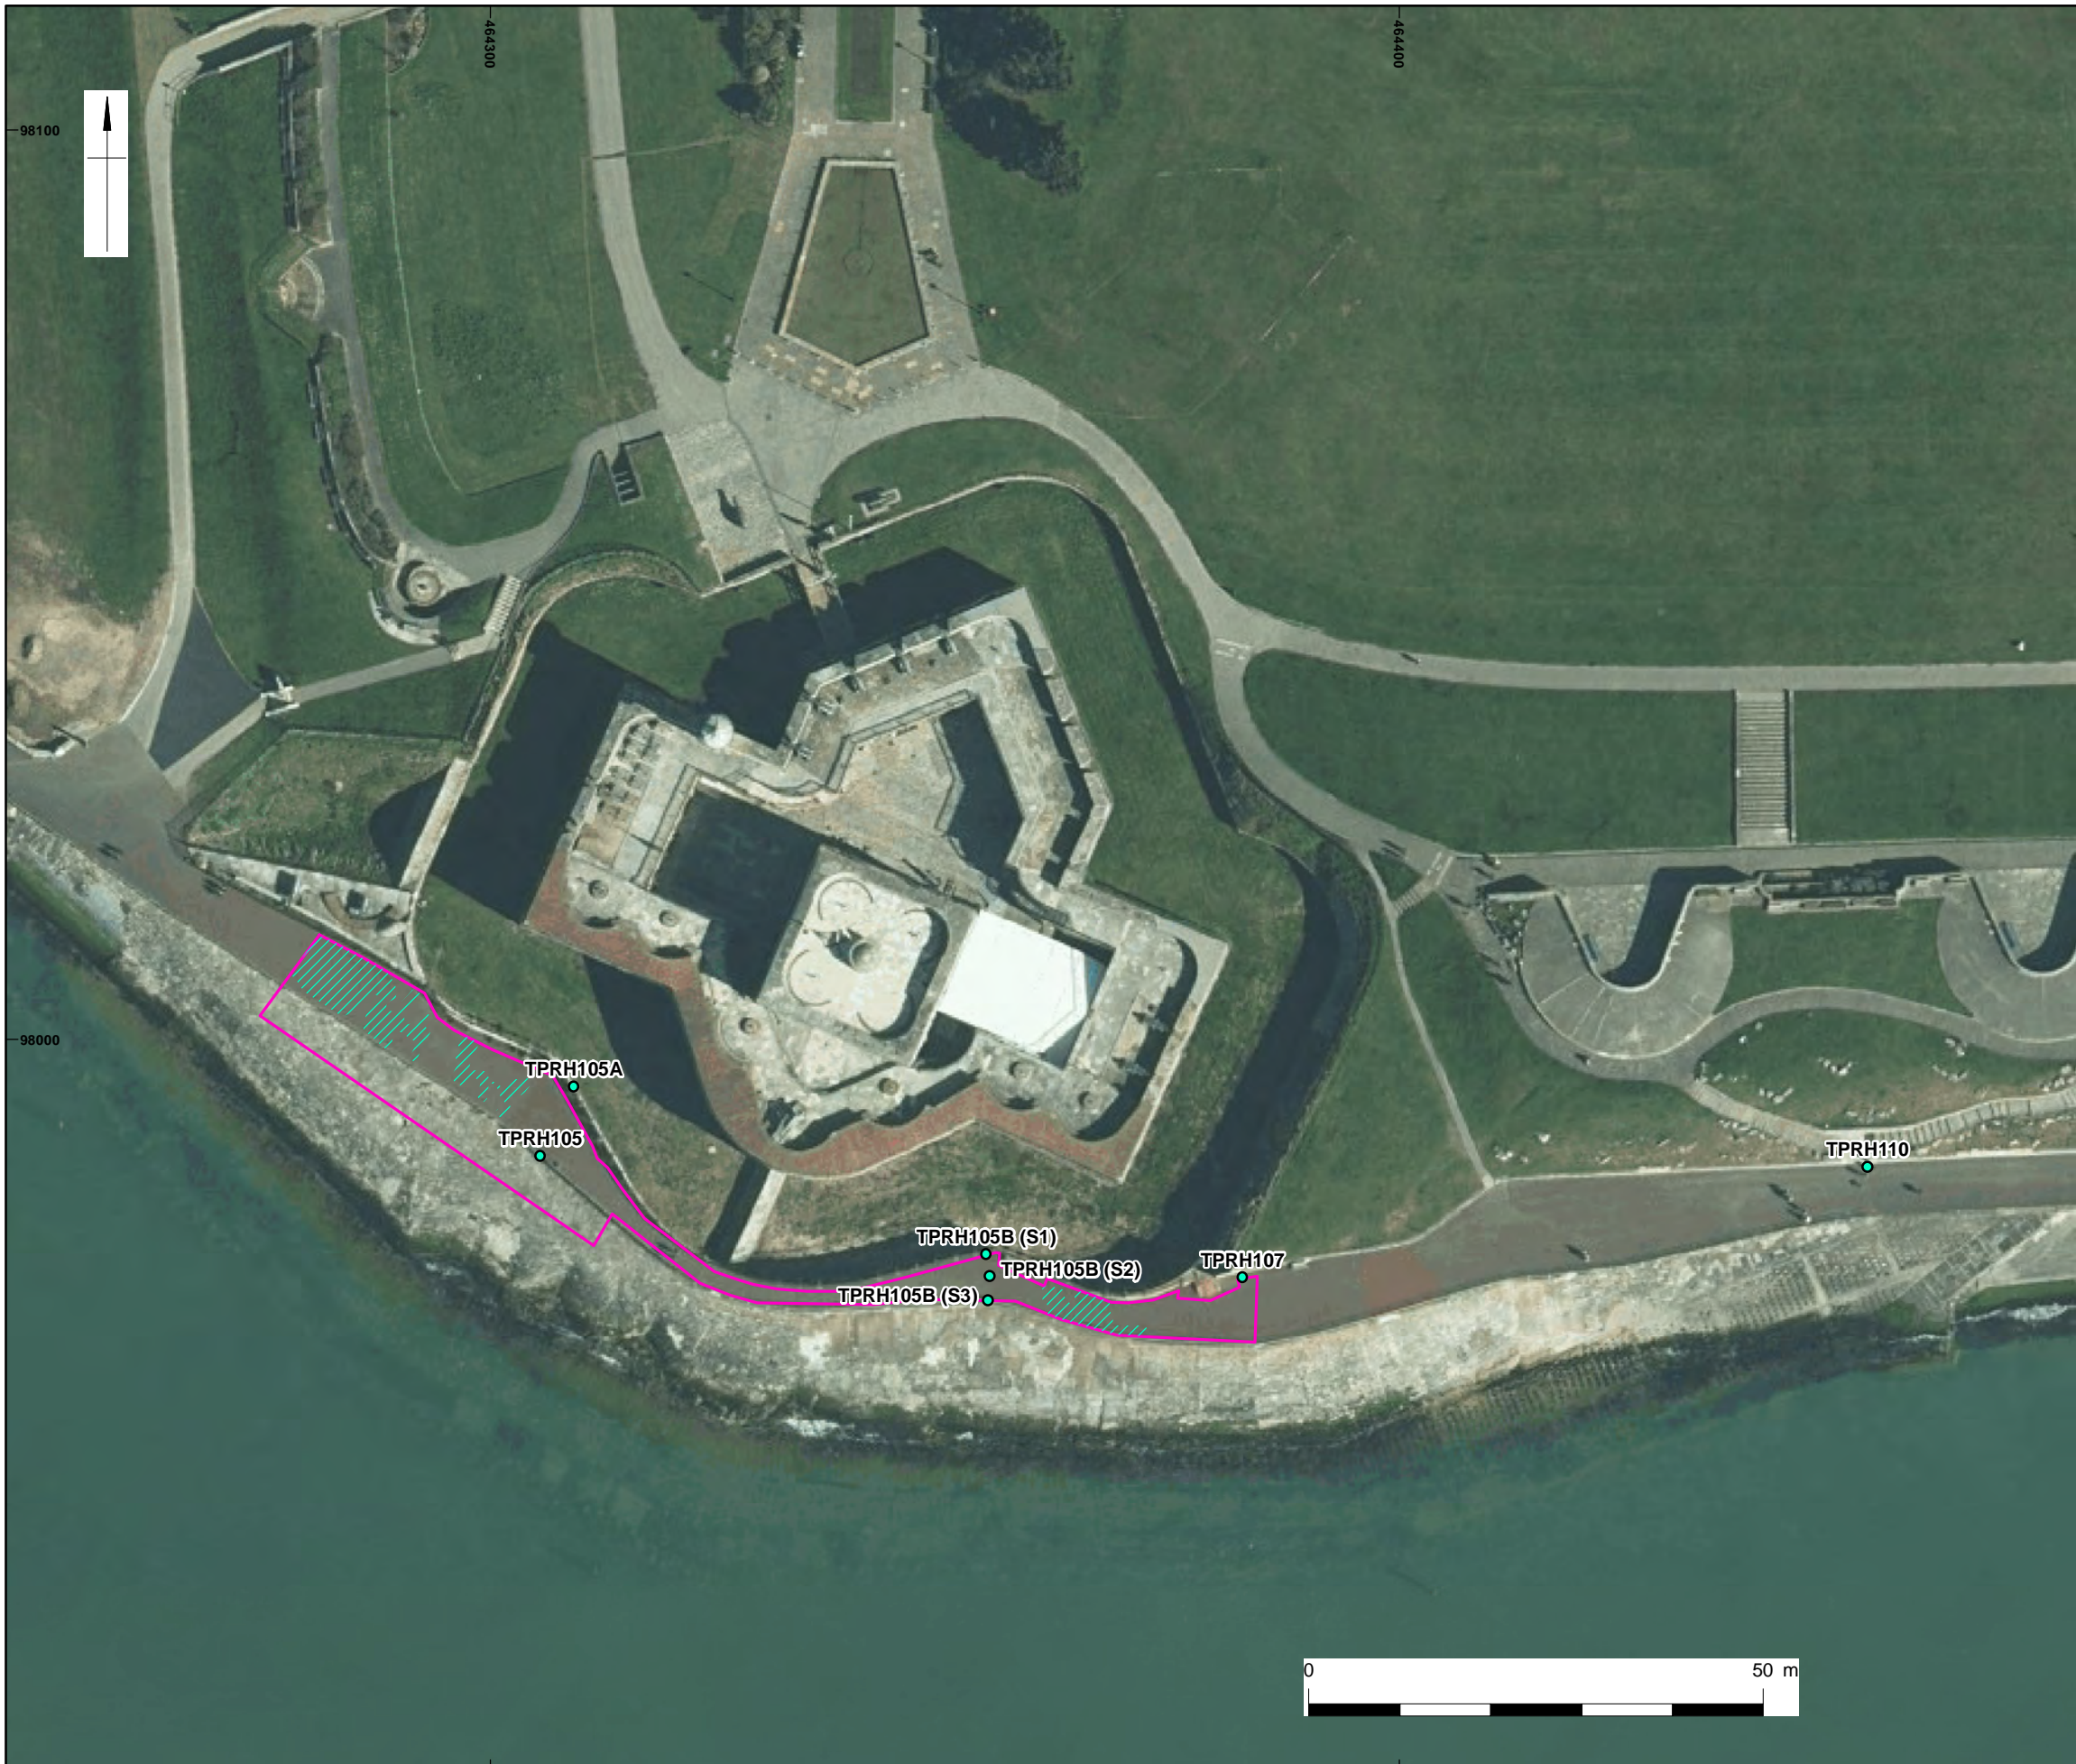
Figure 7

- GPR survey area
- Extent of promenade\*
- Evidence for the former promenade located

Extent of the former promenade surface as identified by the investigations

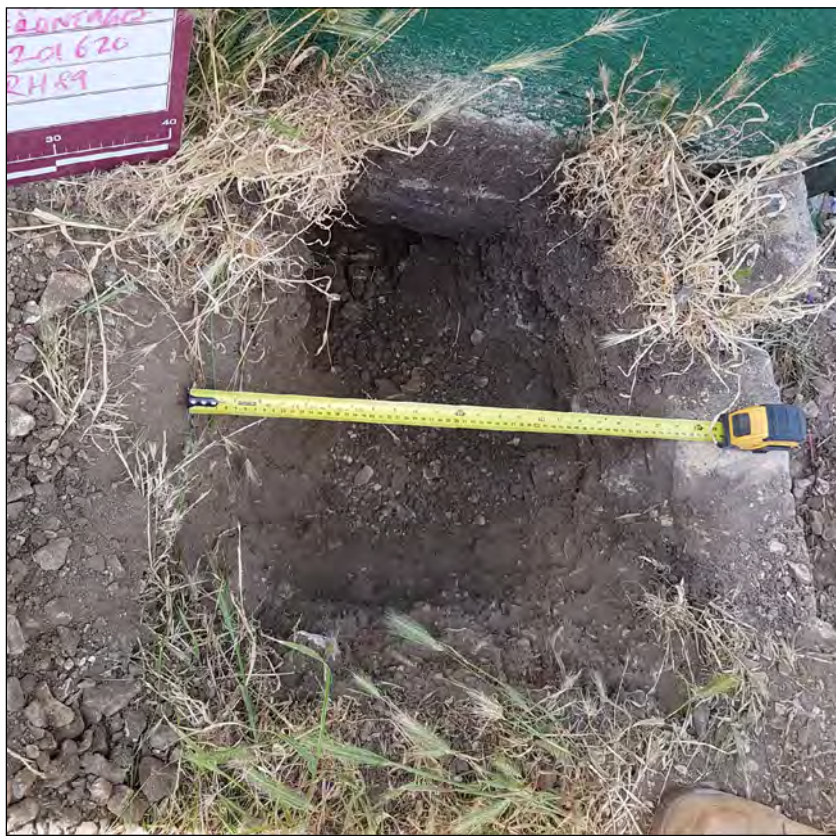
Plate 1) TPRH89, view from the east

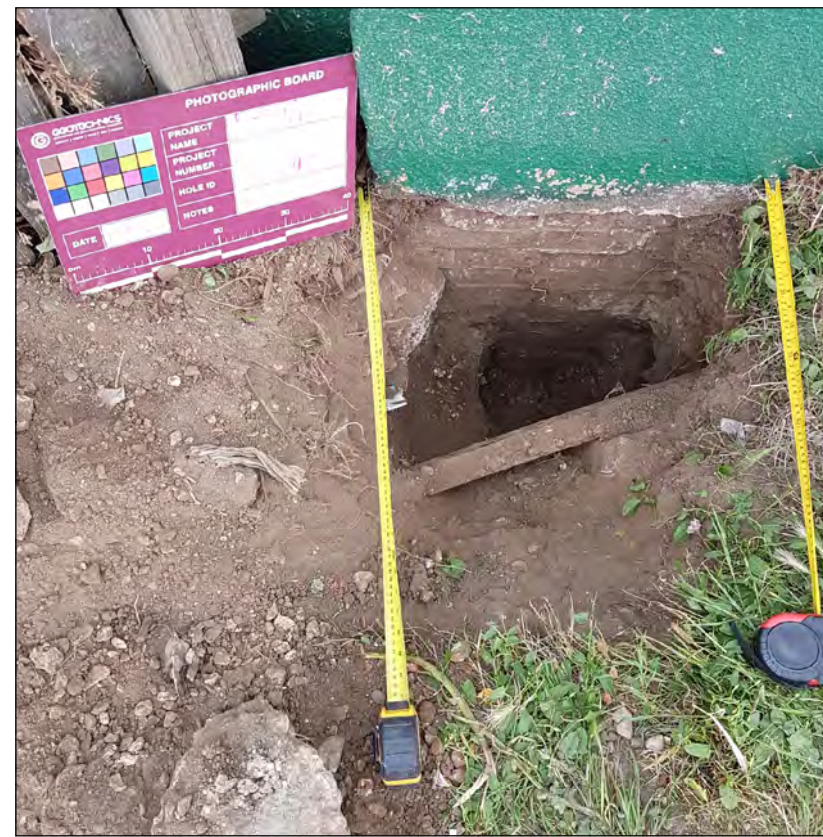
was present in TPRH095. Only in the deepest of these trial holes, TPRH092, was the underlying storm beach deposits uncovered at 0.95 m below the current ground level.

Plate 2) TPRH92, view from the east
