# Southsea Castle Portsea Island, Hampshire

GI Works Archaeological Watching Brief

Document Ref.: 118666.03  
March 2021

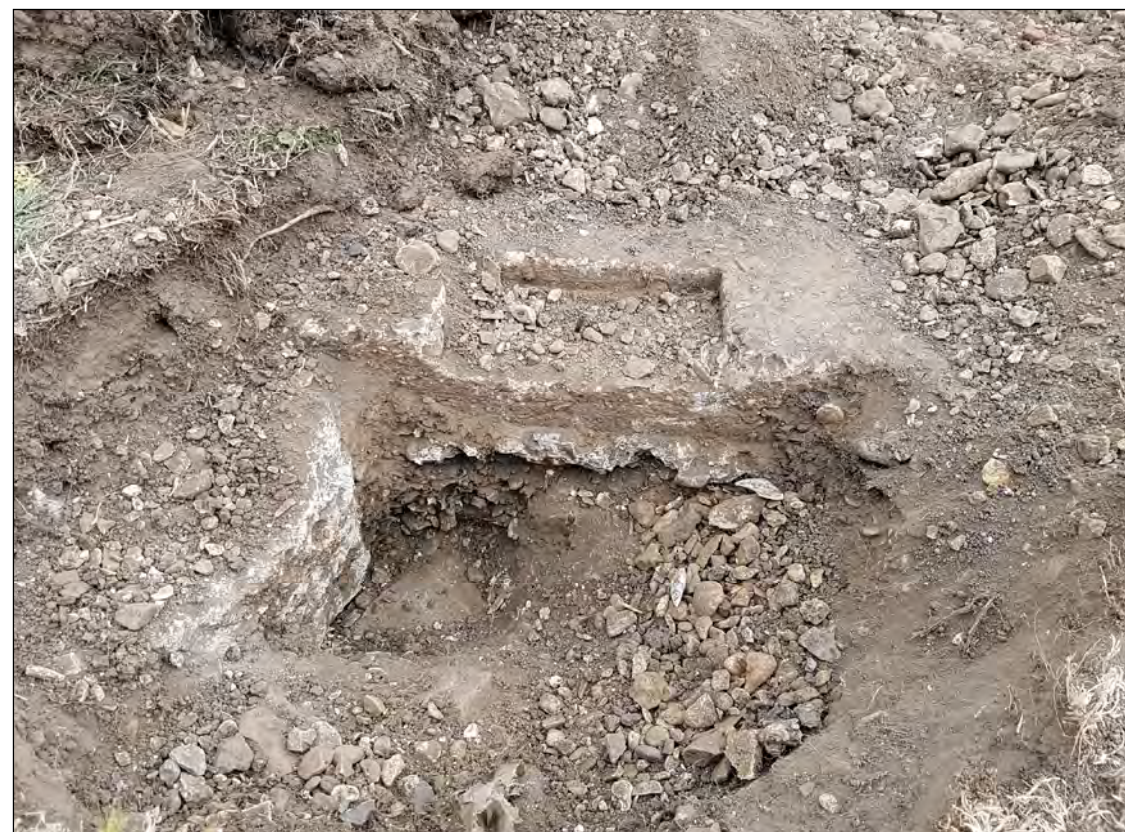
- 5.2.1 Trial pits TPRH89, TPRH92, TPRH95 (**Figure 2**) and TPRH103 (**Figure 3**) were all situated within the area of the Western Battery. While they had the potential to provide further information on this late 19th century structure and later landscaping works, they were all located either off or on the outskirts of the main earthworks. These trial pits were targeted on specific structures to inform the detailed design of the secondary defence retaining wall.
- 5.2.2 In general, around 0.15 m of topsoil was found to overlie up to 0.80 m of modern made ground which included fragments of brick and concrete (**Plates 1-4**). No substantive topsoil

Plate 3) TPRH95, view from the south-west

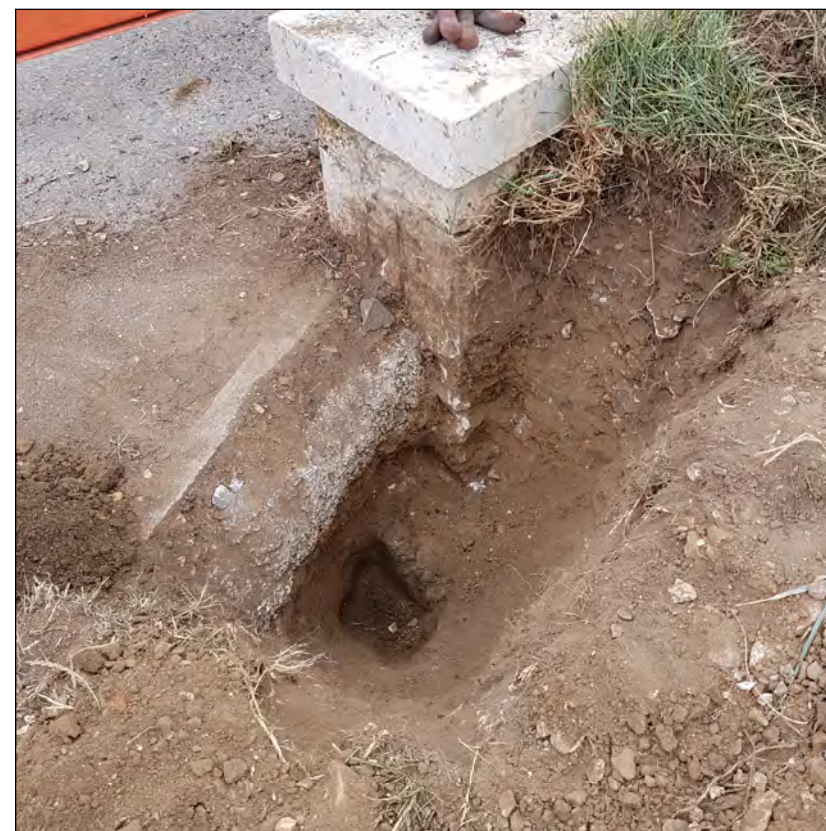
Plate 4) TPRH103, view from the south

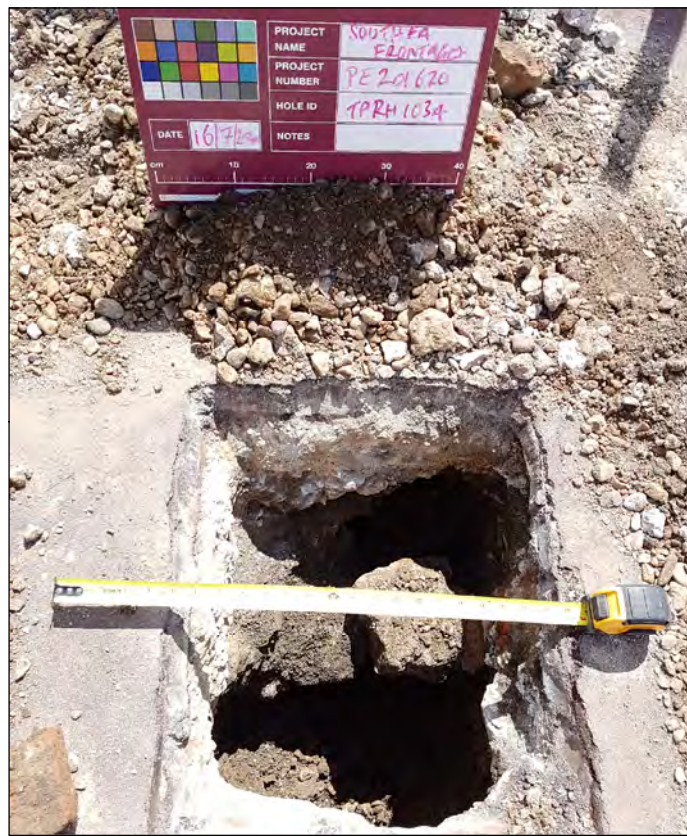
- 5.3.2 TPRH103A encountered modern made ground to a depth of 0.65 m, thought to be levelling material associated with the construction of the modern-day promenade (**Plate 5**). A sandy gravel beneath this had the characteristics of redeposited storm beach deposits. This was not extensively excavated, and the date is unclear but on balance with what is known from previous investigations a modern date seems likely. Trench 6/ BHRH07 which was situated some 25 m to the north-west, located up to 1.90 m of made ground though to be associated with the present sea defences (Wessex Archaeology 2020c).

Plate 5) TPRH103A, view from the north-west

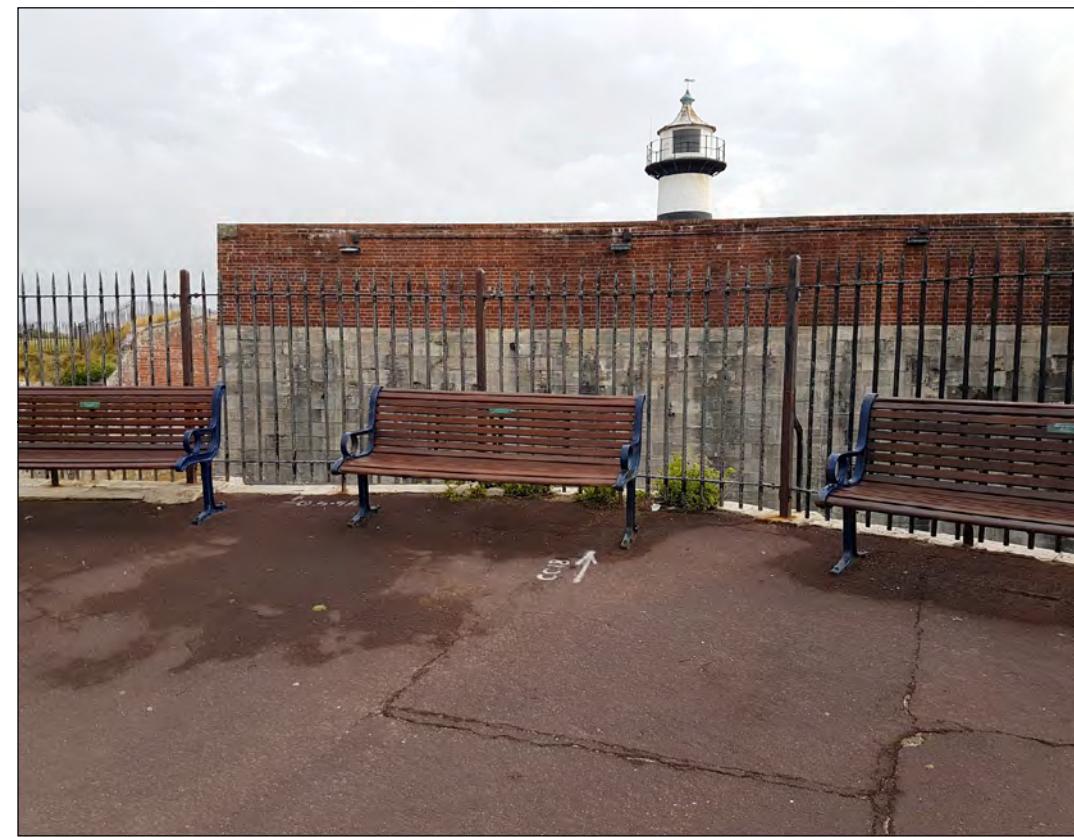
- 5.3.4 TPRH105A was located immediately south-west of the railings at the moat edge on the southwestern side of the castle (**Plate 6**). Beneath modern tarmac and concrete at the northern end, an area of brickwork was exposed bedded into mortar (**Plate 7**). While the visible brickwork only extended 0.70 m southwards into the trench the mortar surface continued to 2.10 m and imprints of slabs or cobbles could be seen within the surface. At 2.10 m the surface terminated with a line of facing stones which extended down to a depth of at least 0.50 m below the current ground surface (**Plate 8**). The limestone cobbles abutting this were considered to form part of the former promenade. This surface did not extend to the end of the trench, here redeposited storm beach deposits were located directly below the modern concrete.

Plate 6) Location of TPRH105A

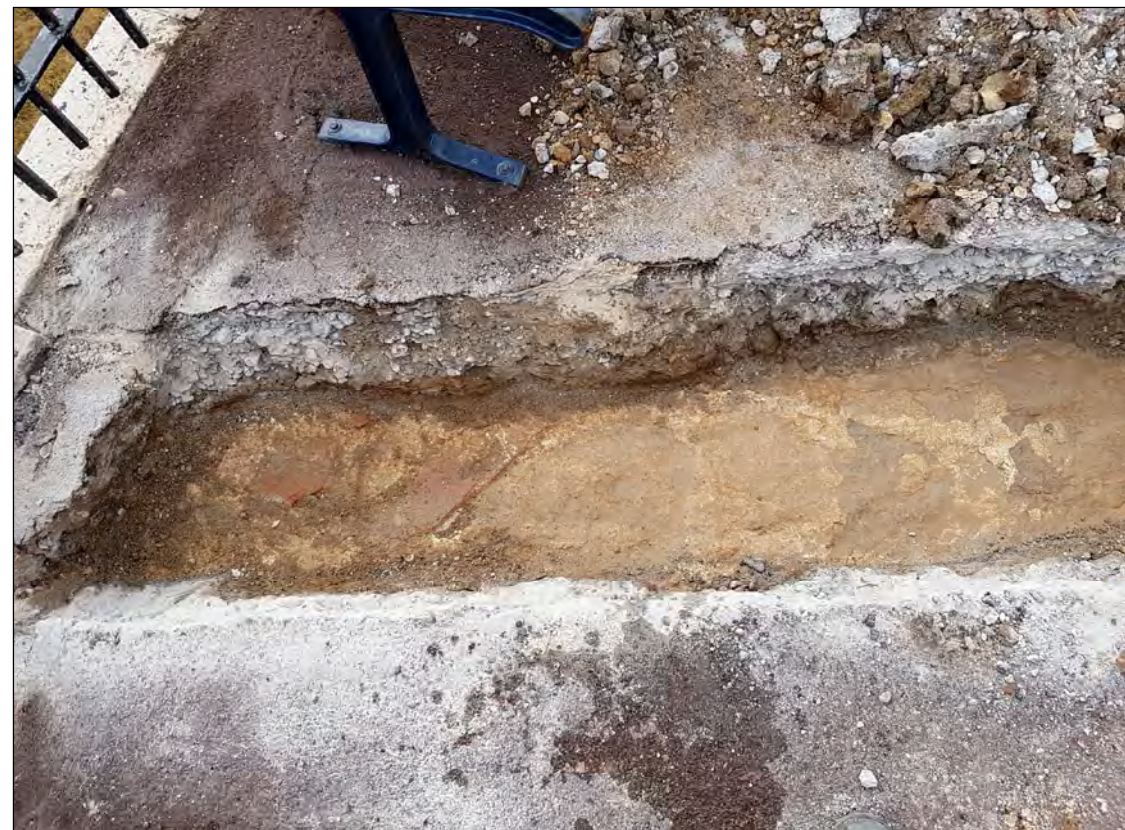
Plate 7) Northeastern end of TPRH105A, mortar surface

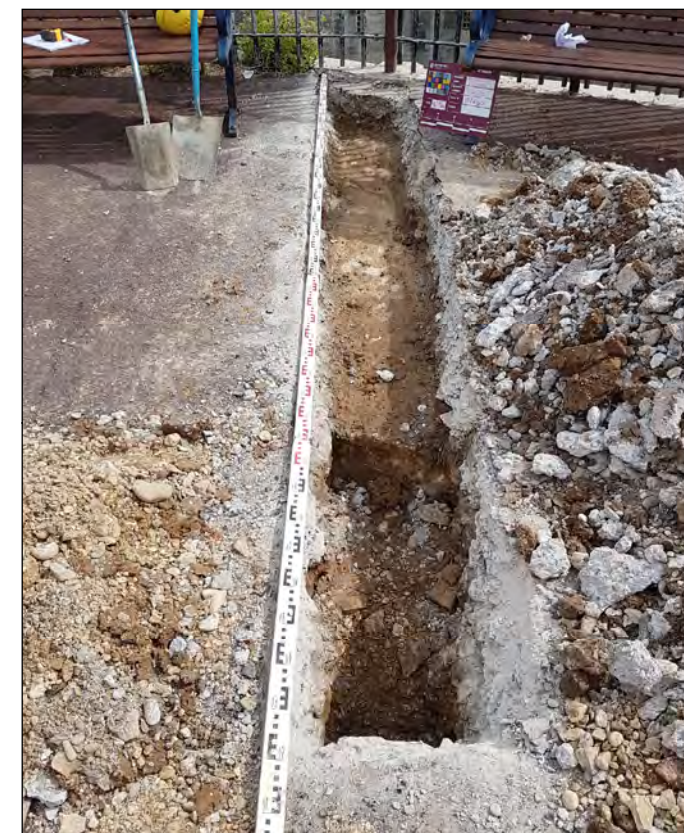
Plate 8) TPRH105A, view from the south-west

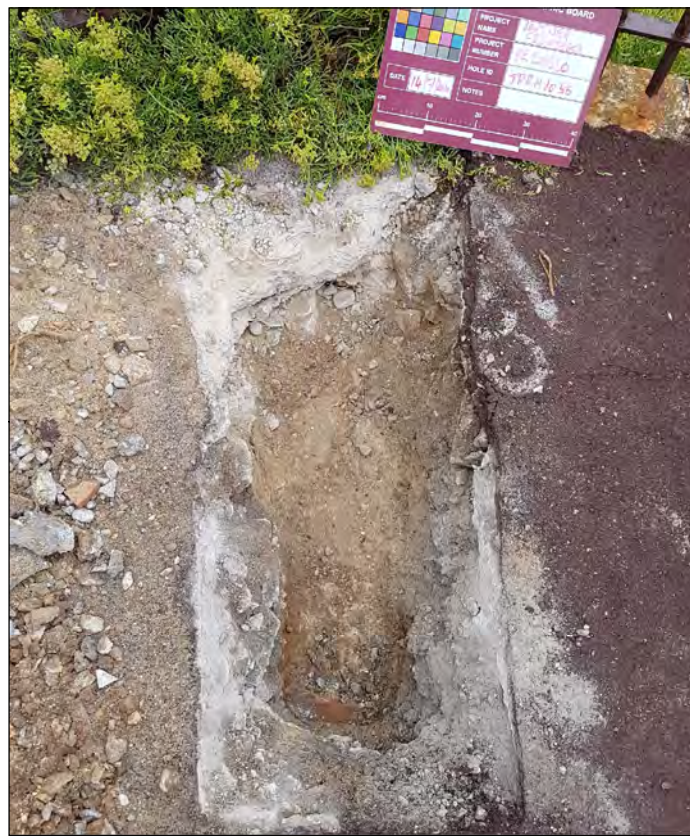
- 5.3.5 TPRH105B was located immediately south of the railings at the moat edge on the south-eastern side of the castle (**Plates 9-12**). Section 1 extended 1.05 m from the railings, after an interval of 0.95 m Section 2 was excavated as a separate test pit, after a further interval of 2 m another test pit Section 3 was excavated which gave a complete cross-section of the upper deposits across the promenade. Substantial structural deposits were left *in situ*.

- 5.3.6 Remnants of the 19th-century promenade were located in all three of the sections at a depth of 0.25 m below the current ground level. In Section 1 a mortar surface, which may be similar to that seen in TPRH105A was located across the majority of the trench (**Plate 9**). Red bricks or tiles were also uncovered in the south-west corner and again seen in the north-east corner of Section 2 (**Plate 10**). A gravely sand appeared to lie beneath or abut this in Section 2. Section 3 was terminated at the depth of the cobbled surface, though here it was patchy and disturbed (**Plate 11**).

Plate 9) TPRH105B (Section 1), view from the south

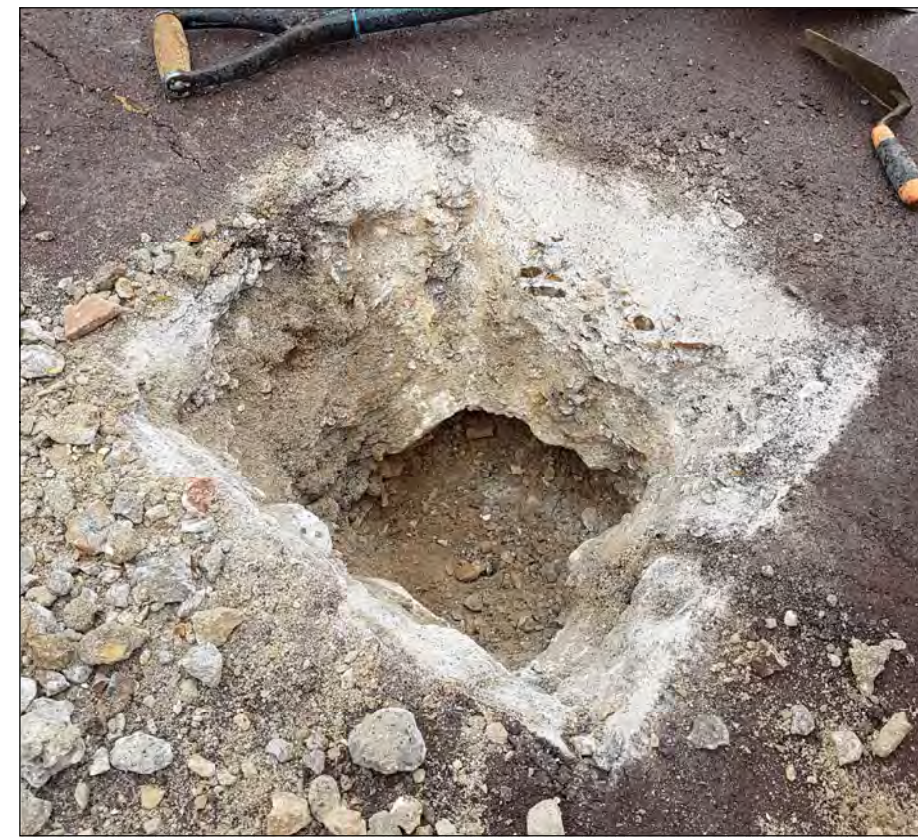
Plate 10) TPRH105B (Section 2), view from the south-west

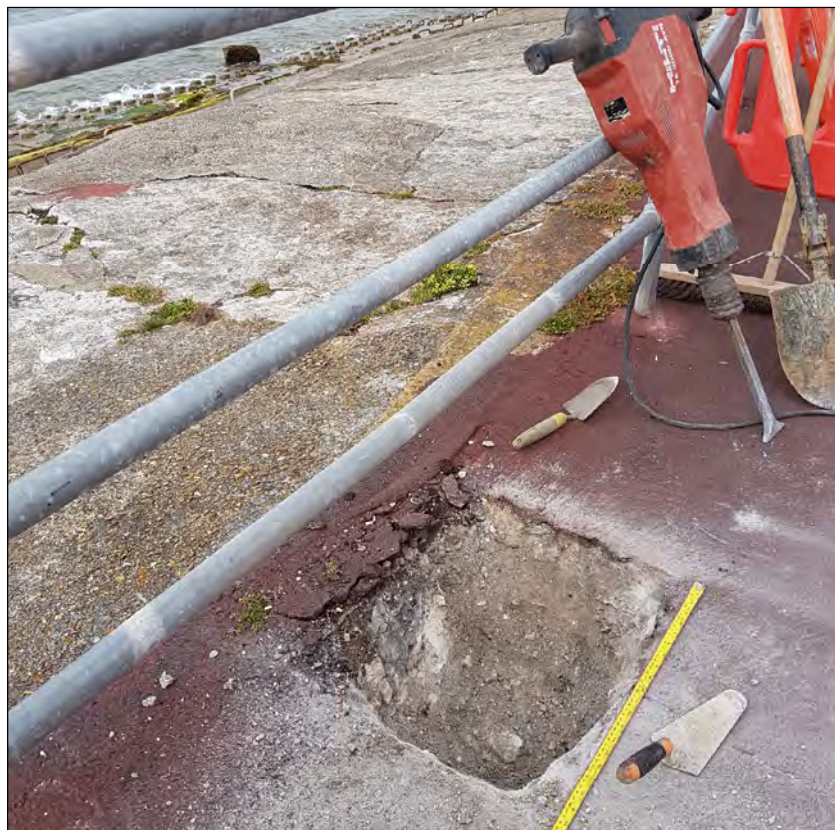
Plate 11) TPRH105B (Section 3), view from the north-east

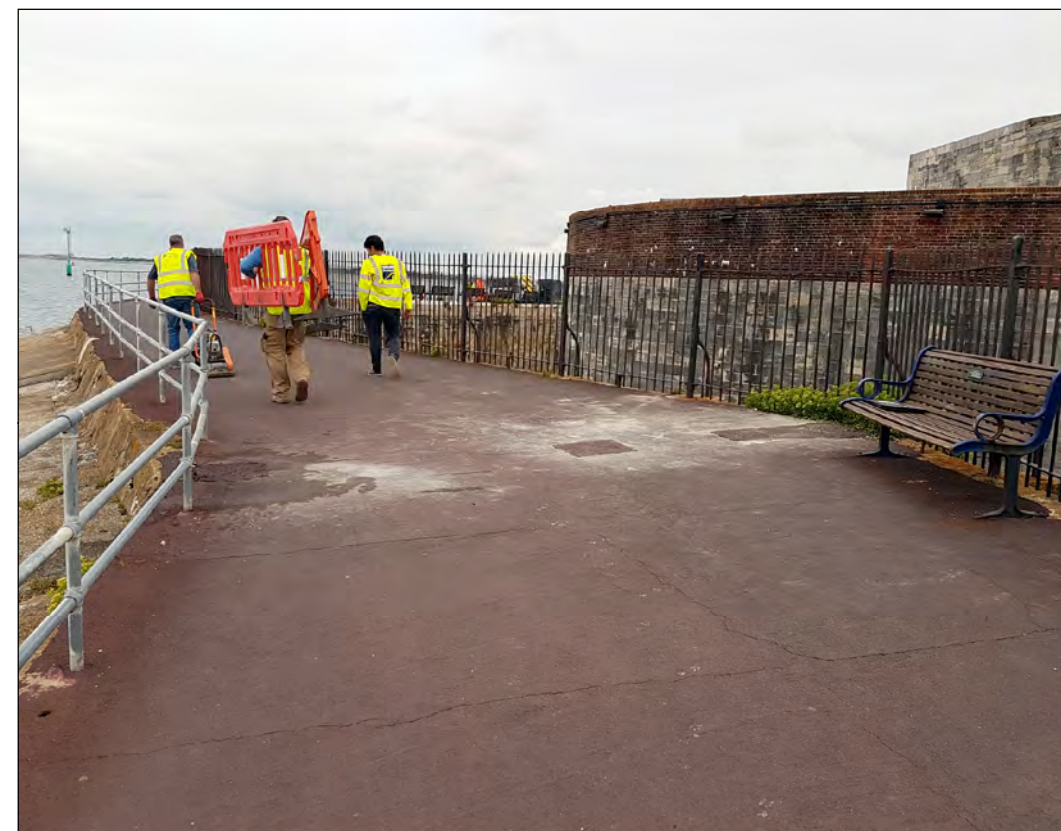
Plate 12) Locations of the separate sections of TP105B after reinstatement

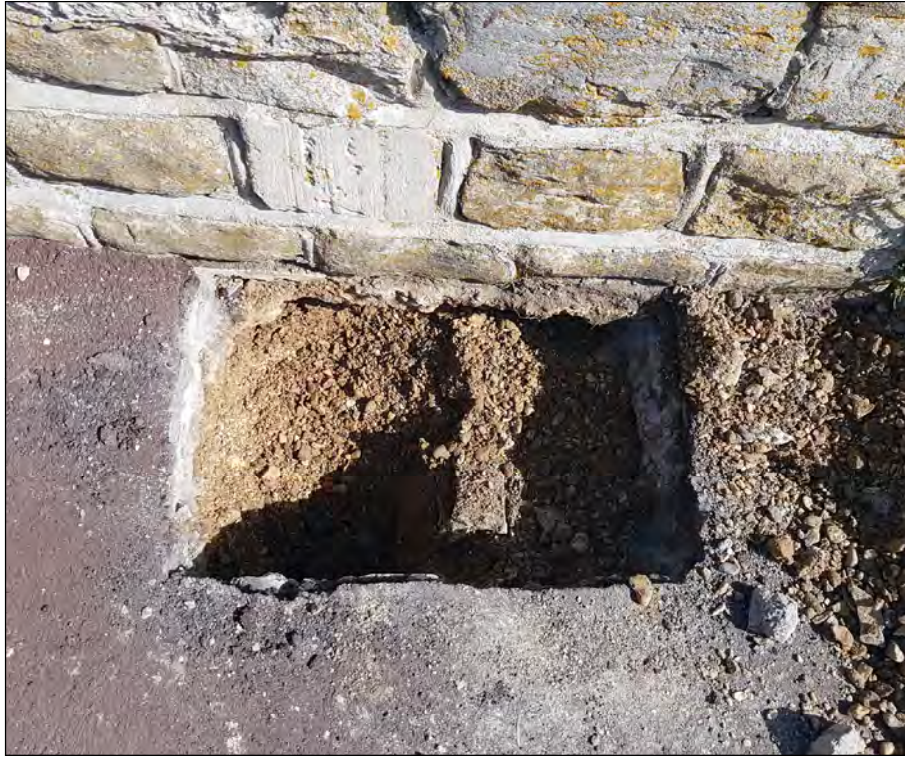
- 5.3.7 While an intact surface was not identified within TPRH107, to the south-east of the castle, occasional limestone cobbles were located at a similar depth to the more intact areas of surfacing seen in the other trial pits (**Plate 13**).

Plate 13) TPRH107, view from the south

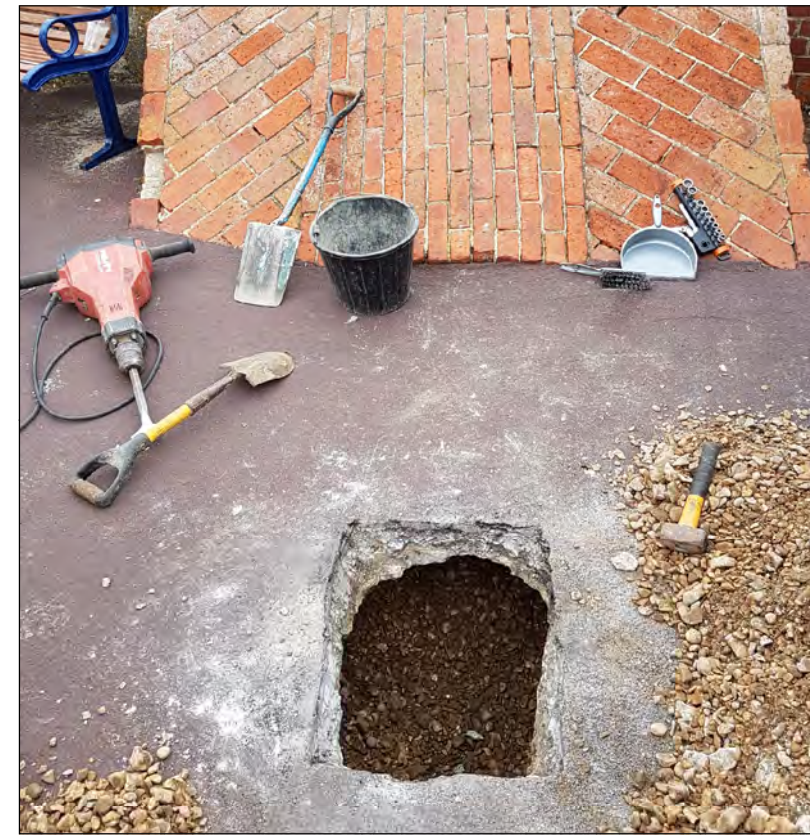
<b>TPRH106</b>			
Easting 464380		Northing 97970	6.08m OD
Length 0.55m		Width 0.45m	Depth 0.75m
Depth from (m)	Depth to (m)	Description	Interpretation
0.00	0.02	Tarmac	Made ground
0.02	0.20	Concrete	
0.20	0.75	Very loose sandy gravel.	Redeposited storm beach deposits
0.75	-	Sloped concrete – dipping downwards towards the sea (south). Base @0.75mbgl.	Concrete – possible top of tunnel.

Plate 14) TPRH106, view from the south-east

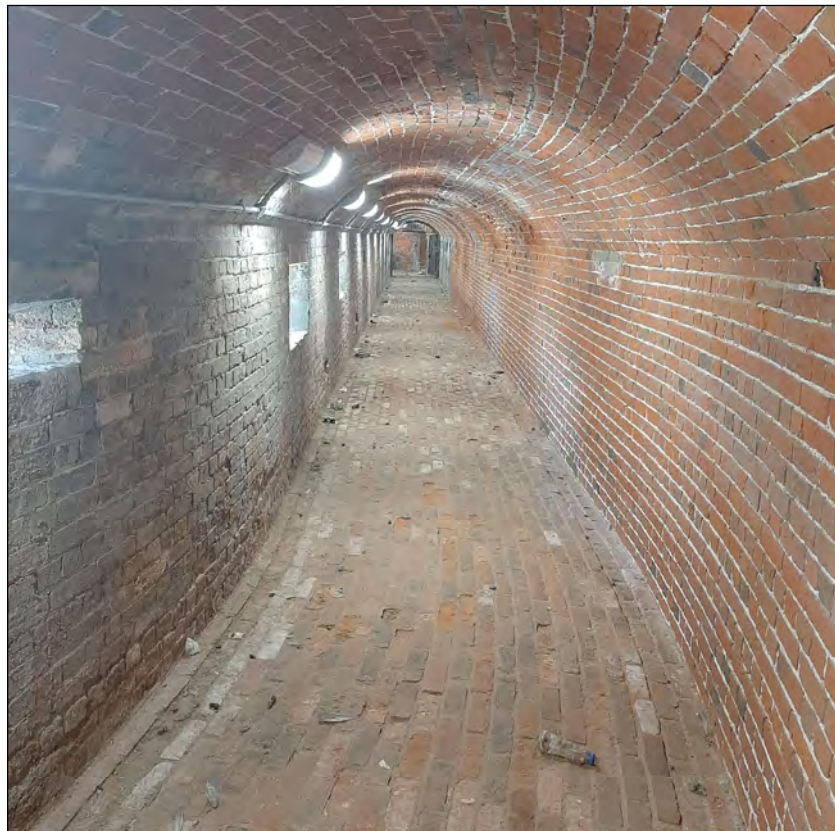
Plate 15) View within the counterscarp tunnels

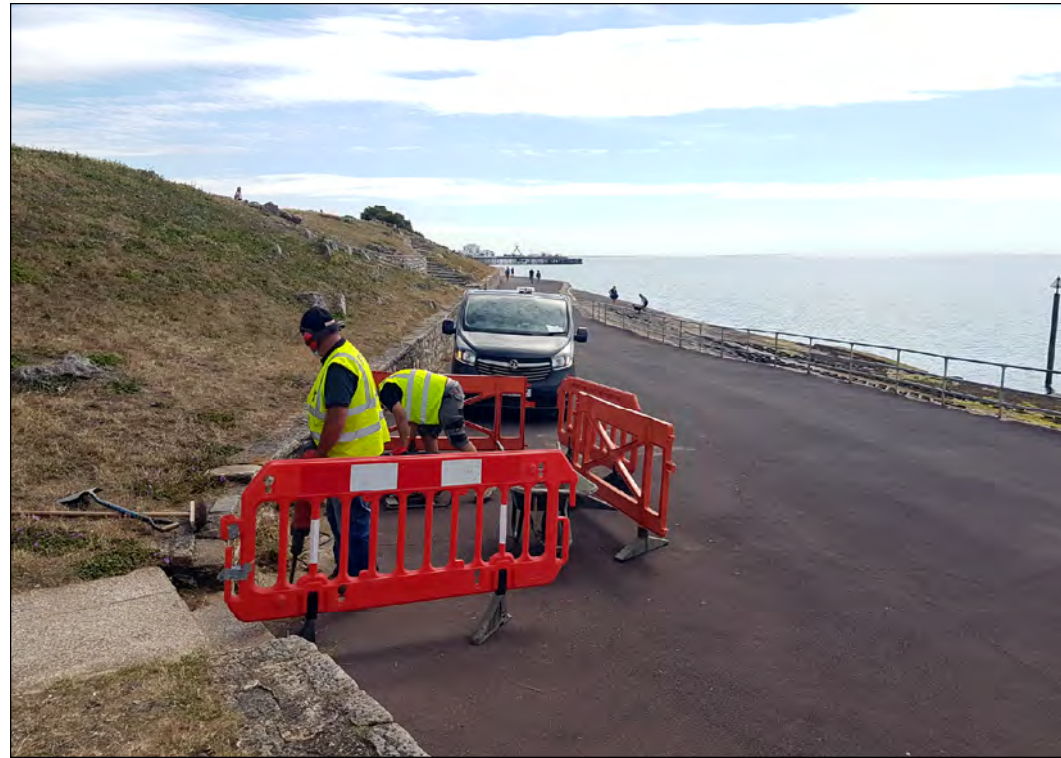
- 5.4.1 Trial pits TPRH108, TPRH110 and TPRH111 were all situated seaward of the Eastern Battery adjacent to the wall at the edge of the promenade (**Figure 4; Plates 17-20**).
- 5.4.2 Beneath the surfacing of the tarmac and the concrete foundation of the wall, a silty sandy clay gravel was encountered which appeared to be predominantly redeposited storm beach deposits, however inclusion of brick and concrete within this confirmed it as modern made ground. The full depth of this deposit was not confirmed within the confines of these investigations but extended to at least 0.80 m below current ground level. A previous borehole within this area (Trench 11/ BHRH08) located made ground to a depth of 1.00 m below ground level overlying storm beach deposits and the sands and clays of the underlying bedrock.

Plate 17) Location of trial pits TPRH108, TPRH110 and TPRH111

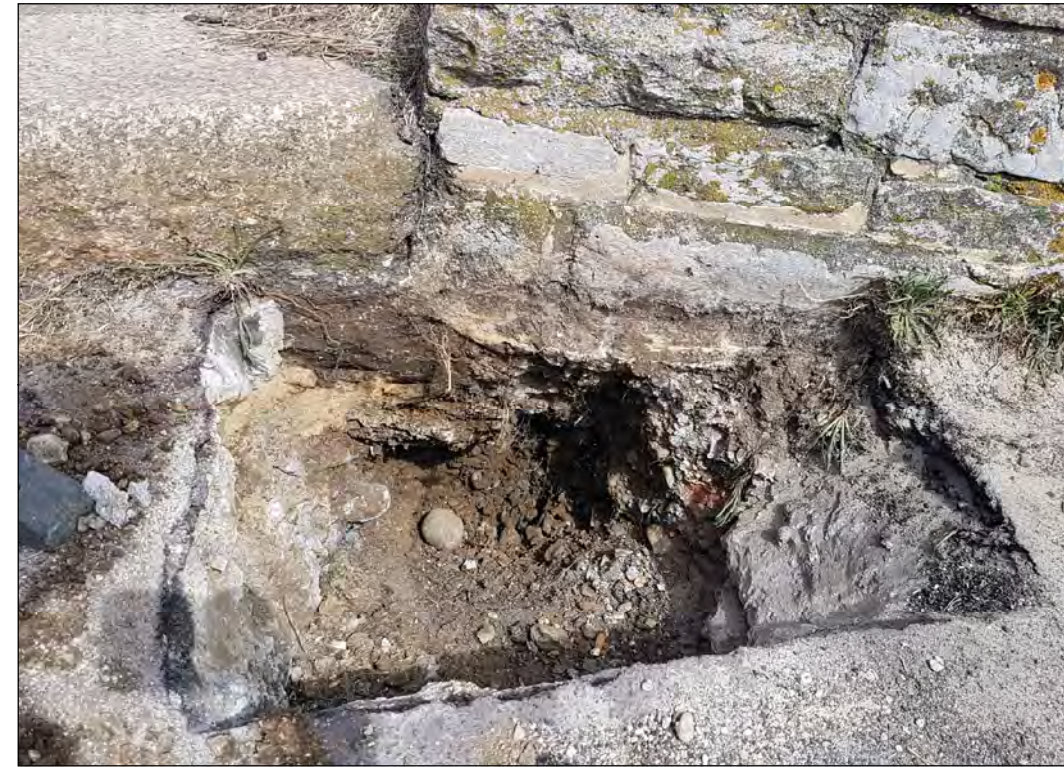
Plate 18) TPRH108, view from the south

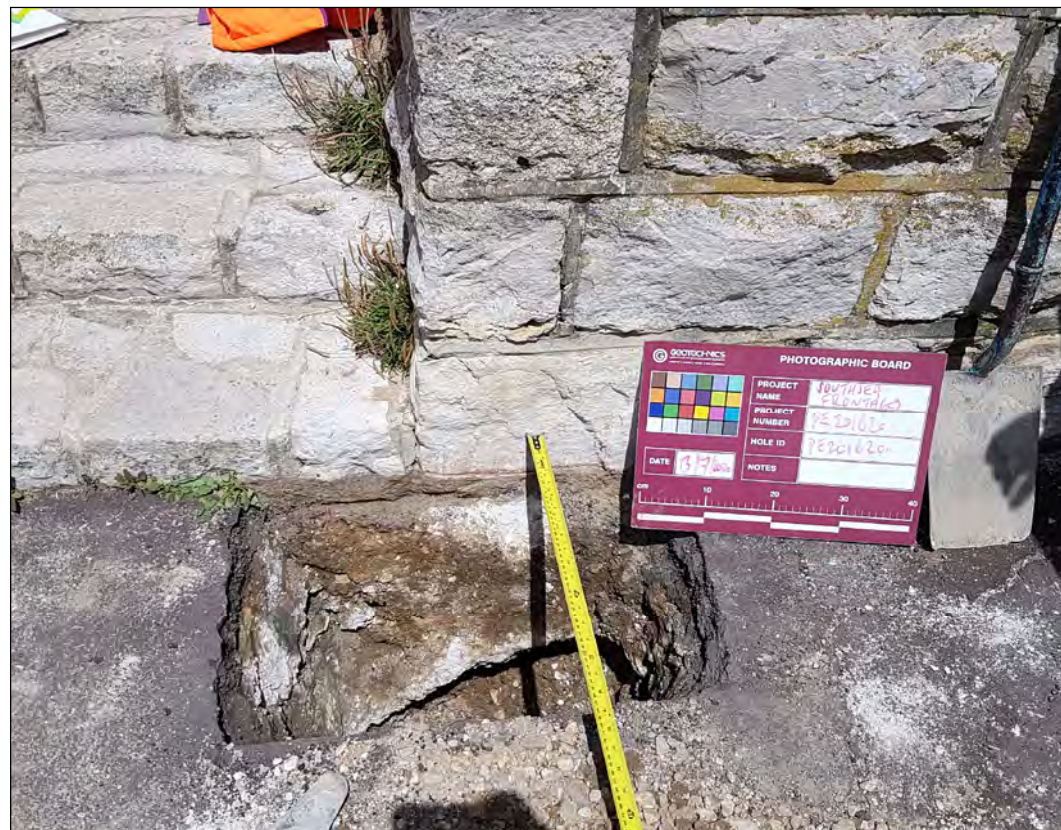
<b>TPRH110</b>			
Easting 464451		Northing 97986	3.64m OD
Length 0.70m		Width 0.40m	Depth 0.75m
Depth from (m)	Depth to (m)	Description	Interpretation
0.00	0.06	Tarmac	Made ground
0.06	0.45	Concrete. Wall foundation.	
0.20–0.50	0.50	Brown silty sandy clay w/ sub-rounded gravel <0.04m and frequent sub-angular flint inclusions <0.05m. Brick and concrete inclusions.	
0.50	0.65	Stone blocks	(?) Cobbles from the former Victorian / Edwardian promenade
0.65	0.75+	Brown silty sandy clay w/ sub-rounded gravel <0.04m and frequent sub-angular flint inclusions <0.05m. Concrete noted. Base @0.75m.	Redeposited storm beach deposits/ made ground

Plate 19) TPRH110, view from the south

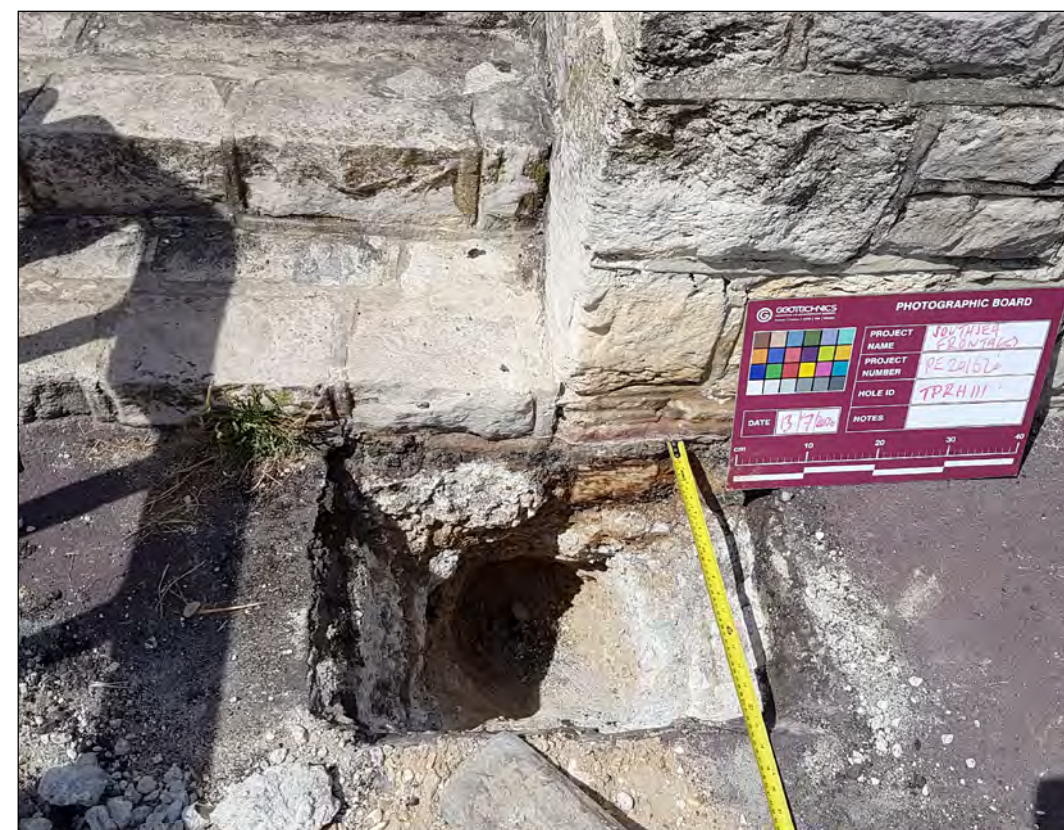
Plate 20) TPRH111, view from the south-east
