14-20 Chesil Street, Winchester, Hampshire

Historic Building Recording

Document Ref: 222450.02
WINCM: AY690
October 2019

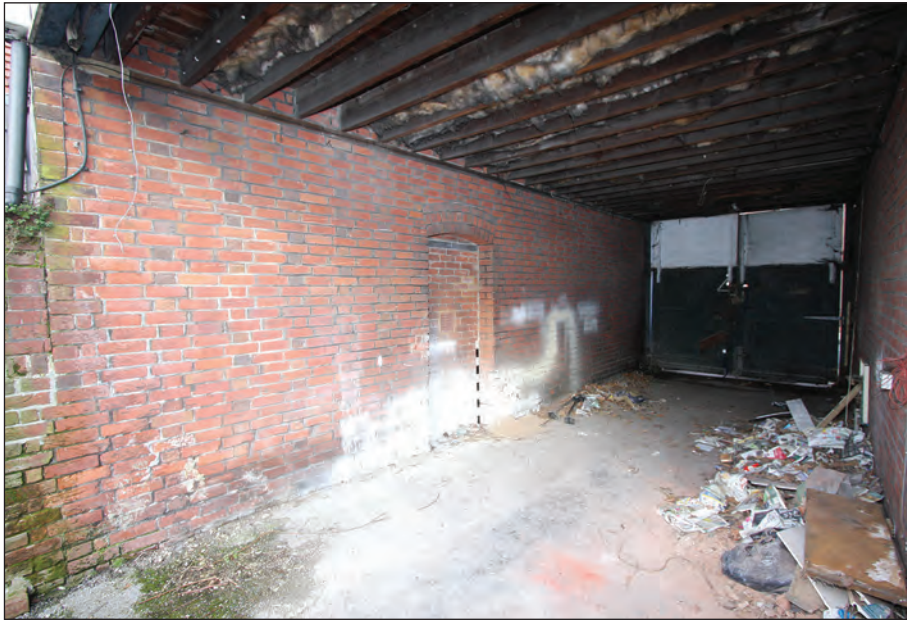
Plate 3: Blocked entrance in the north wall of the covered carriageway at 14 Chesil Street (2012)

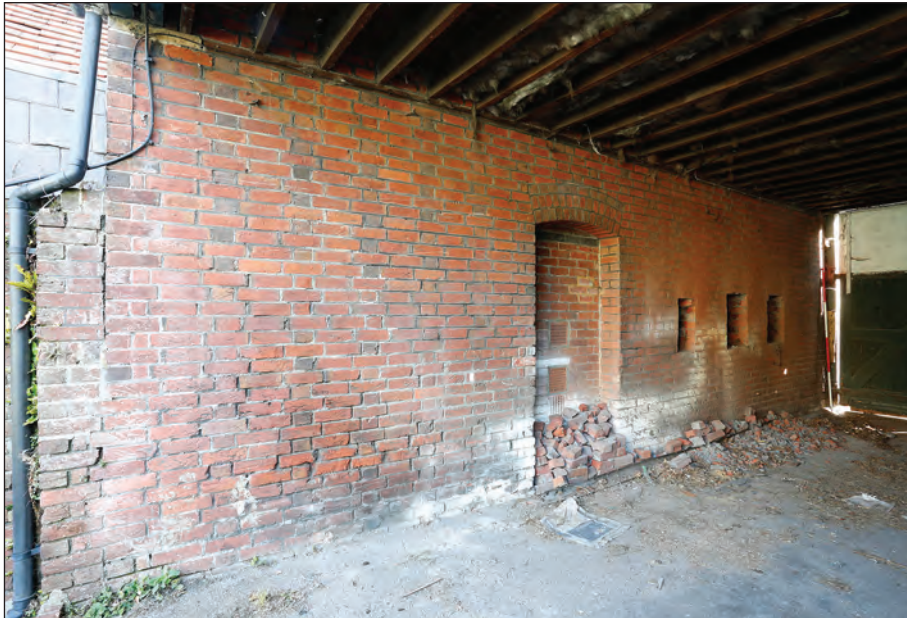
Plate 4: Block entrance and exploratory holes in the north wall of the covered carriageway at 14 Chesil Street (2019)

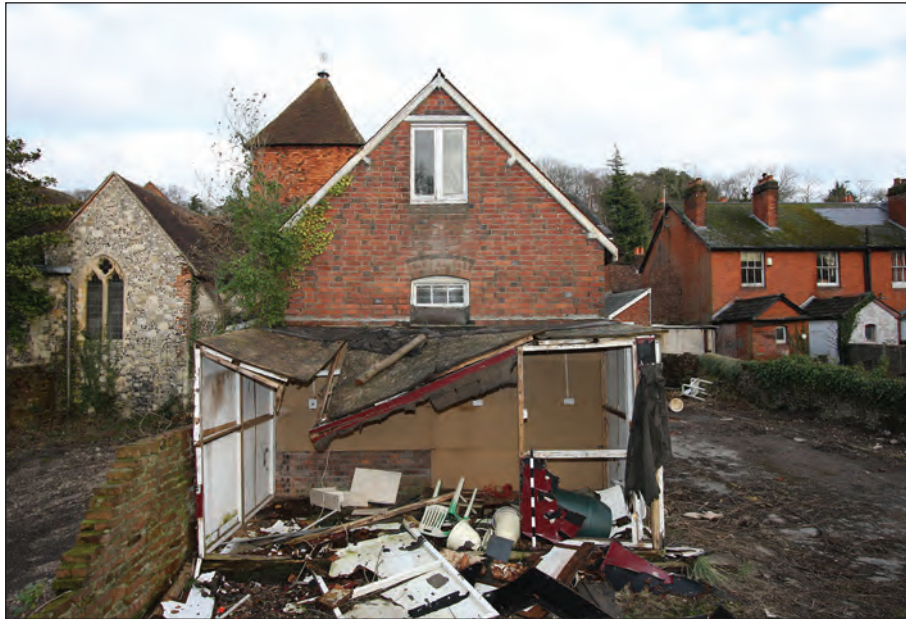
Plate 31: Rear workshop: west elevation with dilapidated lean-to (2009)

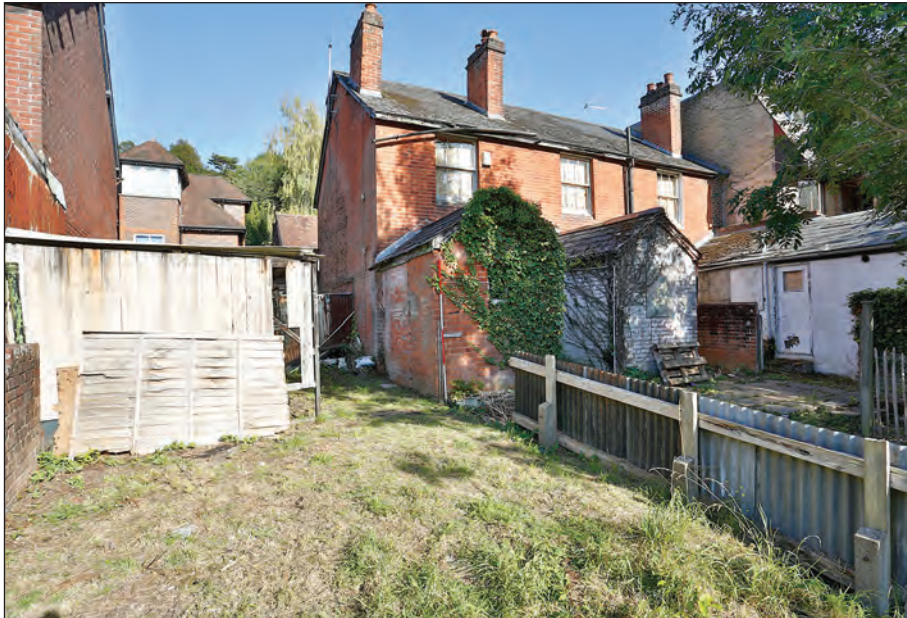
Plate 38: 16-20 Chesil Street: rear elevation showing ground floor extensions (2019)

- 5.2.2 An examination of the cottages indicated that some adaptation and change has occurred over the years, although many original features have survived. The areas for greatest diversification are found in the ground floor rear extensions, which have all developed separately over the years. No. 14 Chesil Street has also undergone modest change with a large part of the first floor converted from storage to domestic use during the early 20th century. The rear workshop behind No. 14 Chesil Street has undergone the most change having been converted from a stable to a garage and then latterly into a workshop.

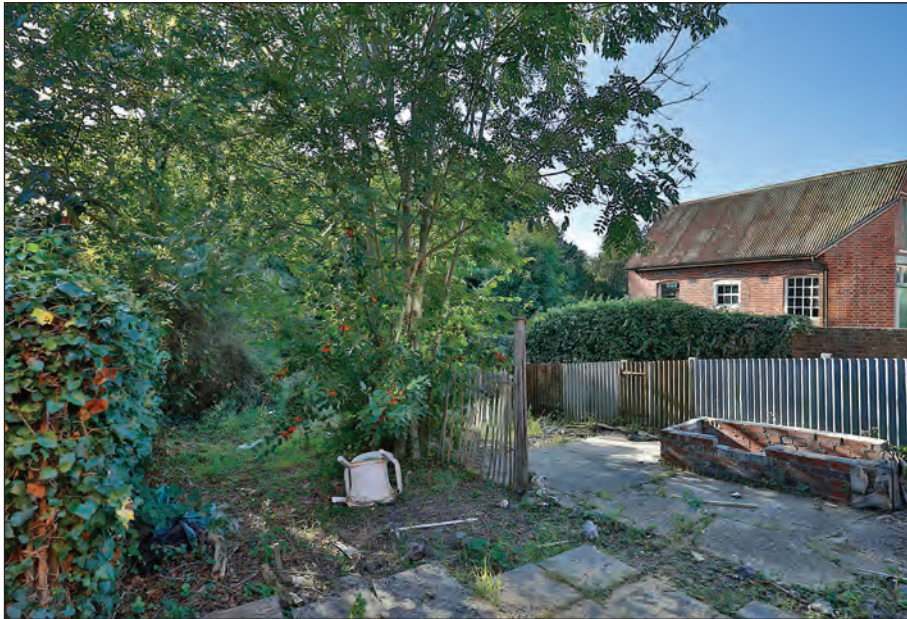
- 4.6.3 Access into the rear chamber from the garden is via a hatch surrounded by a raised brick plinth of approximately 0.5 m in height covered in a sheet of heavy board (**Plate 39**). The plinth shows signs of several phases of repair including numerous modern extruded bricks, concrete blockwork and Portland cement. Removal of the board reveals a straight flight of nine brick steps measuring on average 0.26 m in depth, which leads down to the western end of the rear chamber. Entrance to the rear chamber was blocked in September 2019.

Plate 39: View of the rear gardens of 16-20 Chesil Street, viewed from the southwest (2019)

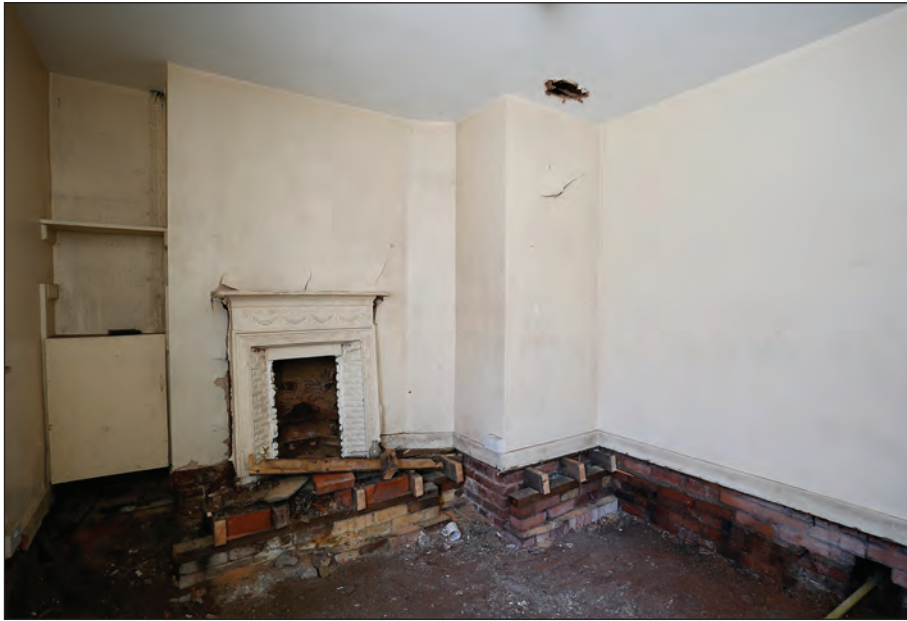
- 4.5.6 Access into the cottages is principally via the front (east) entrance, which leads into a small front room. A central fireplace is present on the north walls of No.s 16 (**Plates 49-50**) and 18 Chesil Street (**Plates 40-41**) whereas this is present on the south wall of No. 20 (**Plate 46**). No.s 16 and 20 Chesil Street retain their original cast iron hearths whereas the hearth at No. 18 is a mid-20th century replacement. In all of the cottage's decoration is simple comprising late 20th century carpet and painted walls.

Plate 41: 20 Chesil Street: front room (2019)

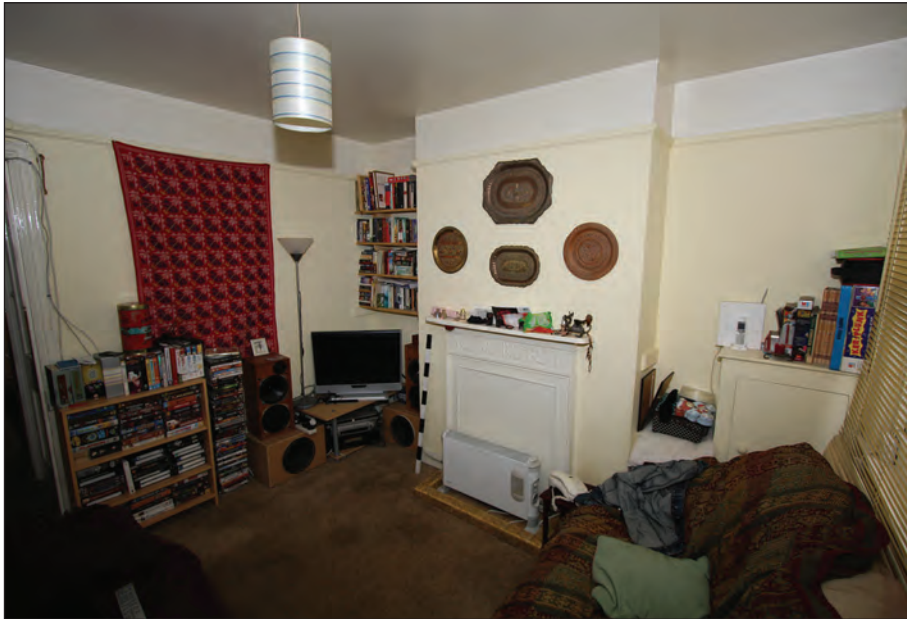
Plate 49: 16 Chesil Street: front room (2009)

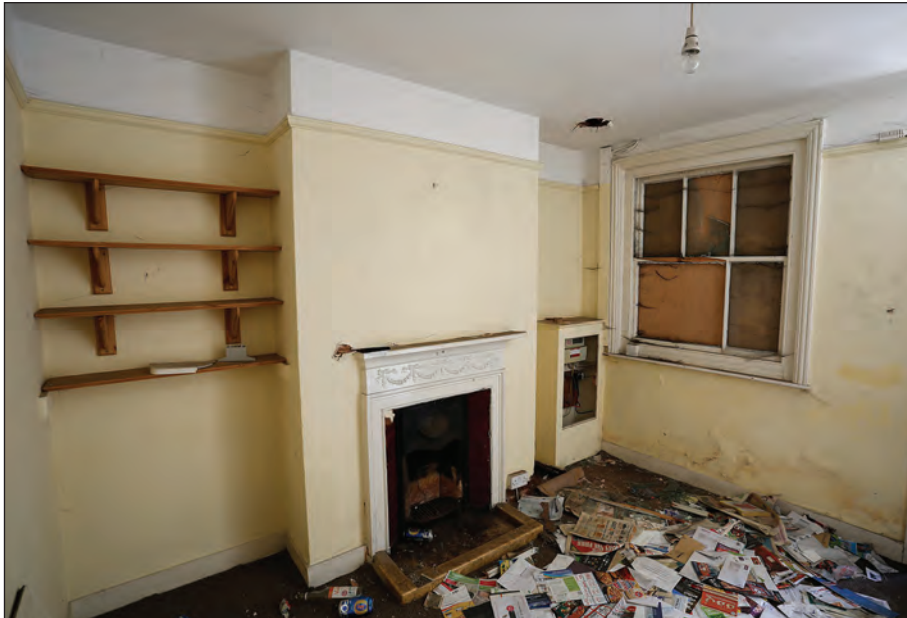
Plate 50: 16 Chesil Street: front room (2019)

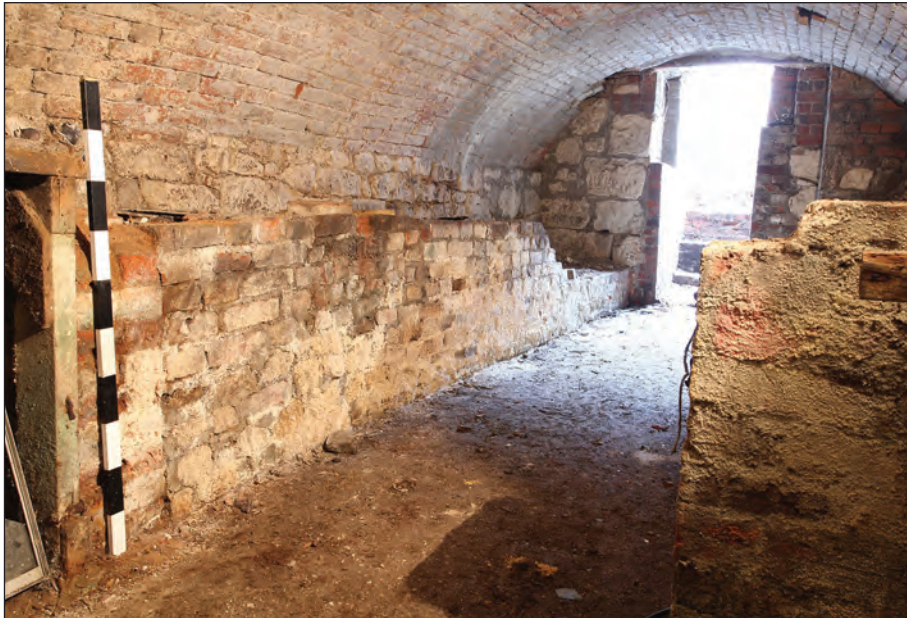
- 4.6.5 The north and south walls within the western part of the rear chamber are largely obscured with the exception of the upper 0.28 m due to the presence of wide 'benches' comprising single brick thick retaining walls which hold a mixture of loose garden soil and occasional rubble and are partially covered with sheets of asbestos and rusted steel. The retaining walls measure c.0.7 m in height and are crudely constructed from a single row of frogless red brick with Portland cement suggesting a 19th – 20th century date (**Plate 58**). An examination of the loose infill found that it comprised greyish brown silty clay with frequent small chalk and flint fragments. This was similar to the composition of the top soil found in the rear garden of the property. A small number of archaeological artefacts were identified within the loose infill including ceramic building material, iron, pieces of clay pipe and creamware pottery, which appeared to be of 18th – 20th century date. None of the finds were retained for further analysis.

Plate 58: Brick 'bench' running along part of south wall of rear chamber

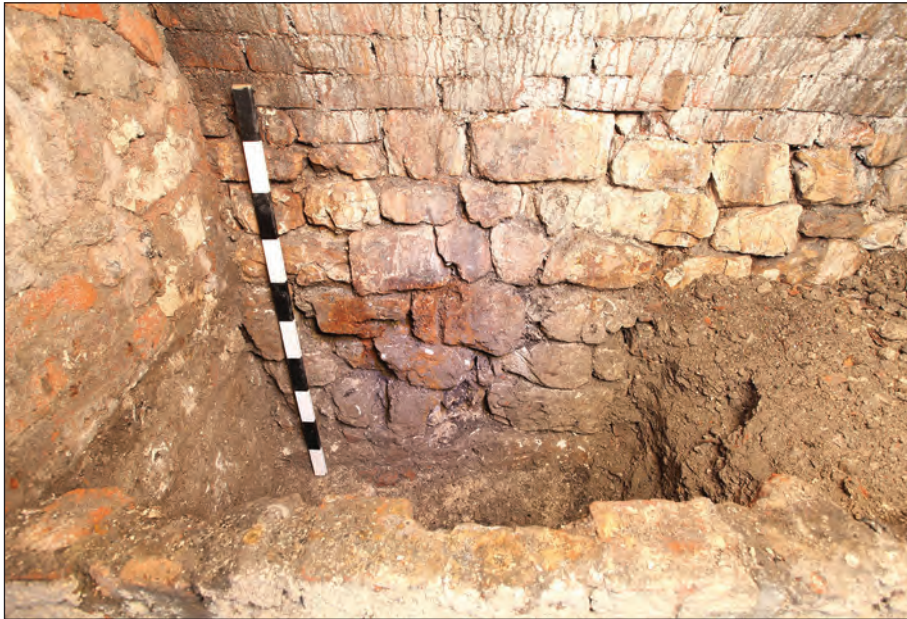
- 4.6.6 The removal of the loose infill material on both sides (north and south) of the rear chamber at the western end allowed for 1m representative sections of the cellar walls to be exposed for analysis and photography. In general, the rear chamber walls appear to be constructed from random rubble chalk blocks, which typically measured 0.25 m in length and 0.15 m in height (**Plate 59**) with occasional brick and tile. The binder comprises a buff-coloured gritty lime mortar although many of the joints are obscured by poorly executed repointing in dark grey Portland cement, indicating a 20th century repair episode. Exposed on the west wall and at the western end of the south wall are several large, semi-coursed, squared chalk blocks measuring up to 0.54 m in length and 0.37 m in height (**Plate 60**). The relatively small number of these larger blocks in comparison with the size and composition of the rest of the wall suggests that they may have been reused from an earlier building.

Plate 59: Exposed north wall of rear chamber

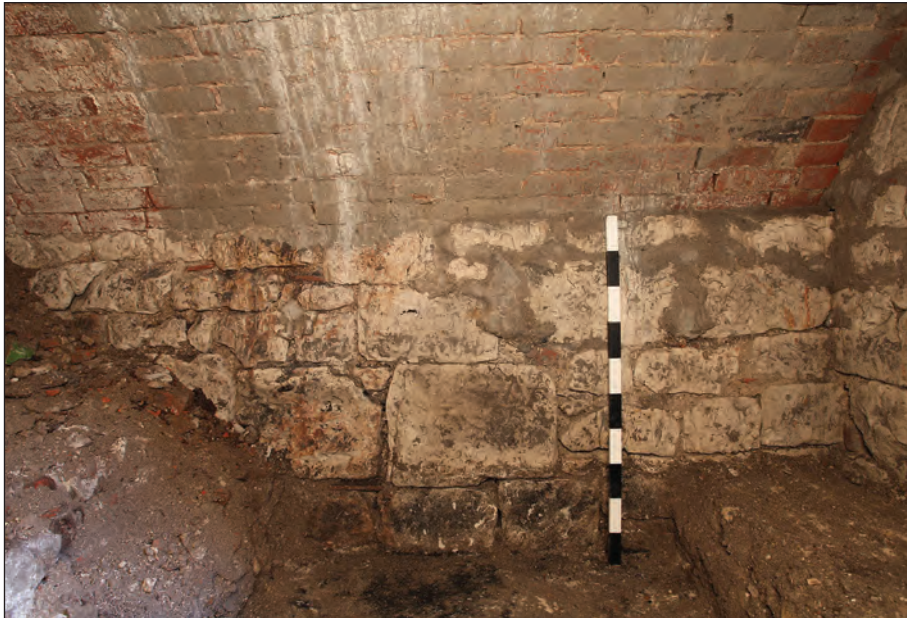
Plate 60: Exposed south wall of rear chamber
