Park View, The Street, Sedlescombe, East Sussex

Archaeological Evaluation Report

Report reference: 64732.03

May 2008

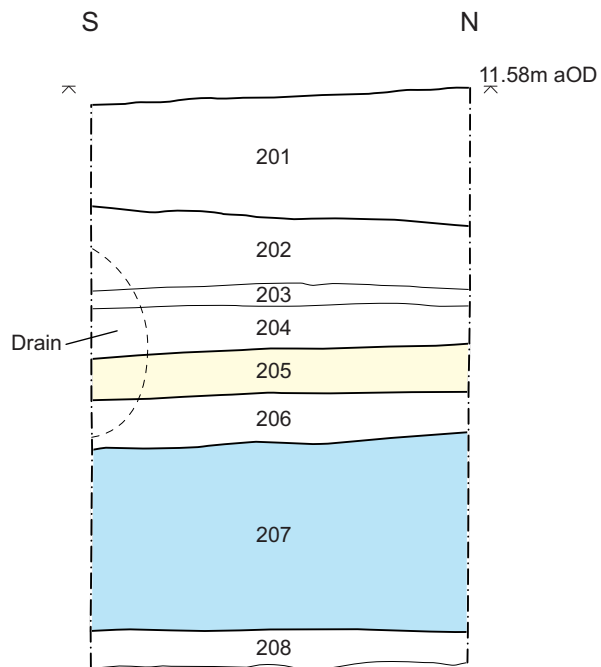
Section through Trench 2 showing peat deposit (viewed from the east)

- 5.2.3 Evidence from Trenches 2 and 5 (**Figure 3**), along with observations recorded during the demolition of the house; suggest that the Site straddles the boundary between the marshy floodplain of the River Brede to the south and east of the Site and the drier high ground in the western and northern areas of the Site.
- 5.2.4 The stratigraphic sequences in these trenches suggest a series of flooding events and the burying of decayed trees and plants at the edge of fen or wet woodland.

205/207 (**Figure 3**) however; this was not established within the confines of the trench area.

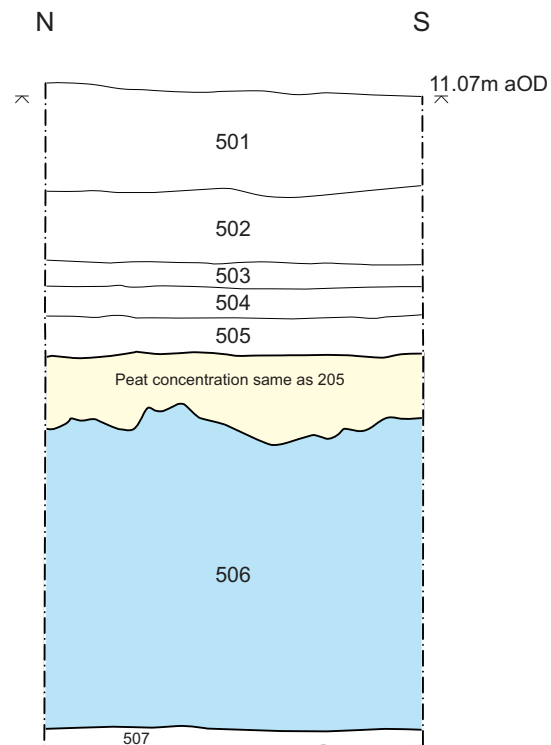
Section through Trench 5 showing peat deposit (viewed from the west)

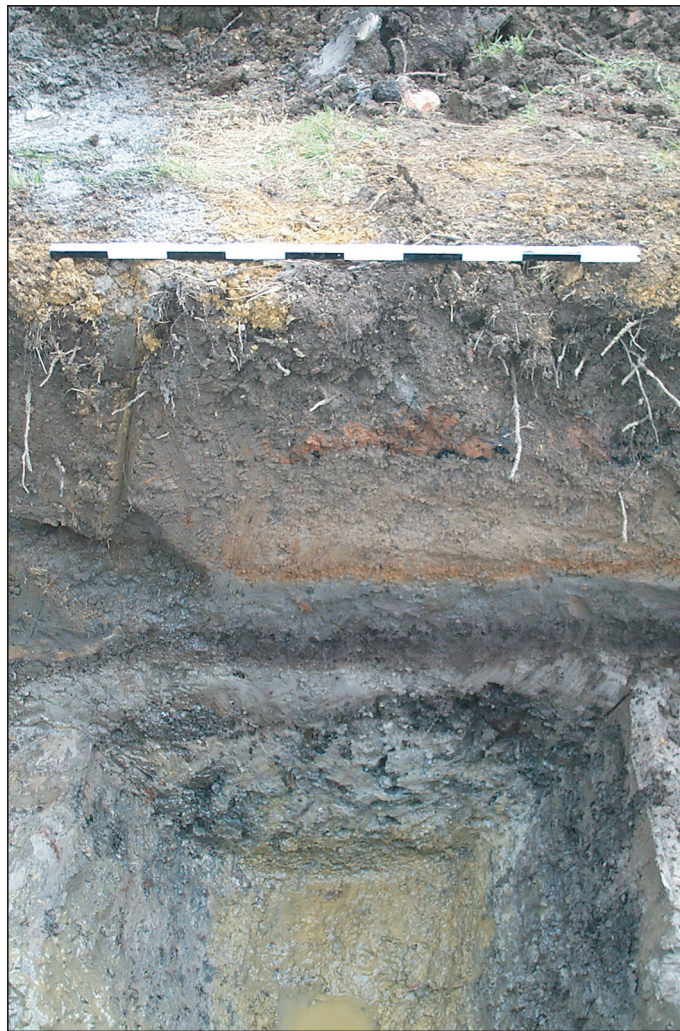
Plate 1: Section through Trench 2 showing peat deposit

5.4.2 The complex stratigraphic sequence in this trench indicated repeated flooding events and an inundation of wet woodland.

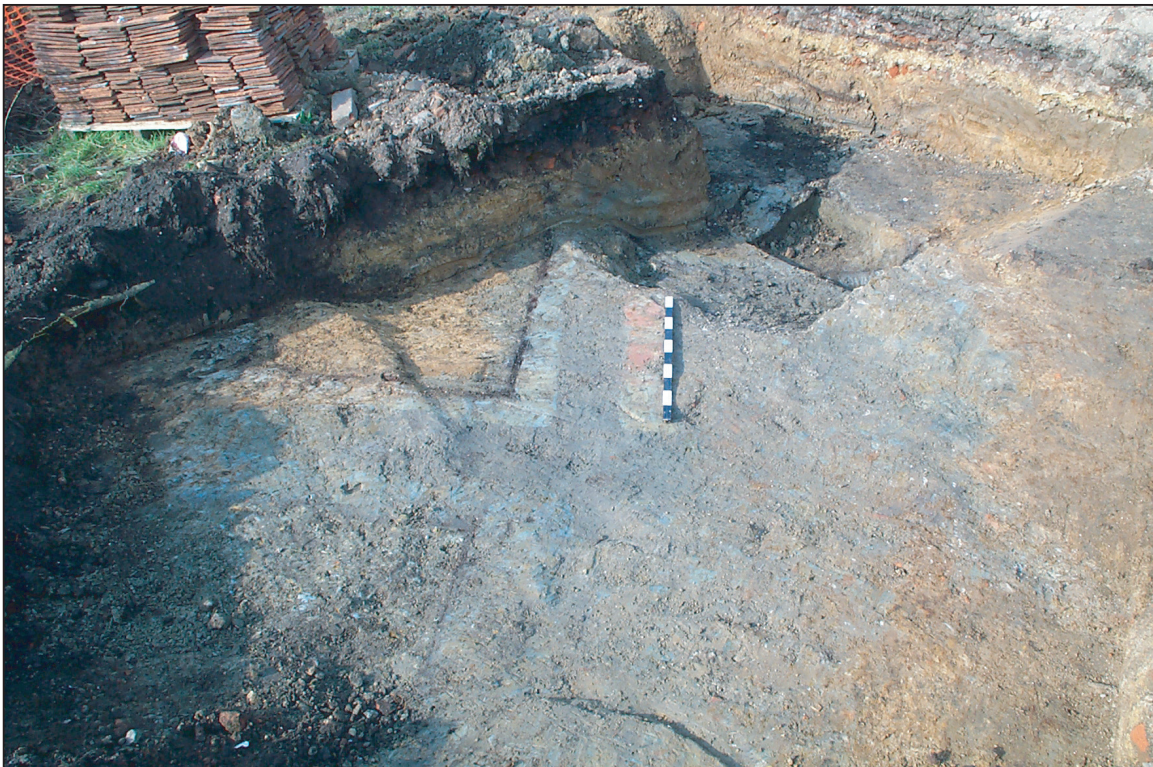
5.5.3 The pits form a grid pattern (**Plate 2**), each c.0.30m apart, with external dimensions of c.2 x 1.5m, internal dimensions of c.1.7 x 1.2m and a depth of c.0.9m. Each pit is lined with a clean, blue-grey and pinkish clay c.0.20m thick. At least some were shown to have an additional wood plank lining on the inside of the clay lining.

Plate 2: Overall view of Trench 3 showing tanning / fellmongers pits

- 9.1.3 Following the strip and map stage, it is recommended that a sample of the tannery/fellmonger's pits should be excavated by hand in order to characterise them, determine their function and obtain dating evidence. It is anticipated that earlier phases of pits or vats and associated drainage features beneath will be uncovered and that the relationship between these and the phase or phases observed within the evaluation trenches should be established.
