Stonebridge Mills Leeds, West Yorkshire

Archaeological Watching Brief

Planning Ref: 18/02140/FU and 18/02141/LI
Ref: 100672.01
July 2022

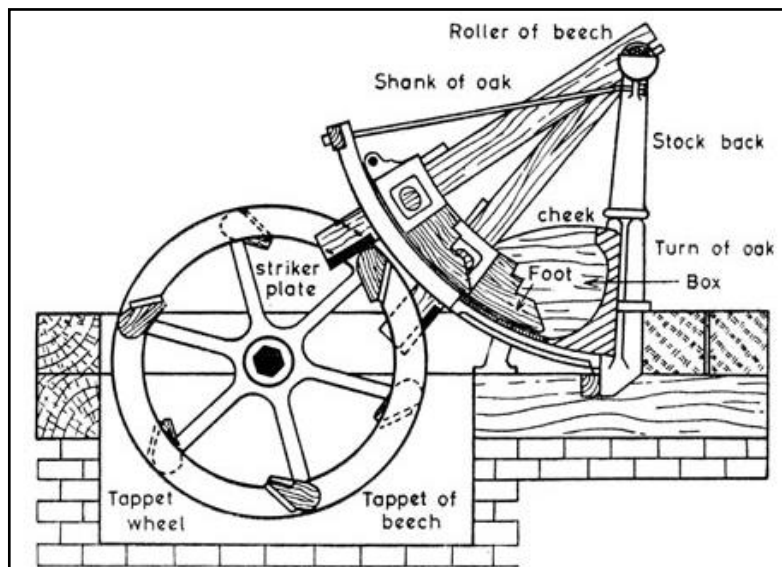
- 2.2.7 A typical fulling stock would have comprised stone, wooden, and, later, cast-iron components, with wrought iron tie-down bolts. Due to the stresses involved the components were large and of robust proportions. Cloth would be placed in a fulling trough, a wooden box with a curved base that was firmly attached to the floor of the workshop by iron fittings. The trough was positioned at the base of an iron stock or column which carried a roller or axle. Two overlong shanks or beams of oak were attached to the axle. Each shank had a foot or hammer attached towards its far end. These hammers were free to move back and forward inside the fulling trough following a short arc. A tappet wheel of c. 1.6m diameter, sat in a masonry-built pit behind the fulling stock. The pit allowed the wheel to be properly positioned with reference to the other components. As the tappet wheel turned, the attached tappets lifted and released the end of each oak shank, letting the foot drop on to the cloth being fulling. These would be arranged to strike the cloth in the fulling box around 40 times per-minute (WYAAS 2021).

A cross section of a typical fulling stock (after WYAAS 2021)

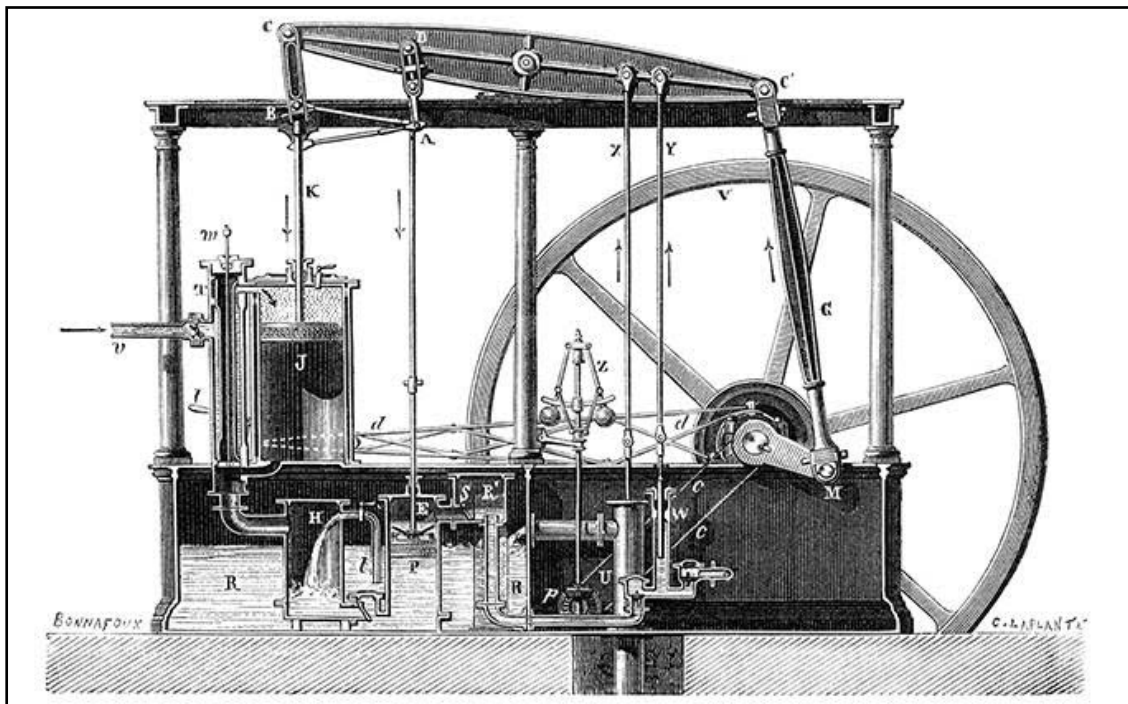
Example schematic of a single-cylinder beam engine; V steam intake from boiler, J cylinder / piston, R coolant cistern / tank, U and X coolant pump, W and Y feed pump for boiler, P and Z governor, V flywheel

- 2.2.10 Steam was raised to power the engine within Building 12, the Boiler House, powering the engine's single cylinder, situated above the existing floor level to the southwest of the room, in front of the plinth area where the room's main stair would have been situated, servicing a gallery above (all since removed). The steam drove a piston within the cylinder, driving the beam, and its flywheel in turn. A pump would have been situated adjacent to the flywheel, driven in parallel, to raise water as a coolant, which was delivered to a large cistern housing a series of condensers, linking to the base of the cylinder. Condensed water and coolant would be drawn off in turn by a second pump within the cistern, with waste water being pumped to the boiler house. A cistern / well and

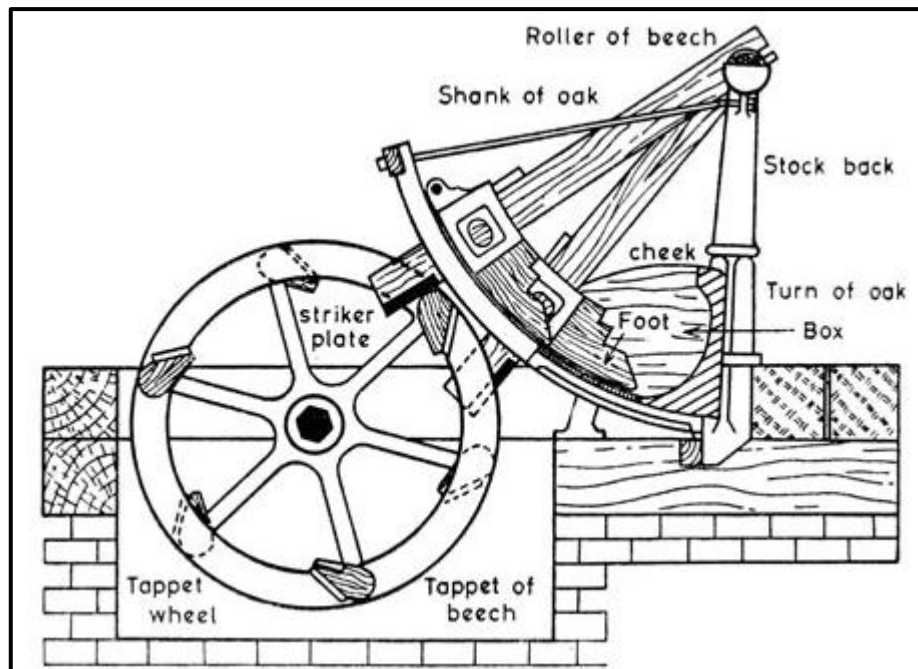
- 2.11. When the tappet wheel turned the attached tappets lifted and then released the end of each oak shank and let the foot drop on to the cloth being fulling and arranged to strike the cloth in the fulling box around 40 times pre-minute (Kilburn 1931).

A Cross Section of a typical fulling stock

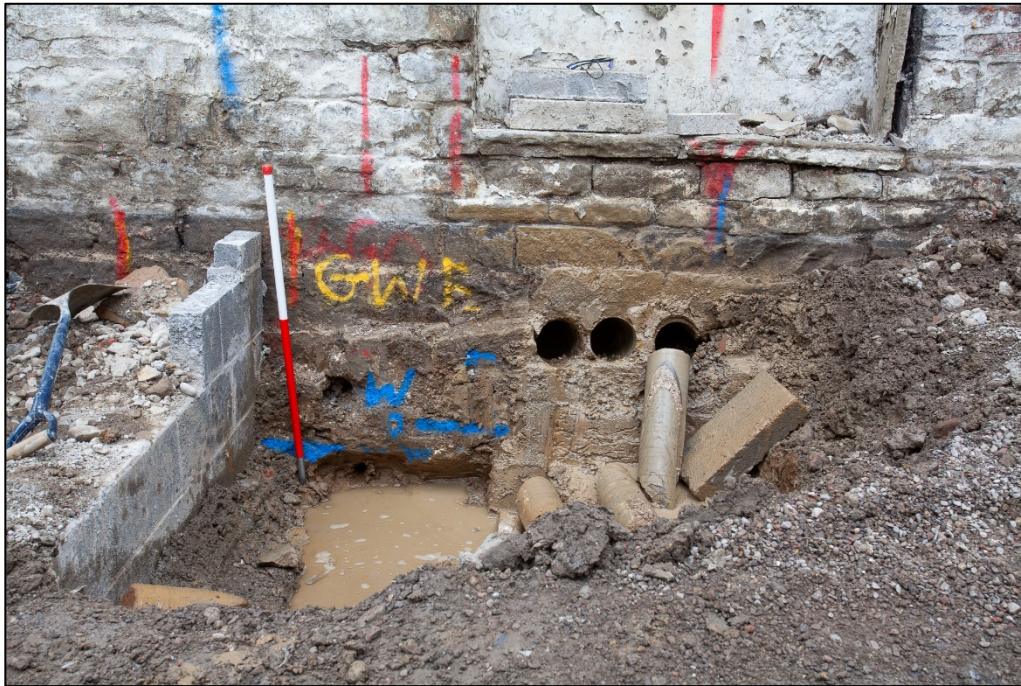
Plate 1: Re-excitation to the north-eastern end of the northwest wall of Building 10, facing northwest

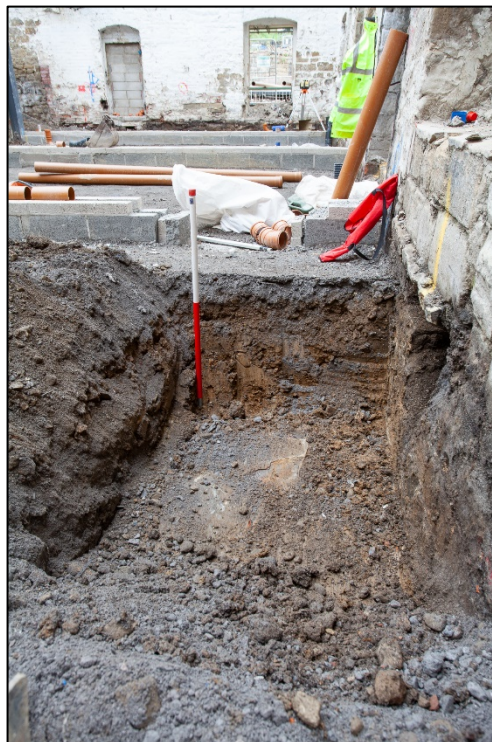
Plate 2: Re-excitation to the south-western end of the southeast wall of Building 10, facing northeast; includes the stone slab to (1003), (1002), and modern deposit (1007)

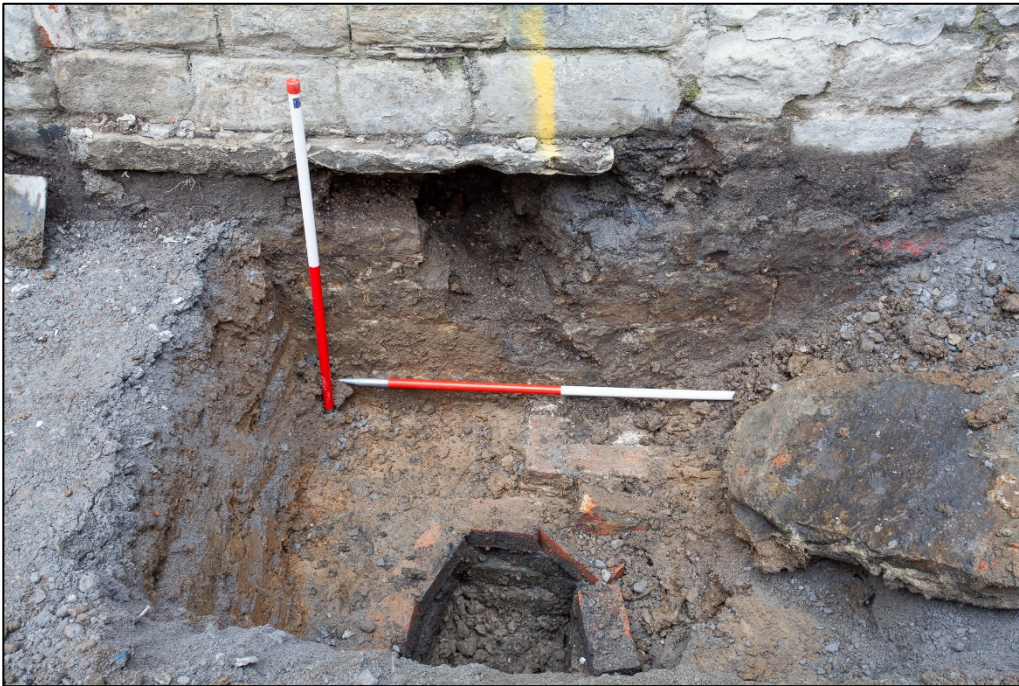
5.2.1 Excavation halted at the contractor's target level. In the instance of Building 10, only the re-excavation of the area was monitored. However, natural geology (1001) was encountered both during the unmonitored works, and in the areas observed during the watching brief, comprising a firm mid-yellow brown sandy clay, giving way to a mid-yellow grey sandy clay with depth (**Plate3-5**).

Plate 3: Re-excavation to the south-western end of the southeast wall of Building 10, facing southeast; showing the drain (1003), with slab removed, (1002), (1001), and brick structure (1005) in relation to the walls of the building (1008).

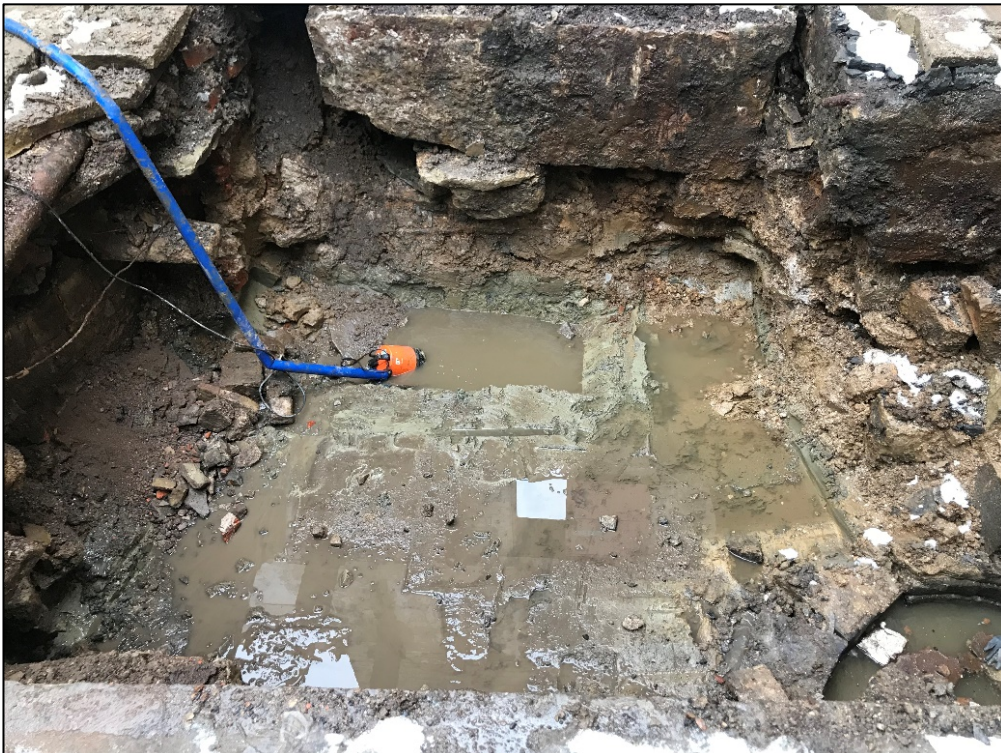
Plate 4: Client photograph 4, showing excavations within the southwest end of Building 10, facing southeast. Note the machine bases (top), redeposited natural (1002), and underlying natural (1001)

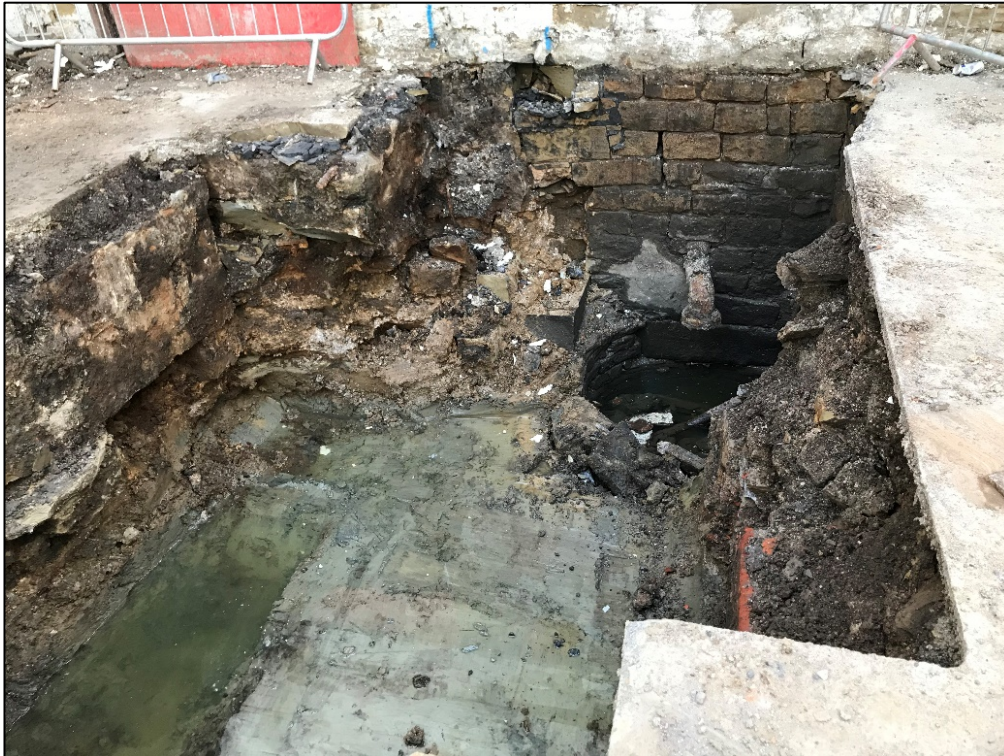
Plate 5: Client photograph 2, showing excavations within the southwest end of Building 10, facing southwest. Note the machine bases (left), redeposited natural (1002), and underlying natural (1001), with a linear brick structure right, leading to a cistern / well abutting the wall to Building 11

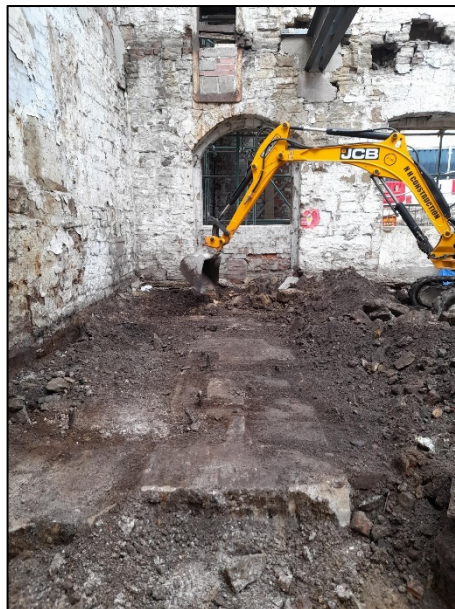
- 5.3.5 The photographs provided by the client also show a series of machine bases to the south-western end of the room; these comprise substantial stone blocks, approximately 0.50 m in depth, with remnant ties (either steel or iron) for plant (**Plate 6 and 7**). The location of these bases suggest that they may relate to the power transmission from Building 11 (thus potentially dating to c.1860) and may have supported gearing. The stone blocks appear to have been set directly onto the underlying clay. A probable wheel pit was noted abutting the party wall with Building 11, adjacent to the machine beds. To the southeast of the machine beds, to the northwest side of the building, a rough brick-paved surface was also documented (**Plate 9**).

Plate 6: Client photograph 5, showing excavations within the southwest end of Building 10, revealing large stone machine beds, facing northwest

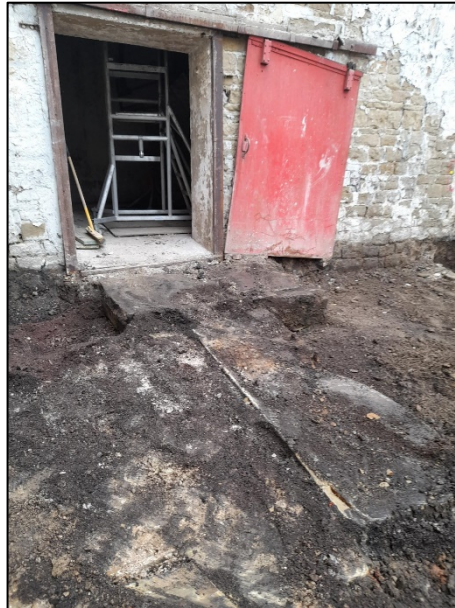
Plate 7: Client photograph 7, showing excavations within the southwest end of Building 10, revealing large stone machine beds adjacent to the doorway to Building 11, facing southwest

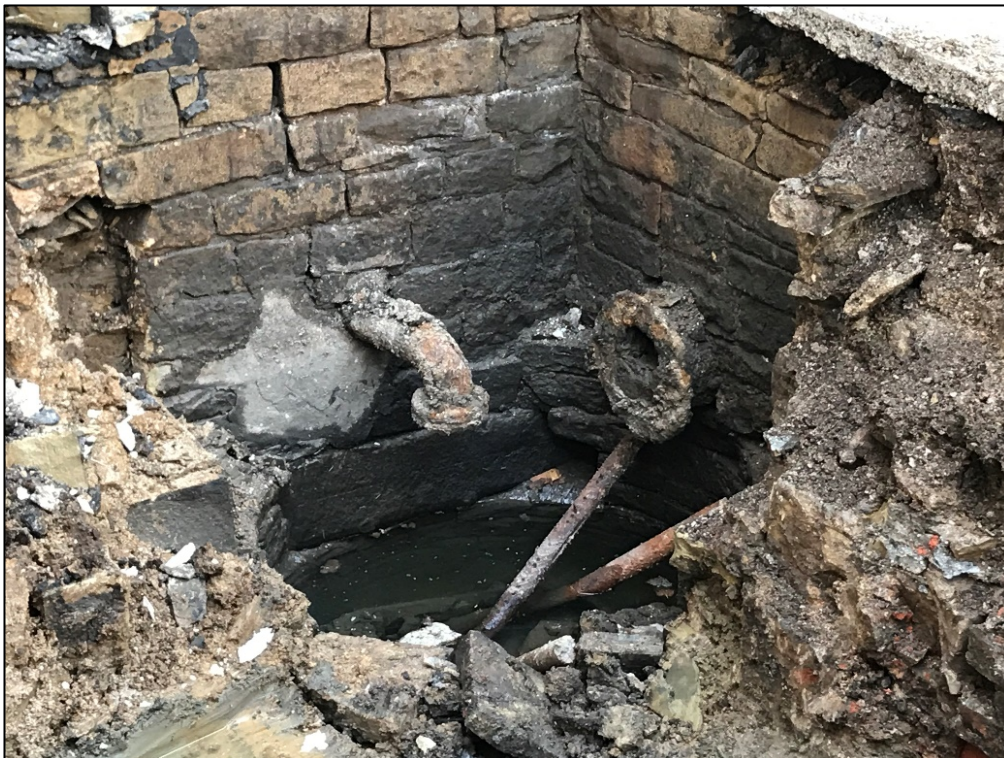
tap within Building 10, documented adjacent to the wall to Building 11 during ground reduction works by site workers, may relate to an overflow from the coolant tank, which could then be recycled, via a fixed outlet within the cistern, as coolant. It is probable that drainage from the fulling process fed this well, to be drawn through as coolant in turn. During the course of the watching brief, it was observed that only some stone machine beds, the wheel pit for the fly wheel, and a section of iron pipework for the coolant pump, remained within the engine house. Much of the engine house's former plant and machine beds were removed to accommodate a large press at some point during the mid-20th century. Observed excavation as part of the recent works terminated at the top of the machine beds, so it is not clear if any further plant / features survive below that level.

Plate 8: Client photograph 3, showing the exposed cistern / well feature within the southwest end of Building 10, facing west

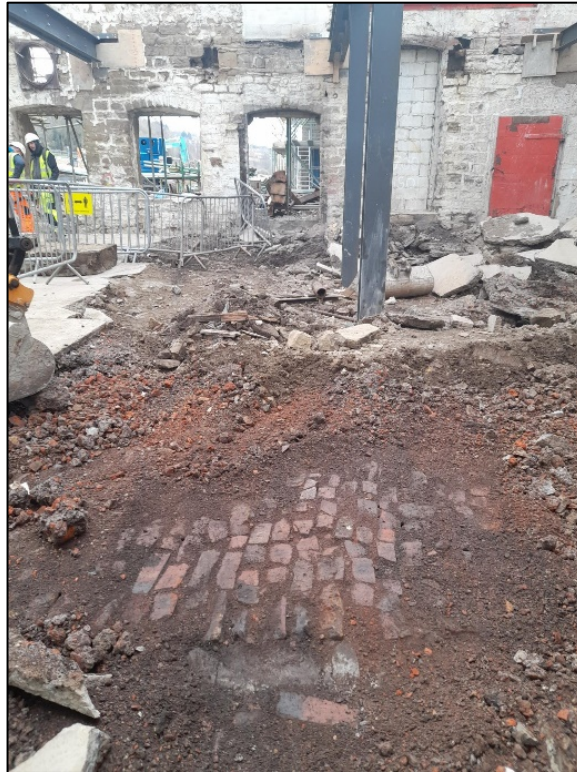
Plate 9: Client photograph 6, exposed brick-paved surface within Building 10, facing southeast

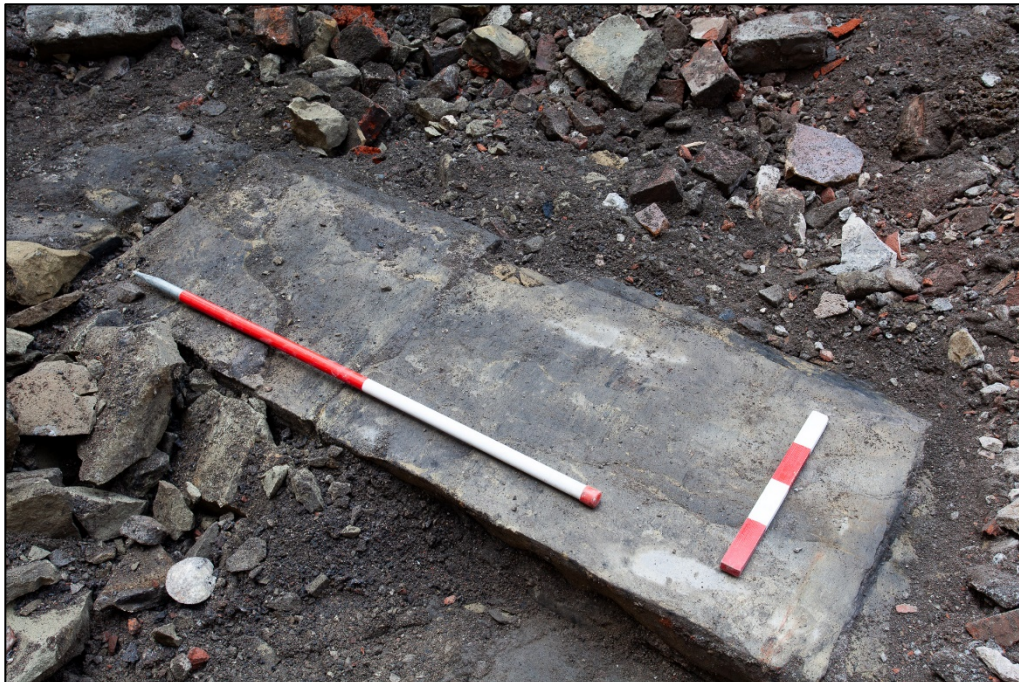
Plate 10: Exposed threshold of former doorway to the boiler house from Building 11, facing south

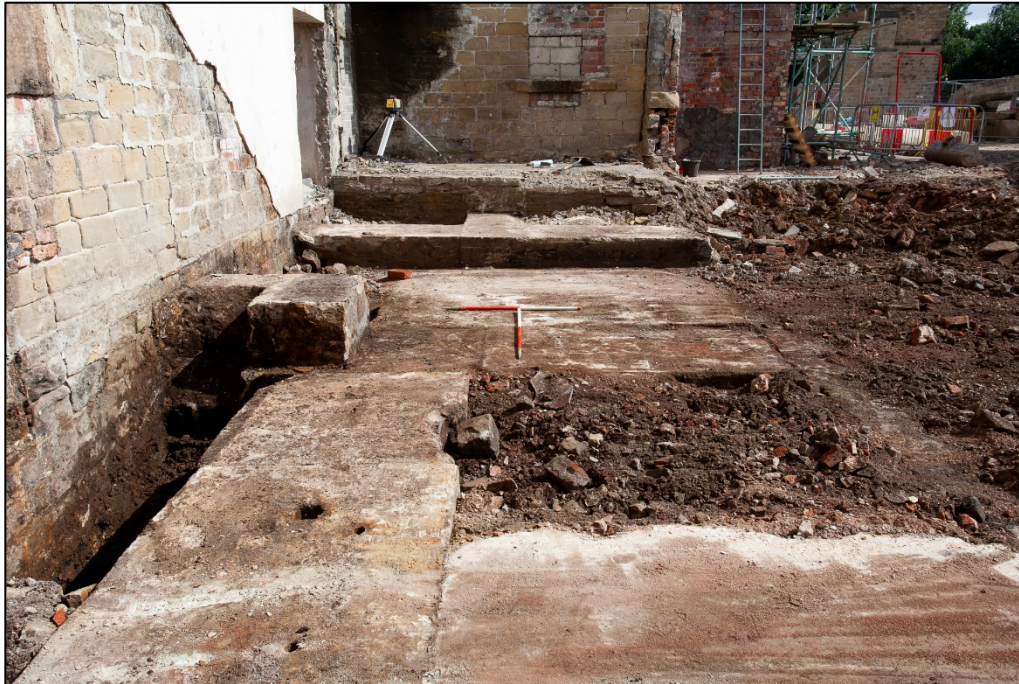
Plate 11: Exposed engine bed (2007), with abutting concrete plinths (2006) for the later press, Building 11, facing southwest (see Figure 3)

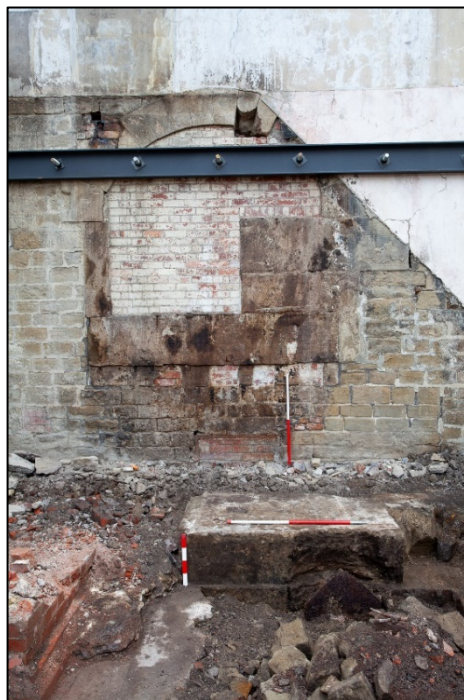
Plate 12: The coolant pump base and remnant metal work, with the unexcavated wheel pit beyond and the principal motion or bearing support structure for the engine's flywheel within the wall to Building 10, facing northeast

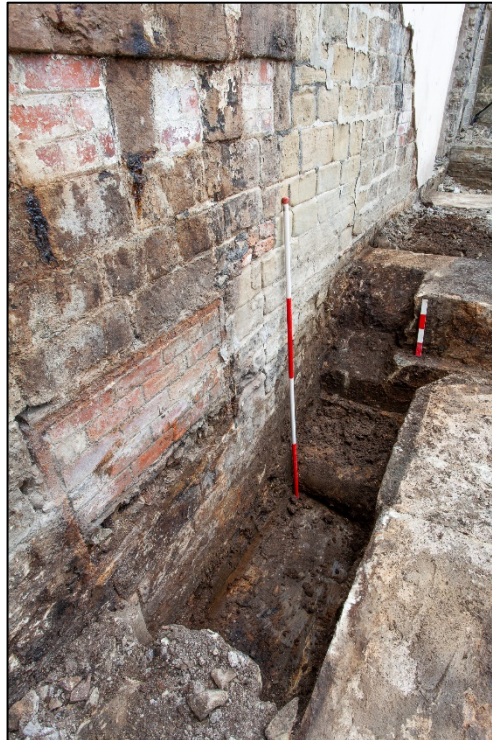
Plate 13: Excavated sondage within the wheel pit, facing southeast. Note the exposed pipe to its base

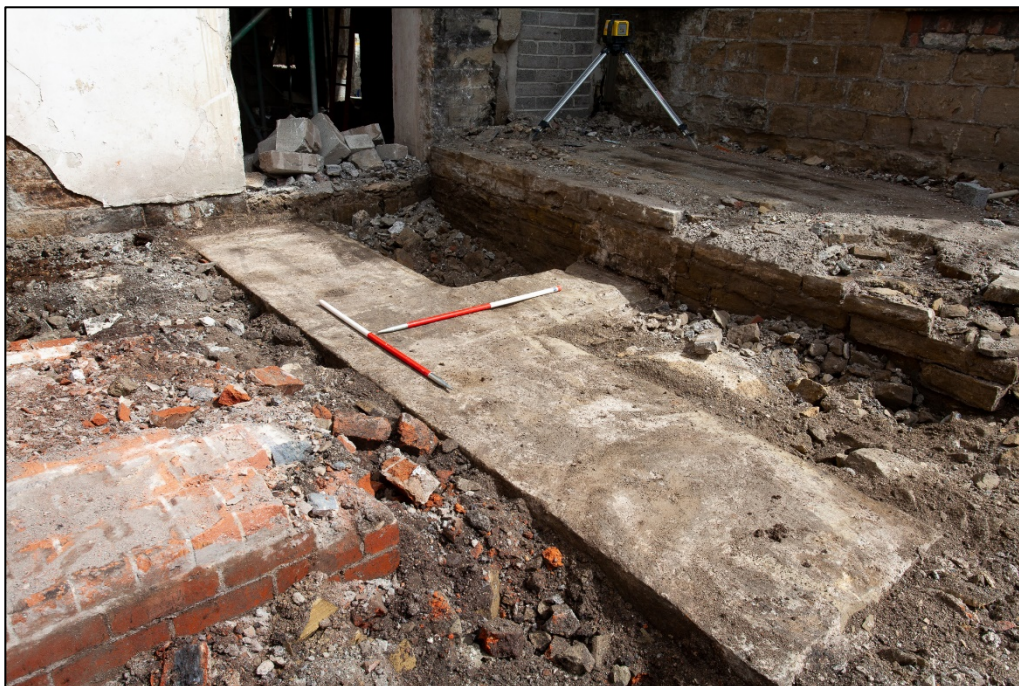
Plate 14: Exposed machine bases / engine bed (2007) within the southeast of Building 11, facing east

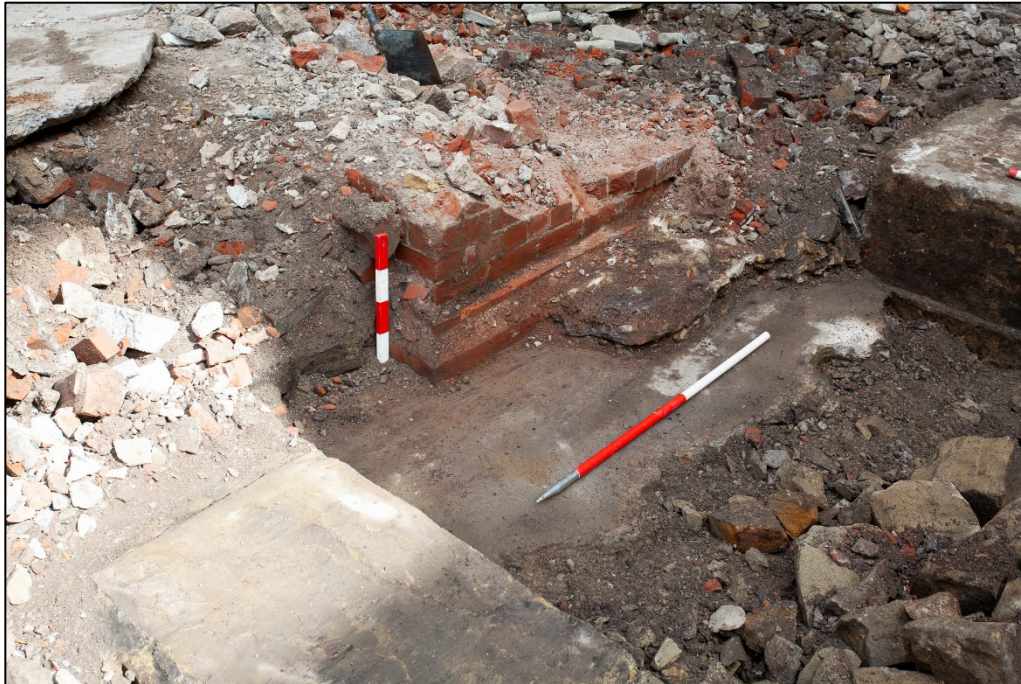
Plate 15: The northwest plinth and press base within Building 11, facing north

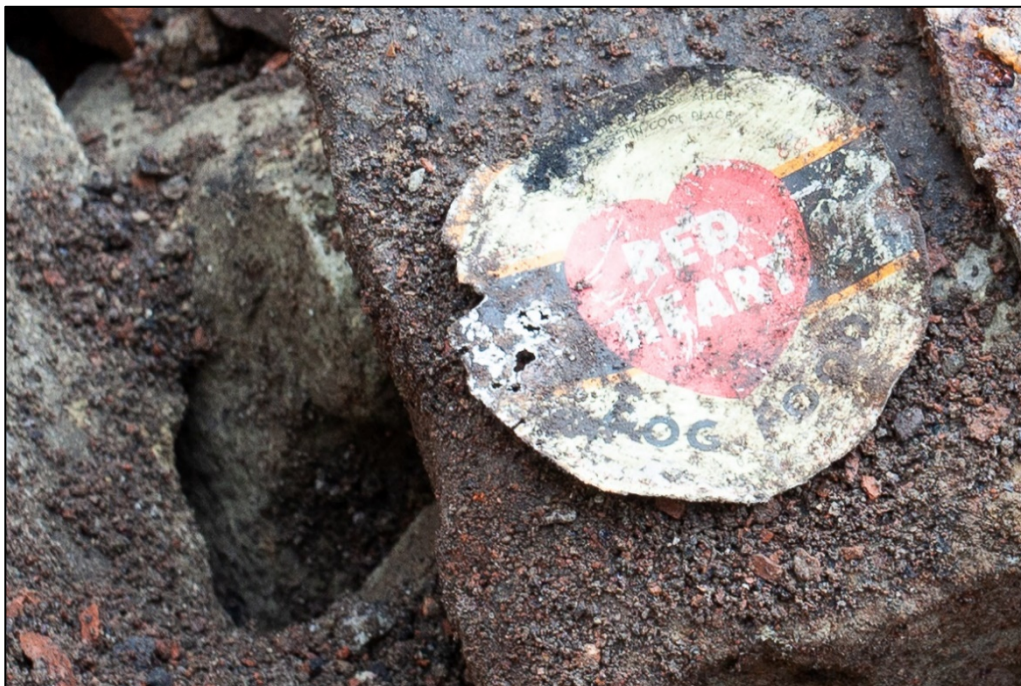
Plate 16: Lid of 'Red Heart' dog food tin, within (2003), Building 11

- 5.4.3 The building was dominated by footings for the cloth press. The construction of the press necessitated the removal of the earlier engine and the majority of its bed structure, to accommodate two substantial concrete footings / plinths (2006), situated at 50.00 m OD. During the demolition of the earlier engine, to make good the floor surface, a mix of demolition material (2003), including some substantial sections of stonework relating to the former engine bed, along with crushed sandstone and brick, was deposited within the room, filling earlier voids such as the wheel pit. This material formed the base of, and was packed around and over, the two concrete press plinths (2006); the south-eastern edge of the northwest plinth had clearly been poured directly onto the demolition material, resulting in ragged edge to the concrete, fusing with some of the demolition material (**Plate 15**). A lid of a tin of Morrell's 'Red Heart' dog food was found within the demolition material² (**Plate 16**). The company, started just prior to the Second World War, with 'Red Heart' becoming a market leader in the early post-war years (Grace's Guide 2021). The presence of the tin lid confirms a mid-20th-century date for the installation of the press.

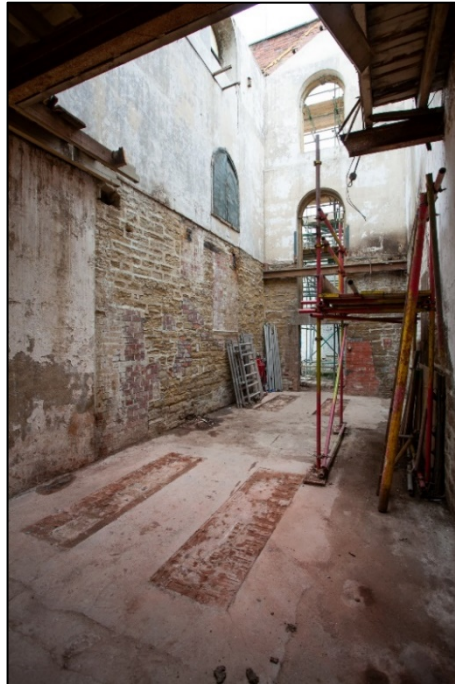
- 5.4.5 The made ground / demolition material was packed around the base of the brick press bases, sealed in turn by a concrete floor surface (2001) (**Plate 17**). The concrete floor surface varied in depth, averaging 100 mm. The floor had slumped and been patch repaired in places, owing to irregularities in the underlying demolition material. The top of the concrete floor was situated at 50.60 m OD.

Plate 17: Building 11 following removal of the press, prior to the demolition of its southwest wall and excavation, facing west

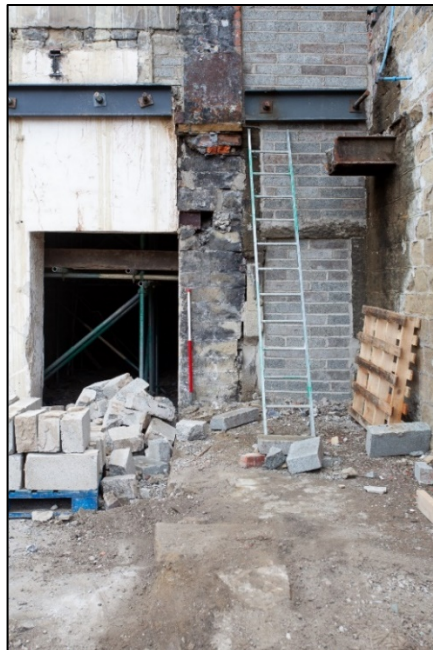
Plate 18: The former void area to the south-eastern end of Building 11, facing northeast. Note the remnant ironwork in the location of the removed dividing wall and to the top right
