Bishop's Waltham Palace Phase II

Archaeological Watching Brief

Ref: 233191.03
November 2022

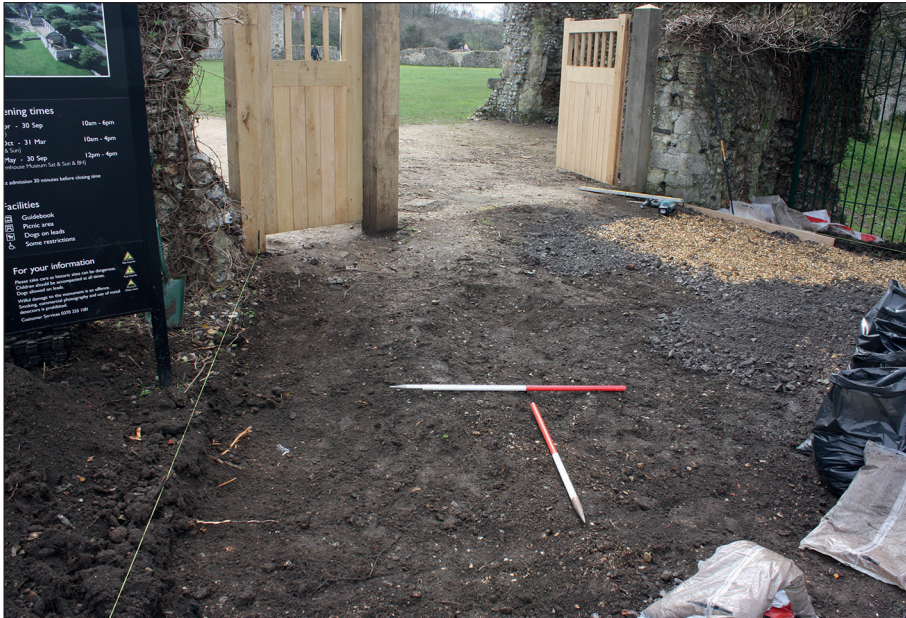
- 5.1.5 Soil sequence observed during the monitoring was found to be the same as that seen in test pits (**Plate 4 and 5**), no additional layers were uncovered. The drainage trench across the western edge of the Gatehouse apron measured 3.50 m long, 0.25 m wide, to a depth of 0.20 m bgl. The drainage trench to the ditch measured 2.80 m long, 0.25 m wide, to a depth of 0.36 m bgl (**Plate 6**).

Plate 4: Gatehouse apron with surface removed, view from the north-west (1 m and 2 m scales)

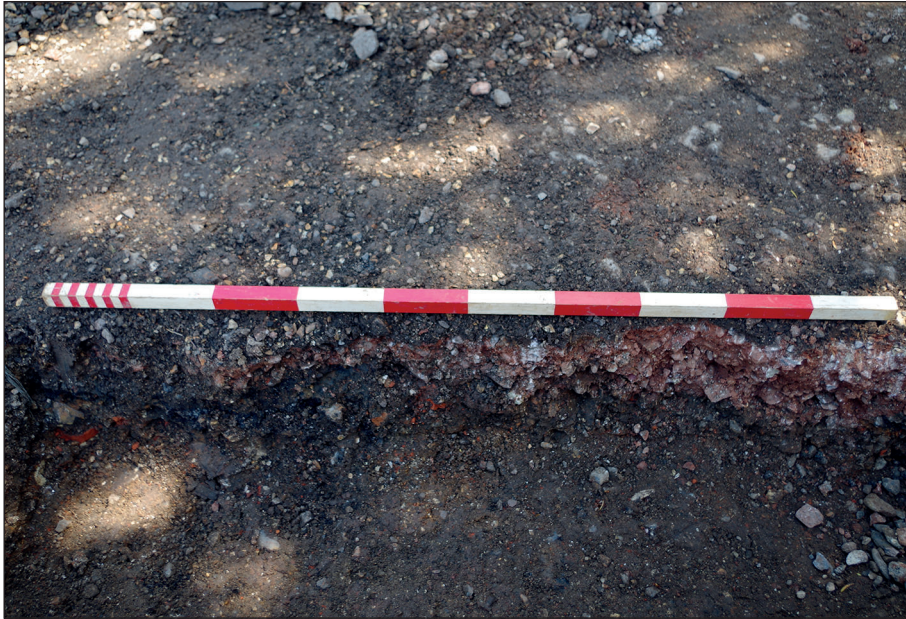
Plate 5: North-west facing section of sub-base in Gatehouse apron (1 m scale)

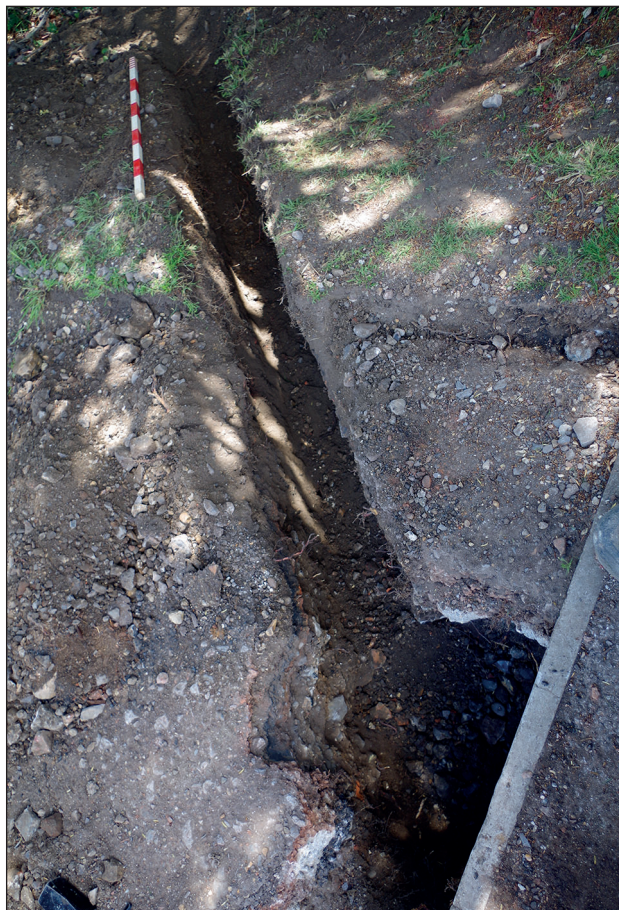
Plate 6: View from the north of drainage trench to ditch (1 m scale)

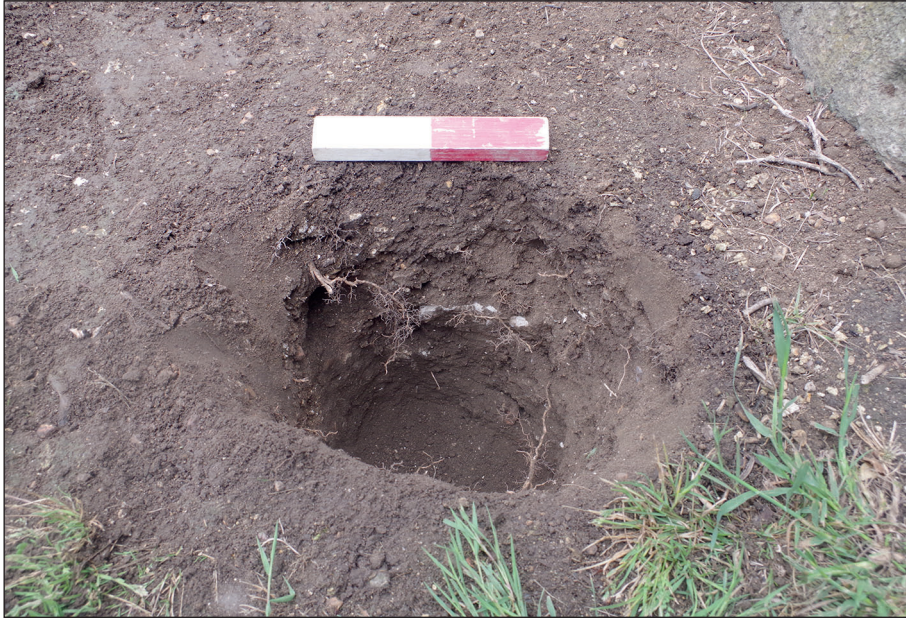
- 5.1.6 The soil sequence (**Plate 7**) consisted of topsoil of dark greyish brown silt clay loam with occasional sub-angular to sub-round flint and chalk fragments, 0.10 m thick. This overlaid a made ground (0.35 m thick) of dark brownish grey silt clay with common sub-angular to sub-round flint and chalk fragments, ceramic building material and roof slate and modern rubbish (sweet wrapping). Beneath this a second made ground layer was observed in the eastern fencepost holes, which consisted of yellowish orange sand 0.20 m thick. A power cable was revealed within some of the post holes so the plan was revised in consultation with English Heritage.

Plate 7: Post hole around North-East Tower, view from the east (0.2 m scale)

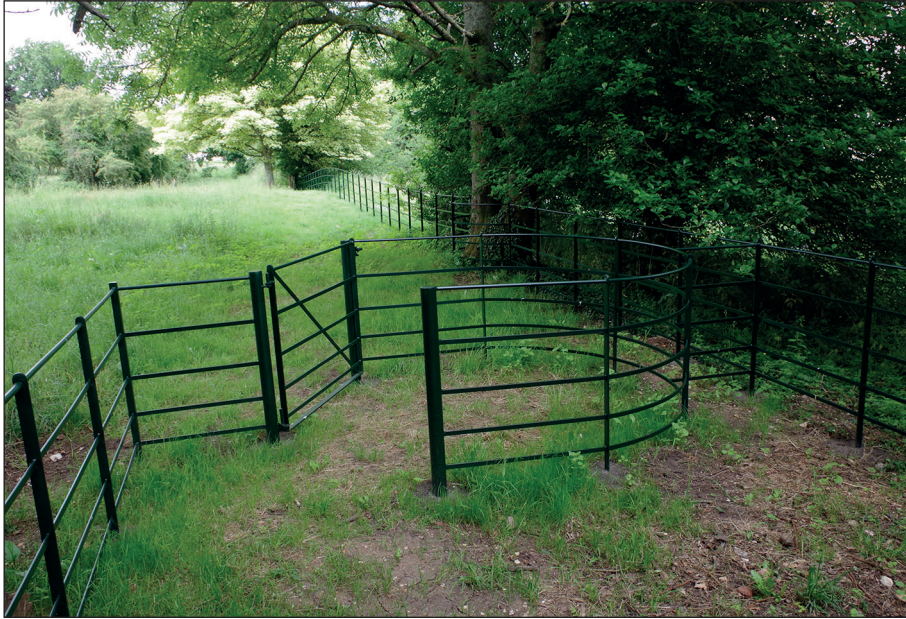
- 5.5.1 Along the Brewhouse Moat the fence line was replaced, and new kissing gate was installed at the north end of the fence line (**Plate 13**). In total of 53 post holes were excavated to facilities these works, each measuring 0.20 m² and 0.17–0.49 m deep.

Plate 13: New kissing gate, view from the north

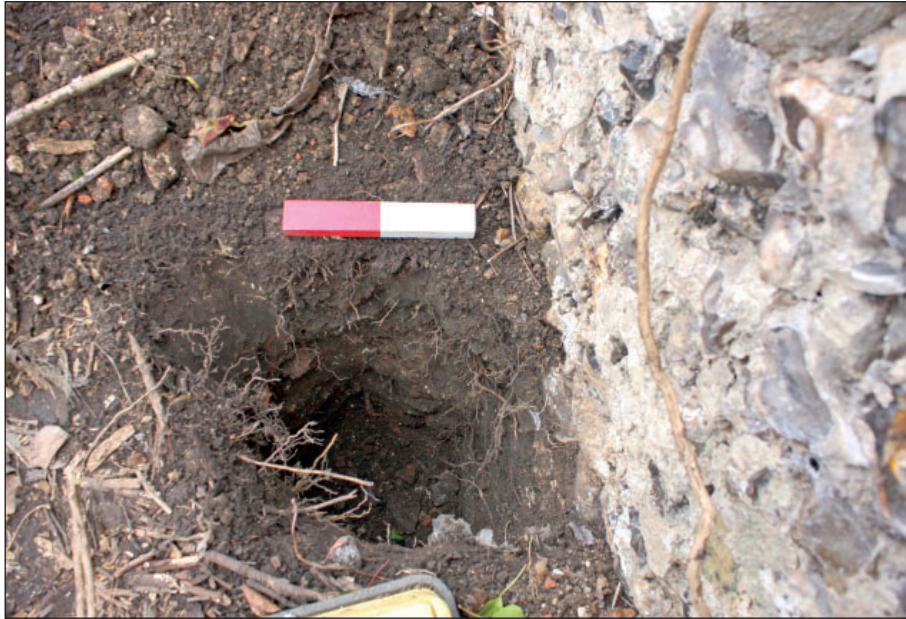
- 5.6.21 Postholes 70 and 71 (**Plate 33**) contained a made ground of mid brown mottled with yellow brown sandy clay loam, with common gravel and CBM, modern glass observed but not retained.

Plate 33: Posthole 71 from the north (0.2 m scale)

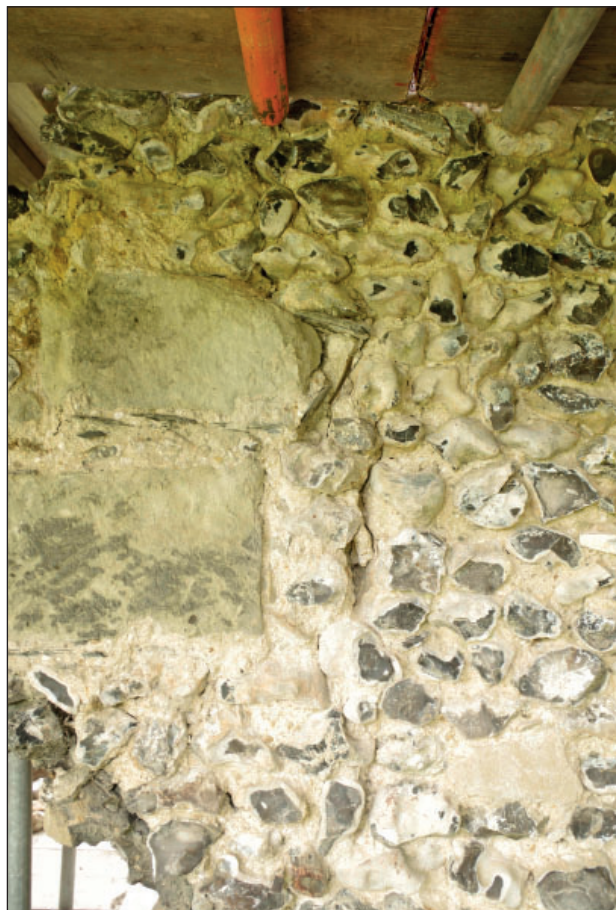
- 5.7.2 The north elevation of the north wall in the Kitchen exhibited a vertical crack in the mortar (**Plate 36**), immediately to the west of a series of large square stones. This wall also contains a significant fracture that runs from the ground the majority of the way up the wall, the top of which was recorded via the scaffolding (**Plate 37 and 38**). The west elevation of

Plate 36: Crack in north wall of Kitchen from the north

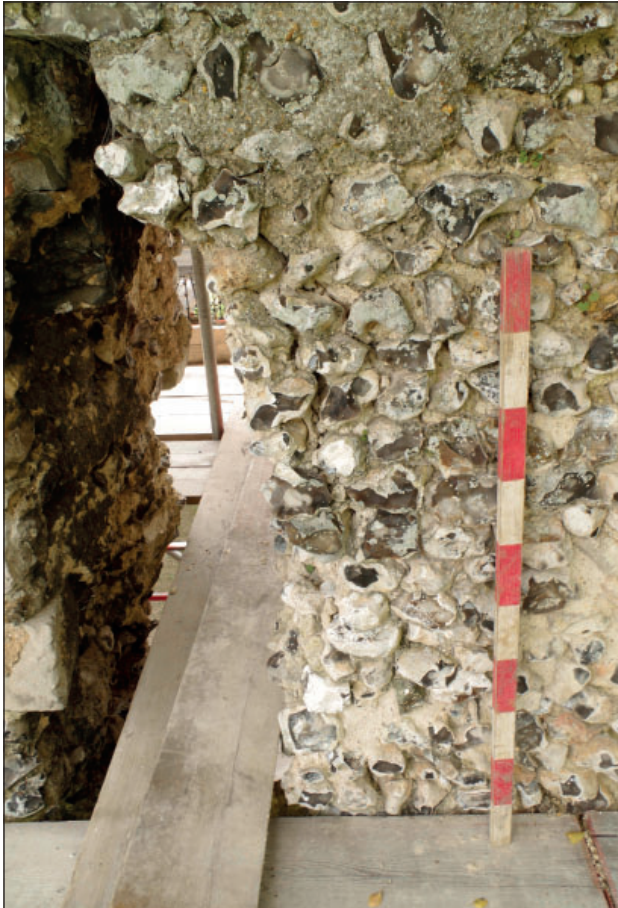
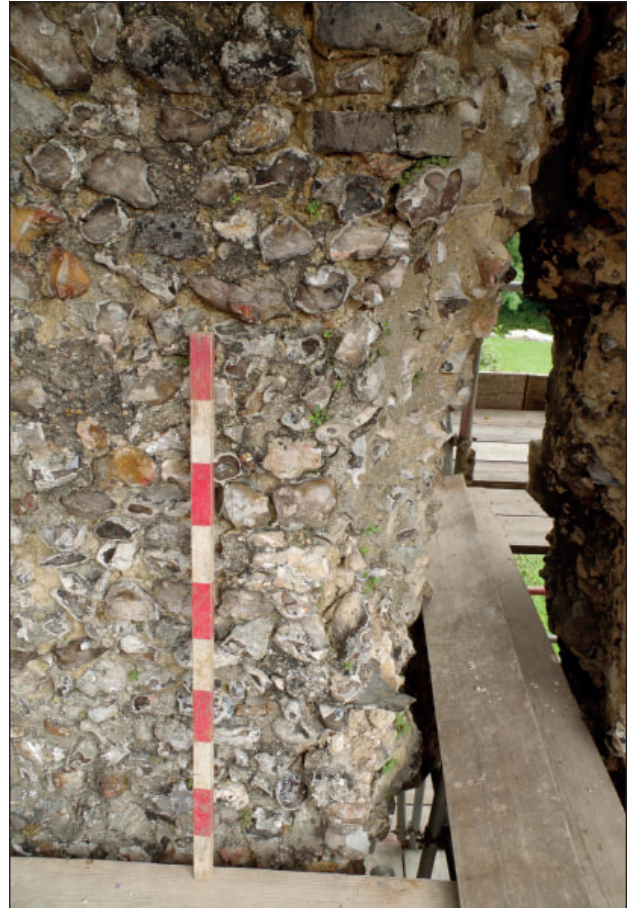
Plate 37: Significant fracture in north wall of Kitchen from the north (1 m scale)

Plate 38: Significant fracture in north wall of Kitchen from the south (1 m scale)

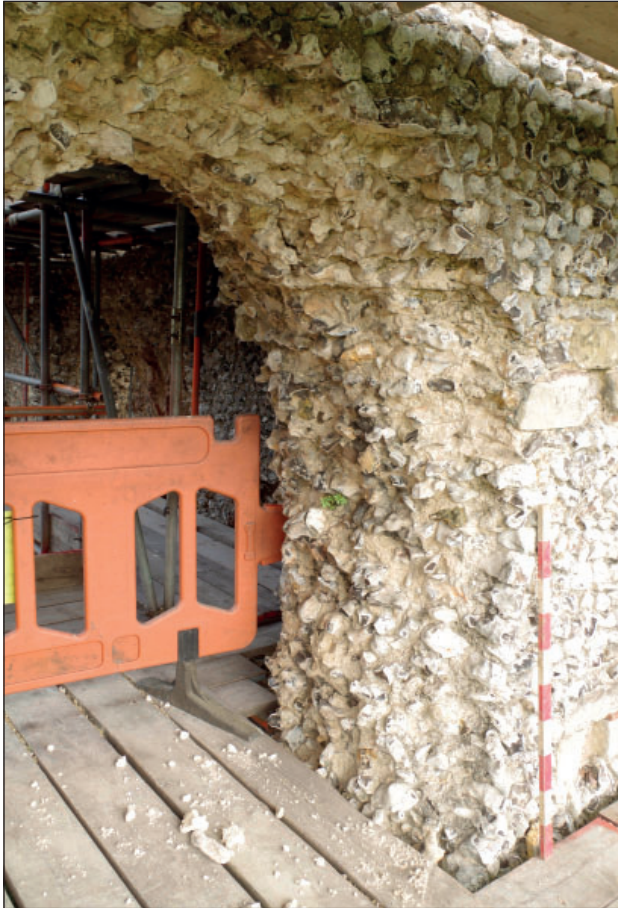
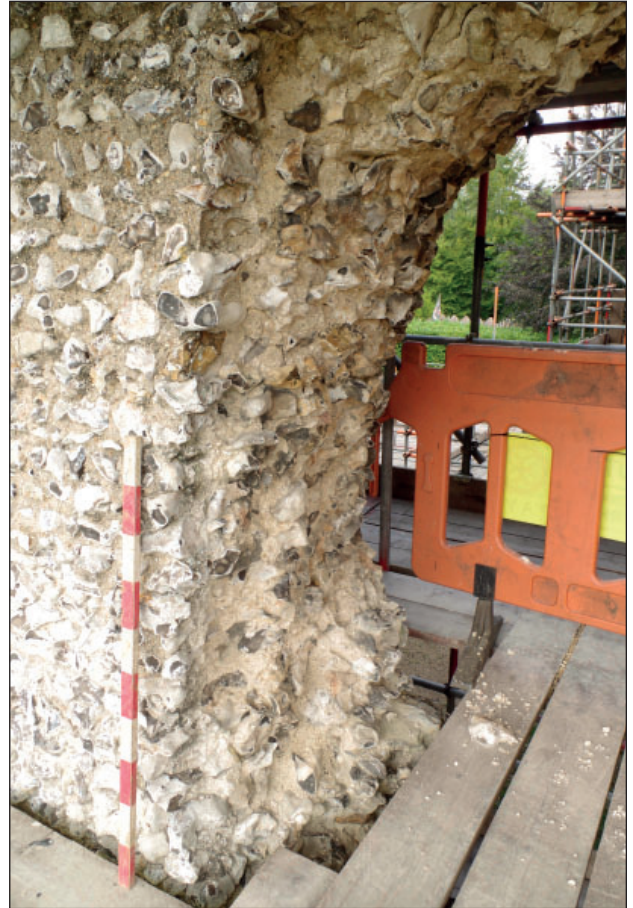
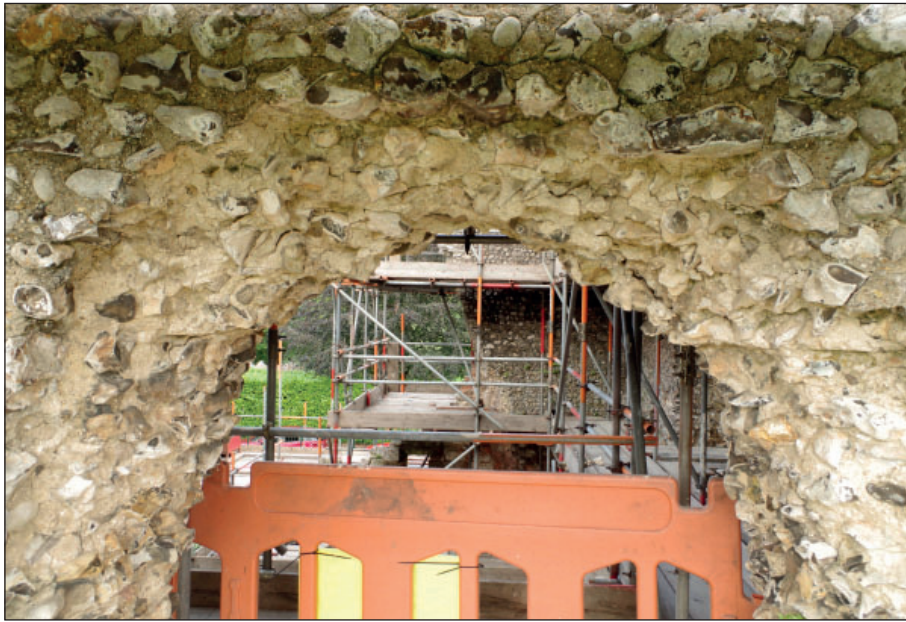
the east wall arch in the Kitchen (**Plates 39-41**) exhibited general degradation to the mortar, loosening the embedded flints. The west elevation of the west wall exhibited damage caused by ivy growing into the mortar (**Plate 42**).

Plate 39: East wall arch in Kitchen from the south-east (1 m scale)

Plate 40: East wall arch in Kitchen from the north-east (1 m scale)

Plate 41: East wall arch in Kitchen from the east (1 m scale)

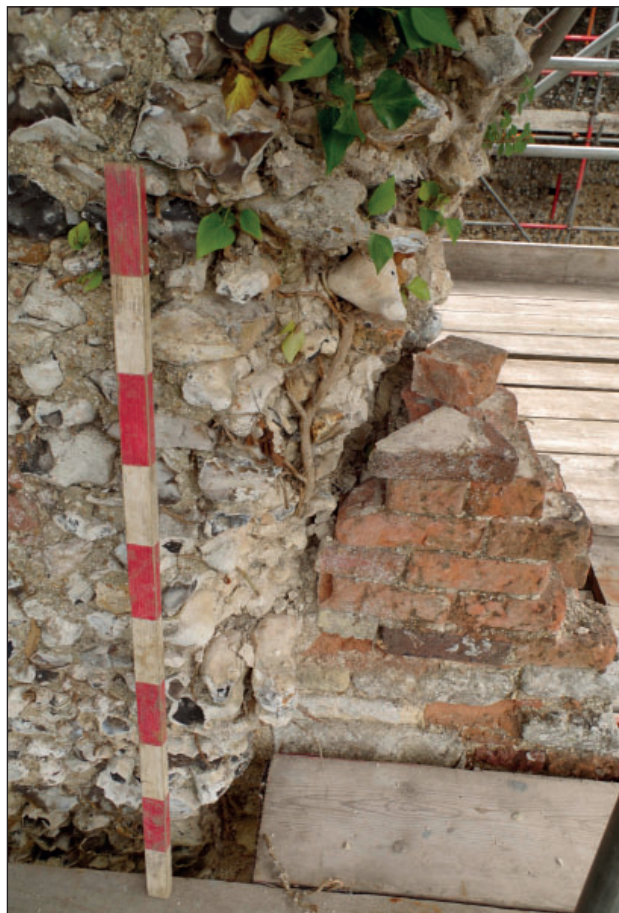
Plate 42: West wall of Kitchen from the west (1m scale)

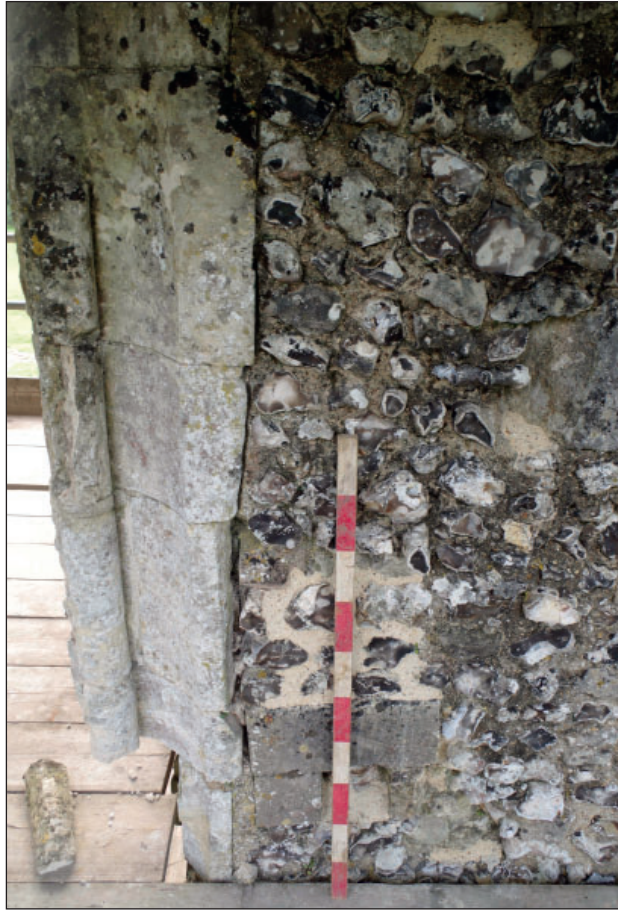
- 5.7.3 A new crack (**Plate 43**) was noted on the south side of the southernmost window at the west tower end of the Great Hall.

Plate 43: New crack in Great Hall, West Tower end from the west (1m scale)
