Alma Estate Regeneration Phase 1a Enfield, London

Archaeological Evaluation Report

Planning Ref: 15/02309/OUT & 15/2040/FUL
MoL No.: ALA16
Ref: 109772.01
December 2016

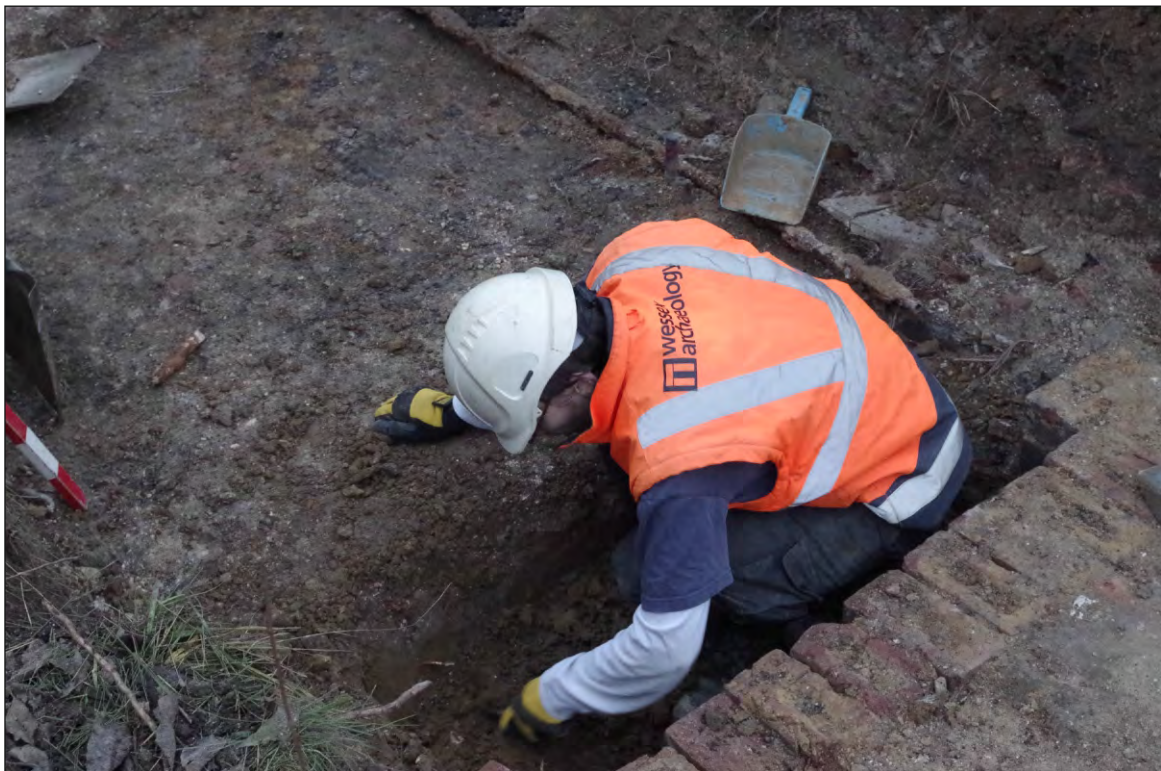
Cover Working shot, excavating foundation cut of 19th century terraced housing in trench 2

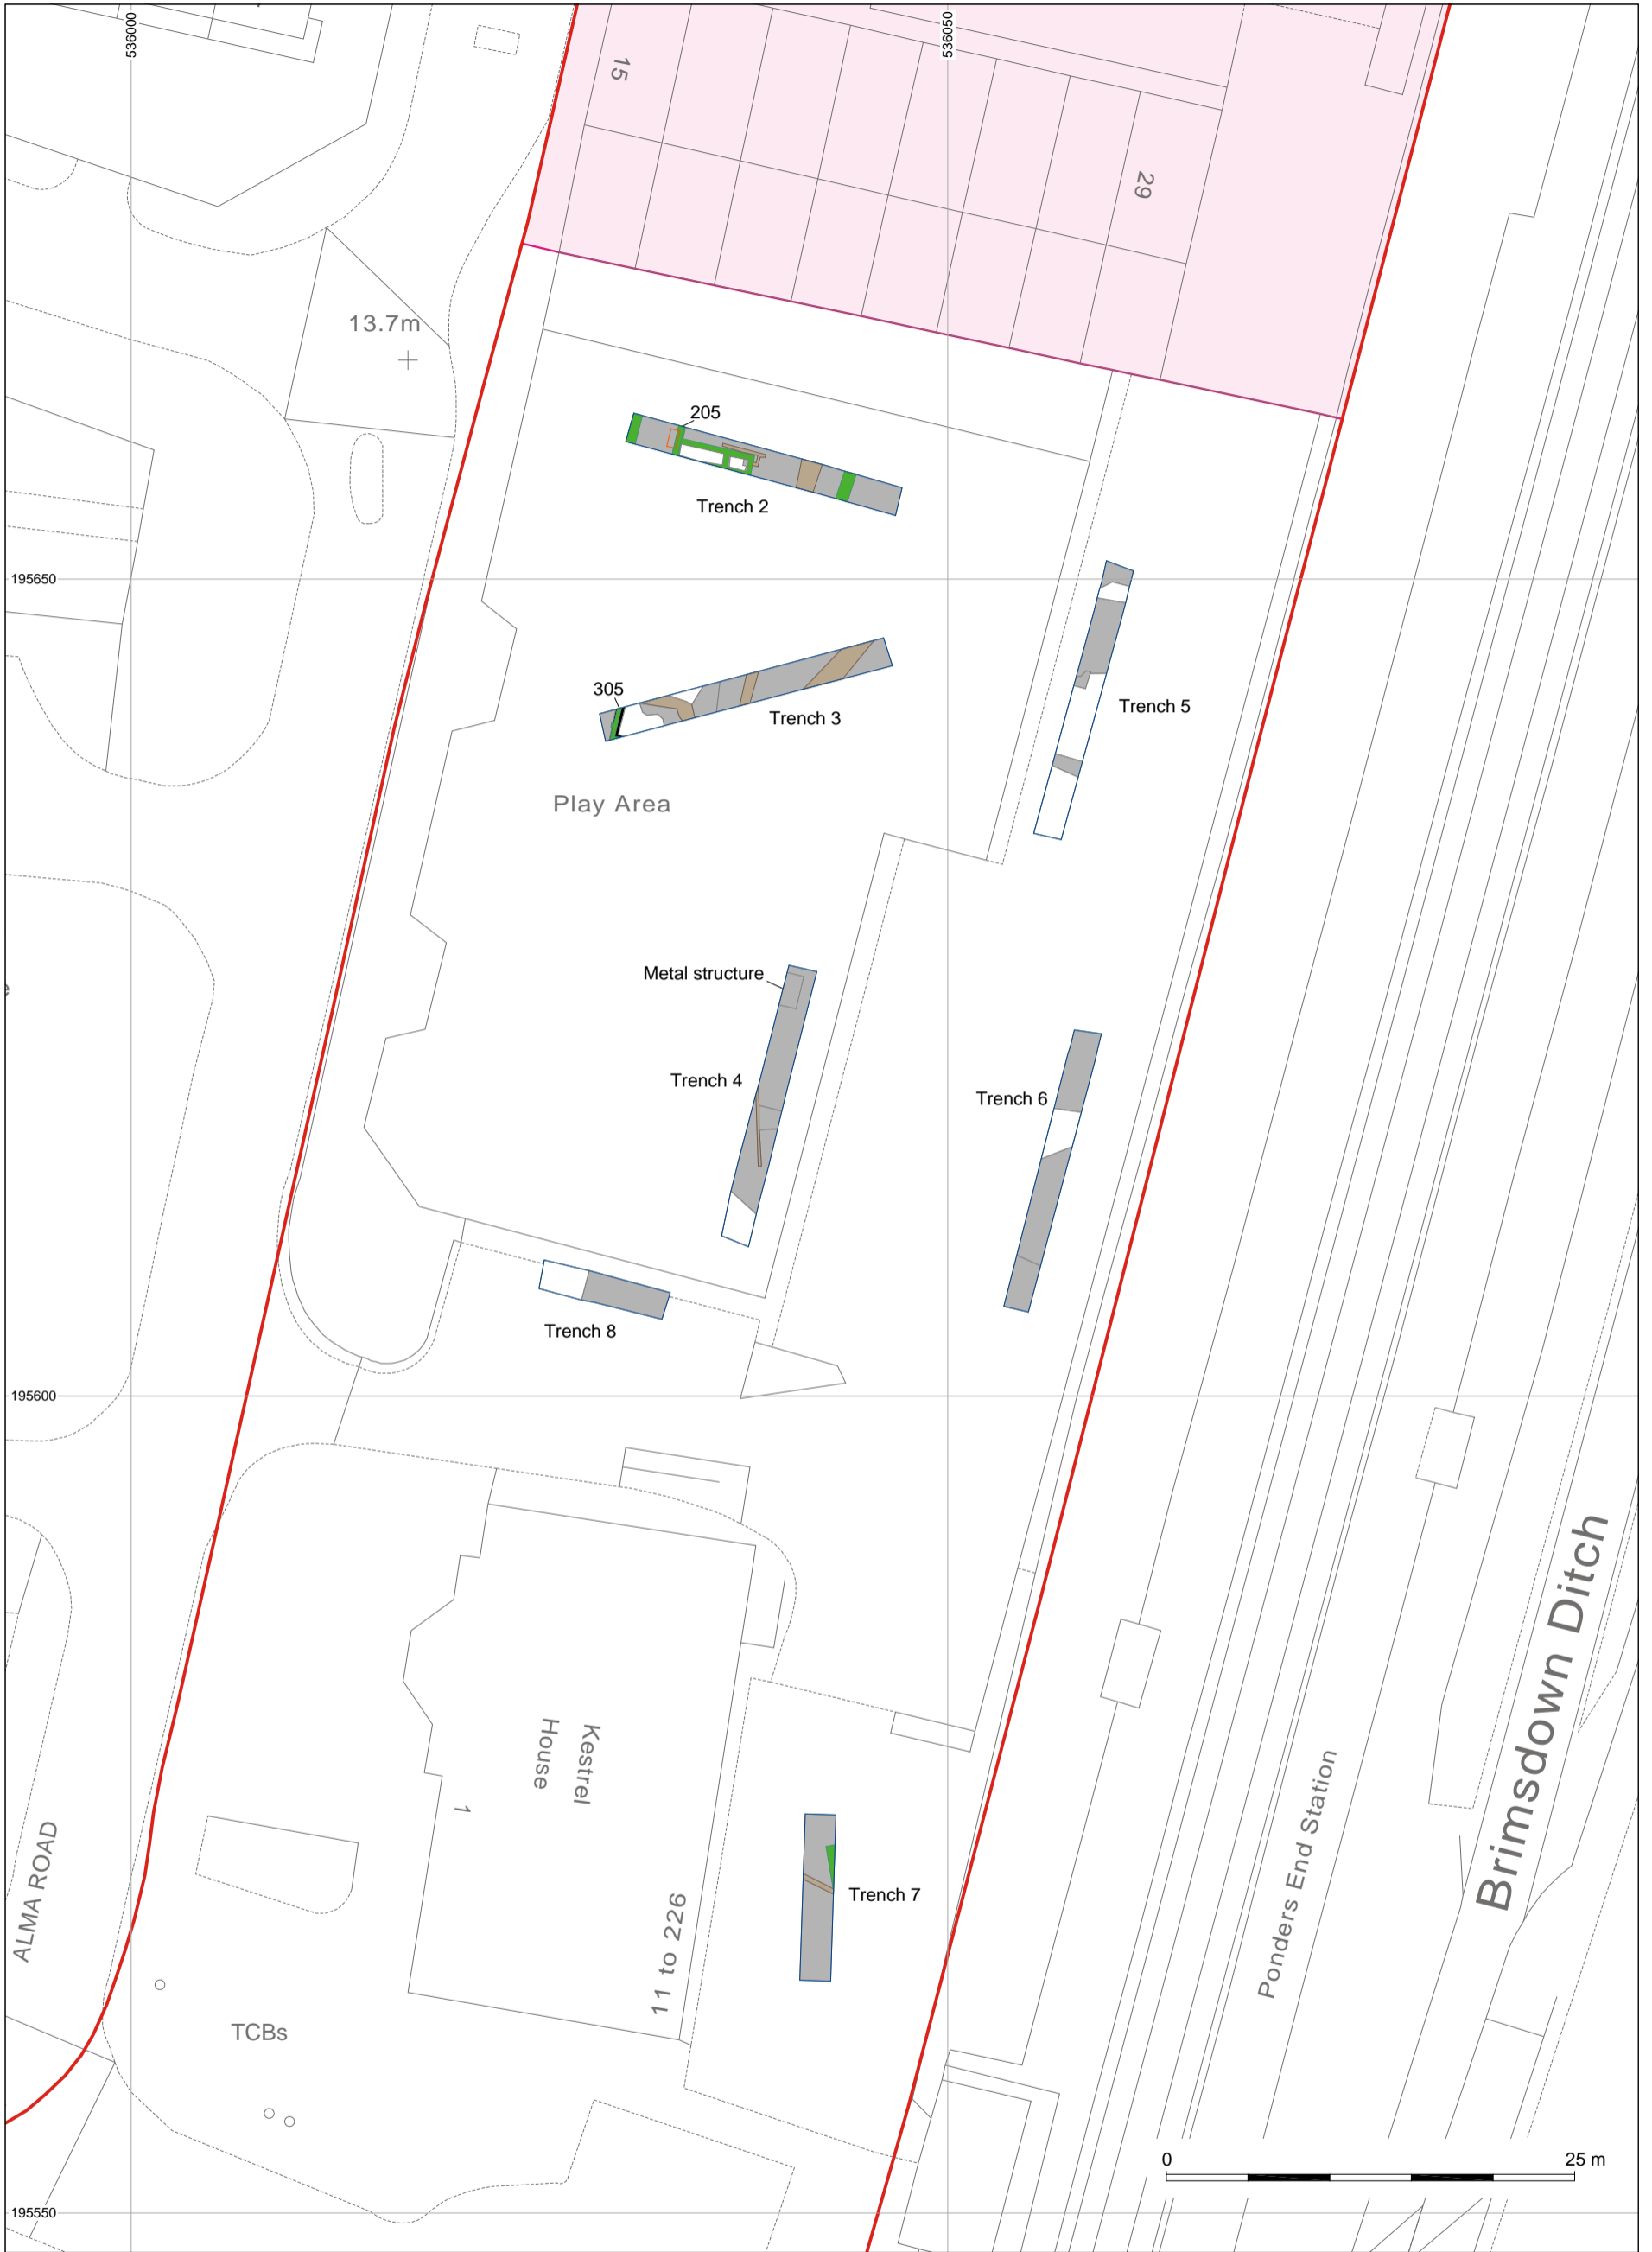
Figure 2

Trench plan

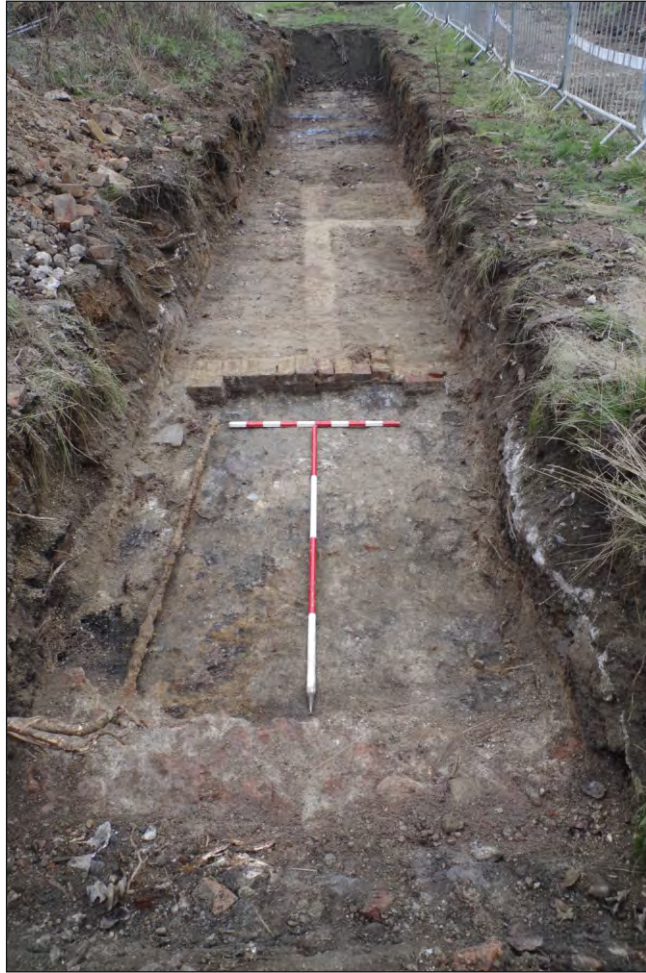
Plate 1: Trench 2, viewed from the west

4.3.2 Trench 2, orientated NNW-ESE, was located towards the north west of the Site and measured 20m x 2m. It was excavated to a depth of 13.1m above ordnance datum (aOD). The east end of the trench was excavated slightly deeper to 12.7m aOD by way of a sondage in order to ascertain any presence of surviving natural. Towards the west end of the trench were the remains of walls of the 19th century terraced houses, and on excavation of the foundation cuts, these did not appear to be basemented structures. A modern drainage pipe, with its associated cut and fill, running SSW-NNE, bisected the trench towards the east (**Plates 1 – 3**).

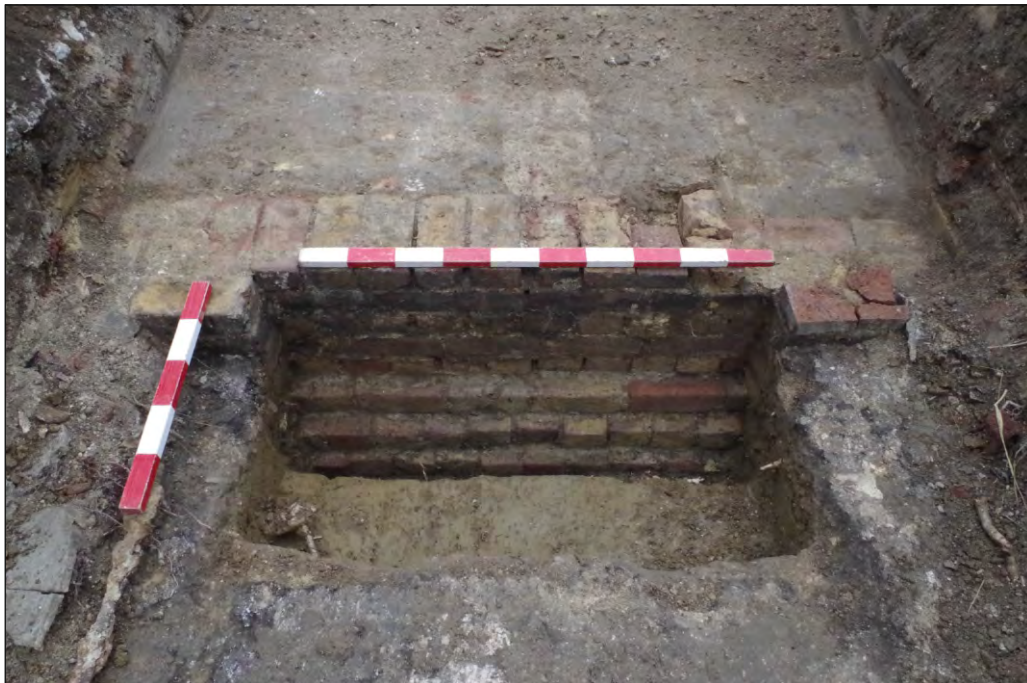
Plate 2: Trench 2, showing 19th century terraced housing walls and footings, viewed from the west

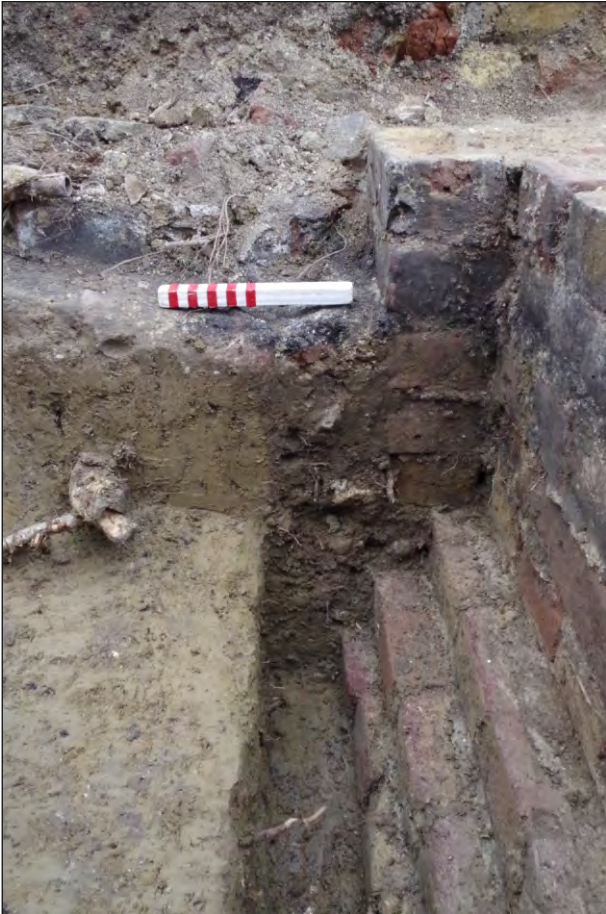
Plate 3: Trench 2, showing 19th century terraced housing walls and footings with foundation cut, viewed from the south

6.1.6 Excavation of the foundation cuts of the 19th century terraced housing showed that there does not appear to be any basements or cellars associated with them.

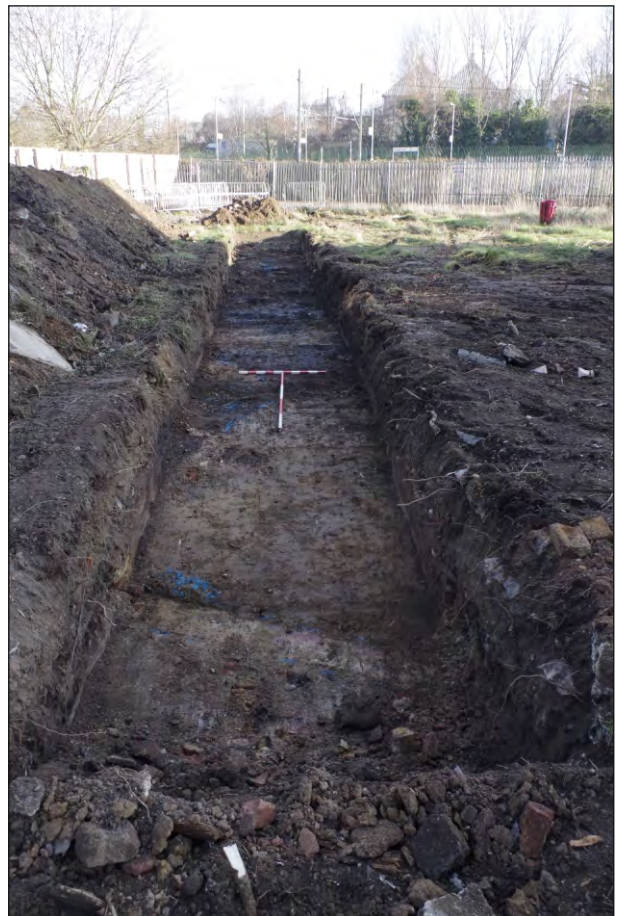
Plate 4: Trench 3, viewed from the west. 19th century terraced housing wall in foreground, modern truncation in the background

4.3.3 Trench 3, orientated WSW-ENE, was located towards the west of the Site and measured 20m x 2m. It was excavated to 12.9m aOD. Walls associated with the 19th century terraced housing were located at the western end of the trench. It was not possible to excavate the trench down to the natural layer due to the presence of several modern

drains and a metal pipe which were present at 12.9m aOD across the majority of the whole of the trench (**Plate 4**).

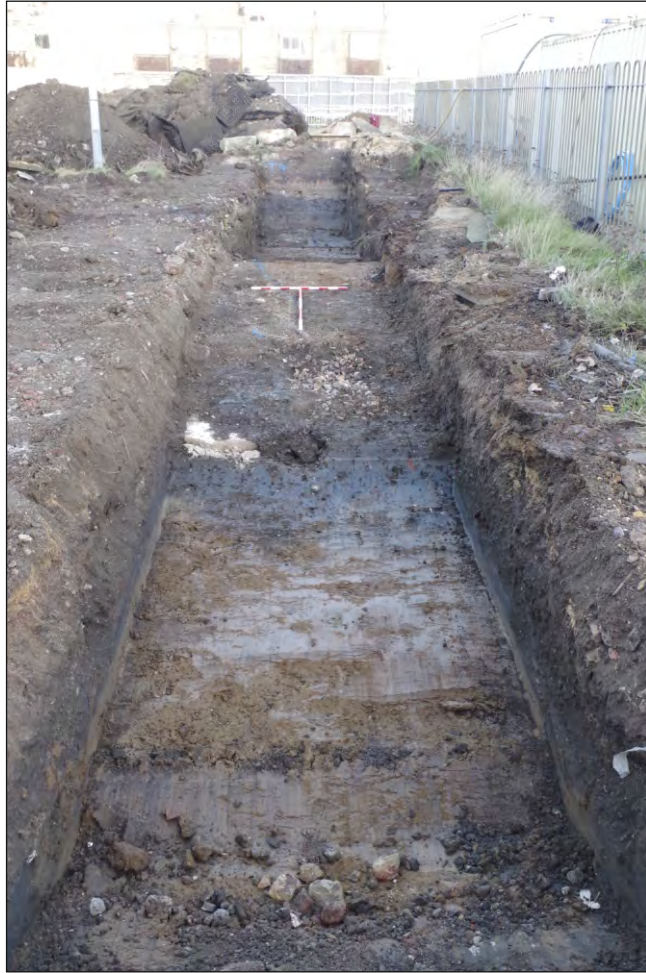
Plate 5: Trench 4, viewed from the south

- 4.3.4 Trench 4, orientated NNE-SSW, was located in the central part of the Site and measured 20m x 2m. It was excavated to 12.9m to the top of the natural horizon. The trench was bisected by a N-S aligned land drain in the central part of the trench. Towards the north end of the trench, there was severe modern truncation to a minimum depth of 12.6m aOD associated with a square metal structure, of presumed modern date due to the modern made ground layers associated with it. (**Plates 5-7**).

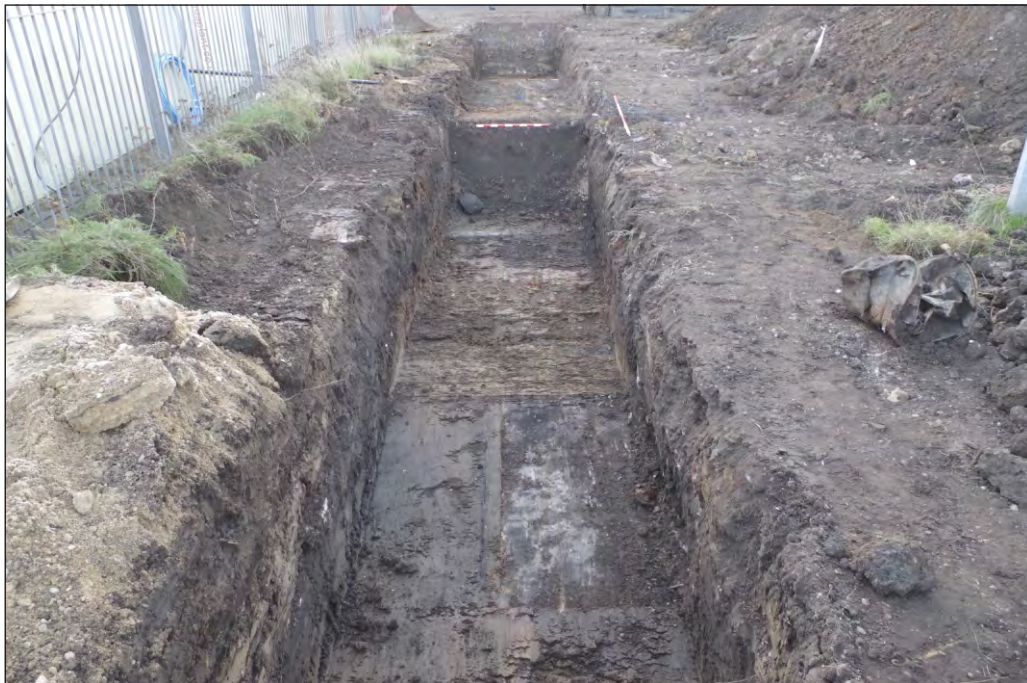
Plate 6: Trench 4, viewed from the north. Metal structure and made ground truncating the natural

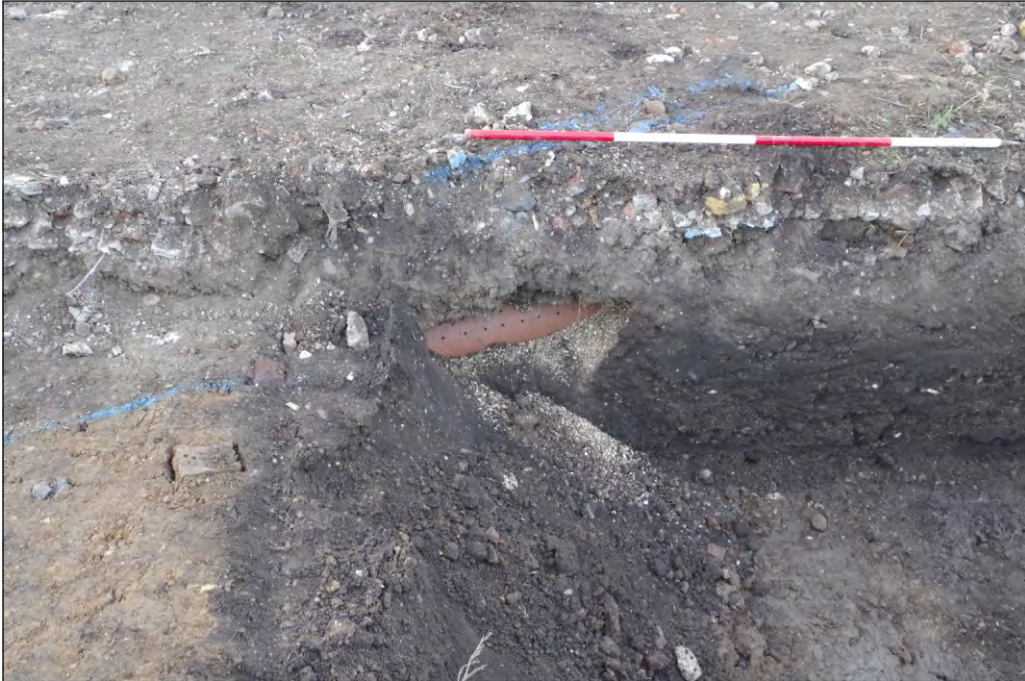
Plate 7: Trench 4, viewed from the east, showing modern drain truncation

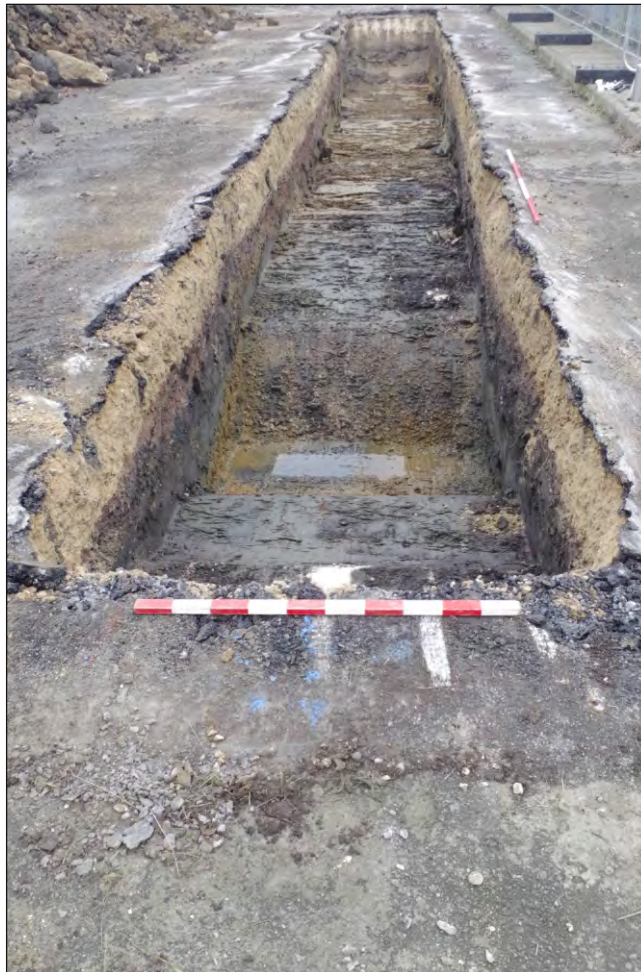
Plate 8: Trench 5, viewed from the north

- 4.3.5 Trench 5, orientated NNE-SSW, was located to the north of the Site in an existing car park area and measured 20m x 2m. It was excavated to 12.4m aOD to the top of the natural horizon. A sondage was dug at the north end of the trench to 12.0m aOD to ascertain the presence of the natural horizon sealed by the made ground layers. The natural horizon was truncated by patches of modern disturbance (**Plate 8**).

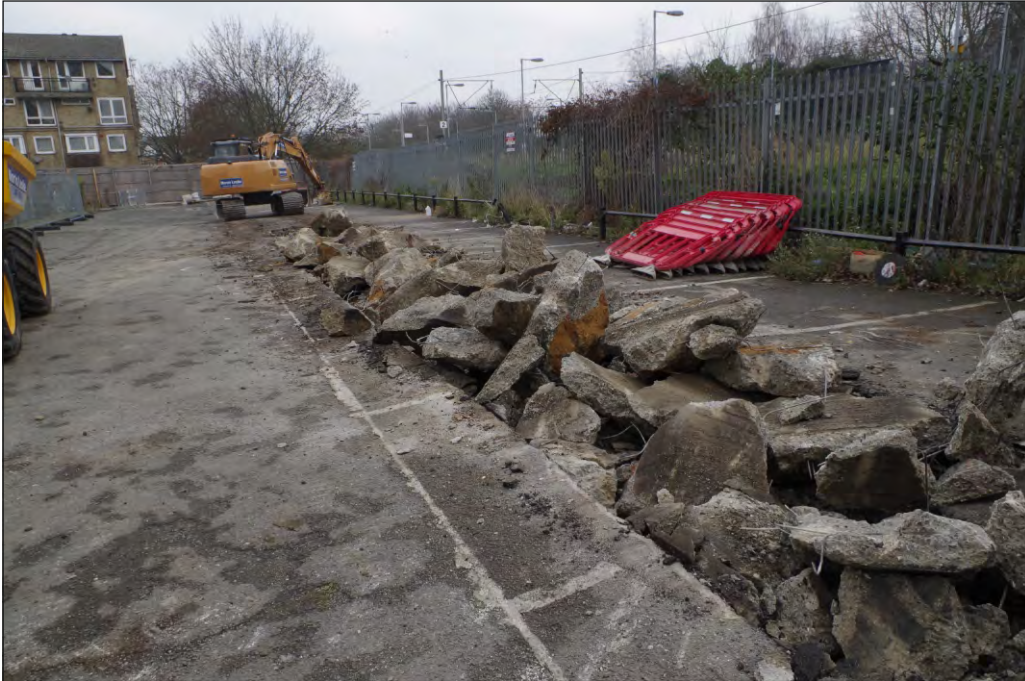
Plate 9: Trench 6, reinforced concrete layer

- 4.3.6 Trench 6, orientated NNE-SSW, was located to the east of the Site in an existing car park area and measured 20m x 2m. It was excavated to a depth of 12.7m aOD to the top of the natural horizon. Towards the south of the trench the natural was truncated by a modern concrete slab, and towards the north the natural was severely truncated by modern disturbance (**Plates 9-10**).

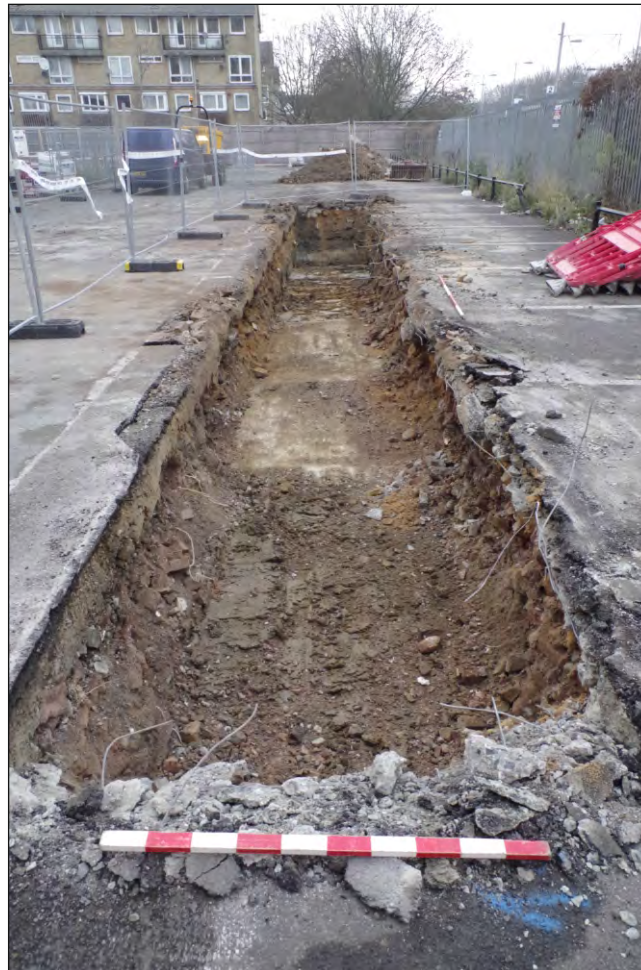
Plate 10: Trench 6, viewed from the south

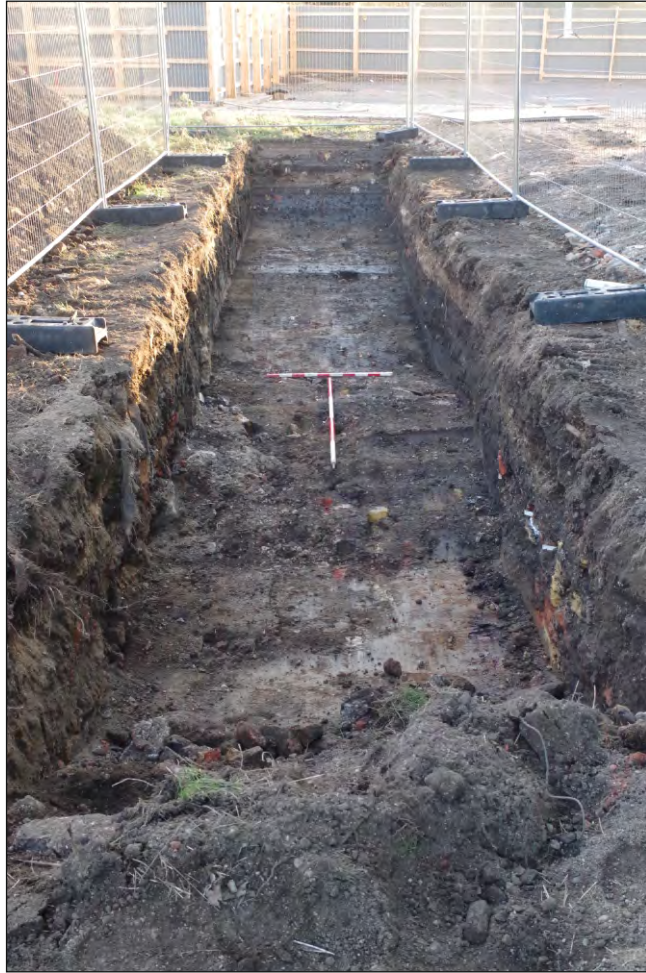
Plate 11: Trench 7, viewed from the north

- 4.3.7 Trench 7, orientated NNE-SSW, was located at the southern end of the Site and was moved south and shortened to 13m x 2m to avoid detected services. It was excavated to a depth of 12.6m aOD and was severely truncated by modern disturbance and drainage (**Plate 11**).

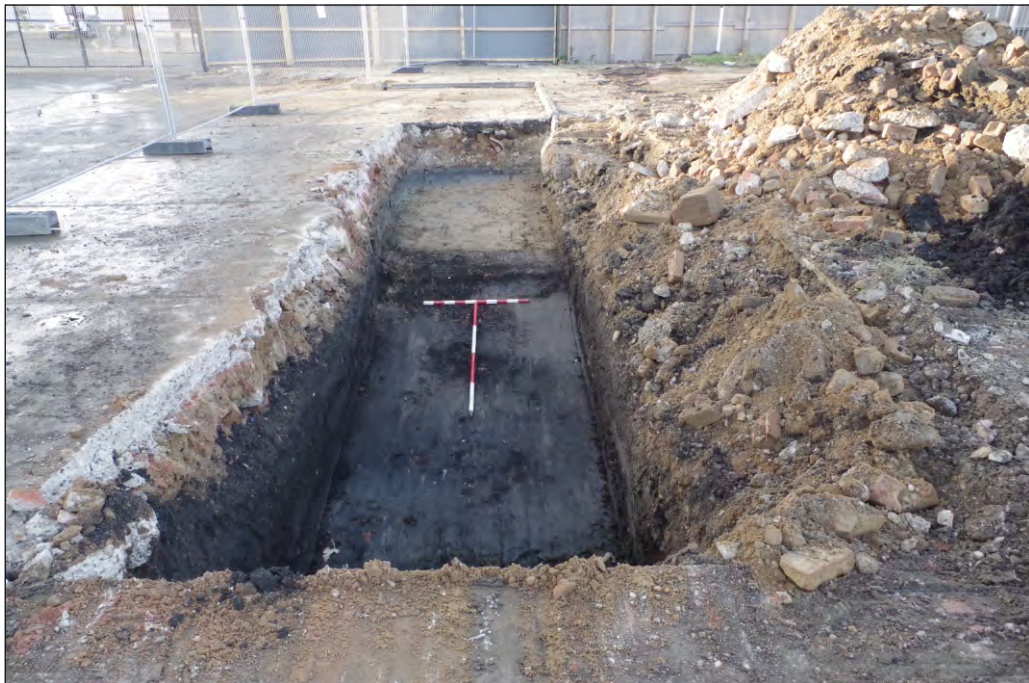
Plate 12: Trench 8, viewed from the east

- 4.3.8 Trench 8, orientated WNW-ESE, was located to the west of the central part of the Site and measured 10m x 2m. It was excavated to the natural horizon at 12.8m aOD. At the eastern end of the trench a sondage to 12.3m aOD showed that the natural was truncated by modern made ground deposits (**Plate 12**).
