118 Putney Bridge Road,
London Borough of Wandsworth
Greater London

Archaeological Evaluation Report

Site code: PBI 08

October 2008

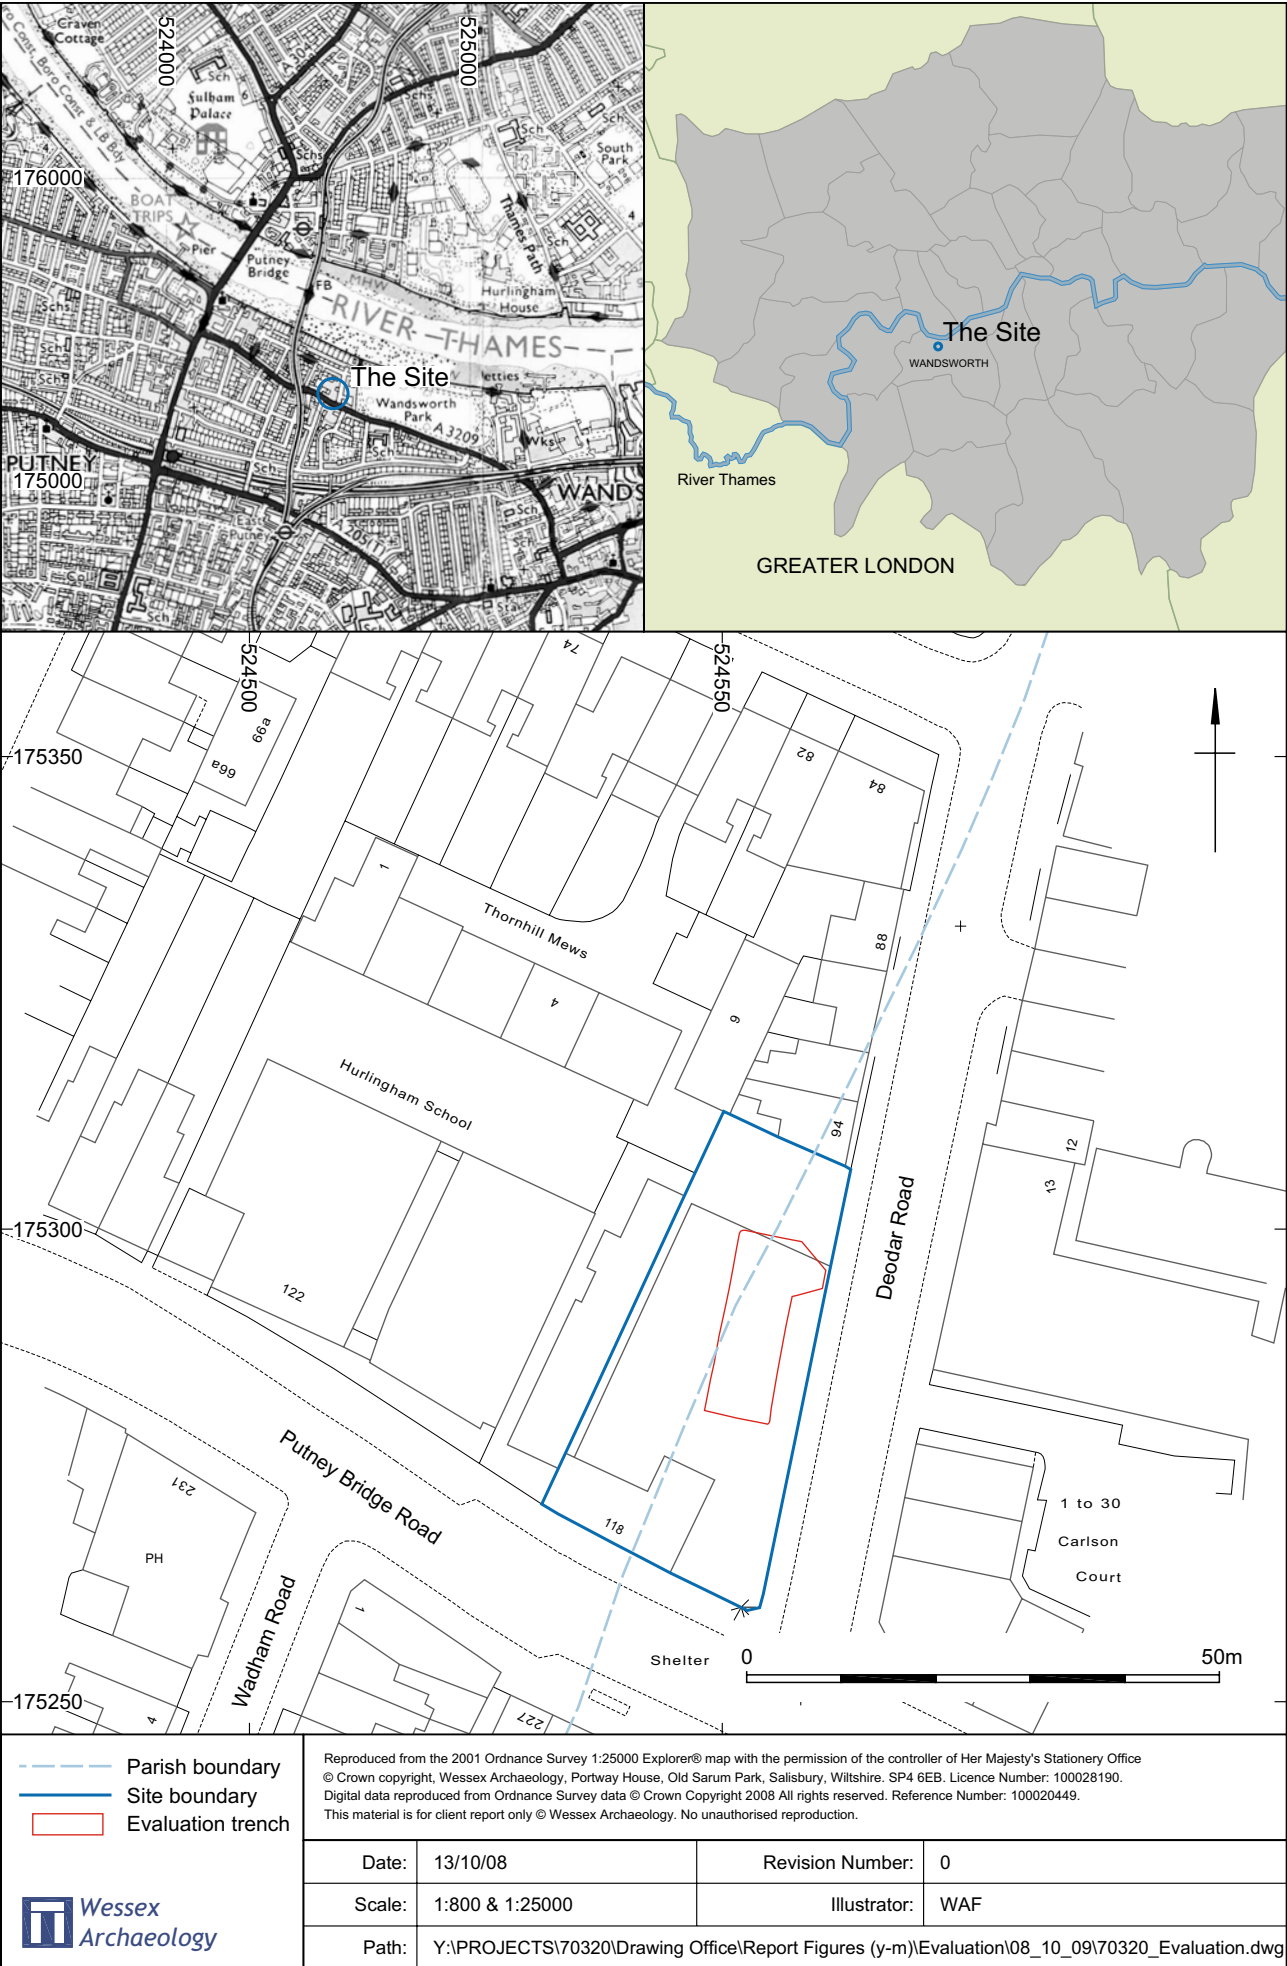
Figure 1

Site and trench location

- 1.1.1 Wessex Archaeology was commissioned by CgMs Consulting to undertake an archaeological evaluation of a c. 0.097Ha area of land at 118 Putney Bridge Road in the London Borough of Wandsworth (**Figure 1**), hereafter referred to as 'the Site'. The fieldwork comprised the machine excavation of a single stepped evaluation trench measuring 130m² in plan at existing ground surface, comprising an approximate 13% sample (by area) of the Site. The fieldwork was undertaken between the 23rd and 30th September 2008. This report describes and summarises the results of the archaeological evaluation of the Site.

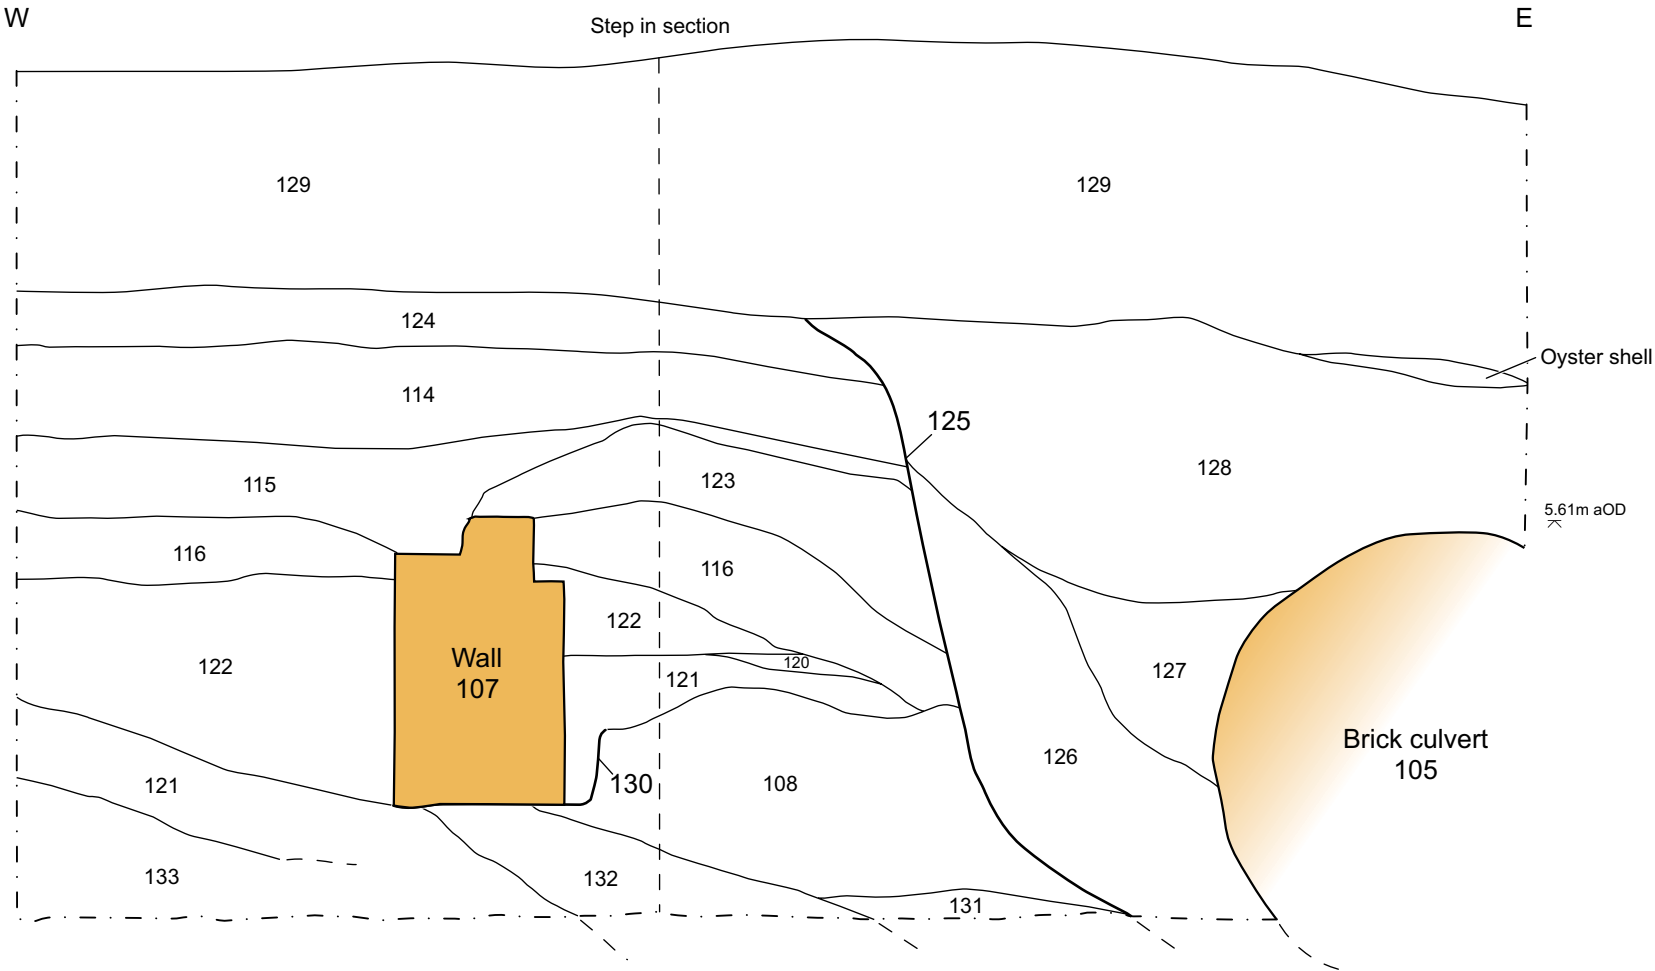
Section 3a

- 5.2.1 The natural geology was encountered at 5.05m (aOD) – **Figure 3a**. It was characterised by both natural chert gravel and clay/sand. The natural gravel (**131**) was characterised by a mid orange/brown fine sand matrix containing very common, well-sorted, dark orange/brown sub-rounded and sub-angular chert gravel (<30mm). Where exposed this deposit had been cut by the foundation trench (**125**) for a large brick-built culvert (**105**) which cut across the Site. This gravel overlay three natural deposits (**121**, **131**, **132**). The two earlier deposits (**131**, **132**) were characterised by light to mid bluish-grey alluvial sand and sandy clay respectively, which contained no coarse components though had common iron staining and degraded waterlogged wood remains (<3mm). Their gleyed aspect indicates their anaerobic deposition in water. The later deposit (**121**) was a disturbed natural layer of mid greyish-brown sandy clay containing rare brick and coal fragments, due to an overlying industrial waste deposit (**122**).

- 5.3.1 Overlying the natural gravel and alluvial deposits was a 1.34m deep sequence of dump deposits (**108**, **114-116**, **120**, **122** – **124**) which have been built up over the natural geology (**Figure 3a**; **Plate 1**). All the deposits except rubble deposit **108**, post-date the construction of the earliest brick wall (**107**) recorded during the fieldwork. Deposit **108** was a crushed lime mortar containing brick fragments and copper smelting waste as well as lumps of degraded lime mortar. The copper smelting material was probably imported onto the Site for use as hard core material and mixed with an earlier (18th century?) reworked rubble (**108**) from the demolition of a brick-built structure on the Site.

South facing section of trench

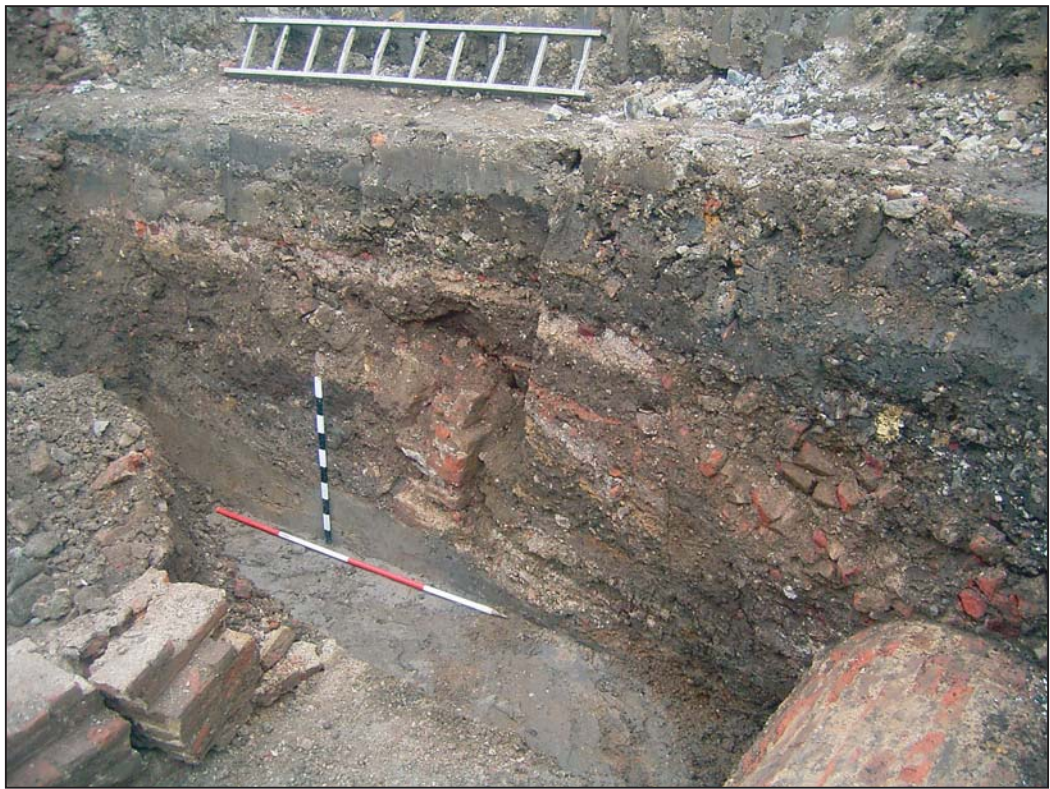
Plate 1: South facing section of trench viewed from the south-east (scales: 2m, 1m)

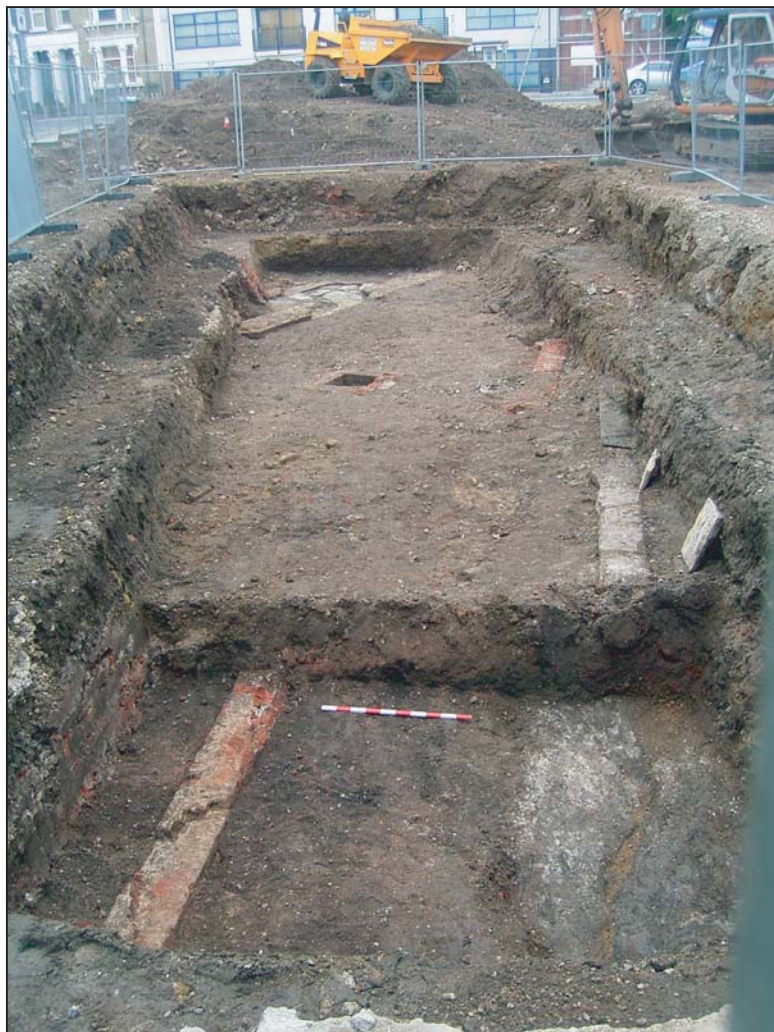
Plate 2: General view of trench from the north (scale 1m)

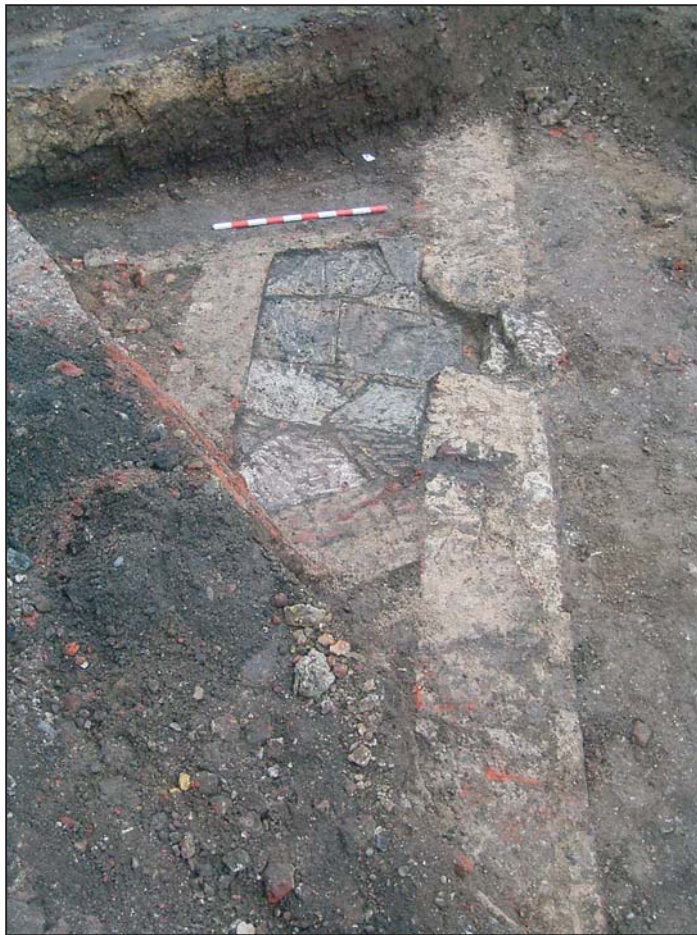
- 5.3.6 At the same stratigraphic position (and depth from surface) as wall **104** was an area of brick walling and associated flagstone and tile flooring in the south-east corner of the trench (**106**) – (**Figure 2; Plate 3**). These structural remains correlate well with the irregular-walled structure recorded first on the 1894 Second Edition Ordnance Survey Map (CgMs 2007, figure 7) which on the 1907 Goad Insurance Map (CgMs 2007, figure 8) is clearly labelled as 'Putney Bridge Steam Laundry'. These structural remains would closely correlate with the angled west wall of the northern structure labelled as the 'Wash House' on the 1907 map (*ibid*, figure 7).

| Trench | Co-ordinates: NW - 524552, 175299; SW - 524548, 175280 Ground Level (m AOD): 8.0 | Dimensions: 17.5x4.5 Max.depth: 3.43 |
|---|---|---|
| 106 | Group of late 19 th century brick walls in the SE corner of trench. Also associated with flagstone floor and floor tiles on edge. Includes a narrow doorway or chute/flue? in the main NE/SW aligned wall. Part of 19 th century laundry complex? | 2.00(+) |

Plate 3: Structural remains (106) viewed from the north-east (scale 1m)

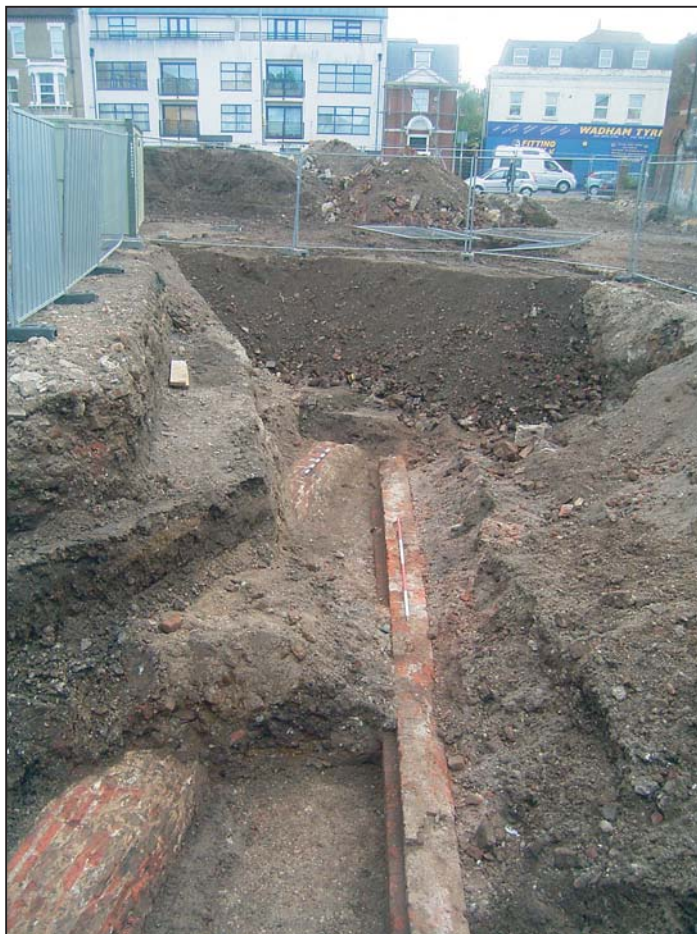
- 5.3.7 By far the largest impact upon the deposits of the Site was the construction of a large, north-north-east/south-south-west aligned, slightly curvilinear brick-built culvert (**105**) which was built slightly to the east of the line of the historical parish boundary between Putney and Wandsworth (**Plate 4**). This boundary probably began in the early medieval period (CgMs 2007, 9) which later became known locally as the 'Putney Gutter'. A possible ditched boundary is shown on the line of the parish boundary on the 1838 Wandsworth Tithe Map (CgMs 2007, figure 3).

- 5.3.8 The culvert is laid within a large foundation cut (**125**) which had truncated the earlier dumps overlying wall **107** and any earlier structural remains as it cut south and slightly west diagonally across the centre of the Site. The culvert's construction also truncated walls **104** and **107** (**Plate 4**) in the south of the trench. The foundation cut was at least 2.60m wide and c. 1.6m deep with near-vertical sides, and backfilled with redeposited natural sands and gravels (**126**) and demolition rubble (**127, 128**). The culvert was an elliptical cross-sectioned brick construction, unrendered on its internal and external surfaces, with walls built of two courses of stretcher-on-edge brickwork. This resulted in a culvert with internal dimensions of 1.0m (high) by 0.7m (wide) with a very gradual fall down to the north (towards the River Thames). A small square inspection manhole for the culvert was recorded at 2.0m depth (6.0m aOD). The spatial and stratigraphic location of the culvert, as well as its characteristics suggest an early-mid 19th century date, prior to the more substantial structures built on the Site (from the later 19th century onwards).

Plate 4: Culvert 105 truncating wall 107. Viewed from the north (scales 2m, 1m)
