25 Lavington Street London Borough of Southwark

Archaeological Evaluation Report

Ref: 111041.02 May 2016

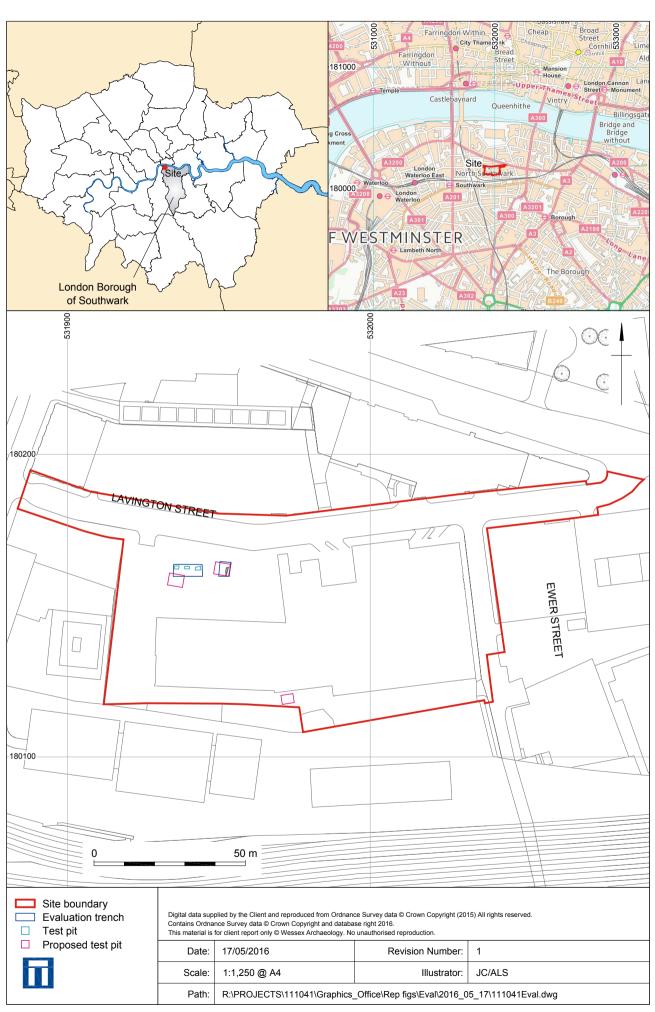
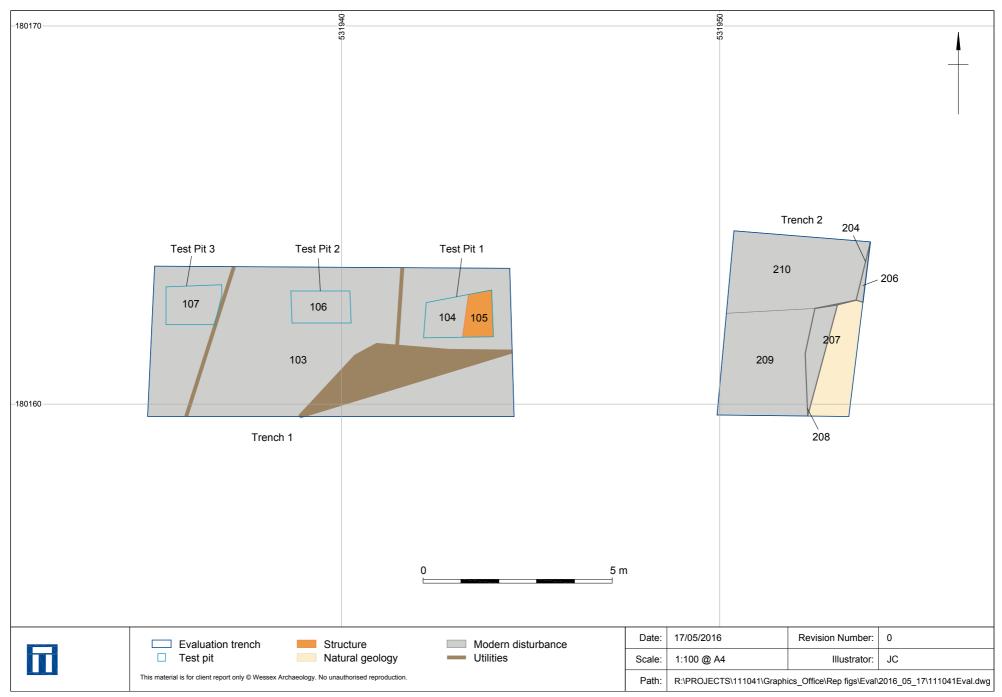
- 4.1.3 Due to the presence of buried services across the Site the northern two trenches were repositioned. The third proposed trench to the south was not excavated due to health and safety and logistical issues. The proposed and excavated trenches are shown on Figure 1. During the excavation of Trench 1, services were encountered (Figure 2) making the full excavation of the trench impossible. The decision was therefore taken to machine excavate three (No. 3) test pits within the confines of the trench footprint in consultation with representatives from the client and Southwark Borough Council (Figure 2).

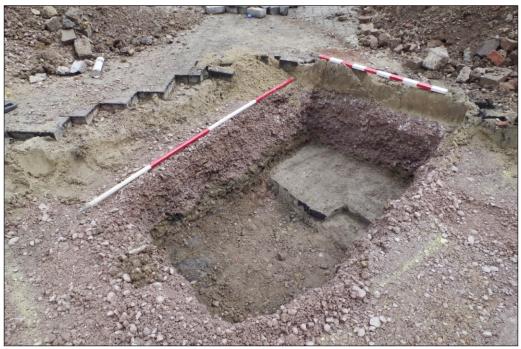
Plate 1: Test Pit 1 viewed from the south west

- 5.2.2 Test pit 1 was located in the north east of Trench 1 and was unable to be excavated to the full depth due to the presence of a large brick and cement drain structure **105** (**Plate 1**). This test pit was excavated to a depth of 2.07m aOD and revealed only a made ground gravel deposit containing abundant brick fragments, wood, concrete and modern metal debris overlaying the structure.

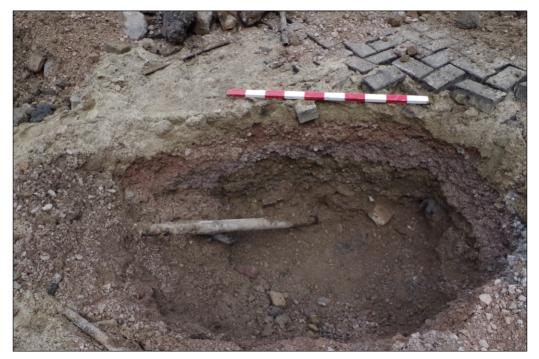
Plate 2: Mid-excavation shot of Test Pit 2 viewed from the north

- 5.2.3 Test pit 2 was located in the centre of Trench 1. The test pit was machined to a depth of 1.60m aOD and a representative section recorded (**Plate 2**). The test pit was then further machined to a depth of 0.84m aOD. No undisturbed deposits were encountered. Of the observed made ground deposits **106** consisted of large amount of modern ceramic building material (CBM) and dumped modern construction material.

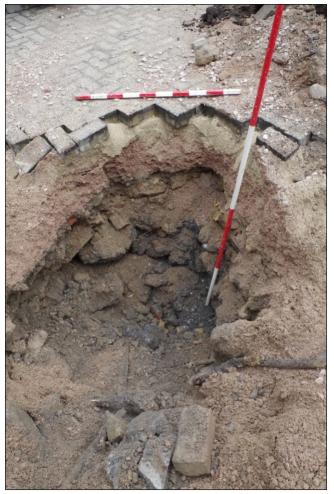
Plate 3: Mid-excavation shot of Test Pit 3, viewed from the south west

- 5.2.4 Test pit 3 was located in the northwest of Trench 1. The test pit was machined to a depth of 1.74m aOD and a representative section recorded (**Plate 3**). The test pit was then further machine excavated to a depth of 0.76m aOD, before the instability of the trench sides and presence of exposed utility services forced the abandonment of the test pit. No undisturbed natural deposits were encountered, and of the observed made ground deposits **107** consisted of large amounts of modern CBM and dumped construction material.

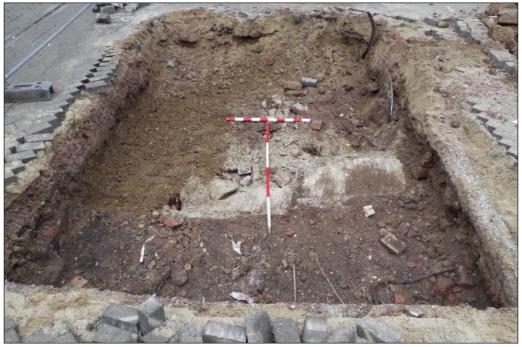
Plate 4: Trench 2 viewed from the north

5.3.1 Trench 2 was located to the northeast of the Site and measured 5m x 3.6m. This trench was excavated to a depth of 1.83m aOD at which level natural gravel deposits **207** were encountered in an isolated area to the east of the test pit (**Plate 4 & Figure 2**). The majority of the trench was heavily truncated by a large modern cut **208** which contained two distinct fills of demolition rubble **209** and **210**. At the north eastern corner of the test pit the edge of a brick-lined modern manhole **206**, was exposed which sat within cut **204** which in turn cut deposit **210** (**Plate 5**).

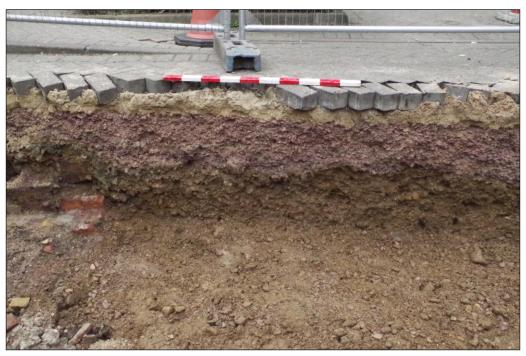
Plate 5: Representative section of Trench 2 viewed from the west showing surviving natural gravels
