Hornsea Offshore Wind Farm Project ONE

Earthwork Survey Report

Ref: 110496.01
August 2016

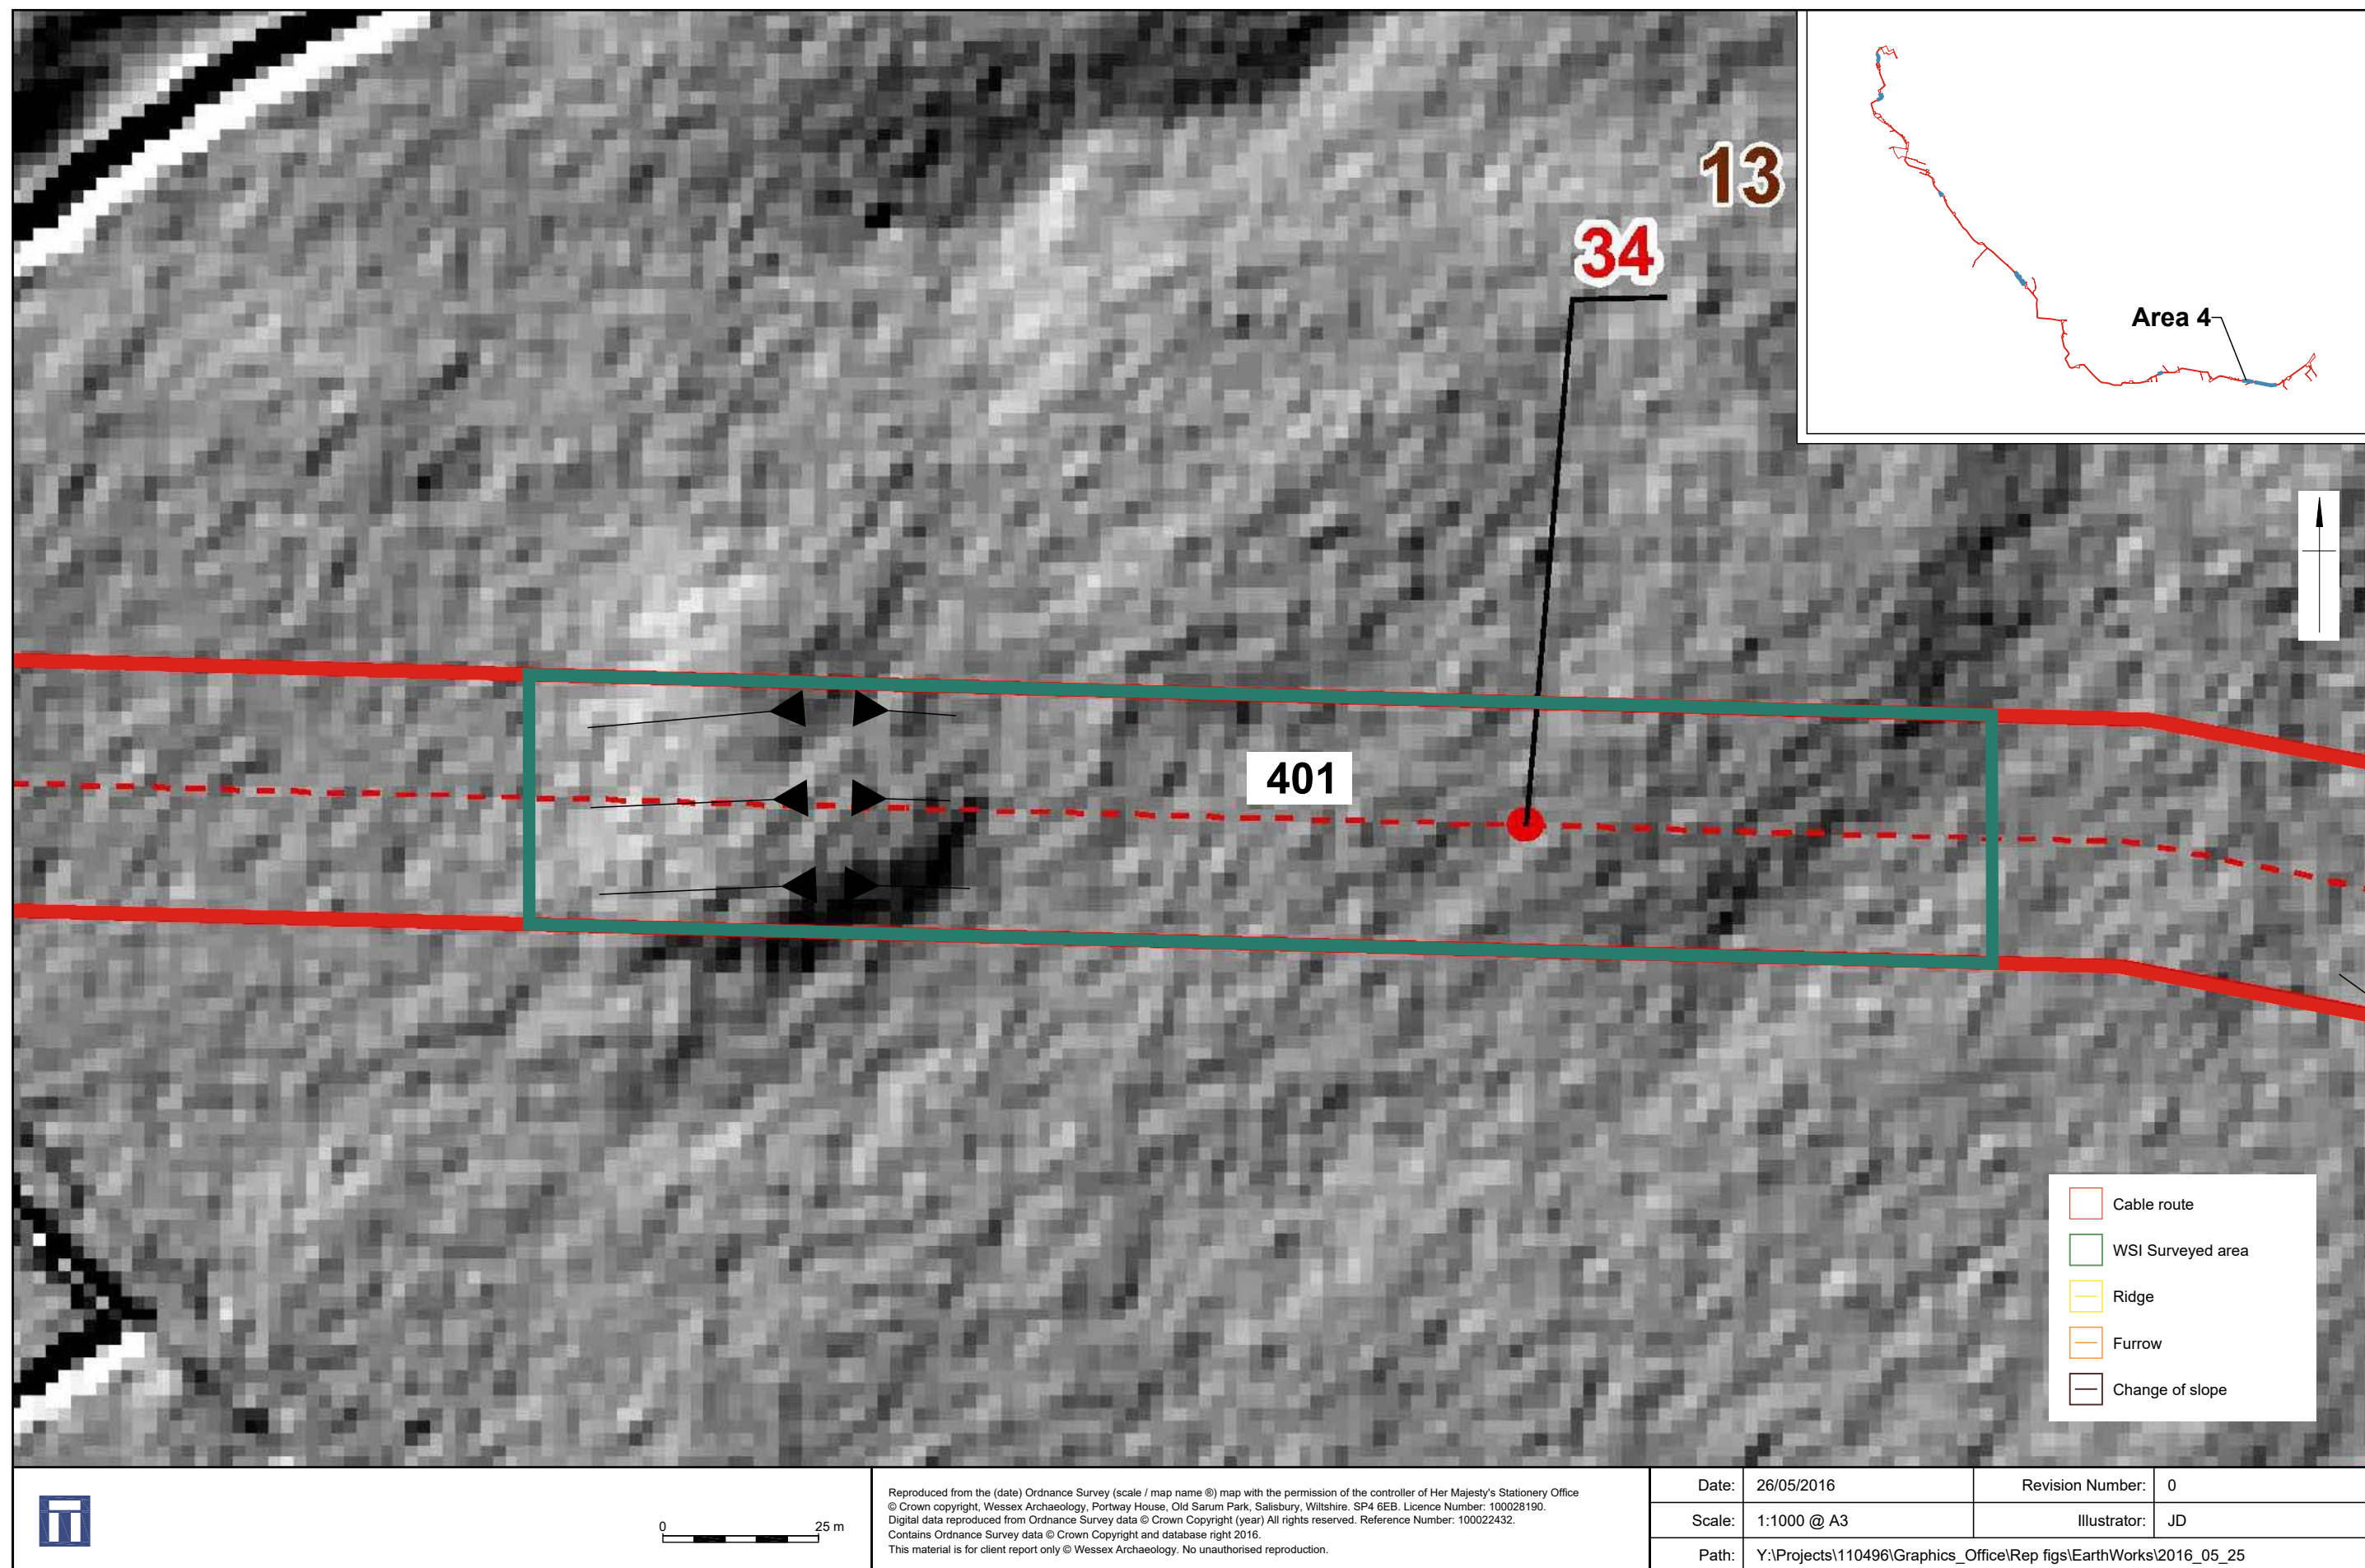
Figure 5

3.5.2 A long slope with low gradient was observed in the centre of the site, feature 401, running downhill from north-east to south-west (**Figure 5**) though it's location did not correlate to any feature identified in the LiDAR assessment and it is unknown if it is archaeological in origin.

Plan of Area 4 topographic survey overlain on LiDAR hillshade

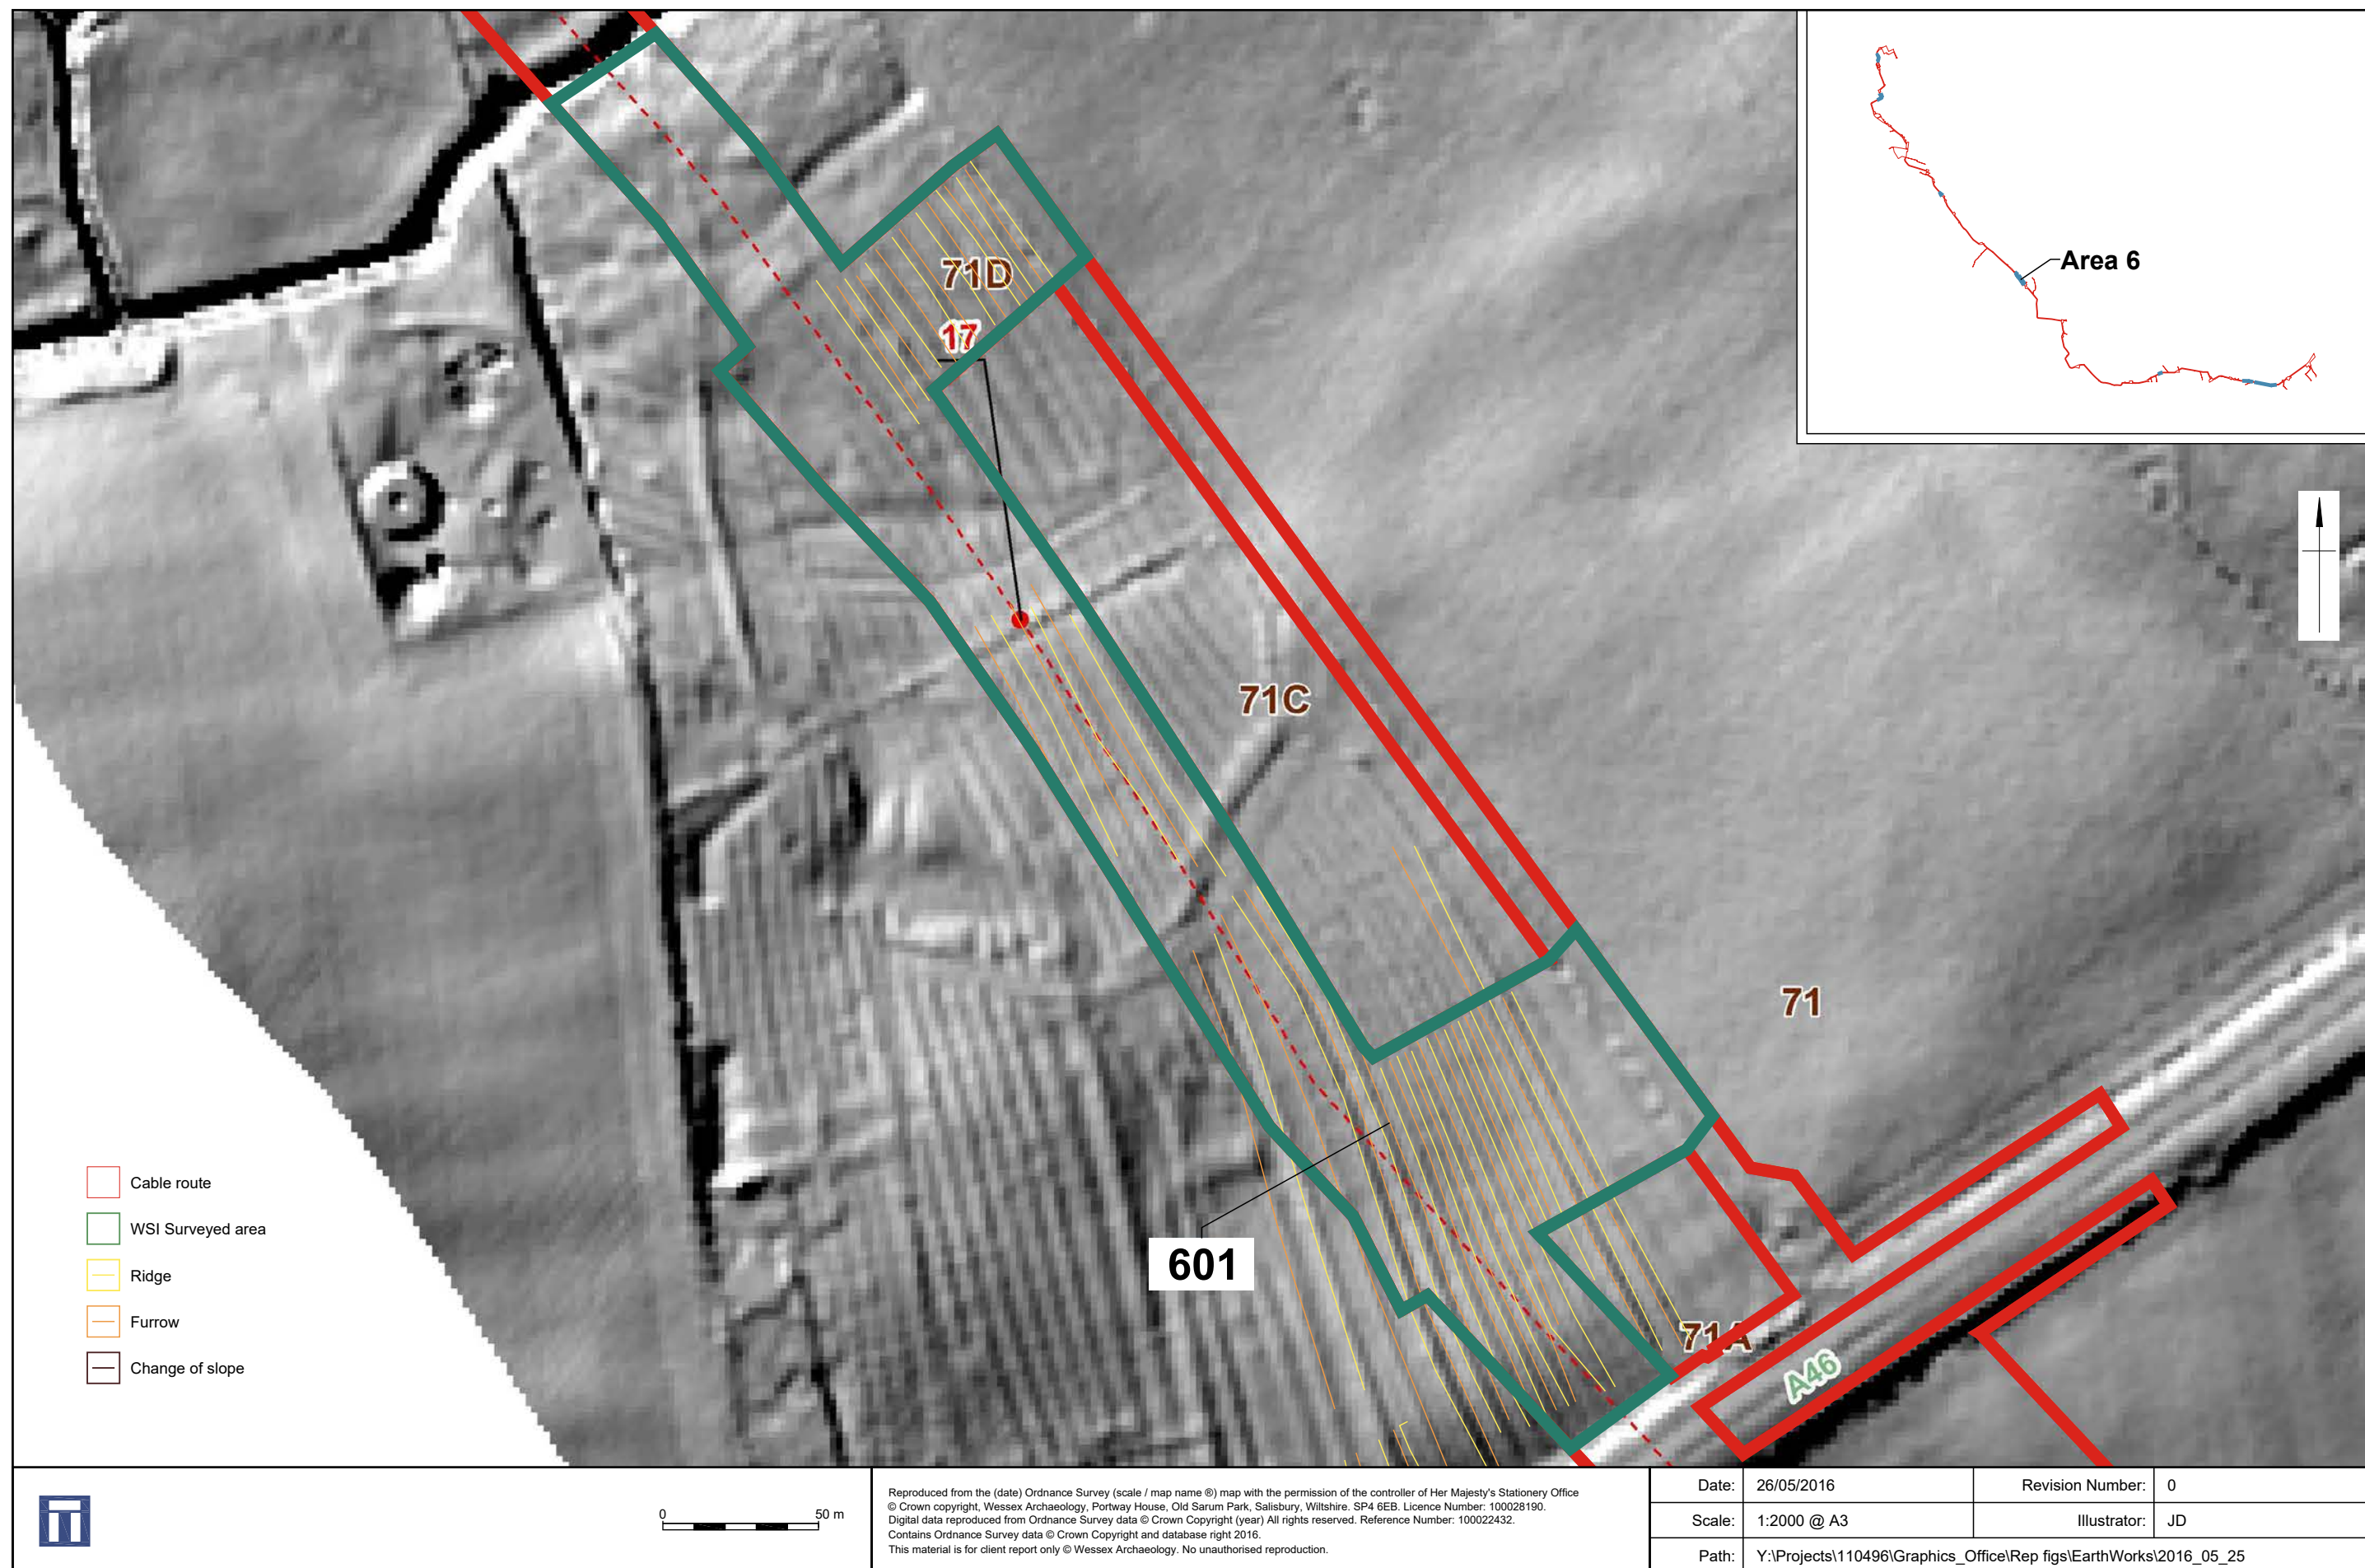
Figure 7

- 3.7.2 The ridge and furrow is orientated north-west to south-east (**Figure 7**) and the land is prone to holding water, which could further affect the level of preservation, especially when being impacted upon by livestock.

Plan of Area 6 topographic survey overlain on LiDAR hillshade

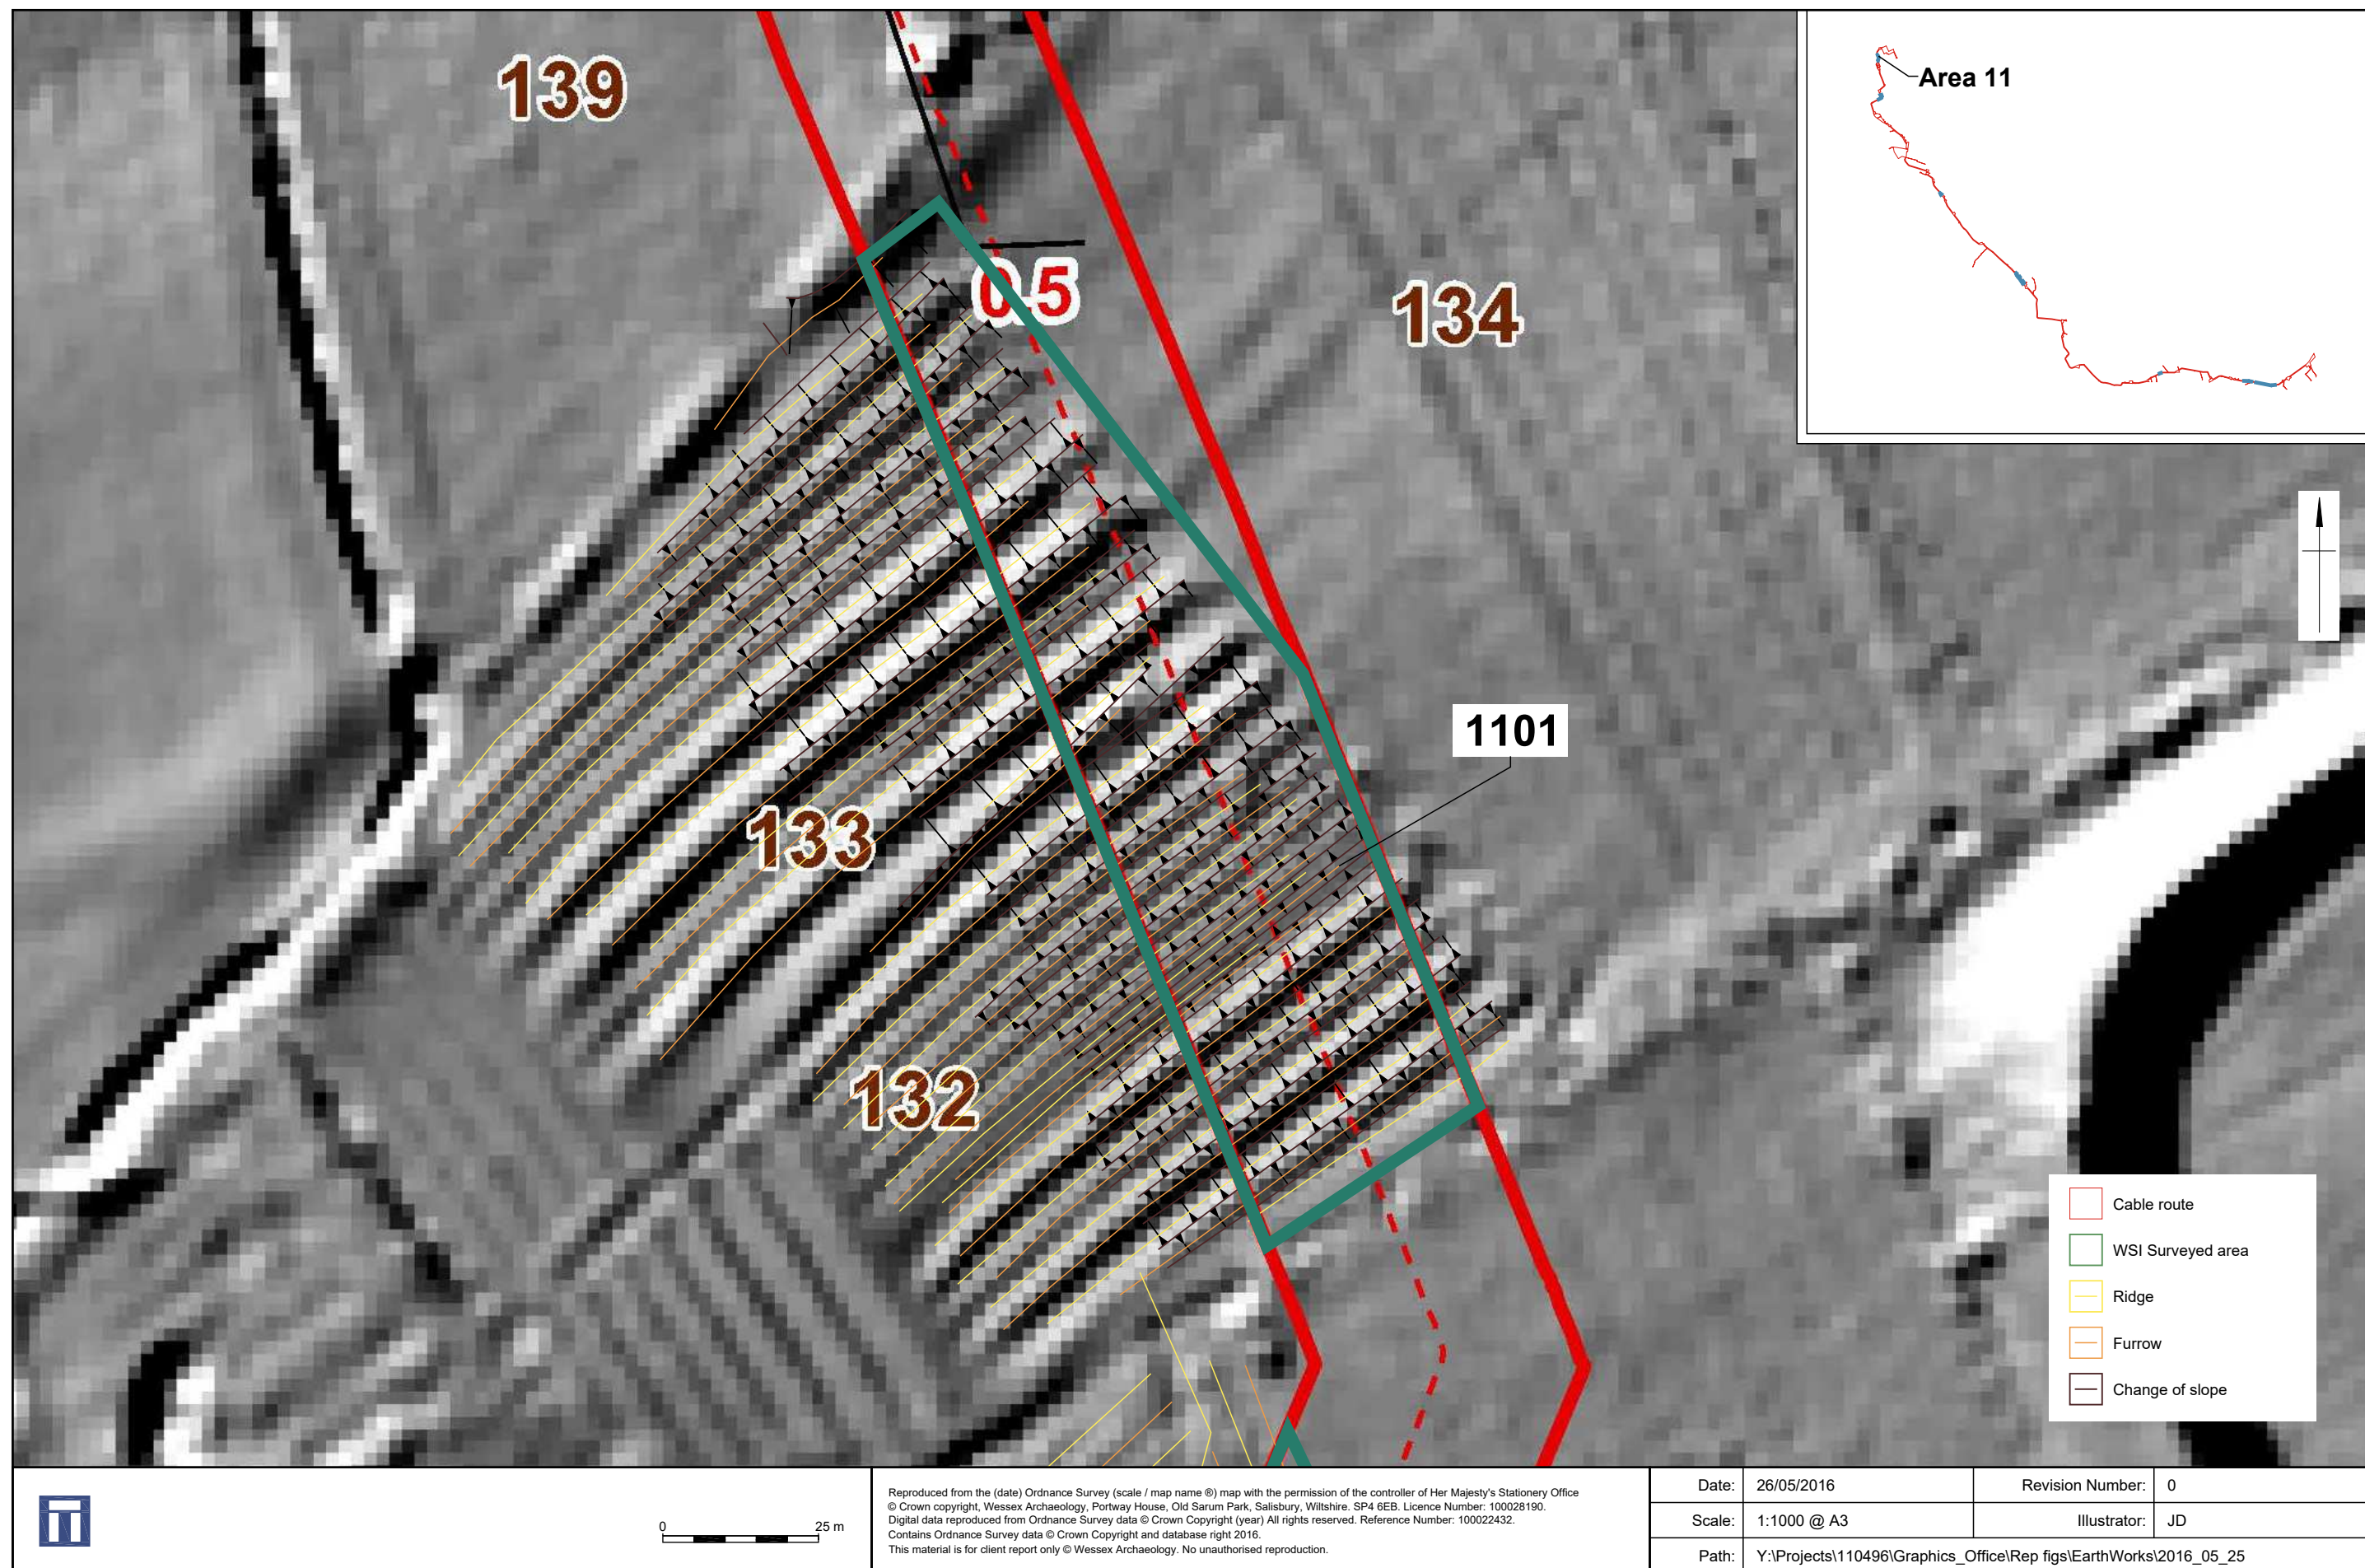
Figure 12

- 3.12.1 This area was identified through the strong presence of ridge and furrow in the LiDAR data orientated north-east to south-west and this was observed on site as feature 1101 (**Figure 12** and **Plate 14**).
- 3.12.2 The ridge width is consistent with much of the instances identified in the other survey areas at approximately 4m. The survey area is relatively narrow but viewing the feature in its wider context from the available LiDAR data it exhibits a slight curve in plan, again associating this feature with earlier ridge and furrow from the medieval period.

Plan of Area 11 topographic survey overlain on LiDAR hillshade

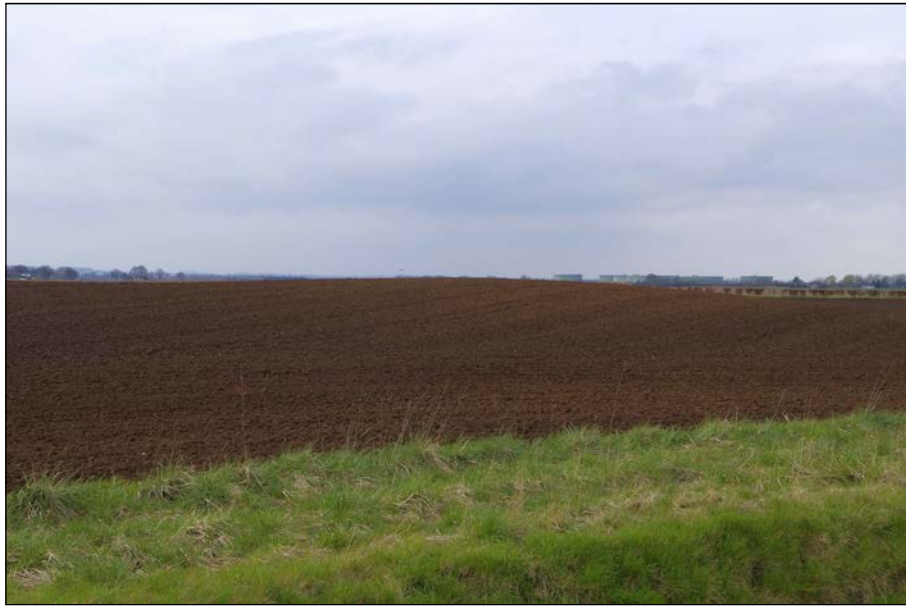
- 3.2.1 Area 1 was identified during the LiDAR assessment as a large, circular mound probably representing a saltern mound. The field survey identified this feature as a sub-circular mound (101) with a flat top (**Figure 2** and **Plate 1**), it was also noted that other mounds were visible in the surrounding area.
- 3.2.2 This feature has been exposed to heavy ploughing which would have had an effect upon its level of preservation, though the ploughing exposes a lighter coloured and more friable topsoil than the surrounding area (RPS, 2013b). This is consistent with the remains of a medieval saltern and can be seen in the photographic record.
- 3.2.3 The interpretation of this feature as a saltern mound is further suggested by the remains within Trench 7 of the archaeological evaluation, which identifies this area as clearly representing a saltern site (RPS, 2013a).

Plate 1: Circular mound 101 in Area 1, possibly a medieval saltern

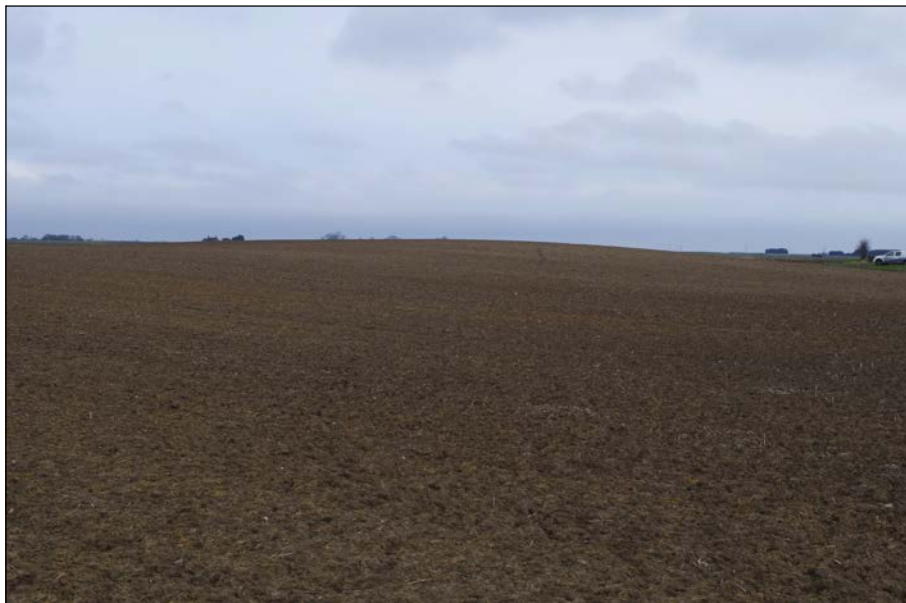
3.3.2 These features, 201 – 204 from west to east, have been heavily ploughed, with the field survey identifying them as large but subtle in form without hard edges or aspects (**Figure 3** and **Plate 2**). The discrete mound features exhibit the same light and friable topsoil coverage as seen in Area 1 and this is visible in the photographic record.

Plate 2: Mound feature 201 in Area 2, possibly a medieval saltern

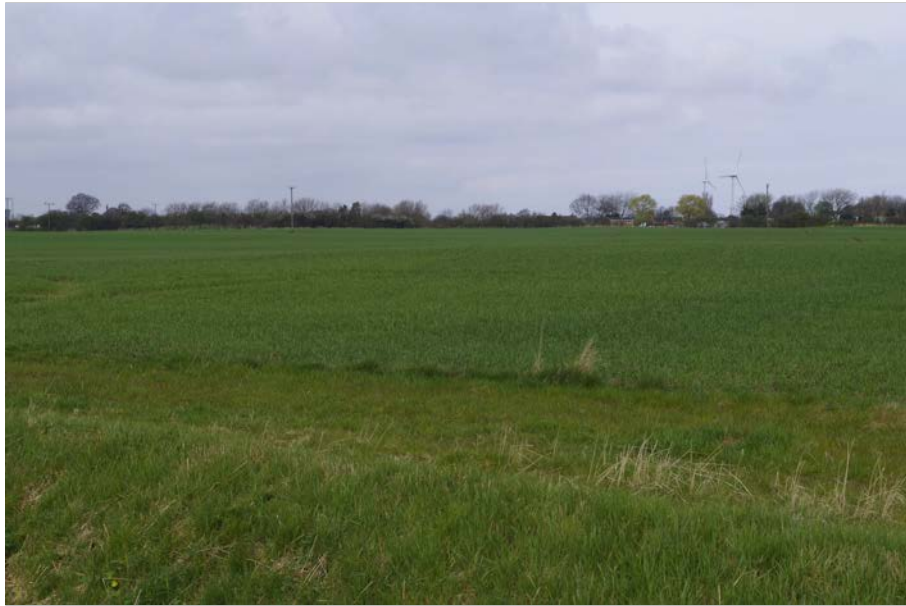
3.4.2 The field survey observed a large subtle feature, 301, with gradual sloping sides and a flat top, which was orientated north-east to south-west across the survey area. Area 3 has been exposed to heavy ploughing, probably affecting the level of preservation of this feature, which was under crop at the time of the survey (**Figure 4** and **Plate 3**).

Plate 3: Low mound 301 in Area 3, probably associated with medieval salt industry

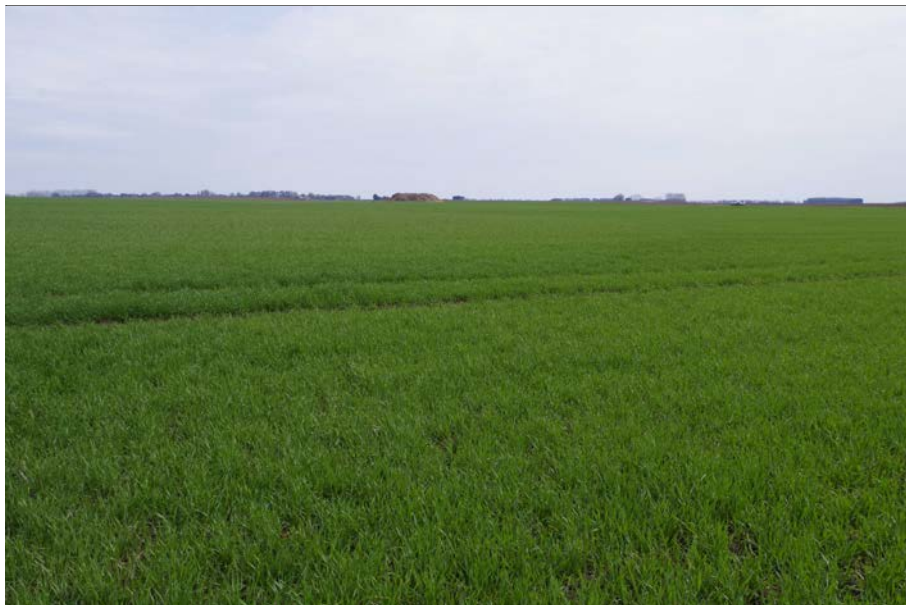
3.5.1 Area 4 is located to the west of Area 3 and was also under crop at the time of the survey. A large mound was identified during the LiDAR assessment that looked characteristic of a medieval saltern mound though such a discrete and pronounced feature was not identified during the field survey. The survey recorded a subtle rise in the landform from east to west and then back to ground level over 70m suggestive of a feature but not as obvious and pronounced as features found in survey areas 1 – 3. It is possible that this feature is now too subtle for identification at ground level due its size, combined with its low, subtle form and the effects of heavy ploughing in the area which has made it indistinct (**Plate 4**).

Plate 4: View across Area 4, looking north-east

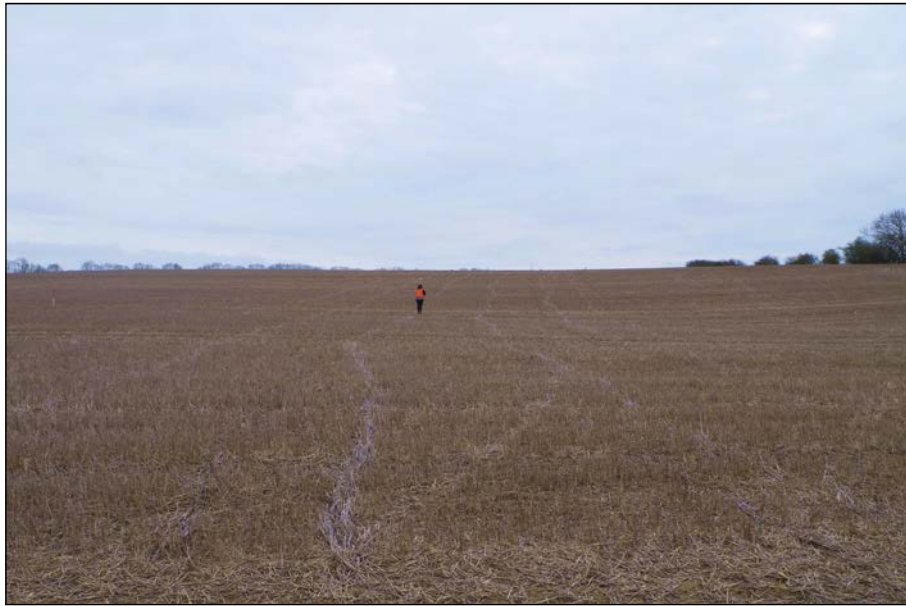
3.6.1 A single large, long bank running downhill from east to west was recorded in this area as part of the LiDAR assessment and this was successfully identified during the field survey (**Figure 6**). This feature, 501, is considerable in size with a rolling form that is inconspicuous within this landscape (**Plate 5**). Its subtle form could be attributed to consistent ploughing, causing the feature to lose definition.

Plate 5: View across bank feature 501 in Area 5, looking east

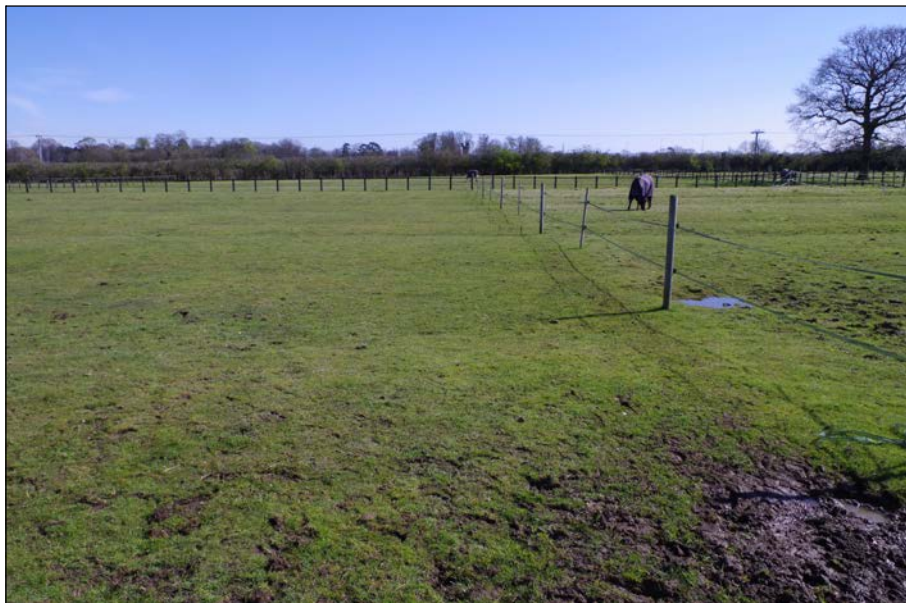
- 3.7.1 Area 6 was identified as a region of extant ridge and furrow during LiDAR assessment and this was observed during field survey. This feature, 601, is well defined in the southern area of the site (**Plate 6**) but becomes increasingly indistinct to the north, where its preservation could have been effected by the installation of horse paddocks (**Plate 7**).

Plate 6: Area of well defined ridge and furrow, 601, in the southern part of Area 6

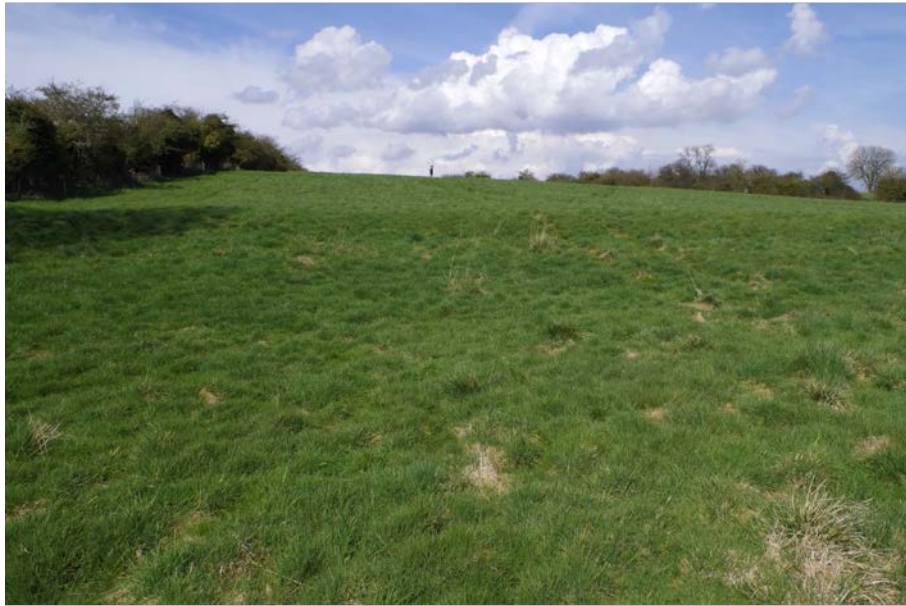
- 3.8.2 The mound is considerable in size being approximately 150m long and 80m wide with a long, gradual sloping side and flat top. A small bank is visible at its south-eastern edge (**Plate 9**) and the feature is covered with a rough grass surface.

Plate 9: Bank at the southernmost edge of feature 701

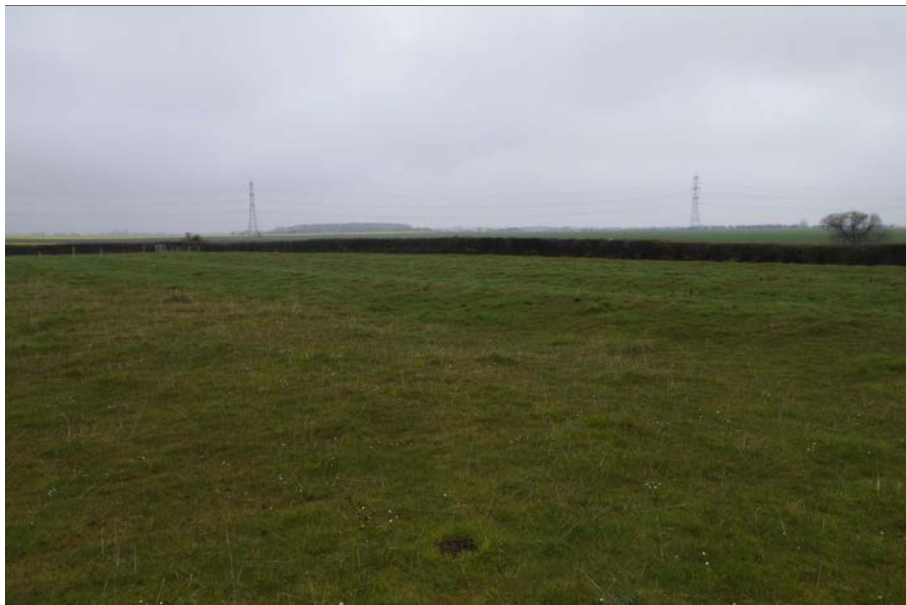
- 3.9.1 Area 8 was identified in both the LiDAR assessment and field survey as an area of ridge and furrow orientated north-west to south-east, feature 801 (**Figure 9** and **Plate 10**).
- 3.9.2 The ridges are predominately approximately 4m wide though some narrower areas of ridge were observed with a width as low as 1m in places. The area is prone to waterlogging and has been used for grazing so it is possible that this has affected the level of preservation in areas of the site.
- 3.9.3 As with feature 601, a slight curve is visible in plan suggesting that this feature originates in the medieval period.

Plate 10: Ridge and furrow 801 in Area 8

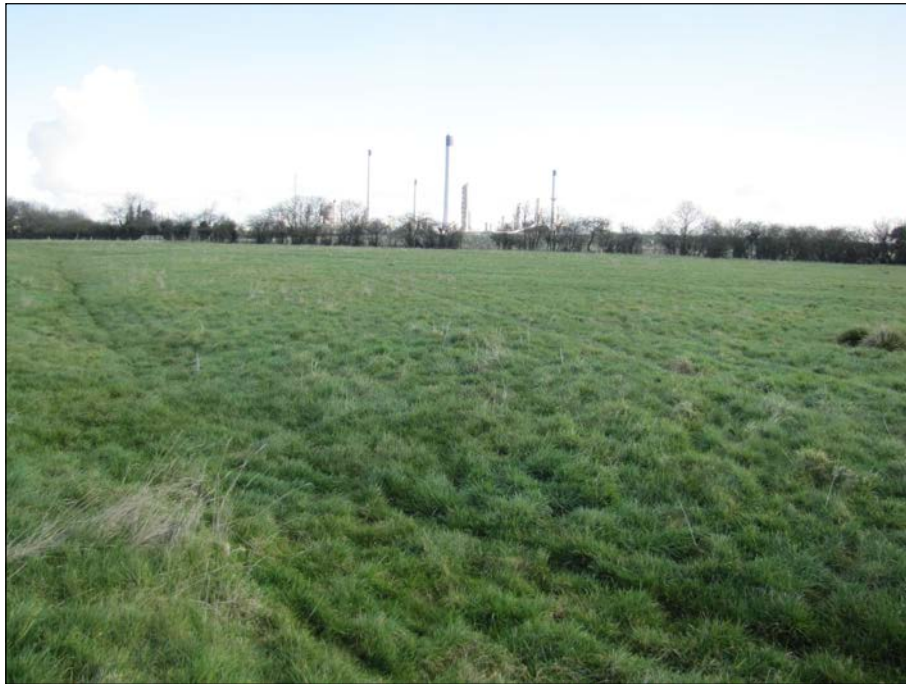
- 3.10.2 The field survey successfully recorded these areas of ridge and furrow, feature 901 (**Plate 11**) to the north and feature 902 to the south. Both features exhibit a similar curved shape to the ridge and furrow in Areas 6 and 8 and are of a similar size suggesting they are also medieval in origin.

Plate 11: Ridge and furrow 901 in northern part of Area 9

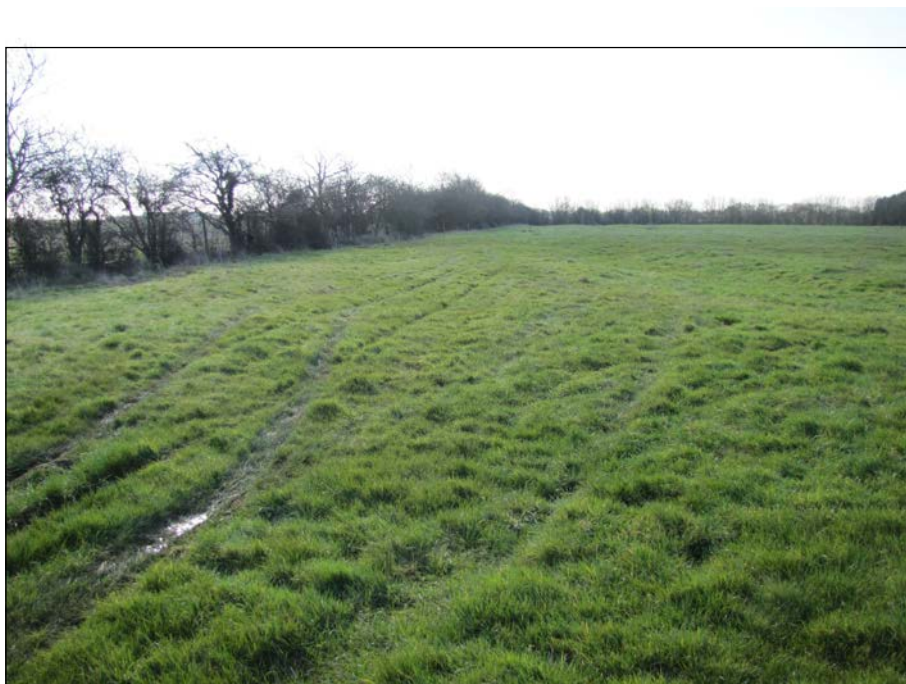
- 3.10.6 A series of field boundaries, 905, (**Plate 12**) run through the survey area and form part of the boundary to the southernmost ridge and furrow, 902. A large ditch runs north to south at the western edge of 902 splitting into two arms 65m northwards along its length from its southern extent. One arm continues northwards where it terminates at the southern boundary of 901. The other arm curves 90 degrees to run east to west and form the northern boundary of 902.

Plate 12: Feature 905 in Area 9, looking north-east

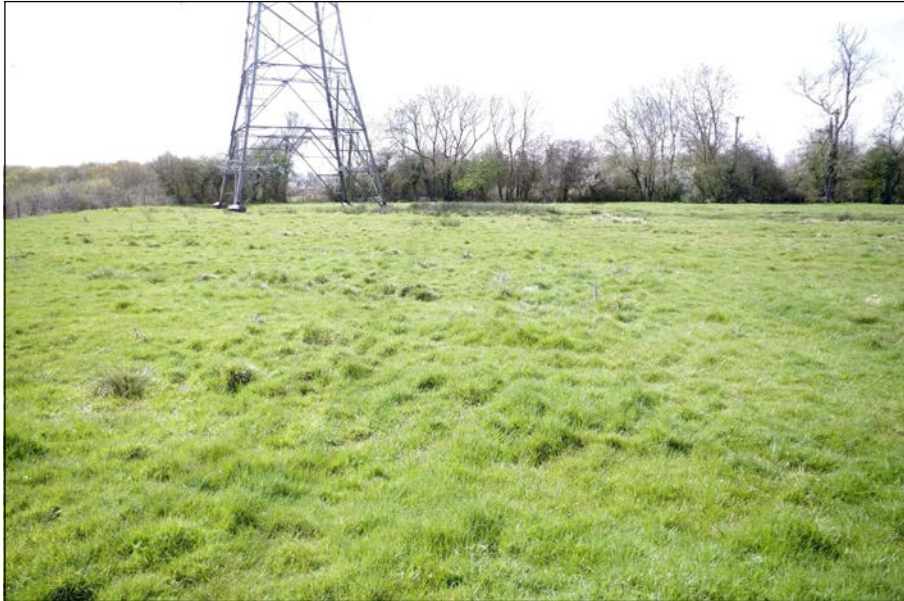
- 3.11.2 Both these features were successfully recorded (**Figure 11**). The westerly area of ridge and furrow, feature 1001, is of similar size and form to the instances observed throughout the rest of the scheme and is likely of similar medieval date. Conversely, the ridge and furrow to the east of the survey area, 1002, is subtler (**Plate 13**) with the survey results indicating that the ridges are consistently straight, possibly suggesting that it is later in period than 1001.

Plate 13: Ridge and furrow 1002 in eastern part of Area 10

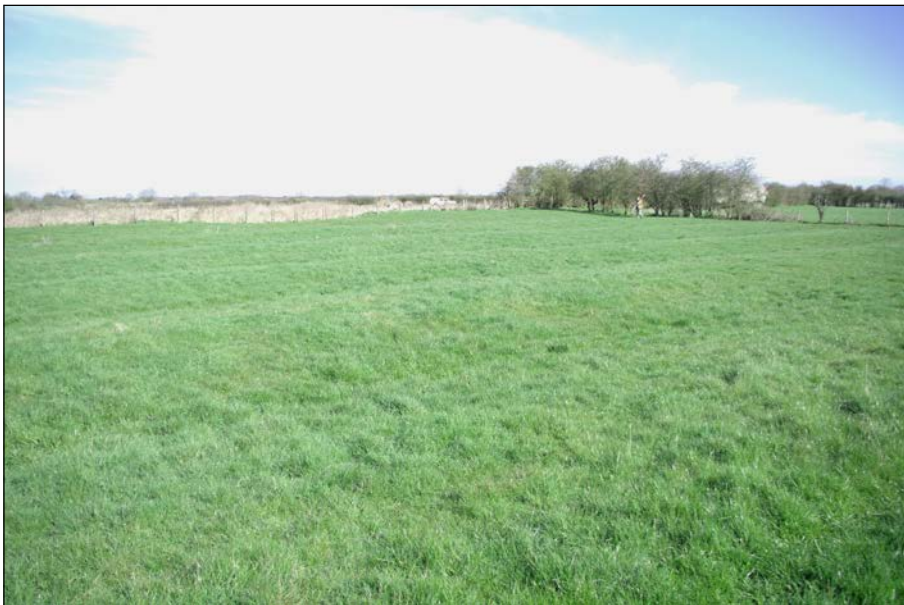
Plate 14: Ridge and furrow 1101 in Area 11
