# Tankerton Bay

Post-excavation Assessment and Updated Project Design

Ref: 200950.03  
February 2019

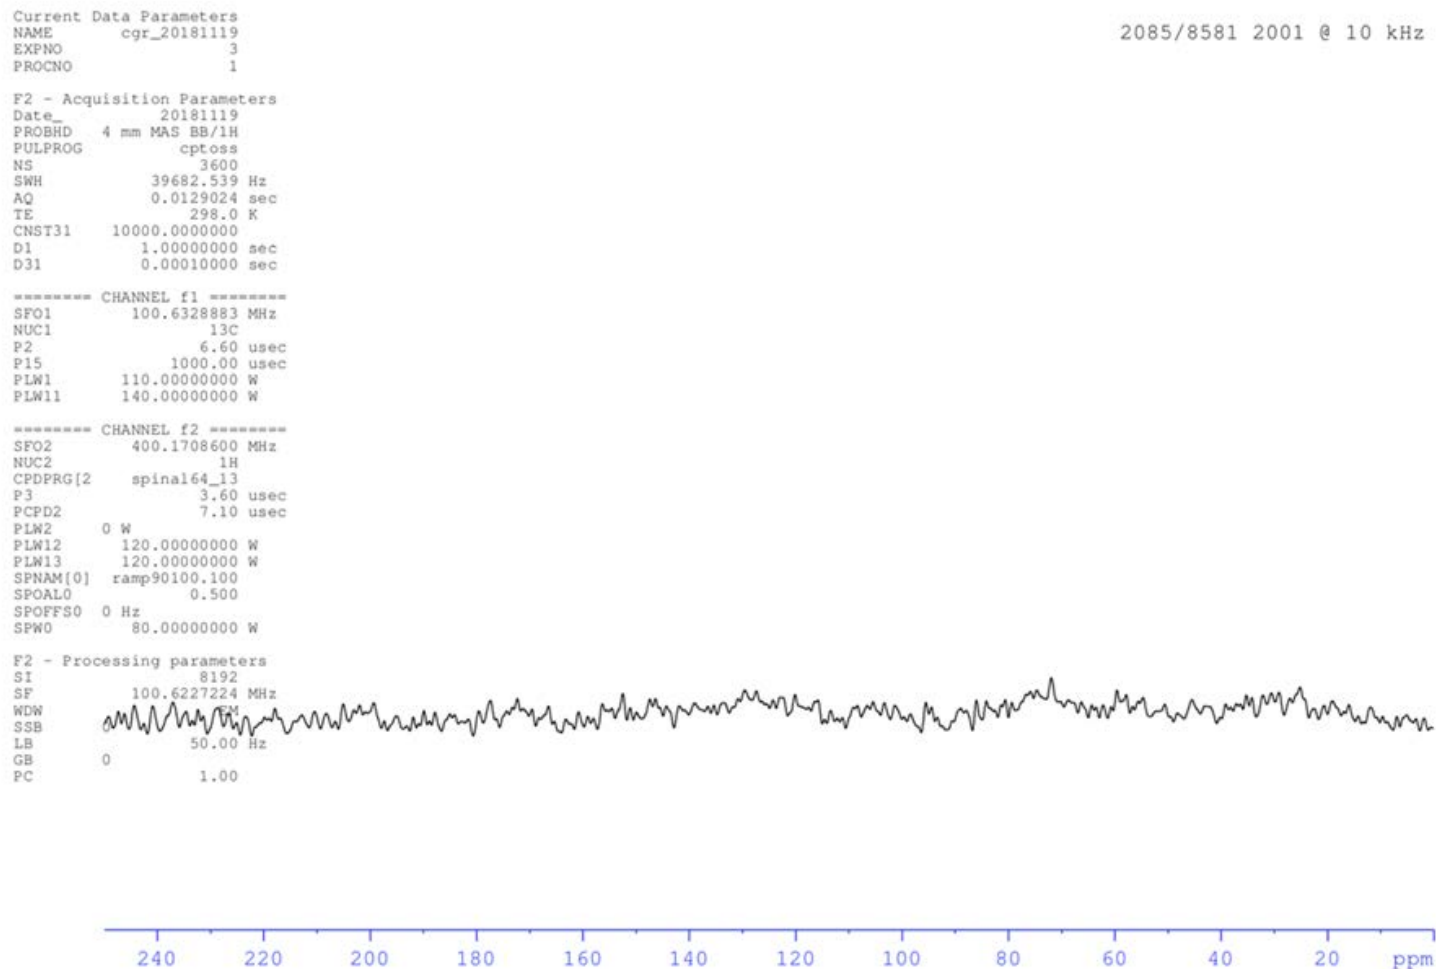
Figure 1. ssNMR analysis spectrum of sample 2001 from TBW.

- 7.3.24 The major chemical components of sample 2001 (Table 1) are cresol, phenol and retene. The first two compounds are major constituents of creosotes (Evershed *et al.* 1985), whilst retene is a product of thermal degradation of pine/spruce resin (Derham 2000). The major chemical components of sample 2004 (Table 2) are also phenols, the major constituents of creosotes, whilst 2-methyliminoperhydro-1,3-oxazine has been shown to be a volatile component of the dried biomass of the various *Pinus* species (Robinson *et al.* 1987).

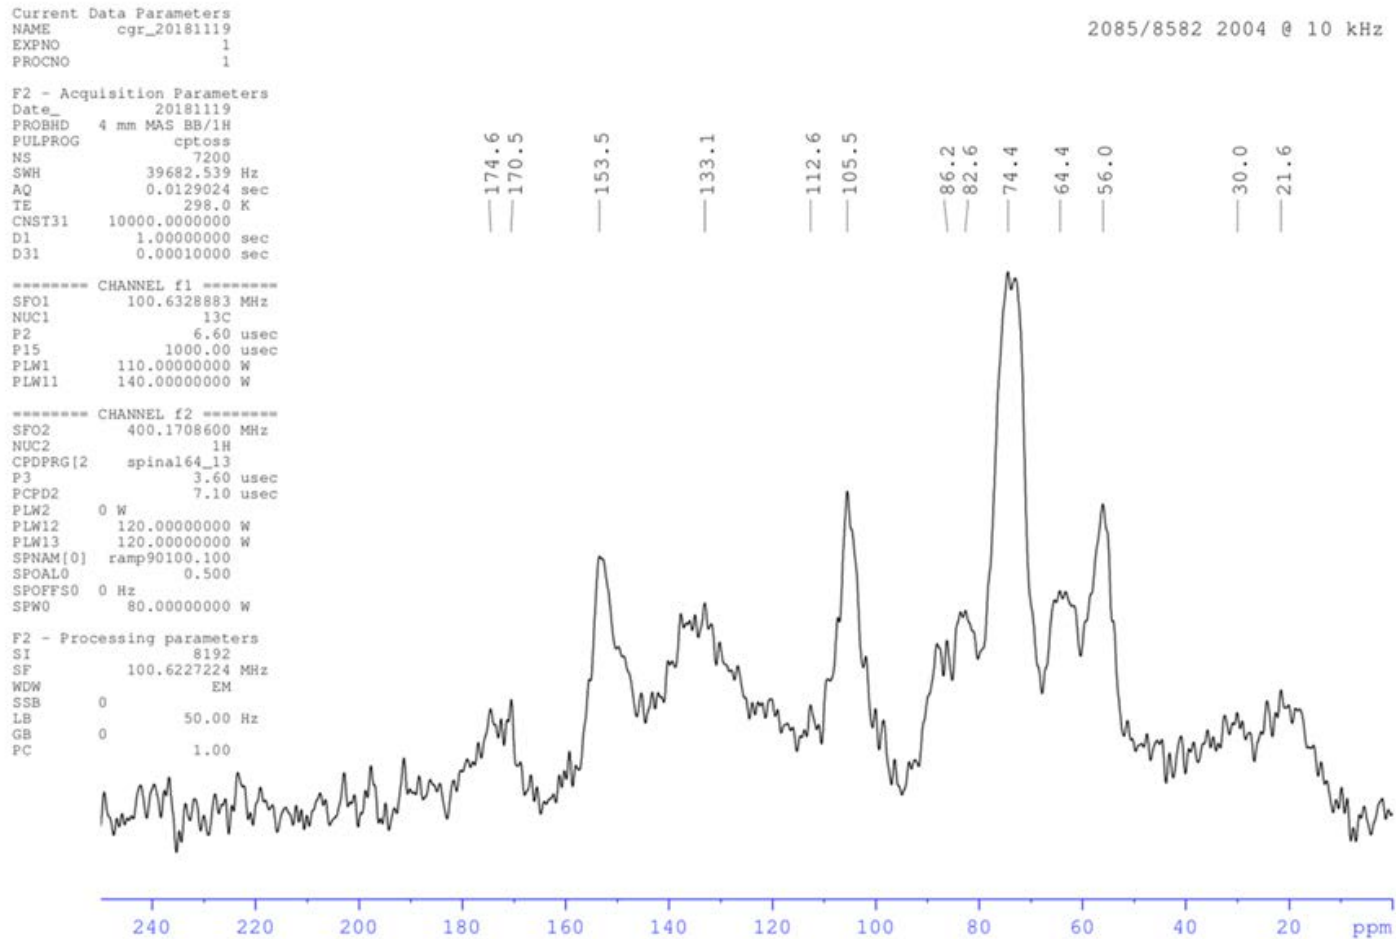
Figure 2. ssNMR analysis spectrum of sample 2004 from TBW.

7.2.7 Sample <2004>: This sample was of caulking but was different from that of the other caulking sample <2001> in the fact that was mostly composed of animal hair, most likely that of pig or horse. Some mosses were identified but they were present in small quantities. Sphagnum moss (*Sphagnum* sp) is most often found on raised and blanket bogs where it can form most of the biomass. The other moss, Dentated/Curved Silk-moss (*Plagiothecium denticulatum/curvifolium*), can be found on soil, rocks, logs and tree bases, mostly in woodland. It can also be found in upland block scree and rock crevices, with the Curved Silk-moss occurring at lower altitudes.
