Lindhurst Wind Farm, Mansfield, Nottinghamshire

Archaeological Watching Brief Report

Ref: 73290.01 March 2010

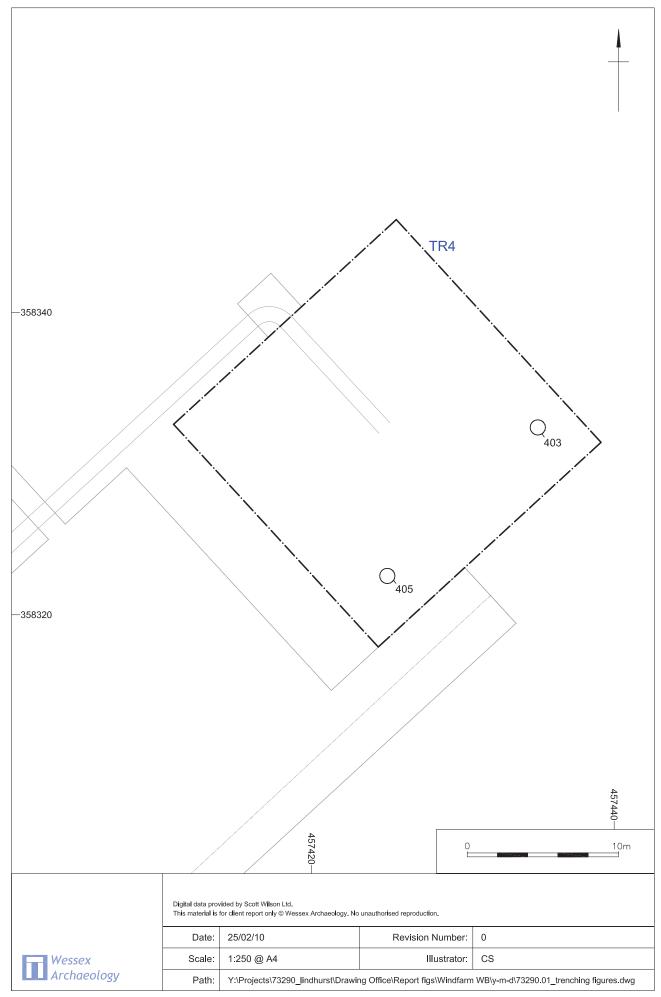
- 4.1.1 In total 7 trenches were excavated totalling an area of approximately 0.5 hectares (Figure 1). Trenches 1, 2, & 7 were located northwest of the corner of Blidworth Lane and the lane leading to Lindhurst Farm. Trenches 4 & 6 comprised excavations associated with the foundations and access road of Turbine 2. Trench 3 comprised the foundation excavation for Turbine 3, and Trench 5 the excavation for the access road to Turbine 4.
- 4.1.2 The following sections provide a summary of the information held in the site archive. Observed features and contexts for each trench are tabulated as Appendix 1.

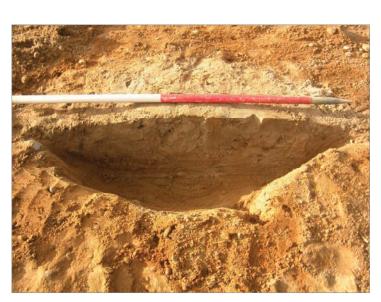
Plate 2: East facing section of feature 704

- 4.3.2 Features identified were restricted to those thought to be associated with former tree cover and were observed sparsely across all monitored areas (occupying 3-5% of each area). Several of these features were excavated to ascertain their depth, date, and nature ([204], [403], [405], [704], and [706]) (Figures 2-5). Although these features had been largely truncated by ploughing some survived to a depth of c.0.5m with irregular steep sides and irregular rounded base. The primary fills of these features were of fine light grey sand consistent with soils observed beneath recently removed hedges (103). The shape of the features and their fills were not consistent with tree throws but were more likely the result of trees, having been cut to ground level with the roots left to rot in situ.

0.70-1.10m	705	Light grey sand with occasional pebble <4cm	Fill of [704]
0.70-1.00m	706	Irregular linear cut with steep sides and irregular base.	Shrub bowl

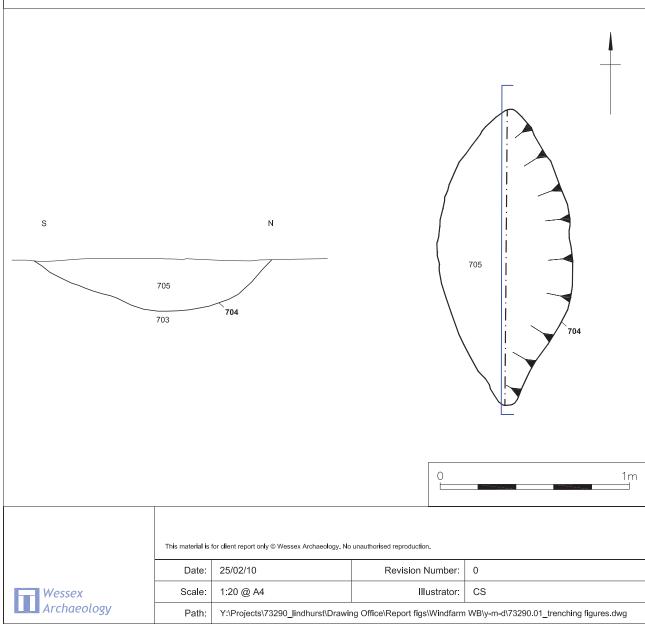
- 4.3.3 Occasional small charcoal fragments were identified across the subsoil with rare concentrations located in proximity to tree clearance features. Two features excavated in Trenches 2 and 7 indicated evidence for in situ burning of vegetation ([204] and [706]) (Figure 3-4), although these appear to have been discrete instances.
